Inspection Report

770 Beverly Drive
Nipomo CA 93444

2/18/2026

Harper Homes: Home Inspection Services

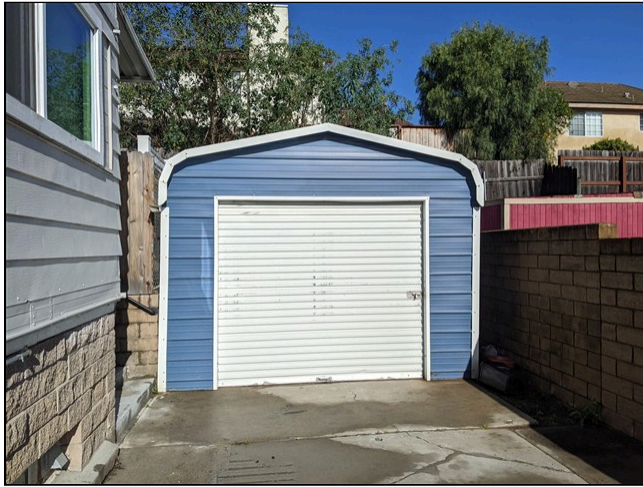
1.4 Item 1(Picture)

Sheds are outside the scope of a standard home inspection. Recommend further evaluation is made as needed.

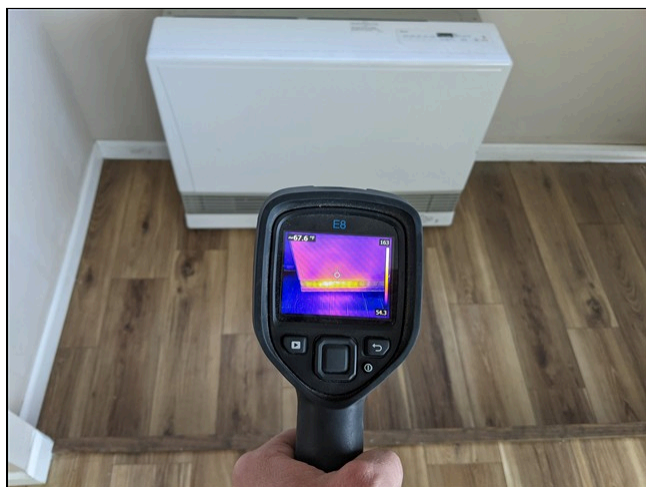
3.0 Item 1(Picture)

The wall heaters were tested and functional at the time of the inspection.

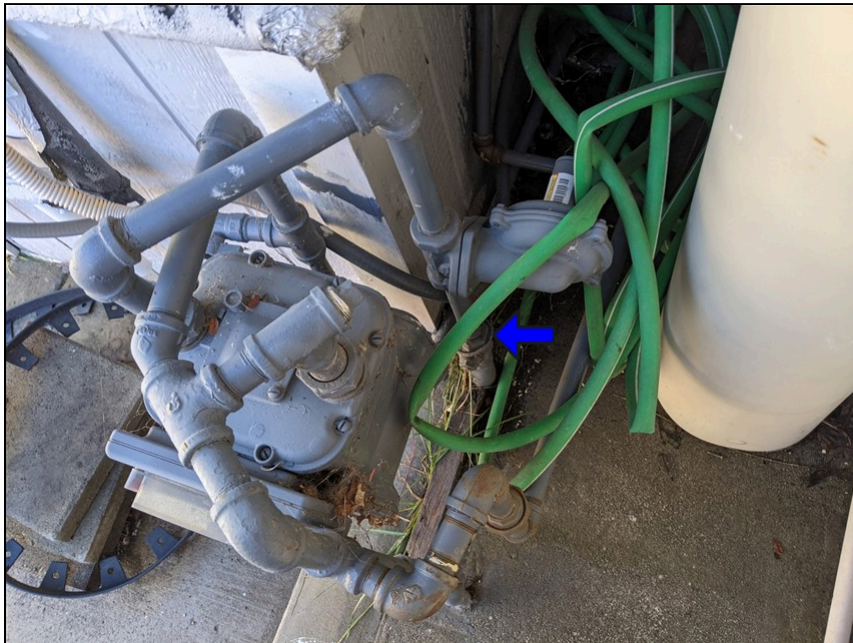
4.3 Item 1(Picture)

The gas shutoff is located at the rear exterior of the home. To turn the gas off turn the valve perpendicular to the piping.
