Inspection Report

Address: 46 Via Santa Barbara Paso Robles, CA 93446

01/15/2026

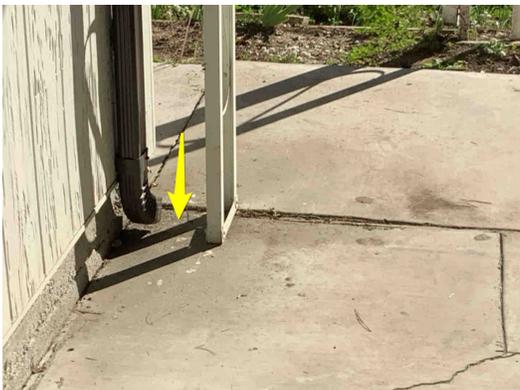
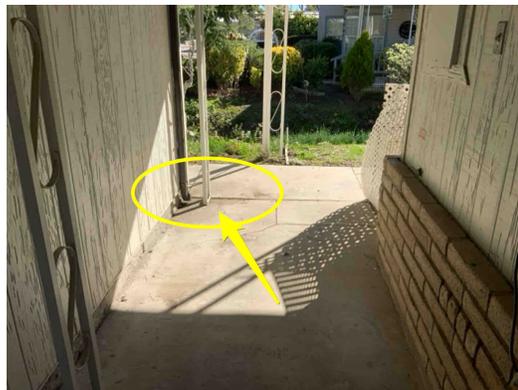
UPG DS 19: **Disclosure**: Areas of suspected poor drainage with evidence of minor ponding of water at the walkway(s).

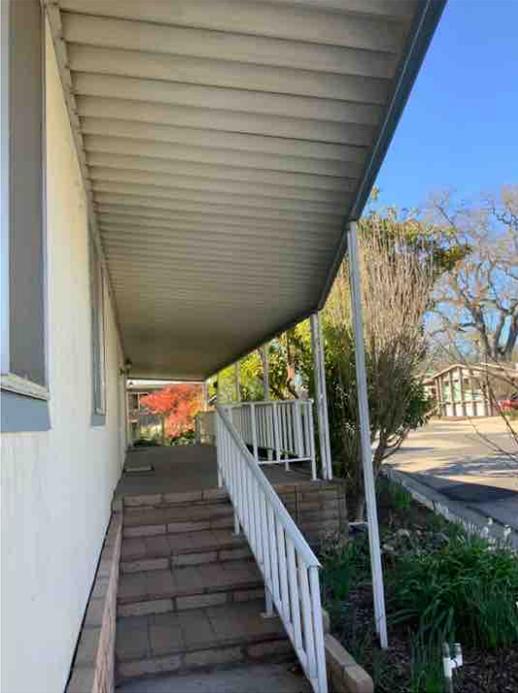
20: FRONT ENTRY AWNING: Appears serviceable and in good condition.

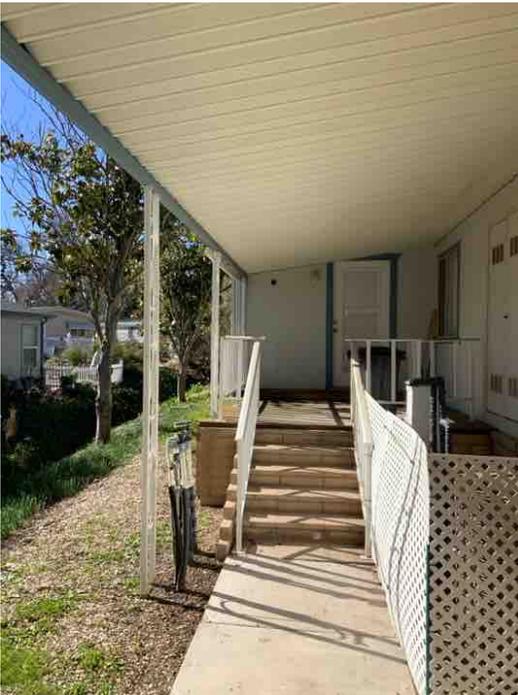
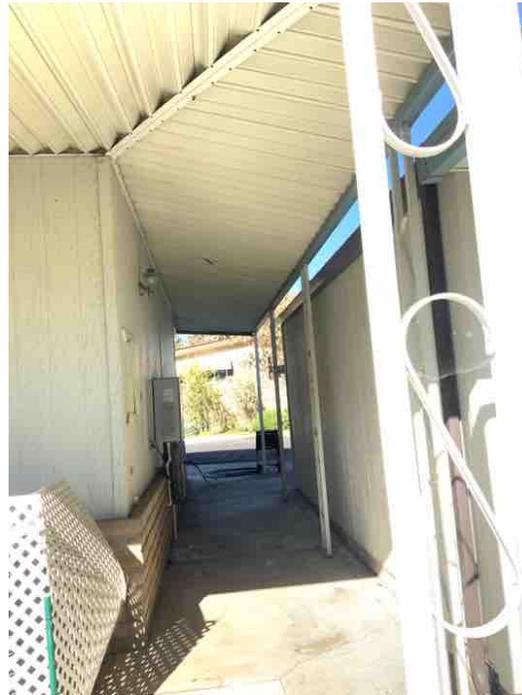
21: BACKYARD WRAP AROUND / AWNING: Appears serviceable and in good condition.

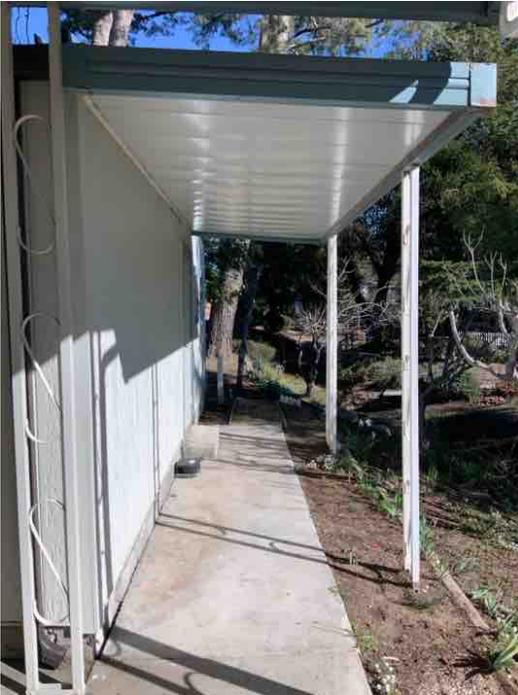
22: AWNING OF THE BACK OF THE GARAGE: Appears serviceable and in good condition.

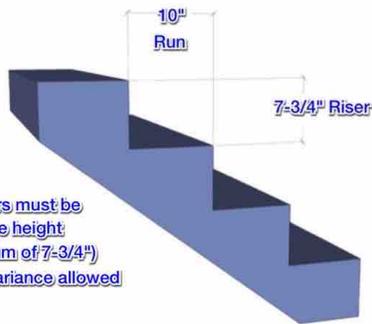
SC 39: Caution. The top step is taller than the rest. Uneven step tread rise, step heights are not all the same, at the exterior stairway off the OFF THE BACKYARD WOOD DECK. Potential trip or fall hazard.

Top step is taller than all the rest

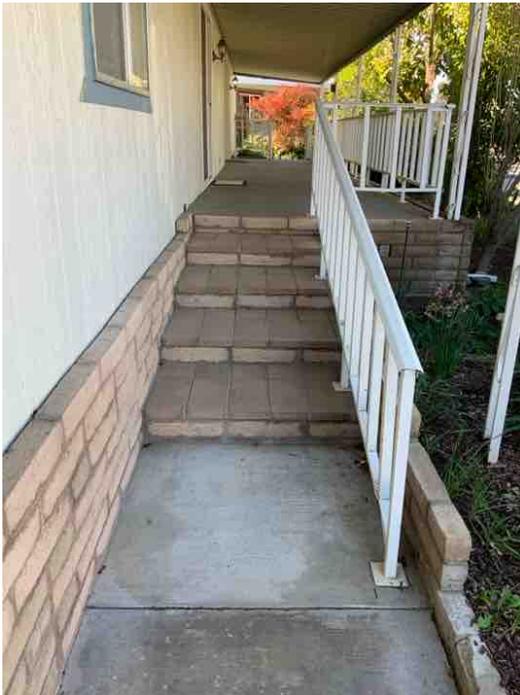
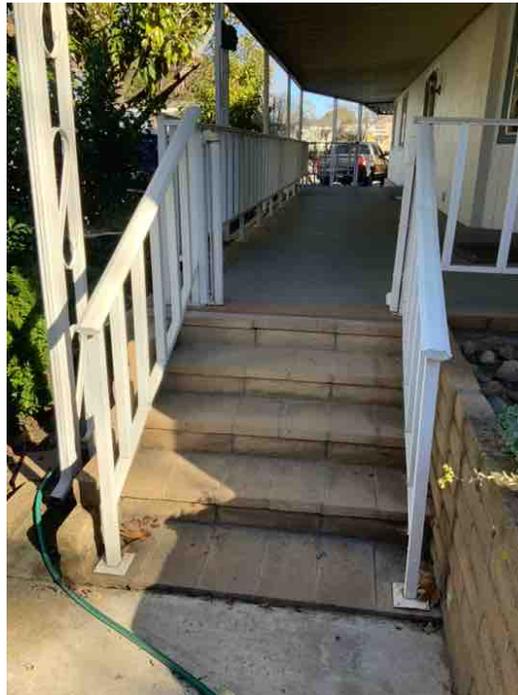
41: Type: Masonry: OFF THE FRONT ENTRY

42: Exterior stairs are serviceable and in good condition.

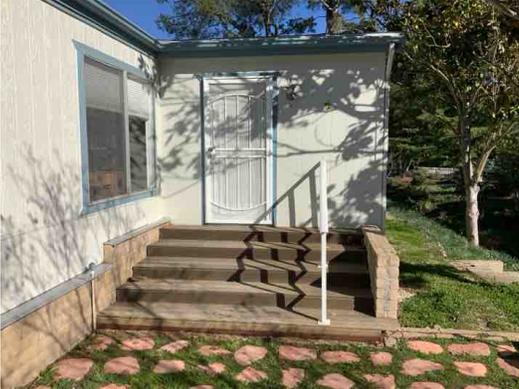
44: **Type:** Wood exterior stairway: OFF THE BACK ENCLOSED DECK / CASITA

45: Exterior stairs are serviceable and in good condition.

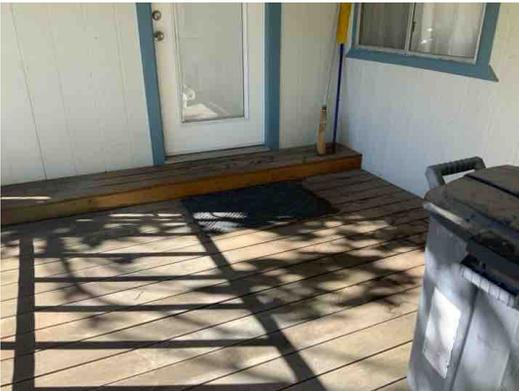
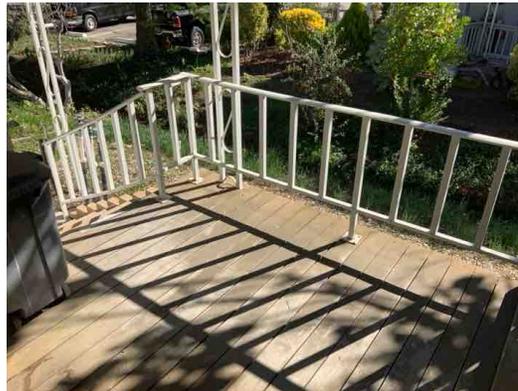
47: **DECK LOCATION:** BACKYARD DECK

E&C 48: Some moisture and/or bug-type damage and deterioration found at areas of the wood decking and/or wood deck railings: BACKYARD WOOD DECK. *Refer to the termite report for additional comments and recommendations.*

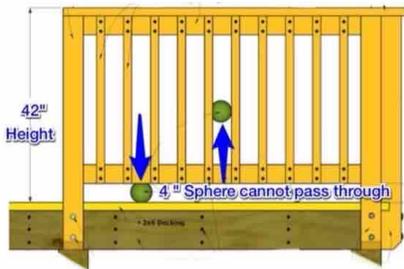
SU 49: *Openings between spindles and the height of the deck railings at the BACKYARD DECK do not meet current standards. Upgrades Recommended for safety.*

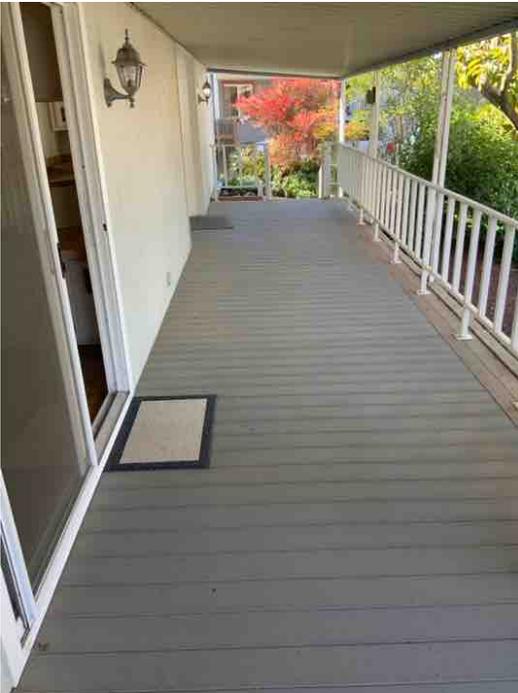
50: DECK LOCATION: FRONT ENTRY DECK

51: DECK CONDITION: *The FRONT ENTRY DECK appears within useful life. Refer to the termite report for additional comments and/or recommendations.*

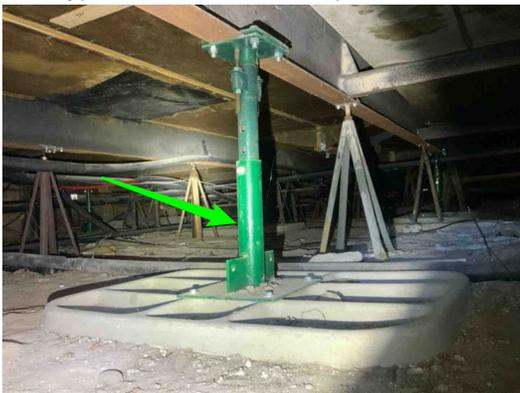
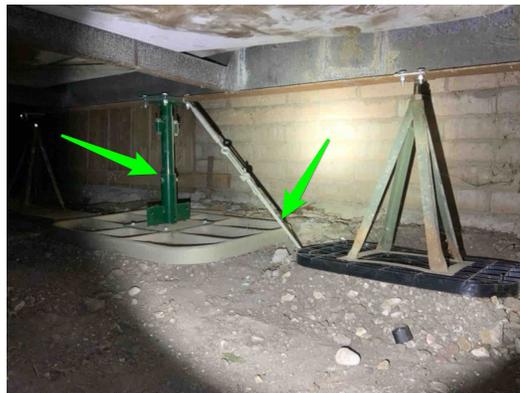
57: Manufactured Home appears to have a permanent type foundation installed. (check with local authority (County or City) for "433" verification).

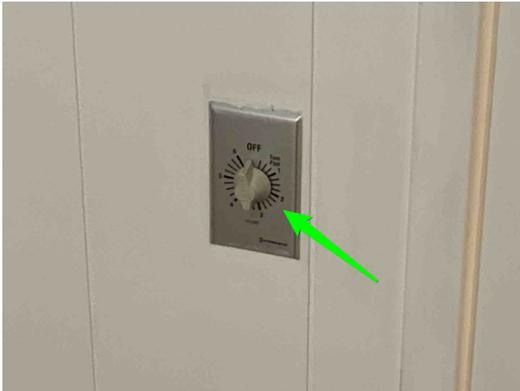
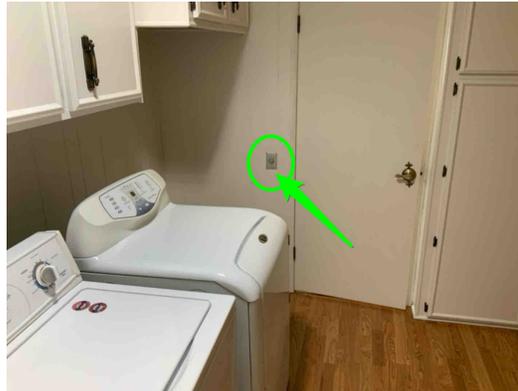
70: The ATTIC fan operated when tested.

Attic fan switch operated wind tested

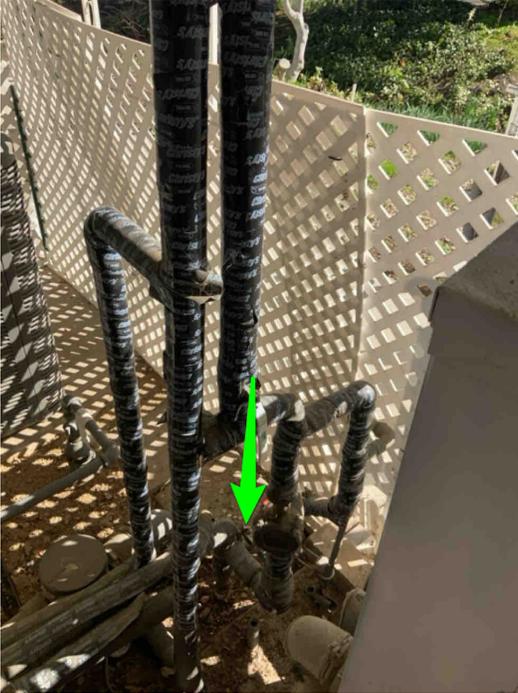
Main water shut off valve

71: Main water supply shut-off location: ON THE BACK OF THE HOUSE. *Main water shut-off valve not tested.*

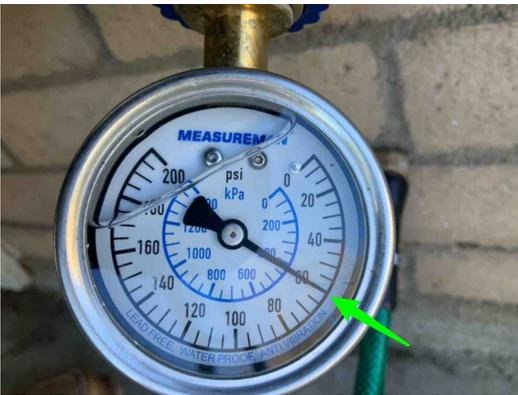
72: **WATER PRESSURE - Is Within Standards:** At Approx. 60 +/- PSI . *Optimal water pressure is between 40 and 80 PSI.*

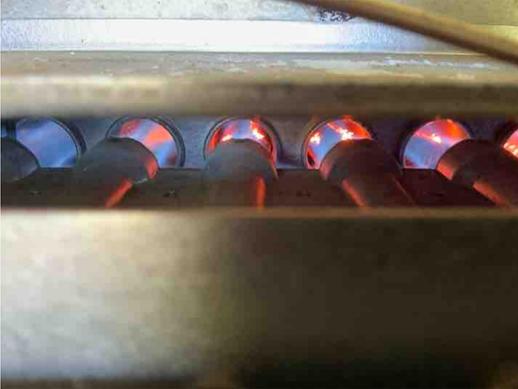
SU 150: Damaged or Deteriorated "NOx" SCREENS found inside the furnace burn chamber. Simple removal or replacement is recommended. Recommend further review recommendations by a qualified and licensed HVAC professional familiar with the minimum installation requirements.

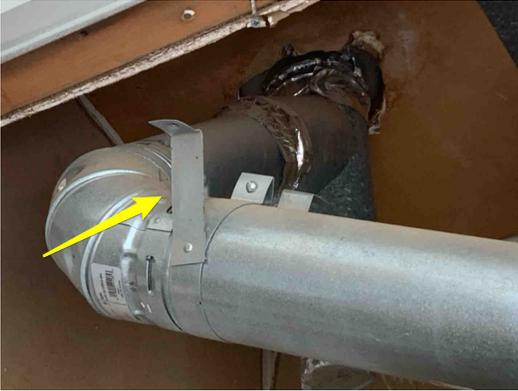
SC 152: The furnace vent pipe is not properly supported or strapped at the horizontal to vertical transition. This can allow the pipe to slip downward and could become dislodged.

Existing straps not fastened

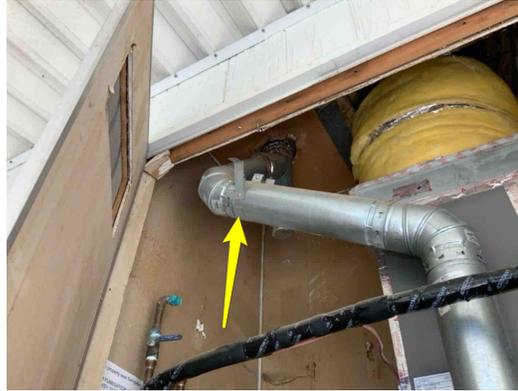
Strapping of the vent pipe required here

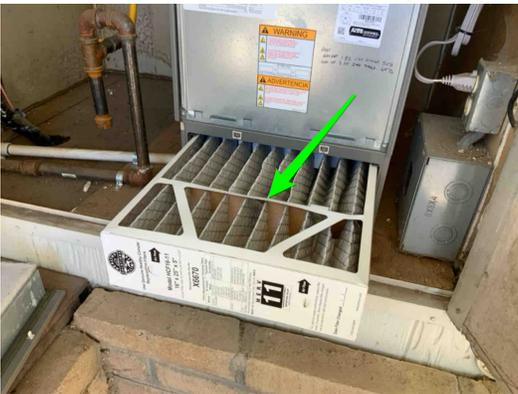
Air filter

155: Air filters found clean and in good condition inside the furnace blower compartment area.

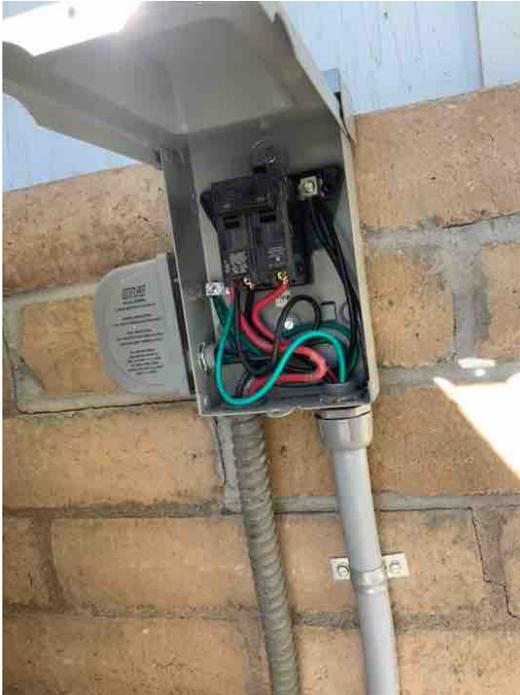
SC 161: Improper unsafe double tap AND two wires of different wire type (copper and aluminum) and gauge in the same lug at the air conditioner electrical service disconnect.

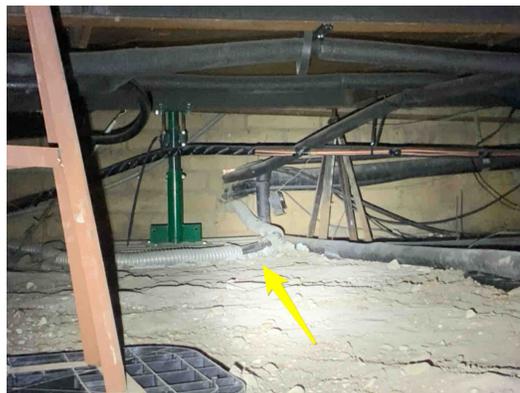
Example

SC UPG 164: The metal electrical service conduit from the main electrical panel (park riser) to the house sub panel found laying in contact with the ground in the crawlspace. This has or can cause deterioration or damage to the conduit as this conduit is NOT rated for earth contact. Evaluation and correction recommended for electrical safety.
