AZTEC PROPERTY INSPECTIONS

PROPERTY INSPECTION REPORT

1890 Calmin Dr
Fallbrook, CA 92028

Imelda Enriquez
02/09/2026

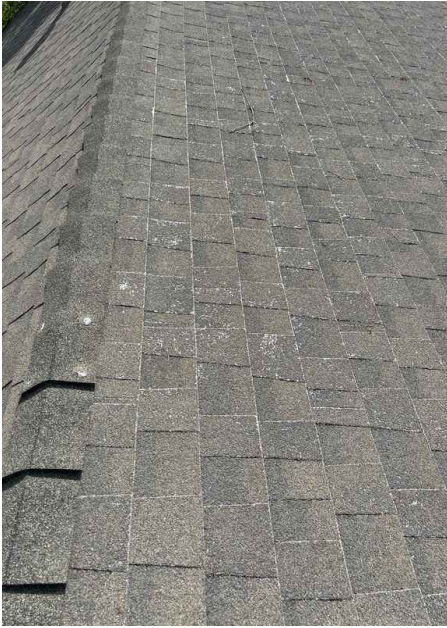
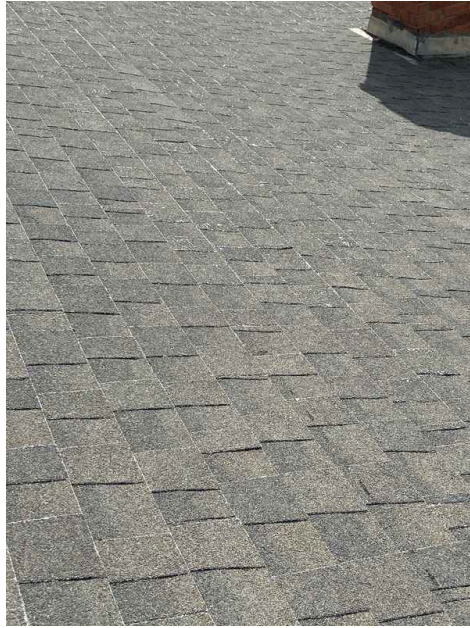
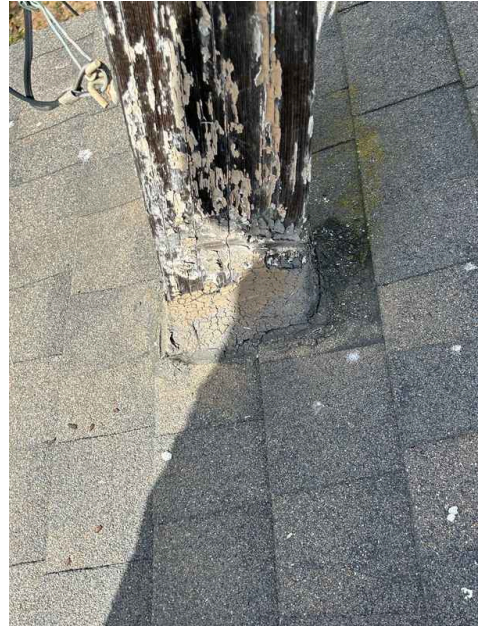
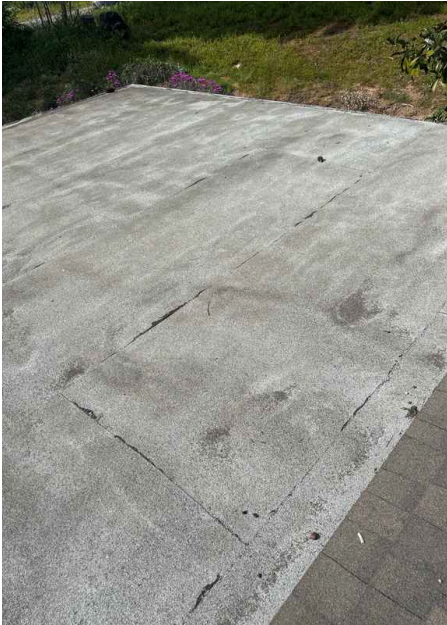
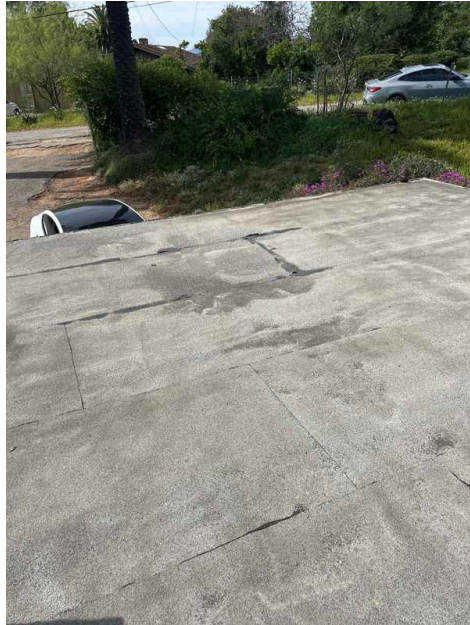
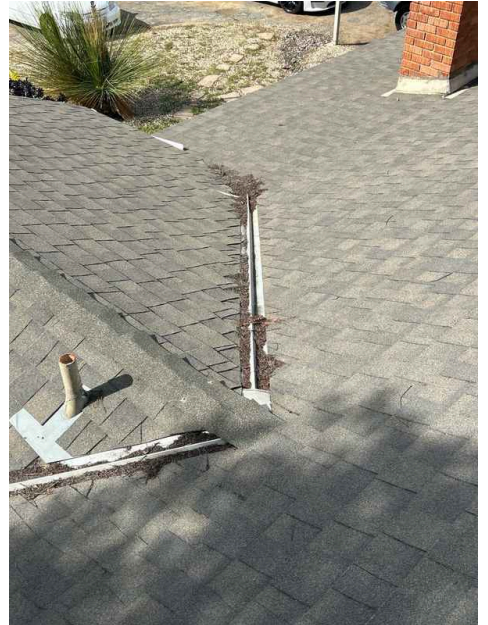
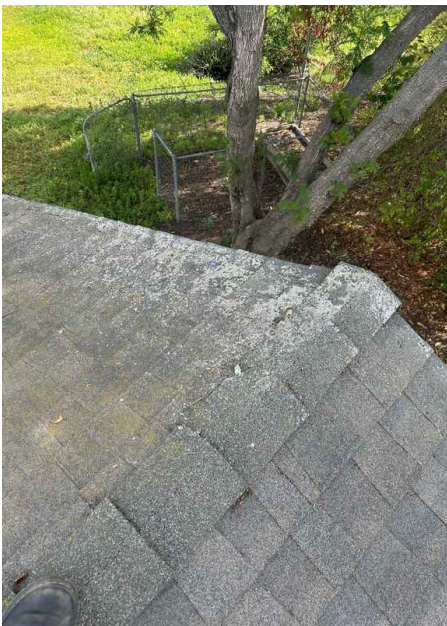
General: View of Roof

View of roof.

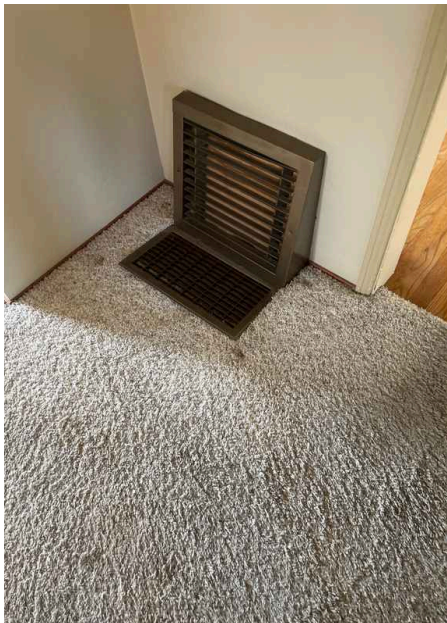
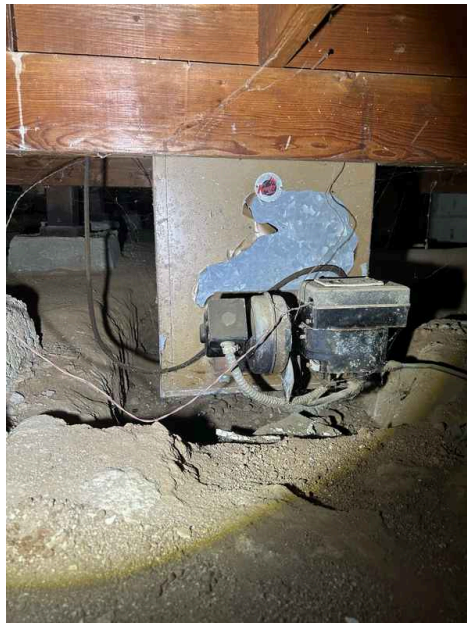
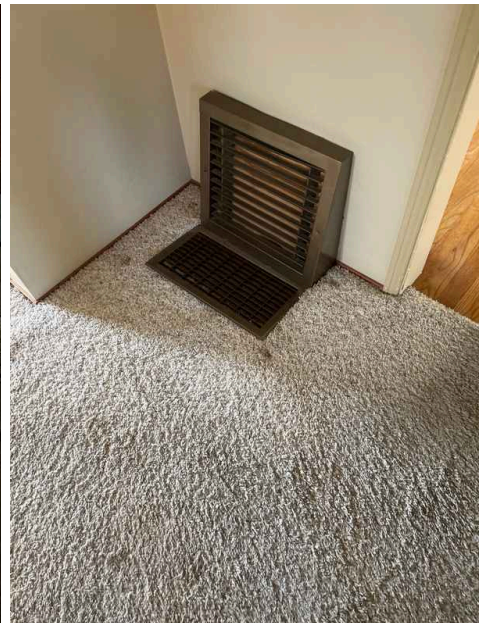
Heating (Forced Air): Furnace Abandoned / Not In Service

Note: A furnace has been abandoned and no longer in service and has not been removed.

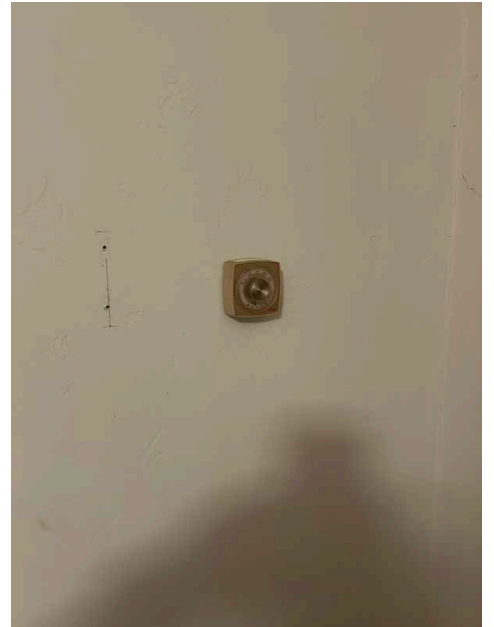
The thermostat is nearing the end of its lifespan and replacement is recommended.

Contact a qualified handyman.

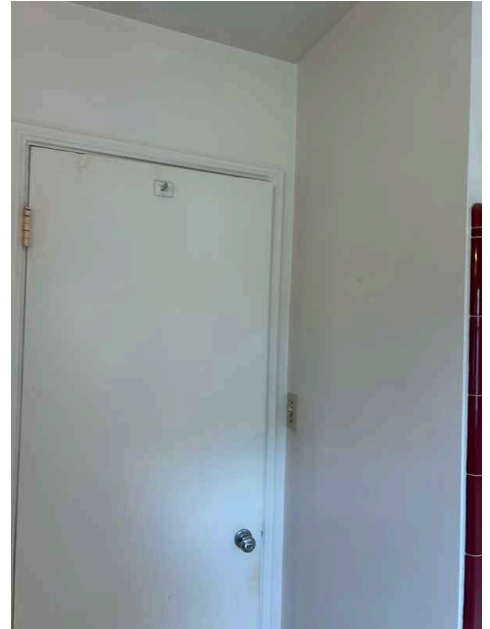
One or more doors rub in the jamb and correction is recommended.

Contact a qualified professional.

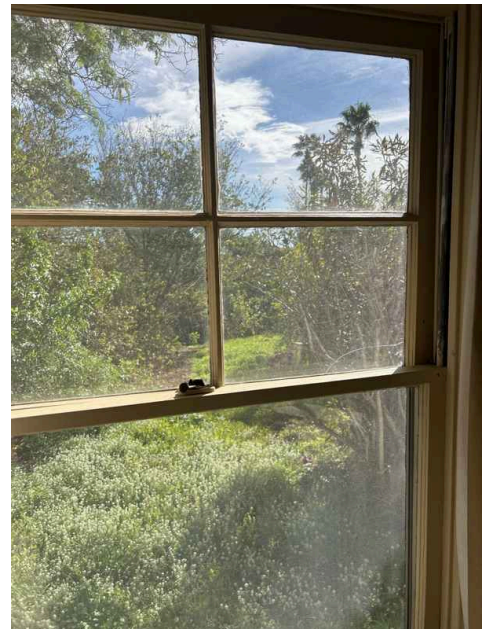
11.4.1 Windows

Safety Item/Defective**BROKEN / CRACKED / CHIPPED WINDOW(S)**

Broken and or damaged glass was noted in one or more areas. Further evaluation is recommended by a licensed specialist.

Contact a qualified window repair/installation contractor.

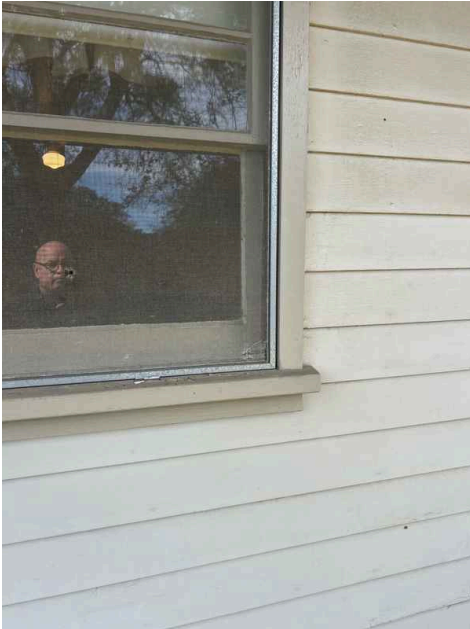
11.4.2 Windows

Observation**SCREEN(S) DAMAGED**

Window screens were damaged in one or more areas. Corrections are recommended.

Contact a qualified window repair/installation contractor.

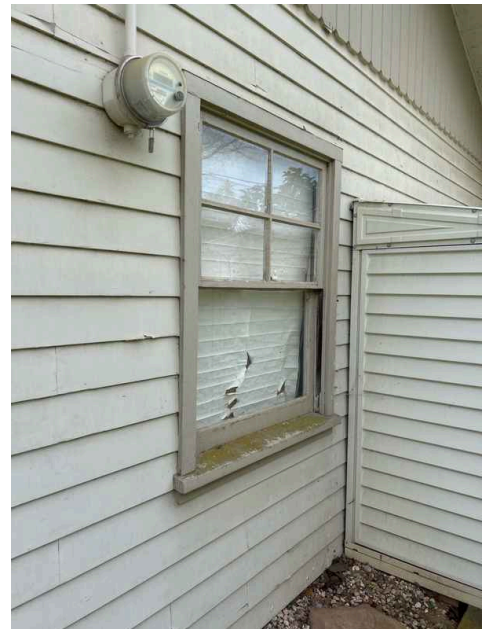
11.4.3 Windows

SCREEN(S) MISSING

Window screens were missing in one more areas. Corrections are recommended.

Contact a qualified window repair/installation contractor.

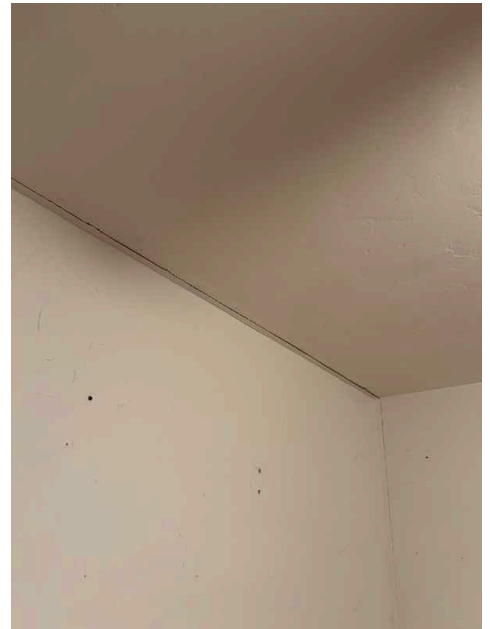
COMMON CRACKS/DETERIORATION NOTED

Common to moderate cracks were present in one or more areas (typical cosmetic damage). Advise paint and/or repairs as needed.

Contact a handyman or DIY project

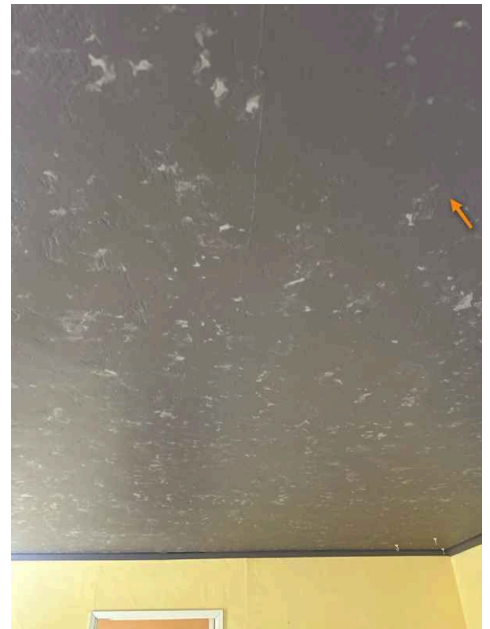
11.5.2 Ceiling

SETTLEMENT CRACKS

The ceiling had cracks in one or more areas. The cause can vary from to typical settlement to structural movement. We recommend repair as necessary. Further evaluation may be desired.

Contact a qualified professional.

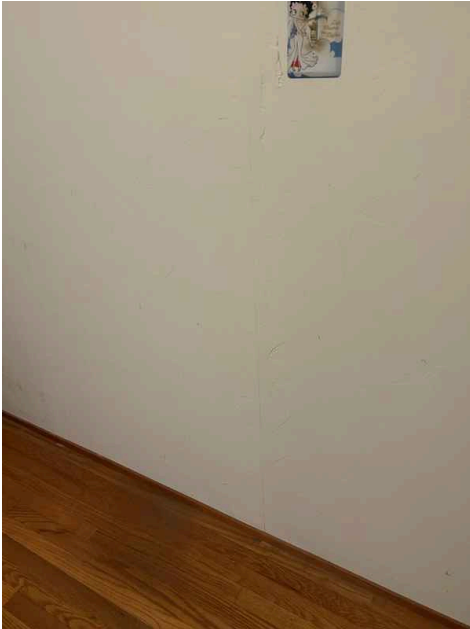
11.6.1 Walls

COMMON CRACKS / DETERIORATION NOTED

Common to moderate cracks were present in one or more areas (typical cosmetic damage). Advise paint and/or repairs as needed.

Contact a handyman or DIY project

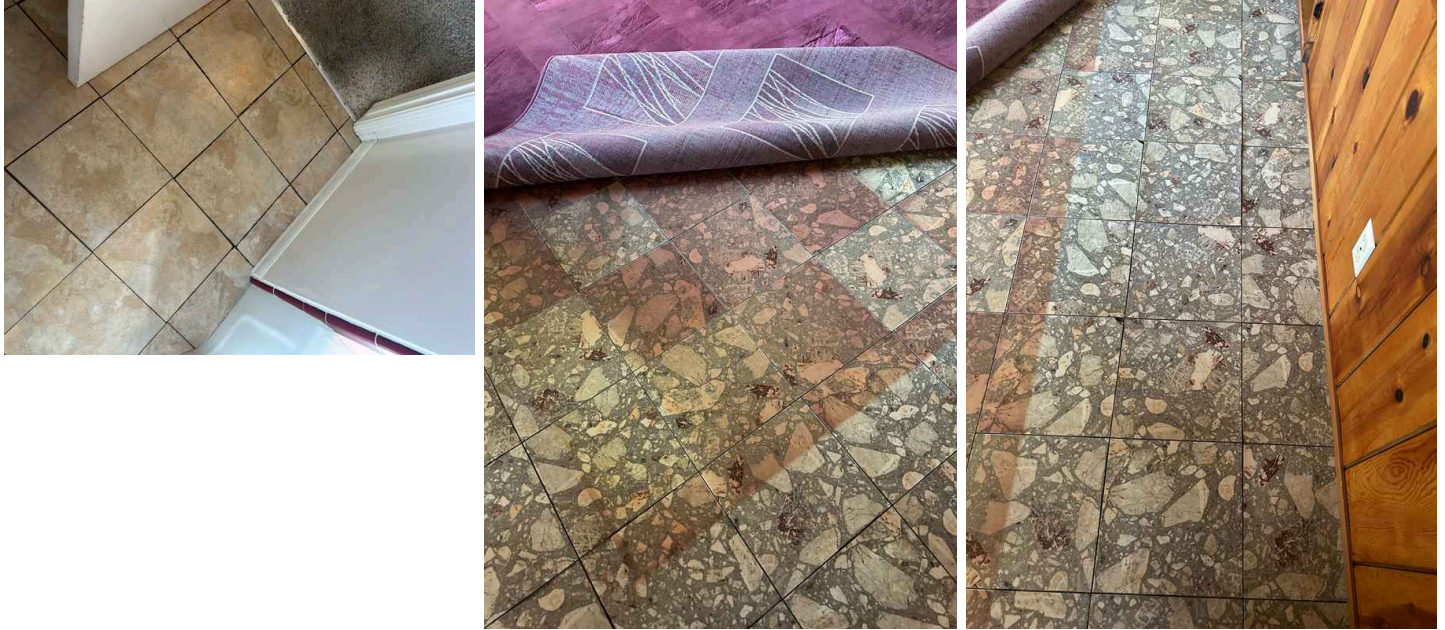
FLOOR DAMAGE / LIFTING / FAULTY

Flooring in one or more areas was damaged, lifting and/or faulty. Recommend that a qualified contractor replace or repair flooring as necessary.

Contact a qualified flooring contractor

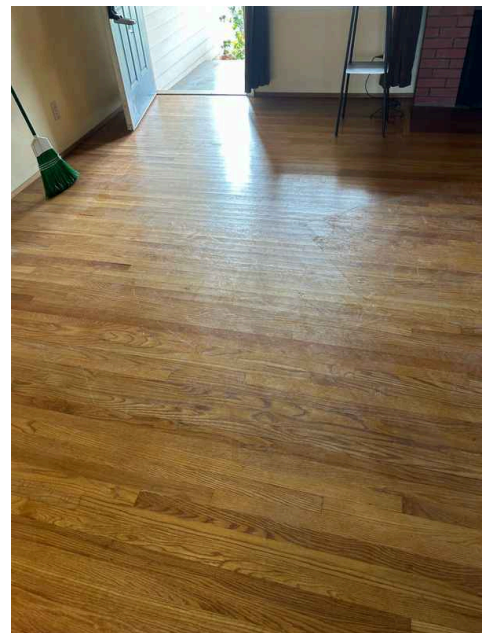
11.7.5 Floors

WOOD "CUPPING" NOTED

Wood flooring in one or more areas was "cupped" which is when the wood is turned up on the ends, discolored. This may indicate that the floor was not dried out properly before installing and or has been exposed to water or that the flooring (possibly from ongoing cleaning). Consult with the owner and monitor the stained area(s) in the future. It is possible that affected areas of the wood flooring will need to be refinished or replaced to obtain a flat surface. A qualified professional is recommended for further evaluation and/or repairs.

Contact a qualified flooring contractor

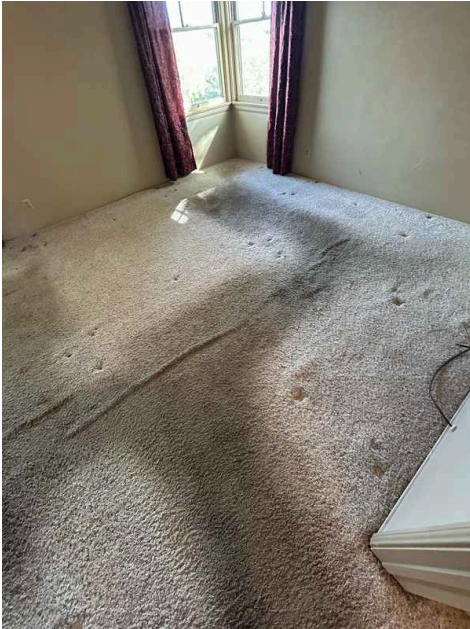
11.7.6 Floors

FLOORING STAINED / SOILED

Flooring in one or more areas was stained or soiled. Recommend having flooring professionally cleaned as necessary.

Contact a qualified cleaning service.

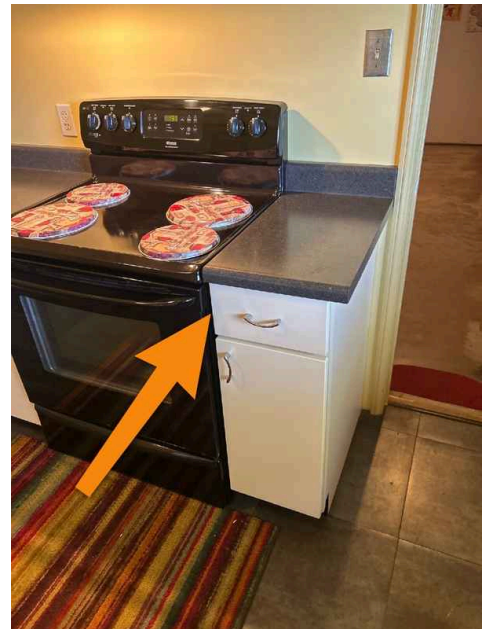
11.8.1 Countertops & Cabinets

CABINET LOOSE

Cabinets were loose in one or more areas. Corrections are recommended.

Contact a qualified cabinet contractor.

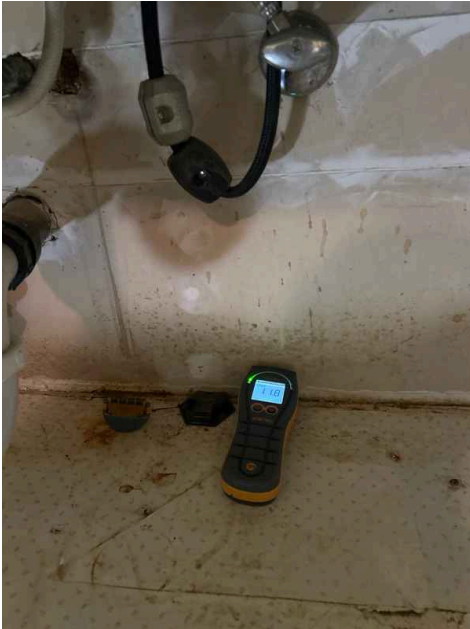
11.8.2 Countertops & Cabinets

CABINET STAINS

Dry water stains were found at interior cabinets. This may be from a past leak. Recommend repair as necessary.

Contact a qualified professional.

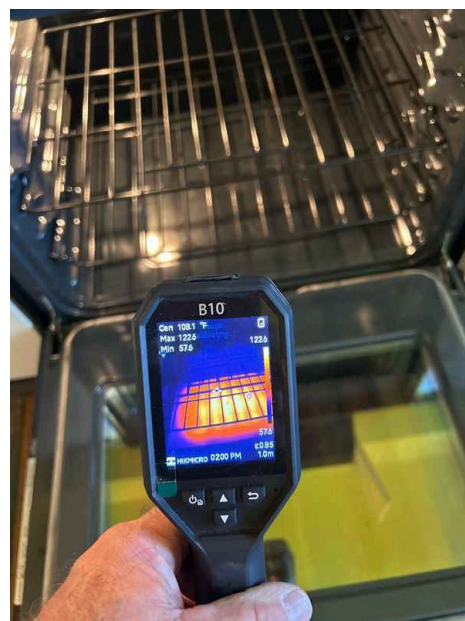
Range/Oven/Cooktop: Thermal Image of Oven Working

Thermal image of the oven working. This unit appeared functional.

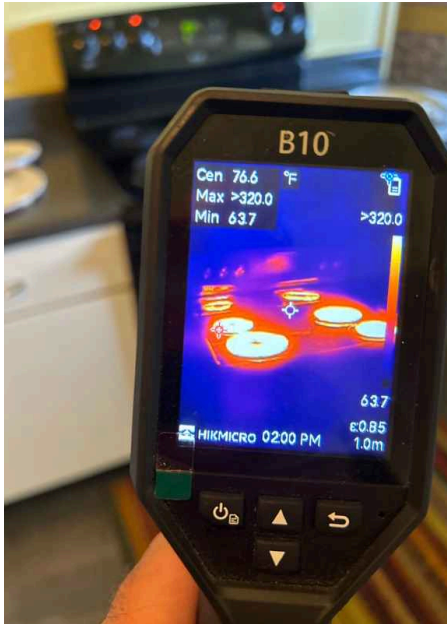
Range/Oven/Cooktop: Thermal Image of Range Working

Infrared picture of range/cooktop in operation. This unit appeared operational.

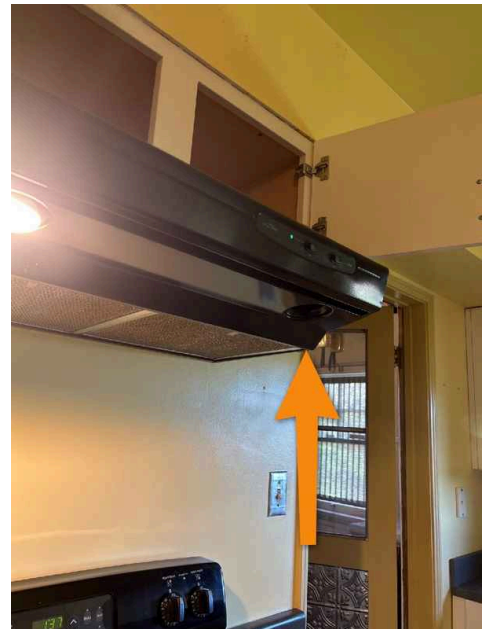
12.3.2 Exhaust / Ventilation

EXHAUST HOOD LIGHT INOPERABLE / MISSING BULBS

The light in the exhaust hood was inoperable and/or missing bulbs. This can restrict visibility of cooktop / stove top. Recommend to replace light bulb(s) or that repairs be made by a qualified person if necessary.

Contact a qualified appliance repair professional.

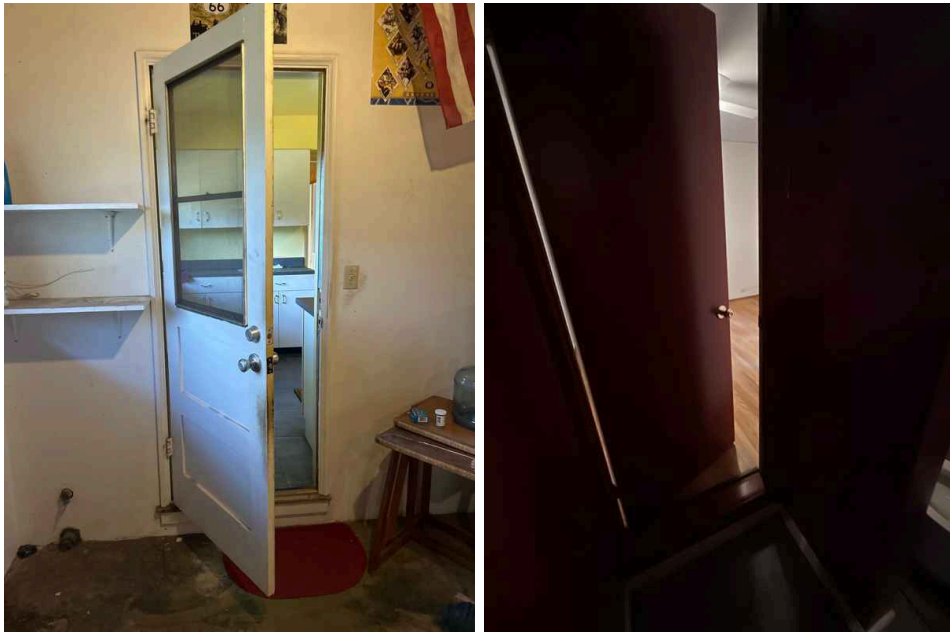
The door between the dwelling and garage did not appear to be fire resistant. This is a potential safety hazard. These doors are intended to prevent fire and/or fumes from spreading from the garage to the living space. Recommend replacement by a qualified contractor as per standard building practices.

Contact a qualified door repair/installation contractor.

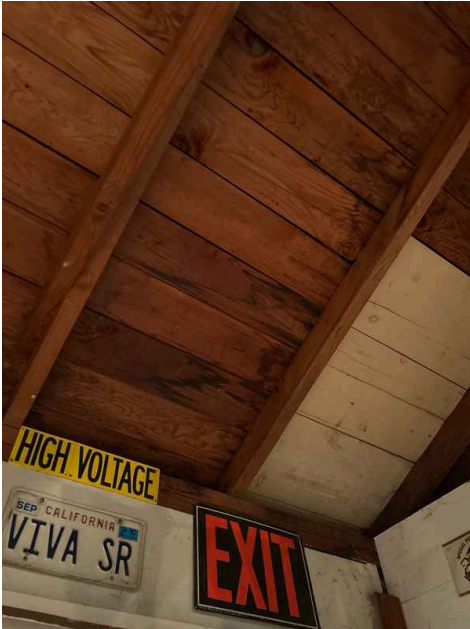
14.6.1 Floor, Walls, Ceiling

WET STAINS CEILING - ROOF

Stains of moisture were found in one or more ceiling areas. The stains appear to be due to a roof leak (past or present). Recommend that a qualified contractor evaluate and repair as necessary.

Contact a qualified roofing professional.

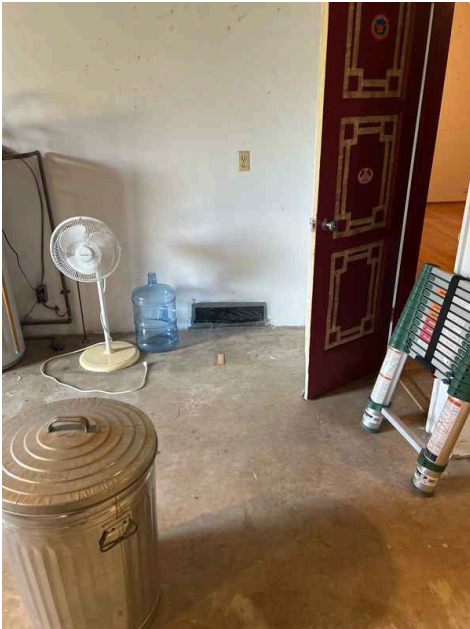
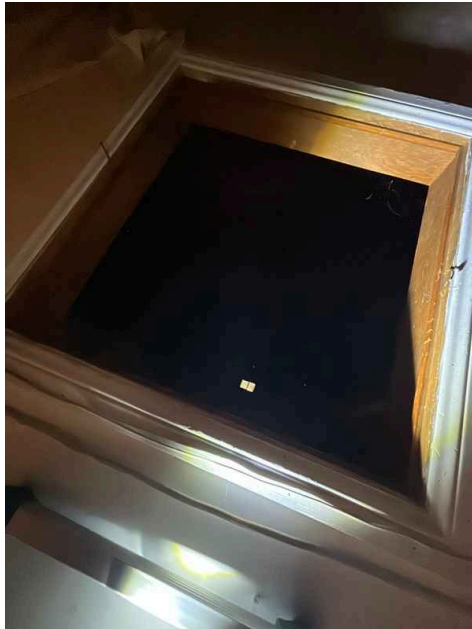
14.6.2 Floor, Walls, Ceiling

FIRE WALL GAPS, HOLES, DAMAGE

Gaps, holes or openings were present at the attached garage walls or ceilings. Walls and ceilings between the garage and house are required to provide limited fire resistance rating to prevent the spread of fire between the garage and house. Recommend that a qualified contractor repair as per standard building practices.

Contact a qualified drywall contractor.

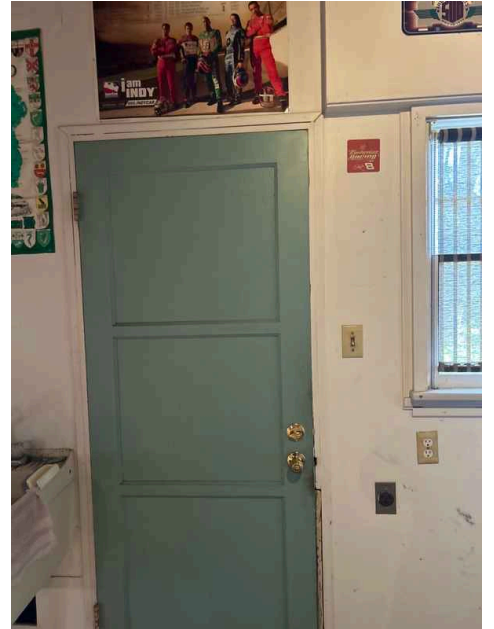
14.7.1 Exterior Door(s)

RUBS IN JAMB

The door rubs in the jamb and/or floor in one or more areas. Correction is recommended.

Contact a qualified professional.
