Inspection Report

Property Address:
110 8th St
Templeton CA 93465

2/23/2026

Harper Homes: Home Inspection Services

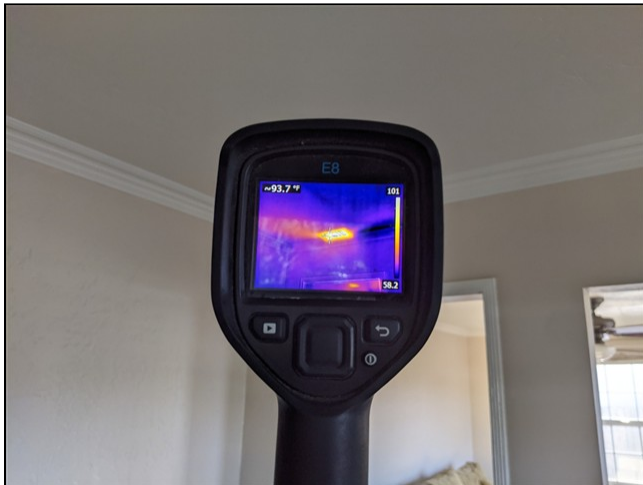
3.0 Item 1(Picture)

The furnace was tested and functional at the time of the inspection.

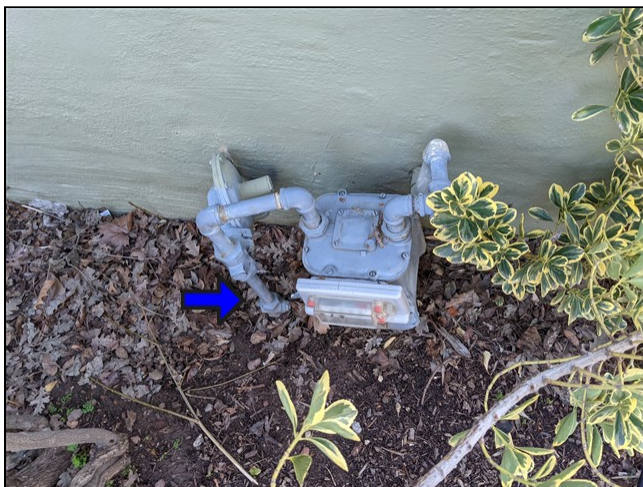
4.3 Item 1(Picture)

The gas shutoff is located at the left exterior of the home. To turn the gas off turn the valve perpendicular to the piping.

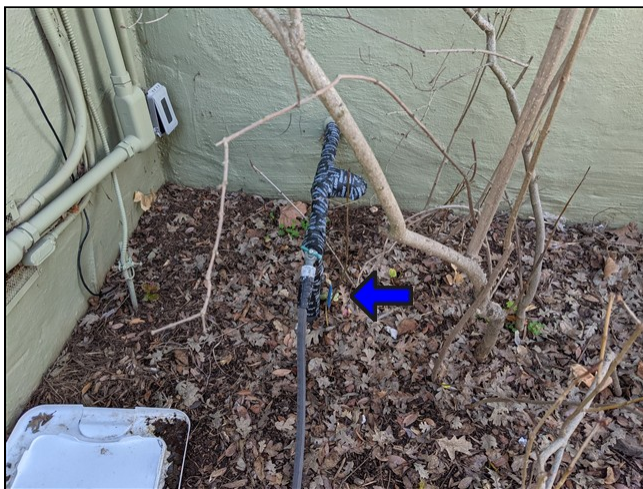
4.4 Item 1(Picture)

The water shutoff is located at the left exterior of the home. To turn the water off turn the handle perpendicular to the piping.
