# PROPERTY INSPECTION REPORT

**FOUR POINT**  
HOME INSPECTION INC.

**6390 Navajoa Ave**

**Date of Inspection: 1/16/2026**

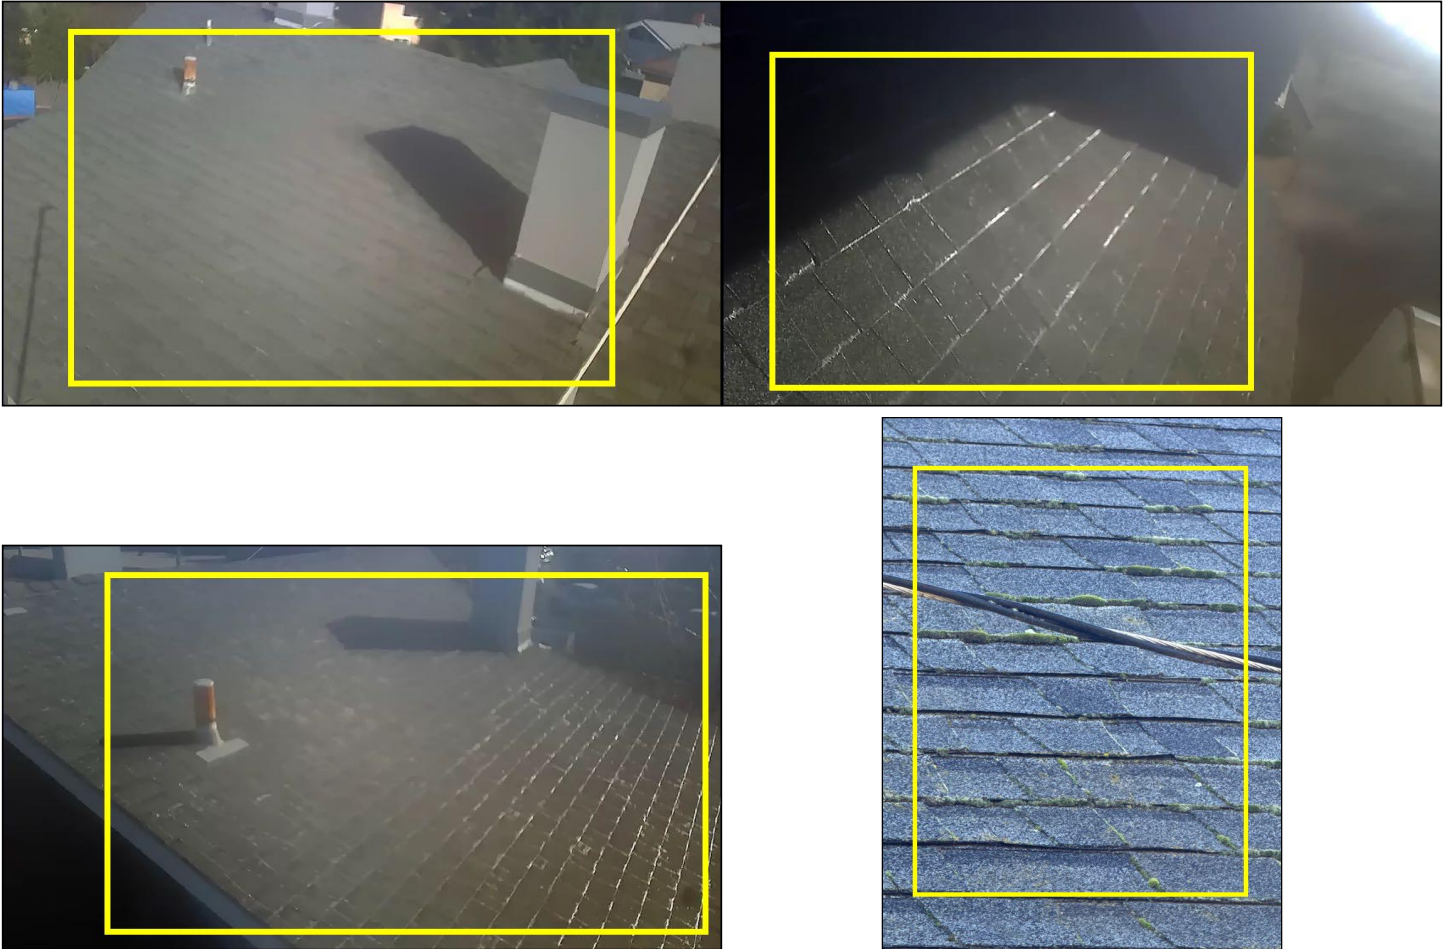
**Maintenance Needed:** Areas of the roof had moss growing on it.

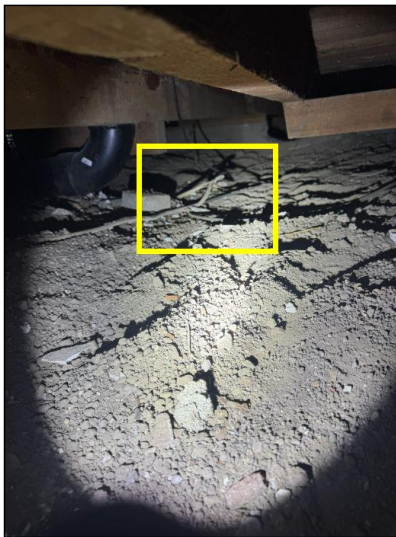
Electrical wires visible in the crawlspace had splices exposed to touch.

| | Page 20 Item: 7 | Foundation Electrical | <ul style="list-style-type: none"> <li>• A junction box in the crawlspace was missing cover plates at the time of the inspection. An approved cover plate should be installed by a qualified electrical contractor to prevent shock or electrocution.</li> <li>• Electrical wires visible in the crawlspace terminated outside of the junction box. Although they were not energized at the time of the inspection, these wires may have the potential to become energized and should be correctly terminated in an approved junction box with a cover by a qualified electrical contractor.</li> <li>• Electrical wires visible in the crawlspace had splices exposed to touch. This condition is a shock potential shock/electrocution hazard. Splices should be contained within an approved junction box with a cover installed. Corrections should be performed by a qualified electrical contractor.</li> </ul> |

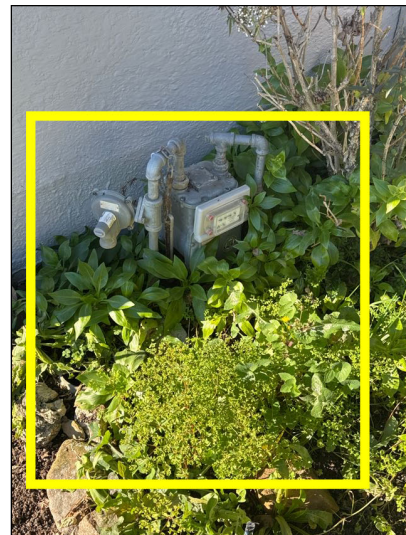
**Safety Improvement:** The main gas supply shut-off valve was difficult to access due to overgrown vegetation.

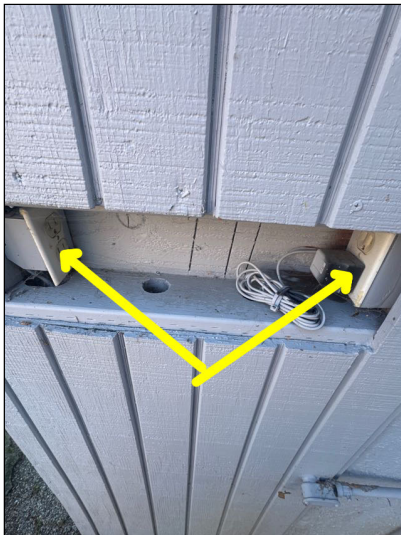
Multiple exterior outlets at the home were not protected from weather.

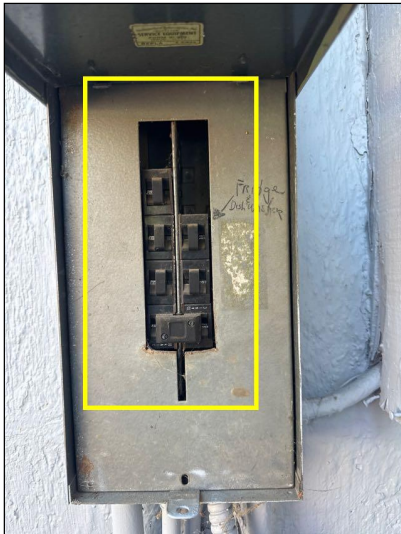
**Safety Improvement:** The Circuit Directory label identifying individual electrical circuits was not complete in the service panel, not all breakers are labeled.

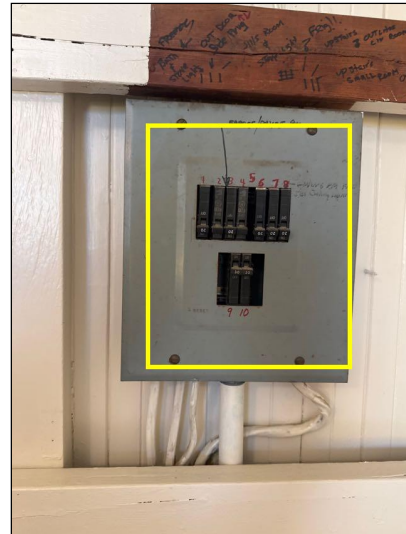
**Safety Improvement:** The Circuit Directory label identifying individual electrical circuits was not complete in the service panel

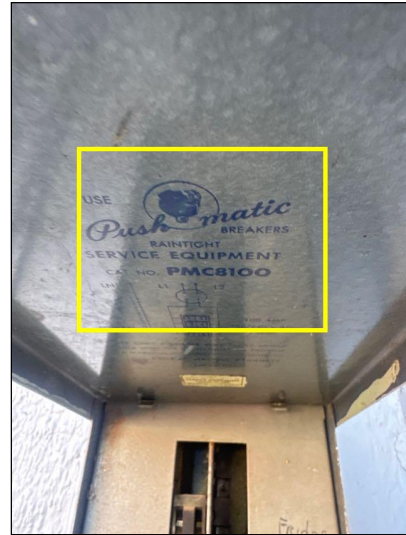
The service panel brand was Pushmatic. Pushmatic service panels are outdated and no longer manufactured. Pushmatic components have become unreliable with age and replacement is recommended. Before the expiration of your Inspection Objection Deadline, you should consult with a qualified electrical contractor concerning the necessity for replacing this service panel.

The service panel brand was Pushmatic.

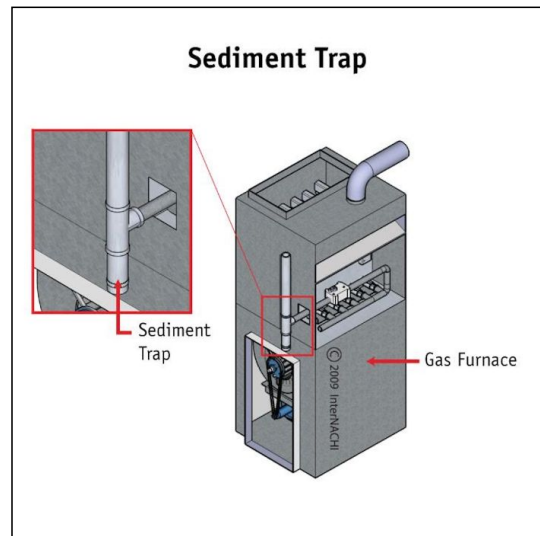
**Improvement:** The gas supply pipe contained no sediment trap.

The purpose of a sediment trap is to prevent sediment or debris particulates from entering and clogging the heaters gas valve.

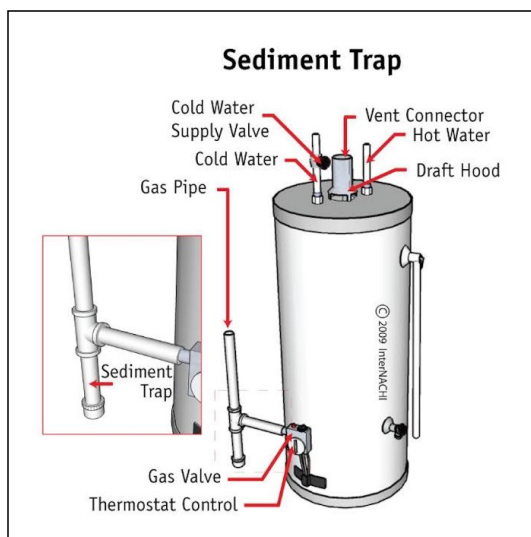
**Improvement:** The gas supply pipe contained no sediment trap.

The purpose of a sediment trap is to prevent sediment or debris particulates from entering and clogging the water heaters gas valve

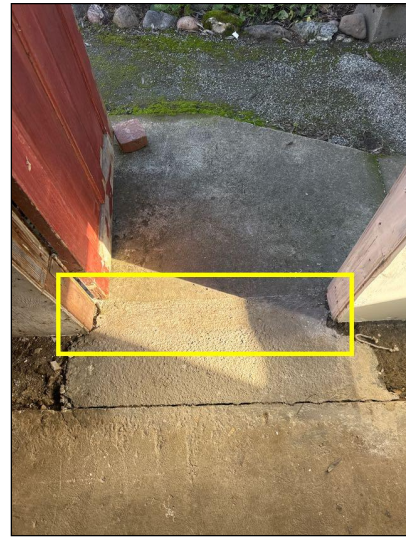
At the time of inspection there was no threshold installed at the exterior door.

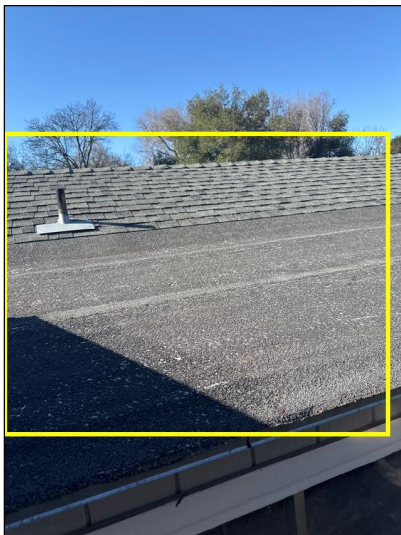
**Moisture damage, wood rot, observed to the sheathing/soffit areas of the garage. Refer to pest report for further details and repair damage as needed.**

The asphalt composition shingles covering the roof of this garage showed moderate deterioration that appeared to be commensurate with the age of the roof.

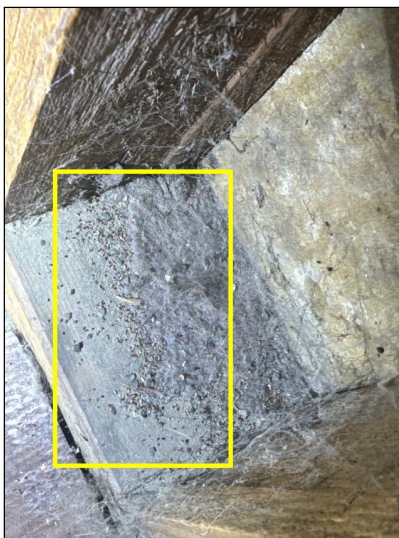
Termite droppings visible in the attic indicated infestation by wood-destroying insects. (hallway wall access)

| | Page 49 Item: 2 | Structure | <p>Termite droppings visible in the attic indicated infestation by wood-destroying insects. The Inspector recommends an inspection be performed by a pest control contractor.</p> |

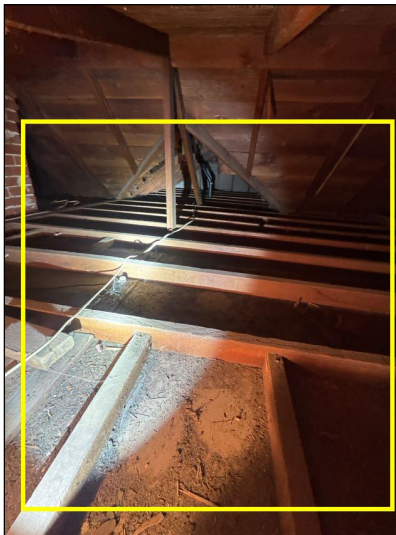
- **Improvement:** No insulation was installed in the unheated attic. Insulation of insulation will help reduce heating/cooling costs.

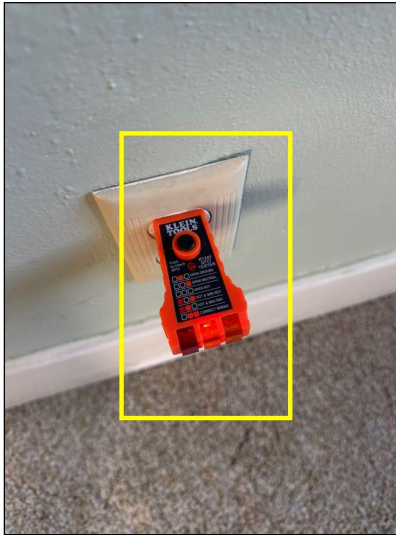
An electrical receptacle in this bedroom had an open ground. This outlet should be corrected by qualified electrical contractor.

An electrical receptacle in this bedroom had an open ground.
