Inspection Report

Address: 333 York Ave Oceano, CA 93445

03/10/2026

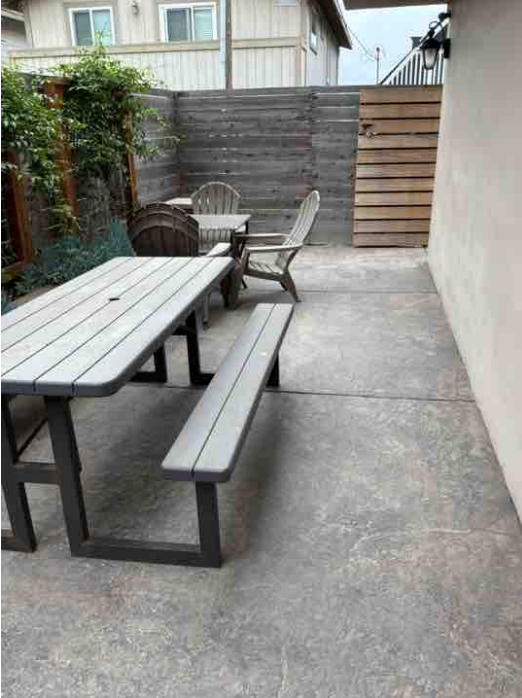
21: Typical and common cracks found.

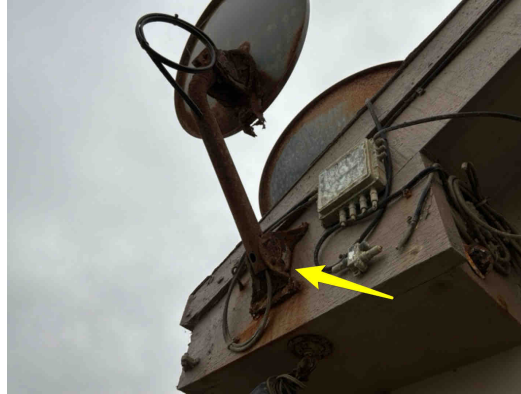
SU 26: Some heavy rust deterioration and damage found at the exterior mounted satellite TV dishes. Removal or replacement may be warranted for safety.

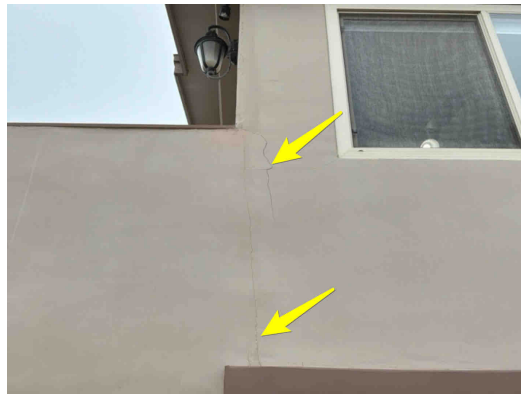
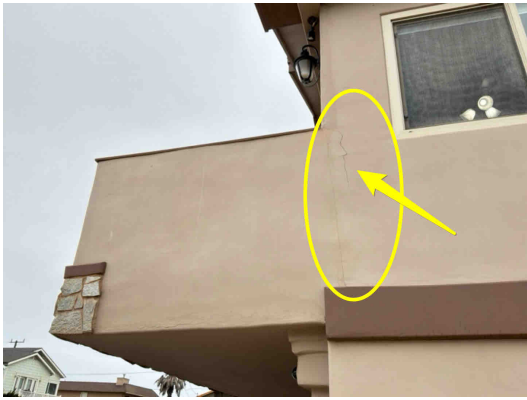
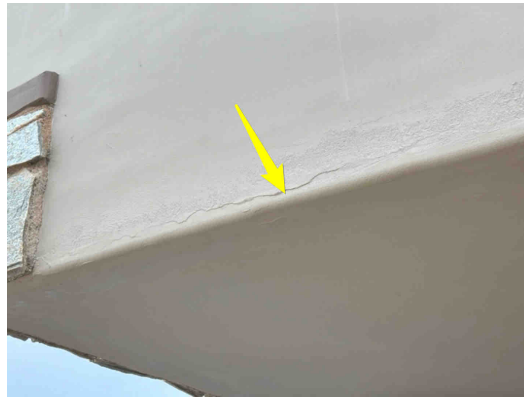
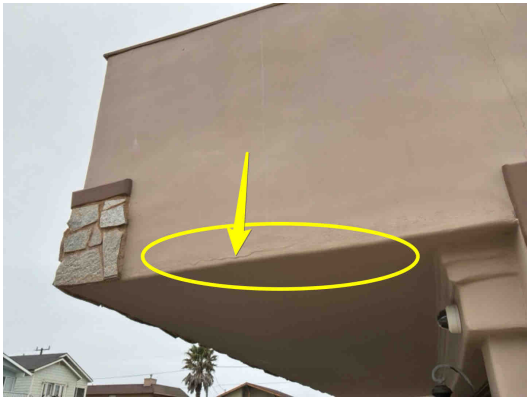
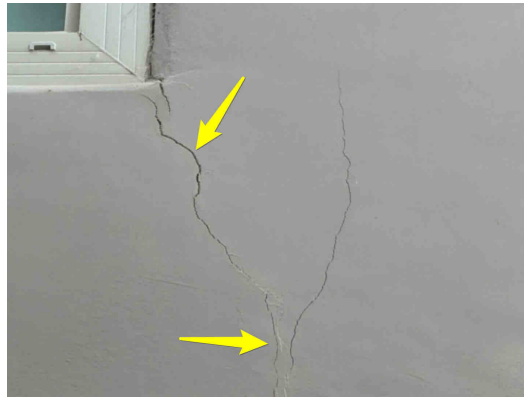
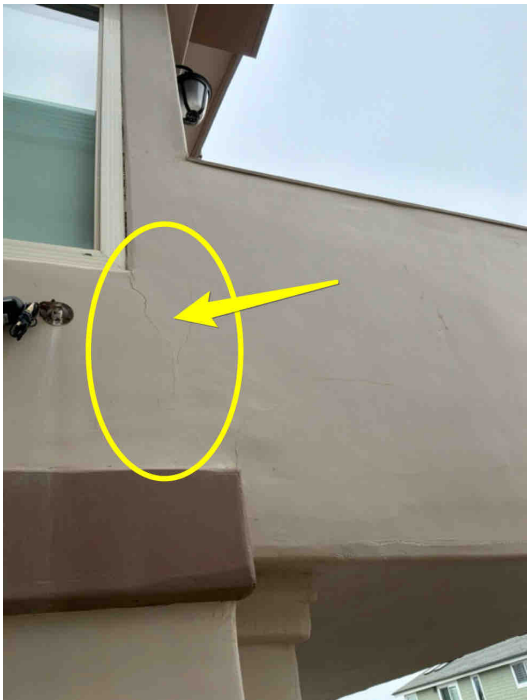
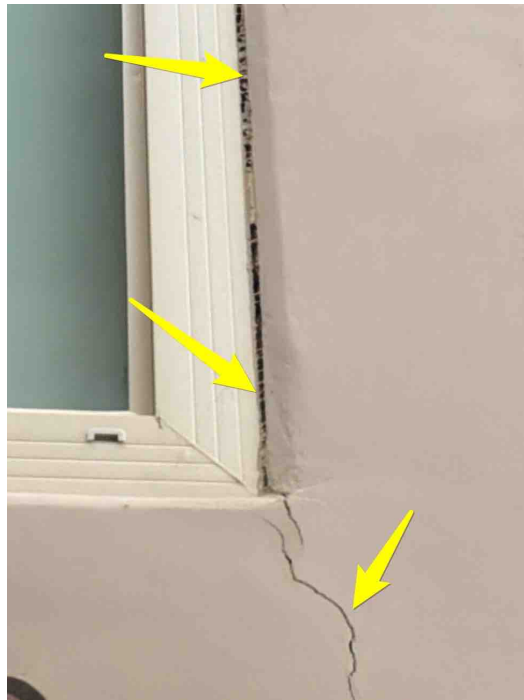
FI 28: Some unusual and large cracks found in the exterior stucco siding. This may be indicative of some uncommon settling of the cantilevered deck off the UPSTAIRS FAMILY ROOM. Client should contact an engineer to evaluate and make an opinion as to the cause, the current condition, potential for future issues and if upgrades and or repairs are warranted.

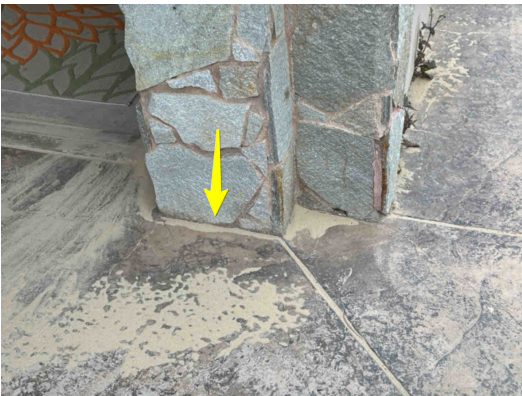
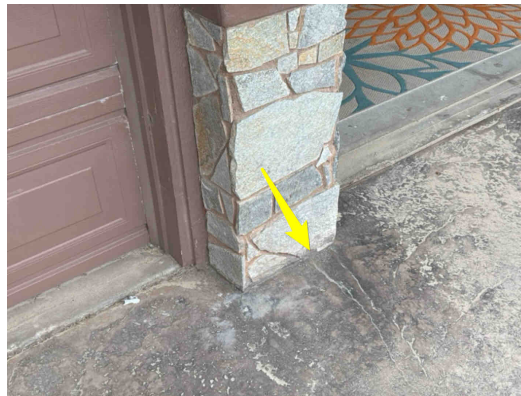
DS 29: Disclosure: No visible weep screed or weep openings found at the base of the of the exterior rock veneer. This can allow water to collect behind the rock and could cause some deterioration of the exterior wall framing and waterproofing which could eventually cause some moisture intrusion, deterioration and/or damage to the wood framing.

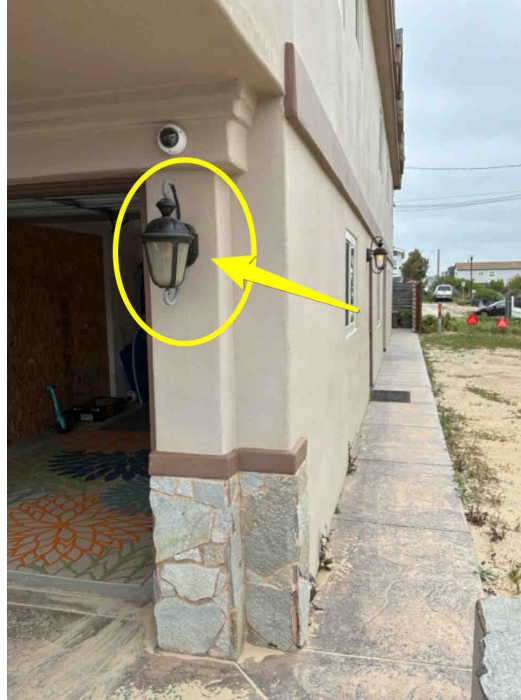
MR 30: Recommend sealing around the exterior light fixtures making sure they are sealed tight to the wall to help prevent water and/or critter intrusion per installation requirements.

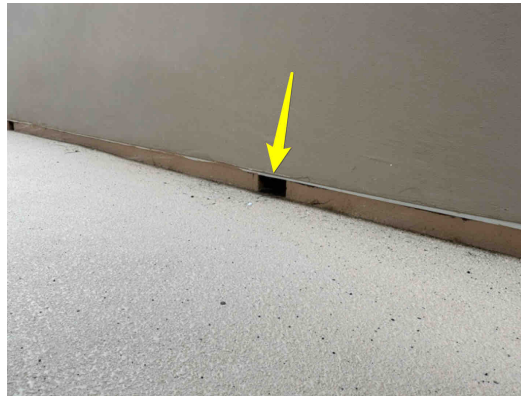
E&C 39: The deck drain scuppers / wall drain at the UPSTAIRS FRONT DECK OFF THE FAMILY ROOM found to be improperly partially blocked by the installation of the stucco railing / scuppers are undersized. At a minimum, the deck drain scupper is required to be 4" above the decking surface. Contact a qualified waterproof deck contractor to evaluate and make recommendations for proper upgrades or repairs.

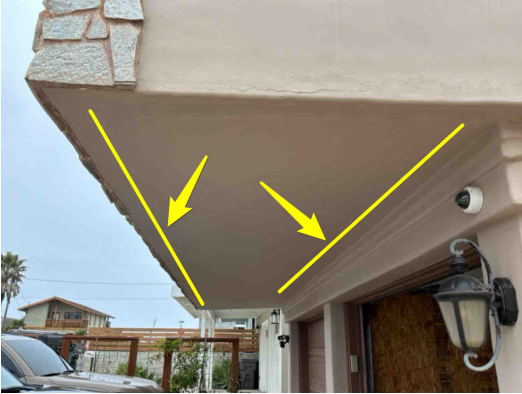
DS 41: No visible ventilation installed on the underside of the enclosed exterior portions of the waterproof deck off the UPSTAIRS FRONT DECK OFF THE FAMILY ROOM. Current Standards dictate that enclosed waterproof decks should be ventilation along the underside to help reduce condensation build up and to help prevent an excessive moisture condition such as fungus growth which could lead to a structural compromise of the wood framing. [CBC 2304.12.2.6 Ventilation beneath enclosed balcony, elevated walking surfaces and stairways]

Current conditions of the enclosed deck wood framing are unknown.

Example location of where ventilation could be installed

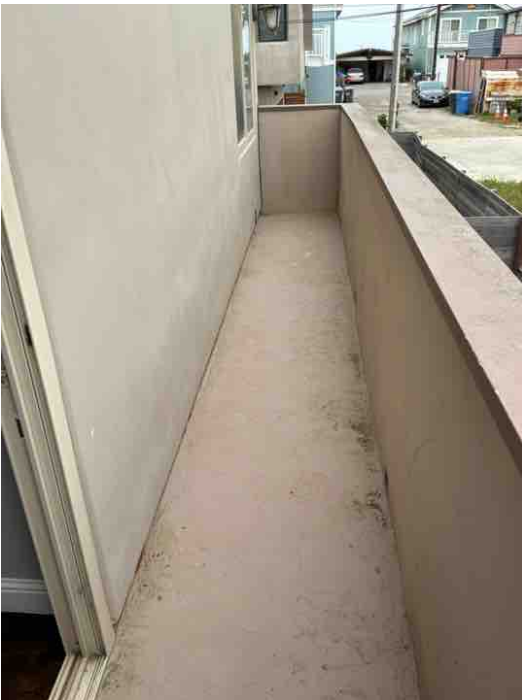
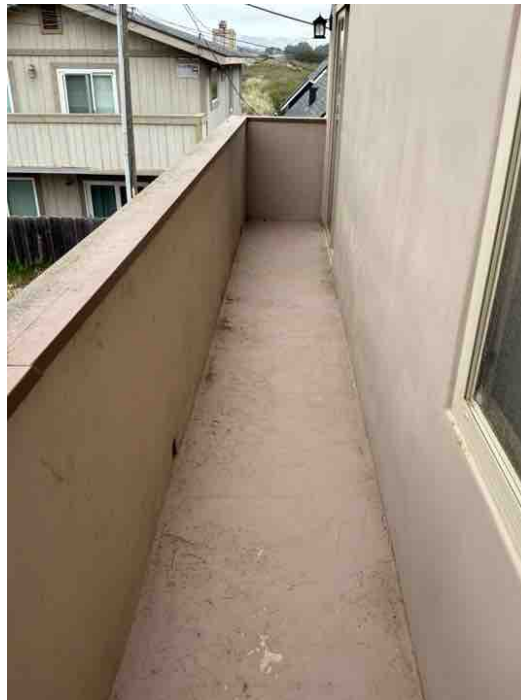
FI 44: DECK CONDITION: Some cracking of the waterproof coating found at areas of the UPSTAIRS BACKYARD DECK.

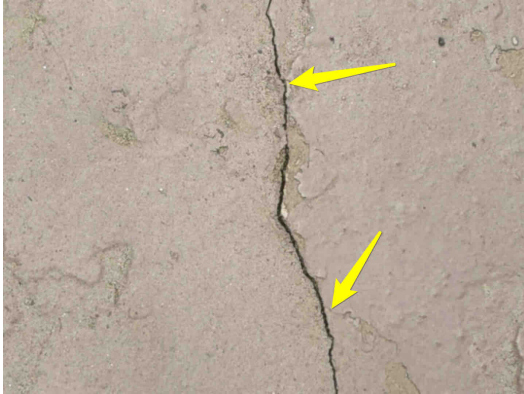
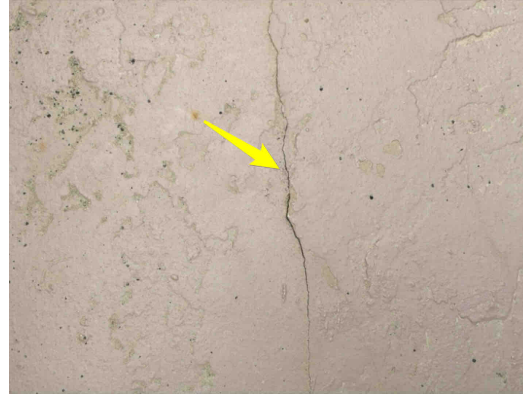
UPG DS 45: Areas of the UPSTAIRS BACKYARD DECK waterproof coating are improperly installed at or above exterior door threshold. This can allow water to potentially intrude under the deck exterior door threshold into the wall cavities. Building codes dictate, 2 inches from the bottom of the stucco to the top of the deck surfacing. Refer to the Termite Report for additional comments and recommendations.

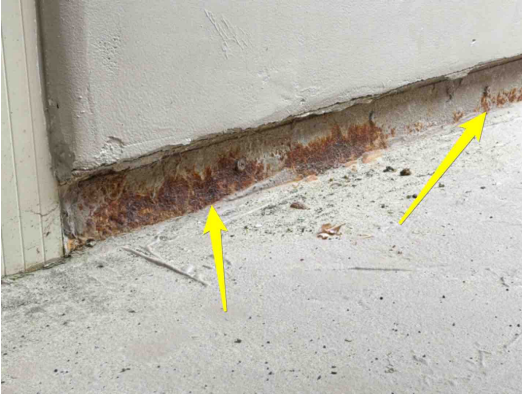
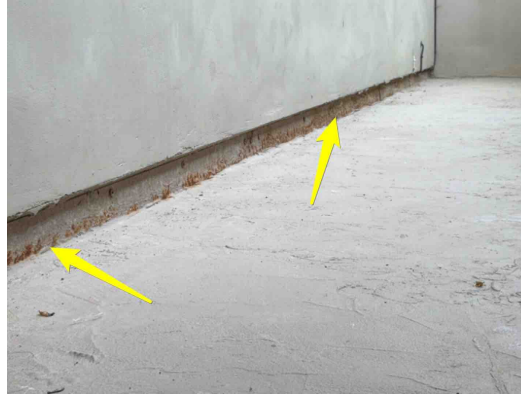
E&C 47: Dusted wall flashing found at the UPSTAIRS BACKYARD DECK

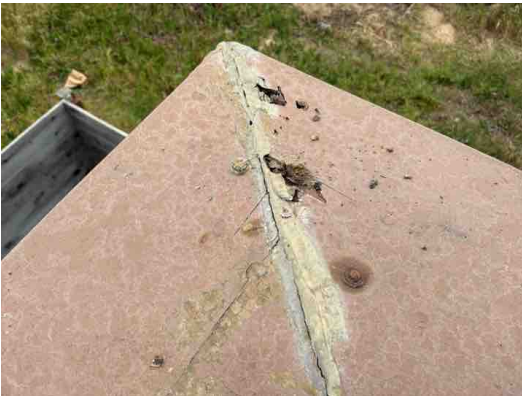
E&C 48: Some moisture stains and damage noted at wood areas of the railings at the UPSTAIRS BACKYARD DECK. Refer to termite report for additional comments and recommendations.

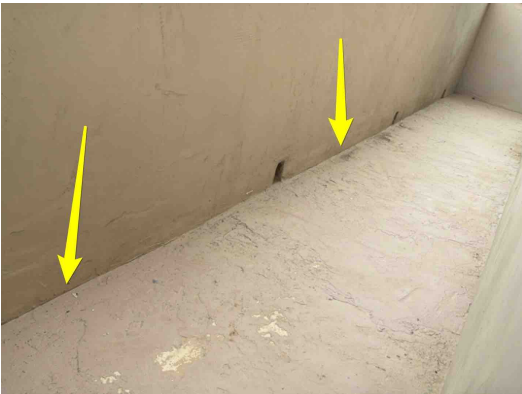
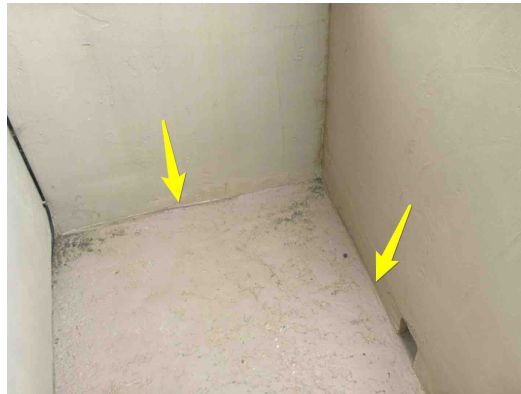
49: Improper installation of the stucco railing, no visible weep screed on the deck side of the stucco wall

No weepscreed

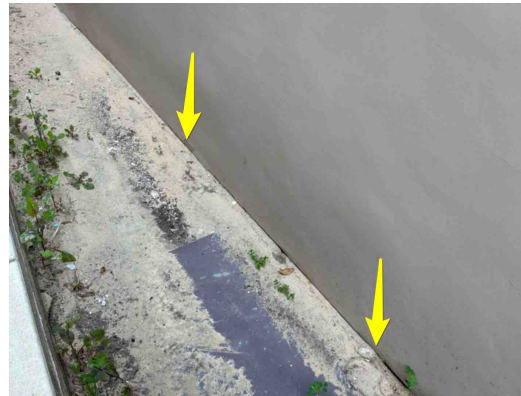
E&C MR 52: Soil level found high at areas of the foundation. (Recommend 4 inches from the bottom of the exterior stucco siding to dirt, rock, mulch or wood chips).

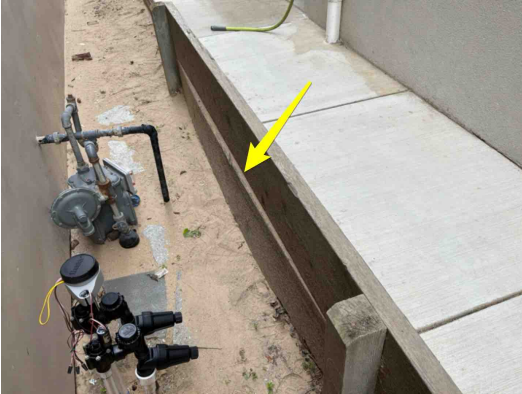
UPG 54: Areas of the wood retaining wall is bowing on the west side yard.

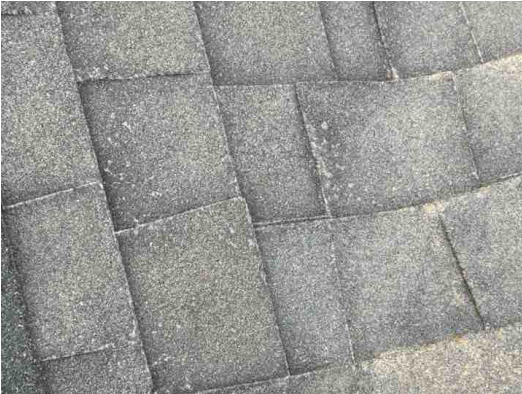
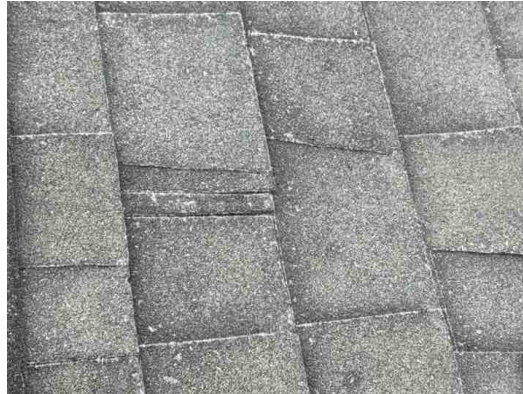
DS 59: ROOF CONDITION: The asphalt composition roof shingles and flashings are old and weathered. The roof may be nearing the end of life expectancy. Recommend monitoring and inspecting regularly as future replacement will be needed. Buyer should contact a licensed roofer for an estimated cost of a new roof.

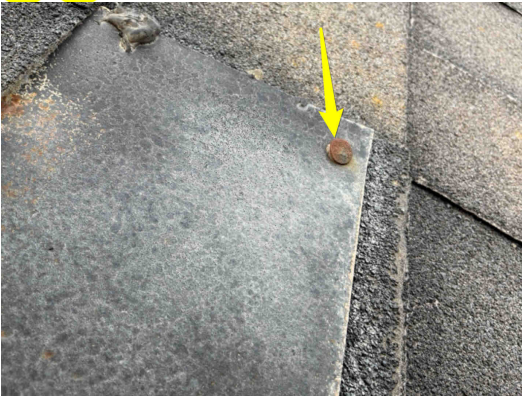
MR UPG 62: Recommend sealing all exposed nails at areas of roof/ roof flashing.

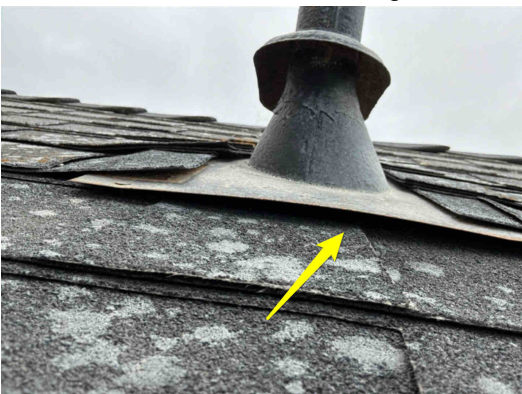
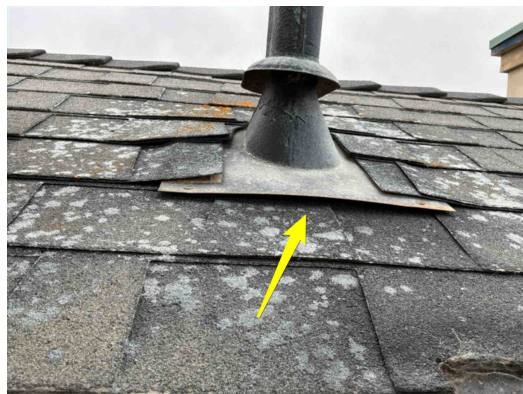
E&C MR 63: Some lifting roof flashings. Corrections, maintenance or repairs are recommended to help prevent water intrusion and/or roof leakage from windy, wet weather.

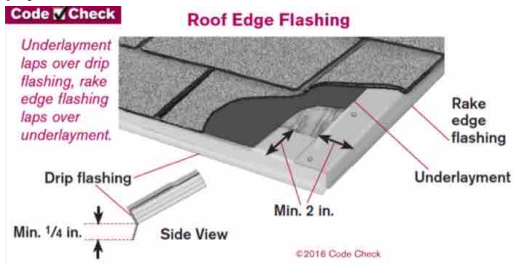
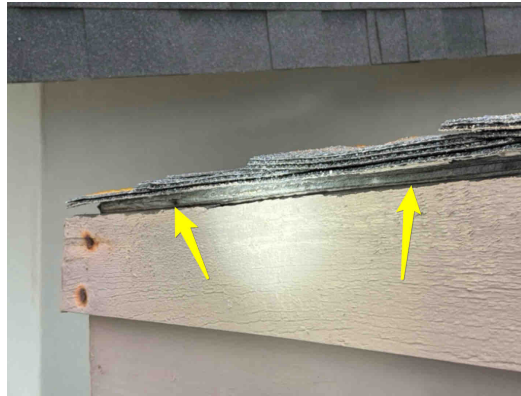
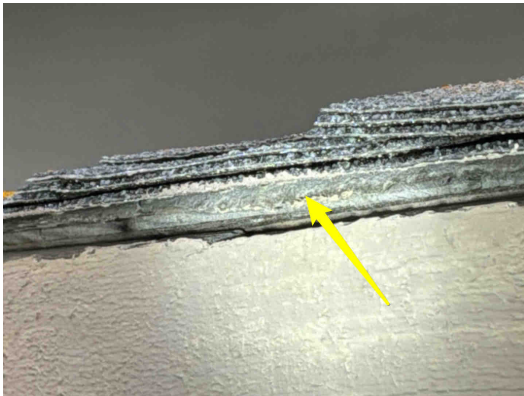
E&C 64: Missing the roofing drip edge flashings at areas along the roof fascia board. Areas of exposed roof plywood. This has / can cause moisture deterioration and damage to the roof plywood.

Exposed roof plywood

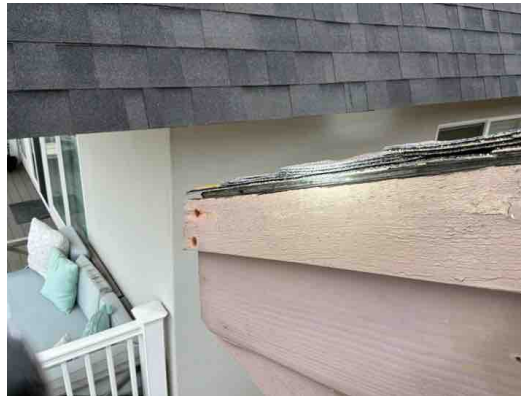
Exposed roof plywood

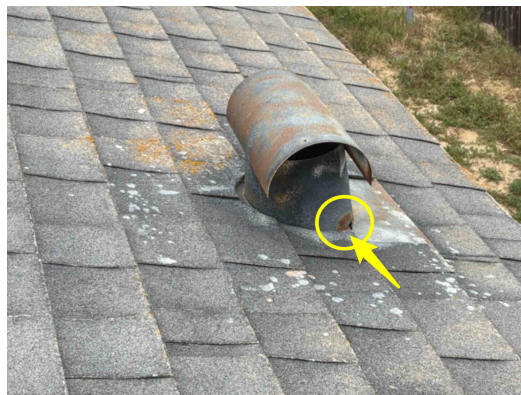
E&C MR 66: Some roof flashings found rusted and deteriorated. Further evaluation and potential upgrades needed by a licensed roofer.

A visible hole in the roof flashing

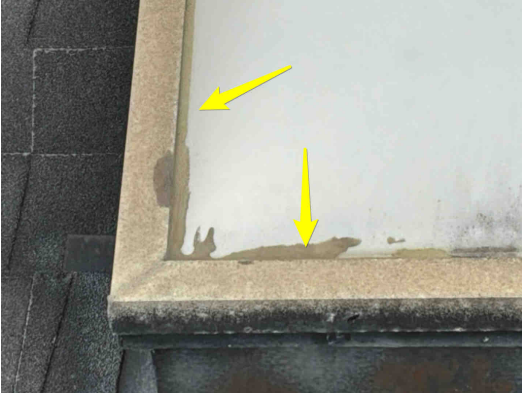
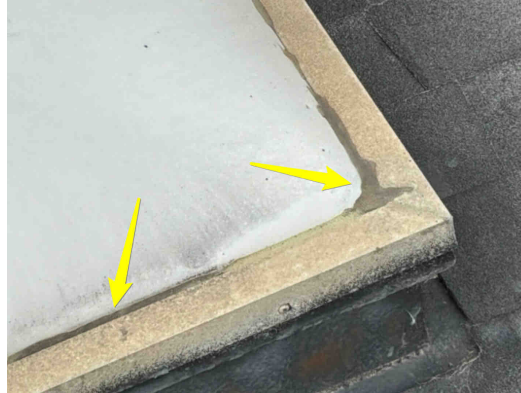
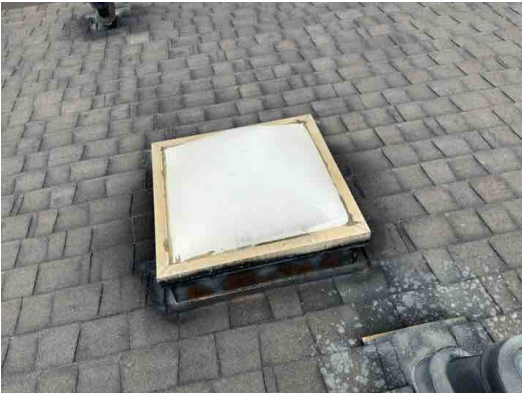
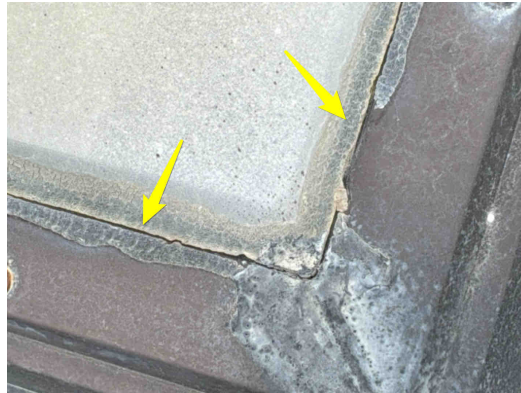
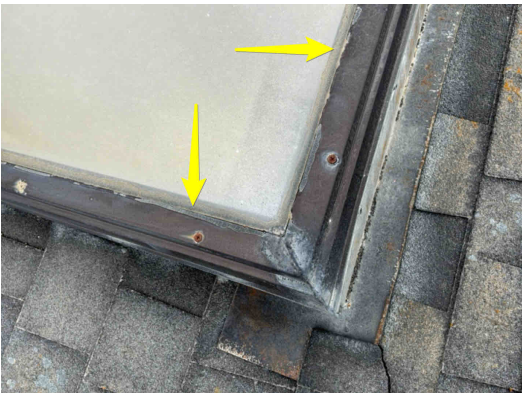
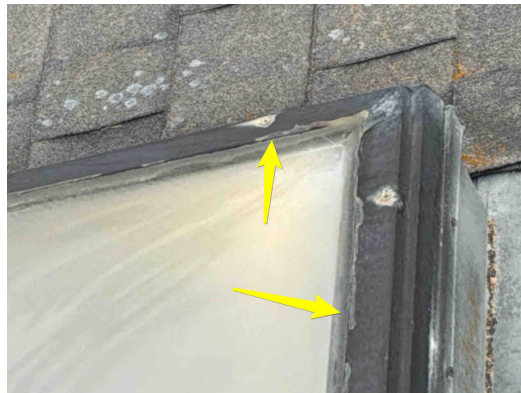
FI 67: Evidence of caulking (heavily deteriorated), a non-professional skylight leak repair noted at the roof skylights. Client should have a licensed roofing contractor investigate further as to the cause, current conditions, potential future issues and determine if corrections or replacement of the roof skylight is needed.

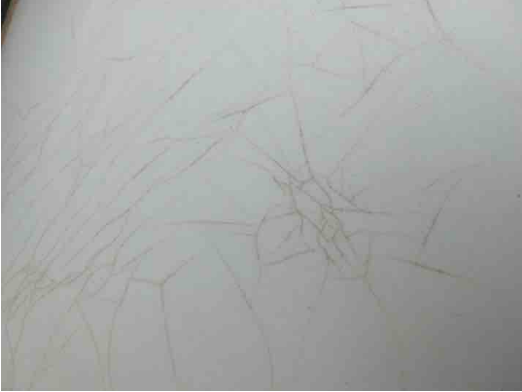
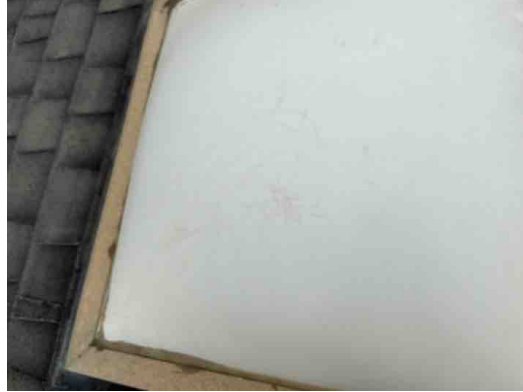
E&C 68: Some of the plastic roof skylights are cracked and damaged. Replacement is recommended. Contact a qualified roofer to evaluate and replace damaged skylights.

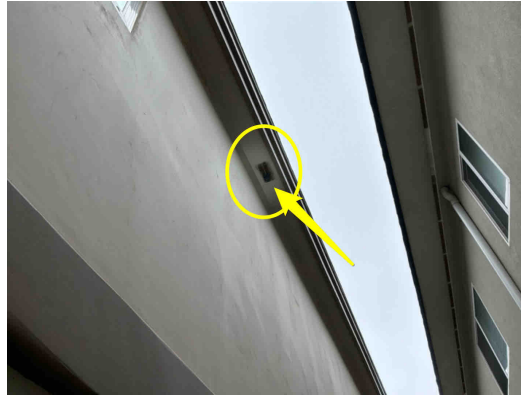
E&C MR 73: Some damaged or missing attic EAVE VENT screens on areas of the exterior at the roof overhangs. Repair or replacement recommended to help prevent critter intrusion into attic areas.

A visible hole found in the west side vent screen

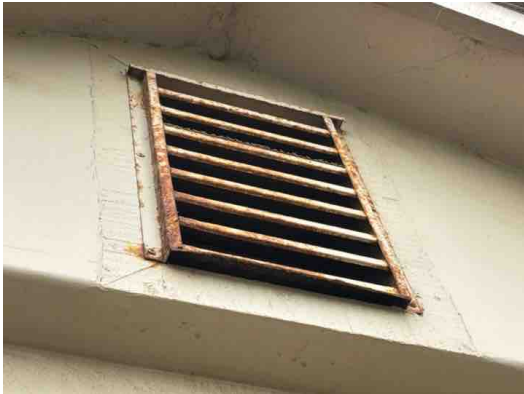
E&C MR 74: Some rusted, damaged attic GABLE VENT screens. Recommend having all attic vent screens reviewed, repaired or replacement by a qualified professional to help prevent critter intrusion into attic areas.

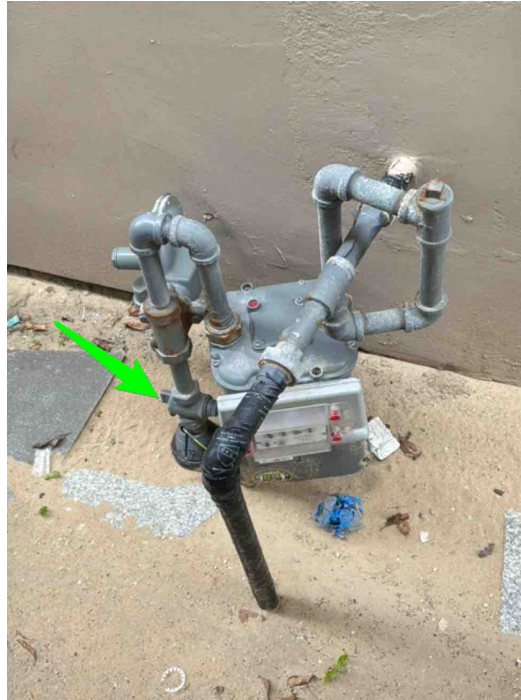
Main gas shut off valve

MR UPG 88: The Gas meter and/or shutoff valve found to be improperly in contact with ground or soil. Deterioration has or may occur. Maintenance or upgrades are needed to help prevent deterioration or damage.

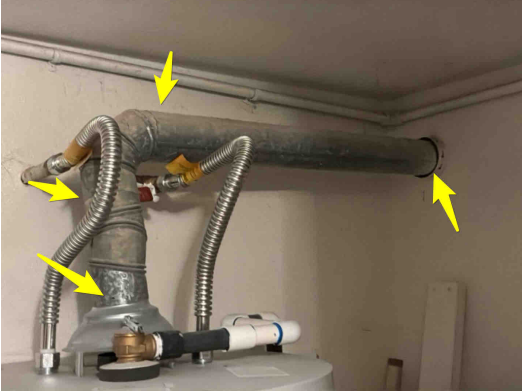
Example locations

SC 96: Water heater vent connector pipe (single-wall) is not properly fastened with the required 3-fasteners at each connection including the draft hood per standards.

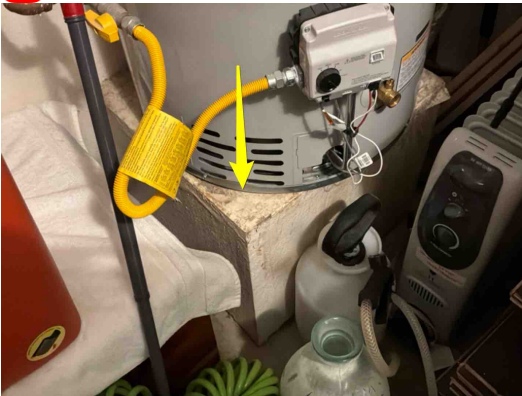
Example

FI 98: Disclosure: Dry Moisture stains noted at areas around the water heater at the platform.

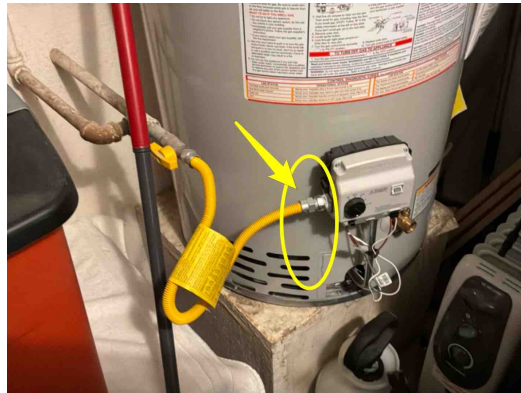
UPG 99: Recommend the installation of a sediment trap / drip leg at the WATER HEATER gas piping at flex connection by a certified or licensed plumbing professional familiar with minimum requirements.

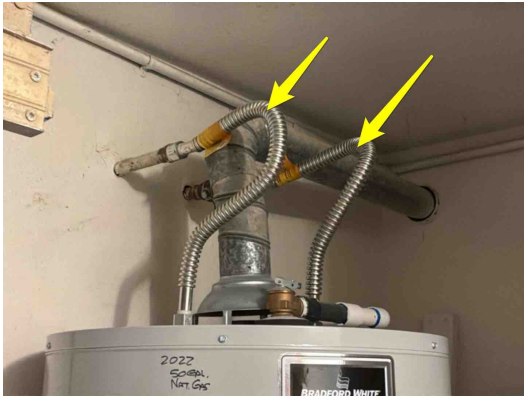
MR 100: Recommend insulation on the HOT and COLD water supply pipes at the water heater per minimum codes and standards.

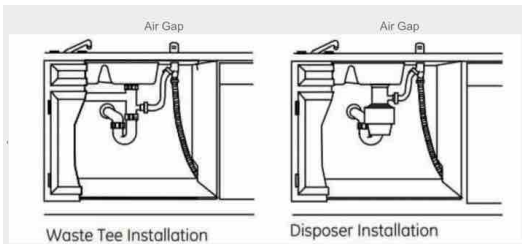
SU 108: Improper installation of the DOWNSTAIRS KITCHEN dishwasher drain hose. Missing the Air Gap Device at the dishwasher drain per minimum codes and standards (California does not allow for high-loop methods or direct waste connections). {CPC 801.2}

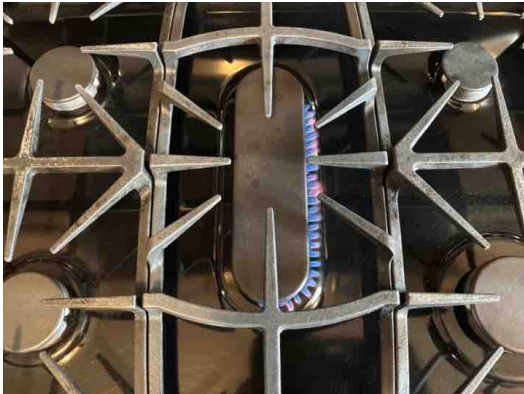
E&C 117: The CENTER Cook top burner did not operate properly when tested at the DOWNSTAIRS KITCHEN. Recommend cleaning / servicing.

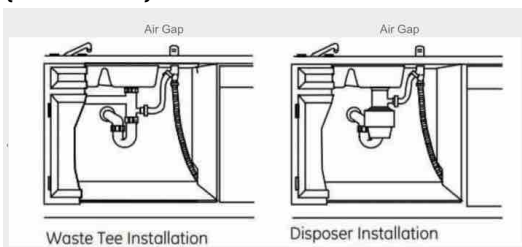
SU 126: Improper installation of the dishwasher drain hose. Missing the Air Gap Device at the dishwasher drain per minimum codes and standards (California does not allow for high-loop methods or direct waste connections). {CPC 801.2}

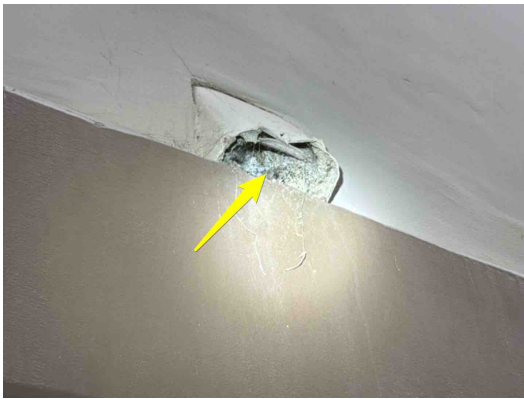
SU 145: The old, unused exterior laundry dryer vent pipe termination on the exterior WEST SIDE should be sealed or screened to help prevent critter intrusion.

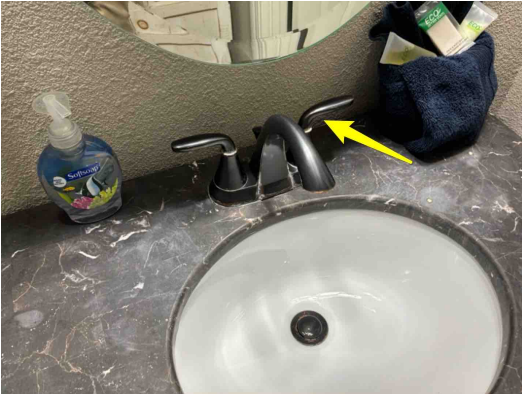
E&C 155: The bathroom sink faucet (COLD WATER) handle found difficult to turn. Maintenance or repairs recommended: DOWNSTAIRS PRIMARY BEDROOM BATHROOM

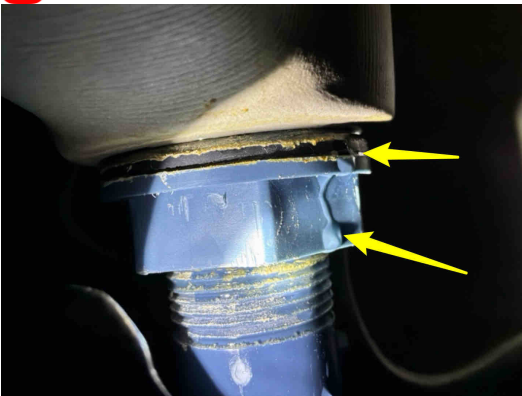
E&C 156: Active leaking from the bathroom sink drain line: DOWNSTAIRS PRIMARY BEDROOM BATHROOM

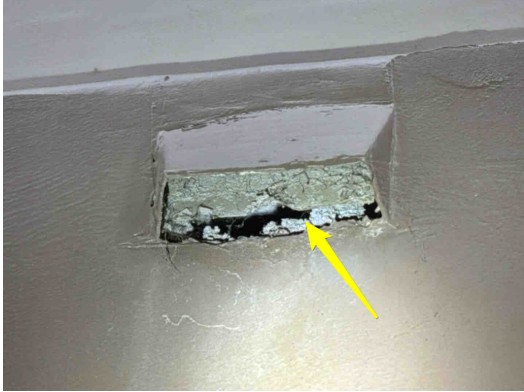
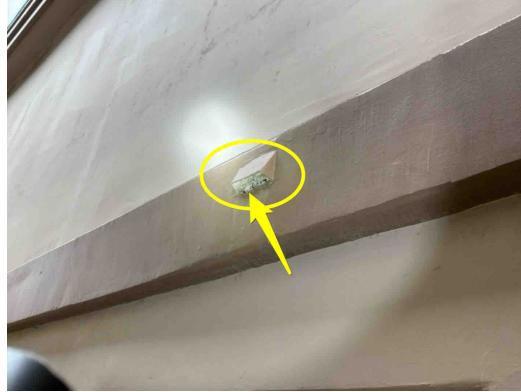
E&C 160: Missing / Recommend screens on the DOWNSTAIRS PRIMARY BEDROOM BATHROOM exhaust fan exterior vent termination cap per standards to help prevent critter intrusion.

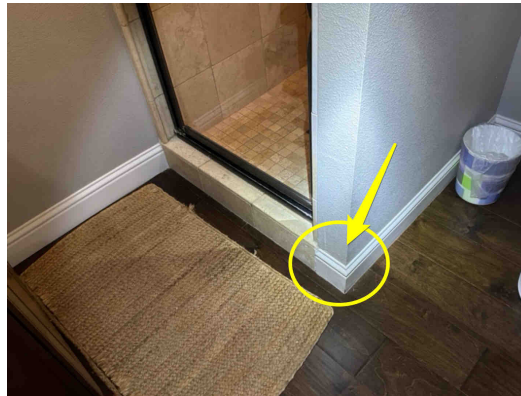
FI 163: Minor moisture stains & damage to baseboard outside shower: UPSTAIRS HALL NORTH END BATHROOM

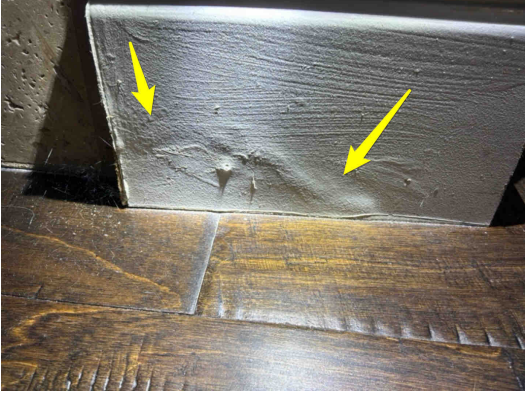
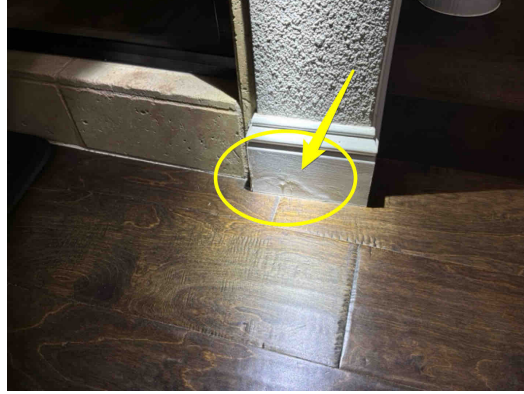
FI 164: Some minor moisture stains and swelling of the baseboards at the walls outside shower: DOWNSTAIRS PRIMARY BEDROOM BATHROOM

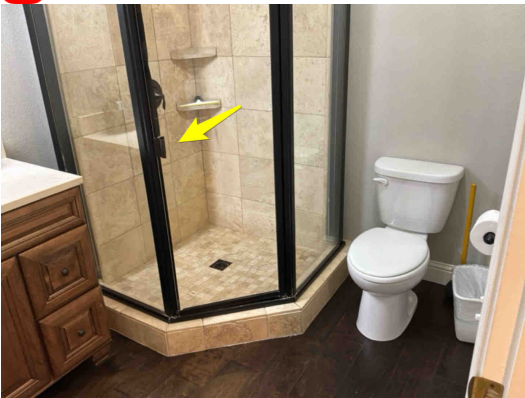
E&C 165: Glass shower door does not seal or latch well: UPSTAIRS HALL

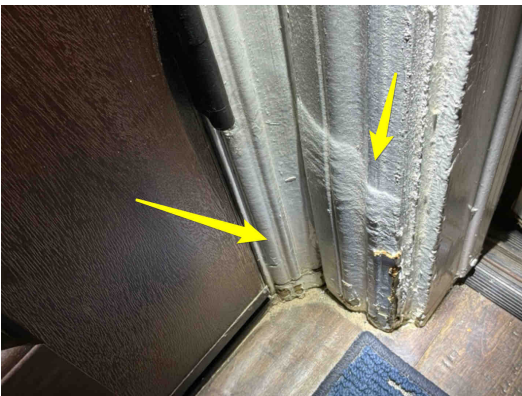
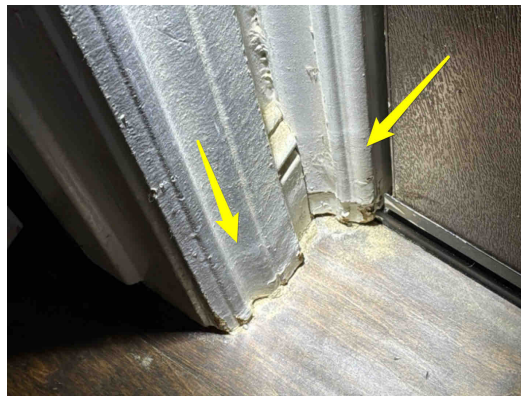
FI 172: Evidence of past water intrusion from around the DOWNSTAIRS STAIRWAY exterior door with stains and/or damage on the interior.

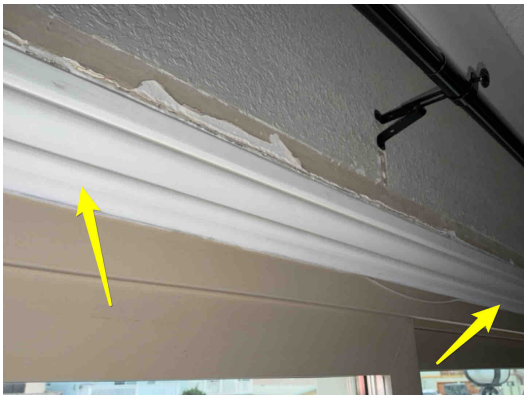
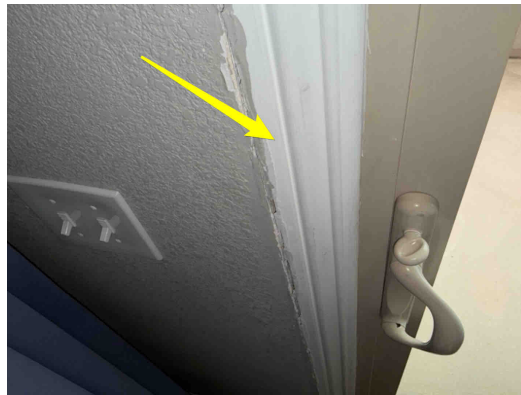
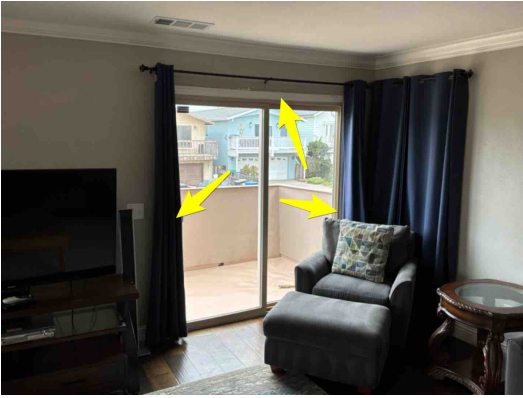
FI UPG 175: Some loose trim installation found around the UPSTAIRS SLIDING GLASS DOOR TO THE FRONT DECK.

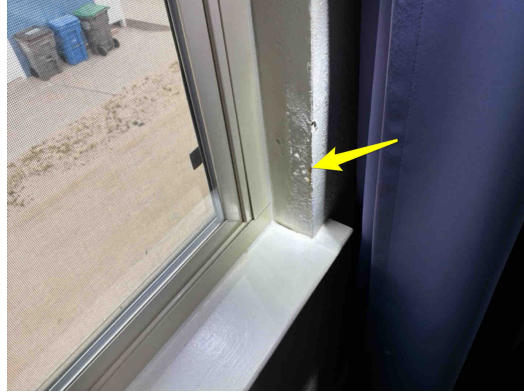
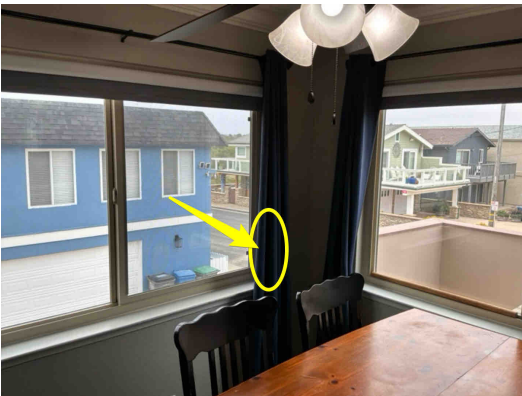
FI 180: Moisture stains and/or damage on the inside at some window sill: Example - UPSTAIRS DINING AREA.
Refer to the termite report for additional comments and recommendations.

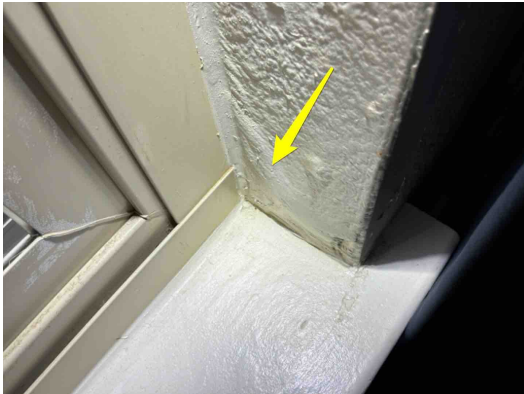
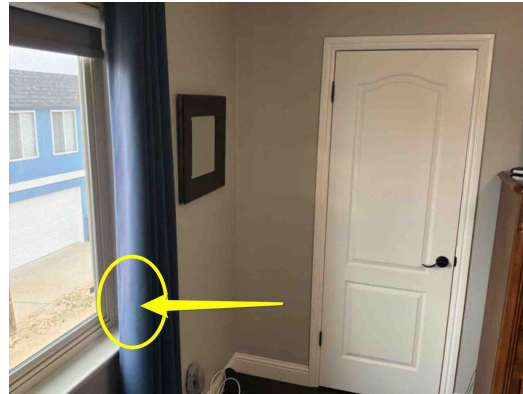
FI 182: Moisture stains and/or damage on the inside at some window sill: Example - UPSTAIRS BEDROOM-1. Refer to the termite report for additional comments and recommendations.

Soft drywall

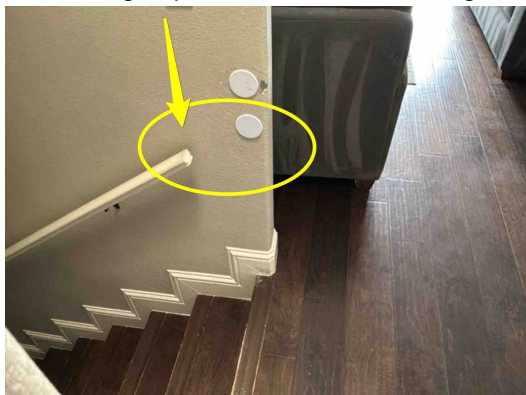
196: The graspable handrail does not go all the way to the top of the UPSTAIRS FAMILY ROOM stairway.

Handrail stop shorts at the top of the stairway

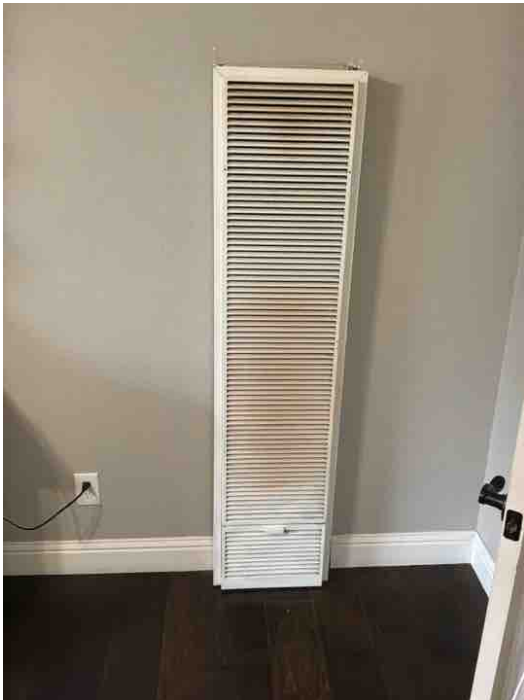
SC SU 198: A Natural Draft Gas Wall Heater is Installed in the **DOWNSTAIRS PRIMARY BEDROOM** - **This is considered a Safety Concern by today's standards.**

A 35,000 BTU gas wall heater was observed installed inside a sleeping room. This unit is not a direct-vent (sealed combustion) type, meaning it draws combustion air from the room and discharges combustion gases into the same space.

Current California Mechanical Codes [CMC §303.3 and California Health & Safety Code §19881] do not permit non-direct-vent gas-fired heaters in sleeping rooms due to the potential for oxygen depletion, carbon monoxide accumulation, and fire hazards unless certain conditions exist.

UPG DS 199: *The average life of this type of gas wall furnace is +/- 35 years. This furnace is approximately 50 years old and may be nearing the end of its useful life. Due to the age of this furnace it may fail without warning. Monitor often.*

- Have this condition evaluated by a qualified, licensed HVAC contractor and the local building department for code compliance.
- Replacement with a sealed-combustion, direct-vent model is typically required for safety.
- Do not operate the heater until it has been confirmed safe and compliant with all current codes.

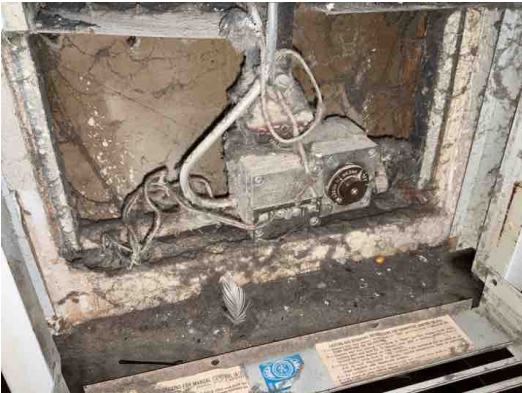
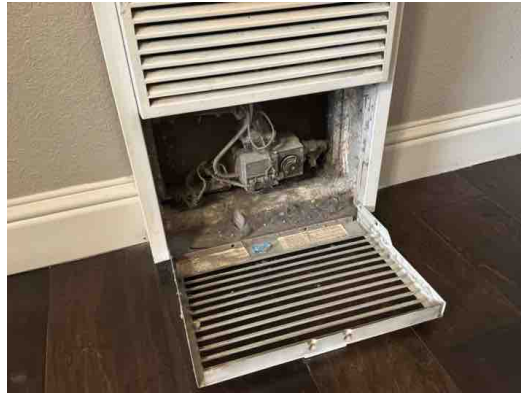
MR SU 200: Recommend cleaning the controller compartment under the gas wall furnace in the **DOWNSTAIRS PRIMARY BEDROOM**. Maintenance needed / recommended.

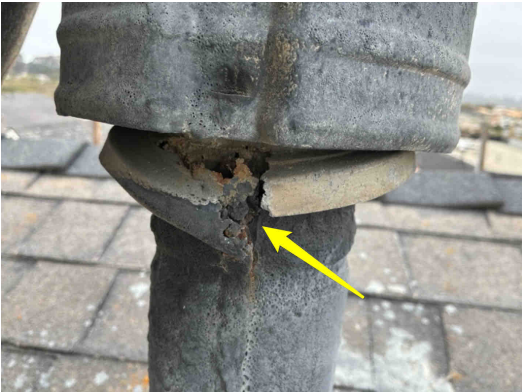
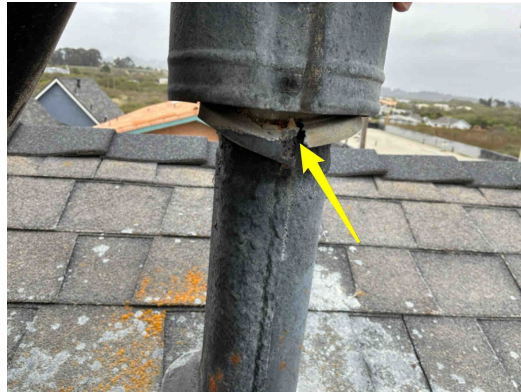
E&C 202: Damaged gas wall furnace vent termination cap at the roof from the DOWNSTAIRS PRIMARY BEDROOM. Recommend replacement.

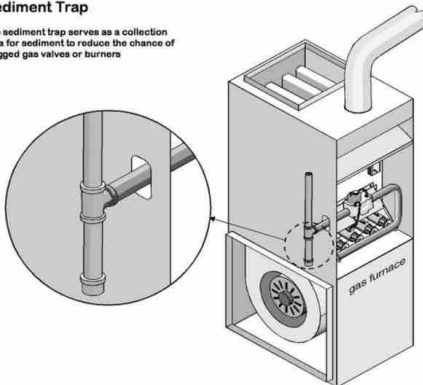
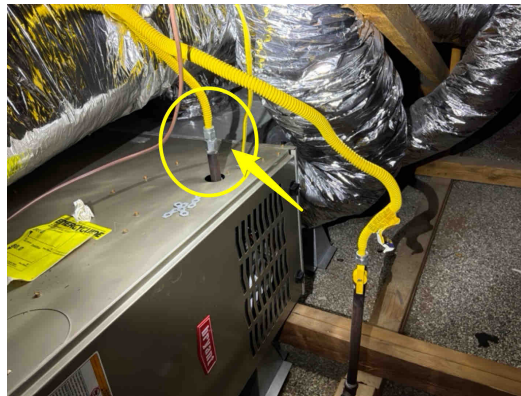
Sediment Trap

UPG 209: Missing the required installation of the sediment trap at the furnace gas piping at flex connection. Correction should be performed by a certified or licensed HVAC professional familiar with minimum requirements.

The sediment trap serves as a collection area for sediment to reduce the chance of clogged gas valves or burners

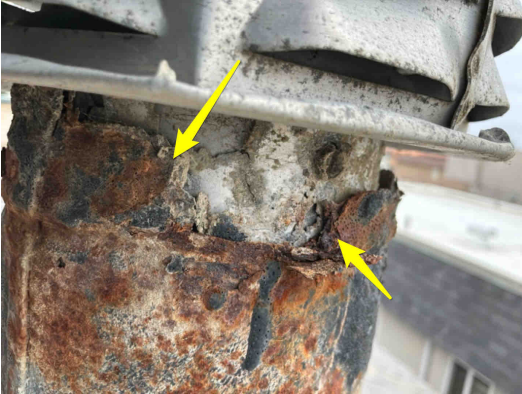
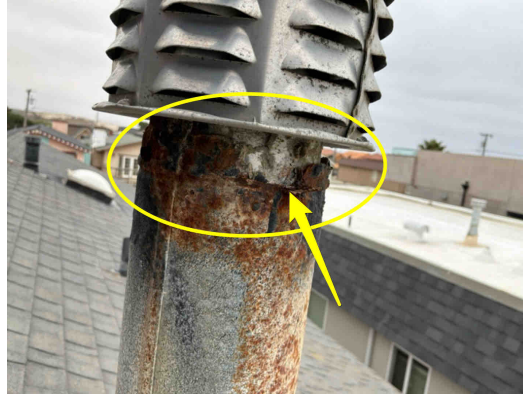
E&C 210: Rusted and damaged vent pipe found at the furnace vent termination at the roof. Recommend replacement of the damaged vent pipe by a qualified & licensed HVAC contractor.

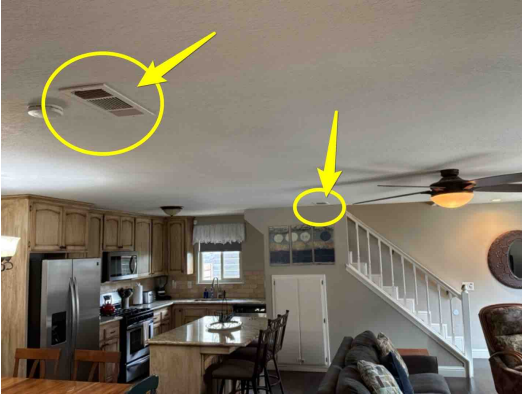
FI 211: The TWO DOWNSTAIRS heating resistors did not function or did not function properly when the heating system was tested. Recommend additional review by licensed HVAC contractor.

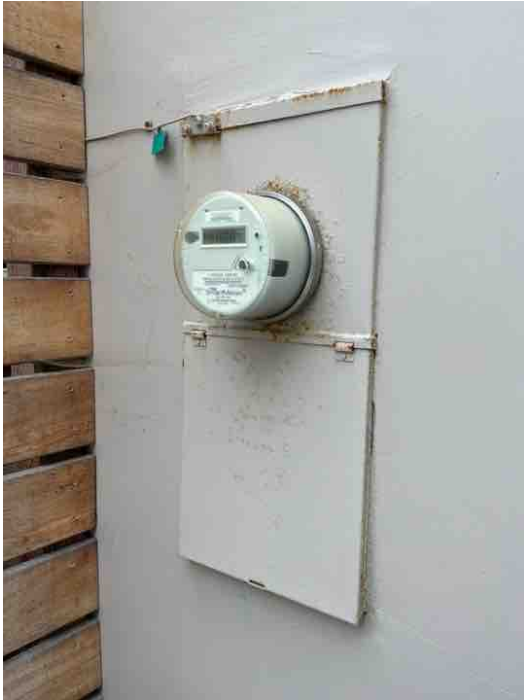
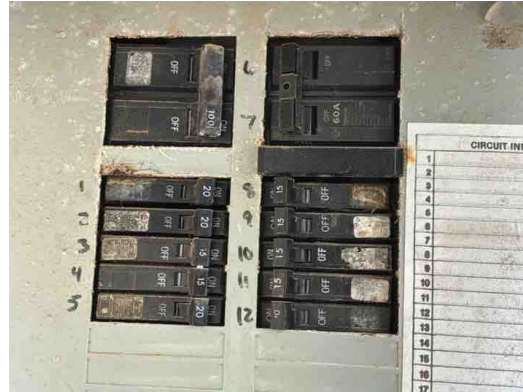
DS 216: There does not appear to have the appropriate amount of circuits in the main electrical panel for the entire house and the two kitchens. No electrical sub panel located. However, there is a 60 amp breaker in the main electrical panel that is not labeled that may go to a sub panel that was not located today. Recommend additional review to determine if a sub panel is present and have it inspected once located by an appropriate qualified electrical contractor.

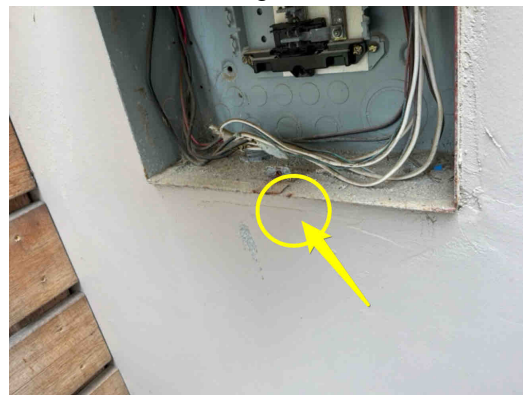
UPG 218: The MAIN ELECTRIC PANEL cover lock is broken, missing.

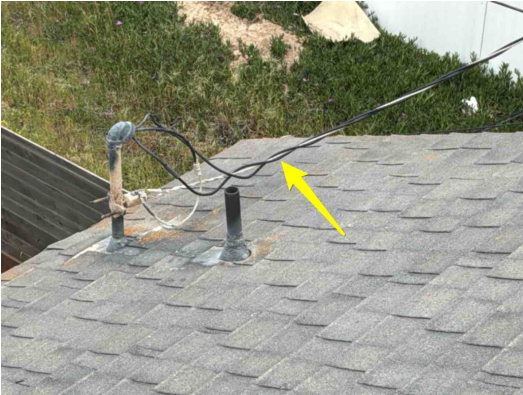
Example

SU 219: The overhead electrical service wires found to be improperly installed and are considered unsafe as the wires are hanging too close to the ROOF. A minimum of (18 inches.) needed above a roof for safety per standards. Recommend further review and repair by a qualified and licensed professional familiar with the minimum installation requirements.

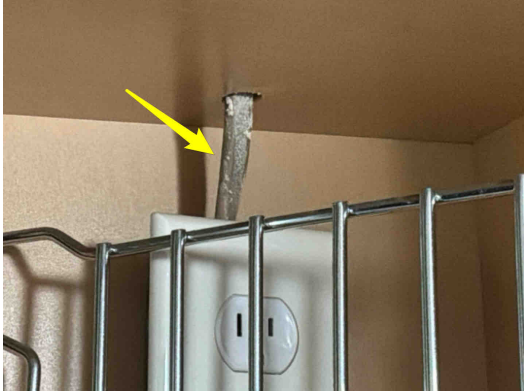
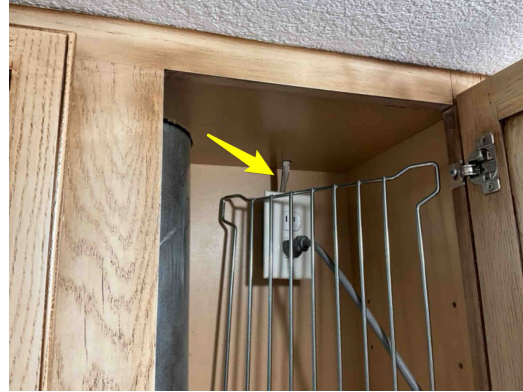
SC 223: Improper exposed electrical wiring, "Romex" improperly installed subject to physical damage, not in a conduit or raceway per standards: UPSTAIRS KITCHEN - in the cabinet above the microwave.

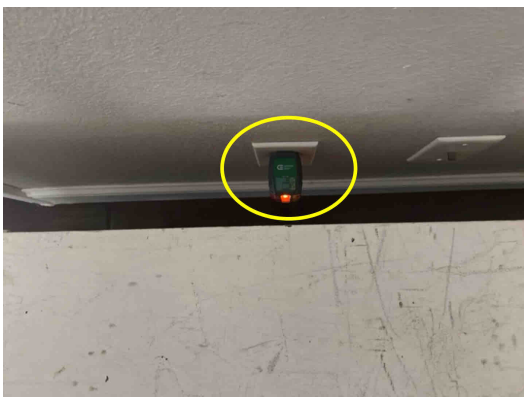
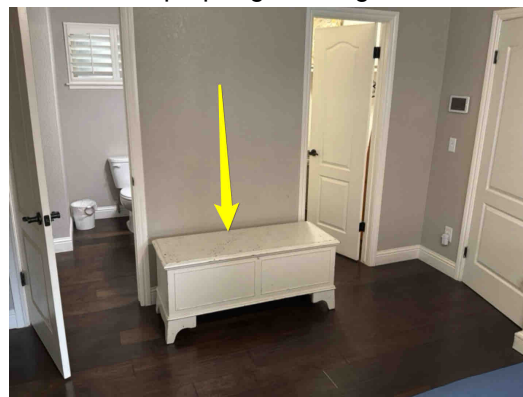
At the outlet behind the Hope chest

SC 225: Three-prong electrical outlets did not test properly grounded: on the WEST WALL in the DOWNSTAIRS PRIMARY BEDROOM. Have electrician check all outlets for proper grounding.
