Inspection Report

Address: 333 York Ave Oceano, CA 93445

03/10/2026

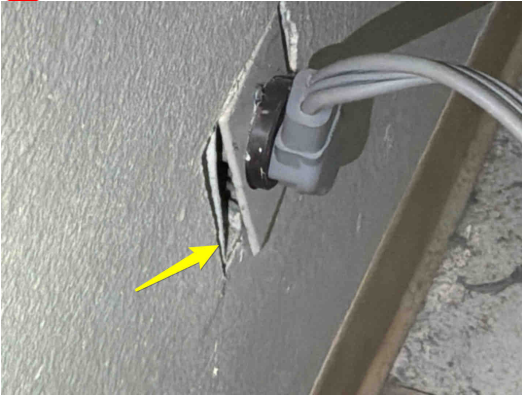
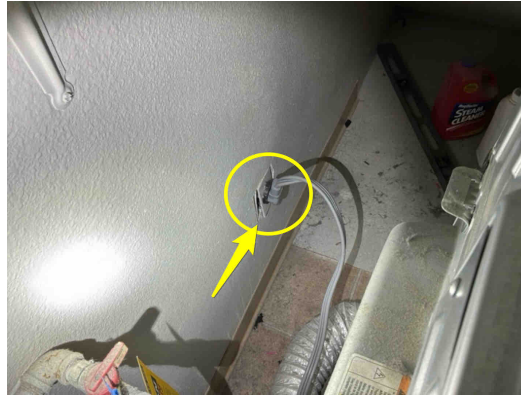
SC 229: loose electrical cover plate at THE LAUNDRY ROOM 240 VOLT OUTLET.

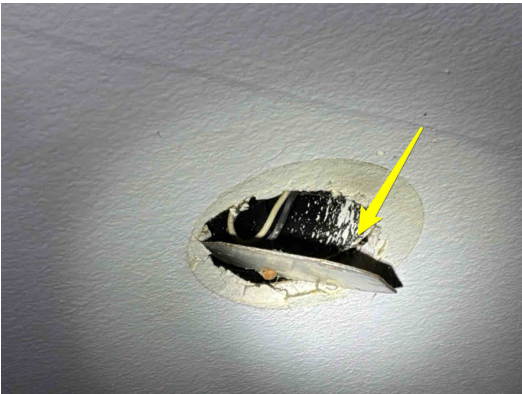
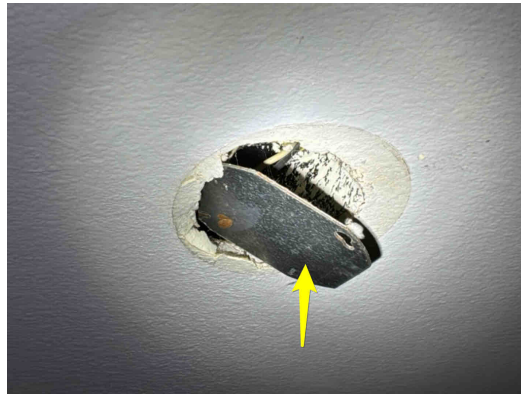
SC 230: A loose / open electrical box cover plate: IN THE WEST END GARAGE AT A CEILING ELECTRICAL JUNCTION BOX.

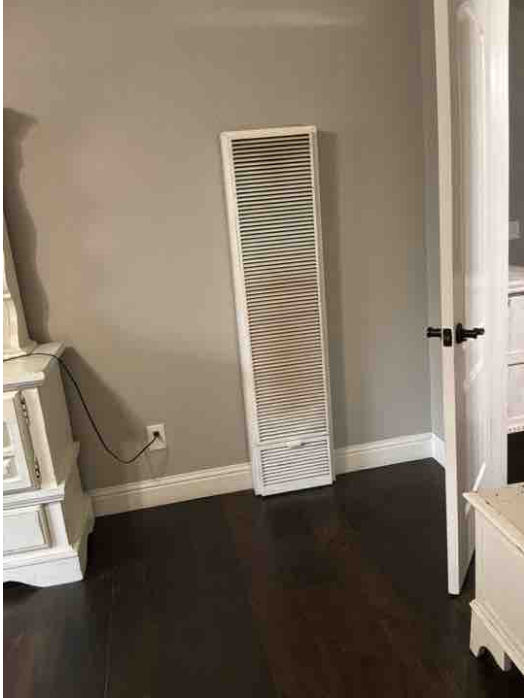
SC 233: Carbon Monoxide detector missing at the required location:

- 1. INSIDE THE DOWNSTAIRS PRIMARY BEDROOM-due to the installation of a gas wall heater inside a sleeping room.**
- 2. IN THE UPSTAIRS FAMILY ROOM**
- 3. IN THE UPSTAIRS BEDROOM HALLWAY**

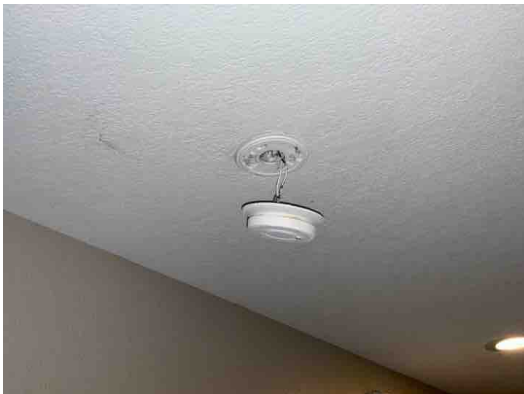
E&C 234: The smoke detector found loose and hanging from the ceiling. Repair is needed: UPSTAIRS AT THE TOP OF THE NORTH END STAIRCASE

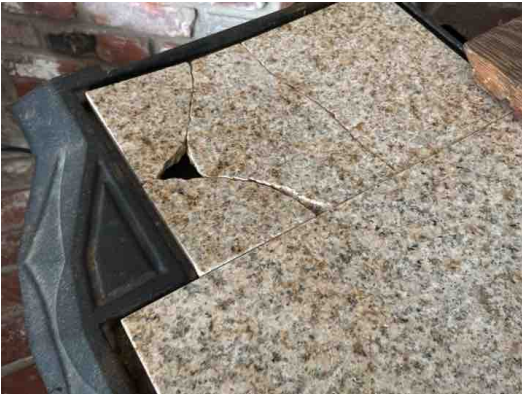
E&C 253: THE FIREPLACE CONDITION: The UPSTAIRS FAMILY ROOM FREESTANDING GAS Fireplace did not operate when tested, found rusted, deteriorated with some damaged stones at the top of the fireplace and an improper vent termination at the top of the fireplace chimney. Fireplace found to be in need of servicing, maintenance and repair. Contact the Gas Company for a free evaluation or a qualified gas fireplace service technician to evaluate and correct all issues as needed.
