### *Inspection Report*

Address: 904 Hartford St Cambria, CA 93428

03/20/2026

Inspector: Keith Vreeken, MCI, FCI  
P.O. Box 415 Templeton, CA 93465 O: 805.462.1978 C: 805.440.5050

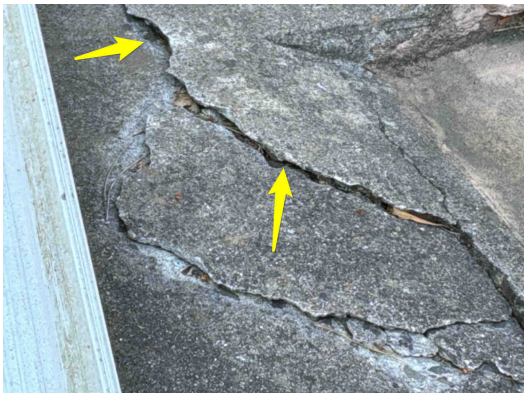
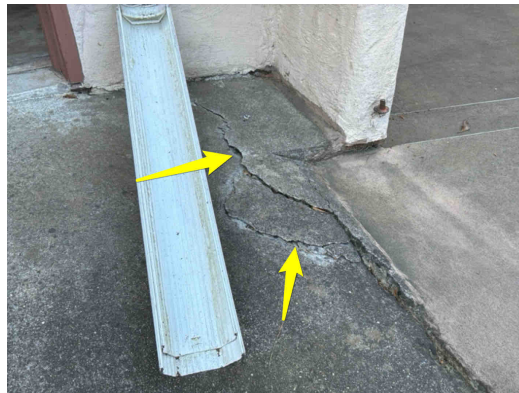
Example

**UPG 15:** Some common and moderate cracks found in areas of the driveway. Client should investigate further the cause and correct.

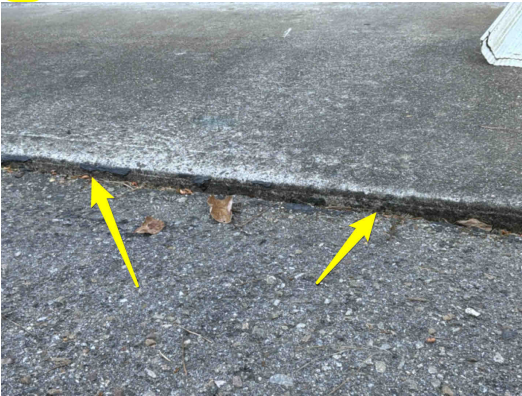
Example

**SU 16:** Areas of the driveway are uneven with potential trip hazards. Upgrades recommended.

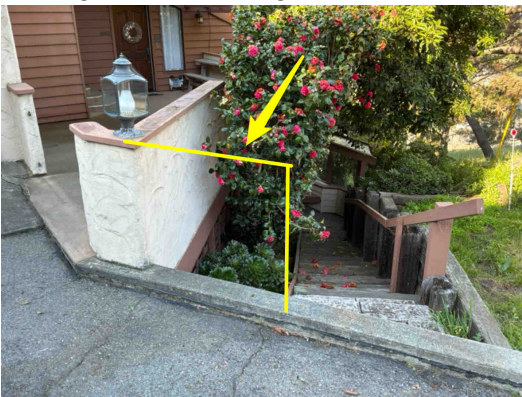
**SU 21:** Railings are missing / recommended at edge West side of the driveway, at the drop off along the driveway to the ground below is greater than 30 inches, to help prevent a fall.

Location of a recommended railing

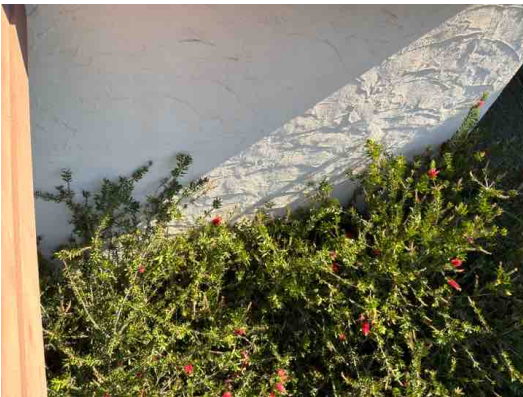
**MR 30:** Areas of the exterior are not fully visible and not inspectable due to overgrown foliage. Conditions behind the foliage in areas not visible are unknown. Client is advised to have the overgrown foliage removed and to have the areas reinspected.

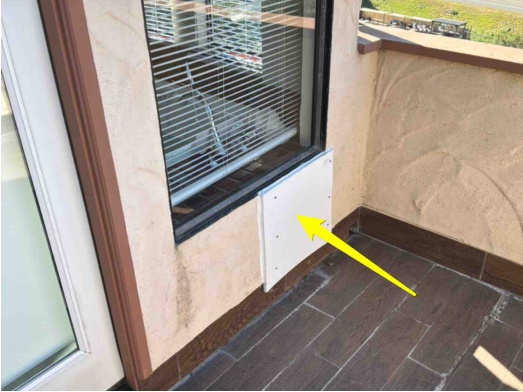
**FI 34:** Unusual improper nonprofessional exterior stucco repair found off the primary bedroom bathroom tub at the exterior waterproof deck OFF THE UPSTAIRS PRIMARY BEDROOM

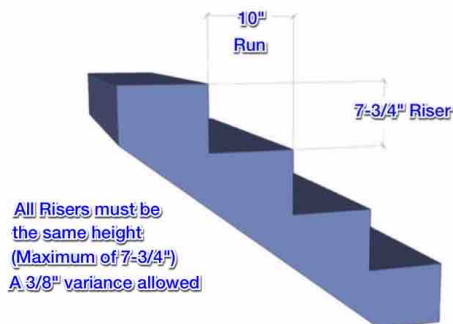
**SC FI 40:** The Stack Railroad Tie exterior stairway - OFF THE WEST SIDE OF THE DRIVEWAY found unsafe due to the improper construction and/or physical damage.

**E&C 41:** The Stack Railroad Tie exterior stairway - OFF THE WEST SIDE OF THE DRIVEWAY does not meet minimum construction and safety standards, potential fall hazard.

**MR 42:** Earth-to-wood contact at the exterior wood framed Stack Railroad Tie exterior stairway - OFF THE WEST SIDE OF THE DRIVEWAY. Refer to a termite report for additional comments and recommendations.

**SC 43:** Uneven step tread rise, step heights are not all the same, at the Stack Railroad Tie exterior stairway - OFF THE WEST SIDE OF THE DRIVEWAY. Potential trip or fall hazard.

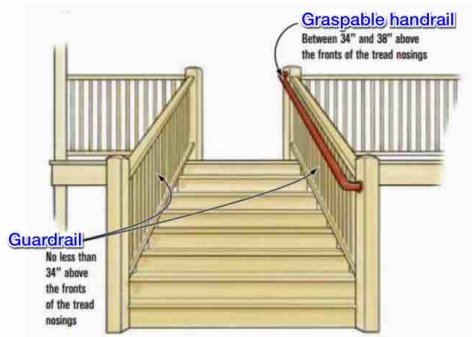
**SC SU 46:** Missing a required proper graspable handrail at the Stack Railroad Tie exterior stairway - OFF THE WEST SIDE OF THE DRIVEWAY. The current 2 x 4 handrail does not meet minimum requirements.

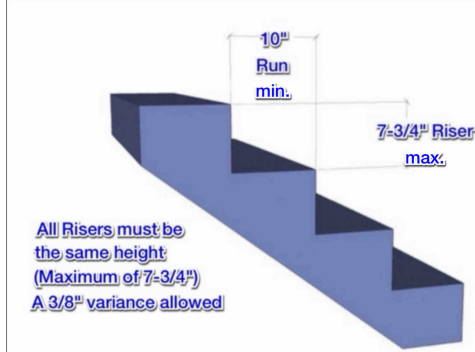
**SC FI 48:** The Stack Railroad Tie exterior stairway - OFF THE EAST SIDE OF THE DRIVEWAY found unsafe due to the improper construction and/or physical damage.

**E&C 49:** The exterior stairway OFF THE EAST SIDE OF THE DRIVEWAY does not meet minimum construction and safety standards, potential fall hazard.

**MR 50:** Earth-to-wood contact at the Stack Railroad Tie exterior stairway - OFF THE EAST SIDE OF THE DRIVEWAY. Refer to a termite report for additional comments and recommendations.

**SC 51:** Uneven step tread rise, step heights are not all the same, at the Stack Railroad Tie exterior stairway - OFF THE EAST SIDE OF THE DRIVEWAY. Potential trip or fall hazard.

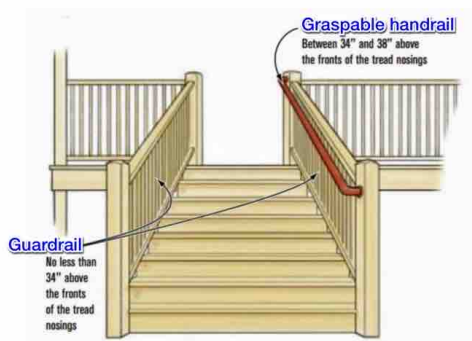
**SC 54:** Missing a required proper graspable handrail at the Stack Railroad Tie exterior stairway - OFF THE EAST SIDE OF THE DRIVEWAY.

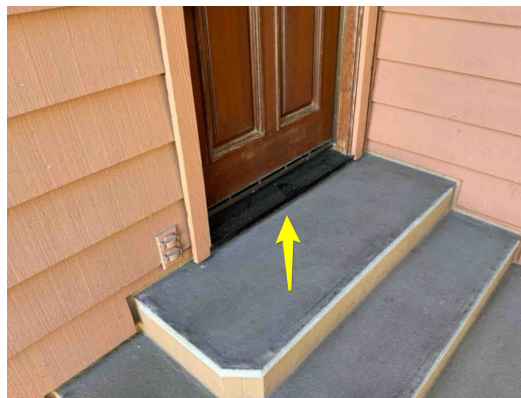
**DS 58:** Waterproof deck found to be installed a little too high at the door thresholds at the FRONT ENTRY DECK. There should be a minimum of 2 inches between the bottom of the siding and door threshold to the surface of the deck. This could potentially lead to deterioration and water intrusion. Contact a waterproof deck professional for additional comments and recommendations.

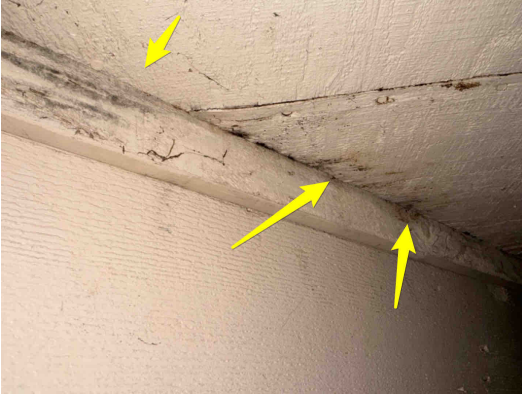
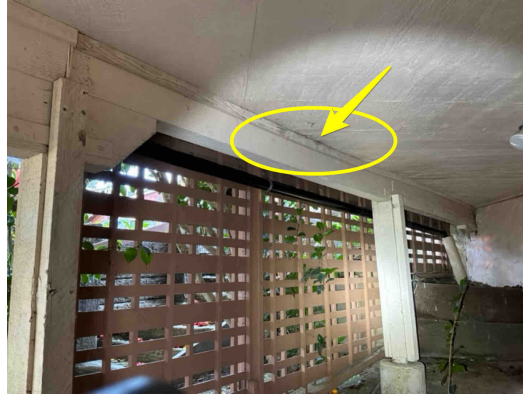
**FI 59:** Suspected leaking of the waterproofing at the FRONT ENTRY WATERPROOF DECK. Stains and moisture damage noted on the underside of the waterproof deck. Recommended further review and opinion by a licensed waterproof decking contractor familiar with water testing and/or leak detection standards to determine if deck is actively leaking and if repairs are warranted.

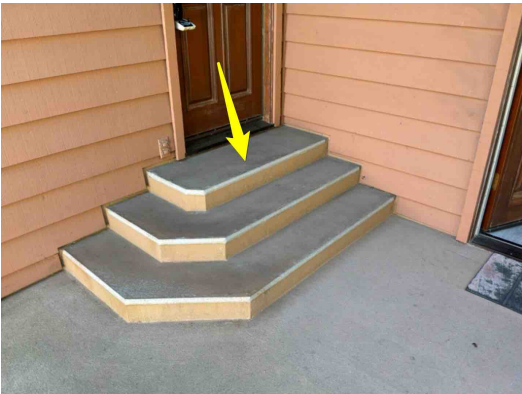
**UPG 60:** Missing / Recommend a proper 3-foot exterior door landing per standards off the FRONT ENTRY exterior door TO THE UPSTAIRS BONUS ROOM

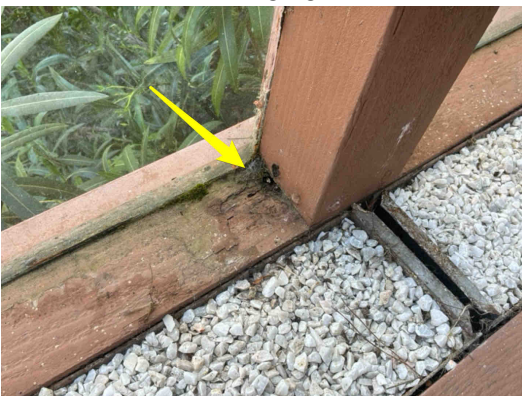
Example

**E&C 66:** Some moisture stains and damage noted at areas of the railings at the WEST SIDE YARD LOWER DECK Wood and Glass railing / glass wall. Refer to termite report for additional comments and recommendations.

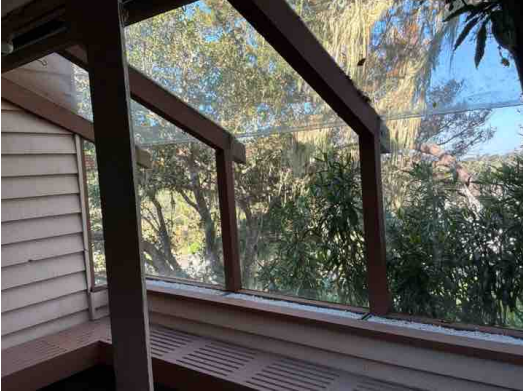
**SU DS 67:** Unable to verify if glass walls and ceiling at the WEST SIDE YARD LOWER DECK is tempered glass.  
No visible watermark or stamp

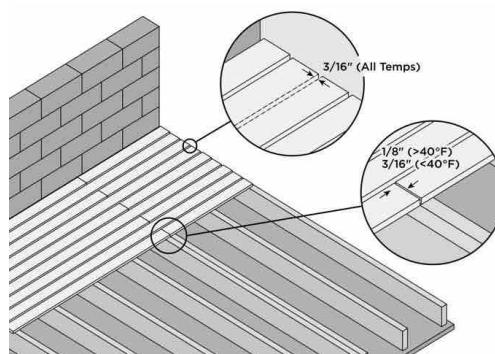
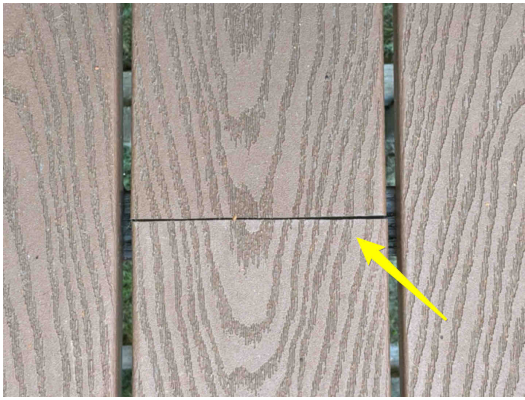
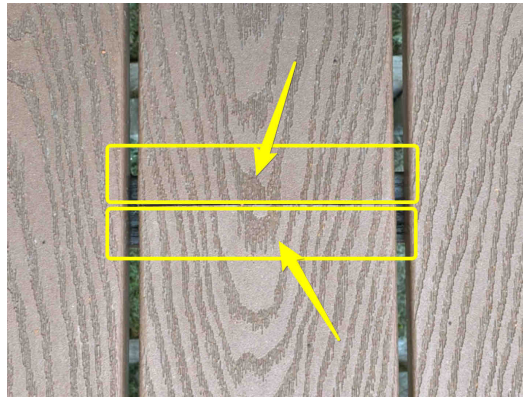
**E&C 72:** Installation of the UPSTAIRS DECK OFF THE DINING ROOM synthetic planks do not meet minimum installation standards. The end splices at the synthetic deck planks are required to have a minimum of 1-1/2 inch support under each side of the end splice. Currently the joints are only supported by splitting the single 1-1/2 inch joist and is supported by only 3/4 of an inch. Proper blocking at each splice per minimum standards is recommended per the installation requirements.

Joints at synthetic decking cannot split a single floor joist

For butt joints, where boards meet over a single joist, add a 2" x 4" "nailer" board at the butt joint. This allows screw-in at 90 degrees and allows fasteners to be used at end of each board.

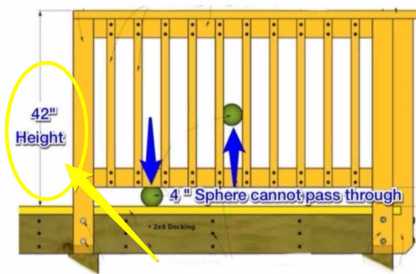
**SU 74:** The height of the deck railings at the UPSTAIRS DECK OFF THE DINING ROOM do not meet current standards. Upgrades Recommended for safety.

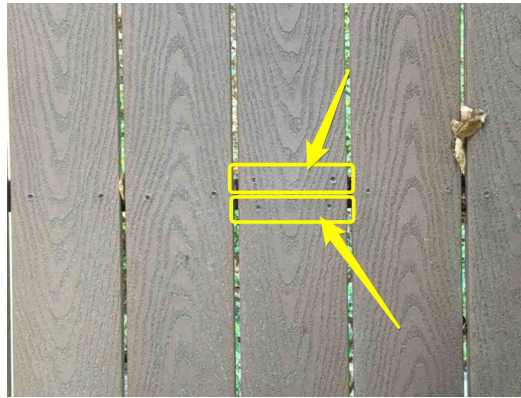
**E&C 77:** Installation of the UPSTAIRS DECK OFF THE FAMILY ROOM synthetic planks do not meet minimum installation standards. The end splices at the synthetic deck planks are required to have a minimum of 1-1/2 inch support under each side of the end splice. Currently the joints are only supported by splitting the single 1-1/2 inch joist and is supported by only 3/4 of an inch. Proper blocking at each splice per minimum standards is recommended per the installation requirements.

Joints at synthetic decking cannot split a single floor joist

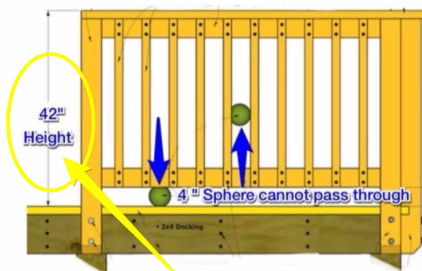
**SU 79:** The height of the deck railings at the UPSTAIRS DECK OFF THE FAMILY ROOM do not meet current standards. Upgrades Recommended for safety.

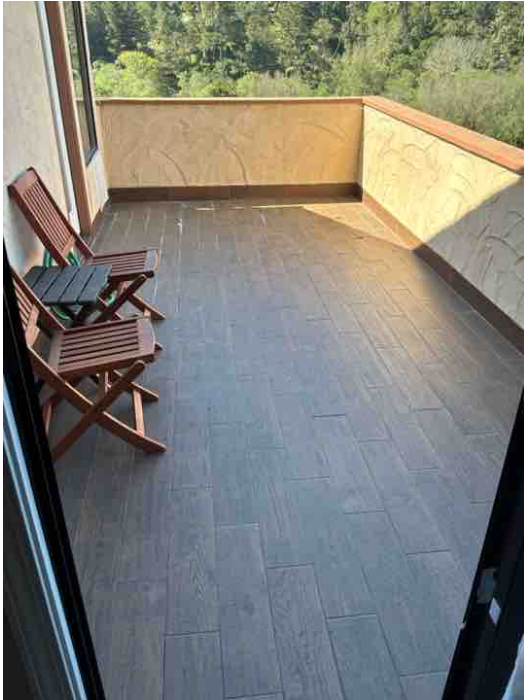
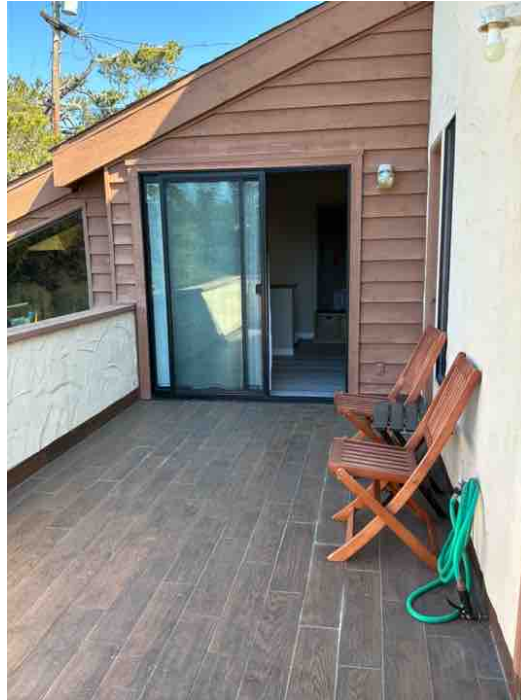
80: DECK LOCATION: **OFF THE UPSTAIRS PRIMARY BEDROOM**

**E&C** **UPG** **81:** Missing the proper secondary overflow drains at the tiled waterproof decking at the OFF THE UPSTAIRS PRIMARY BEDROOM per [CPC §1108.]. The secondary deck drain or scupper must have its inlets located at 2 inches above the primary deck drain inlet, should be below the door threshold, and discharge to a conspicuous above grade location to serve as a visible warning of blockage. Evaluation and correction by a qualified licensed contractor is advised. If scuppers are used they must be a minimum of 4" tall. There should be one secondary overflow drain for each primary drain inlet.

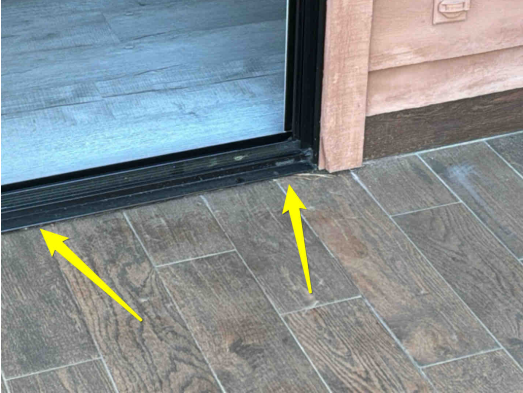
**FI DS 83: Disclosure:** Areas of the OFF THE UPSTAIRS PRIMARY BEDROOM tiled waterproofed deck were improperly installed at or above exterior siding, door trim and/or exterior door threshold. A minimum of 2 inches is needed from the bottom of the door threshold to the top of the tile unless other specific upgrades were performed during construction. This could lead to water intrusion inside the building. Recommend monitoring, maintenance and upgrades to help ensure water tightness and integrity of the walls and door thresholds.

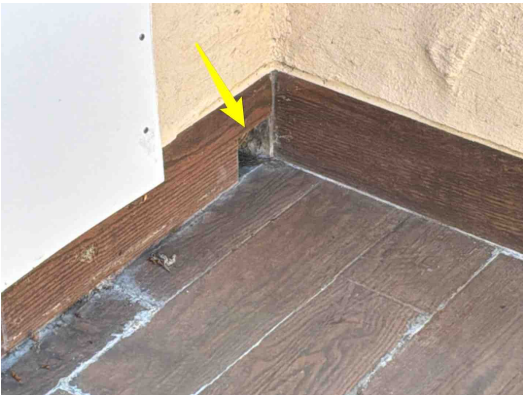
**84:** Inadequate quantity of deck drains provided for the tiled waterproof deck OFF THE UPSTAIRS PRIMARY BEDROOM.

A single scupper drain

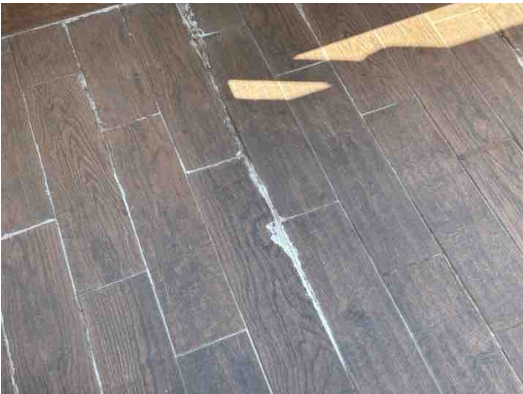
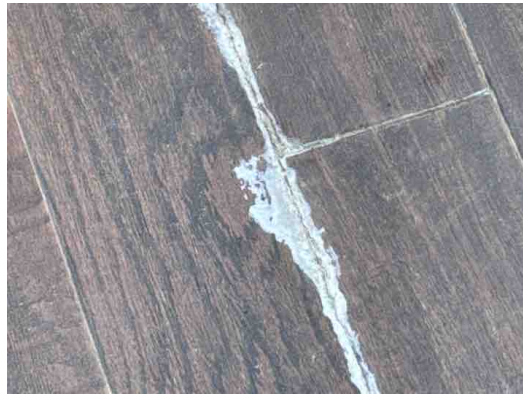
**85:** Some unusual calcification found at some of the grout joints at areas of the tiled waterproof deck OFF THE UPSTAIRS PRIMARY BEDROOM. Cause and condition should be investigated by a licensed waterproof deck installation contractor or a licensed tile install installation contractor.

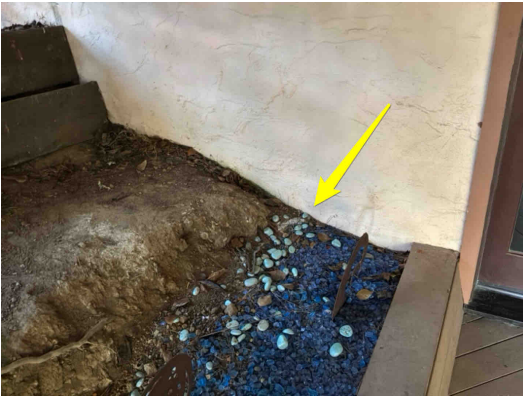
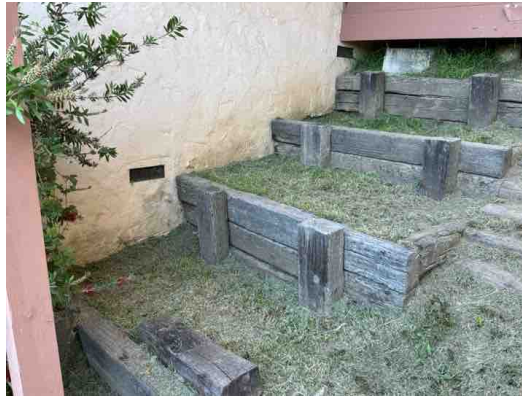
**E&C MR 89:** Soil level found high at areas of the perimeter along the foundation. (Recommend 6 inches from the bottom of the interior floor level and all wood wall framing to the exterior dirt, rock, mulch or wood chips).

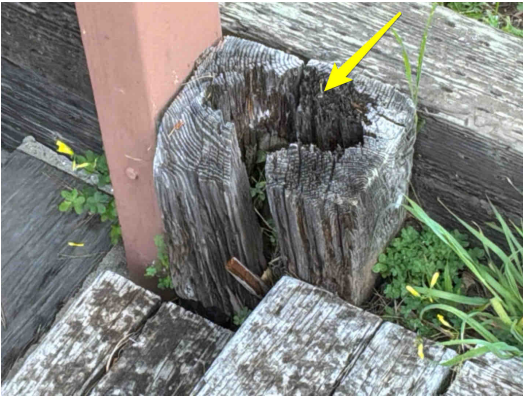
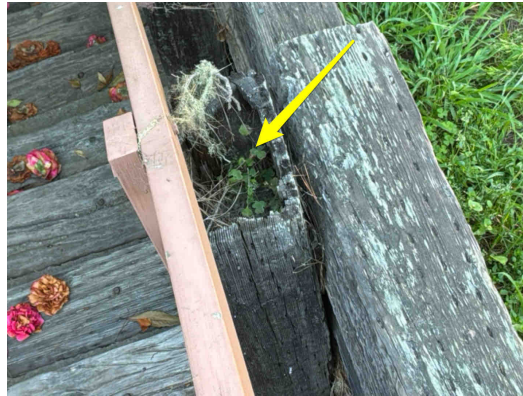
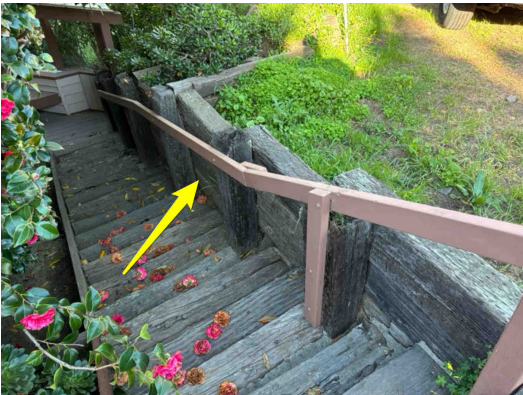
**E&C 92:** Some moisture damage, deterioration, and/or leaning of the railroad tie wood retaining walls. *Be aware that wood retaining walls have a limited lifespan and will warrant eventual replacement. Monitor all wood walls and upgrade or repair as needed.*

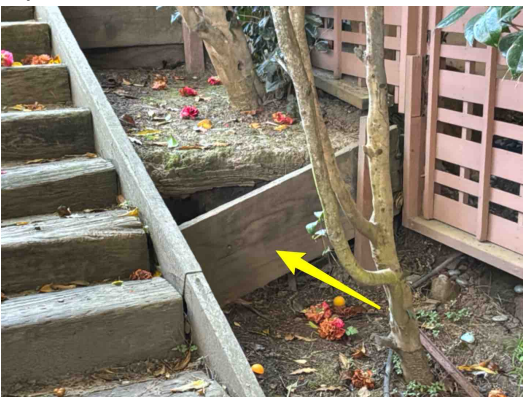
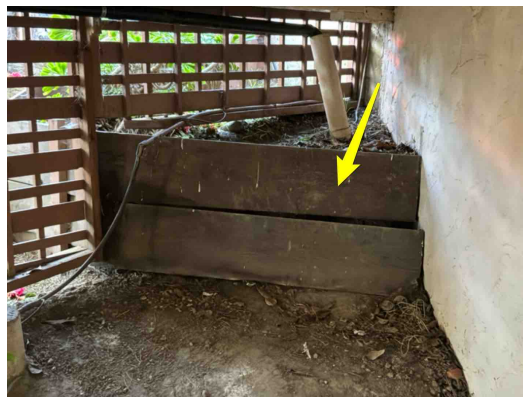
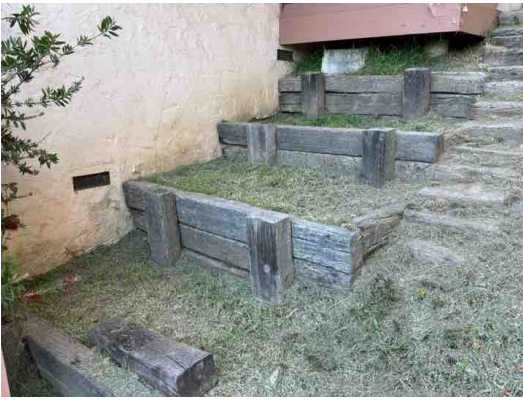
**E&C 93:** Some moisture damage, deterioration, and/or leaning of the wood retaining walls. *Be aware that wood retaining walls have a limited lifespan and will warrant eventual replacement. Monitor all wood walls and upgrade or repair as needed.*

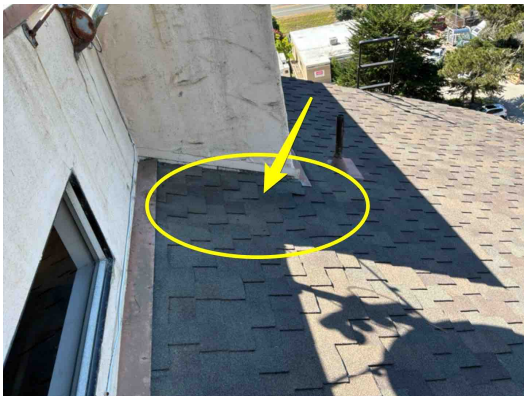
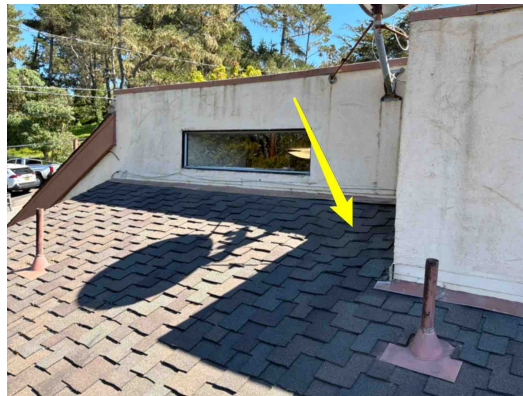
**SC FI 110:** An unusual soft spot found at the roof framing. Some excessive moisture damage to the roof sheeting and possibly the roof attic framing with a large dip in the roof shingles: **OUTSIDE THE KITCHEN WINDOW OVER THE UPSTAIRS BONUS ROOM OVER THE GARAGE.** Recommend additional review by licensed roofing contractor.

Unusual soft spot in the roof framing. Suspected moisture damage

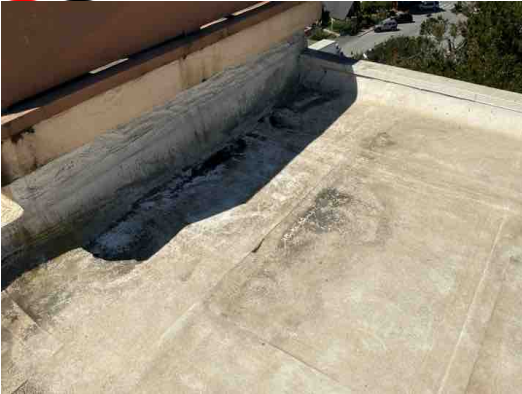
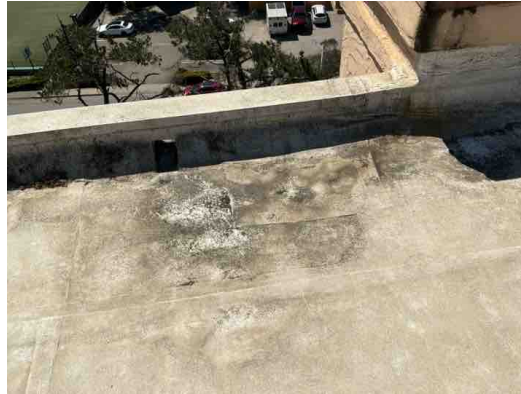
**FI DS 111:** Disclosure: Small areas of ponding water/ past ponding water on roof noted.

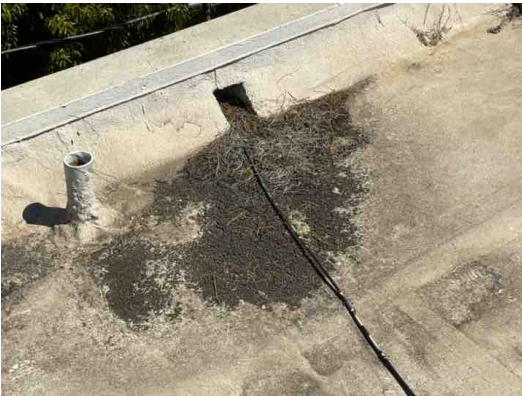
**FI MR 112:** Some debris buildup on areas of the roof and/or roof drainage inlets. Areas not fully visible. Continuous maintenance / cleaning warranted to help prevent roof leakage.

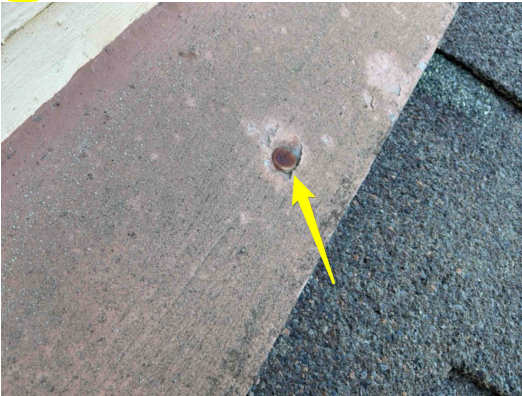
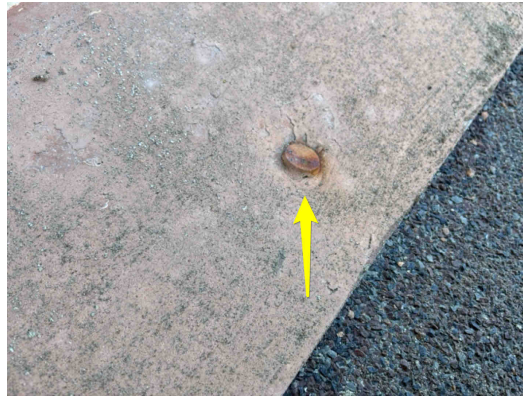
Example

**E&C MR 113: ROOF FLASHING CONDITION:** Some roof flashing were found to be needing maintenance, servicing and/or repair. Contact a qualified roofing professional to review all roof flashings and provide maintenance and/or repairs as needed.

**MR 114:** Recommend sealing all exposed nails at areas of roof/ roof flashing.

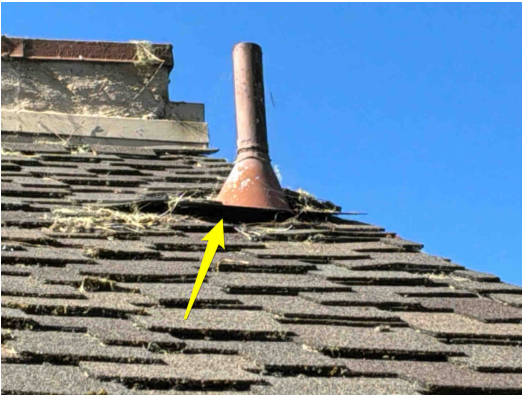
Example

**E&C MR 115:** Some lifting roof flashings. Corrections, maintenance or repairs are recommended to help prevent water intrusion and/or roof leakage from windy, wet weather.

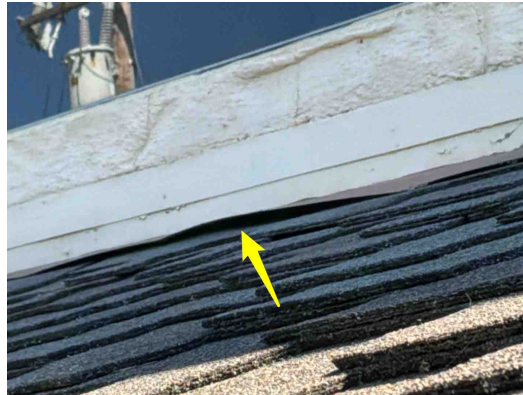
Example. At some head wall flash

**FI 116:** Some roof flashings found rusted and deteriorated. Maintenance or replacement of deteriorated and damaged roof flashings are recommended.

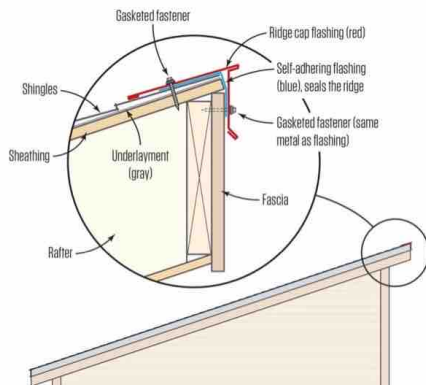
**E&C 117:** Missing a proper cap flashing at the top exposed area of the asphalt shingle single slope roof at some small areas .

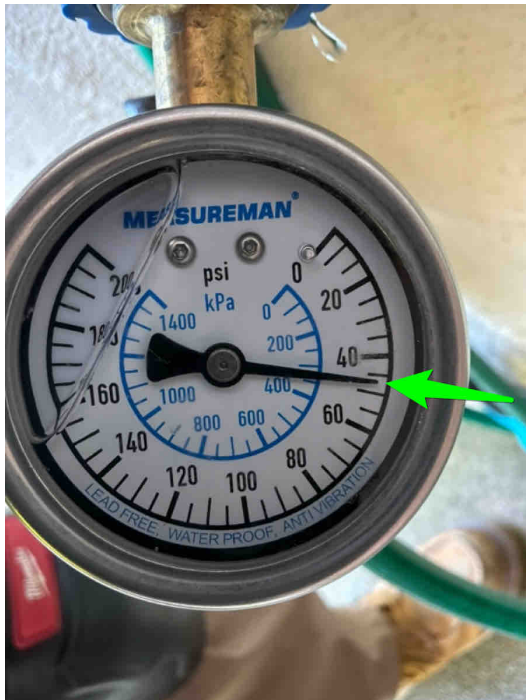
**124: Approx. water pressure PSI: 45**

*Maximum water pressure for CAMBRIA is: 50 psi.*

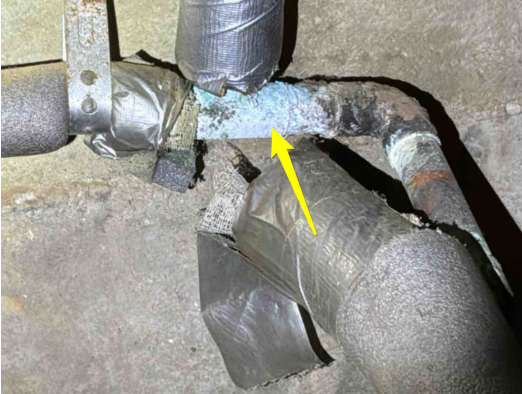
**E&C 129:** Some moderate corrosion noted at areas of the copper water supply piping in the crawlspace.

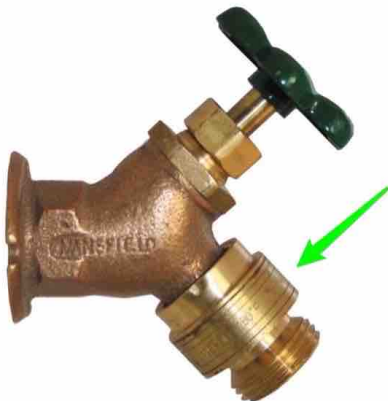
**UPG 132:** Anti-siphon valves are missing / recommended on all exterior hose faucets per Cambria requirements.

Example of an anti-siphon valve on a hose faucet

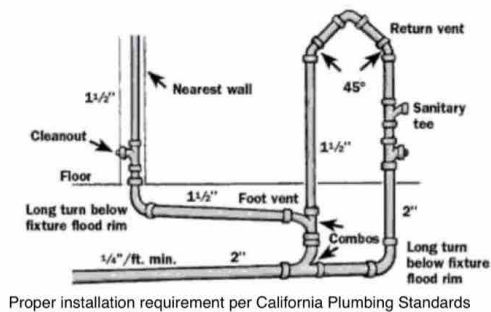
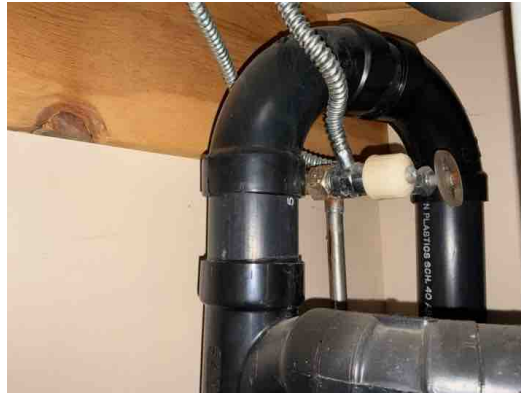
**E&C** **UPG** **134:** It is not recommended and is considered improper to install a 2 elbows to create the top of the vent at the kitchen wet bar "island" vent. However, the wet bar sink appears to be draining properly at this time.

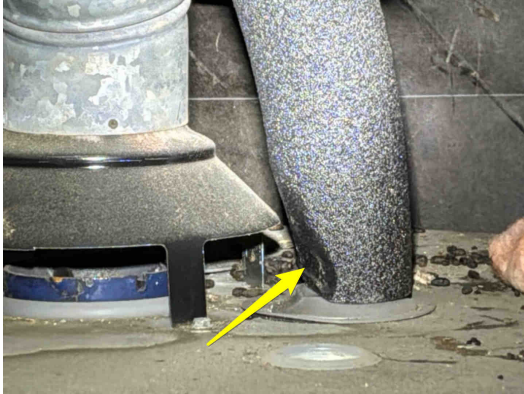
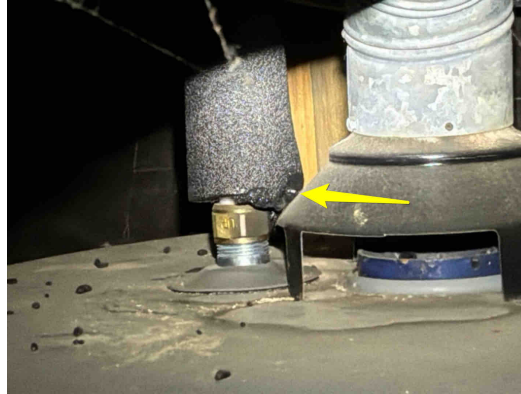
**SC 150:** Evidence of some minor back-venting of the water heater vent system. Some melting of the insulation around hot and/or cold water supply piping atop the water heater.

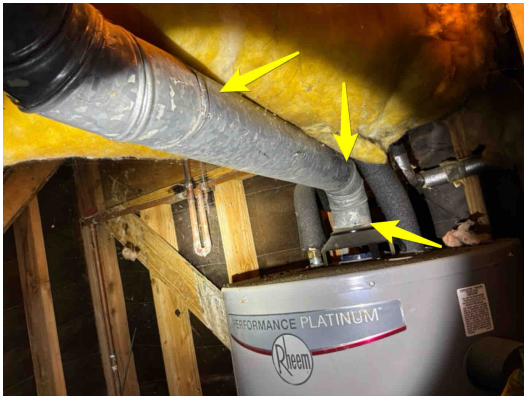
**SC 151:** Water heater vent connector pipe (single-wall) is not properly fastened with the required 3-fasteners at each connection including the draft hood per standards.

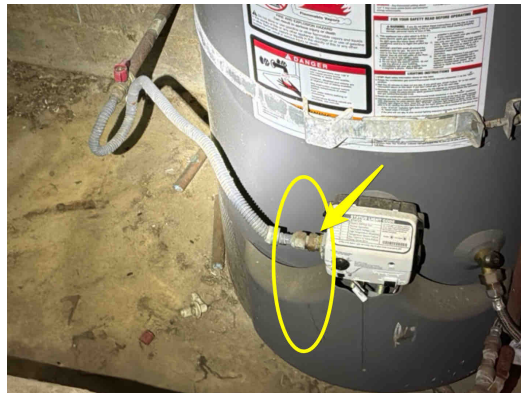
**SU 153:** Recommend the installation of the missing sediment trap / drip leg at the WATER HEATER gas piping at flex connection by a certified or licensed plumbing professional familiar with minimum requirements. [CPC 1212.8]

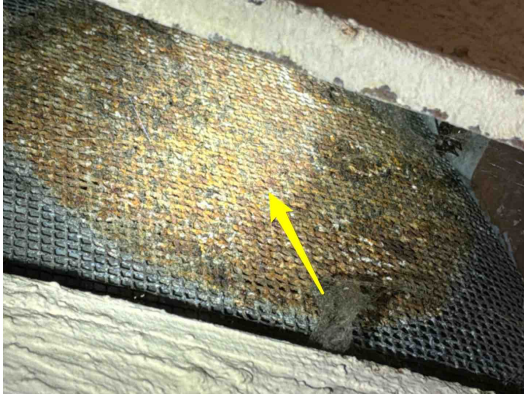
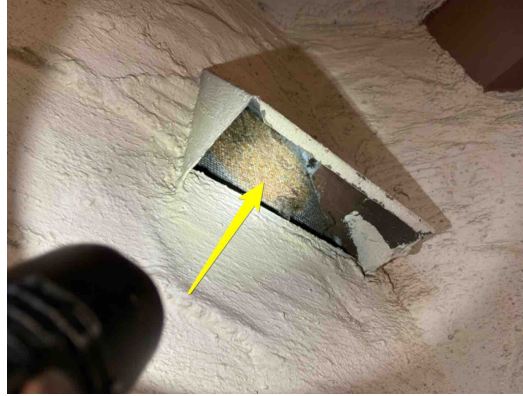
**MR UPG 168:** The screen in the exterior termination cap for the kitchen cooktop exhaust vent hood system found a little blocked or clogged. Upgrades recommended.

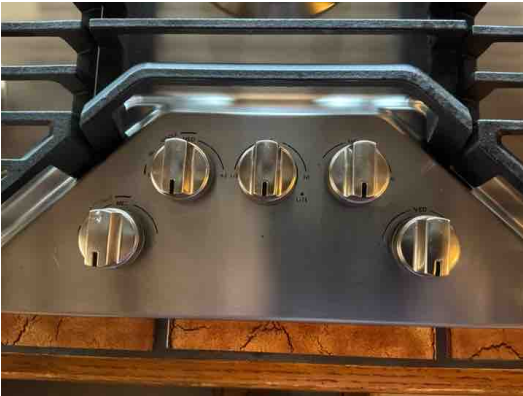
**SU 170:** Deteriorated labeling of the kitchen cooktop knobs. Deteriorated labeling at kitchen cooktop knobs, in some cases, can be considered a safety hazard as an occupant may not know where the actual or proper OFF is located which can lead the occupant to accidentally leave the cooktop on.

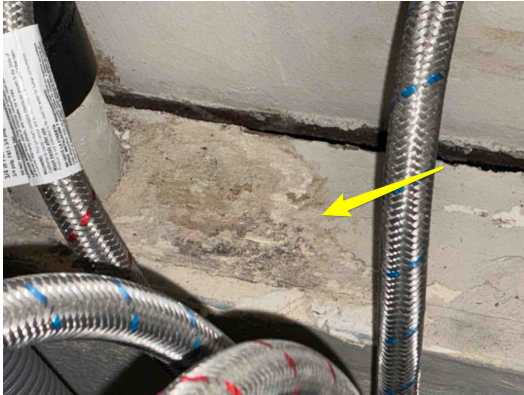
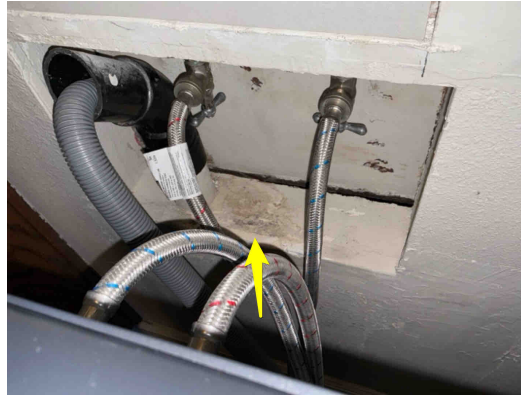
**FI 194:** Evidence of past water stains and damage on the drywall behind the laundry machines below the washing machine drain pipe. Area found dry today. Client should investigate further as to the cause, current condition, potential future issues and correct if needed.

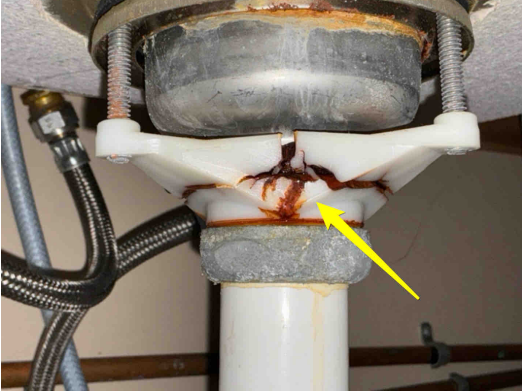
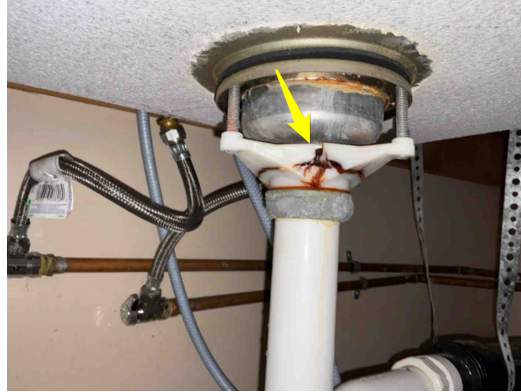
**E&C 198:** The connection of the LAUNDRY ROOM Utility sink drain pipe to the sink found cracked and damaged with evidence of ACTIVE leaking or water. Recommend for the repairs by a licensed plumbing professional.

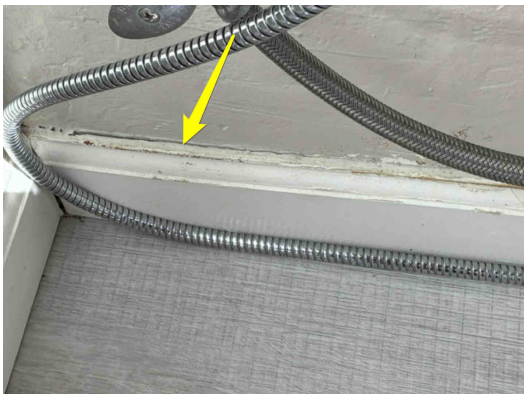
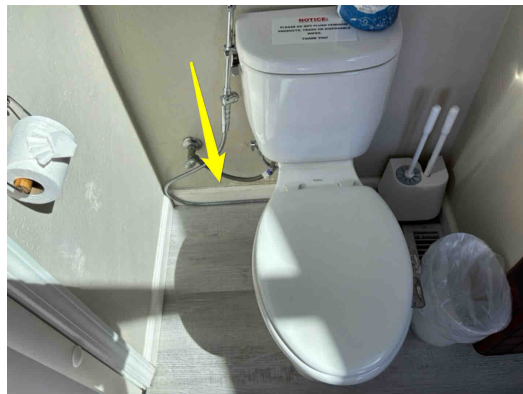
**FI 205:** Moisture stains and/or damage at the baseboard behind and/or around the toilet: PRIMARY BEDROOM BATHROOM. Conditions behind the baseboard are unknown.

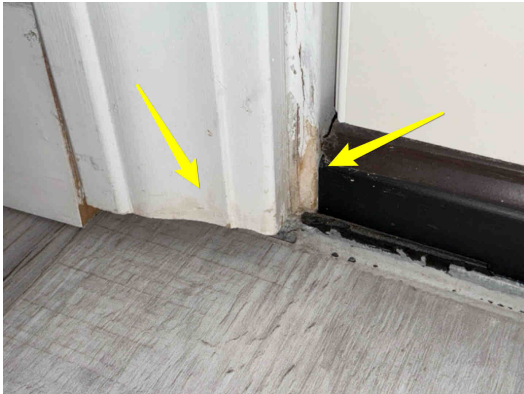
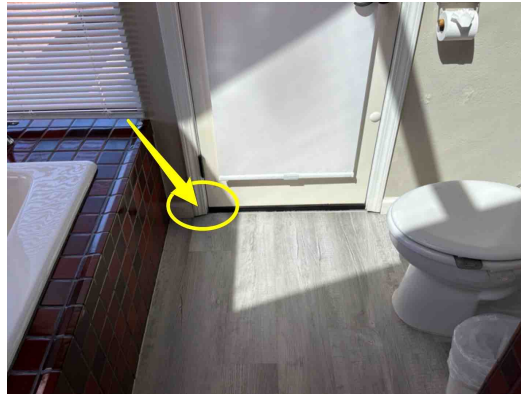
**FI 223:** Evidence of past minor water intrusion from around the PRIMARY BEDROOM BATHROOM exterior door with stains on the interior.

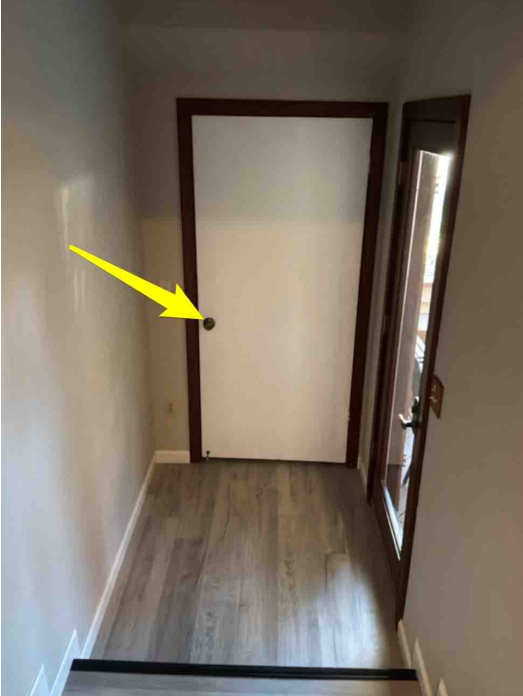
**E&C 228:** The DOWNSTAIRS HALL CLOSET door AND the closet door at the top of the stairway to the UPSTAIRS BONUS ROOM OVER THE GARAGE are locked, not accessible not inspected.

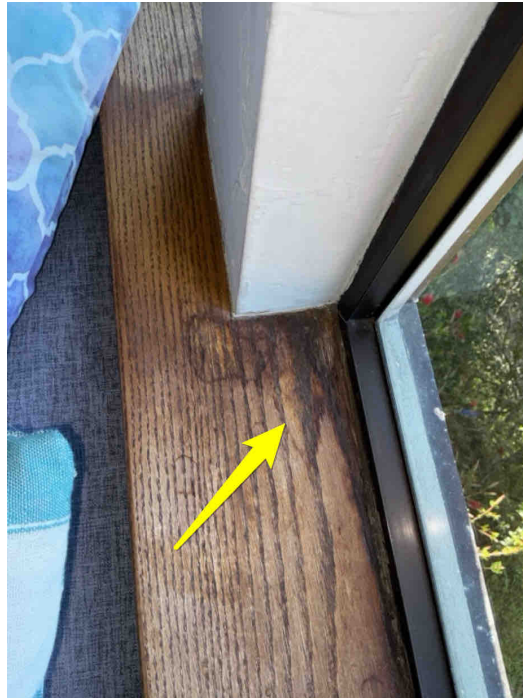
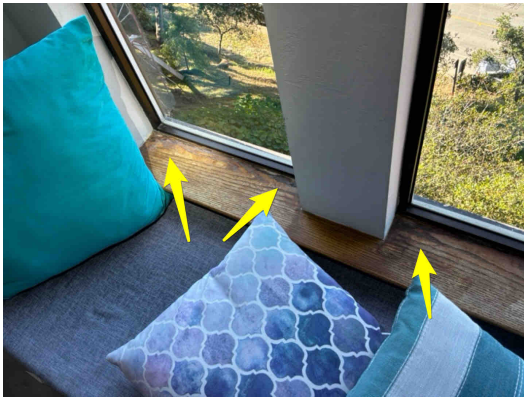
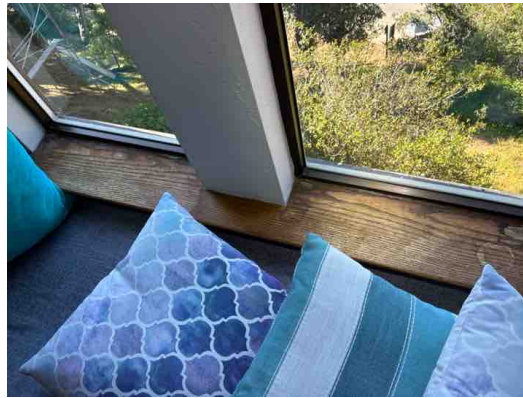
**FI 230:** Moisture stains on the inside at some window sills. Refer to the termite report for additional comments and recommendations.

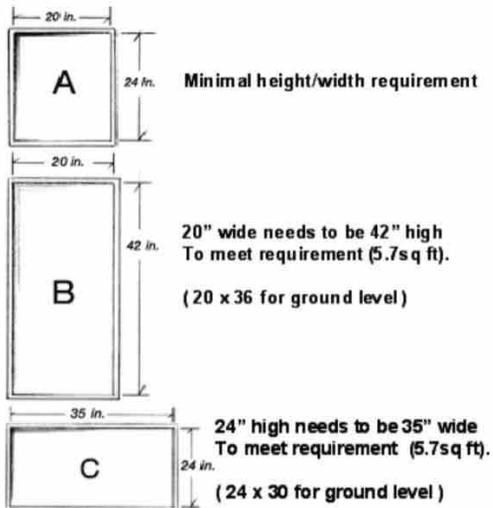
**SC 231:** Windows in the UPSTAIRS BONUS ROOM OVER THE GARAGE currently used as a sleeping room do not meet the current minimum fire egress standards.

Total window area needs to be 5.7 sq ft  
 (5.0 for ground level)

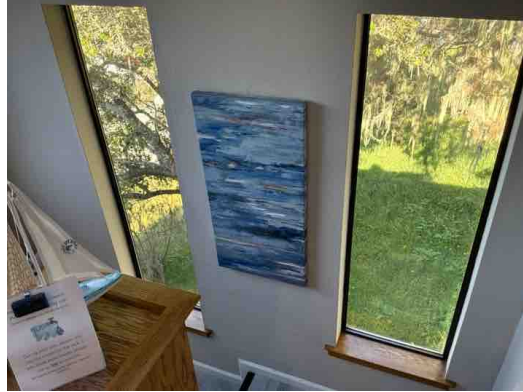
**SU 232:** Disclosure: the windows at the interior stairway do not appear to be tempered glass for safety. Upgrades recommended to help prevent damage to the window or accidentally crashing through if a fall were to occur

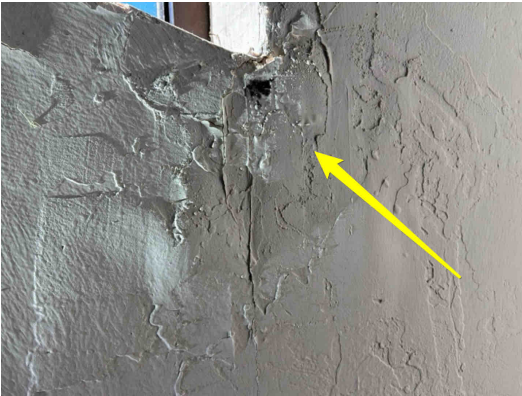
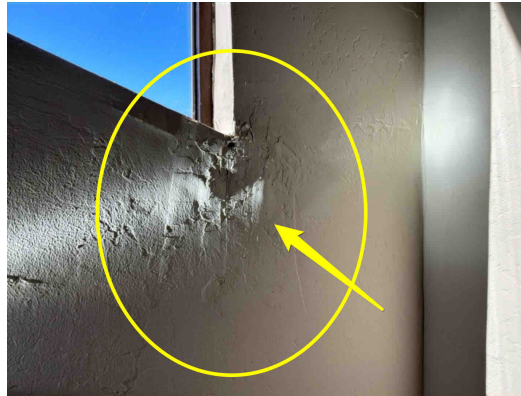
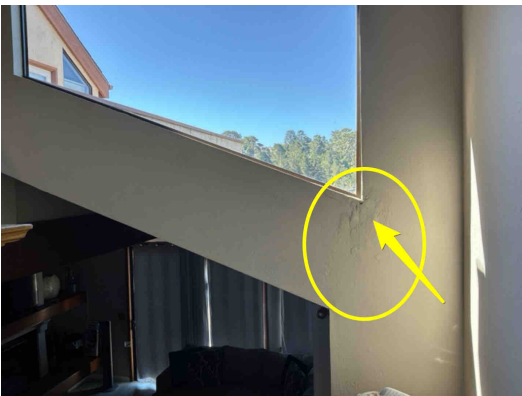
**FI 243:** Evidence of moisture stains and/or damage at the walls in the UNDER THE WINDOW IN THE DOWNSTAIRS STAIRWAY. Recommend further review of the water stains to determine the cause, the current condition and if repairs are needed.

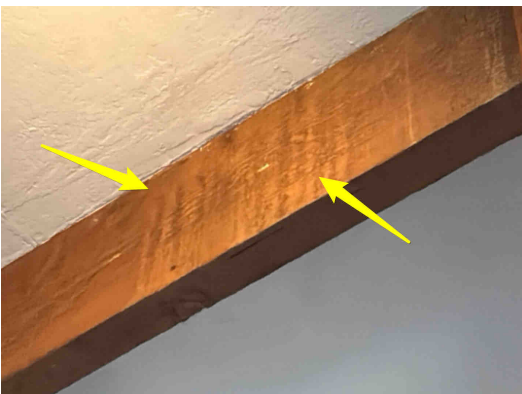
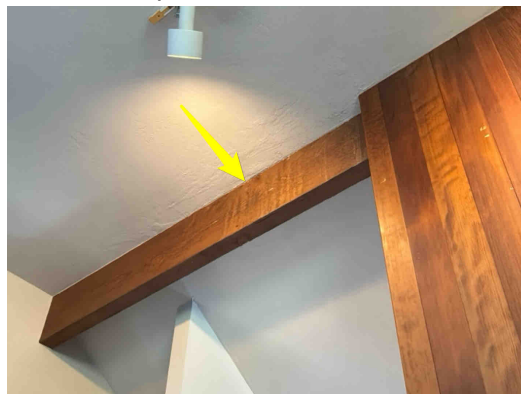
**FI 244:** Evidence of moisture stains at the beam PRIMARY BEDROOM. Recommend further review of the water stains to determine the cause, the current condition and if repairs are needed.

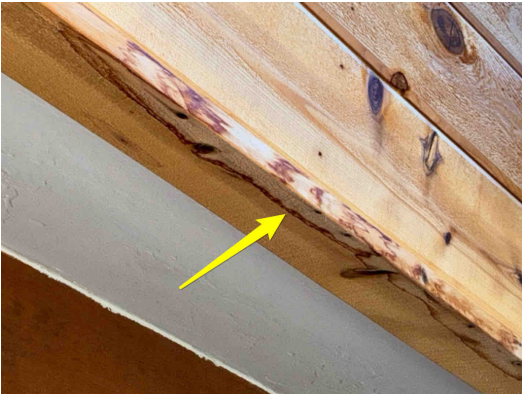
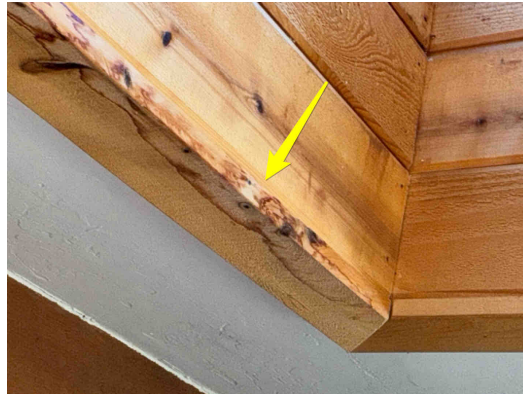
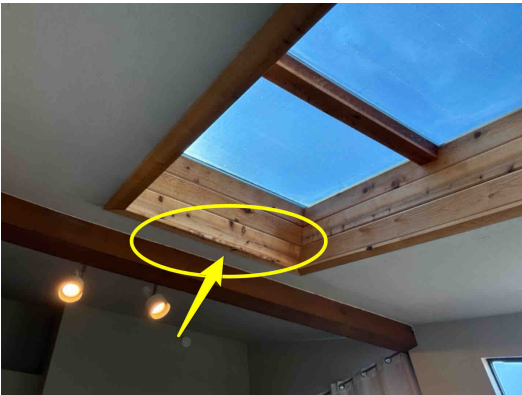
**FI 245:** Evidence of past moisture stains & damage at ceiling area AROUND THE SKYLIGHT AT THE INTERIOR STAIRWAY. Recommend further review of the water stains to determine the cause, the current condition and if repairs are needed.

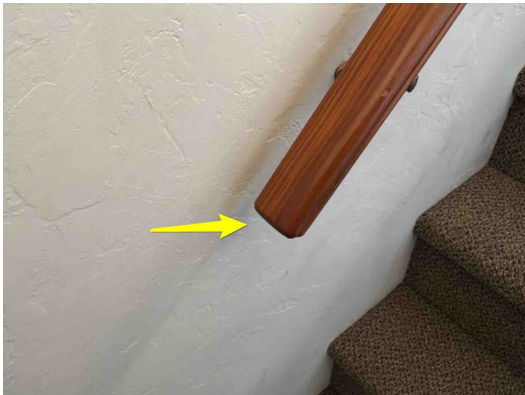
**SU 247:** Recommend returns at the interior stairway gripable handrails to the BONUS ROOM ABOVE THE GARAGE for safety per standards. A Return / turning the ends of the handrail into wall to help prevent catching coat or bag.

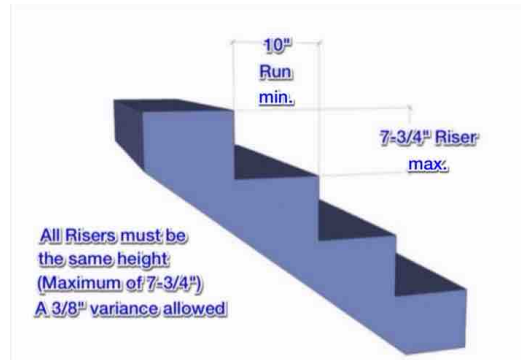
**SC 248:** The interior stairway to the UPSTAIRS BONUS ROOM OVER THE GARAGE does not meet minimum construction standards and may be a potential fall hazard. Stair treads are too tall and the step surface / tread is not deep enough per minimum standards. This can create a steep set of stairs.

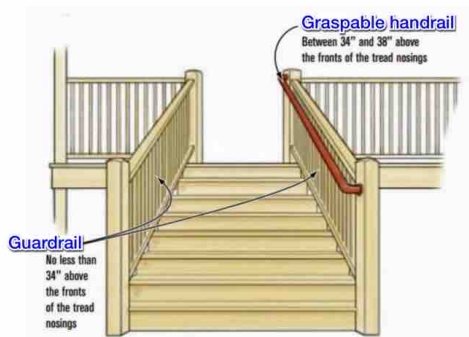
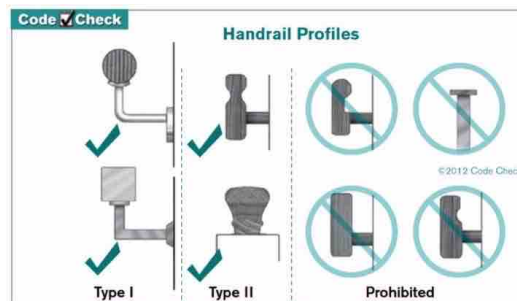
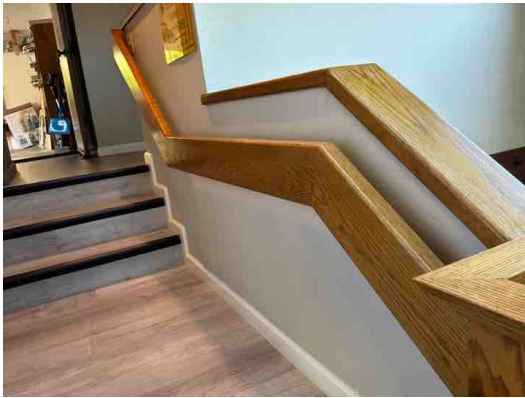
**SC 250:** The gripable handrail at the MAIN HOUSE interior stairway does not meet current minimum safety standards.

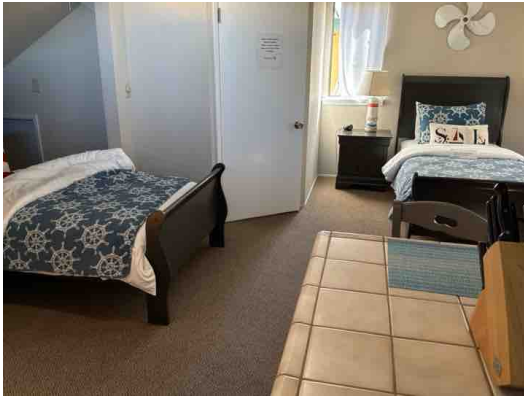
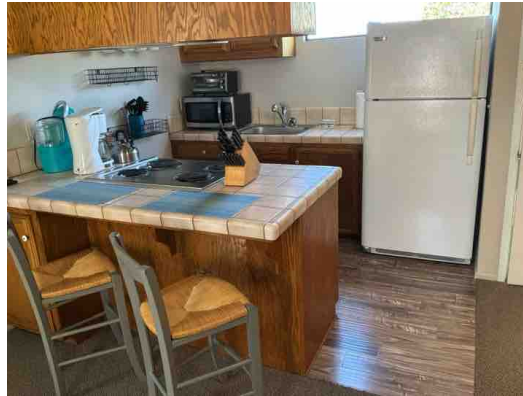
**SC 252:** No permanently installed thermostatically controlled heat source found in the: UPSTAIRS BONUS ROOM OVER THE GARAGE - currently being used for living space and sleeping room. Recommend further evaluation and correction by qualified HVAC contractor.

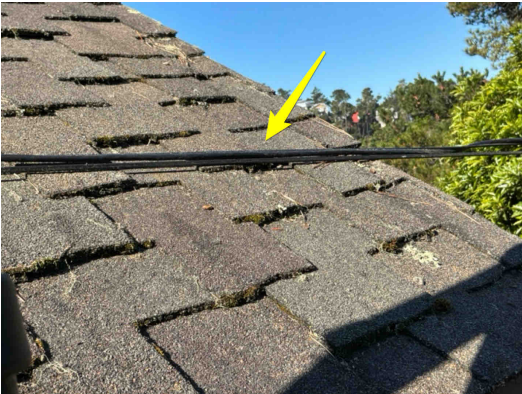
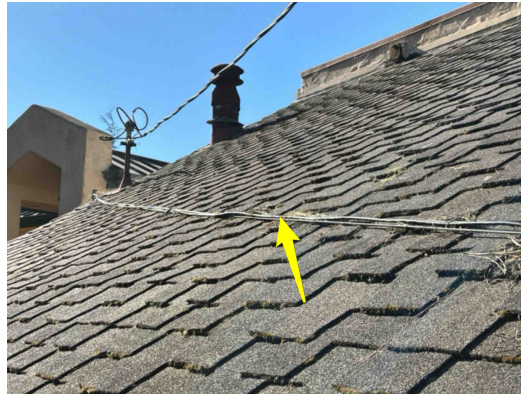
**E&C 264:** The overhead Telephone / TV Cable wires found to be improperly laying and rubbing on the roof. A minimum of (18 inches.) needed above a roof for safety per standards. Recommend further review and repair by a qualified and licensed professional familiar with the minimum installation requirements.
