### *Inspection Report*

Address: 904 Hartford St Cambria, CA 93428

03/20/2026

Inspector: Keith Vreeken, MCI, FCI  
P.O. Box 415 Templeton, CA 93465 O: 805.462.1978 C: 805.440.5050

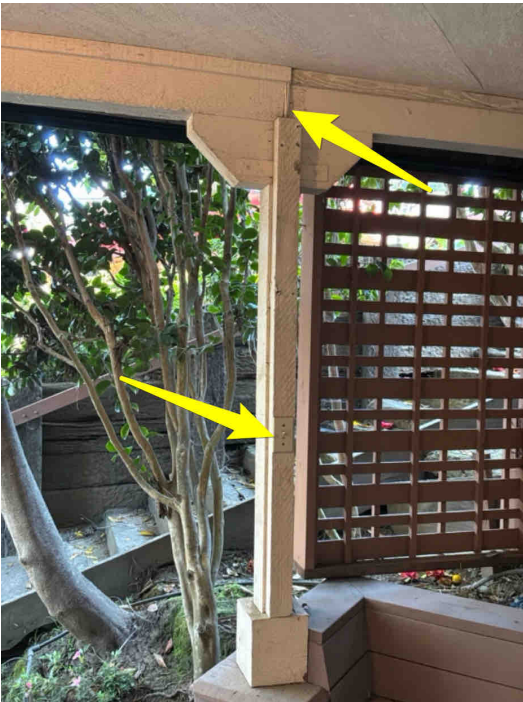
**SC 268:** Improper exposed electrical wiring:

1. "Romex" improperly installed subject to physical damage, not in a conduit or raceway per standards
2. Improper use of a non-exterior rated box and cover at the added light switch, for the WEST SIDE YARD LOWER DECK ceiling light

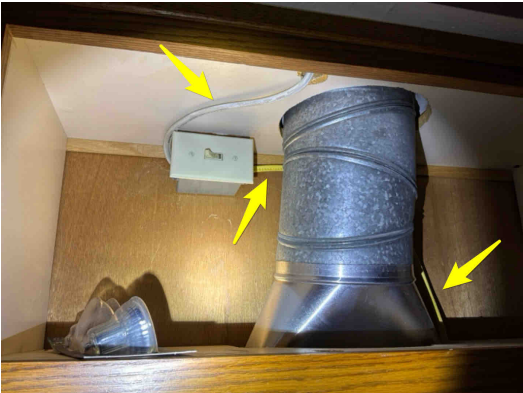
**SC 269:** Improper and unsafe electrical wiring: INSIDE THE KITCHEN CABINETRY ABOVE THE COOKTOP. Ex. Exposed electrical wiring, "Romex" improperly installed subject to physical damage, not in a conduit or raceway per standards.

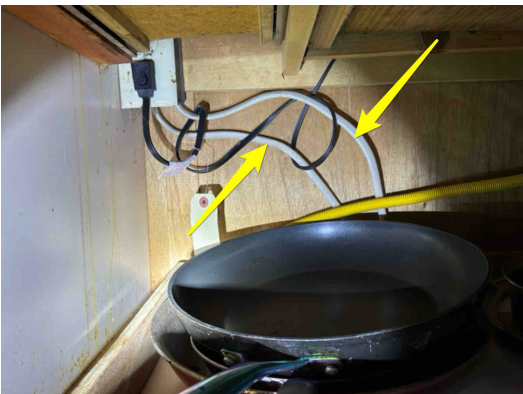
**SC 270:** Improper and unsafe electrical wiring: IN THE KITCHEN CABINETRY BELOW THE COOKTOP. Ex. Exposed electrical wiring, "Romex" improperly installed subject to physical damage, not in a conduit or raceway per standards.

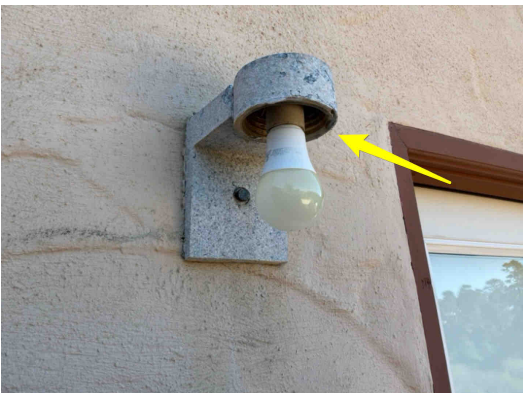
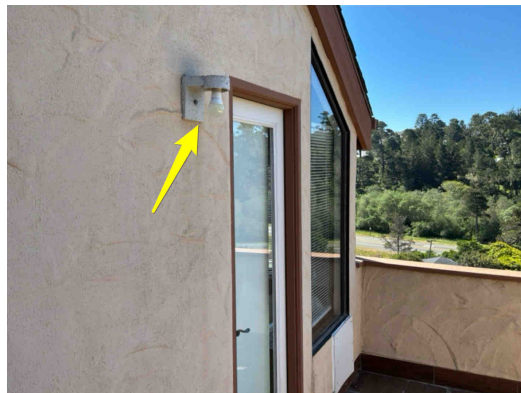
**SC 274:** Light fixture is missing with exposed wires: AT THE EXTERIOR LIGHT OFF THE EXTERIOR DOOR OFF THE PRIMARY BED BATHROOM.

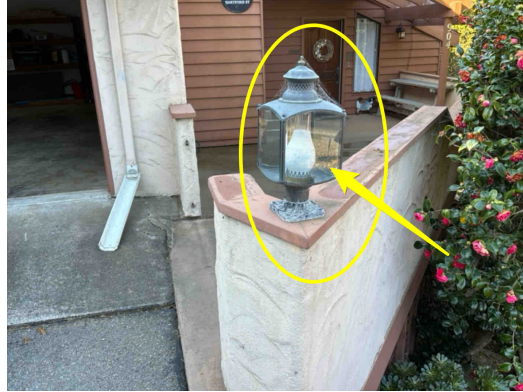
**E&C 275:** Lens at light fixture is cracked: exterior front entry light at the driveway area on the front entry deck handrail.

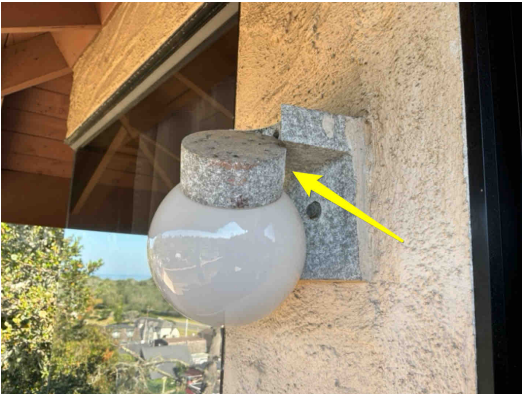
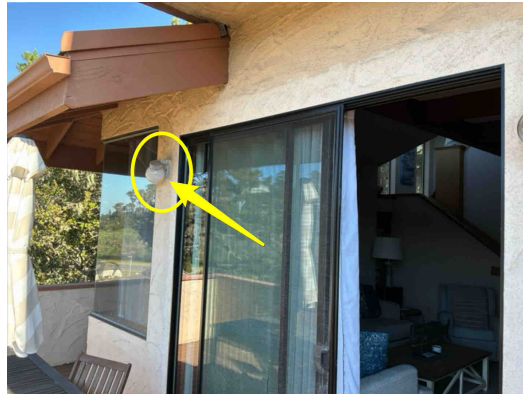
**E&C 276:** Light fixture is damaged: AT THE EXTERIOR LIGHT OFF THE DOWNSTAIRS FAMILY ROOM SLIDING GLASS DOOR.

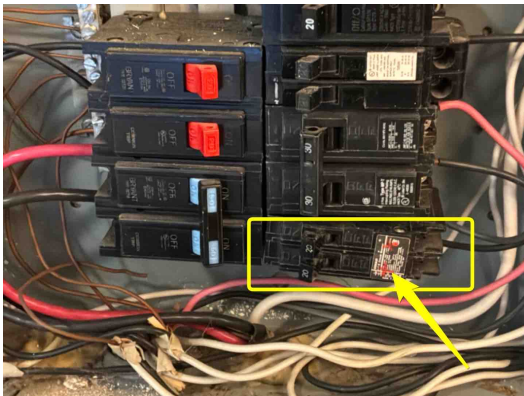
**SC 278:** Electrical panel defect / Over-fusing (breaker found too large for wire), (15-amp wire on a 20-amp breaker) in the LAUNDRY ROOM ELECTRICAL SUB PANEL.

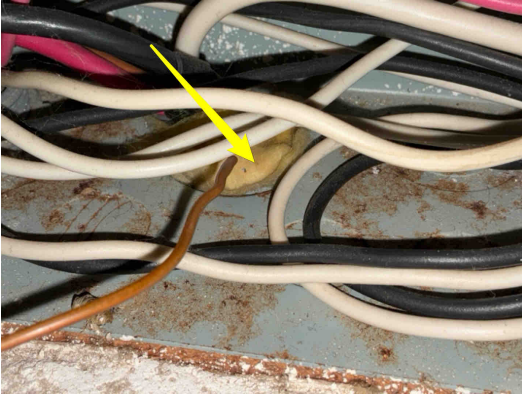
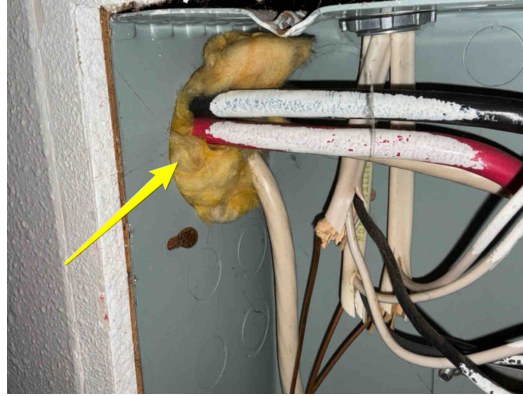
**SC 280:** Missing bushing clamp as wires are passing into the LAUNDRY ROOM ELECTRICAL SUB PANEL.

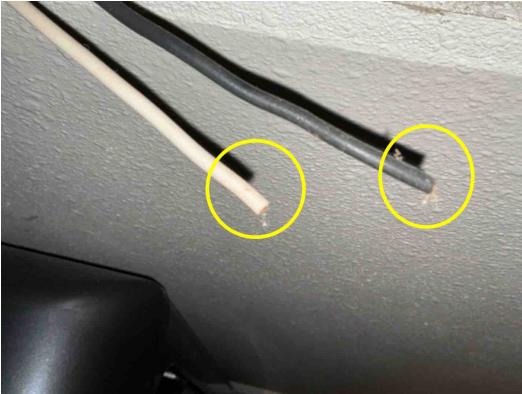
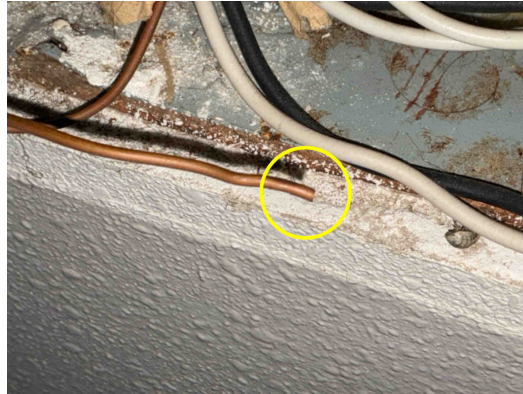
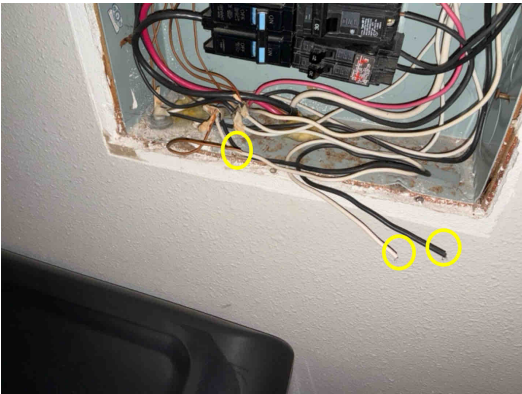
**SC 281:** Some unused wires in the LAUNDRY ROOM ELECTRICAL SUB PANEL found missing proper wire nuts. Repairs are recommended for safety to help prevent a short or shock. Contact a qualified professional.

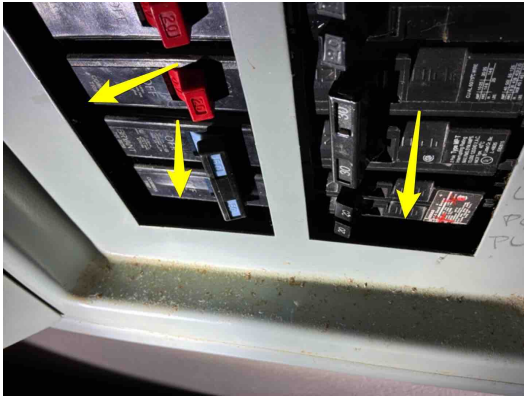
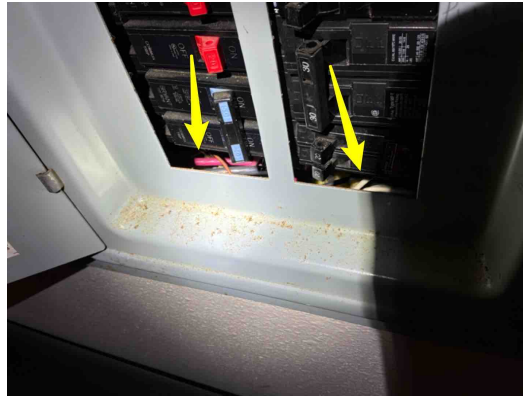
Example

**SC 282:** The LAUNDRY ROOM ELECTRICAL SUB PANEL found to be improperly installed too deep in the wall so the dead front cover does not sit flush and tight up against the circuit breakers. Contact qualified electrical contractor to evaluate and correct.

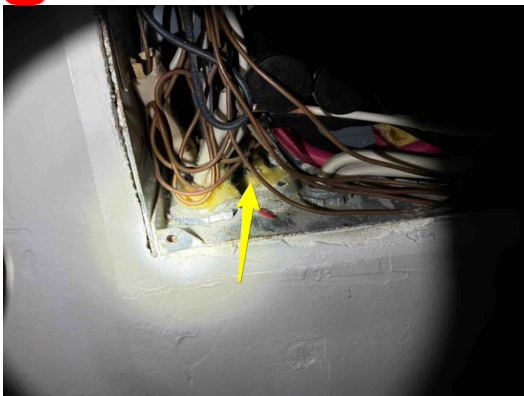
**SC 285:** Missing bushing clamp as wires are passing into the BEDROOM CLOSET MAIN ELECTRICAL PANEL.

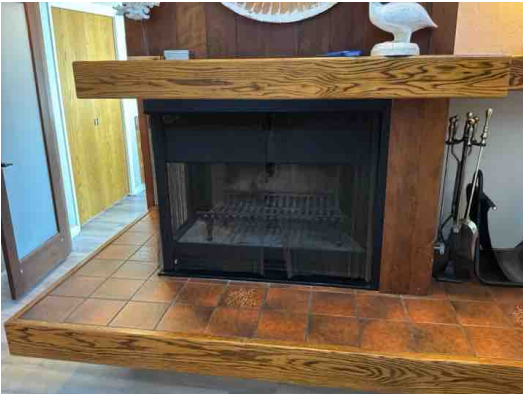
**SC 289: Carbon Monoxide detector missing at the required location:**

1. INSIDE THE PRIMARY BEDROOM - due to the installation of a fireplace
2. AT THE TOP OF STAIRWAY OUTSIDE THE UPSTAIRS BONUS ROOM OVER THE GARAGE

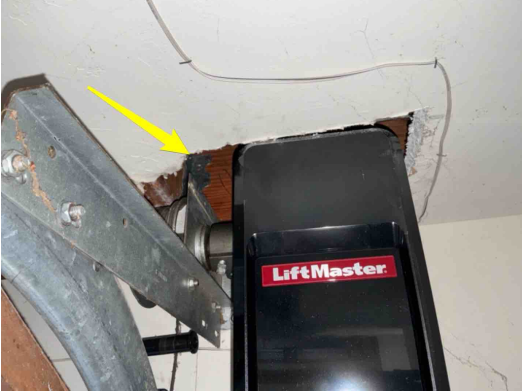
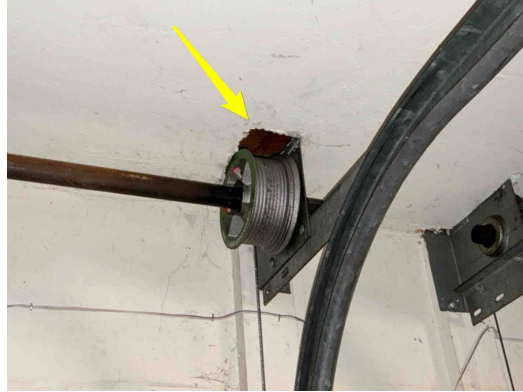
**SC FI 295:** Some small holes or openings found in the garage firewall. Corrections warranted for fire safety. Contact an appropriate professional to repair or correct as needed.

Example. around the garage vehicle door opener

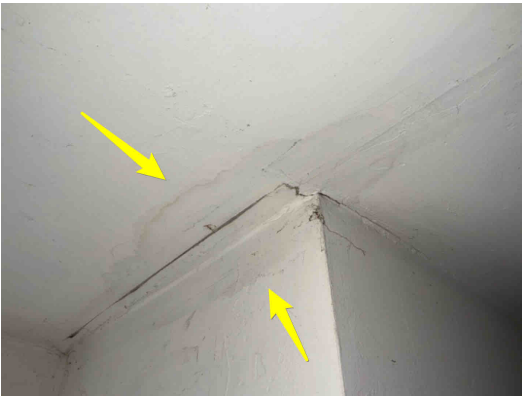
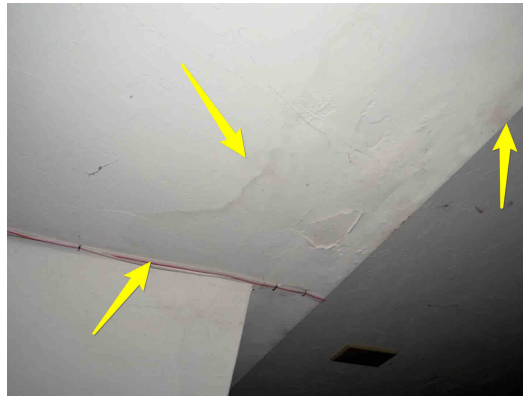
**FI 296:** Moisture stains and/or damage found on areas of the garage ceiling: UPSTAIRS BONUS ROOM OVER THE GARAGE is above. Recommend further review to determine cause, current condition and if repairs are needed. Areas found dry today.

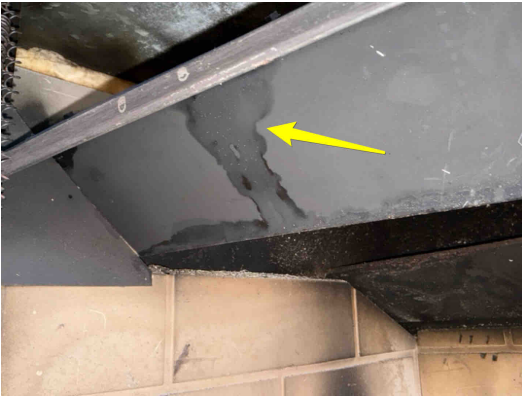
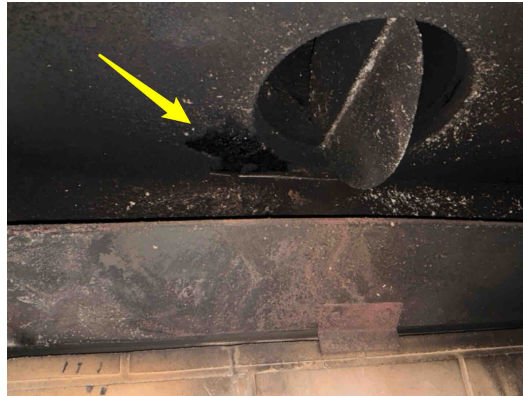
**FI SU 309:** Evidence of past minor poor drafting with an unusual buildup of soot/carbon on the inside past the smoke guard and/or outside the DOWNSTAIRS FAMILY ROOM fireplace.

**FI 310:** Some past or recent water intrusion with water stains at the fireplace firebox at the DOWNSTAIRS FAMILY ROOM fireplace. Additional review by a qualified fireplace chimney sweep is recommended to determine source of the water and ascertain if repairs are needed.

**MR 311:** Recommend cleaning & sweeping the DOWNSTAIRS FAMILY ROOM fireplace and chimney by a qualified chimney sweep.

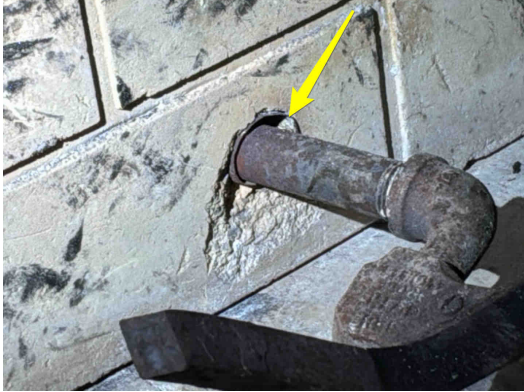
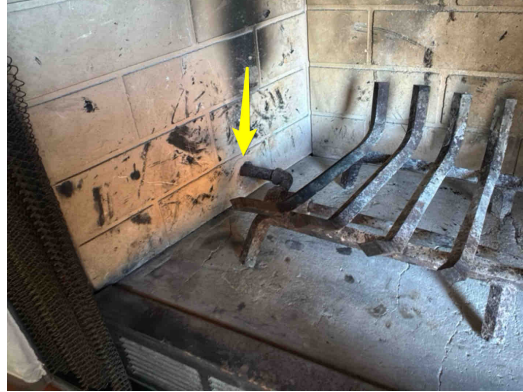
**SC 317:** Recommend sealing the opening around the gas pipe through the sidewall inside the DOWNSTAIRS FAMILY ROOM fireplace for safety per standards.

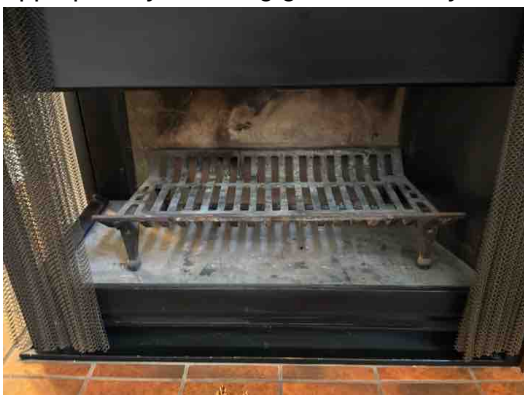
**SC** 328: Oversized log grate found in the PRIMARY BEDROOM fireplace firebox. The front tip of the log grate should not extend past the back of the smoke guard at the top of the fireplace. This can negatively affect the drafting of the fireplace and allow smoke to back-vent into the house. Recommend replacement with an appropriately sized log grate for safety.

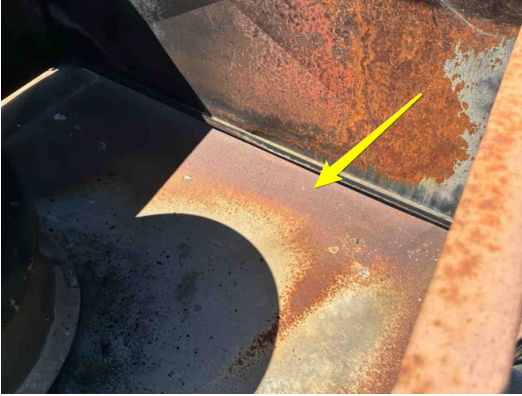
Example

**MR 333:** The metal chimney chase cap is rusted. Maintenance / rust inhibiting paint is recommended.

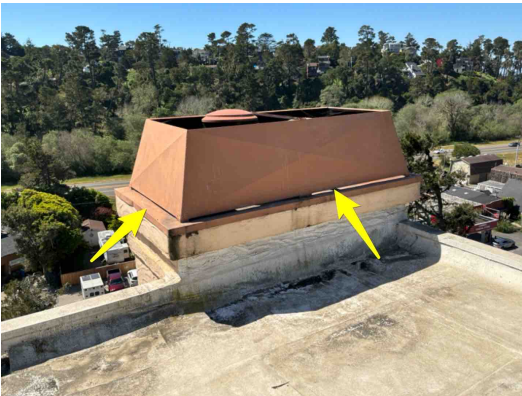
**SU 334:** Improper use and installation of a non-UL listed decorative surround atop the chimney. All UL listed four sided surrounds require a 4 inches air inlet opening on all four sides of the surround at the bottom. This surround only has opening on two sides. This can negatively affect the drafting of the chimney. Proper repairs are warranted per standards. Recommend having a qualified professional open the two sides, easy repair.

Must have a minimum of a 4 inch opening around the decorative surround
