Inspection Report

Claro Home Inspections LLC

6519 Denver Ave, Los Angeles, CA 90044

Three units inspection,
Duplex Front Units 1 - 2 rpts

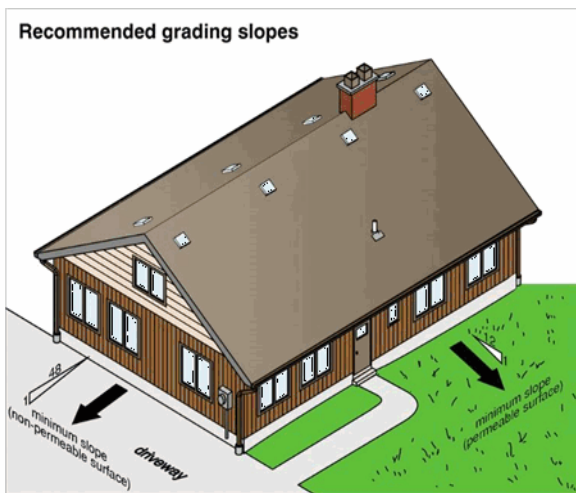
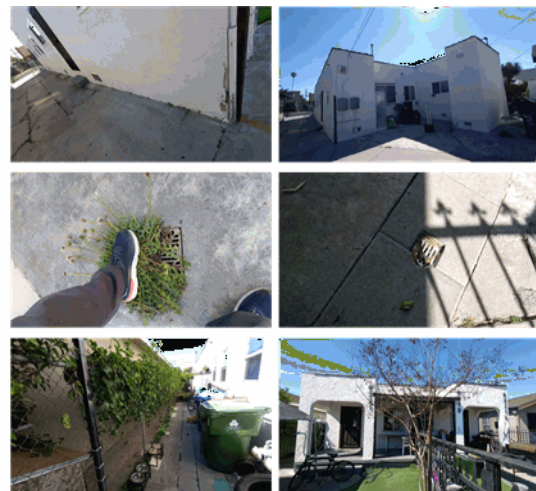
9) Grading Conditions Fnc Overall grade of the property is flat or nearly flat. A 5% grade away from the homes foundation is considered most ideal.

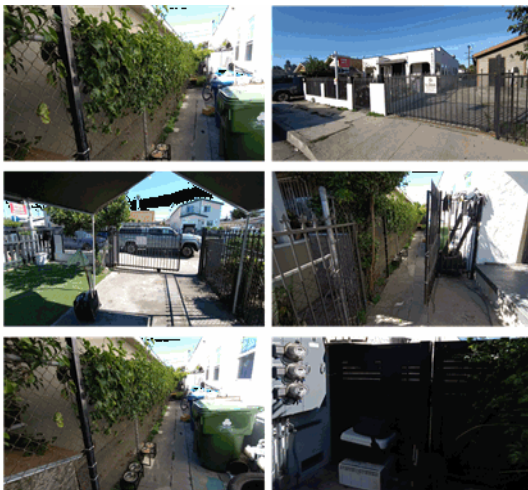
Maintenance is recommended. A 12" clearance between shrubs and plantings is needed to help prevent the buildup of moisture. A 5' clearance between trees and the building structure is recommended to help prevent damage. Trees that are too close to buildings may be fire hazards. Soffit vents provide easy access for flames to enter a house. Leaves and broken branches can clog gutters, potentially causing water penetration into the building. Old, damaged or otherwise weak trees may fall and endanger lives and property. Tree roots may enter plumbing or drain lines causing clogs and or ruptures.

A limited view and inspection was caused by vegetation. This inspection was therefore limited to visible and accessible areas only.

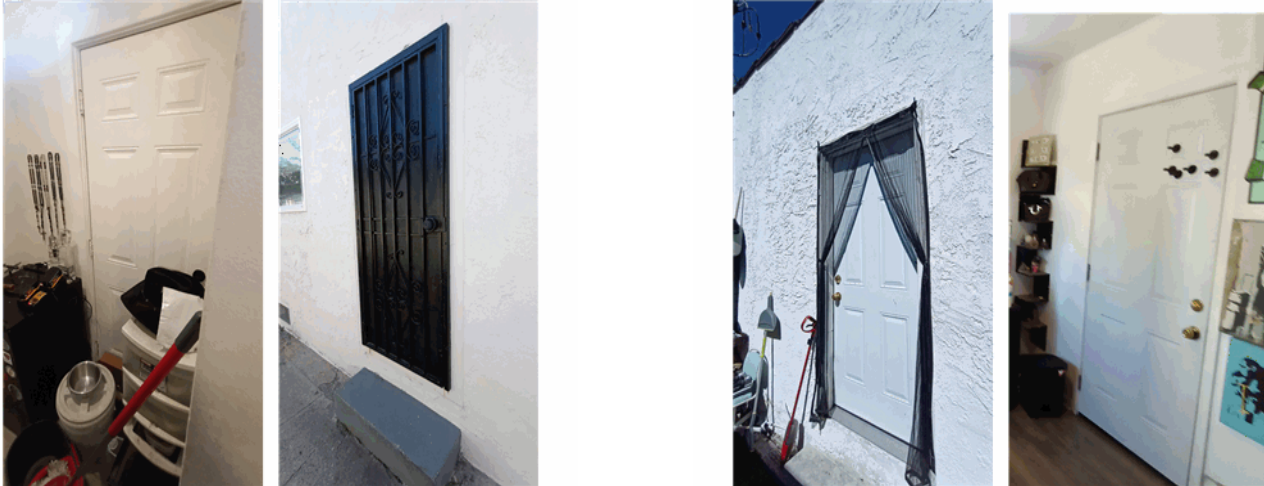
Unit 6521. The door appeared to be in serviceable condition at the time of the inspection. Door operates normally. There were no signs of water infiltration at the time of the inspection

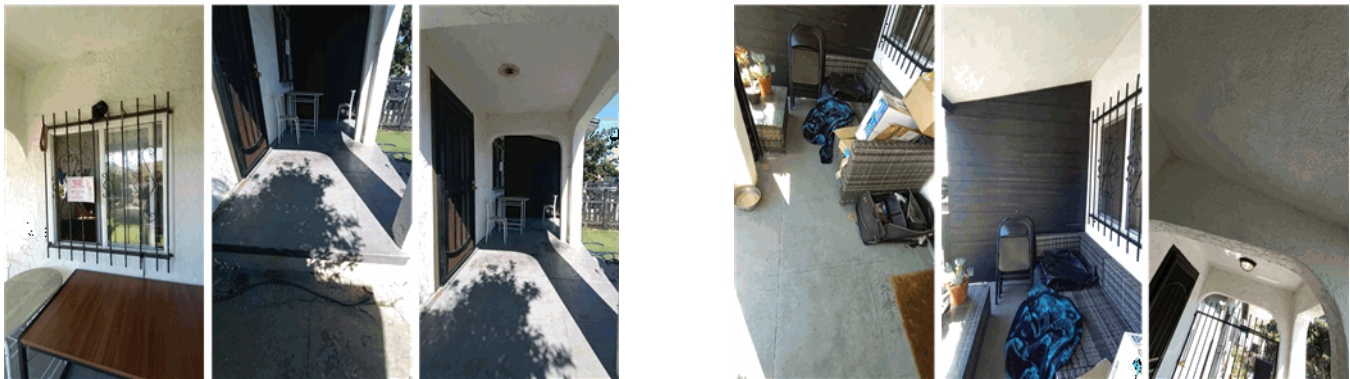
#1. and #2.
The visible and accessible areas of the porch appeared to be in functional condition consistent with the age of the home at the time of the inspection.

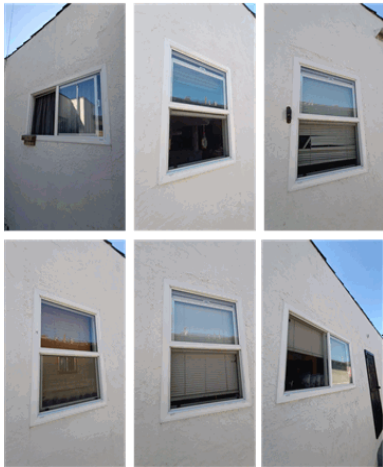
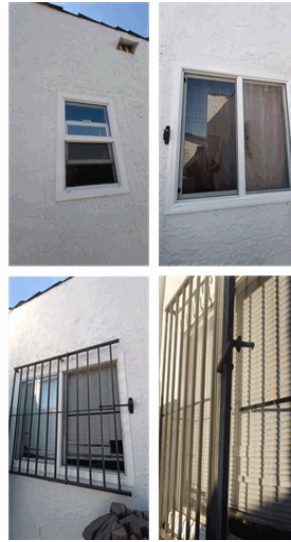
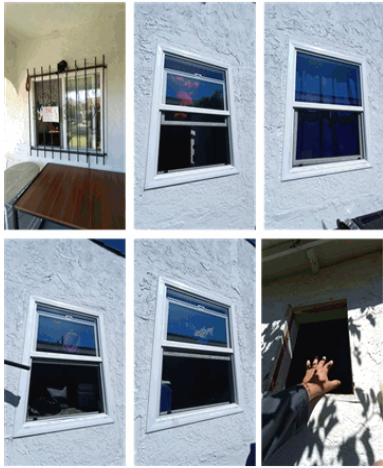
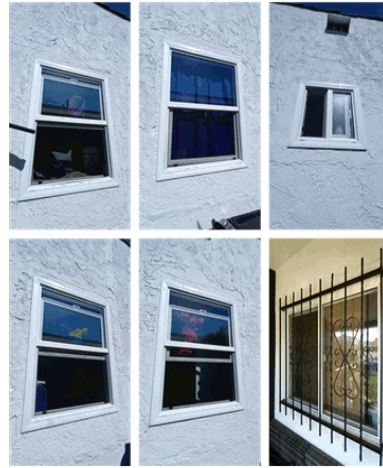
Unit 6521 laundry area. Missing window. The area was open to the elements. Consider the cost of window installation.

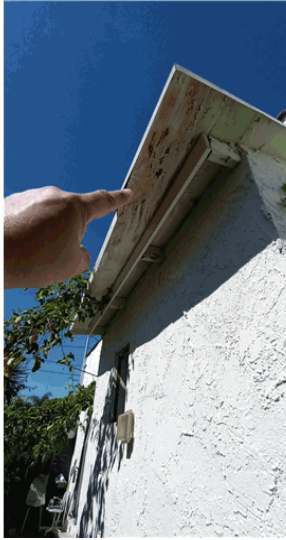
Bump out laundry area eaves, evidence of moisture intrusion and or damage was noted at the deck//eave. Further evaluation is needed to determine evidence of water damage or concealed conditions. Consult a qualified contractor for further evaluation.

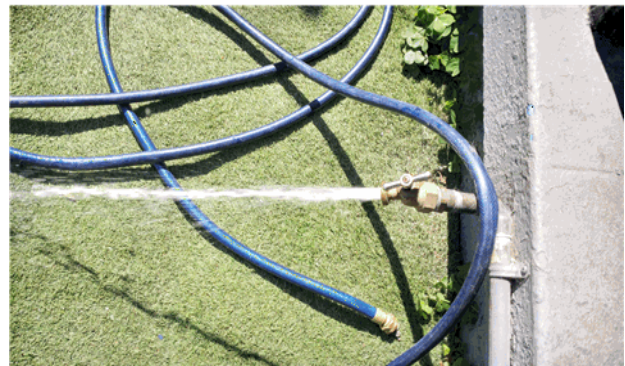
A representative number of hose bibs were tested and found to be in functional condition. **Back-flow preventers were not present.** Back-flow preventers should be installed at all hose bibs to prevent contamination to the homes drinking water. Maintenance, such as tightening of the packing nut, or replacements may be needed to prevent leaks while hoses are in use.

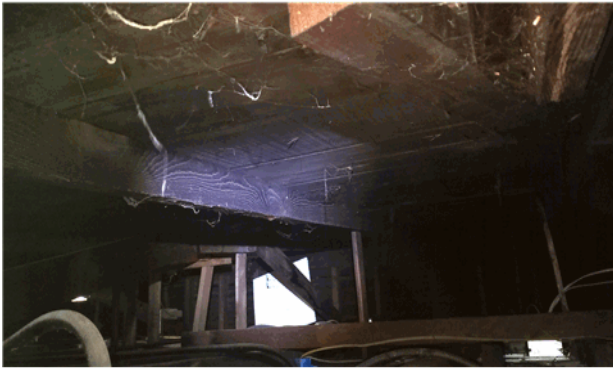
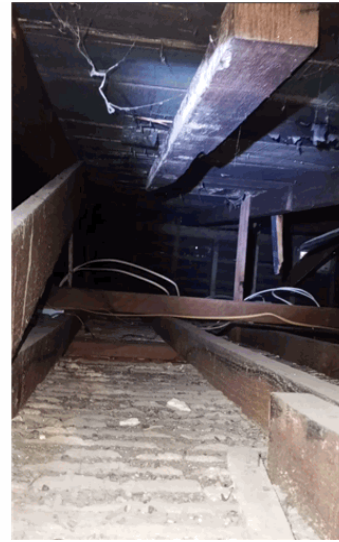
Fnc Approximately 20% of the roof deck was visible from the attic areas. There was no damage to roof deck in any of the visible areas. [\(Also see attic notes\)](#)

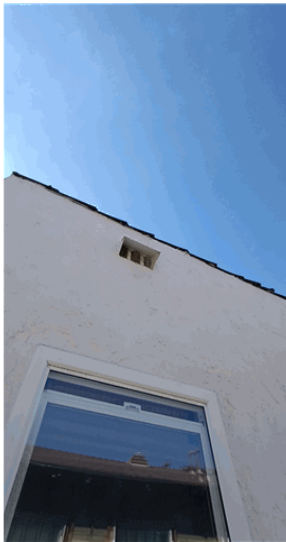
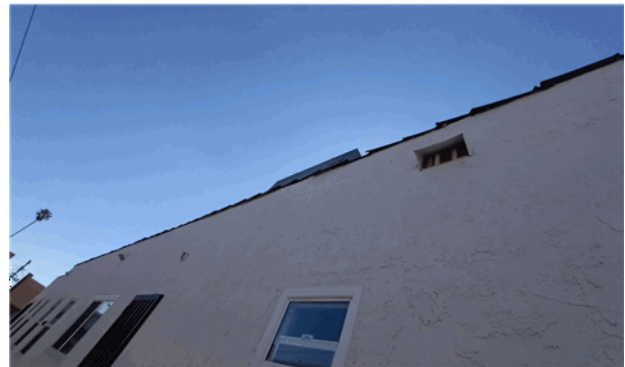
The roof was properly ventilated for the type and style of roof system installed at the time of construction. Power Ventilator. None present or visible.

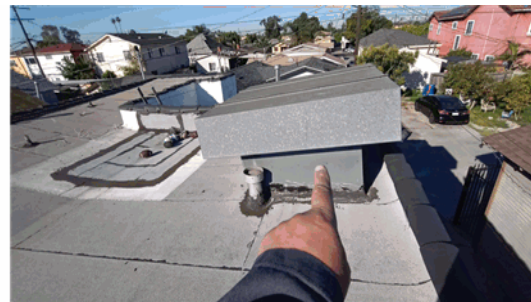
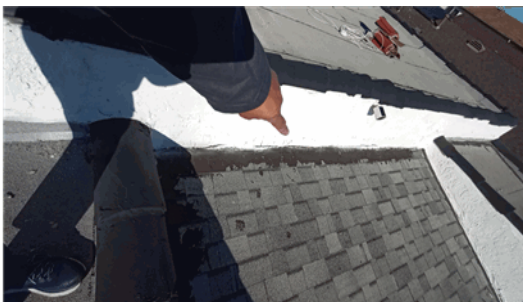
**33)
Penetrations-Flashings Conditions**

The exposed roof vent penetrations and flashings appeared to be in functional condition at the time of inspection. There were no apparent signs of water infiltration. The flashings had evidence of substandard patching and repair. Given this condition, it is likely that the roof may have leaked at one time. The inspector cannot offer an opinion as to whether the roof leaks today unless it is moderately raining at the time of inspection.

Head wall flashing at shingle roof substandard patching or repair, metallic head wall flashing not visible. Consult a licensed roofer for maintenance.

Findings: Visible rust and evidence of repeated, substandard mastic/sealant applications indicate deferred maintenance. These "patches" are prone to failure.

Action: A licensed roofer should be consulted to evaluate the unit's integrity and provide a permanent flashing solution.

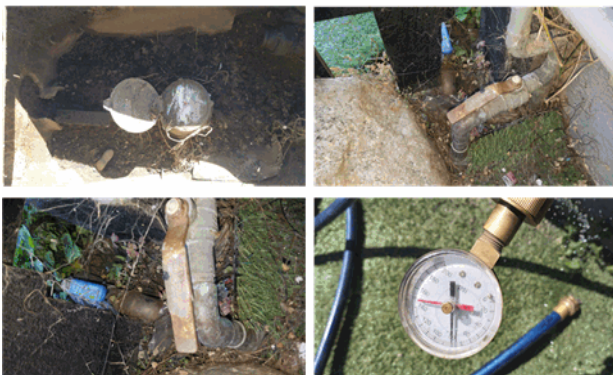
34) Images

Copper was observed exiting the soil line. Materials used underground are unknown.

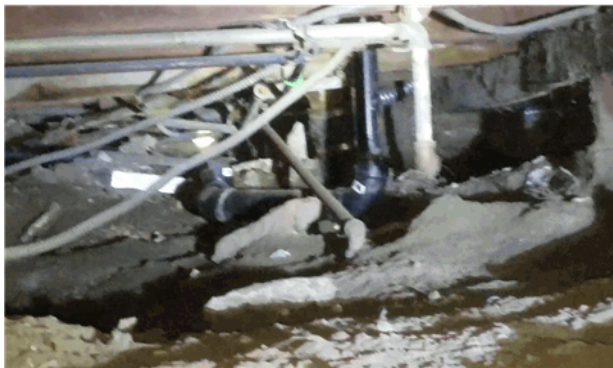
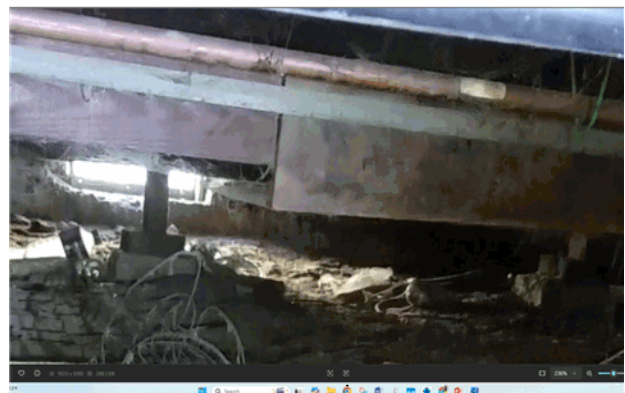
37) Plumbing System Condition

The visible portions of the supply lines appeared to be in serviceable condition at the time of inspection.

There were no apparent leaks present in the plumbing system at the time of inspection.

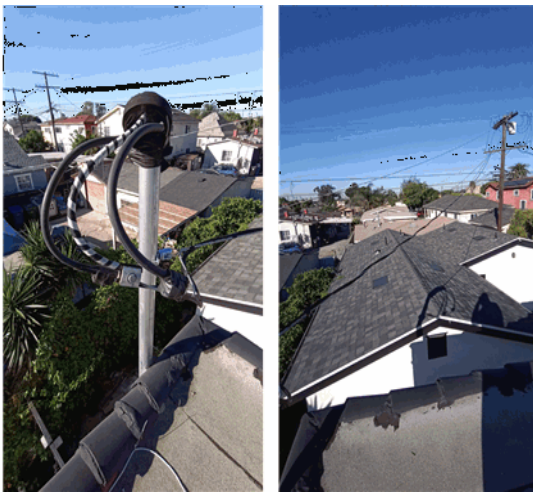
39) Electrical Service Conditions

Fnc Power is fed to the structure via overhead service utility. This is a common method for providing power to modern residential homes. The main service entry appeared to be in serviceable condition at the time of inspection.

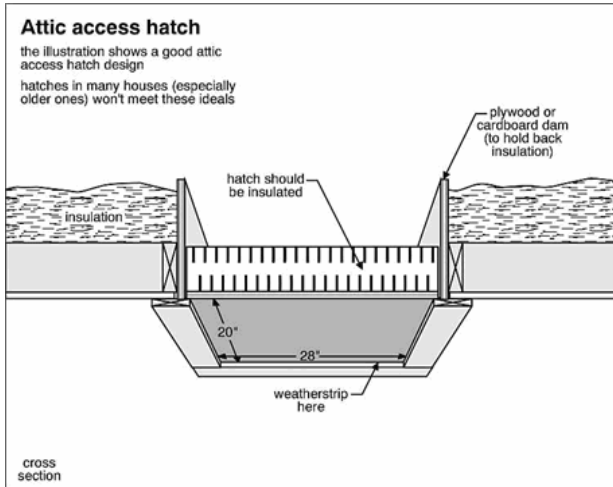
**41) Attic Entrance
Location - Condition**

Panel cover insulation was not installed. Additional insulation material at access door is recommended for energy efficiency and comfort.

Client should note that inspection of the attic is limited / restricted to the safe observable areas.

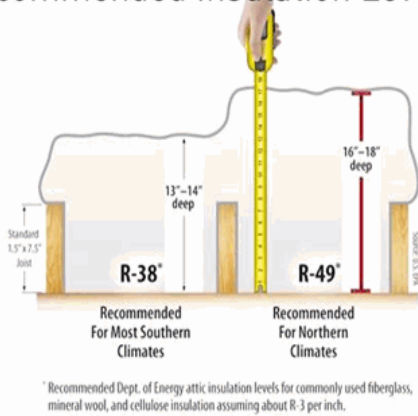
Recommended Insulation Levels

Minimal to no insulation was noted in the attic area. Proper insulation is essential for improving energy efficiency, maintaining indoor comfort, and reducing utility costs. It is recommended that the client consult with a qualified insulation professional to evaluate

options, estimate costs, and ensure compliance with current standards and energy efficiency requirements.

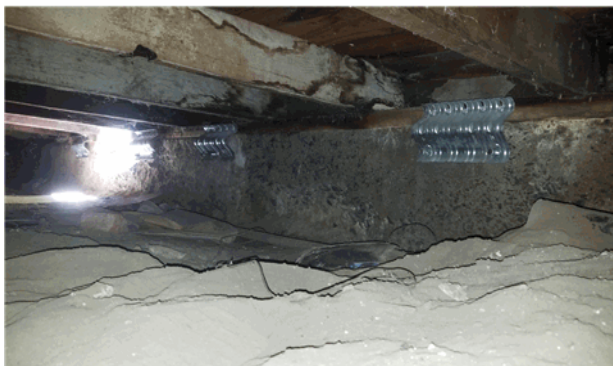
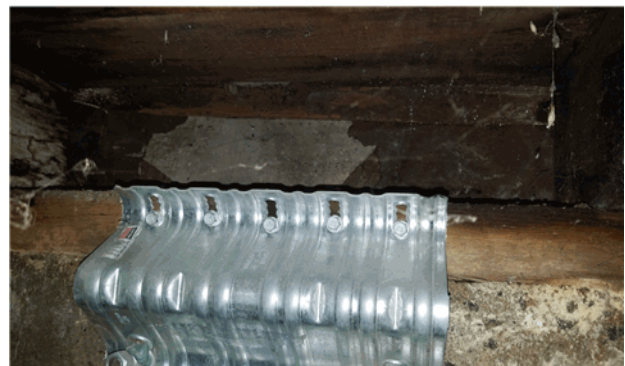
52) Foundation Anchor Bolts

Fnc The home is bolted to the foundation. Earthquake retrofitting was observed. It is recommended client consult with current home owner for the extend of any warranties and / or general information.

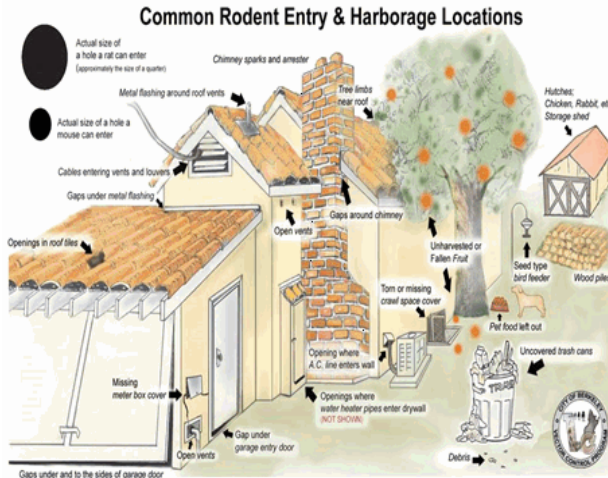
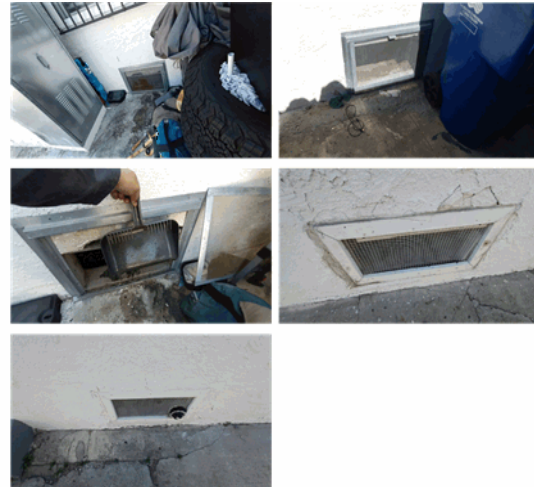
Access. Crawl space access panel cover was in serviceable condition at the time of the inspection.

Vents. The visible foundation screens vents were found to be in satisfactory condition. Foundation screen vents help to restrict any rodent or animal activity in the crawspace.

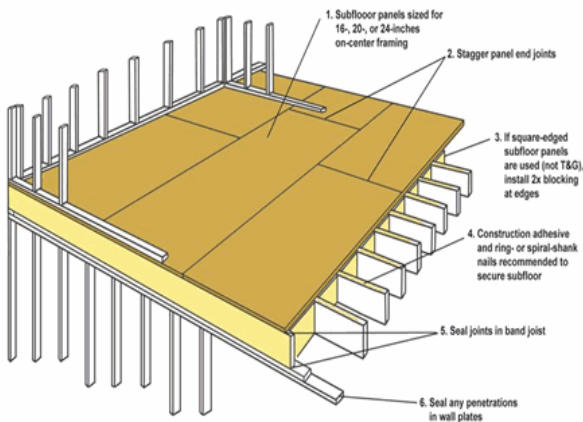
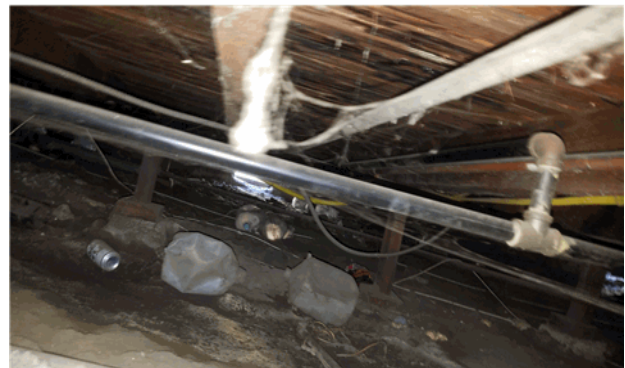
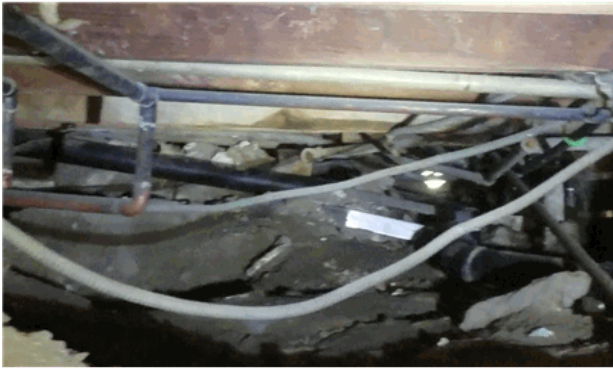
54) Sub Floor Deck Conditions

The visible and accessible portions of the decking appeared in functional condition, for the age of the home. Stains were noted around the bathroom and kitchen areas. Water stains are common in bathroom and kitchen decks. Moisture tests are not performed in the crawspace due to limited access.

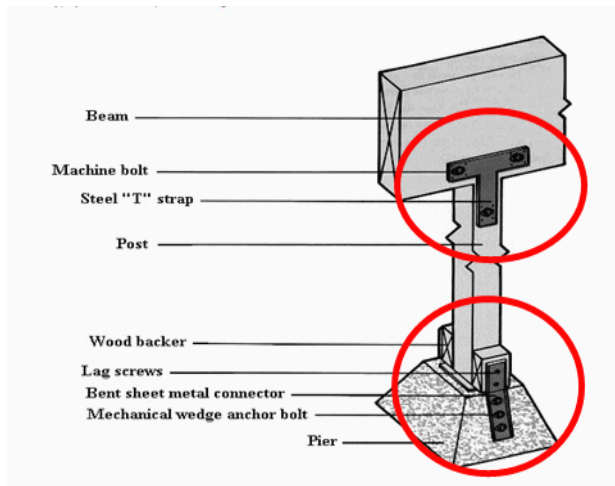
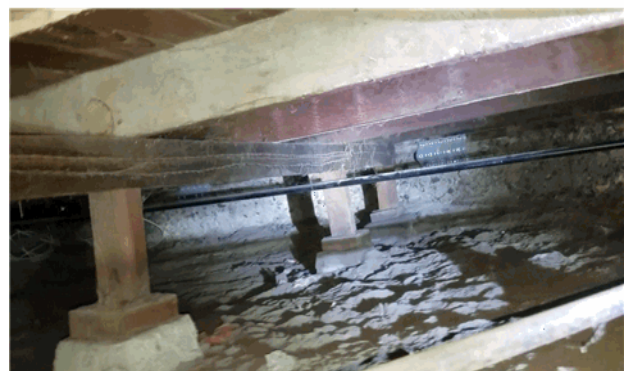
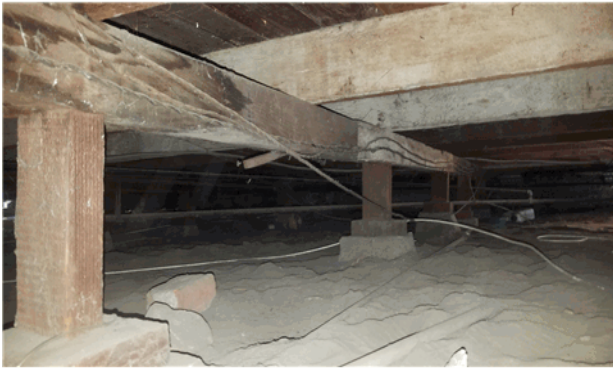
55) Post and Pier Condition

Earthquake retrofitting was observed around the perimeter foundation walls. However. Client should consult a qualified earthquake retrofitting contractor for more information on post and pier seismic bracing.

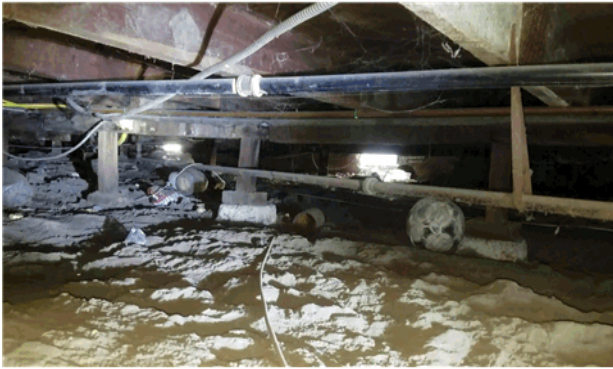
**57) Plumbing
Conditions**

Pipe insulation was not installed at hot water supply lines. By current standards, hot water supply pipes should be insulated to help prevent condensation of metal pipes on cool nights and drips. Recommend Installation.

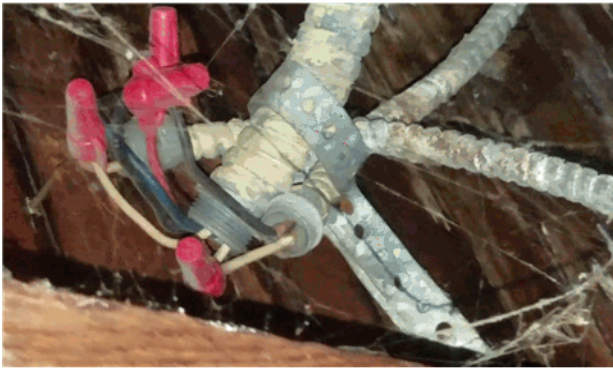
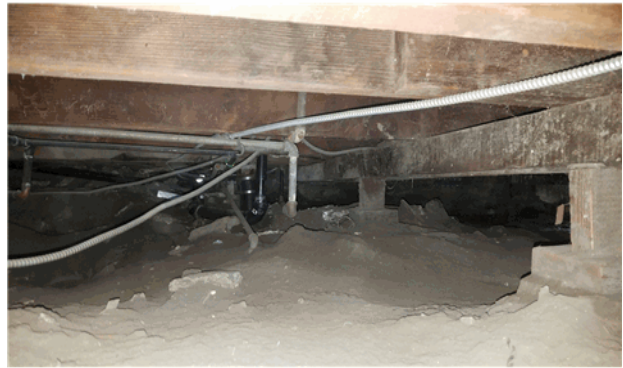
59) Electrical Conditions

Rep A number of in-line wire splices were noted in the crawlspace. It is recommended client consult a licensed electrician for evaluation and correction.
 Communication cabling should be professionally strapped to prevent damage and to allow for appropriate access to the crawlspace area for servicing and repair. What appears to be abandoned electrical wire/conduit was present in the crawlspace. Recommend removal of all abandoned electrical wiring, material or conduit. Consult a licensed electrician for evaluation and correction.

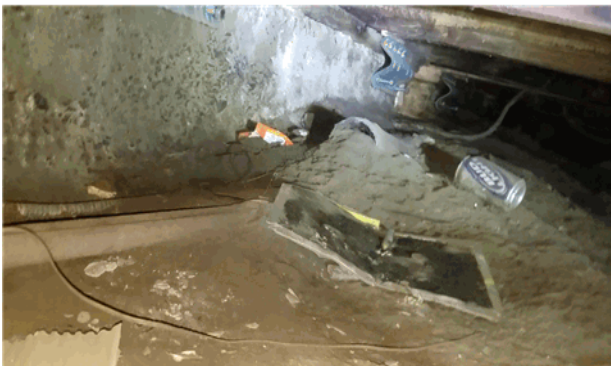
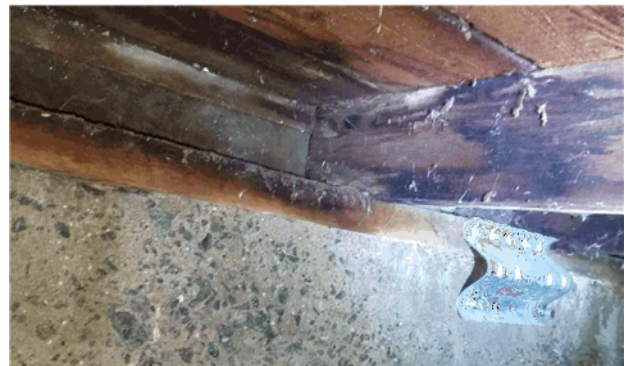
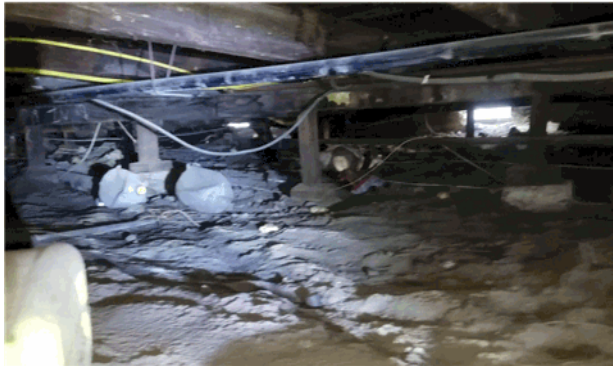
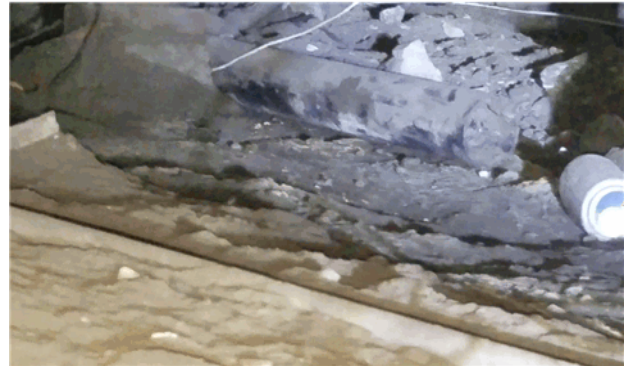
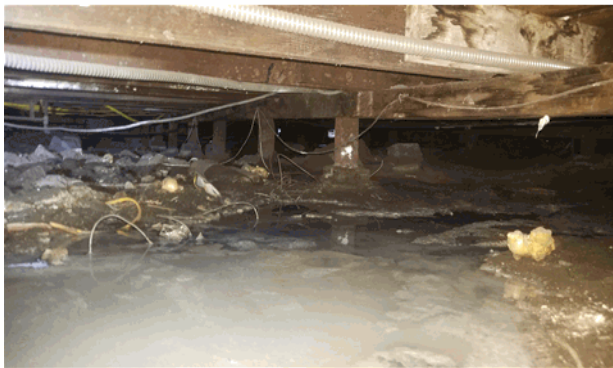
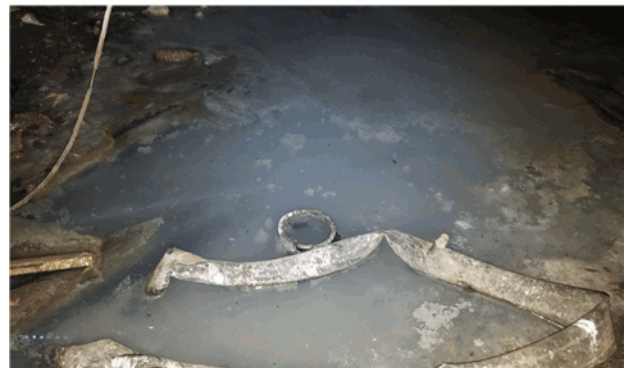
60) Moisture

Rep Moisture & Ongoing Leak: Excessive moisture and an ongoing water leak were observed. The inspector entered through the front unit access but could not crawl to the rear due to excessive wetness. Access via the rear bathroom entrance was also

Source: While the exact origin was not located, the volume of water suggests a damaged supply, irrigation, or drainage pipe.

Structural Seepage: Moisture has seeped into foundation walls, post piers, and structural beams. This environment is highly conducive to wood rot, rust, and the compromise of structural integrity.

Health & Safety: Standing sewage and moisture release toxic fumes and airborne mold spores, which can migrate into the living area and cause respiratory issues, headaches, or nausea.

Vapor Barrier: A moisture/vapor barrier was not installed. This is recommended for energy efficiency and moisture control.

Remediation: Consult a qualified water damage remediation contractor to evaluate moisture/mold issues and assess soil conditions.

Plumbing: A licensed plumber should be engaged to locate and repair the active leak once the area is accessible. (Rep)

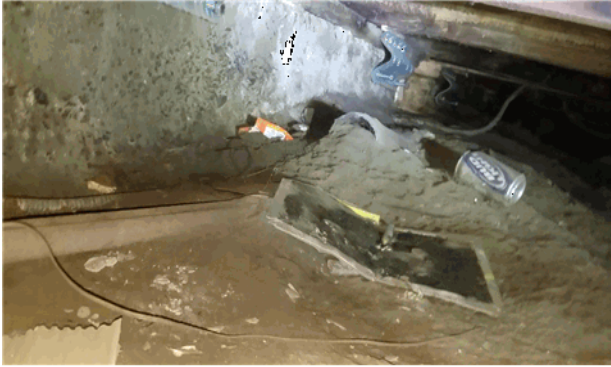
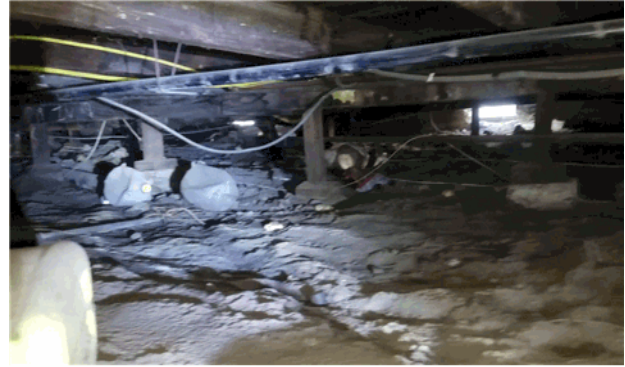
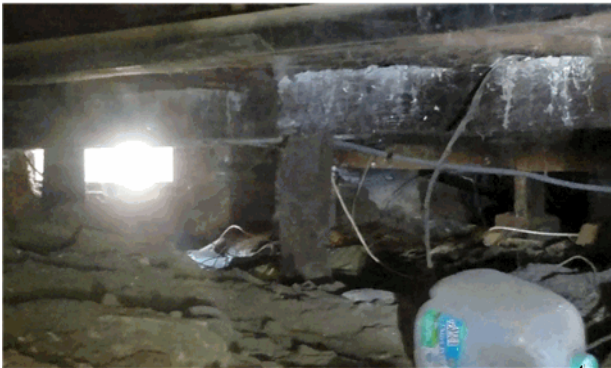
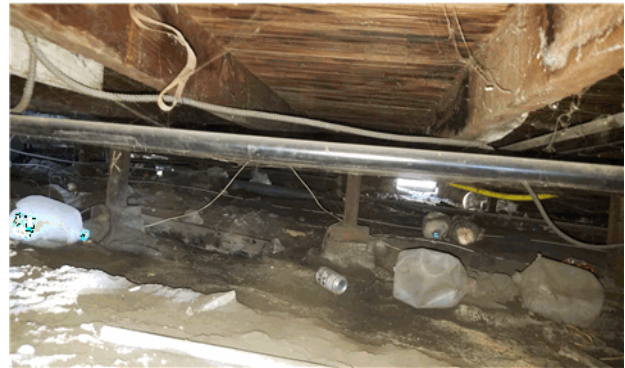
No insulation was present / installed in the crawl space area. Although this may have been typical at the time of construction. It is recommended client consider insulation installation for increase energy efficiency, savings and comfort.

Cellulose / debris, paper or wood based material was laying directly on top of soil at the sub-floor crawl space. Cellulose and debris in the crawlspace promote habitat for rodents and pests. It is recommended remove any cellulose and or debris from the crawlspace area.

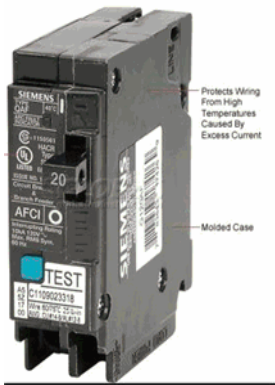
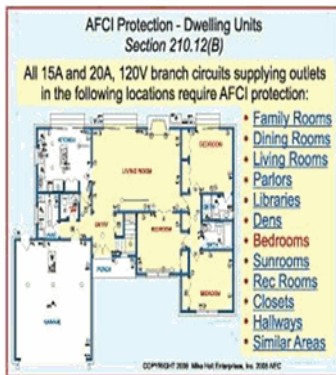
AFCI circuit breakers were not present. AFCI circuit breakers help to prevent electrical fires caused by arc fault conditions at bedroom receptacles. Conventional circuit breakers only respond to overloads and short circuits; so they do not protect against arcing conditions that produce erratic, and often reduced current. **AFCI circuit breakers are a modern requirement for new construction, upgrades and or where branch circuit wiring is modified, replaced, or extended, for all bedroom and similar receptacle circuits. Consult a License Electrician for local requirements.**

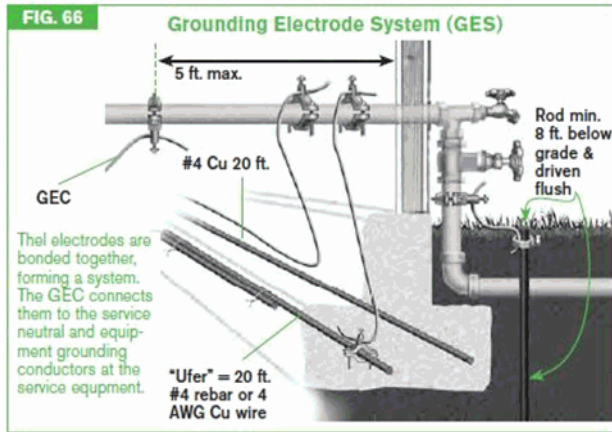
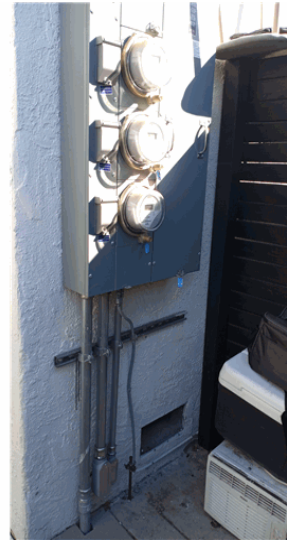
68) Cold Water Clamp - Ground Rod Connection

The ground clamp to the ground rod connection was secured in place. There were no signs of rust or corrosion. Grounding continuity tests are not perform as part of the basic home inspection.

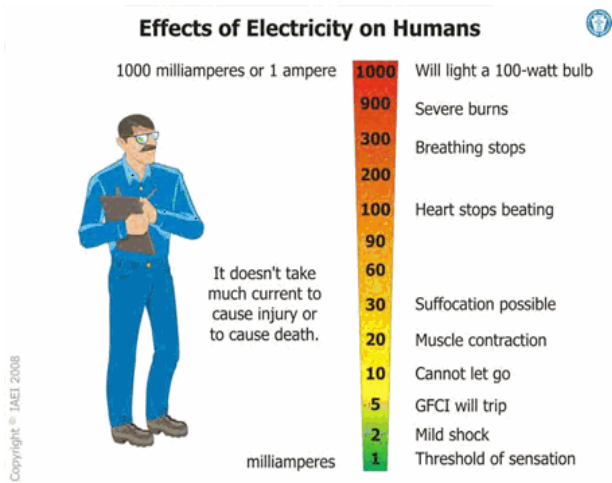
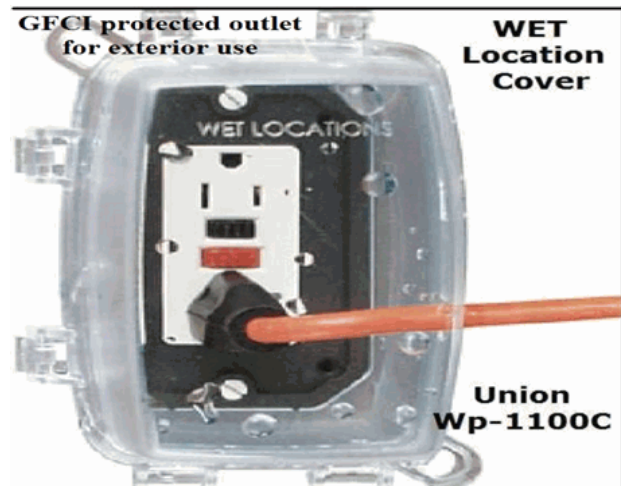
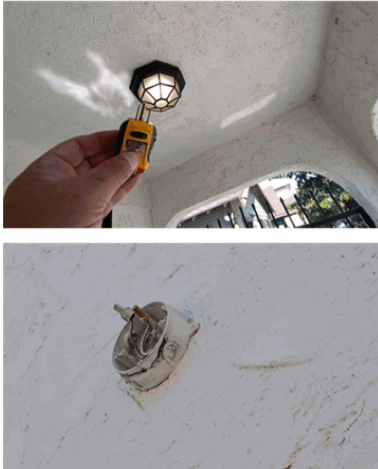
69) Exterior Lighting - Receptacles

Exterior Lighting. Exterior lighting that could be tested was found to be functional. It is recommended that all exterior light fixtures be properly sealed to the structure. Rear door exterior lighting was missing. Open junction box. Client should consult a license electrician for lighting replacement.

There was no visible convenience receptacle outlet. It is a modern requirement that any balcony deck or porch accessible from the interior of the dwelling unit. Be provided with a convenience receptacle outlet. It is a modern requirement that all exterior receptacles be GFCI protected for occupant's safety. Weatherproof covers are also required for receptacles in wet locations.

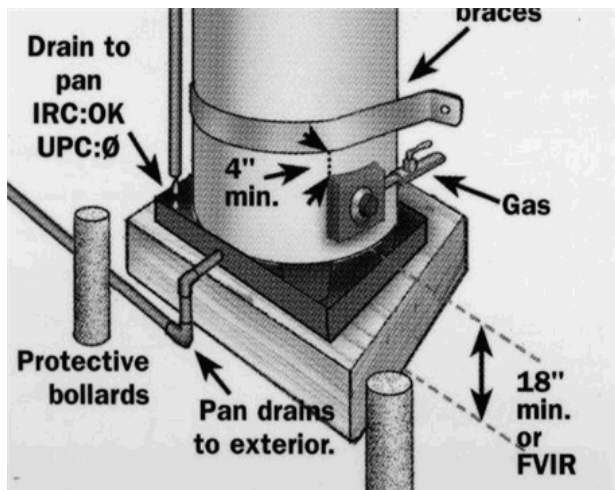
Temperature and pressure relief valve was in satisfactory condition. However the discharge overflow pipe was not extended to the exterior. Recommend installation of an extension pipe for increased safety. Client should consult a licensed plumber for additional information.

A drip leg (sediment trap) at the gas line connection was missing / not installed. It is recommended client consult their local utility provider / license plumber for local installation requirements.

Drip pans are recommended below all hot water heaters. Drip pans should drain to the exterior. This will help contain leaks and prevent water damage.

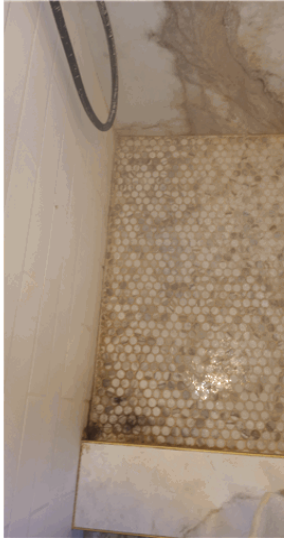
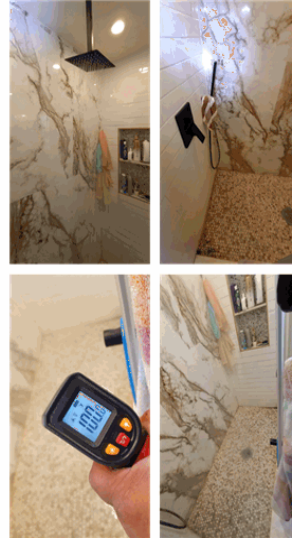
134) Tub and Showers

Mtc Bathroom #1. Shower. Shower head and wand. Hot and cold running water was present.

Drainage was functional. However. The shower was slow to drain. Likely the result of a local clog. Recommend drain cleaning. Tub and shower were in serviceable condition showing signs of normal use. General caulking / sealing is recommended throughout.

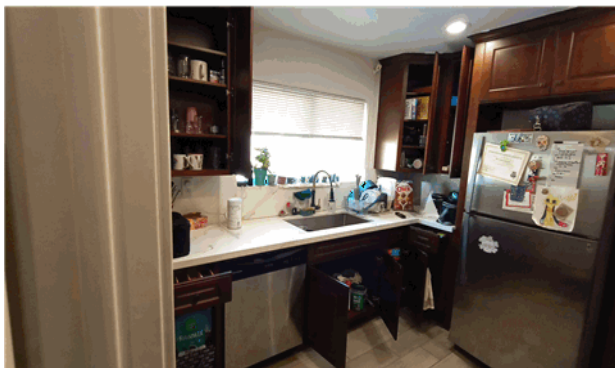
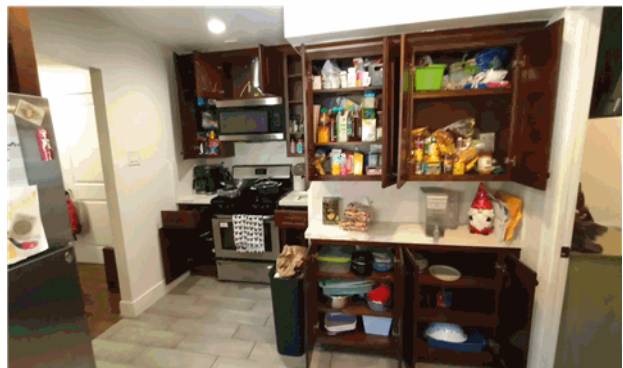
144) Images.

The visible portions of the kitchen counters appeared to be in serviceable condition at the time of the inspection. Moderate everyday common wear and tear of daily use was present.

The kitchen cabinets appeared to be in normal serviceable condition for the age of the home. Doors and drawers function normally. Moderate everyday common wear and tear of daily use was present.

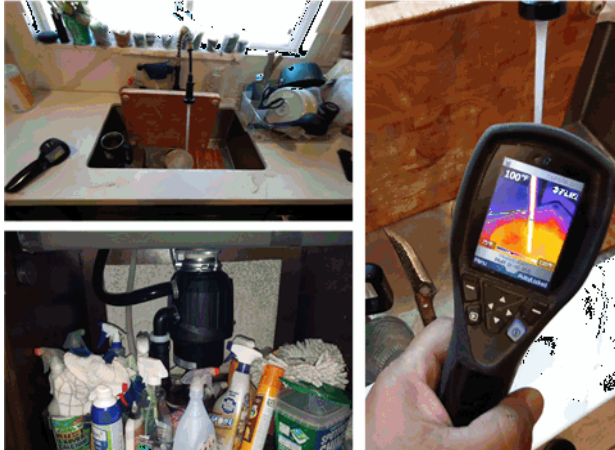
147) Sink - Plumbing Conditions

The kitchen sink was in functional condition. Faucet was operational. Hot and cold running water was present. Drain assemblies functioned normally with no signs of active leaks.

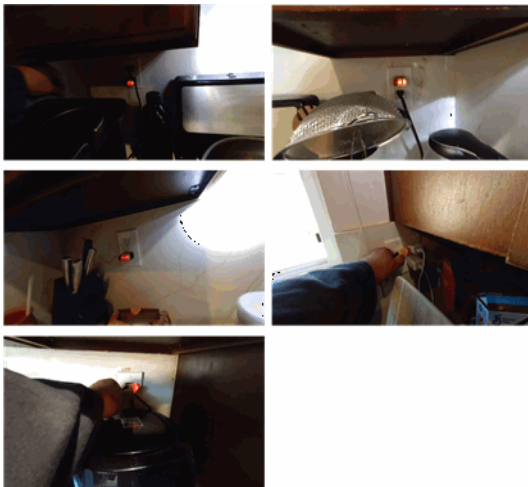
149) Images

Lights and switches that were tested were found to be functional with appropriate cover plates properly installed.

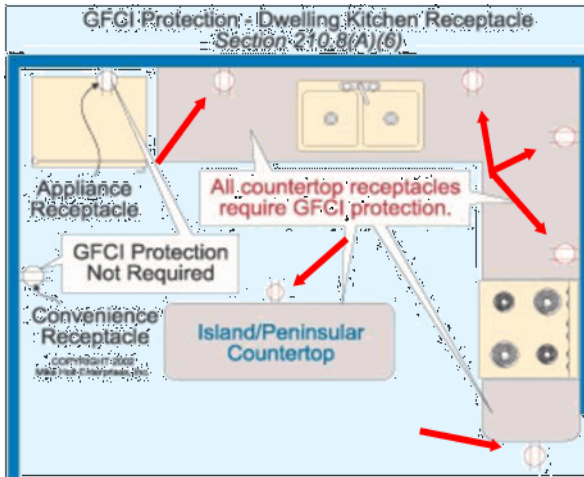
151) GFCI Receptacle Outlets Condition

GFCI receptacle outlets that could be tested were found to be functional.

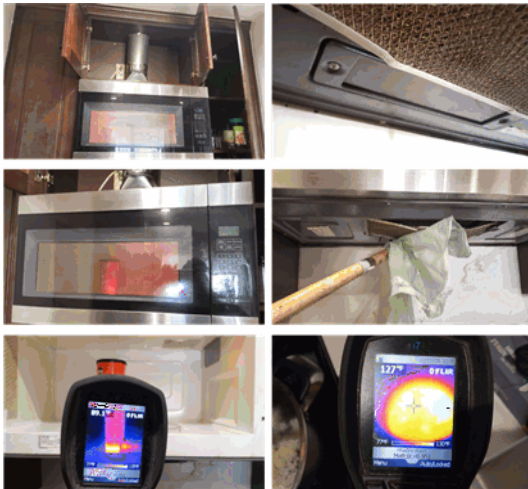
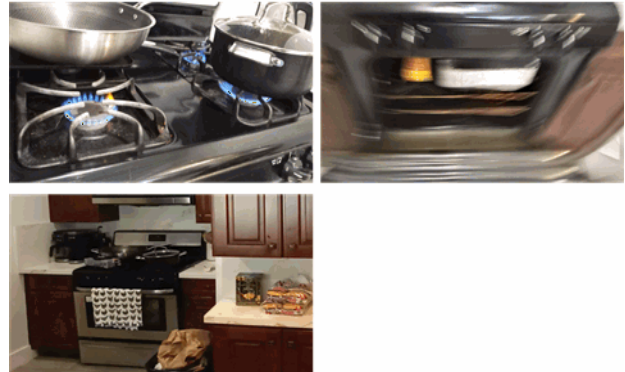
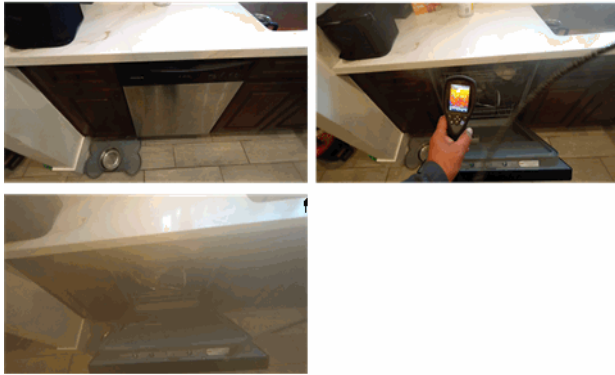
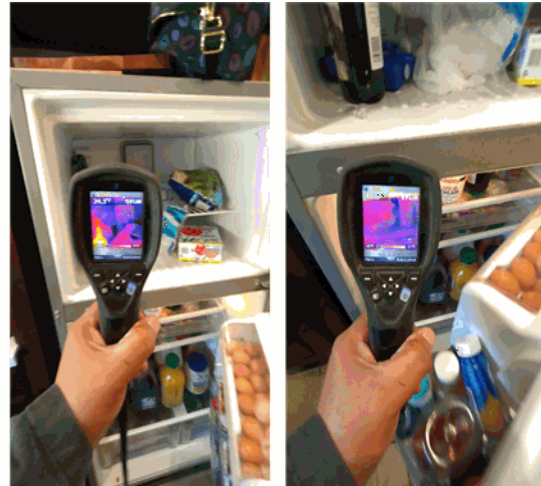
152) Images.

The combination microwave and vent hood were tested by way of normal operating controls. Exhaust-Vent Hood was found to be functional.

Note that the exhaust vent filter appears to be in poor condition. Recommend replacements.

A light bulb (s) was out, missing or inoperative. Recommend replace light bulbs and retest.

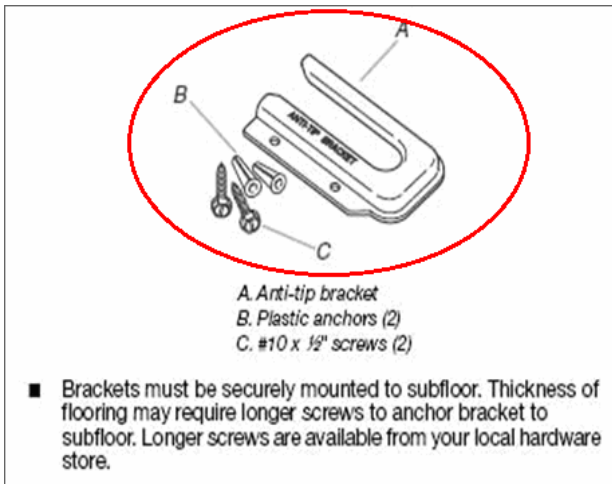
154) Stove - Range Conditions

The gas range was tested by way of normal operating controls. It was found to be functional.

Gas has been provided for stove/range connection. There were no apparent signs of gas leaks from this appliance.

Personal items obstructed testing of the anti-tip bracket safety device. It is recommended client consult with an appliance technician for further evaluation of anti-tip safety device.

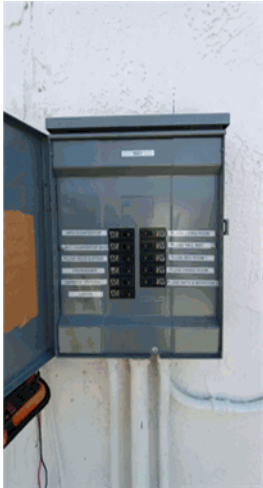
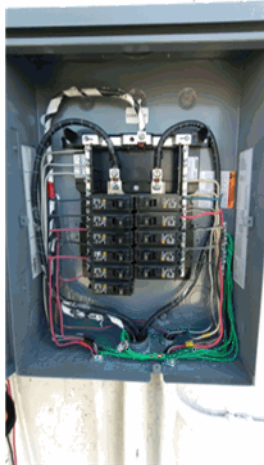
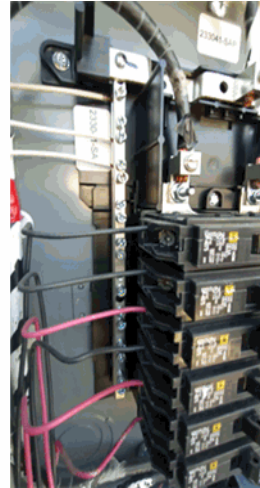
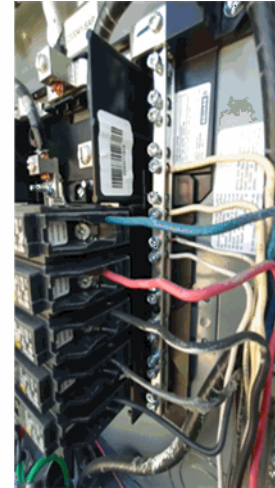
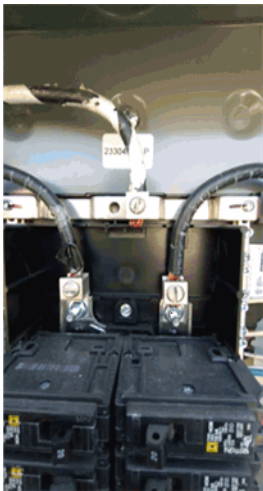
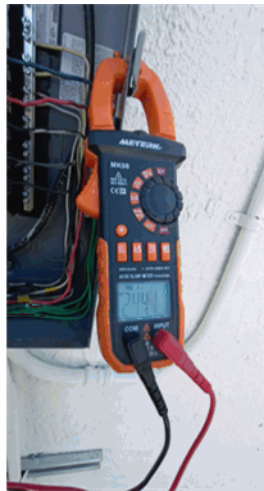
158) Images.

The main service disconnect switch is located at the main electrical panel.
The main electrical panel was manufactured by Square D Corporation.
The main electrical panel is rated for 120/240 volts, 100 Amps.
Magnetic trip circuit breaker.

This sub-panel was located at the rear wall at the exterior. The units electrical subpanel appeared to be in normal operable condition, there was no visible evidence of overheating, corrosion or damage at the time of the inspection. Voltage was tested and well within guidelines.

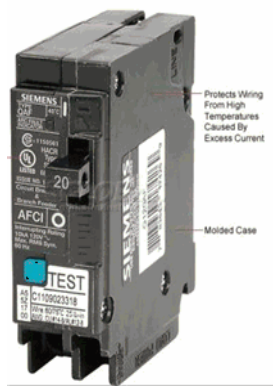
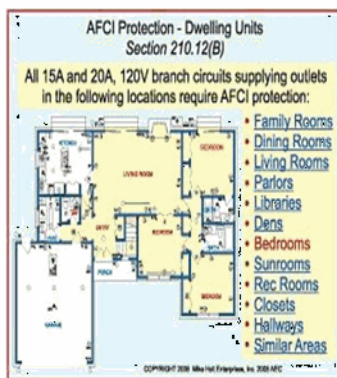
AFCI circuit breakers were not present. AFCI circuit breakers help to prevent electrical fires caused by arc fault conditions at bedroom receptacles. Conventional circuit breakers only respond to overloads and short circuits; so they do not protect against arcing conditions that produce erratic, and often reduced current. **AFCI circuit breakers are a modern requirement for new construction, upgrades and or where branch circuit wiring is modified, replaced, or extended, for all bedroom and similar receptacle circuits. Consult a License Electrician for local requirements.**

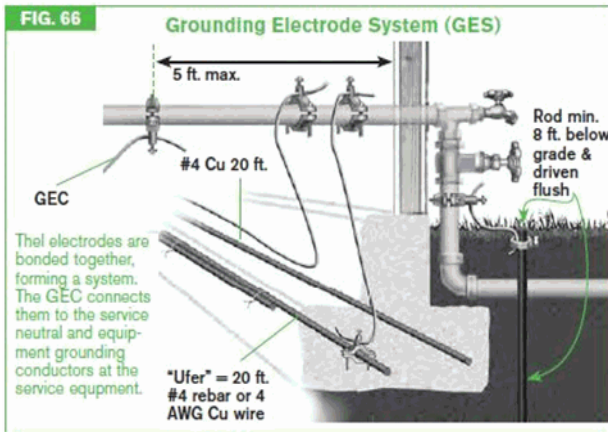
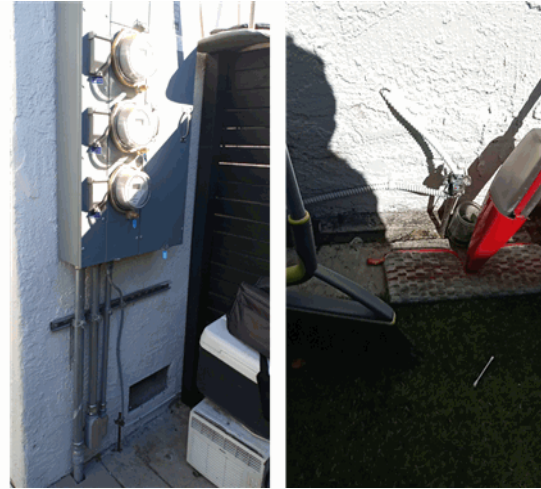
162) Cold Water Clamp - Ground Rod Connection

The ground clamp to the ground rod connection was secured in place. There were no signs of rust or corrosion. Grounding continuity tests are not perform as part of the basic home inspection.

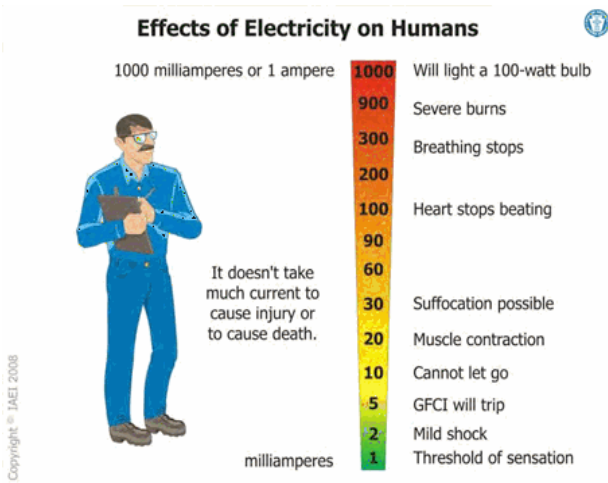
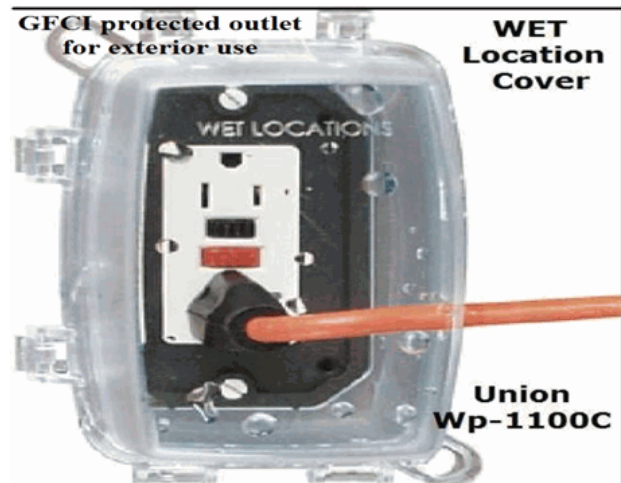
163) Exterior Lighting - Receptacles

Exterior Lighting. Exterior lighting that could be tested was found to be functional. **However lighting fixture substandard installation or damaged. Consult a license electrician for replacement.**

Exterior Receptacles. GFCI (ground fault circuit interrupter) protected receptacles at the exterior of the home that could be tested were found to be functional on the day of the inspection. (GFCI a safety device for outlets near water).

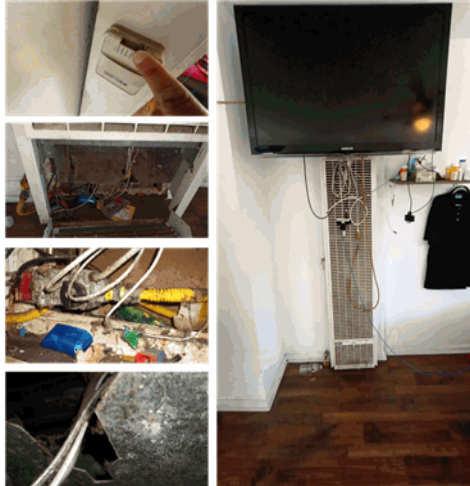
164) Images.

The gas furnace is located on the main floor of the home.

The thermostat. Could not be tested. The pilot light / Furnace unit was not functional. Further evaluation is recommended. Evaluating the calibration of the thermostat is outside the scope of the general home inspection.

Gas furnace pilot was not lit. The inspector was unable to inspect. Repairs, modifications and / or adjustments of any type are prohibited by the inspector. If pilots are off, a full inspection is not possible. It is suggested that the heating systems be activated and fully inspected by a license HVAC contractor prior to close of this property. The equipment must have the capability of providing heat to at least 68 degrees Fahrenheit.

It should note that unit show signs of deferred maintenance. Note the trash and debris's at the interior of the equipment box. General servicing is recommended before relighting or testing.
