Inspection Report

Claro Home Inspections LLC

6519 Denver Ave, Los Angeles, CA 90044

Three units inspection,
Duplex Front Units 1 - 2 rpts

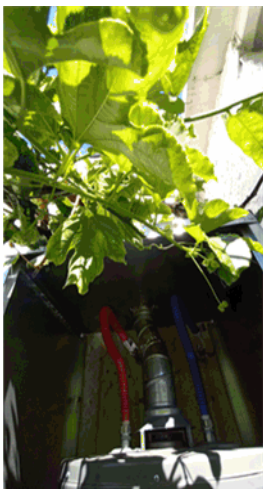
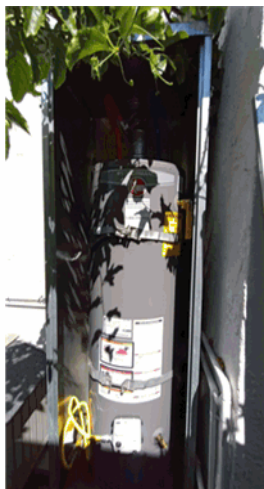
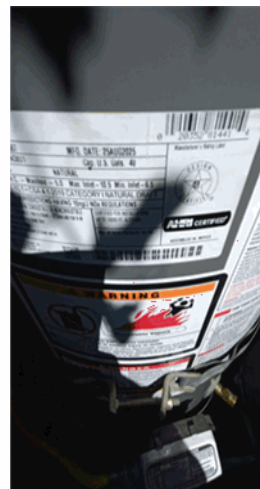
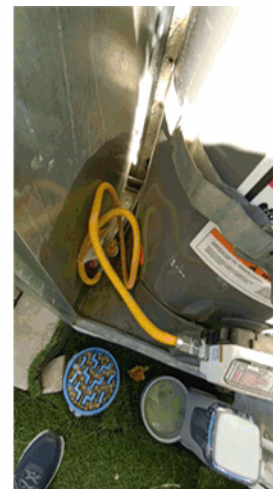
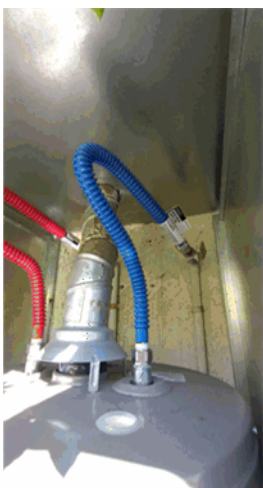
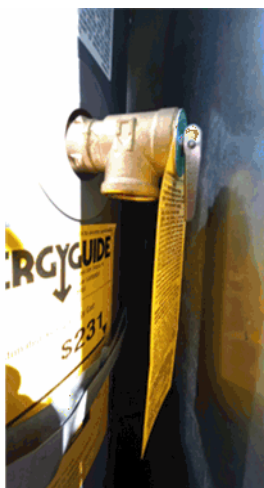
174) Images.

Gas-fired, storage tank.

Mtc Hot water heater was found to be functional on the day of the inspection. Output temperatures were satisfactory. There were no visible signs of leaks, rust or corrosion at the time of inspection. **Hot water heater temperature was measure at 138°. We recommend a temperature setting of 120°F or less. Water temperatures over 125°F can cause severe burns instantly or death from scalds. Note: Households with small children or invalids may require a 120°F or lower temperature setting to prevent accidental contact with HOT water.**

Combustion air venting. Was found to be satisfactory.

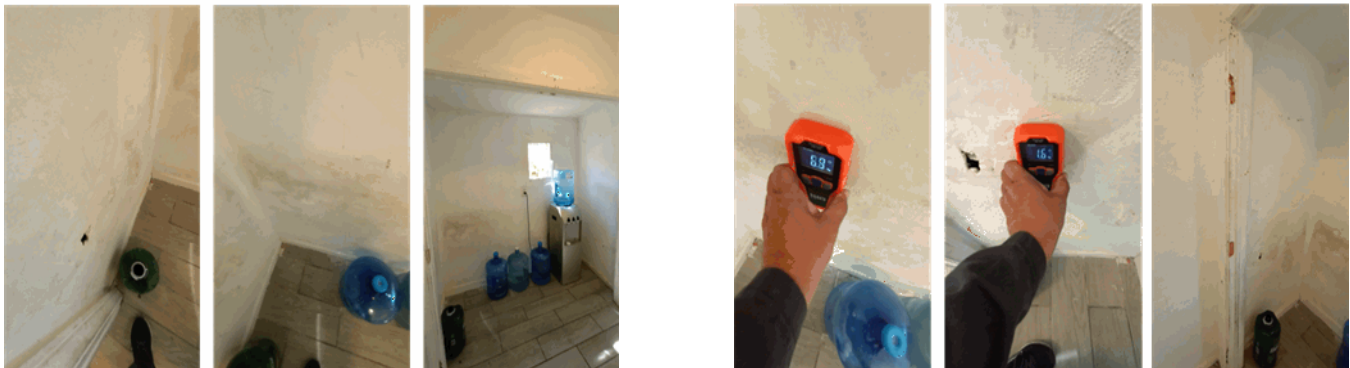
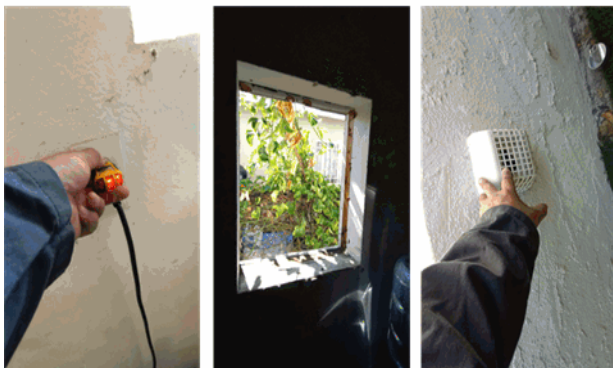
183) Images

Located on the main level of the home.

GFCI. Required GFCI receptacles were not present. It is a modern requirement that all laundry countertop surfaces or within 6 feet of a wet location should be protected by ground fault circuit interrupters for safety.

Exhaust Fan. None present. Window (opening) ventilation only was observed in the laundry area. While this was considered adequate by today's standards, we strongly advise the installation of a powered ventilation system. Failure to remove excess moisture from laundry areas can cause mold and moisture conditions.

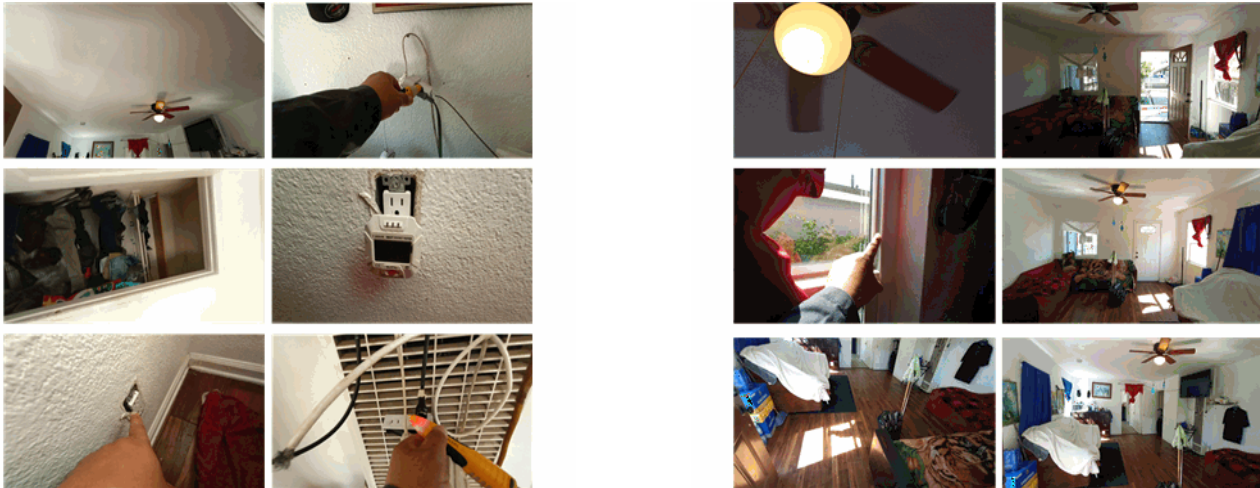
Images.

Fnc Living - Dining - Areas. The general condition of the visible and accessible portions of the floors appeared to be in fair condition at the time of the inspection.

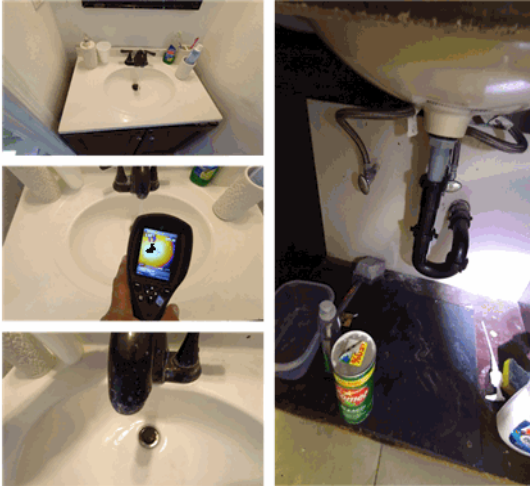
230) Images.

Fnc Bathroom #1.
Sink was in operational condition showing signs of daily wear and tear.
Faucet was functional. Hot and cold running water was present.
Drain assemblies functioned normally with no signs of active leaks.

Fnc Bathroom #1. The visible portions of the bath counters appeared to be in functional condition showing signs of wear and tear
The bath cabinets appeared to be in serviceable condition showing signs of daily wear and tear. Doors and drawers function normally.

Rep Bathroom #1. Toilet was tested and found to be functional on the day of the inspection. **Toilet had a loose connection to the floor. Consult a licensed plumber to reattach flange bolts. Wax ring replacement may be needed.**

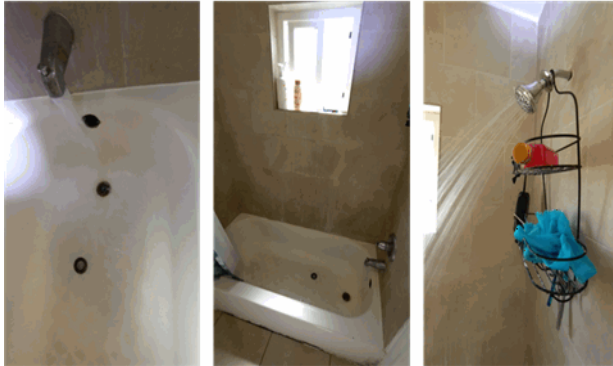
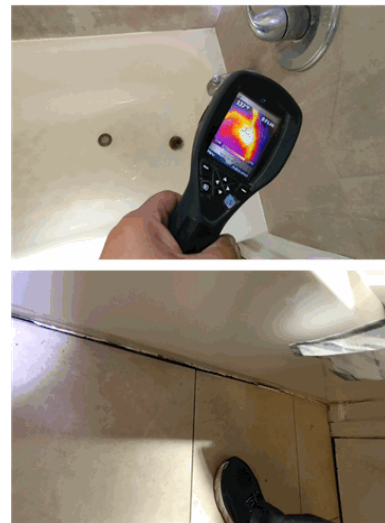
Mtc Bathroom #1.
Tub and shower.
Hot and cold running water was present.
Drainage was functional. **The drain stopper was missing or not**

operational in bath.
 Tub and shower area show signs of significant daily wear and tear.
 General caulking / sealing is recommended throughout.

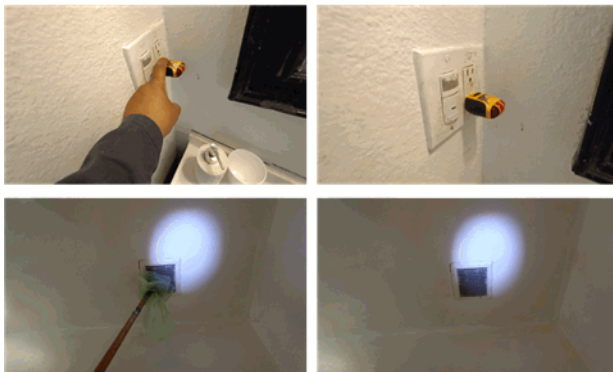
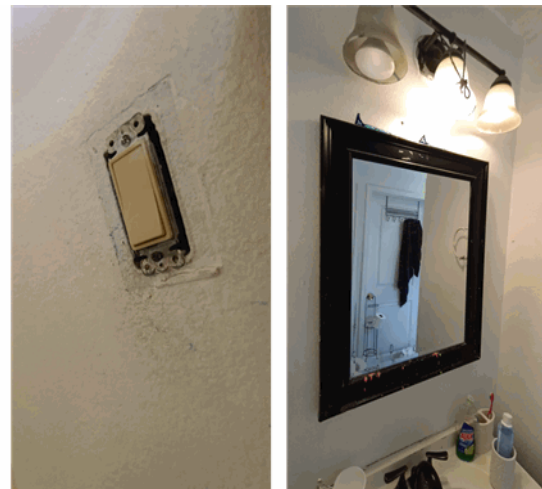
235) Image

Mtc Bathroom #1. Lights and switches that were tested were found to be functional with appropriate cover plates properly installed. A light bulb was out, missing or inoperative. Recommend all lights be operable prior to close.
 Missing or damaged cover plates / componets observed at the switch outlets. Safety hazard. Client to consult a licensed electrician for repairs.

Mtc Bathroom #1. The ventilation appeared to be serviceable in the bath. Excessive lint observed at the exhaust. Bath fans draw in dust and lint, which can eventually clog the grille and limit airflow. For effective air movement. Recommend cleaning.

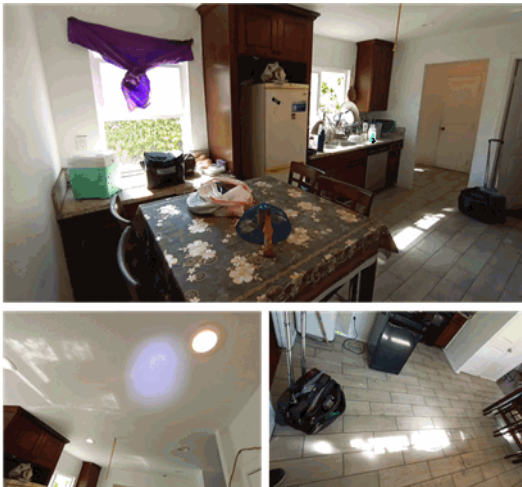
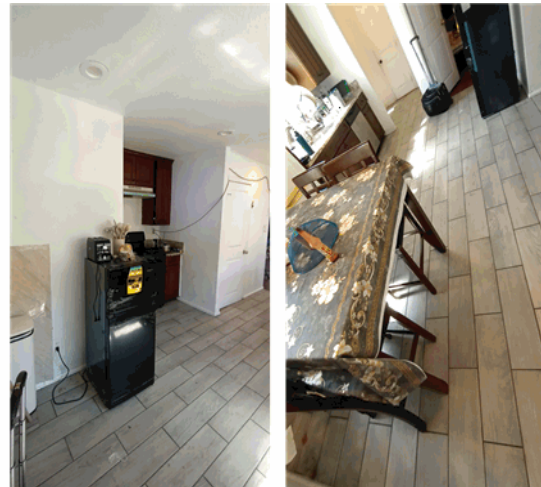
239) Kitchen Sec A Images.

Kitchen. The general condition of the visible and accessible portions of the floors appeared to be in fair condition at the time of the inspection.

Kitchen. Walls were in fair condition for the age of the home. There were no significant signs of stains or damage visible.

Kitchen. Ceilings were in fair condition for the age of the home. There were no significant signs of stains or damage visible.

Kitchen. The general condition of the visible and accessible windows appeared serviceable at the time of the inspection.

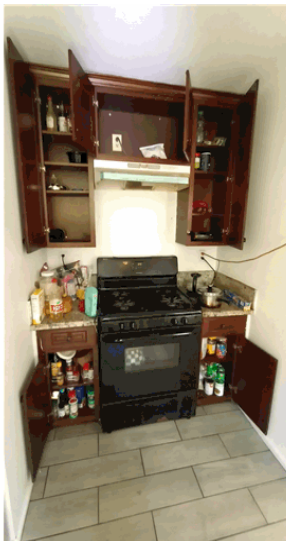
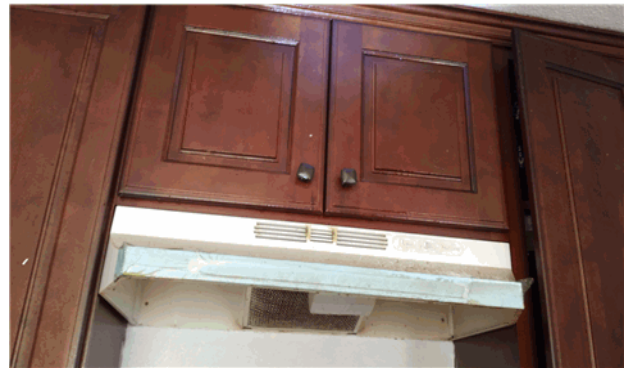
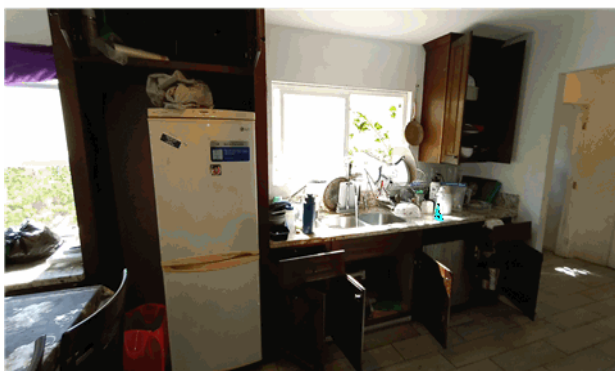
244) Images.

Countertop Condition: The visible portions of the kitchen counters appeared to be in fair condition for the age of the home. (Fnc)
Maintenance & Wear: Counters showed evidence of heavy daily wear and tear, including an accumulation of kitchen grease, dirt, and grime. (NI)

Maintenance & Wear: Similar to the countertops, the cabinet surfaces showed evidence of heavy daily wear and tear, including an accumulation of kitchen grease, dirt, and grime. (NI)

The kitchen sink was in functional condition. Faucet was operational. Hot and cold running water was present. Drain assemblies functioned normally with no signs of active leaks. However, slow drain was observed at kitchen sink. Consult a licensed plumber to clear slow drain lines at drain assembly.

What appears to be rodent or pest droppings was noted at the interior of the sink cabinet. It is recommended client consult a pest professional for further evaluation.

Outlet box covers were missing. Recommend installation of covers for increased safety.

Recommendation: Client should consider the potential costs associated with professional cleaning, repairs, or future upgrades/replacements.

Recommendation: Client should consider the costs associated with deep cleaning, hardware replacement, or potential refinishing/upgrades.

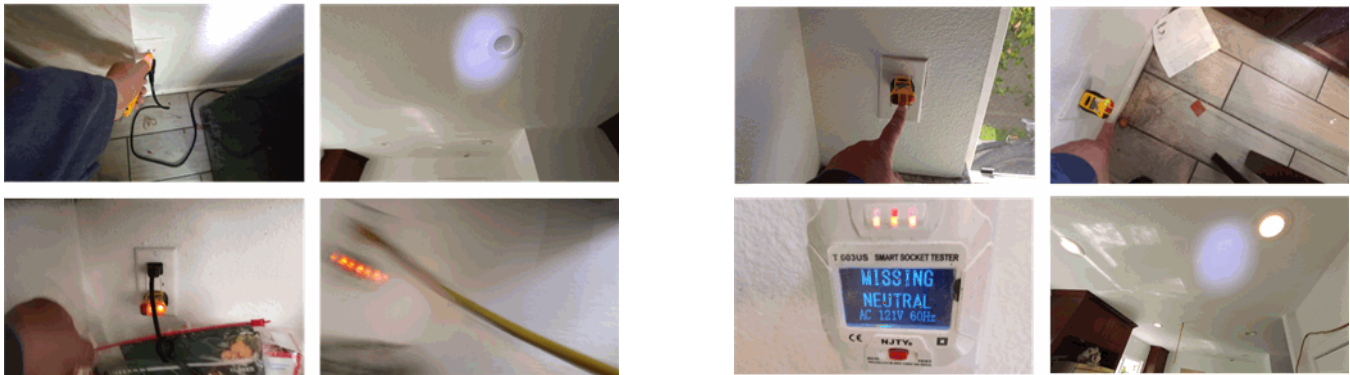
249) Images

Lights and switches that were tested were found to be functional with appropriate cover plates properly installed. A number of light(s) bulb(s) were out, missing or inoperative. Recommend all lights be operable prior to close.

An open neutral wire condition was observed at an outlet(s). It is recommended client consult a licensed electrician for correction. Safety hazard.
