## Home Inspection Report

Prepared exclusively for  
**Jim Graser**

PROPERTY INSPECTED:  
**11821 Raspberry Lane**  
**Oak Glen, CA 92399**

**Date of Inspection: 01/12/2026**

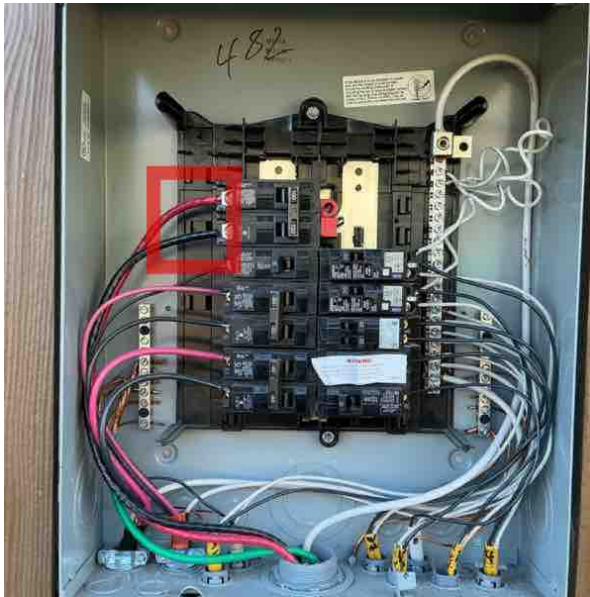
**(Guest house east exterior)**

### 7.6.2 SUB-PANEL FEEDER – UNDERSIZED CONDUCTORS OBSERVED

The sub-panel feeder was found to have 6-gauge conductors connected to a 100-amp breaker. This wire size is typically not rated for a 100-amp overcurrent device, creating an undersized-conductor condition that may pose a safety concern and does not align with common installation standards. Proper feeder sizing, conductor type, and breaker compatibility are critical for safe operation and reliable panel performance.

A qualified electrician should evaluate the sub-panel feeder, correct the conductor-to-breaker mismatch, and verify proper sizing and installation to help ensure safe operation and support a market-ready presentation.

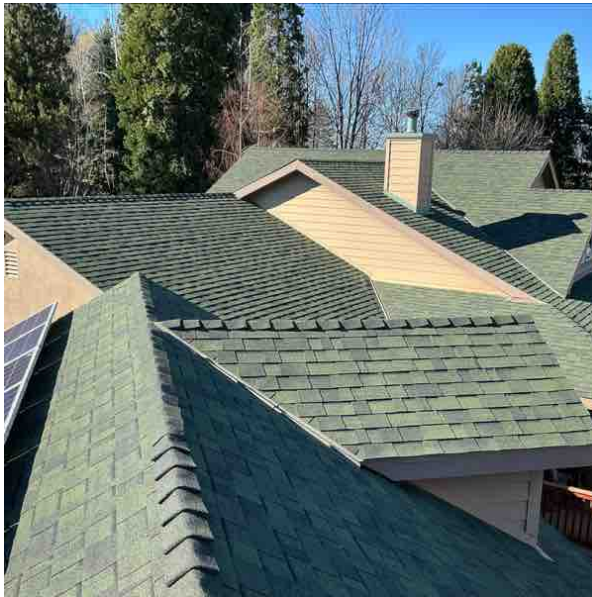
4.2.1 The roof was inspected by traversing its surface. Inspection was limited to visible and accessible components; underlying materials such as sheathing, underlayment, and fasteners were not exposed or evaluated.
