### *Inspection Report*

Address: 4837 Tumbleweed Way Paso Robles, CA 93446

03/25/2026

Inspector: Taylor Vreeken, CCI

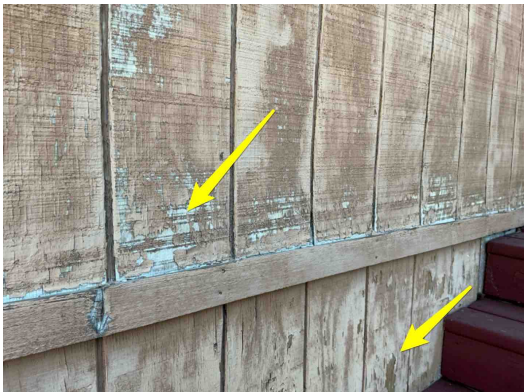
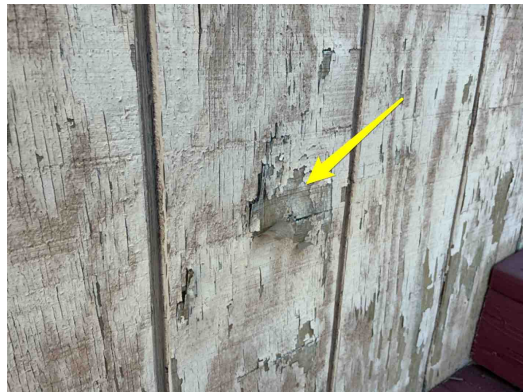
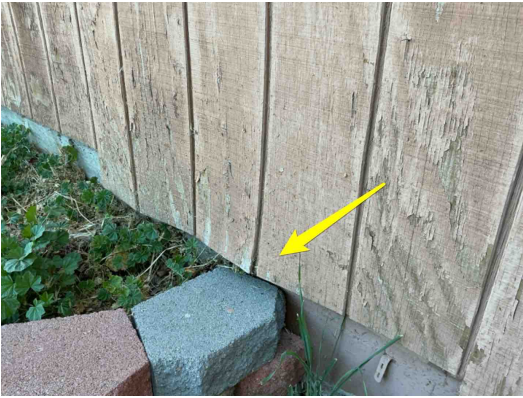
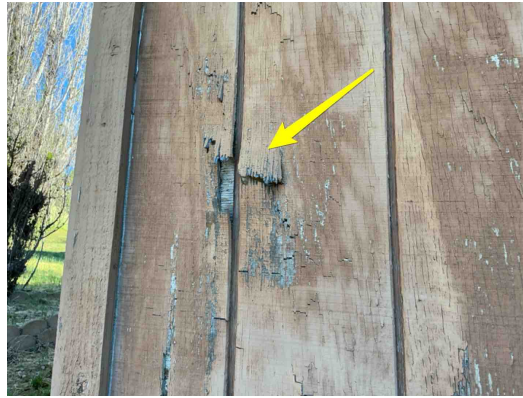
**s-27:** The exterior wood siding found heavily deteriorated and damaged at multiple locations throughout. Too many individual defects and locations to list. Recommend further evaluation in corrections/repair by a licensed contractor familiar with minimum codes and standards.

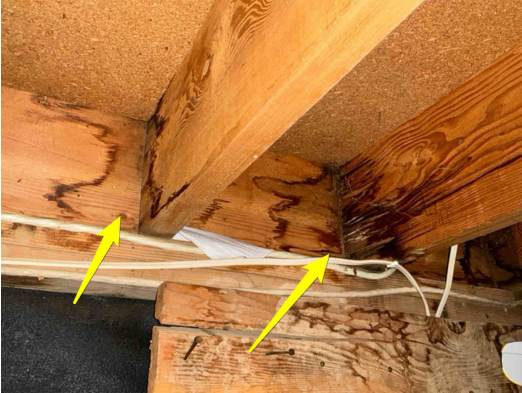
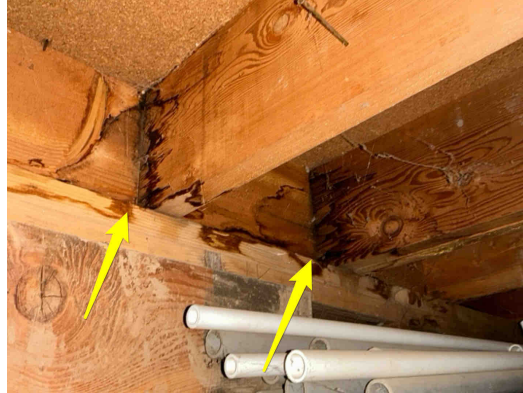
**E&C s-42:** Evidence of water intrusion below the front entry deck where the joists enter the crawlspace. Recommend repairs and adequate waterproofing to avoid further moisture damage.

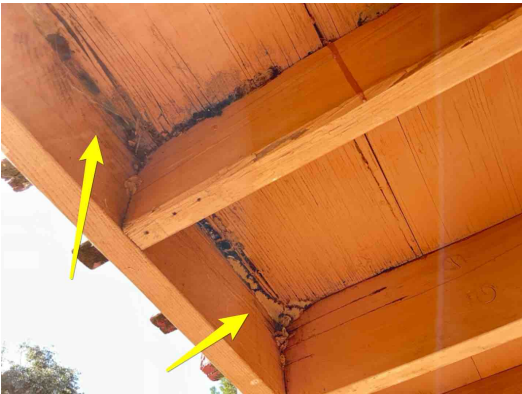
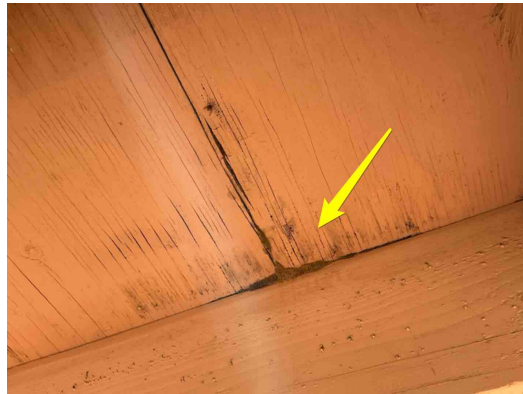
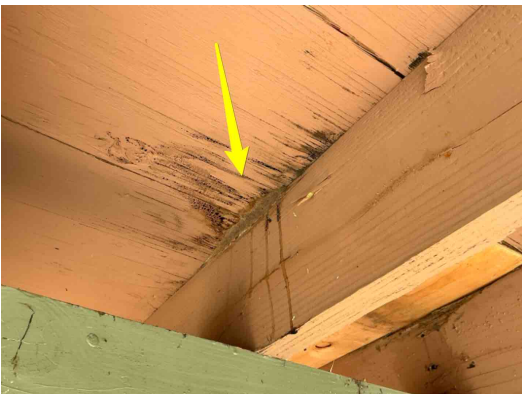
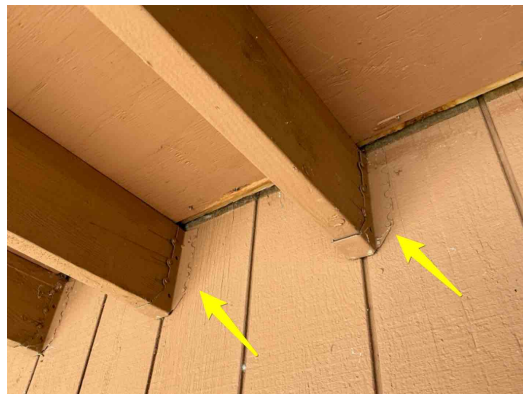
**E&C SC s-43:** The UPSTAIRS DECK OFF THE LIVING ROOM is improperly constructed and not a proper waterproof assembly. Too many individual defects to list. Areas of the decking found unsafe. Contact a qualified decking contractor for further evaluation and reconstruction/ repairs.

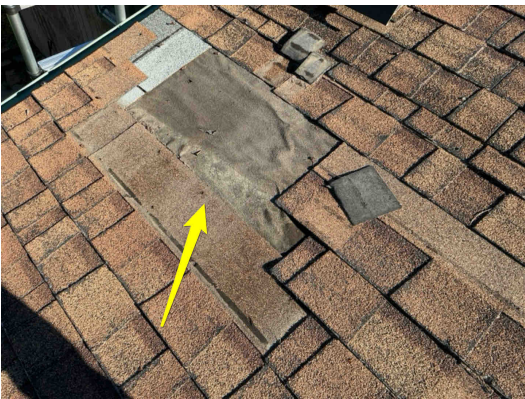
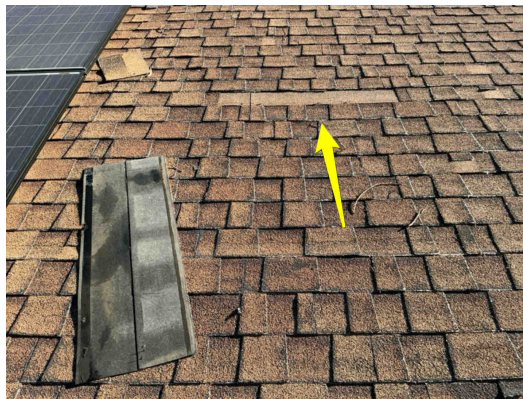
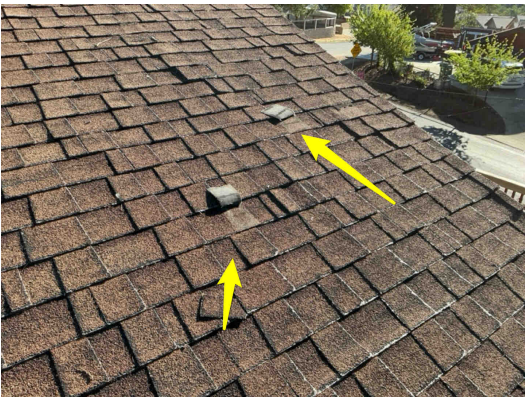
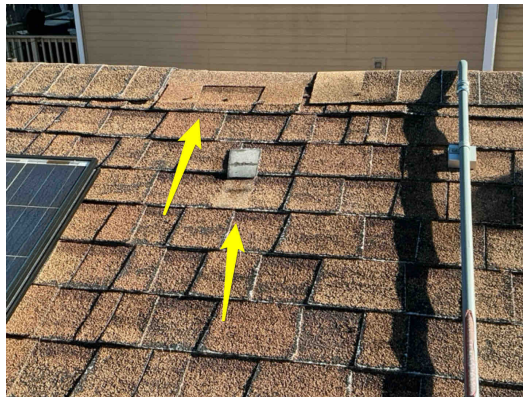
**E&C** **DS** s-72: **ROOF CONDITION:** Roof is at or past the end of its life expectancy. Recommend contacting a licensed roofing contractor for a price / proposal for replacement.

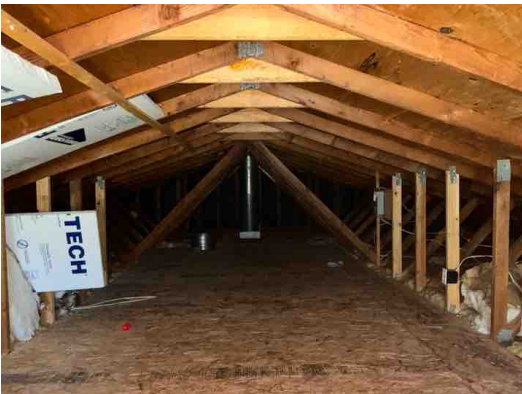
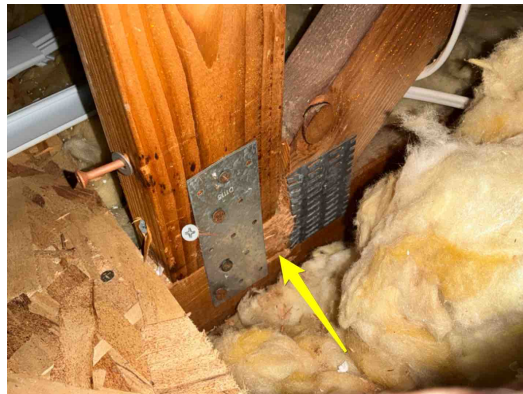
**E&C SC s-80:** Roughly 2/3 of the attic truss system found heavily altered and removed. This substandard alteration to attic framing is a significant structural concern and warrants further evaluation by qualified engineer.

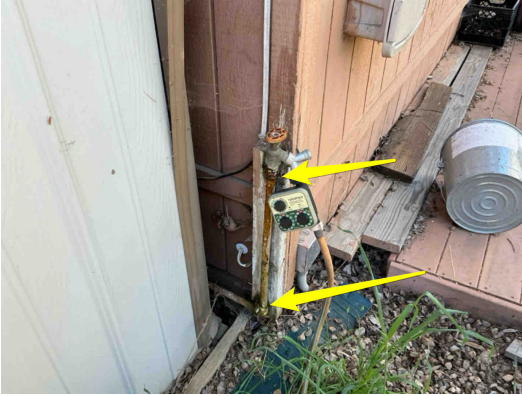
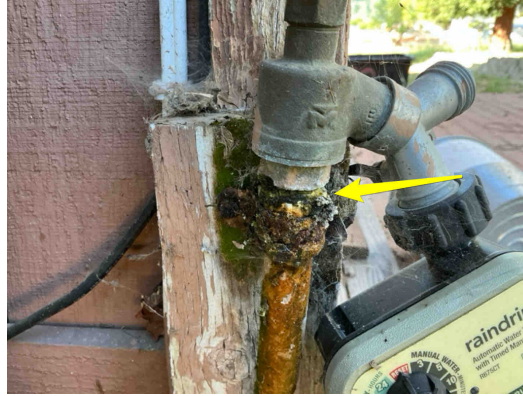
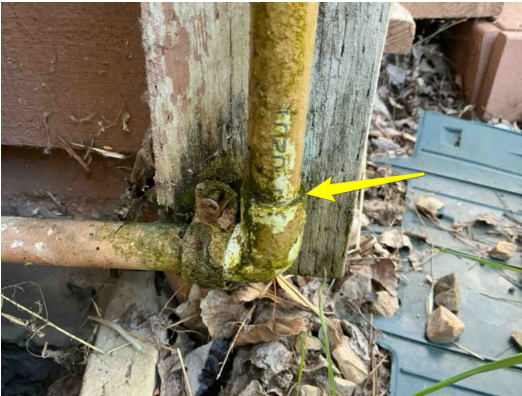
**E&C s-90:** Active water leak found at NORTHWEST ADDED HOSE BIB SUPPLY LINE. Recommend further evaluation and repairs by qualified plumbing professional.

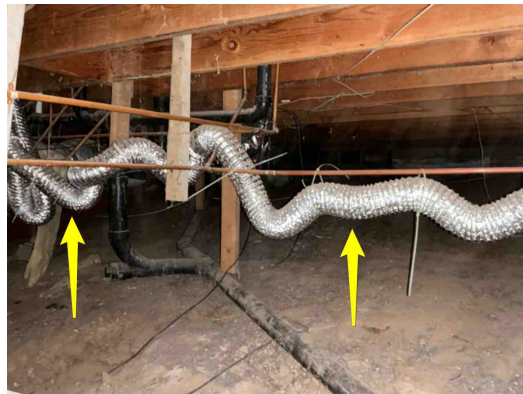
**SC s-127:** An improper use of a non-fire rated / flexible laundry dryer vent pipe through the crawlspace. Replacement recommended for fire safety. Contact a qualified, HVAC contractor. The maximum length of a flexible laundry dryer flex connector is 6 feet.

- Dryer exhaust ducts are required to discharge directly to the exterior of the building and shall not terminate into a crawlspace, attic, chimney, vent connector, gas vent, or other concealed space.
- Exhaust ducts shall be constructed of rigid metallic material.
- Ducts shall not be assembled with screws or fasteners that penetrate into the duct interior, as these can catch lint and reduce airflow efficiency.
- The exterior termination is required to include a backdraft damper and must not contain a screen, which can accumulate lint and restrict airflow.
- Where duct sections are joined, the male end must be installed in the direction of airflow.

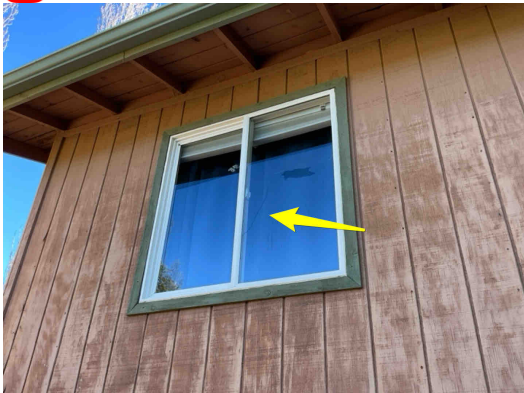
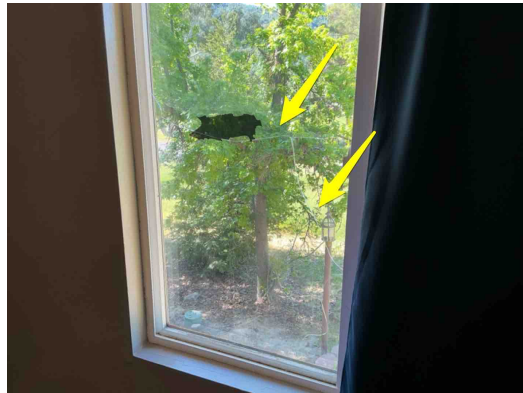
**SC** s-151: Cracked or broken window glass found: BEDROOM-2

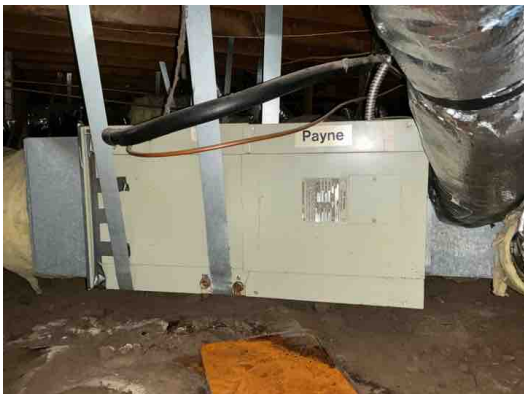
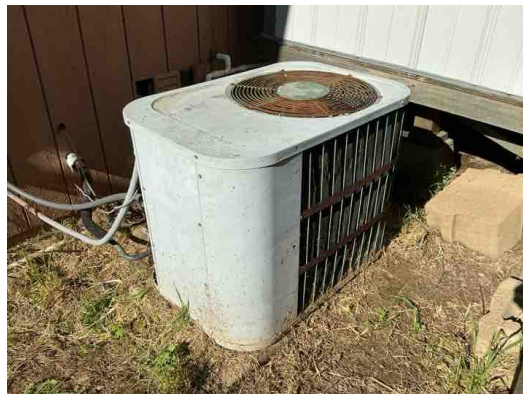
**E&C** **SU** s-169: This type of heating and cooling system has an anticipated 20+/- year life span and is currently 48 years old. **The heating and cooling did not operate today and may warrant full replacement.** Contact a licensed HVAC professional for evaluation and repair/replacement.

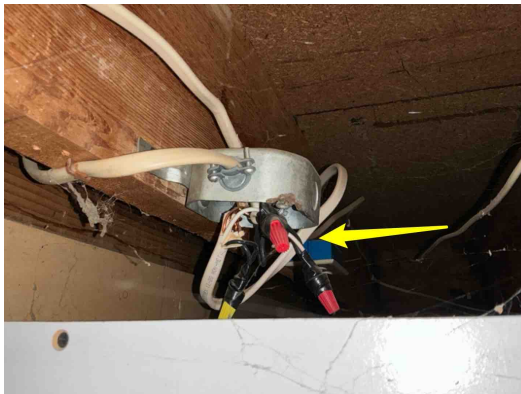
**SC** s-182: Missing electrical cover plate: MULTIPLE IN THE CRAWLSPACE

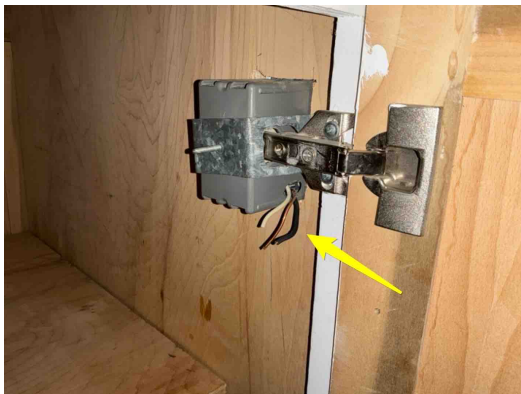
**E&C** s-186: The kitchen island GFCI found non-operational/ abandoned.

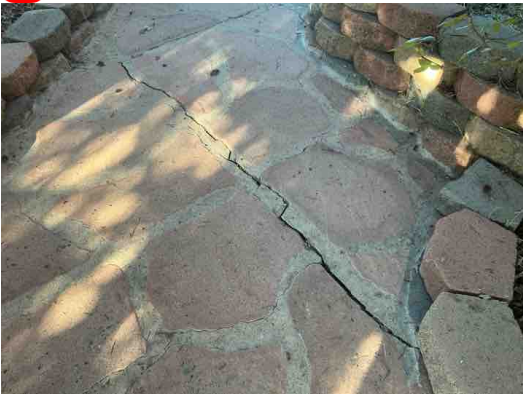
**E&C** **21:** Some moderate and heavy cracks found at areas of the concrete walkways.

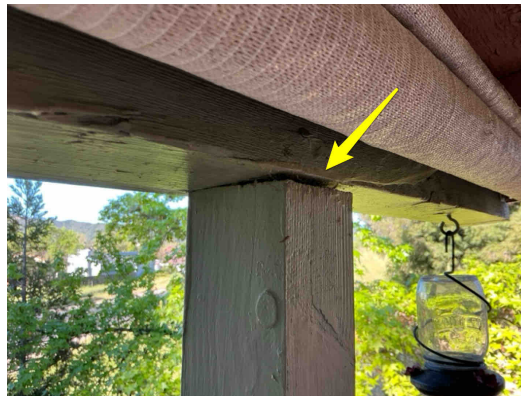
**E&C SU 22:** Areas of the wood framed FRONT PORCH COVER do not meet minimum construction or engineering standards. Certain issues can negatively affect the overall integrity of the structure. Further evaluation with upgrades or repairs by a licensed contractor familiar with minimum construction and engineering standards is recommended.

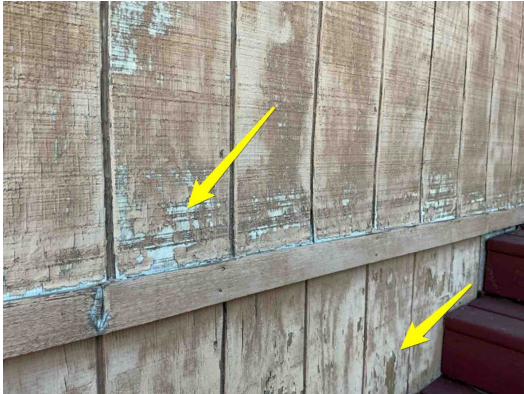
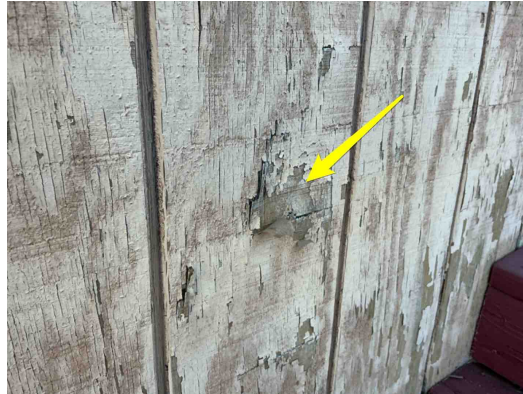
**27:** The exterior wood siding found heavily deteriorated and damaged at multiple locations throughout. Too many individual defects and locations to list. Recommend further evaluation in corrections/repair by a licensed contractor familiar with minimum codes and standards.

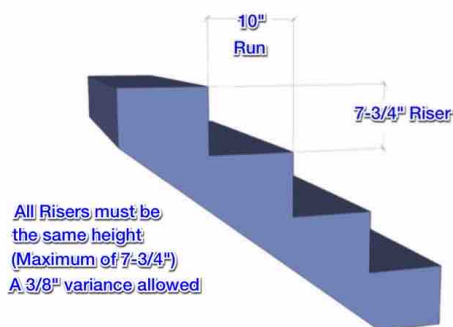
**SC 37:** Uneven step tread rise, step heights are not all the same, at the exterior stairway off the FRONT ENTRY DECK. Potential trip or fall hazard.

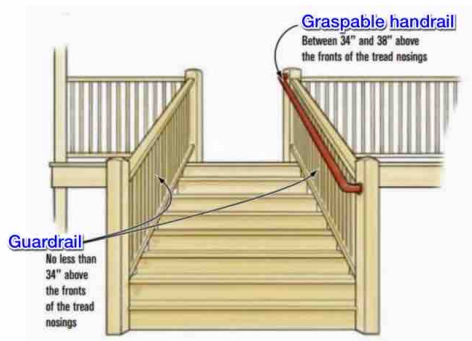
**SC 38:** Missing the proper / required graspable handrail at the exterior stairway OFF THE FRONT DECK.

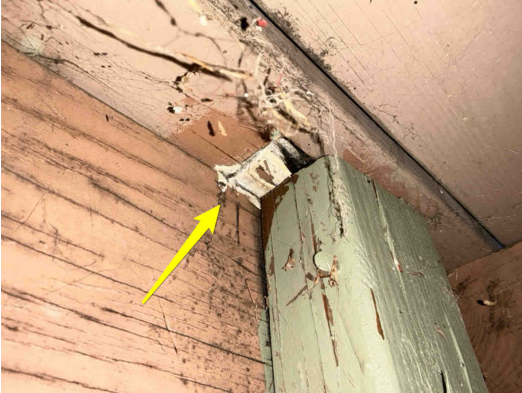
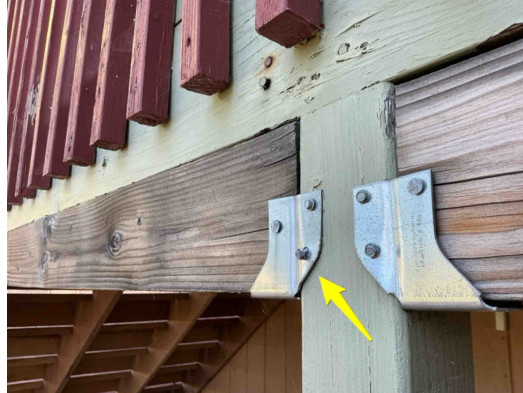
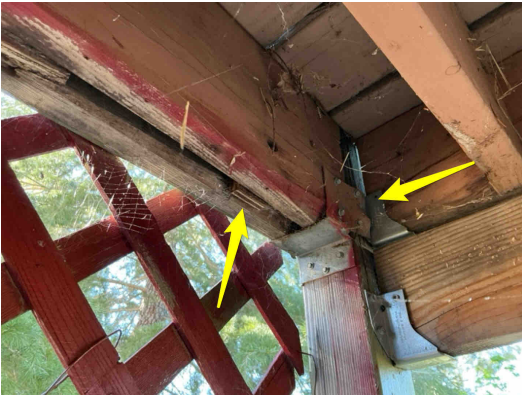
**E&C 41:** The FRONT ENTRY DECK does not meet minimum construction standards, has moderate moisture damage, and appears to be at the end of serviceable life. Contact a qualified contractor for evaluation and repairs or replacement.

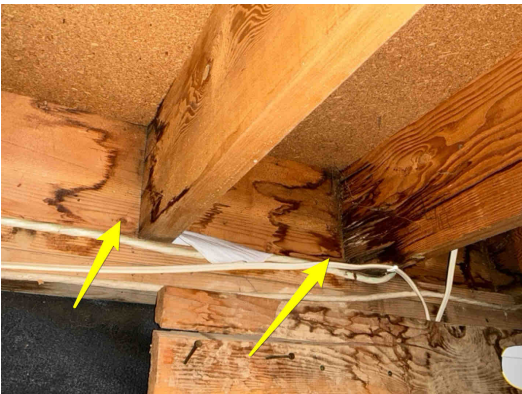
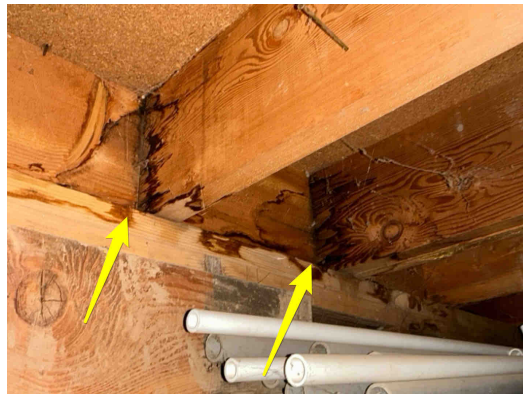
**E&C 42:** Evidence of water intrusion below the front entry deck where the joists enter the crawlspace. Recommend repairs and adequate waterproofing to avoid further moisture damage.

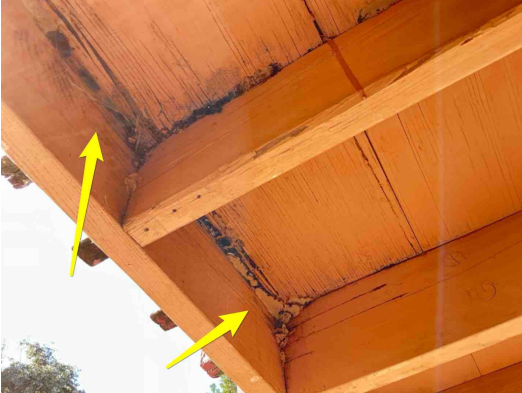
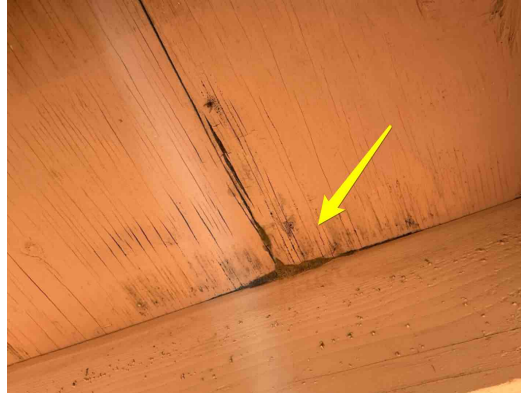
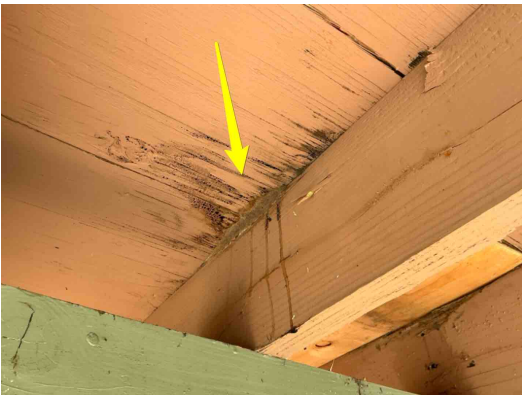
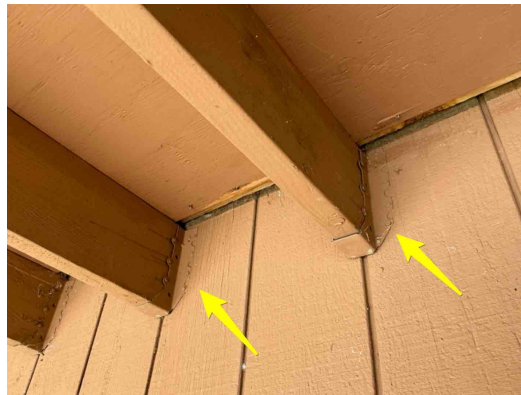
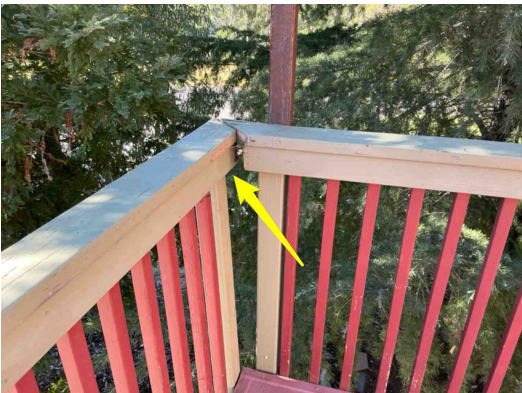
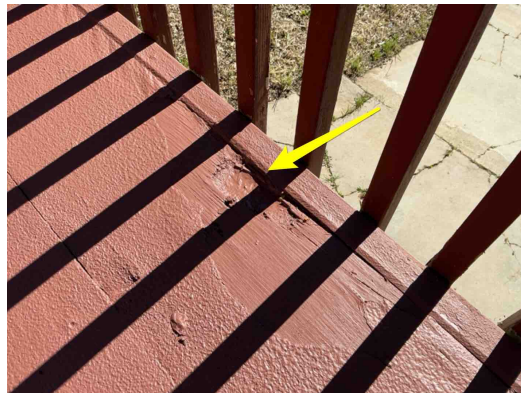
**E&C SC 43:** The UPSTAIRS DECK OFF THE LIVING ROOM is improperly constructed and not a proper waterproof assembly. Too many individual defects to list. Areas of the decking found unsafe. Contact a qualified decking contractor for further evaluation and reconstruction/ repairs.

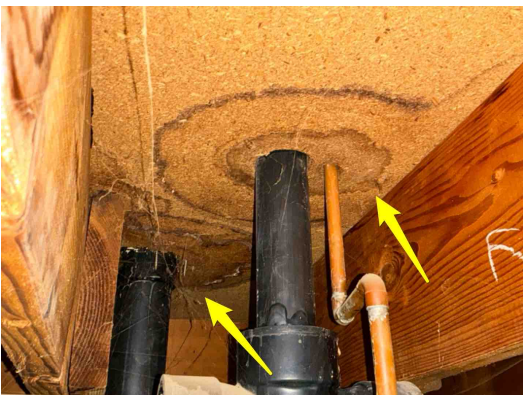
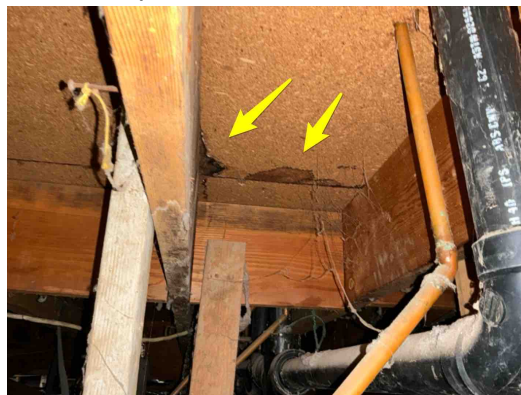
**FI 52:** Some water stains noted on the underside of the wood framing in areas of the crawlspace under some exterior doors, bathrooms and/or kitchen. Refer to the Termite report for additional comments and recommendations as to the exact location, extent, and if repairs are needed.

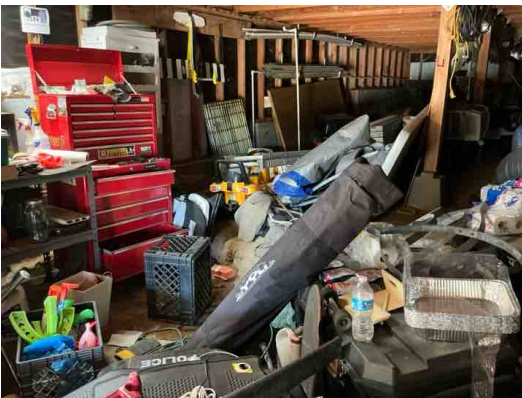
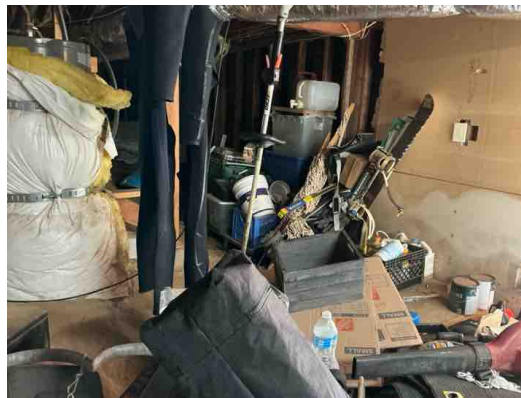
**57: Disclosure:** Areas of the crawlspace are not fully visible, not fully accessible and not inspected due to occupant's belongings HVAC unit, ducting, plumbing, and area is too small for physical access.

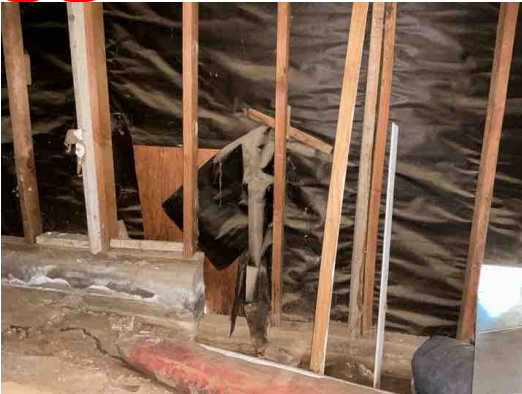
**E&C FI 64:** Heavily damaged/ deteriorated watershed paper visible from inside the crawlspace.

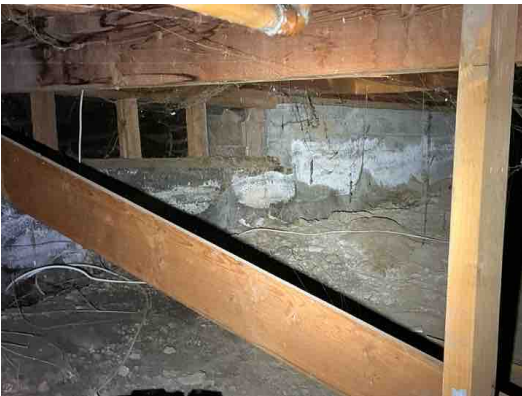
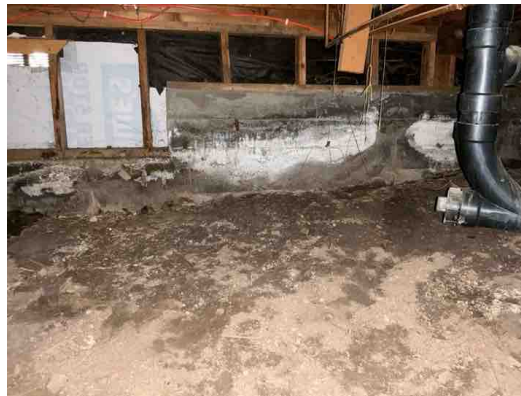
**E&C 65:** Evidence of moisture intrusion into the crawlspace from around the concrete exterior walls due to insufficient grading at the exterior. Contact a qualified contractor for corrections.

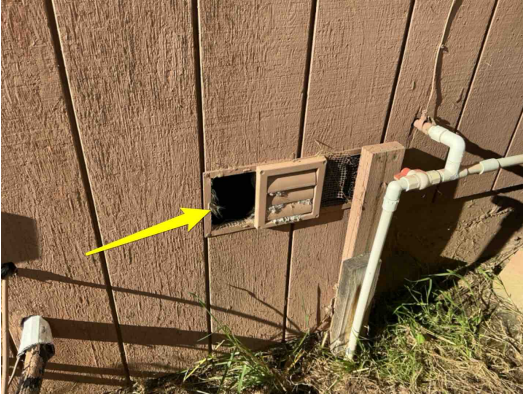
**E&C 66:** Unscreened opening(s) into crawlspace areas needing to be filled or screened to help prevent critter intrusion.

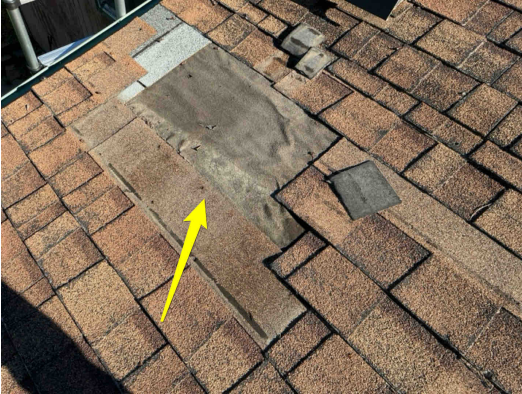
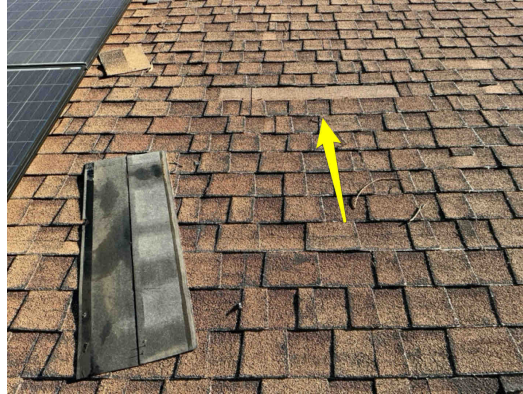
**E&C DS 72: ROOF CONDITION:** Roof is at or past the end of its life expectancy. Recommend contacting a licensed roofing contractor for a price / proposal for replacement.

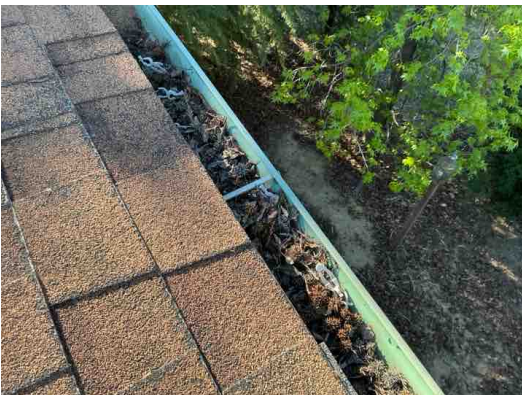
**MR 74:** Recommend some typical rain gutter maintenance. This should at minimum consist of cleaning, sealing, and re-fascinating of loose gutters and downspouts.

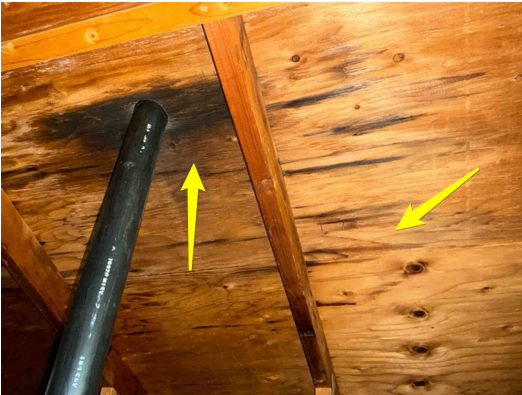
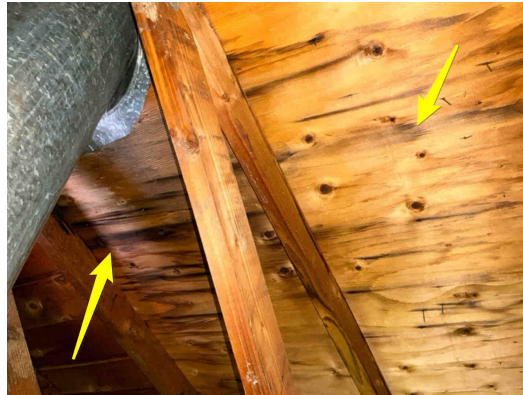
**FI DS** 79: Some moderate and heavy moisture stains noted in areas throughout the attic. All water stains should be investigated by a licensed roofer. Refer to termite report for additional comments and/or recommendations.

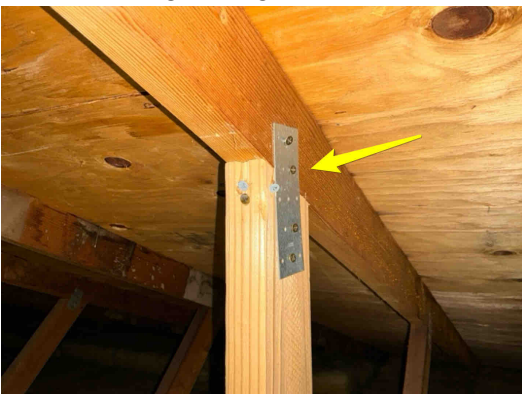
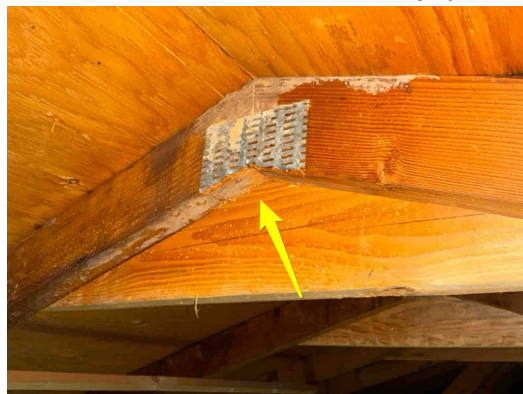
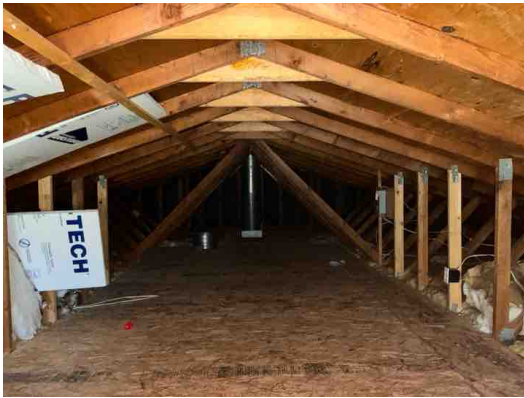
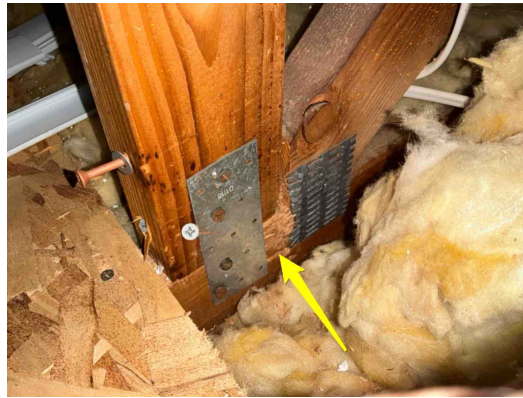
**E&C SC** 80: Roughly 2/3 of the attic truss system found heavily altered and removed. This substandard alteration to attic framing is a significant structural concern and warrants further evaluation by qualified engineer.

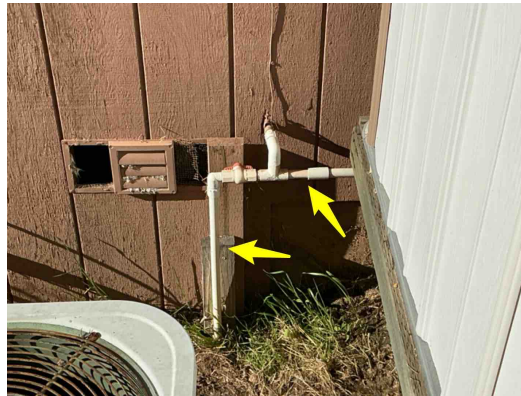
**MR UPG 89:** Exposed exterior water supply pipes subject to freezing are not insulated, not insulated well or have damaged or deteriorated insulation installed. Upgrades are recommended.

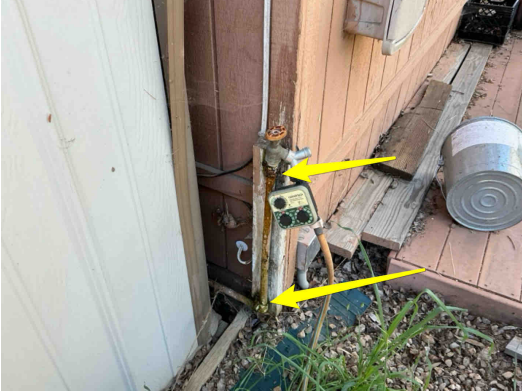
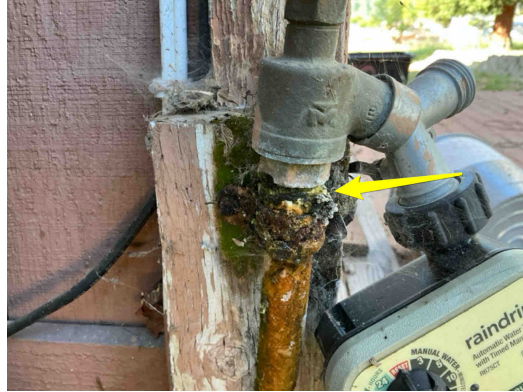
**E&C 90:** Active water leak found at NORTHWEST ADDED HOSE BIB SUPPLY LINE. Recommend further evaluation and repairs by qualified plumbing professional.

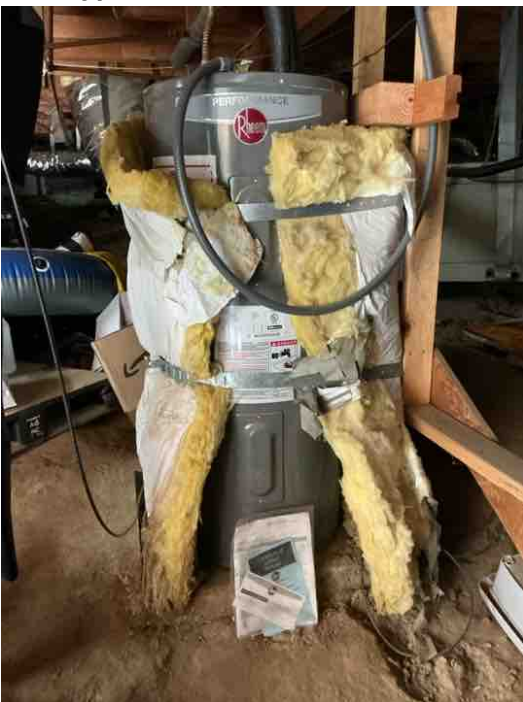
**Fuel Type:** Electric

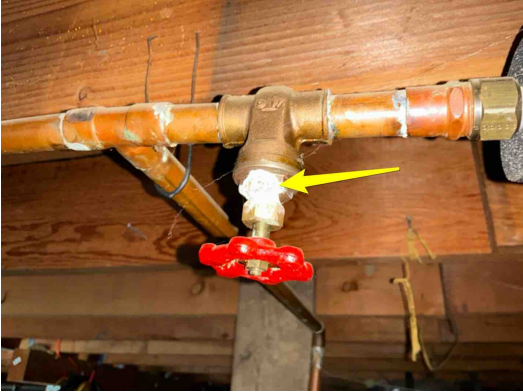
**E&C 103:** Evidence of past leaking with corrosion at the COLD water supply shut-off valve at the water heater. Recommend replacement.

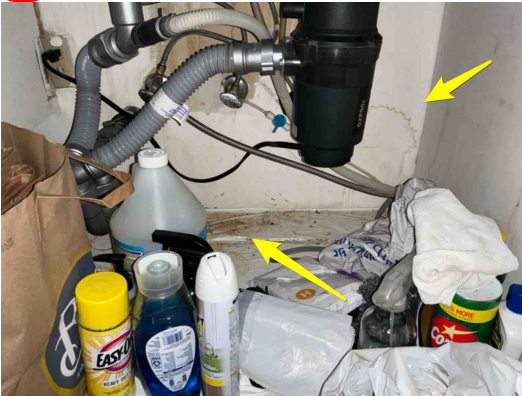
**FI 110:** Some dry moisture stains and damage in the cabinetry below the kitchen sink.

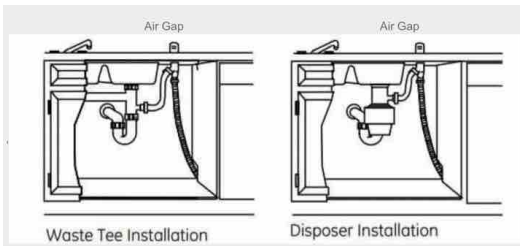
**SU 111:** Improper installation of the dishwasher drain hose. Missing the Air Gap Device at the dishwasher drain per minimum codes and standards (California does not allow for high-loop methods or direct waste connections). {CPC 801.2}

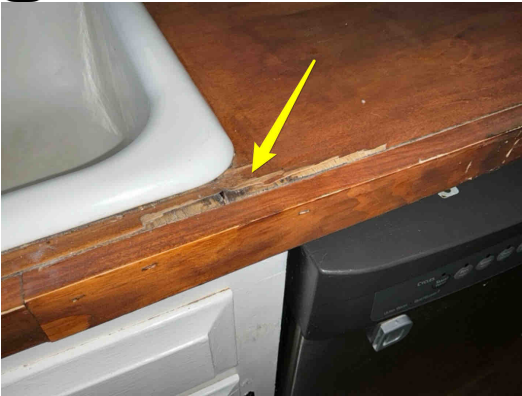
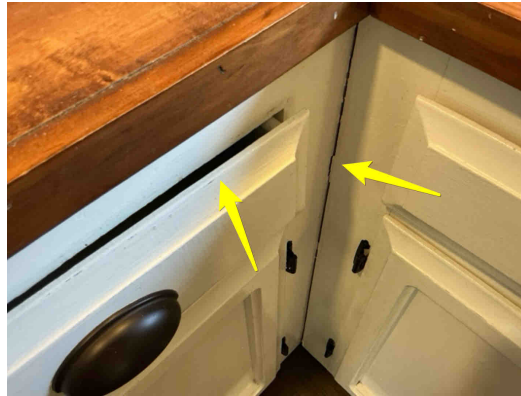
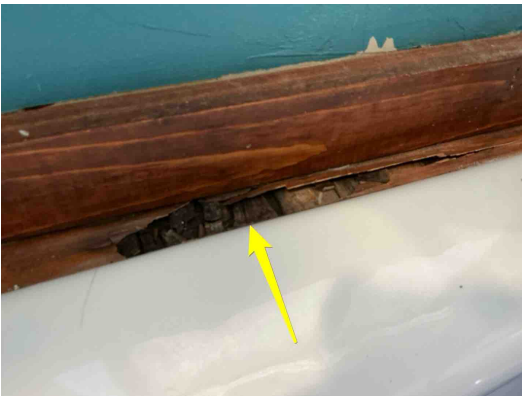
**DS 116:** Kitchen counters & cabinets have moderate and heavy wear and deterioration.

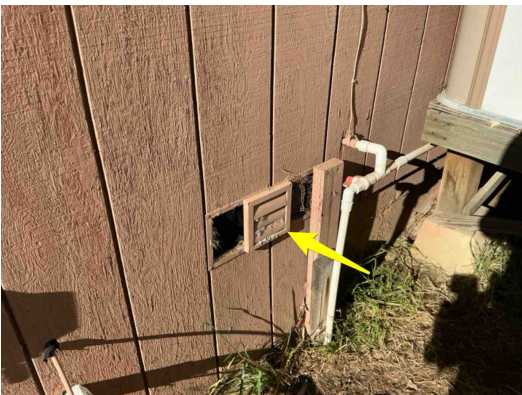
**MR 126:** Recommend cleaning and servicing the laundry dryer vent system, pipe and cap, for safety as part of typical ongoing maintenance.

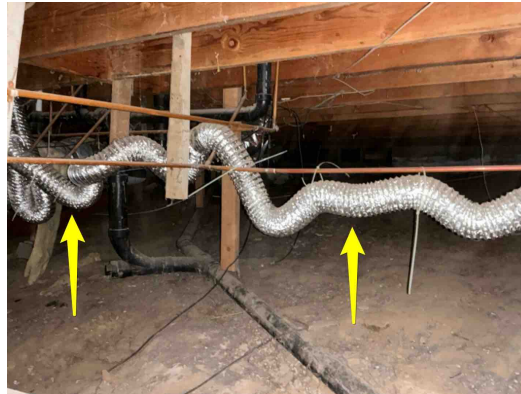
**SC 127:** An improper use of a non-fire rated / flexible laundry dryer vent pipe through the crawlspace. Replacement recommended for fire safety. Contact a qualified, HVAC contractor. The maximum length of a flexible laundry dryer flex connector is 6 feet.

**Reference- California Mechanical Code (CMC) Section 504.4**

- Dryer exhaust ducts are required to discharge directly to the exterior of the building and shall not terminate into a crawlspace, attic, chimney, vent connector, gas vent, or other concealed space.
- Exhaust ducts shall be constructed of rigid metallic material.
- Ducts shall not be assembled with screws or fasteners that penetrate into the duct interior, as these can catch lint and reduce airflow efficiency.
- The exterior termination is required to include a backdraft damper and must not contain a screen, which can accumulate lint and restrict airflow.
- Where duct sections are joined, the male end must be installed in the direction of airflow.

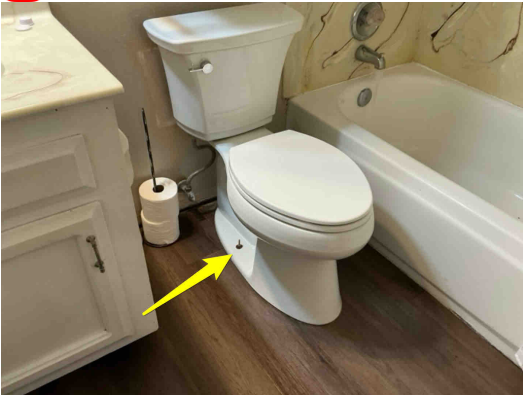
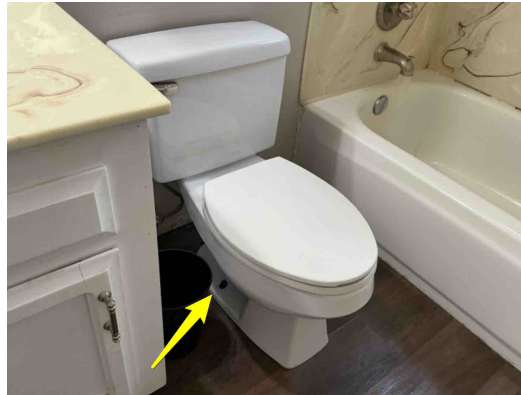
**E&C 131:** Toilet loose at floor: HALLWAY BATHROOM and PRIMARY BEDROOM BATHROOM

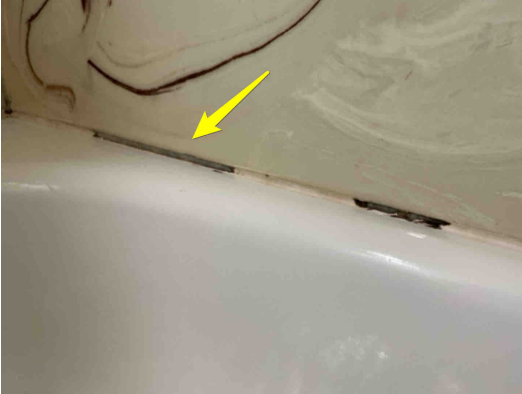
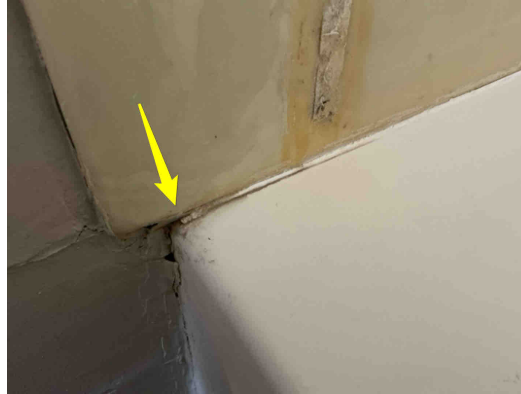
**MR 138:** The grout and/ or caulking in the HALLWAY BATHROOM and PRIMARY BEDROOM BATHROOM showers is in need of cleaning, maintenance or replacement recommended

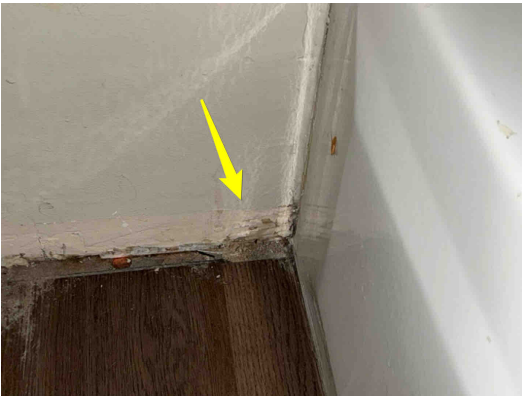
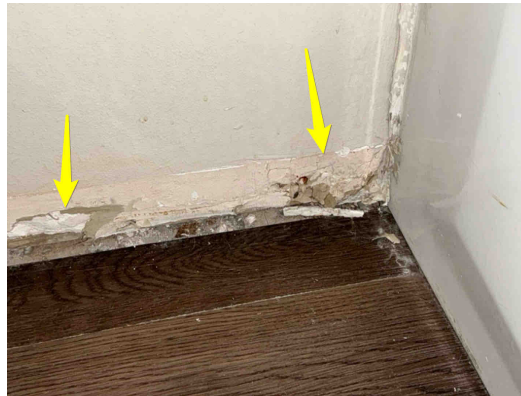
**FI 139:** Moisture stains & damage to walls, baseboards and/or floor outside shower: HALLWAY BATHROOM and PRIMARY BEDROOM BATHROOM

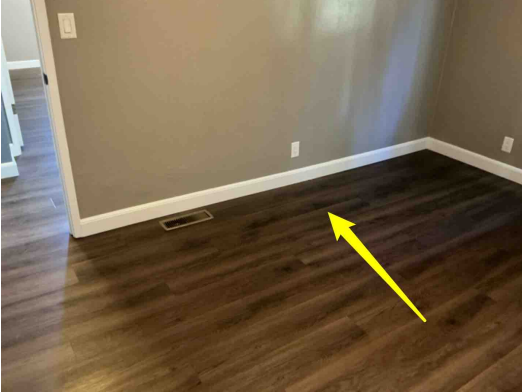
**FI DS 158:** *Disclosure: Some floor squeaks and pops noted in areas of the house.*

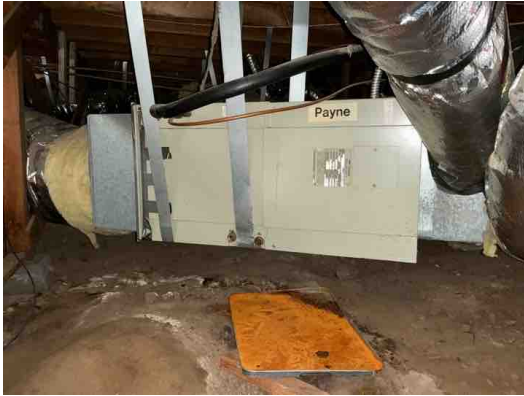
**168:** Electric Heating Type & Location: Electric Heat Pump / CRAWLSPACE

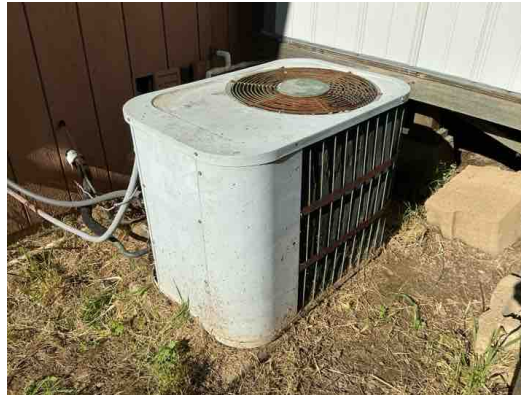
**E&C** **SU** **169:** This type of heating and cooling system has an anticipated 20+/- year life span and is currently 48 years old. **The heating and cooling did not operate today and may warrant full replacement.** Contact a licensed HVAC professional for evaluation and repair/replacement.

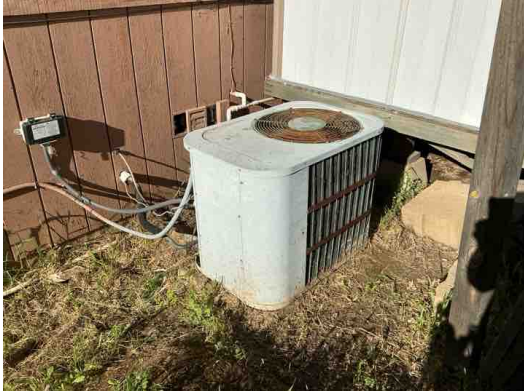
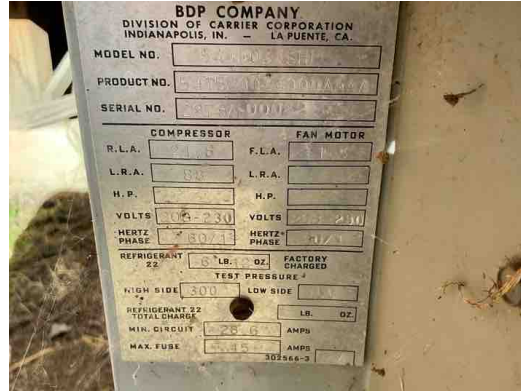
**Date:** 1978

**Refrigerant Type:** R-22. The phasing out of R-22 began in 2010, when manufacturers were no longer able to produce new equipment designed with it. In 2020 and the ban expanded to only allow the use of recycled or previously stockpiled Freon to service existing air conditioners.

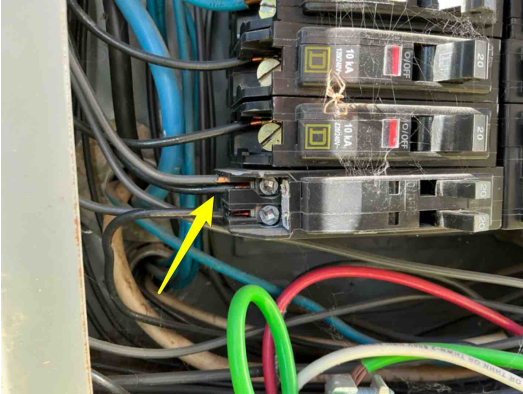
**E&C** **178:** Improper installation of two wires on single-wire rated circuit breaker in the MAIN ELECTRICAL PANEL.

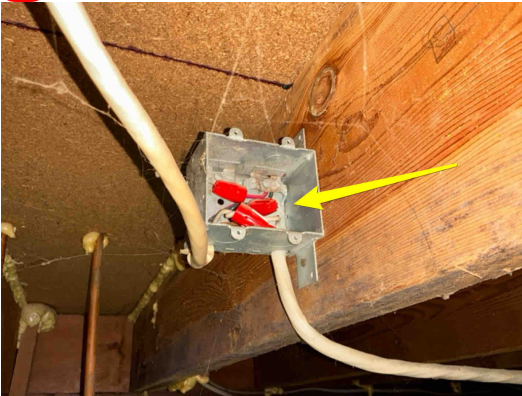
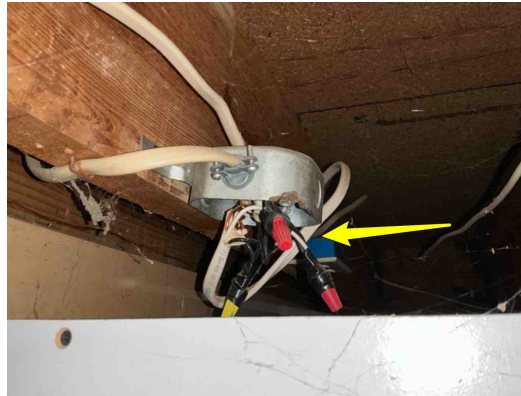
**SC 182:** Missing electrical cover plate: MULTIPLE IN THE CRAWLSPACE

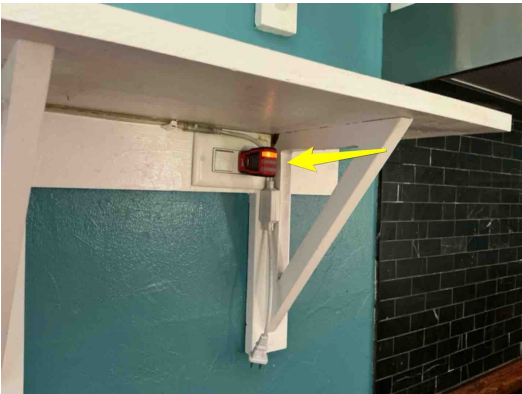
**SC 183:** Miswired electrical outlet (open neutral). Have electrician check all outlets and correct as needed:  
KITCHEN

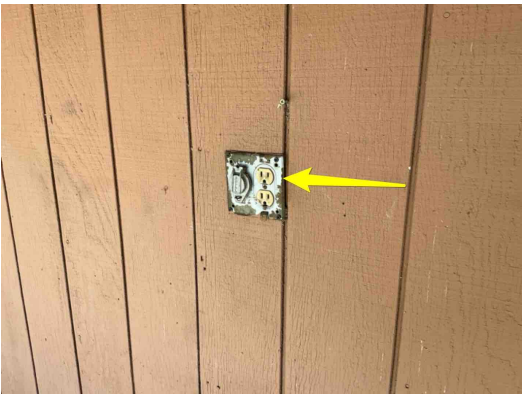
**SC 184:** Exterior electrical outlet found with a damaged exterior rated cover at the BELOW THE UPSTAIRS DECK.

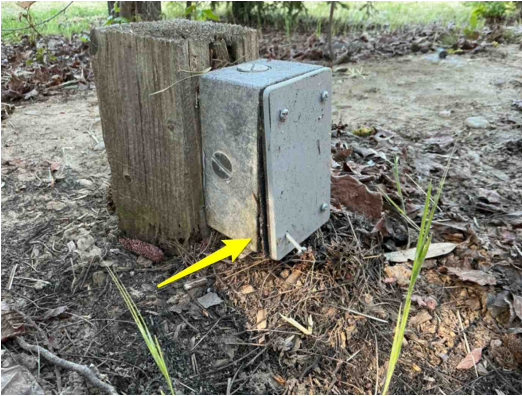
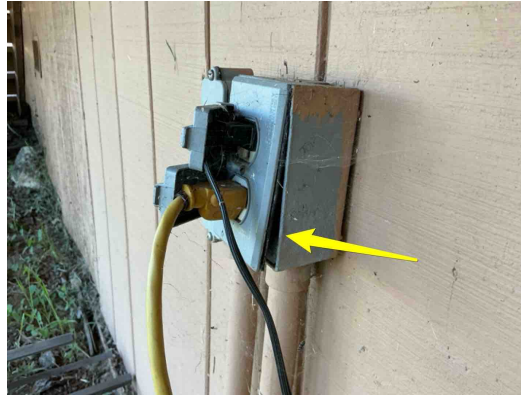
**185:** Multiple electrical cover plates found loose and improperly installed. Simple corrections recommended.

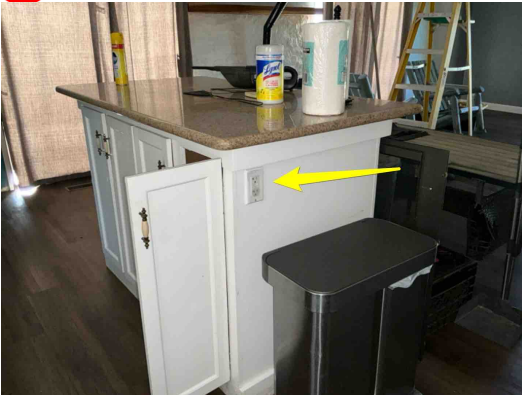
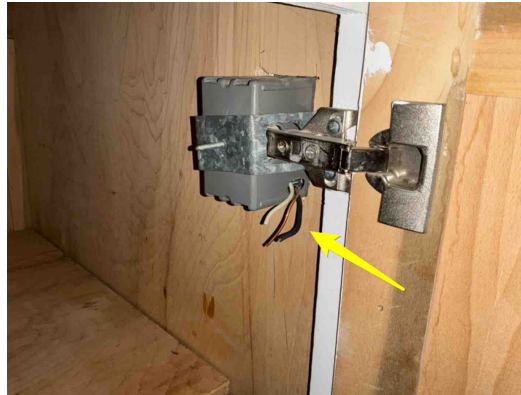
**E&C 186:** The kitchen island GFCI found non-operational/ abandoned.

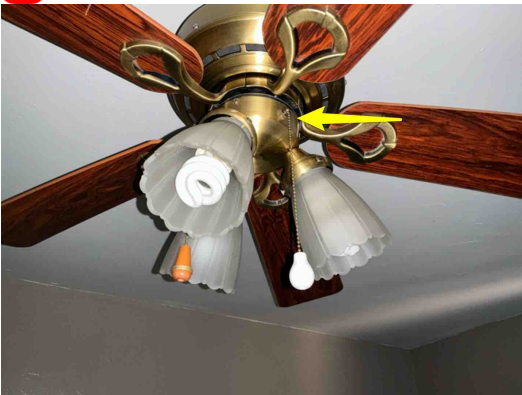
**E&C 189:** The light fixture pull chain found damaged/ non-operational: BEDROOM-1

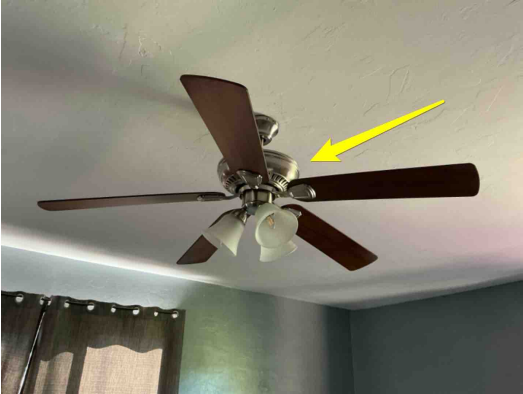
**DS 190:** Ceiling fan and light found non-operational from a wall switch. Fan appears to be on a remote which was not located. Ask seller for remote and to demonstrate proper operation: LIVING ROOM

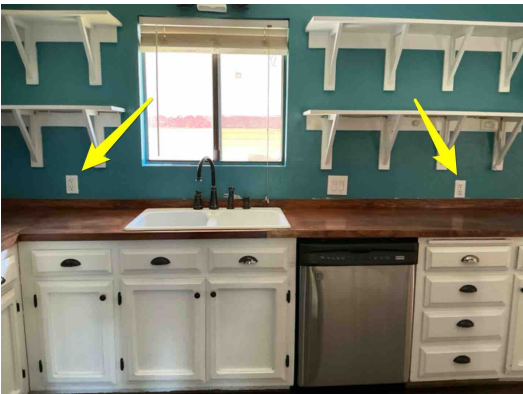
**E&C 192:** The KITCHEN LEFT SIDE GFCI outlet found to be improperly wired in series with the KITCHEN RIGHT SIDE GFCI outlet (improper line / load reversal). When the GFCI trips off it improperly trips off a second GFCI in a different location and will not reset unless the other outlet when found is reset first. This is considered an improper installation.

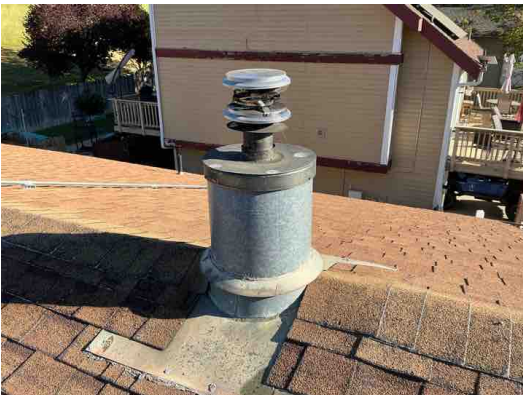
202: The LIVING ROOM fireplace chimney.

**E&C** **MR** **203:** Missing the proper storm collar at the top of the fireplace chimney pipe around the chase collar to help prevent water intrusion down the metal chimney pipe and into the wood chase.
