# PROPERTY INSPECTION REPORT

**FOUR POINT**  
HOME INSPECTION INC.

**65380 San Lucas Rd**  
**Inspection Prepared For: Hector Macias**  
**Agent: -**

**Date of Inspection: 7/9/2025**

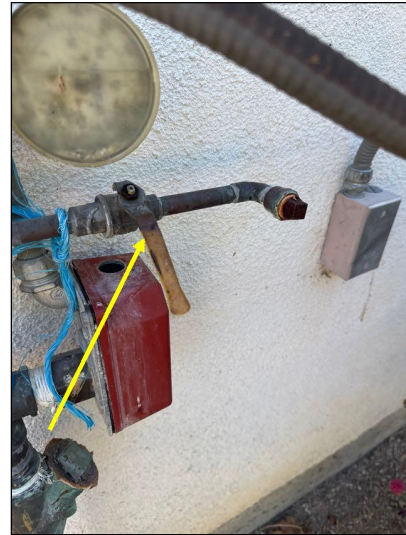
• This valve is used to test the fire bell of the fire sprinkler system by creating water flow from the system that should activate the fire bell. The valve handle should be removed for safety so there is not an accidental discharge or loss of pressure to the fire system. Any inspections or maintenance work should be done by a licensed fire protection expert.

The valve handle should be removed for safety so there is not an accidental discharge or loss of pressure to the fire system.

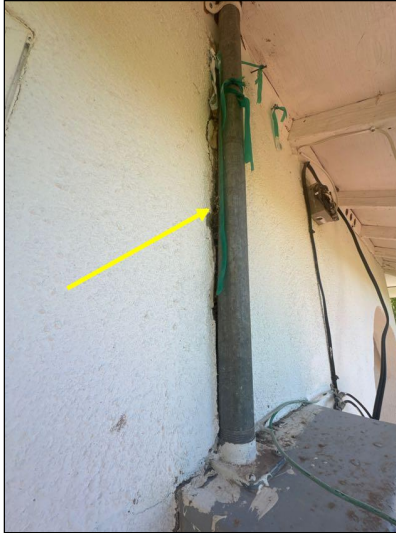
**Monitor:** Normal cracking was visible in stucco covering exterior walls of the home at the time of the inspection.

**Maintenance:** All gaps and holes in the stucco surface should be sealed to keep unwanted moisture out.

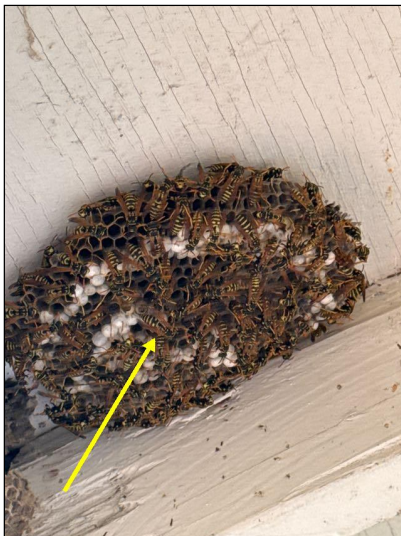
**Monitor:** Wasp nests were visible under the roof eaves at the time of the inspection.

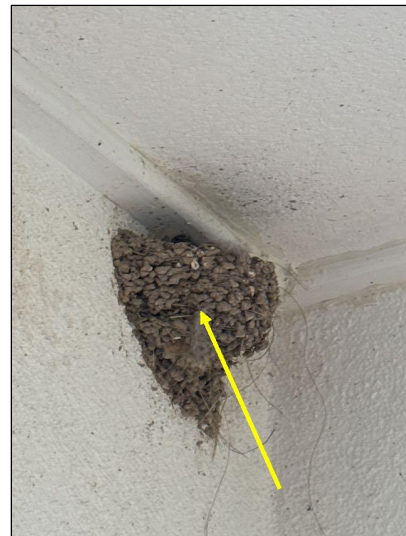
**Monitor:** Past Swallow nest evident under the soffits.

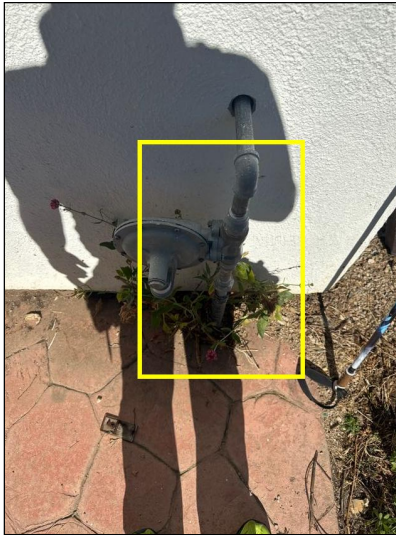
- **Safety:** The main gas line where it enters the home did not have a shut off valve. The main gas valve should be readily accessible for emergency shut-off for emergency. The Inspector recommends correction by a qualified plumbing contractor for safety improvement.

**Safety:** The main gas line where it enters the home did not have a shut off valve.

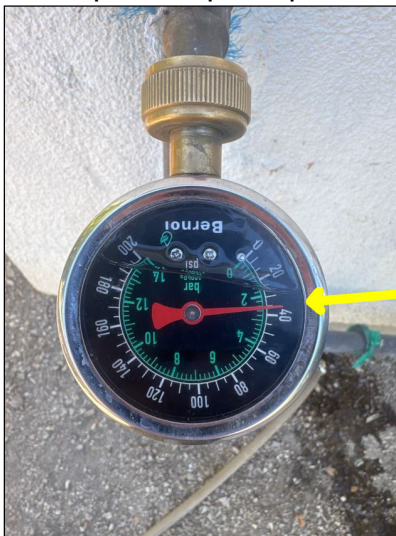
- **Monitor:** Low pressure: Home water supply pressure was lower than the 40 pounds per square inch (PSI) considered adequate by generally-accepted current standards. The Inspector recommends service by a qualified plumbing contractor.
- Recommend 40-80 PSI.
- Home water pressure measured 35 pounds per square inch (psi) at the time of the inspection.

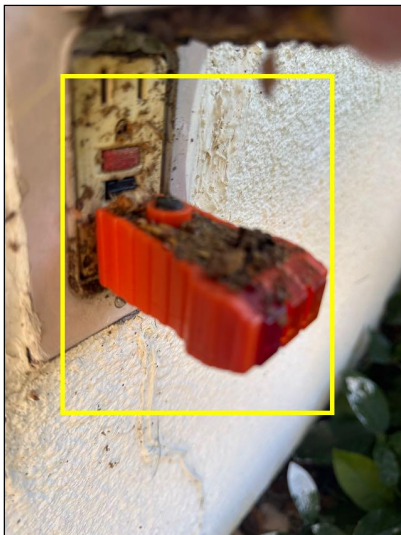
GFCI electrical receptacle was inoperable at the time of the inspection. (courtyard)

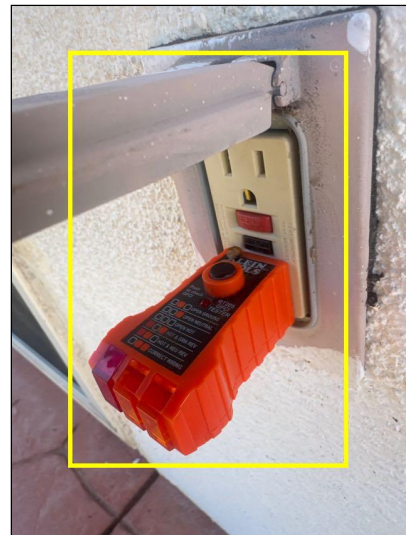
GFCI electrical receptacle was inoperable at the time of the inspection. (left side of the home)

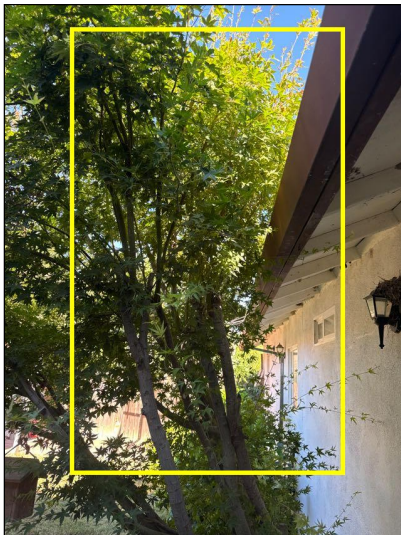
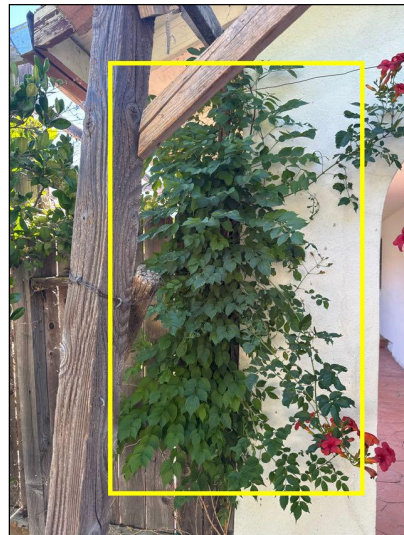
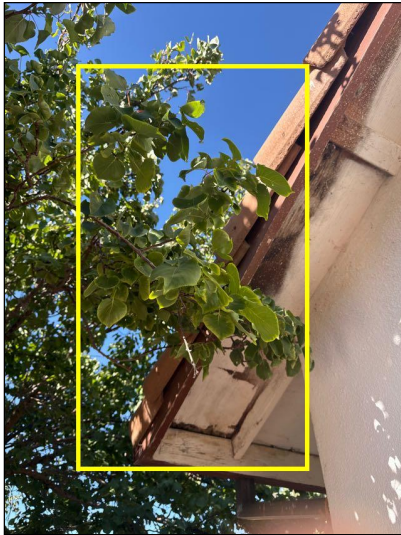
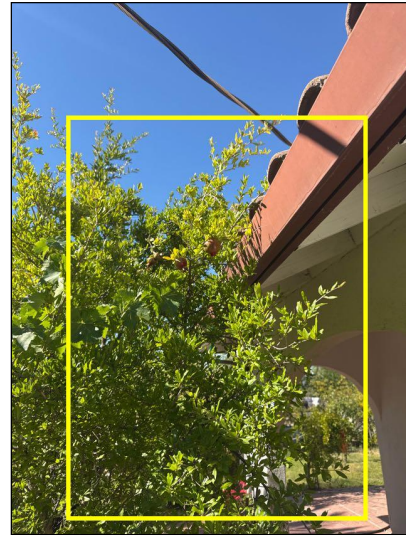
- **Monitor:** Vegetation in contact with the exterior walls should be cut back to avoid potential problems from moisture or insects.

- **Monitor:** Trim trees that are in contact or proximity to home, as branches can abrade roofing or siding. Branches should be cut back to avoid contact with the home.

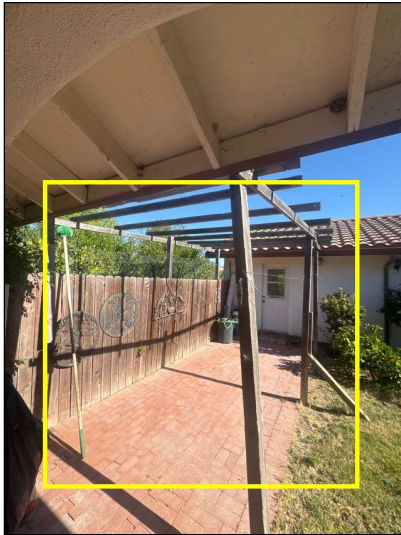
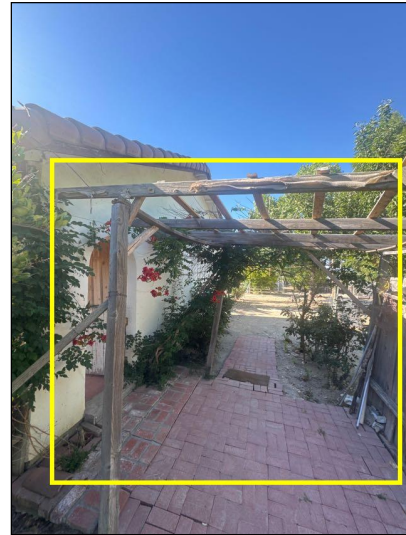
The structure covering the patio moved excessively when tested. The Inspector recommends that before the expiration of your Inspection Objection Deadline you consult with a qualified contractor to discuss options for stabilization costs and/or removal.

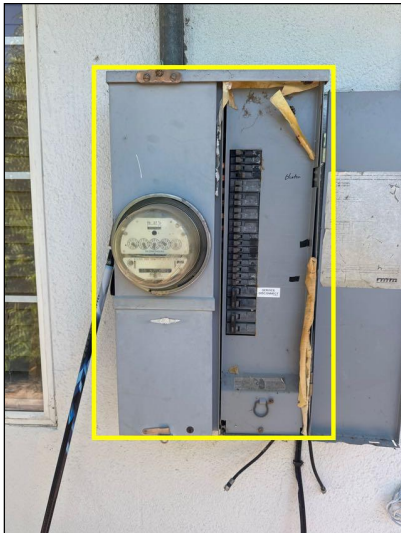
| | Page 34 Item: 2 | Electrical Panel | <b>Monitor:</b> The interior of the electrical service panel cabinet contained stinging insect nests. This condition may affect the ability of electrical components within the service panel to function as they were designed. The Inspector recommends nests be removed and action taken to close off any openings that may allow insect intrusion in the future. All work should be performed by a qualified electrical contractor. |

**Monitor:** The interior of the electrical service panel cabinet contained stinging insect nests. This condition may affect the ability of electrical components within the service panel to function as they were designed. The Inspector recommends nests be removed and action taken to close off any openings that may allow insect intrusion in the future. All work should be performed by a qualified electrical contractor.

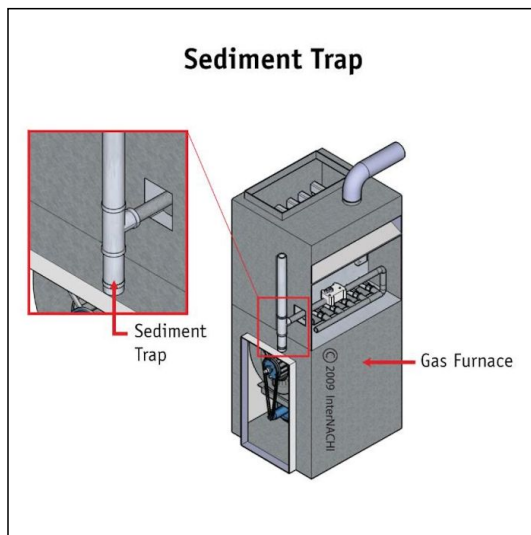
**Improvement:** The gas supply pipe contained no sediment trap.

The purpose of a sediment trap is to prevent sediment or debris particulates from entering and clogging the heaters gas valve.

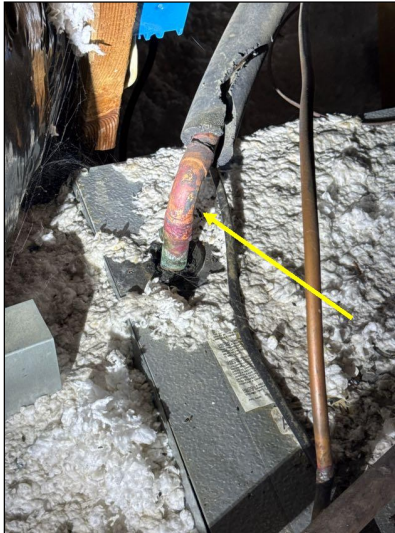
| | Page 41 Item: 13 | Refrigerant Lines | Condensation will drip from the air-conditioning suction (large, insulated) line at the furnace where the insulation has been removed or damaged. This should be repaired before moisture damage occurs to the furnace or area near the furnace. |

Condensation will drip from the air-conditioning suction (large, insulated) line at the furnace where the insulation has been removed or damaged. This should be repaired before moisture damage occurs to the furnace or area near the furnace.

Condensation will drip from the air-conditioning suction (large, insulated) line at the furnace where the insulation has been removed or damaged.

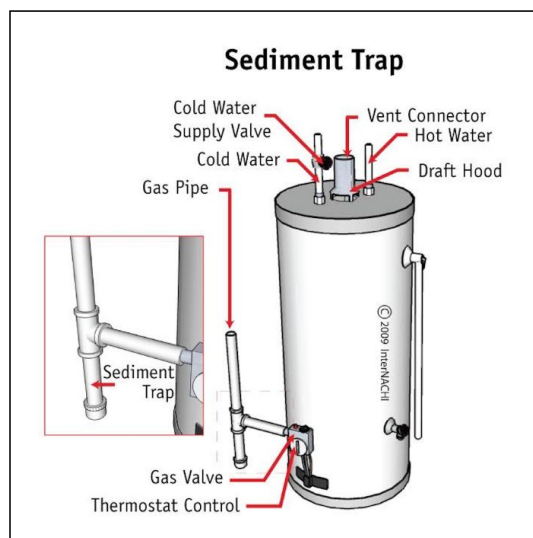
**Improvement:** The gas supply pipe contained no sediment trap.

The purpose of a sediment trap is to prevent sediment or debris particulates from entering and clogging the water heaters gas valve

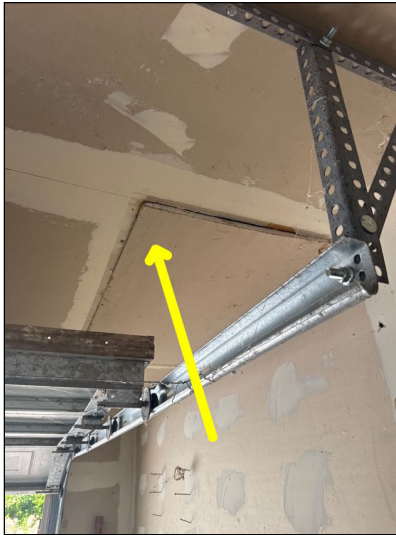
| | Page 46 Item: 9 | Firewall | Garage ceiling repair was not fire-taped as is required by generally-accepted current safety standards. The Inspector recommends that the wall be fire-taped by a qualified contractor. |

Garage ceiling repair was not fire-taped as is required by generally-accepted current safety standards. The Inspector recommends that the wall be fire-taped by a qualified contractor.

Garage ceiling repair was not fire-taped as is required by generally-accepted current safety standards.

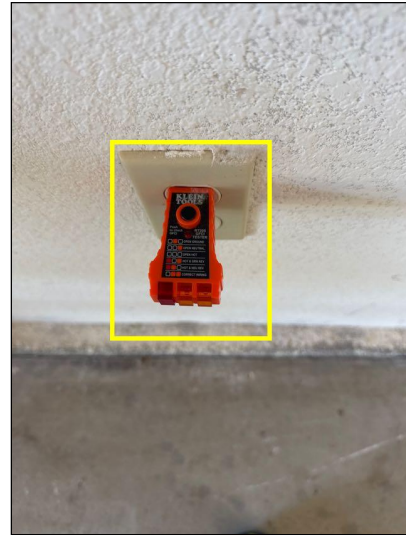
| | Page 48 Item: 5 | Garage Electrical | One or more electrical receptacles in the garage were inoperable at the time of the inspection. The Inspector recommends evaluation and correction by a qualified electrical contractor. |

One or more electrical receptacles in the garage were inoperable at the time of the inspection.

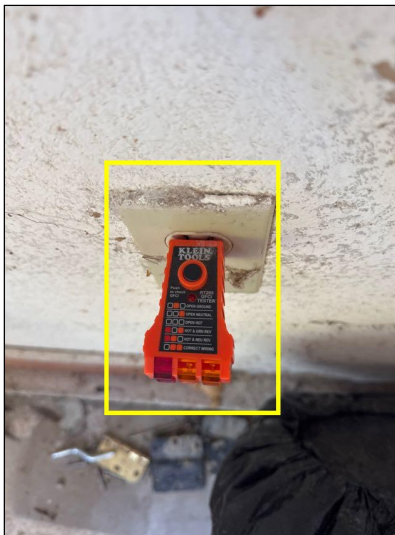
One or more electrical receptacles in the garage were inoperable at the time of the inspection.

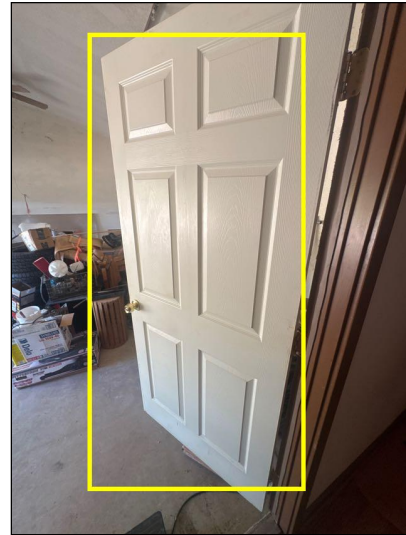
| | Page 49 Item: 7 | Fire Door | <p>The door in the wall between the garage and the home living space did not meet generally-accepted current safety standards. Doors in firewalls must be a minimum of 1 3/8 inches thick, metal or a 20 minute fire-rated panel door, with a properly installed threshold and self-closing hinges.</p> <p><b>Safety Improvement:</b> The fire door between the garage and the home interior may not open directly to a bedroom/sleep area. The Inspector recommends that before the expiration of your Inspection Objection Deadline you consult with a qualified contractor to discuss options and costs for repair.</p> |

Doors in firewalls must be a minimum of 1 3/8 inches thick, metal or a 20 minute fire-rated panel door

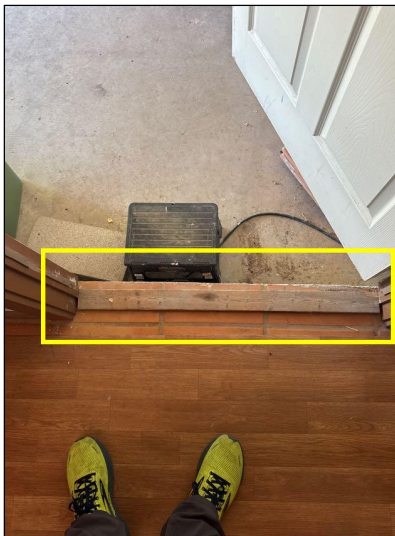
The door in the wall between the garage and the home living space did not meet a properly installed threshold.

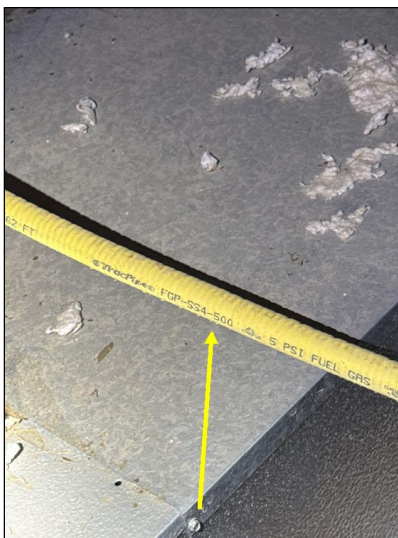
At the time of the inspection, the Inspector observed no deficiencies in the condition of the gas supply pipes. Most pipes were not visible due to interior wall coverings.

Installed correctly, CSST must be properly bonded and/or grounded

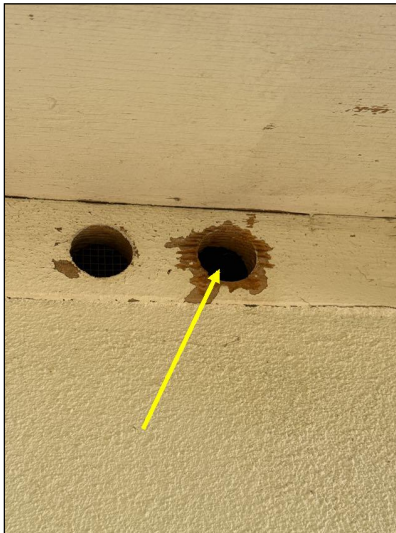
**Maintenance Needed:** Vent screens are damaged or missing, suggest repairing or replacing screens as necessary to prevent entry of unwanted pests.

• **Maintenance Needed:** Vent screens are damaged or missing, suggest repairing or replacing screens as necessary to prevent entry of unwanted pests.

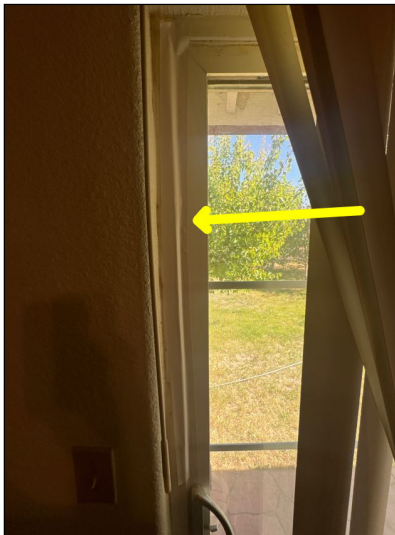
Sliding glass door in the home was generally old, worn, and seal with tape to prevent air leakage. The Inspector recommends that before the expiration of your Inspection Objection Deadline you consult with a qualified contractor to discuss options and costs for repair or replacement.

Sliding glass door in the home was generally old, worn, and seal with tape to prevent air leakage.  
(living room)

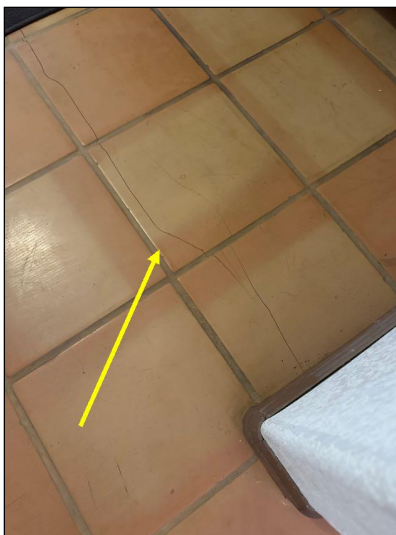
The Hallway, Dining Room had cracked floor tiles visible at the time of the inspection. You should ask the seller if spare tiles are available as matching replacements. The Inspector recommends that before the expiration of your Inspection Objection Deadline you consult with a qualified contractor to discuss options and costs for replacement.

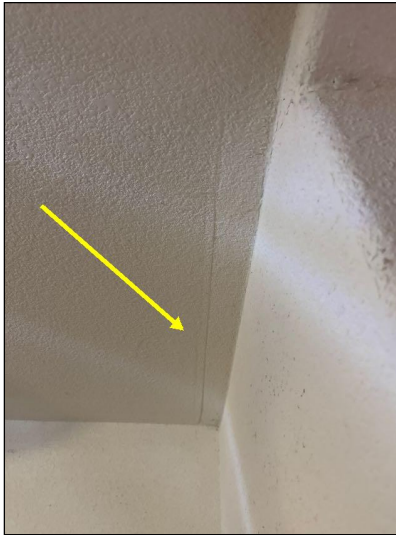
**Monitor:** Normal settlement cracking was visible in interior ceiling of the home at the time of the inspection. This cracking appeared to be consistent with that caused by normal settlement. Settlement typically takes place in the first few years after original construction, and then stops. Cracks can be repaired and sealed, but may reappear over time with temperature and humidity levels.

**Monitor:** Normal settlement cracking was visible in interior ceiling of the home at the time of the inspection.

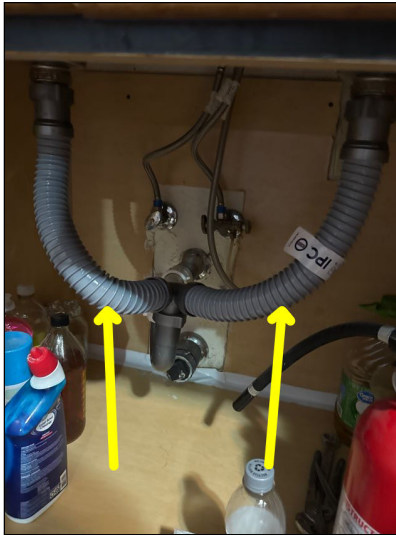
**Monitor:** Flex drain observed, these are subject to frequent clogging.

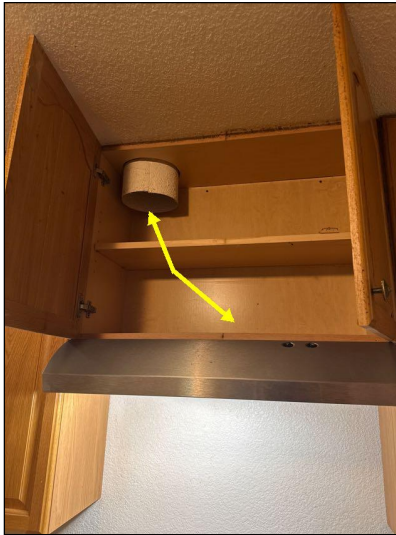
**Safety Improvement:** The exhaust fan is only re-circulating so no exhaust duct is vented to the exterior.

• **Safety Improvement:** The exhaust fan is only re-circulating so no exhaust duct is vented to the exterior. To prevent possible moisture damage and grease accumulation on walls and ceiling adjacent to the range, the Inspector recommends that an exhaust duct be installed to exhaust moisture and odor created during cooking to the home exterior.

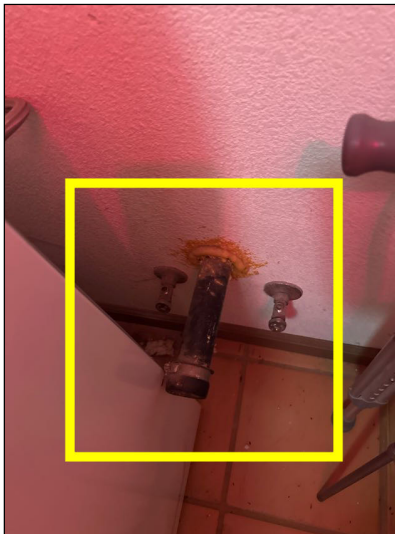
Plumbing in place if washbasin is desired to be installed

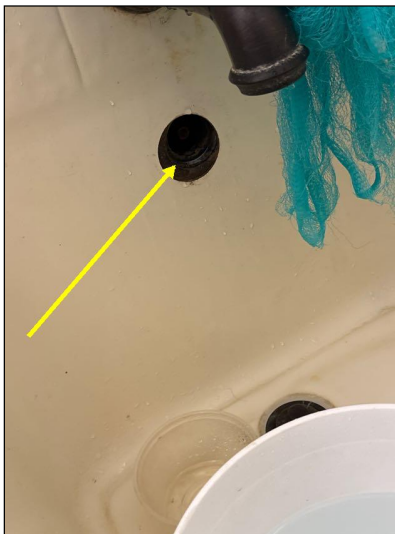
The overflow cover for the tub drain is missing in this bathroom. The Inspector recommends service by a qualified contractor.

The overflow cover for the tub drain is missing in this bathroom.

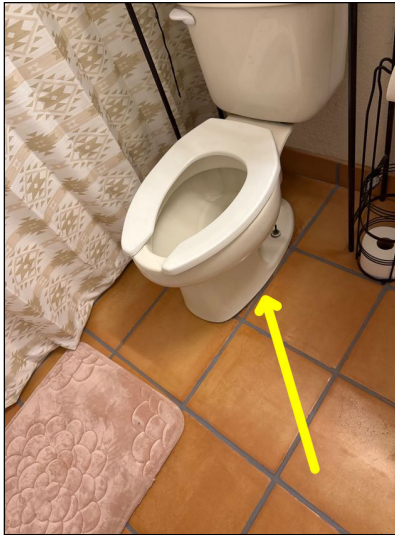
In this bathroom, the toilet was loose at the floor and should be re-attached by a qualified plumbing contractor.

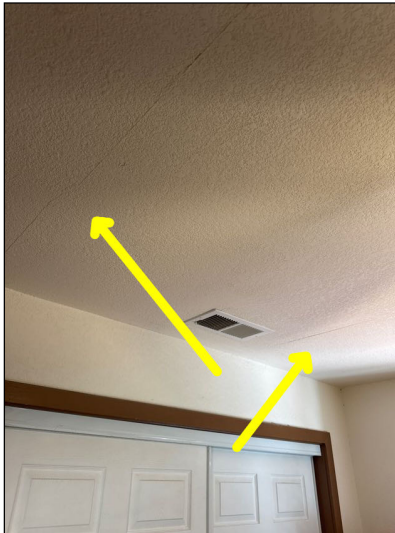
- The bedroom ceiling appeared to be in serviceable condition at the time of the inspection.
- **Monitor.** Normal settlement cracking was visible in interior ceiling at the time of the inspection. This cracking appeared to be consistent with that caused by normal settlement. Settlement typically takes place in the first few years after original construction, and then stops. Cracks can be repaired and sealed, but may reappear over time with temperature and humidity levels.

**Monitor:** Normal settlement cracking was visible in interior ceiling at the time of the inspection.

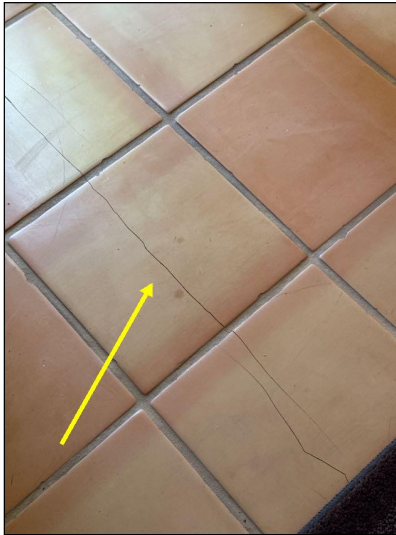
- The Inspector observed few deficiencies in the condition of floors. Notable exceptions are listed.
  - This bedroom had cracked floor tiles. You should ask the seller if spare tiles are available as matching replacements. The Inspector recommends that before the expiration of your Inspection Objection Deadline you consult with a qualified contractor to discuss options and costs for replacement.
