# HOME INSPECTION REPORT

3267 Sueno Drive, San Jose

674732

April 11, 2026

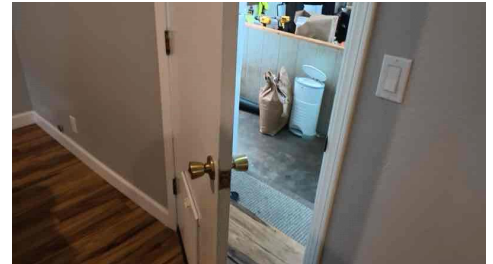
Photo 10

- ! 1. The door between the garage and the house did not have an automatic closing mechanism. The door between the garage and the interior of the house should be fitted with an automatic closing mechanism. This will reduce the potential of toxic automobile gases entering the house and serves as a fire break. (See Illustration 3G) (See Photo 10)

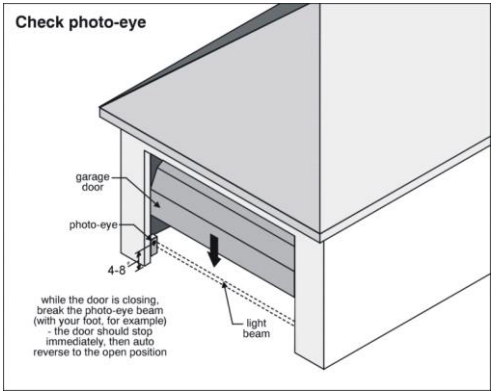
Illustration 3B

5. The garage door did reverse properly when the infrared detection system for the auto reverse was tested; however, we did note that the detection system for the auto reverse was installed too high or too low from the ground. We recommend proper mounting of the devices on the base of the garage jambs between 4" to 8" inches from the ground as per manufacturers recommendations. Information on the garage door openers is available from the consumer product safety commission at [www.cpsc.gov](http://www.cpsc.gov). (See Illustration 3B) (See Photo 5)

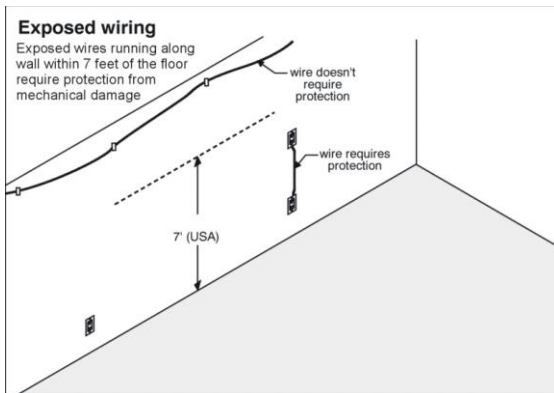
Illustration 4E

6. We found exposed wiring at the garage walls below 7' feet. Even if insulated, we recommend all wiring be encased in conduit or otherwise protected in accordance with present standards. (See Illustration 4E) (See Photo 8)

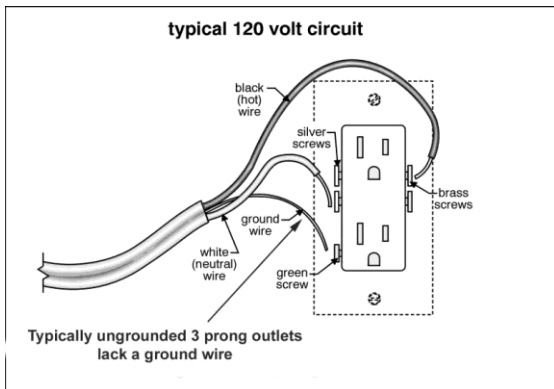
Illustration 4O

7. Ungrounded "3-prong" outlets at the dining room, upstairs bedrooms should be improved. A grounded cable or ground wire could be installed at these outlets, the outlet labeled as ungrounded or the original "2-prong" receptacle could be reinstalled. Based upon our inspection of a representative number of outlets, we recommend testing of every outlet. Repairs or rewiring are recommended at all deficient locations. For additional information we recommend a licensed electrician be consulted. (See Illustration 4O) (See Photo 12) (See Photo 14) (See Photo 15)

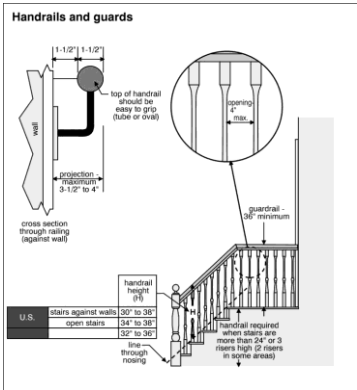
Illustration 9K

10. The openings in the staircase railing are larger than 4". For improved safety it is recommended that the railing be altered for an opening of less than 4". (See Illustration 9K) (See Photo 17)
