### *Inspection Report*

Address: 482 Yerba Buena St Morro Bay, CA 93442

04/07/2026

Inspector: Keith Vreeken, MCI, FCI  
P.O. Box 415 Templeton, CA 93465 O: 805.462.1978 C: 805.440.5050

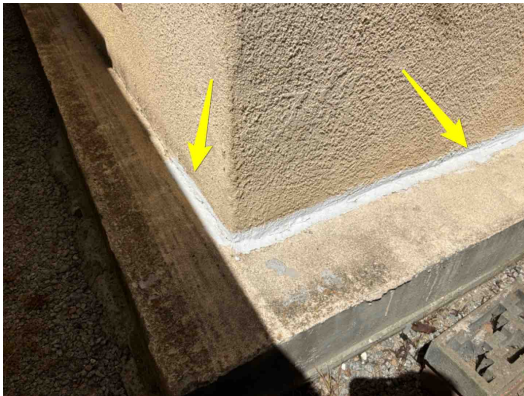
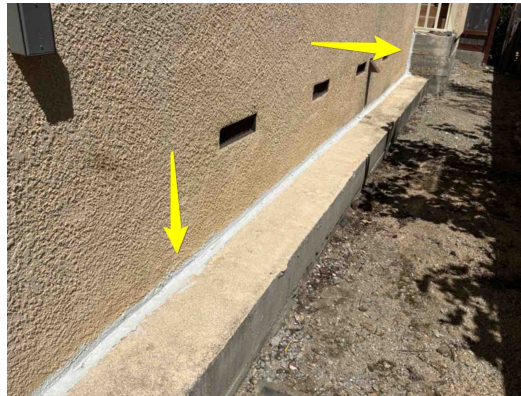
**FI** 19: Unusual and non-standard sealant was observed at the exterior stucco wall-to-concrete foundation interfaces at areas along the back of the home. This condition is not typical of proper installation practices and is commonly associated with prior water intrusion or moisture-related deficiencies. The presence of sealant in these locations suggests a possible concealed or previous water intrusion condition. Further evaluation is warranted to determine reasons for the unusual and added sealant by an appropriate contractor to determine if there is a concealed condition such as past water intrusion and if proper upgrades or repairs are needed.

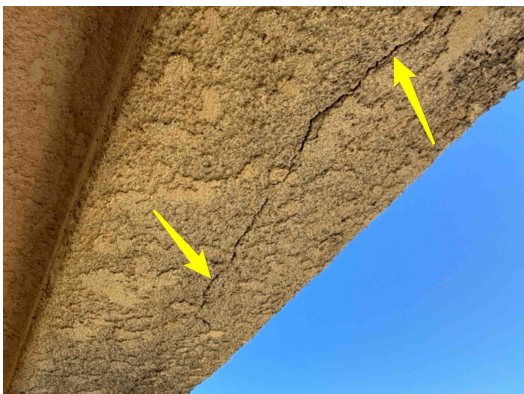
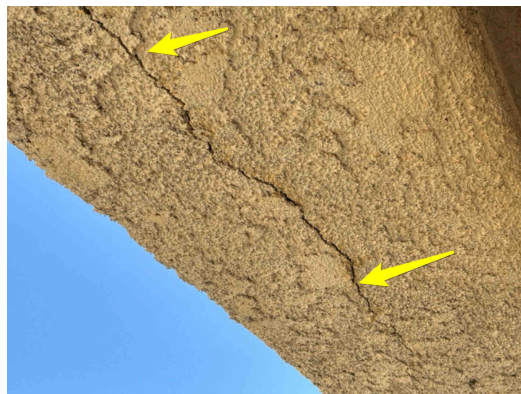
**FI** 21: Some unusual and moderate cracking at areas of the exterior stucco AT A BEAM ON THE SOUTH SIDE OVER THE UPSTAIRS BACKYARD WATERPROOF DECK. Referred to photo for specific location. This type of cracking is indicative of a failure of the waterproofing under the stucco which is causing swelling, deterioration and/or damage to the structural wood framing. Client should investigate further by removing the stucco until satisfied as to the cause, condition, potential future issues and correct as needed. Refer to termite report for additional comments and recommendations.

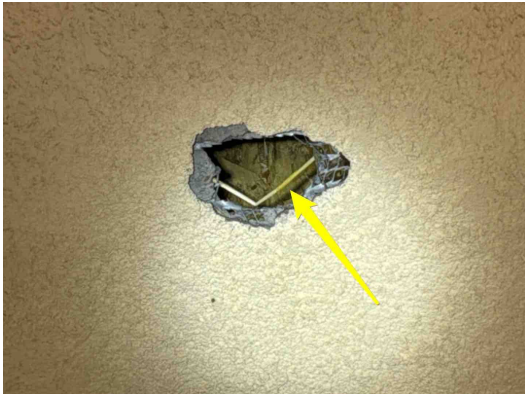
- FI 24:** Some damaged exterior stucco found at the
1. stucco ceiling area above the backyard upper waterproof deck, and
  2. at one of the support posts at the the backyard upper waterproof deck

Ceiling stucco damage

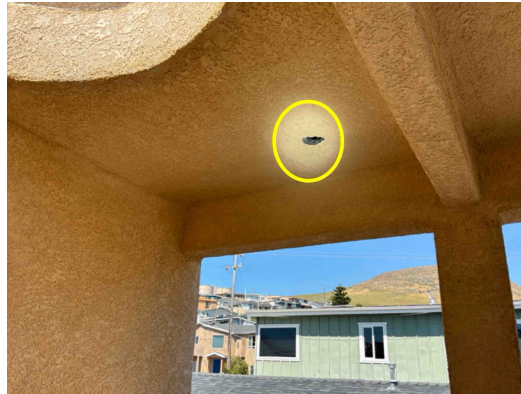
Ceiling stucco damage

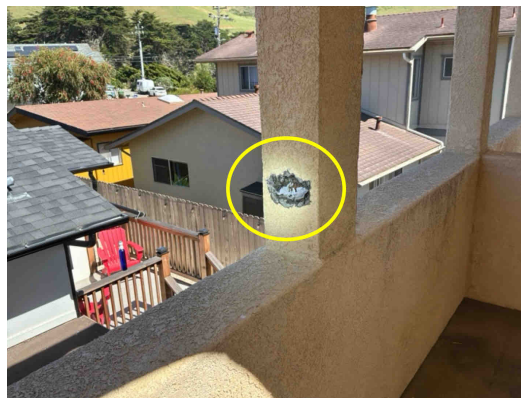
Support post Stucco damage

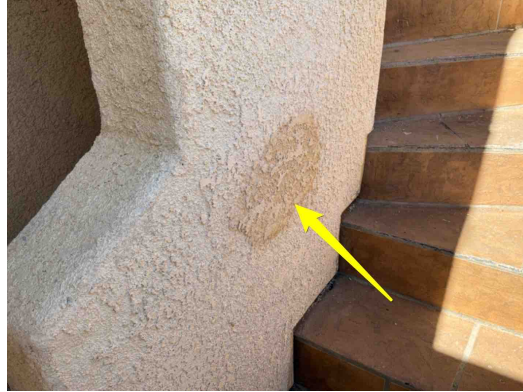
**FI 25:** Some recent stucco repairs found at areas of the exterior stairway stucco wall walls off the upstairs backyard waterproof deck

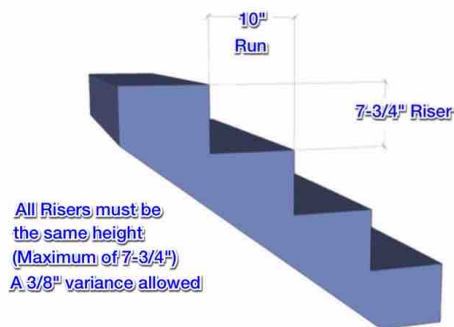
**SC 29:** Uneven step tread rise, step heights are not all the same, at the exterior stairway off the BACKYARD UPPER DECK. Potential trip or fall hazard.

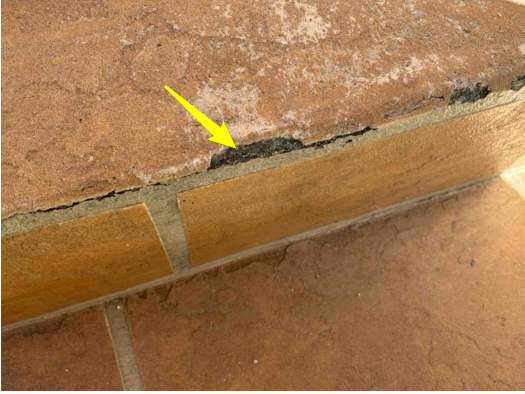
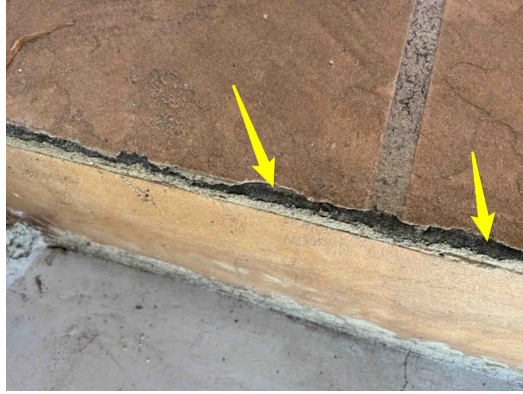
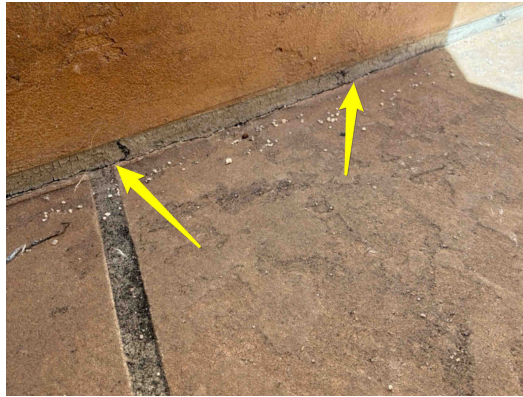
**E&C 30:** Some visible deterioration and or damage noted at areas of the exterior stairway waterproof coating at the exterior stairs OFF THE BACK OF THE HOUSE TO THE UPSTAIRS DECK.

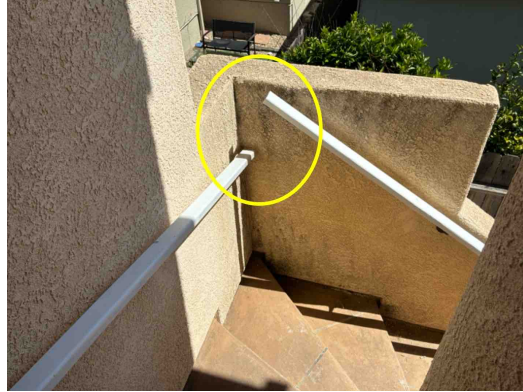
**SC 32:** Handrail off the backyard upper deck is required to be one single railing and should not be broken or disconnected creating one single railing all the way from the top to the bottom.

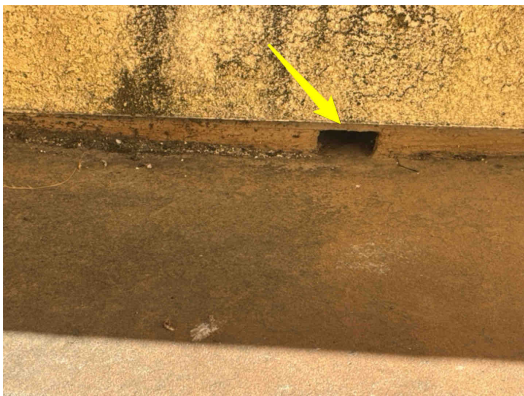
**FI 34:** The deck drain scupper / wall drain at the UPSTAIRS FRONT WATERPROOF DECK found to be undersized. A minimum of one 4"x4" overflow scupper for each +/- 20 ft.<sup>2</sup> of decking is required. Contact a qualified waterproof deck contractor to evaluate and make recommendations for proper upgrades or repairs.

R903.4.1 Secondary (emergency overflow) drains or scuppers. A minimum of one overflow scupper for each 20 ft.<sup>2</sup> of decking, shall be installed and is required to have an opening height of no less than 4 inches (102 mm) and a minimum width of 4 inches (opening = 4" x 4") and shall be installed in the adjacent parapet walls with the inlet flow (bottom of the scupper) located 2 inches (51 mm) above the low point of the deck drain inlet.

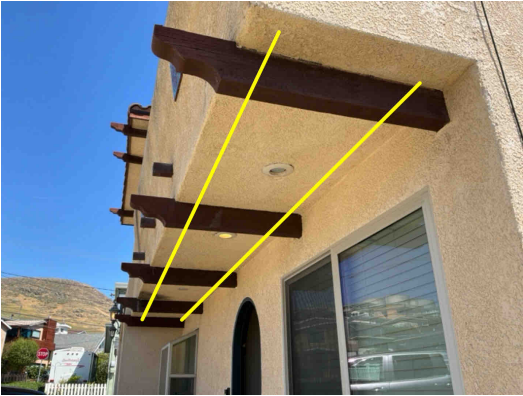
Example location

**UPG DS 35:** No visible ventilation installed on the underside of the enclosed exterior portions of the waterproof deck off the UPSTAIRS DECK OFF THE PRIMARY BEDROOM. Current Standards dictate that enclosed waterproof decks should be ventilation along the underside to help reduce condensation build up and to help prevent an excessive moisture condition such as fungus growth which could lead to a structural compromise of the wood framing. [CBC 2304.12.2.6 Ventilation beneath enclosed balcony, elevated walking surfaces and stairways]

Current conditions of the enclosed deck wood framing are unknown.

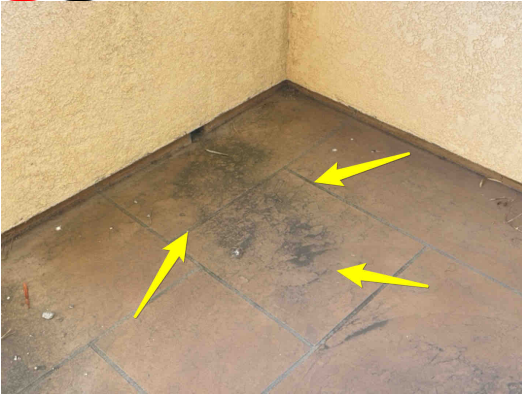
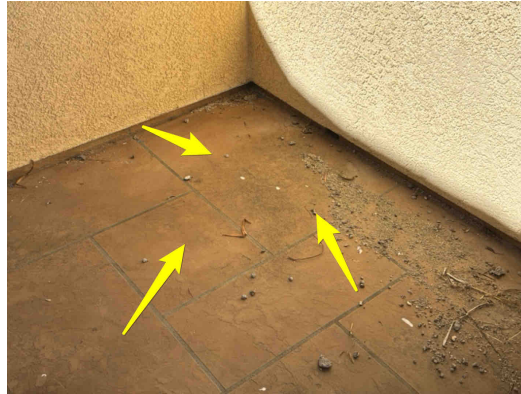
**E&C DS 37:** Disclosure: Small areas of ponding water noted at the waterproof decking.

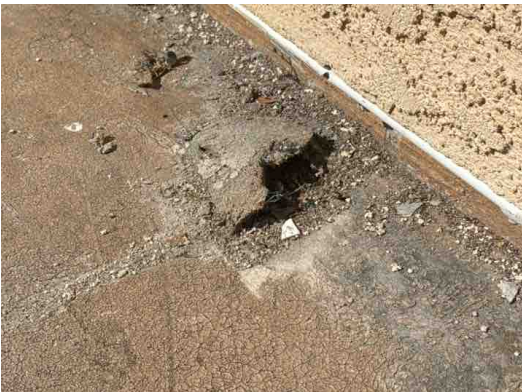
**E&C 40:** Waterproof coating found damaged and in need of repair or replacement at the: UPSTAIRS ROOF DECK. Contact a licensed waterproof deck contractor to evaluate and repair.

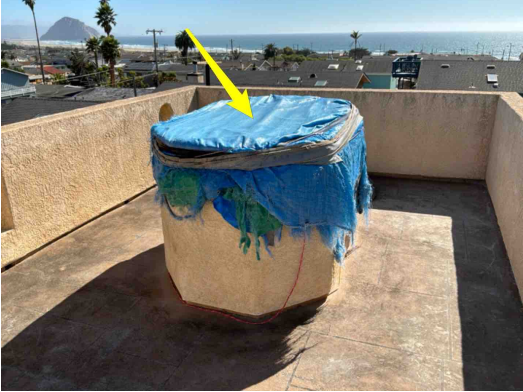
**FI 41:** Center Island installed at the UPSTAIRS WATERPROOF ROOF DECK is covered with a tarp. Suspected past leakage. Recommend additional review by licensed waterproof Deck professional.

Suspected past roof leakage. Area appears to been covered with a tarp

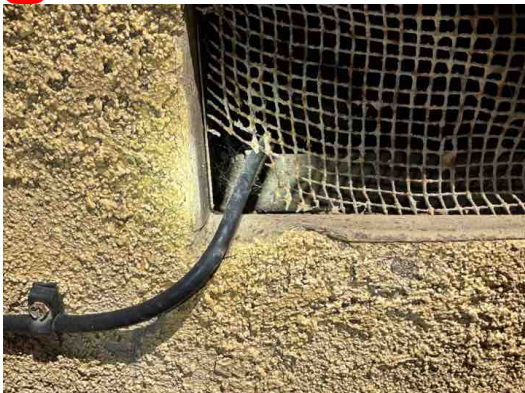
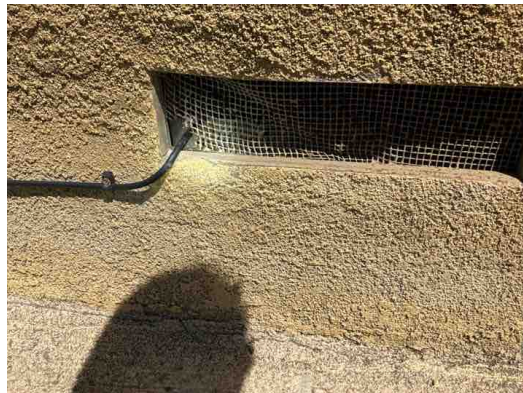
**E&C 50:** Damaged exterior crawlspace ventilation screens found in need of repair to help prevent critter intrusion.

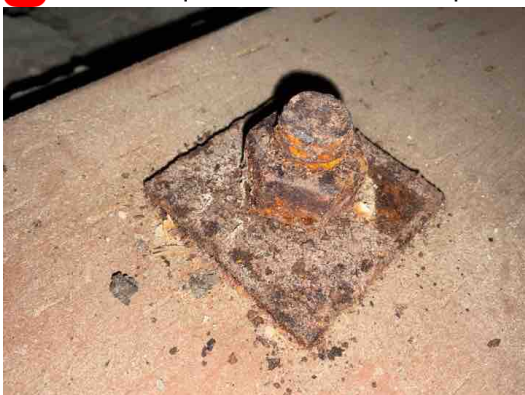
**E&C 51:** Inadequate amount of crawlspace ventilation. Upgrades recommended.

Some moderate to heavy rust found at the anchor bolts in the crawlspace.

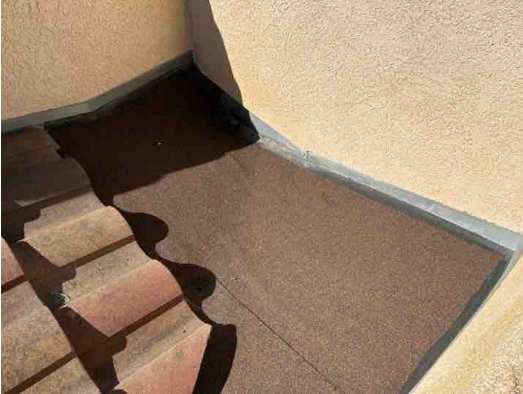
**FI 60: ROOF CONDITION:** The Rolled Composition roof material appears within useful life. **However, some maintenance, upgrades or repairs are needed by a licensed roofer to help prevent roof leakage and maintain overall life.**

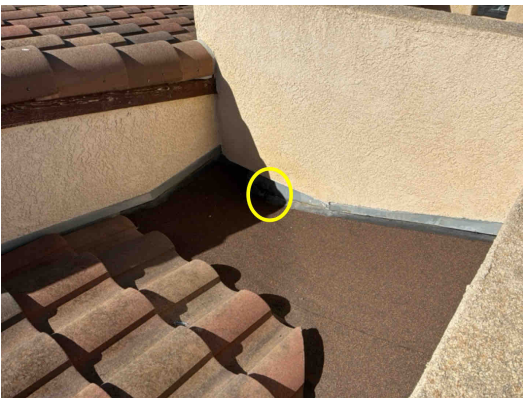
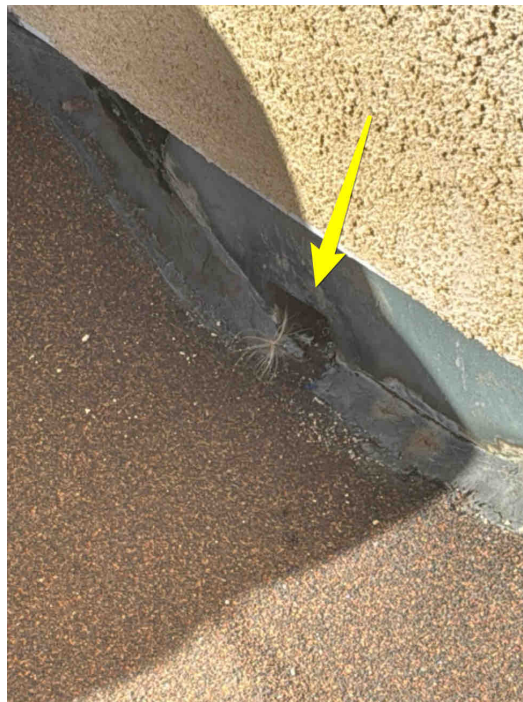
**FI 61:** The flat roof drain scuppers / wall drains found to be undersized, improperly installed, missing the secondary roof drainage and has an improperly quantity of required drain openings: **ADD THE ROOF ASPHALT CRICKET.** Contact a qualified roofing contractor to evaluate and make recommendations for proper upgrades or repairs.

Overflow scuppers area required to have an opening of no less than three times the size of the roof drains and having a minimum opening height of 4 inches (102 mm) (with a minimum opening size of 4" x 4" ) installed in the adjacent parapet walls with the inlet flow located 2 inches (51 mm) above the low point of the roof served.

**E&C 62:** Missing the required secondary roof drain(s) at the low slope roof system. Overflow roof drains or scuppers are required to be installed at 2 inches (51 mm) above the primary roof drain inlet. [Section 1506.3 of the CA building code]. This can be accomplished by adding additional roof drainage through the roof system or adding appropriate roof scuppers, at 4" x 4" - two inches above the primary roof drain pipe.

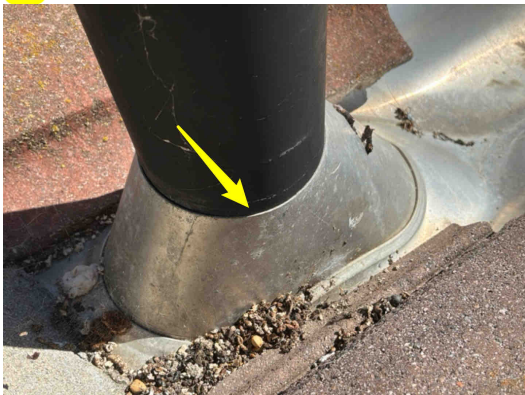
Example location

**MR 66:** Missing and/or deteriorated sealant at roof jack flashings.

**E&C MR 64: ROOF FLASHING CONDITION:** Some roof flashing were found to be needing maintenance, servicing and/or repair. Contact a qualified roofing professional to review all roof flashings and provide maintenance and/or repairs as needed.

**MR 65:** Resealing of the roof flashings is recommended as part of needed maintenance.

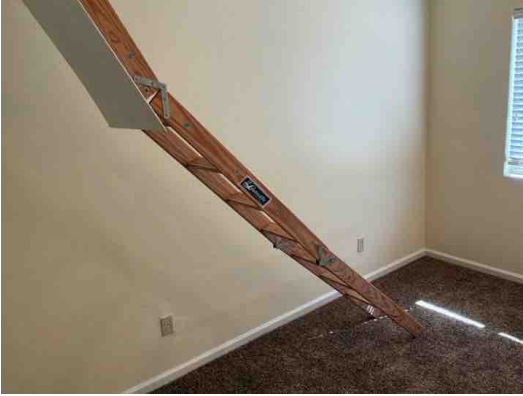
**SC 70:** Unsafe and improper installation of the attic access ladder in the UPSTAIRS BEDROOM-2

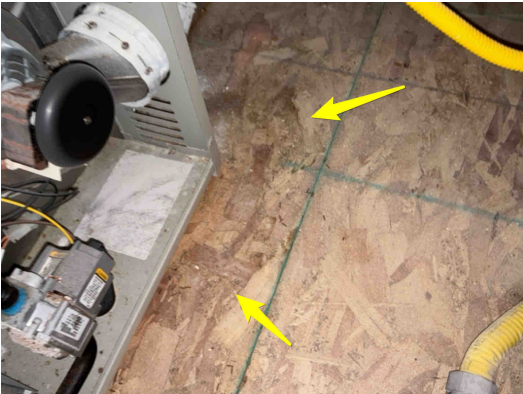
**FI DS 72:** Some moisture stains noted in the attic AROUND THE FURNACE AREA. All water stains should be investigated by a licensed roofer. Refer to termite report for additional comments and/or recommendations.

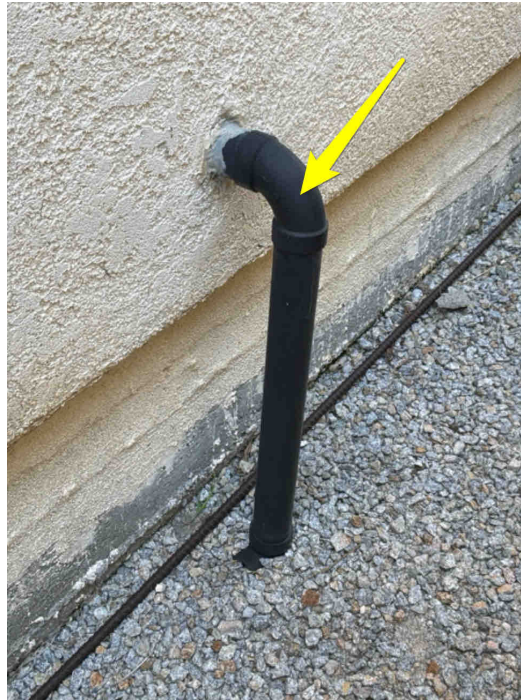
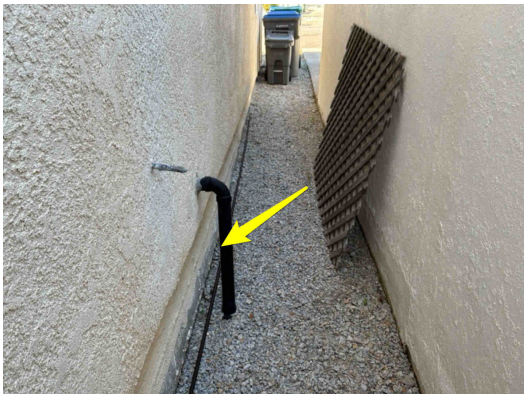
**MR** **UPG** **85:** Exposed plastic sewer piping extending through the exterior wall of the house found not painted/not UV protected and/or not protected from physical damage.

- (1) PVC piping exposed to sunlight that is protected by water based synthetic latex paints.
- (2) PVC piping wrapped with not less than 0.04 inch (1.02 mm) thick tape or otherwise protected from UV degradation.

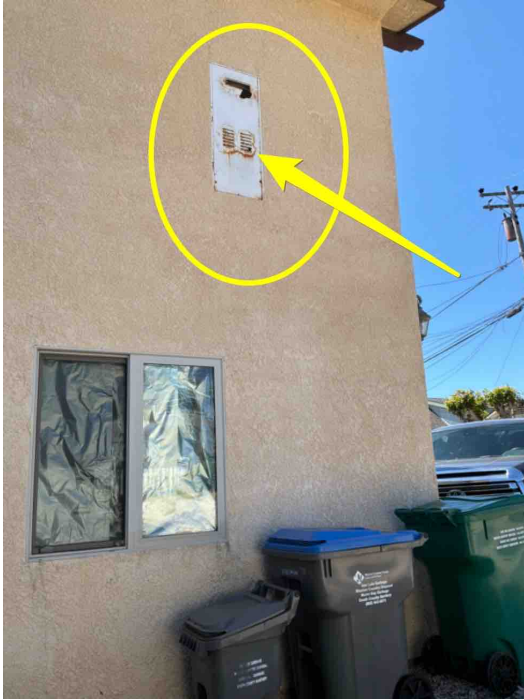
**SC 89:** The tankless water heater and/or associated venting components are installed at an elevated exterior wall location approximately 14 feet above grade without any permanent or safe means of access and a non-level surface below. Tankless water heaters should be serviced annually. This installation does not provide the required accessibility for inspection, service, repair, or replacement as required by the California Mechanical Code and manufacturer installation requirements. The absence of a service platform or approved access method is considered improper and creates a potential safety hazard. Recommend correction by a licensed contractor to provide compliant access or relocation of the equipment.

Water heater is not accessible for inspection

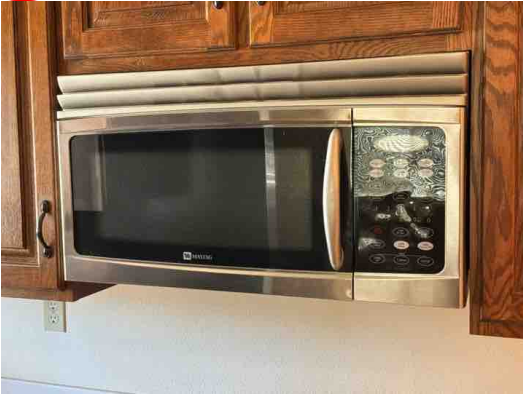
**E&C 102:** The kitchen Microwave found non-operational.

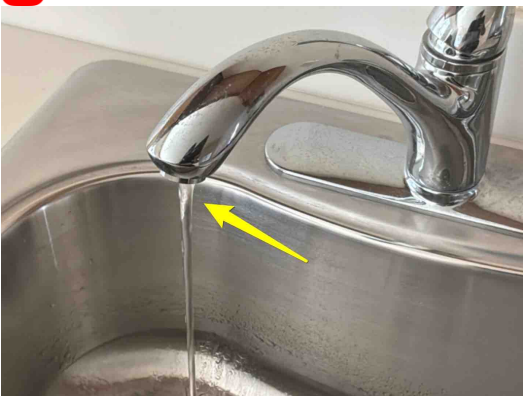
Hot water volume

**E&C 106:** Low water volume from the hot side faucet UPSTAIRS ADU KITCHEN SINK.

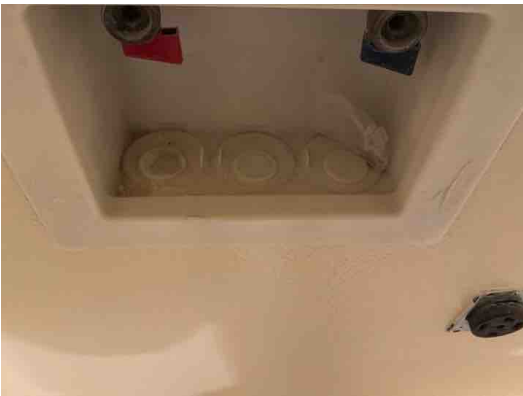
120: No visible drain pipe provided for the UPSTAIRS ADU LAUNDRY WASTE

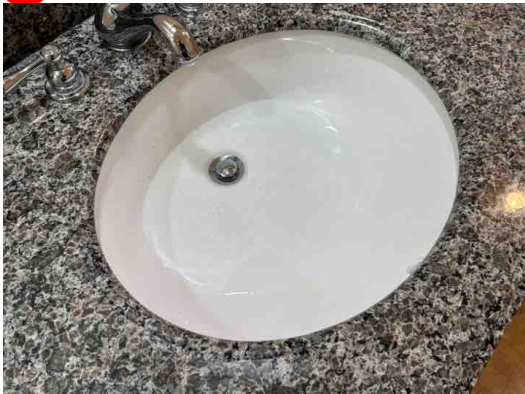
**FI** 128: Slow draining at bathroom sink: UPSTAIRS PRIMARY BEDROOM BATHROOM

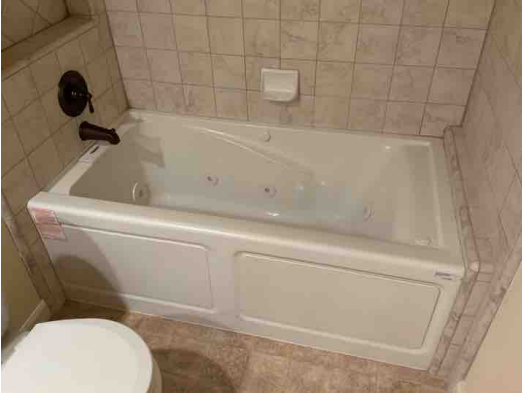
**E&C 132:** Whirlpool tub jets are non-operational: UPSTAIRS HALL BATHROOM

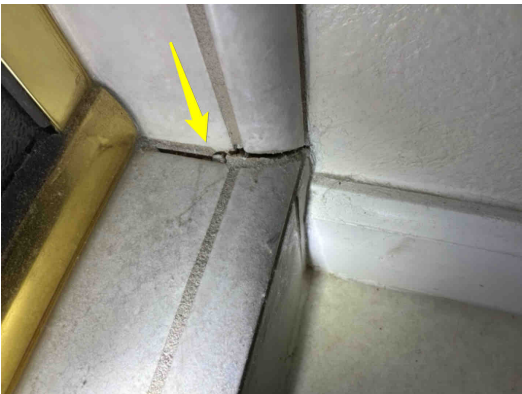
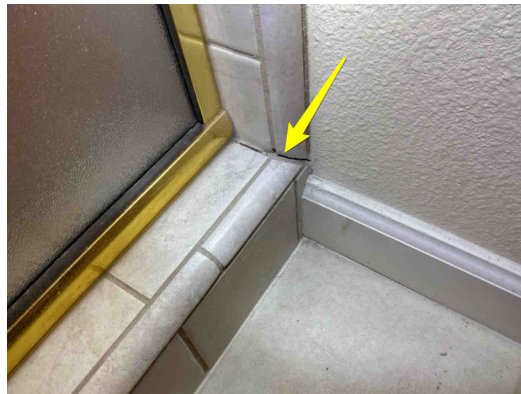
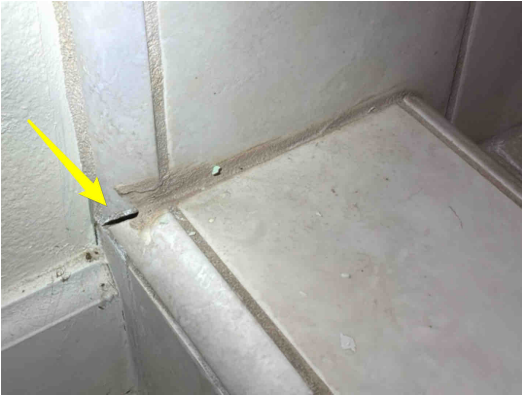
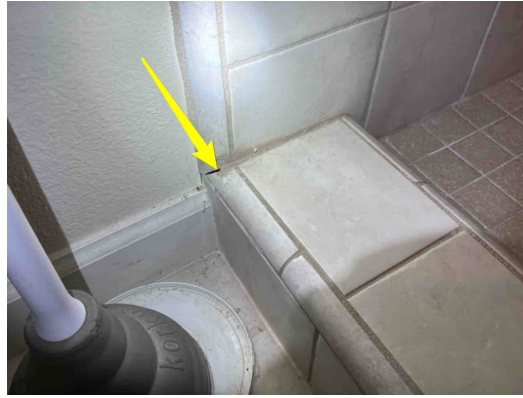
**FI MR 134:** Some cracked and separated grout found in areas of the shower at the walls and/or floor connections in the DOWNSTAIRS HALL BATHROOM. Maintenance or repairs recommended.

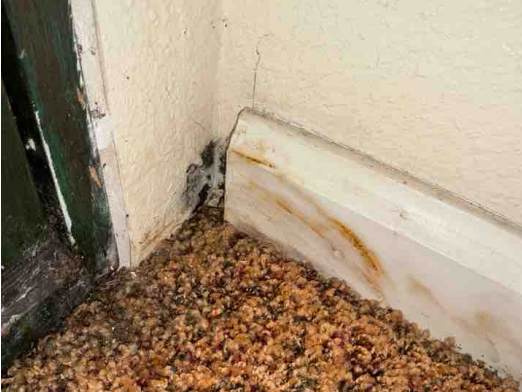
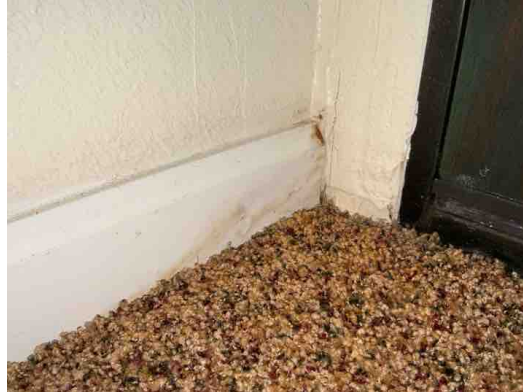
**FI 141:** Evidence of past water intrusion from around the UPSTAIRS BEDROOM HALLWAY exterior door with stains and damage with visible mold on the interior.

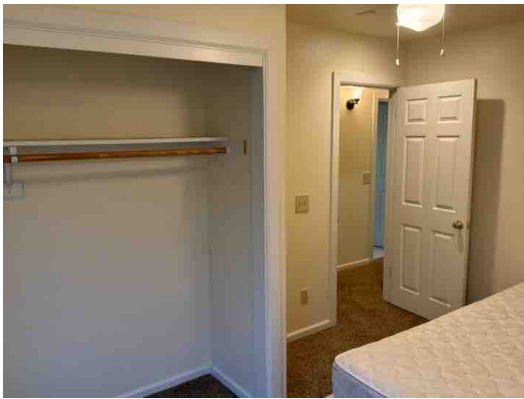
Bedroom-1

**DS 148:** Some interior bedroom closet doors are missing or not installed:

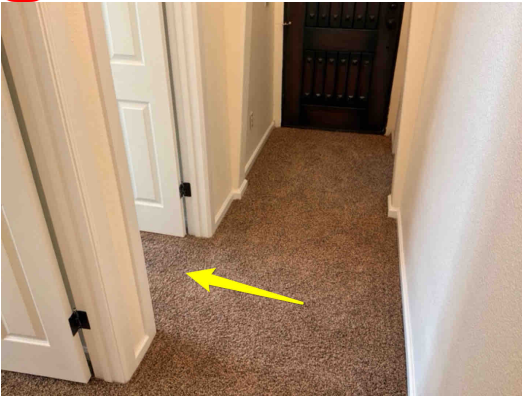
Example location

**FI 155:** Some uneven areas of the floor under the carpet at areas on the interior. Reasons Unknown.

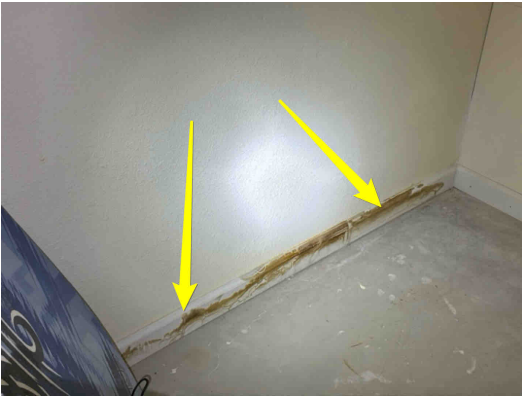
**FI 163:** Evidence of moisture stains and/or damage at the walls in the AREAS THROUGHOUT THE EXTERIOR STAIRCASE INSIDE THE UNDER STAIRWAY ENCLOSURE OFF THE BACK OF THE GARAGE. Recommend further review of the water stains to determine the cause, the current condition and if repairs are needed.

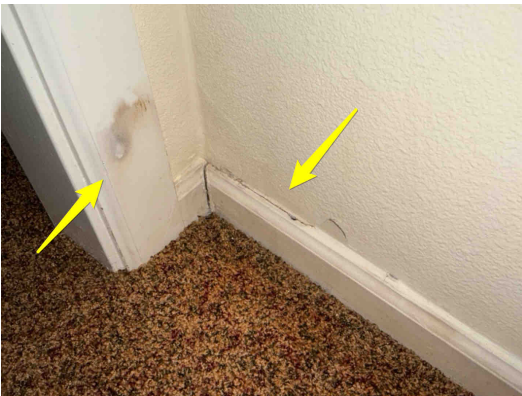
Example location - outside the closet

**FI 164:** Evidence of moisture stains and/or heavy water damage with visible mold growth at the walls, baseboard and closet door trim in BEDROOM-2 NEXT TO THE CLOSET UNDER THE WINDOW. Water intrusion appears to be coming from above the window. Recommend further review of the water stains to determine the cause, the current condition and repair as needed.

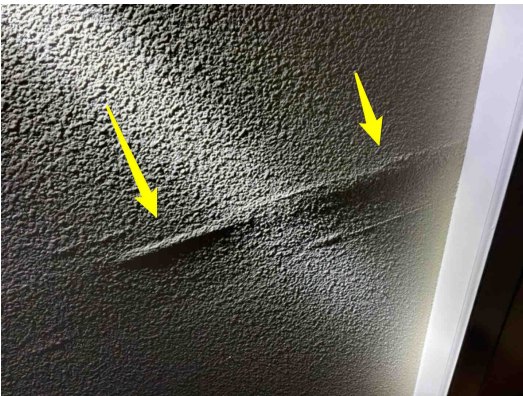
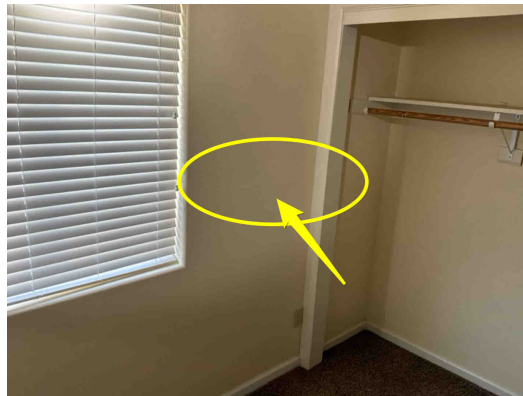
**FI 165:** Evidence of some displaced puffy drywall at wall area in the BEDROOM-1 EXTERIOR SOUTH WALL. Recommend further review determine the cause, the current condition and if repairs are needed.

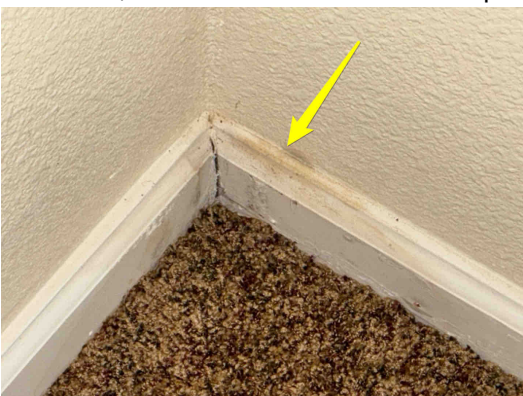
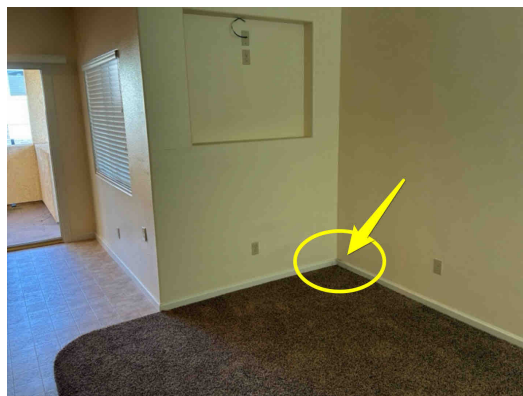
**FI 166:** Evidence of past moisture stains & damage at the wall, baseboards and wood subfloor in the IN THE UPSTAIRS ADU FAMILY ROOM at the exterior wall. Recommend further review of the water stains to determine the cause, the current condition and if repairs are needed.

Shows the excessive damage of the wood subfloor

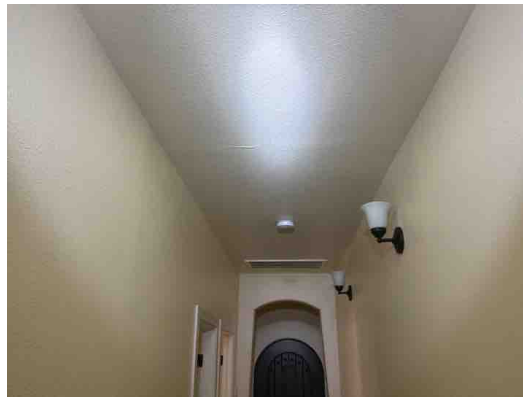
**FI 167:** Evidence of past moisture stains & damage at ceiling area in the UPSTAIRS BEDROOM HALLWAY BELOW THE FURNACE. Recommend further review of the water stains to determine the cause, the current condition and if repairs are needed.

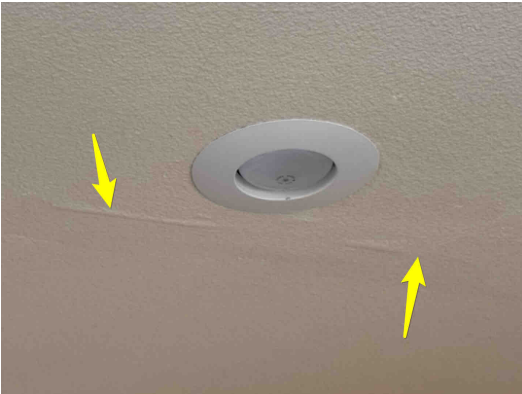
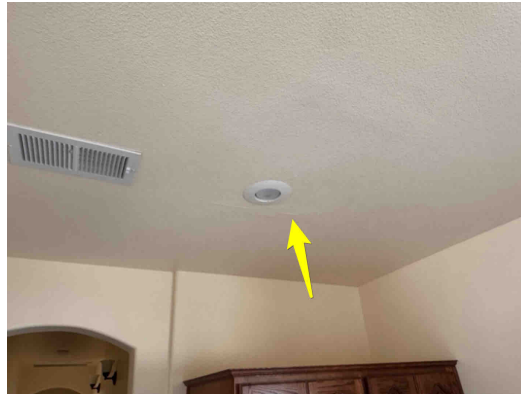
**FI 168:** Evidence of past moisture stains & damage at ceiling area in UPSTAIRS DINING ROOM AREA. Recommend further review of the water stains to determine the cause, the current condition and if repairs are needed.

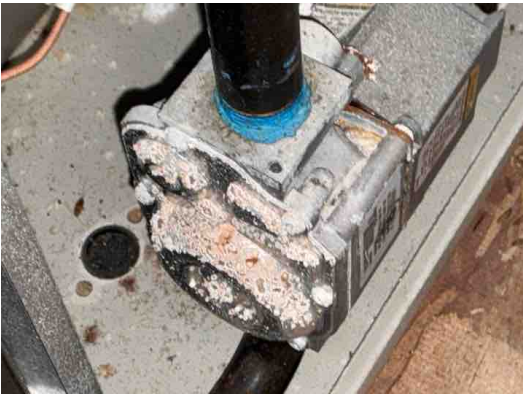
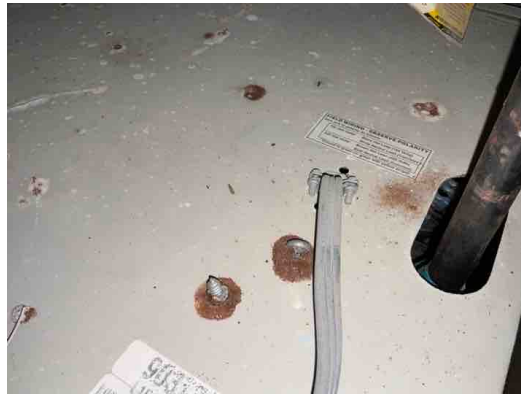
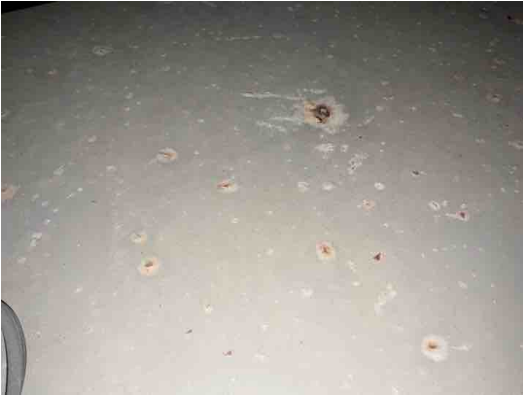
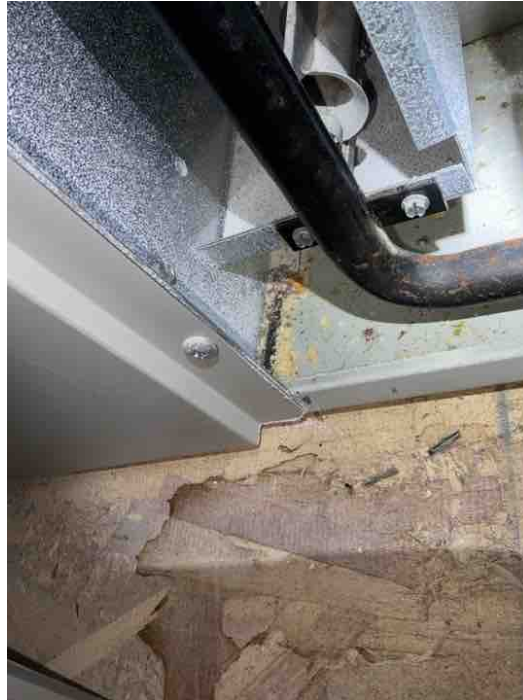
**FI 175:** Some heavy and unusual corrosion found at parts of the furnace installed in the attic. Recommend additional review by licensed HVAC contractor to determine cause, current condition and if or what repairs are needed

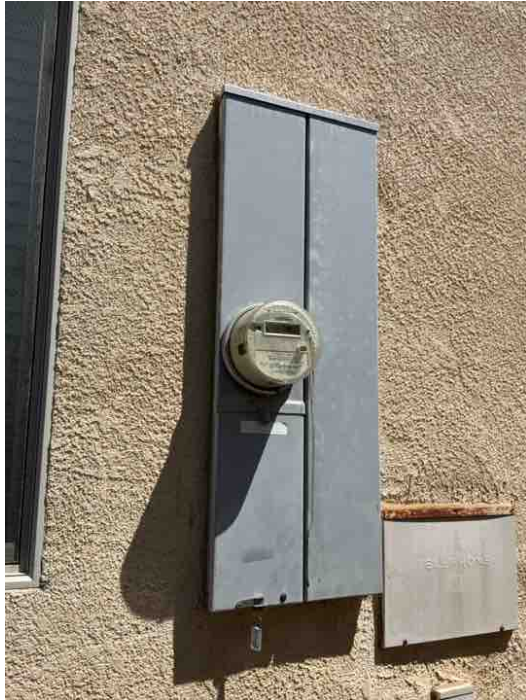
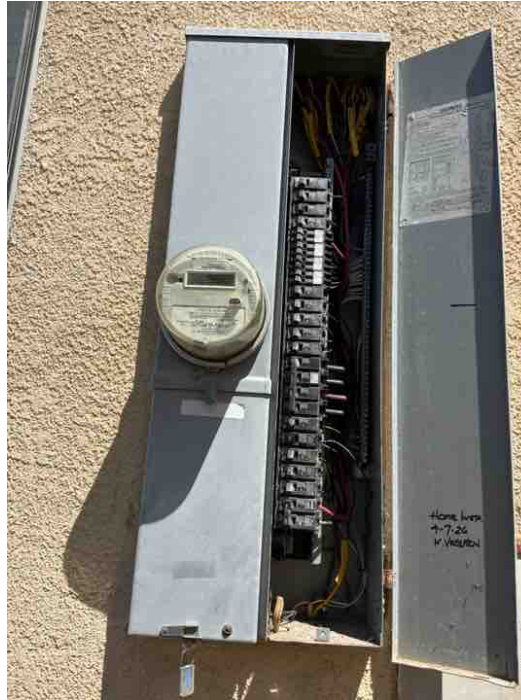
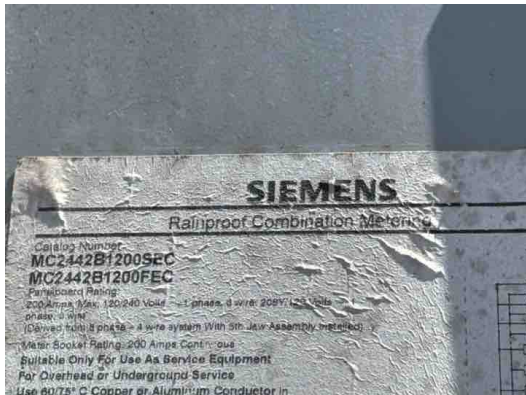
**SC FI 183: MAIN ELECTRICAL PANEL:** Some electrical defects found in the MAIN ELECTRICAL PANEL.

Contact a qualified electrical contractor to evaluate and make appropriate corrections as needed. See additional comments or disclosures below.

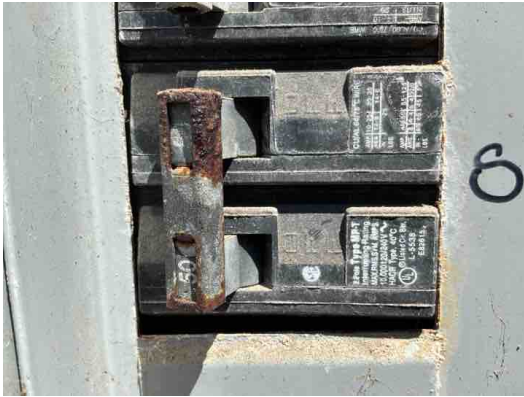
**SC FI 184:** Areas of excessive deterioration and damage were observed at multiple circuit breakers in the MAIN ELECTRICAL PANEL, This is likely due to prolonged exposure from the panel cover being left open or not properly secured. The affected breakers show signs of significant wear and degradation. Replacement of all deteriorated and damaged breakers is recommended by a qualified electrician.

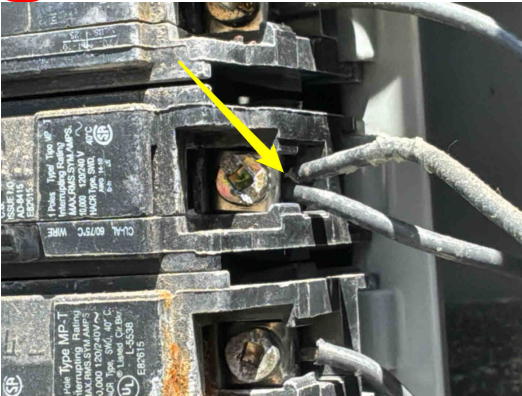
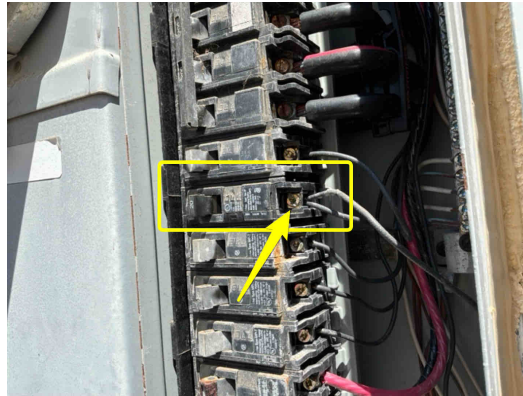
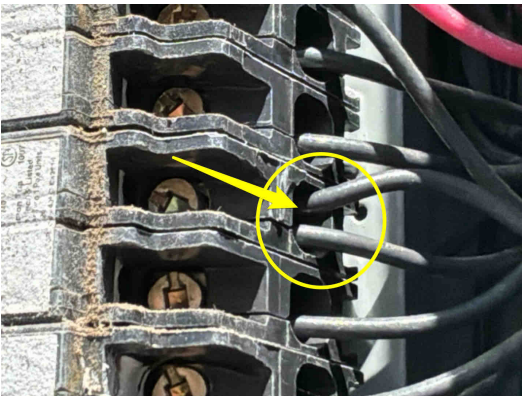
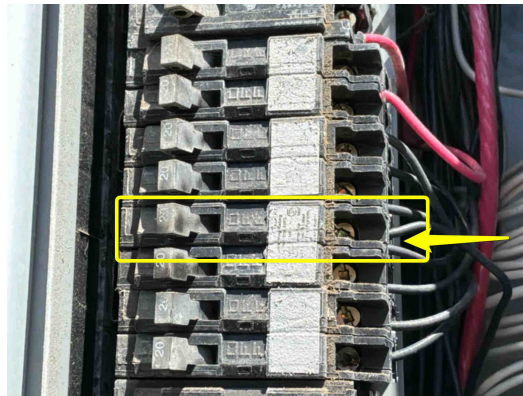
**E&C 186:** Improper installation of two wires on single-wire rated circuit breaker in the MAIN ELECTRICAL PANEL.

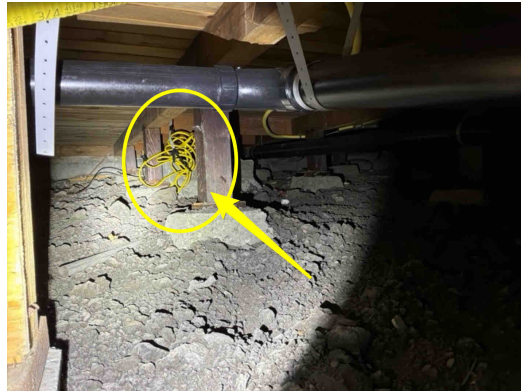
**SC 193:** Improper and unsafe electrical wiring IN THE CRAWLSPACE

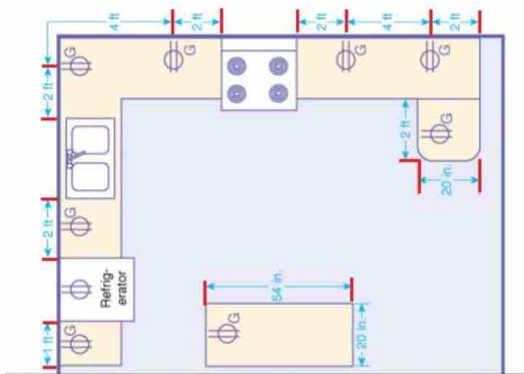
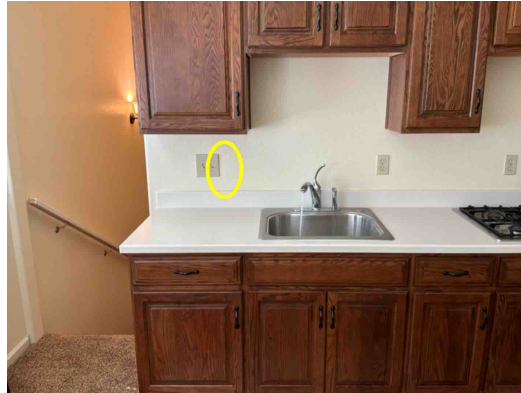
**SC 194:** Required electrical receptacles are missing at some required location in the UPSTAIRS ADU KITCHEN for countertop appliances. This condition does not comply with CEC 210.52(C), which mandates receptacle placement at countertop spaces 12 inches or greater in width and requires spacing such that no point along the wall line exceeds 24 inches from an outlet. Missing outlets at these locations are considered improper and may lead to unsafe use of extension cords and overloading conditions.

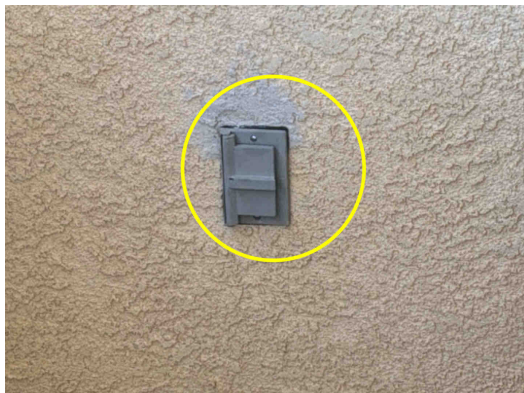
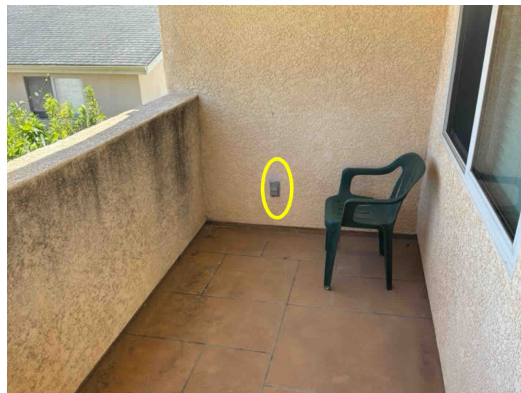
**SC FI 195:** Electrical outlet found non-operational: AT THE UPSTAIRS BACKYARD WATERPROOF DECK AREA. Have outlet reviewed to determine the cause and have corrected by licensed electrical contractor.

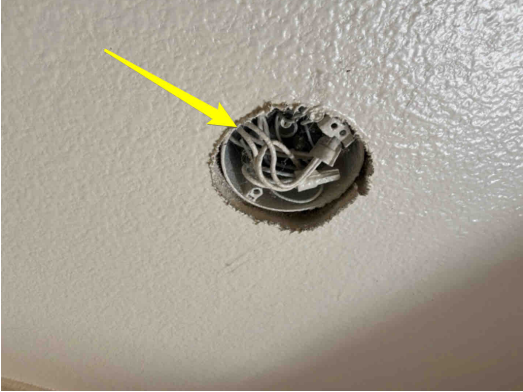
**SC 200:** Light fixture is missing with exposed wires: ON THE INTERIOR CEILING LIGHT FIXTURE ABOVE THE GARAGE PEDESTRIAN DOOR

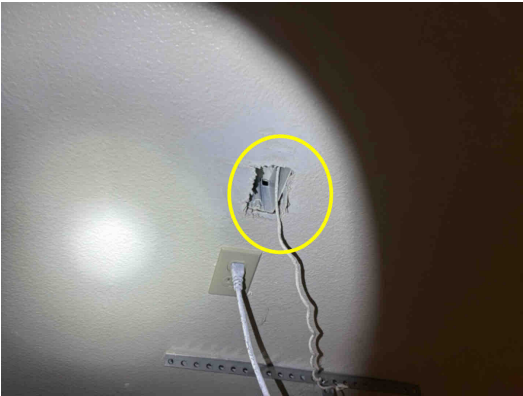
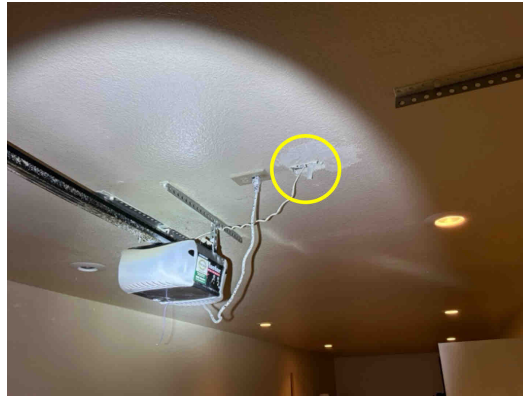
**SC 201:** Missing electrical cover plate at the garage ceiling for the garage door opener low-voltage electrical box. It covers required to maintain proper firewall separation.

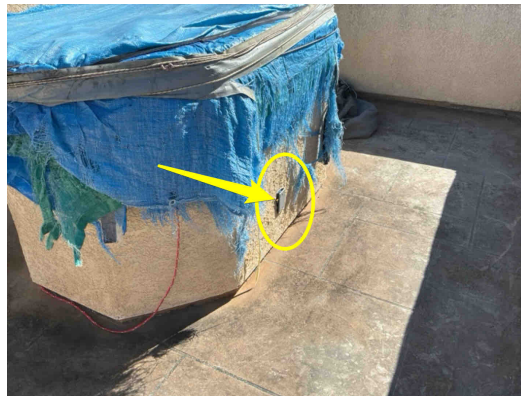
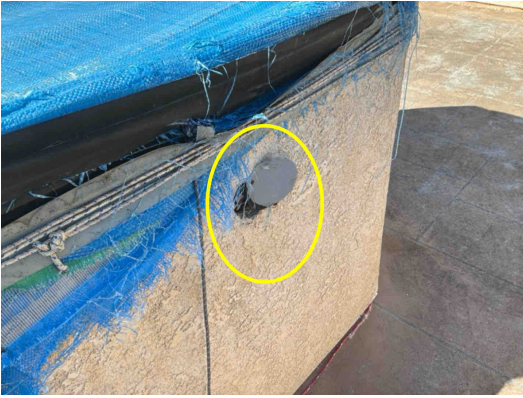
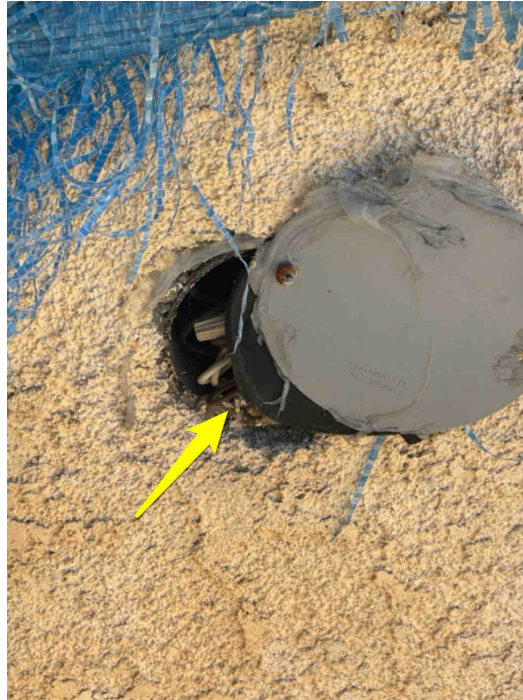
**SC 203:** Loose, improper installation of TWO separate weather tight junction box cover at the AT THE UPSTAIRS ROOF DECK ISLANDS ELECTRICAL JUNCTION BOX. Exposed electrical wiring, potential water intrusion into the wall cavities.

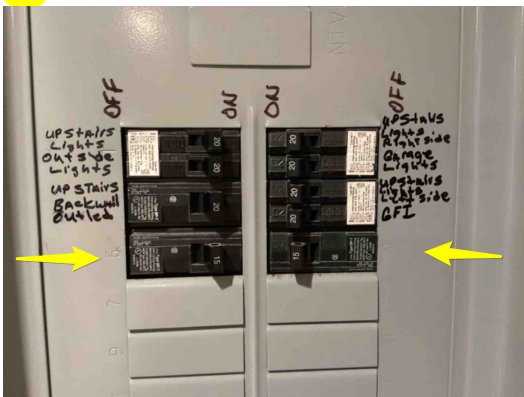
**SU 206:** Breakers in the ELECTRICAL SUB PANEL are not fully or properly labeled per standards.

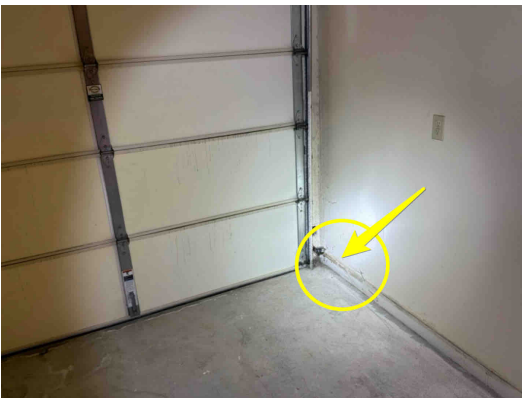
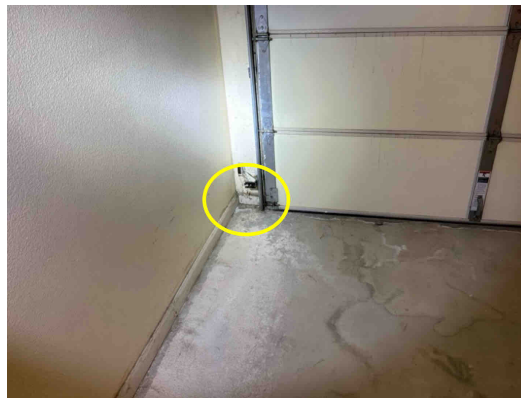
**FI 213:** Moisture stains and/or damage found on areas of the garage wall in baseboard. Referred a photo for location. Recommend further review to determine cause, current condition and if repairs are needed. Areas found dry today.

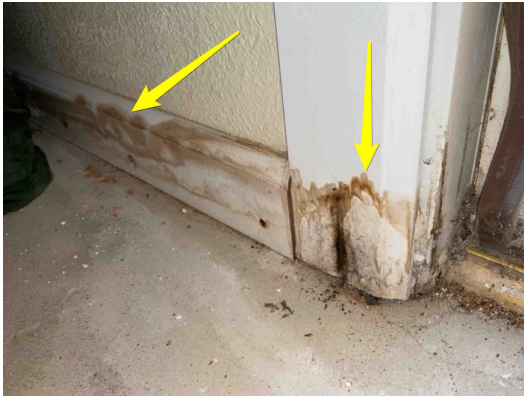
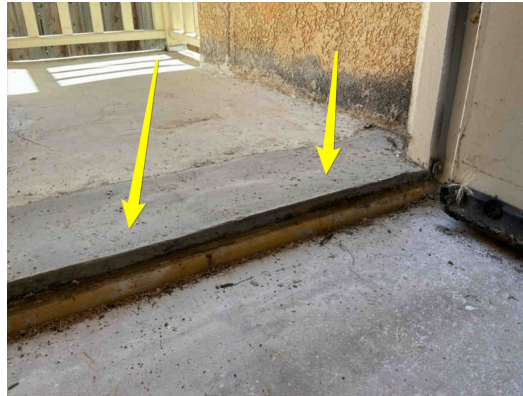
**FI 216:** Some moisture damaged found at the garage pedestrian exterior door, door jamb and/or trim the improper construction on the exterior portion, walkway outside the pedestrian door, bottom of the exterior stairway. Areas of the concrete installed on the exterior were improperly installed too high above the door threshold and exterior stucco. This allows for excessive water intrusion into the garage and exterior wall cavities. Contact a qualified contractor to evaluate and correct. Refer to the Termite report for additional comments and recommendations.

Concrete installed too high above the door threshold

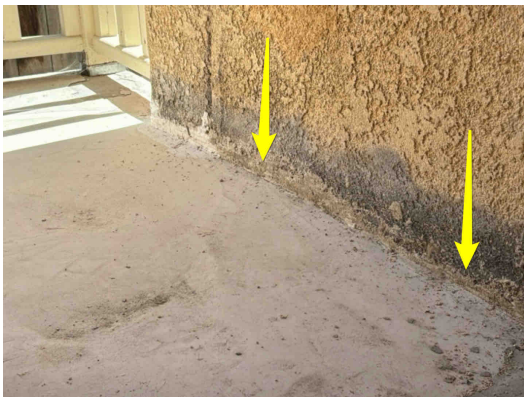
Concrete outside the pedestrian door improperly installed too high at the exterior stucco

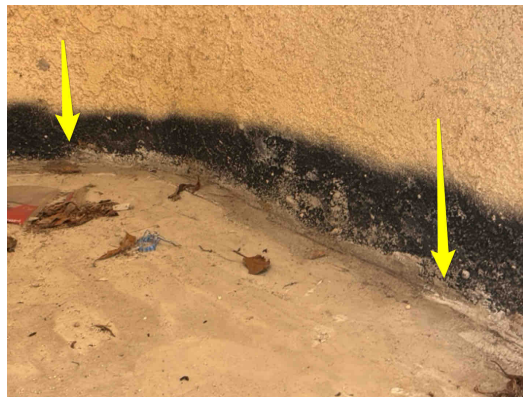
Concrete outside the pedestrian door improperly installed too high at the exterior stucco
