### *Inspection Report*

**Address: 7955 Las Lomas Ave Atascadero, CA 93422**

**04/11/2026**

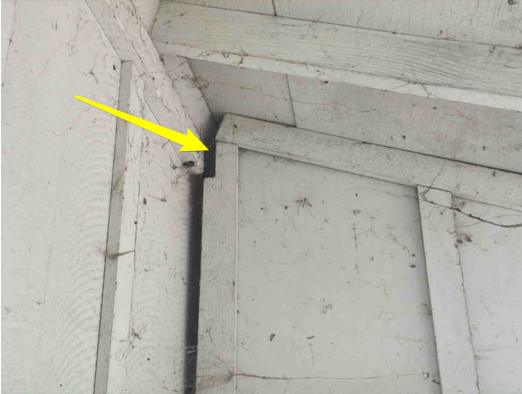
**FI 22:** The added Shed on the south side of the house found to be pulling off the building and separating. Evidence of a compromised structural integrity. Upgrades are warranted.

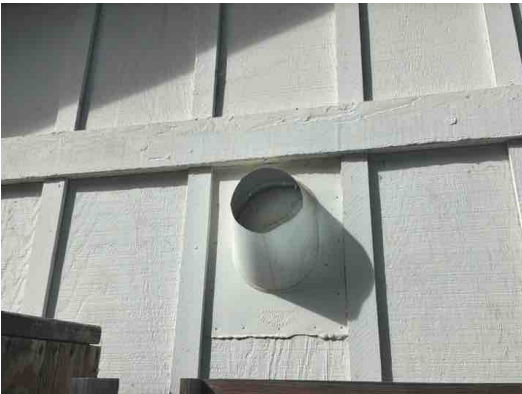
**E&C 23:** Open hole through the exterior Garage wall found on the North side of the home. The open hole needs to be sealed to prevent critter and water intrusion.

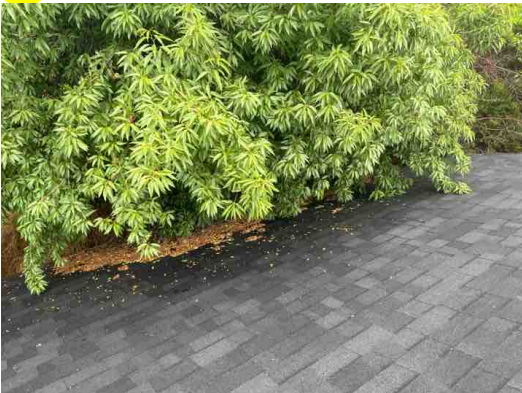
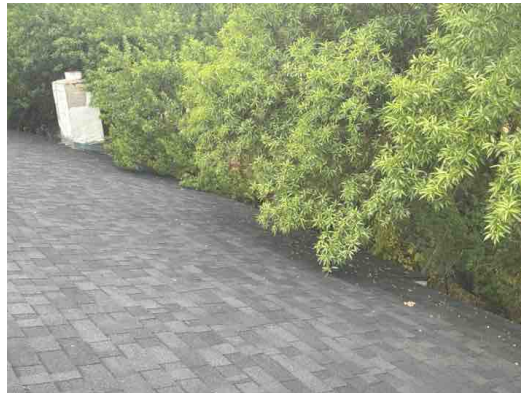
**MR 31:** Plants and/or trees touch the buildings exterior and/or the roof. Proper landscape maintenance needed.

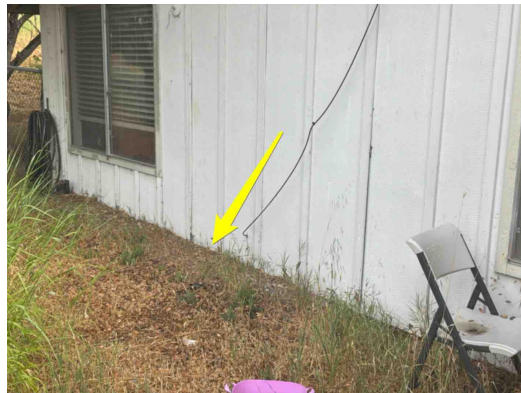
**MR 32:** Soil level found high along areas of the perimeter of the foundation and exterior siding (recommend 6 inches from the bottom of the exterior siding to dirt, rock, mulch or wood chips).

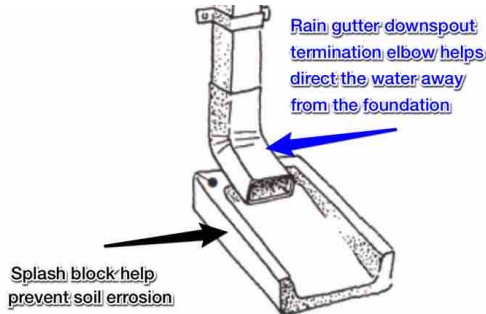
**MR 63:** Recommend splash blocks at the bottom of some rainwater downspouts to assist in proper flow of roof water away from the house and to help prevent soil erosion where not installed.

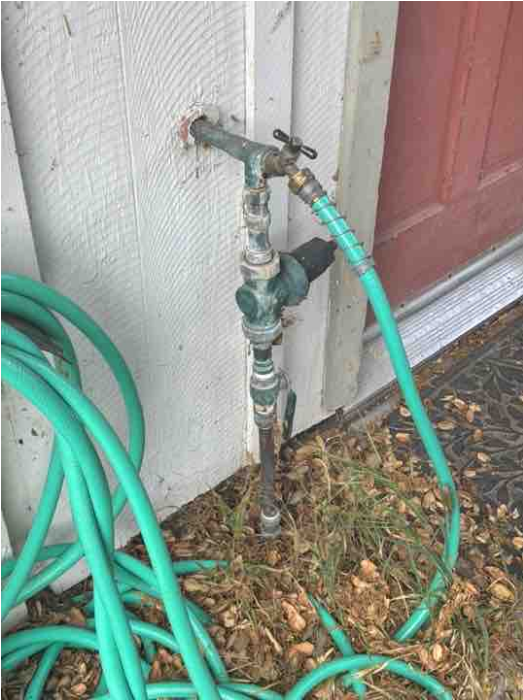
**66:** Main water supply shut-off location: SOUTH SIDE- Exterior. *Main water shut-off valve not tested.*

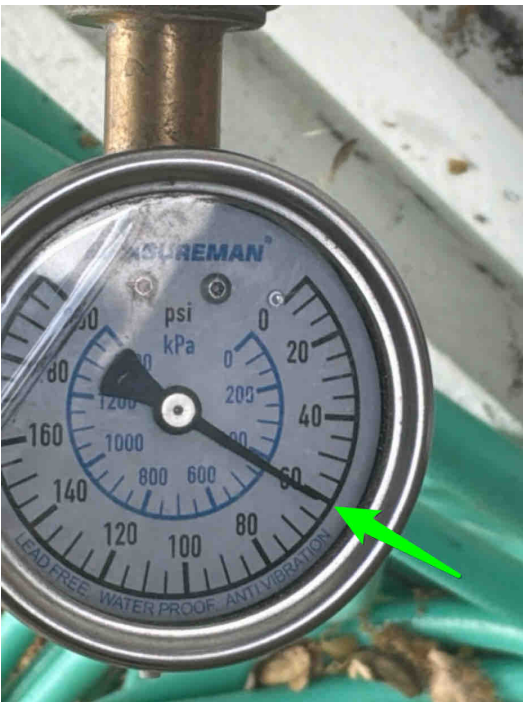
**67: WATER PRESSURE - Is Within Standards:** At Approx. 60 +/- PSI . *Optimal water pressure is between 40 and 80 PSI.*

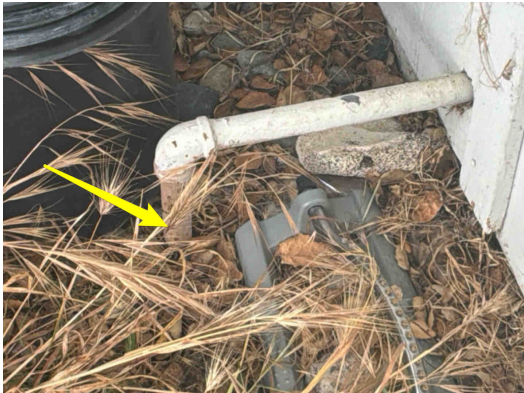
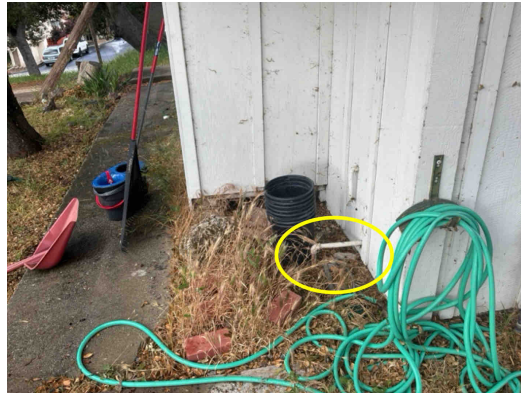
**E&C MR 80:** An improper use and installation of unprotected / unwrapped metal Gas pipe through the soil. All gas piping which runs under ground or within 6 inches off the ground must be protected from rust and corrosion to help prevent a gas leak. Contact a qualified plumber to evaluate the current condition of all gas piping and replace or upgrade all of the unprotected gas piping as needed.

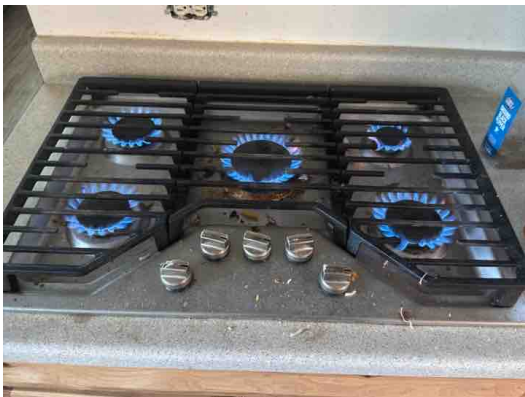
**106:** The cooktop is Natural Gas and operated when tested

**SU 107:** Damaged / Deteriorated knobs at cook top.

**SC 108:** Deteriorated labeling of the kitchen cooktop knobs. Deteriorated labeling at kitchen cooktop knobs, in some cases, can be considered a safety hazard as an occupant may not know where the actual or proper OFF is located which can lead the occupant to accidentally leave the cooktop on.

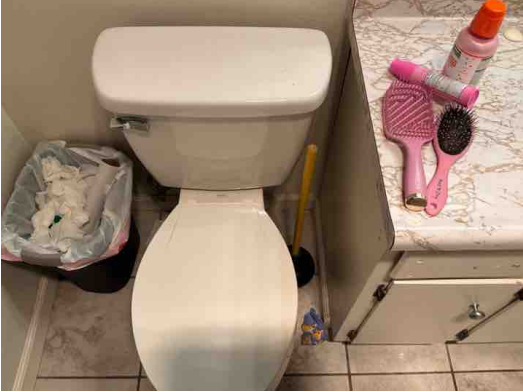
**DS 124:** Toilet found too close to the CABINET and does not meet the minimum standards, (15-inches each side of center): HALLWAY BATHROOM

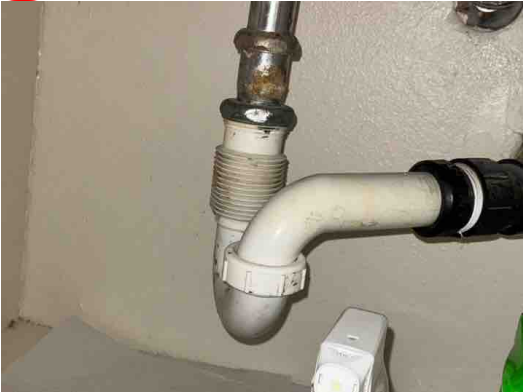
**E&C 128:** Improper use of corrugated drain pipe for the drain under: HALLWAY BATHROOM sink

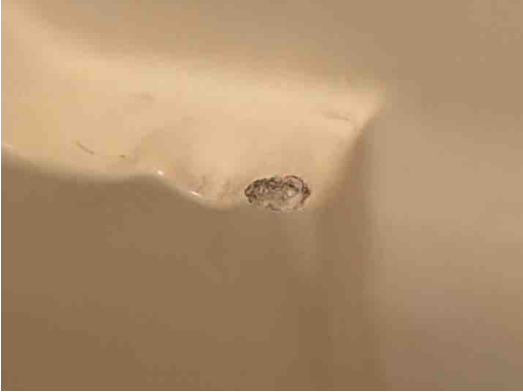
**E&C** **UPG** **135:** Damaged fiberglass shower enclosure in the PRIMARY BEDROOM BATHROOM. Additional review is warranted to determine if water had intruded behind the waterproofed shower wall enclosure.

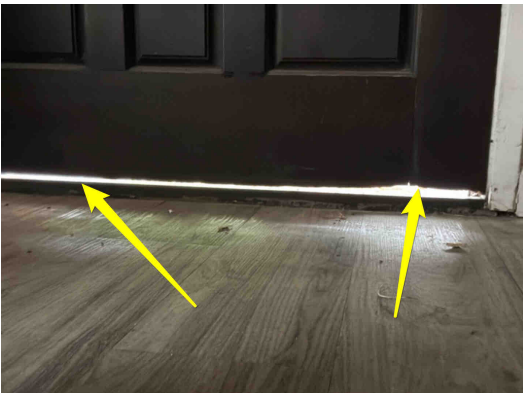
**MR** **138:** Some visible daylight noted around the exterior front entry door. Adjustment and/or repair of the weather stripping is recommended to help prevent water and critter intrusion.

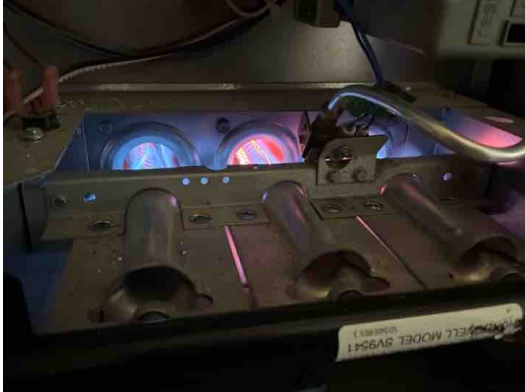
**SU 161: Disclosure:** It is considered an improper installation to have the flex gas connector pass through the metal sidewall of the furnace cabinet. Upgrades recommended.

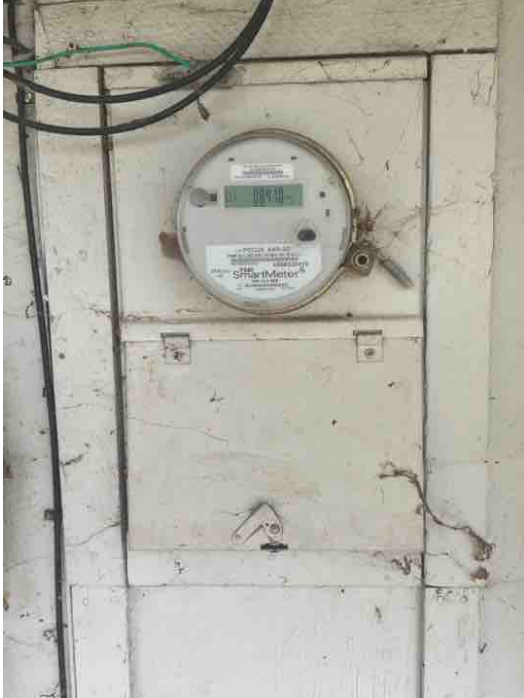
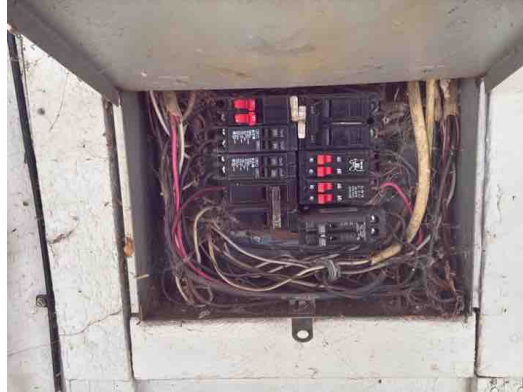
**SU 178:** Breaker panel is not labeled per standards: MAIN ELECTRICAL PANEL.

**SC 179:** Missing the dead front cover inside the MAIN ELECTRICAL PANEL.

**SC 180:** Some of the protective coating around the outside of the electrical wire found to be over-stripped exposing the energized portion of the wire at some circuit breakers connections inside the MAIN ELECTRICAL PANEL. Exposed electrical wires should be protected to help prevent accidental contact.

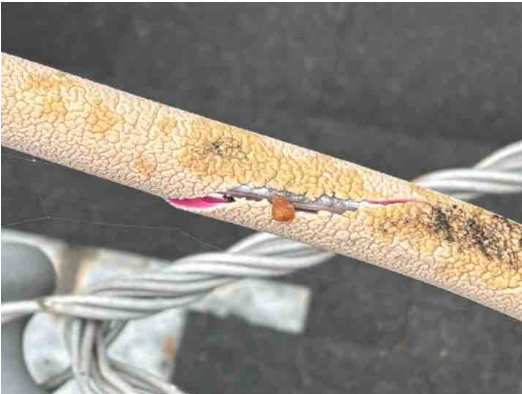
**MR SU 181:** Overhead main electrical service wires touch trees. Potential hazard. Contact utility company.

**SC 182:** Improper use of non-exterior rated wire as the coating on the wire found excessively damaged with exposed metal wire at the main electrical main overhead service where the wires enter the electrical mast. Recommend contacting a qualified electrical professional to evaluate and correct. This is considered a safety hazard and warrants repair.

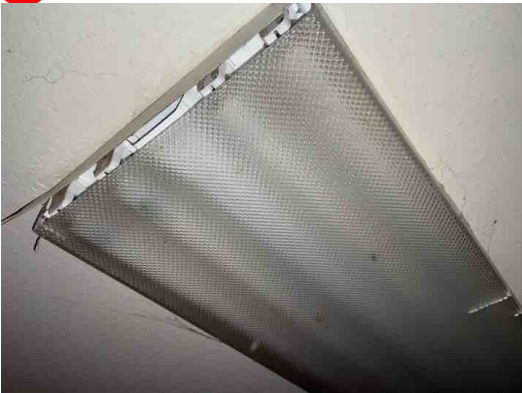
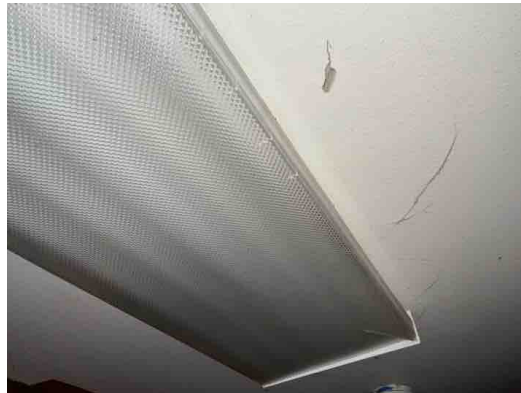
- SU 190:** Lens at light fixture is missing: AT SOME LIGHT FIXTURES
- E&C 191:** Light fixture / lens is damage: LAUNDRY ROOM CEILING FLUORESCENT LIGHT

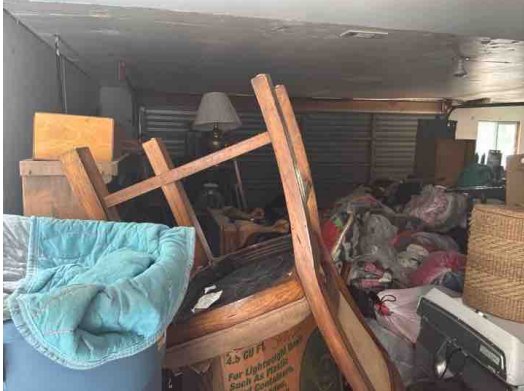
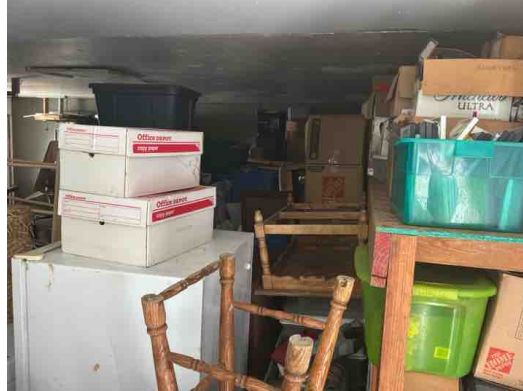
**DS 202:** Due to an excessive amount of stored items and/or cabinetry in the garage, the majority of the garage walls and/or floor, is not accessible, not visible, nor inspected. A re-inspection is recommended once access is made available.

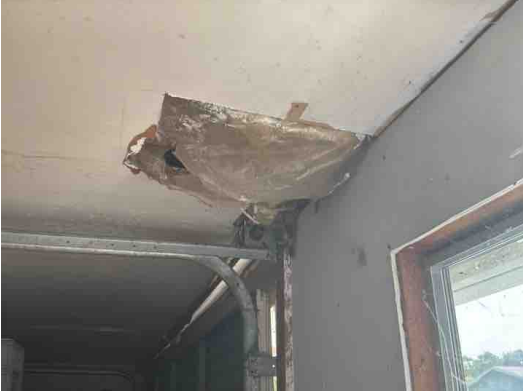
**SC FI 206:** Some small holes or openings found in the garage firewall. Corrections warranted for fire safety. Contact an appropriate professional to repair or correct as needed.

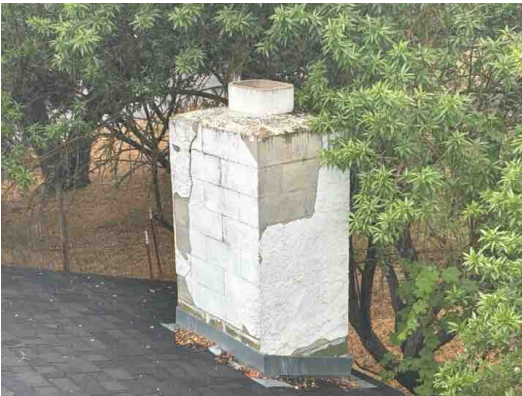
**221:** Photo of the LIVING ROOM Masonry Chimney

**SC 222:** Tree too close to LIVING ROOM fireplace chimney termination. This can negatively affect the drafting of smoke from the fireplace. Potential fire hazard. Maintenance recommended.

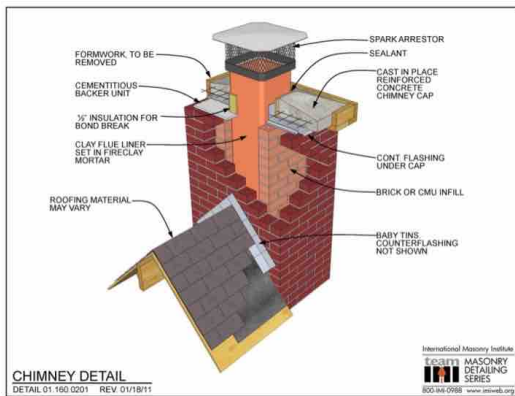
**SC 224:** Missing a proper spark screen & rain cap at the top of the LIVING ROOM fireplace masonry chimney per standards. Safety concern. A cap and screen is needed at the top of the fireplace chimney for fire safety and to help prevent water and critter intrusion.

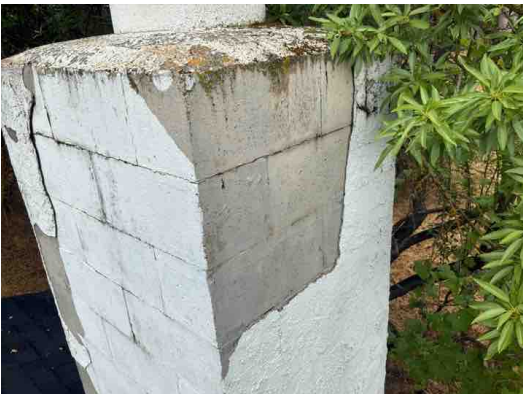
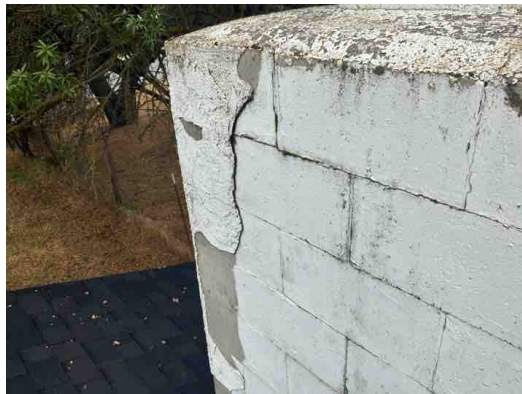
**E&C 228:** The exterior stucco appears to be peeling from the masonry chimney. This is due to poor or improper adhesion. Contact the qualified professional to evaluate and correct.
