Southland Pest Control Inc.

9145 Garfield St.
Riverside, CA 92503

WOOD DESTROYING PESTS AND ORGANISMS INSPECTION REPORT

Building No. 9145	Street Garfield St.	City Riverside	ZIP 92503	Date of Inspection 01/05/2026	Number of Pages 9
----------------------	------------------------	-------------------	--------------	----------------------------------	----------------------

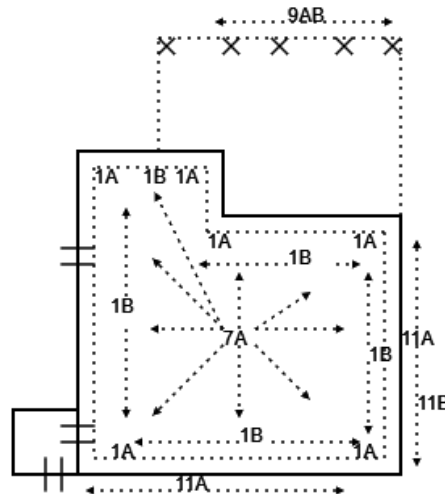
Diagram Not To Scale

Dry-wood Termites Finding: Evidence of dry-wood termite infestation was found at the found thru out the crawl space area in multiple corners of home. Wood was not brittle to the touch but there were mounds of termite grass in multiple locations as indicated on the attached diagram.

Recommendation to fumigate - SEE 11B
