Inspection Report

Property Address:
6520 Mira Cielo (Main, Pool, Barn)
San Luis Obispo CA 93401

3/12/2026

Harper Homes: Home Inspection Services

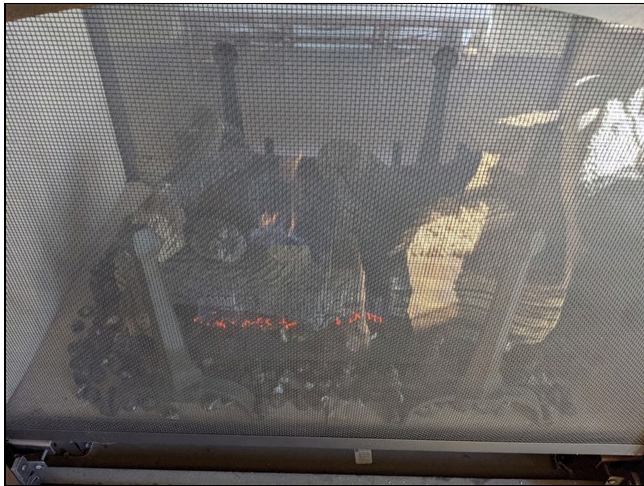
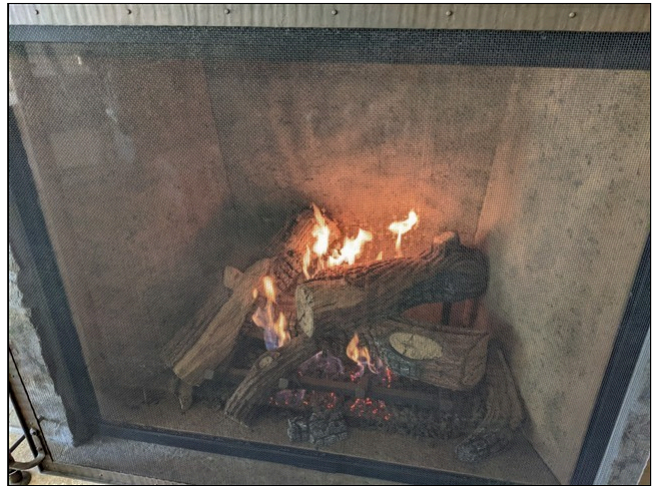
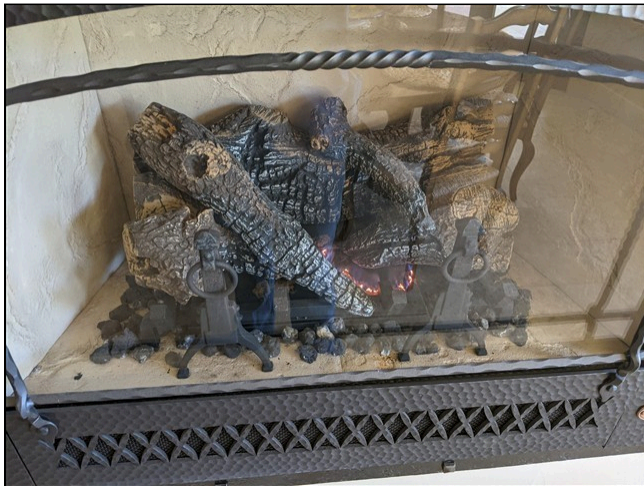
The fireplaces were tested and functional at the time of the inspection.

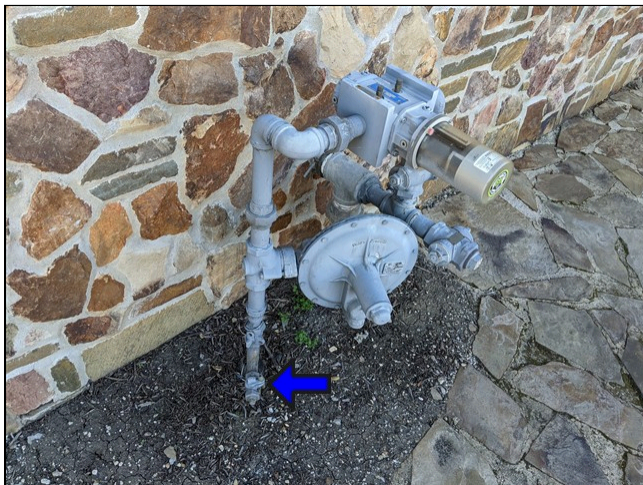
6.3 Item 1(Picture)

The gas shutoff is located at the front left corner of the home. To turn the gas off turn the valve perpendicular to the piping.

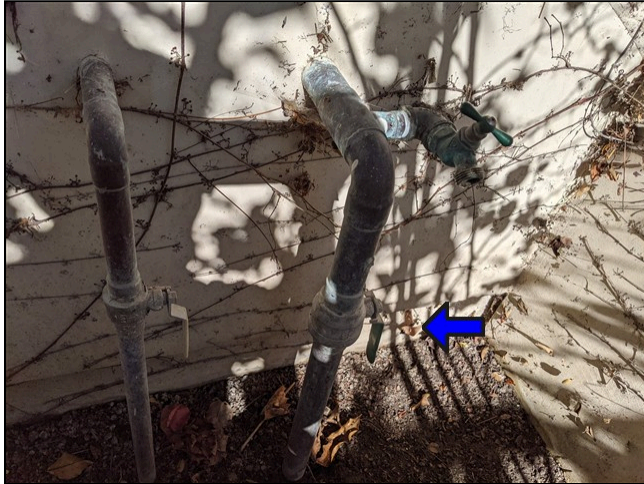
6.4 Item 1(Picture)

The water shutoff is located at the rear exterior of the home. To turn the water off turn the

handle perpendicular to the piping.
