# Home Inspection Report

3229 Westridge Drive, Kelseyville , CA 95451

Monday February 2, 2026

2133

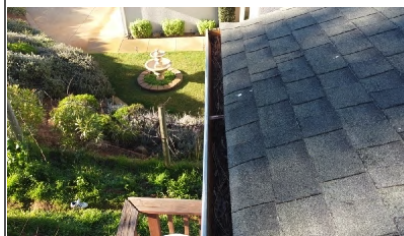
Gutter is full of debri and rusting, recommend cleaning

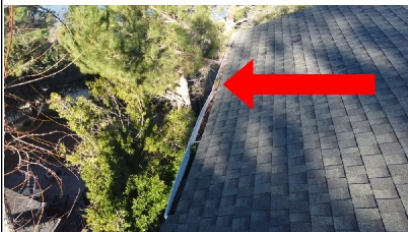
Gutter is full of debri and damaged, recommend repair

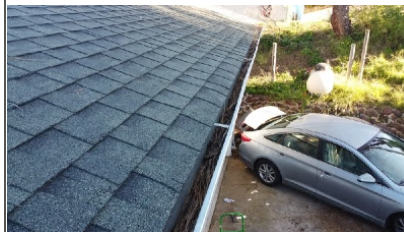
Gutter is full of debri and rust, recommend cleaning

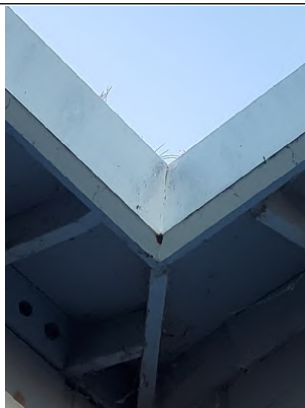
Active leak is evident on gutter, recommend replacing

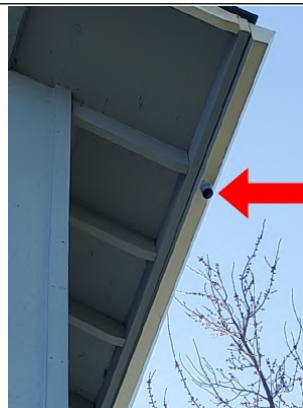
Missing downspout, recommend repair

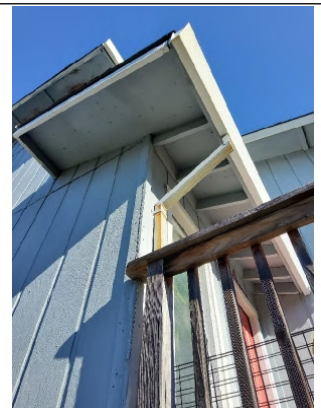
Significant rust is evident on downspout, gutters are nearing end of life, recommend replacing

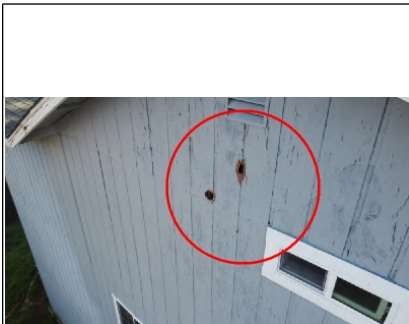
Siding has significant damage, recommend repair

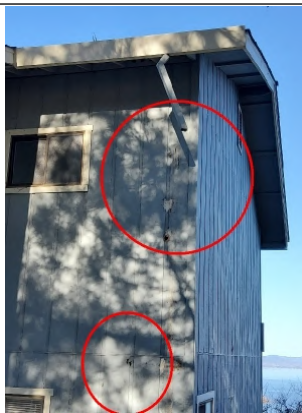
Siding has significant damage, recommend repair

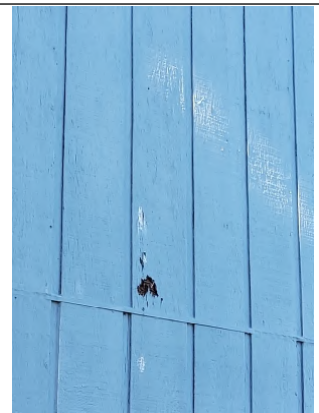
Siding has significant damage, recommend repair

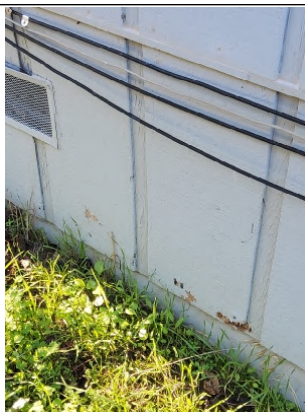
Siding has significant damage, recommend repair

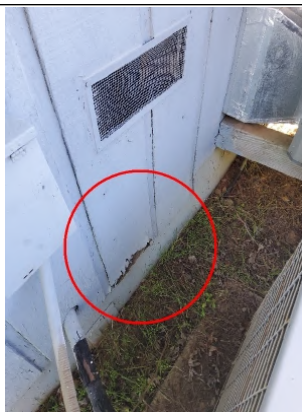
Siding has significant damage, recommend repair

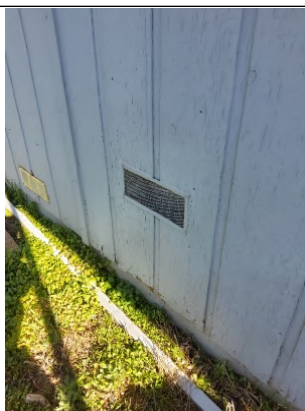
Siding has significant damage, recommend repair

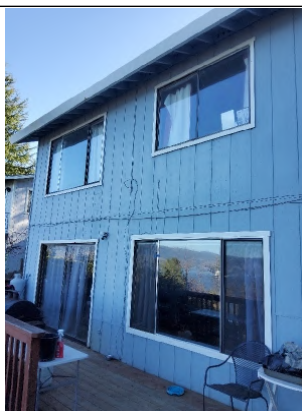
Siding at section is warped, recommend having replaced by a licensed contractor.

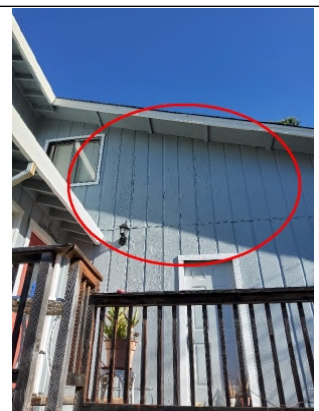
Siding at section is warped, recommend having replaced by a licensed contractor.

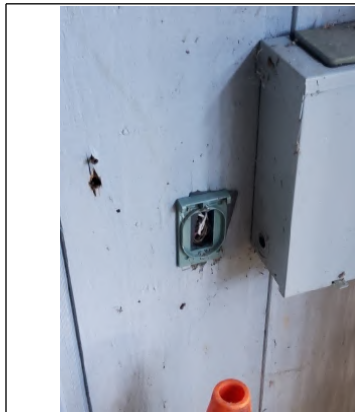
Broken outlet, recommend repair by a licensed electrician.

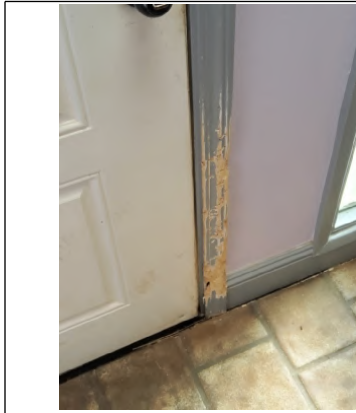
Recommend replacing damaged trim

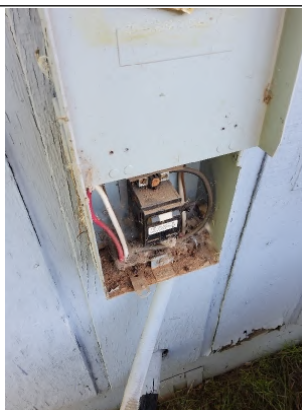
Missing cover, recommend repair

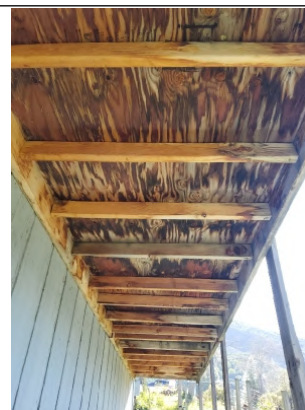
Cover installed over units is not structurally sound, recommend new posts minimum 4x4 be installed to replace 2x6. Also roll asphalt should be installed over new wood sheathing to replace existing.

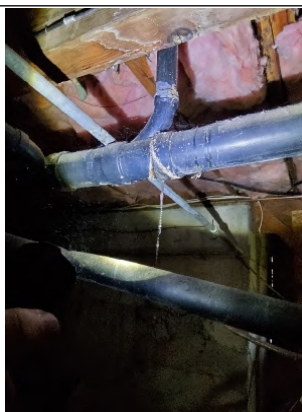
Active plumbing leak, recommend repair

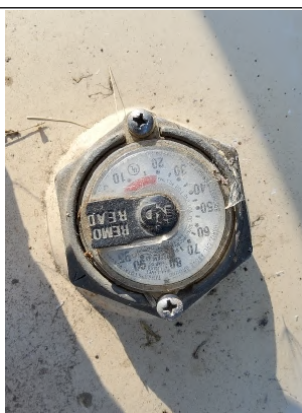
Propane tank is 80 percent full during time of inspection.

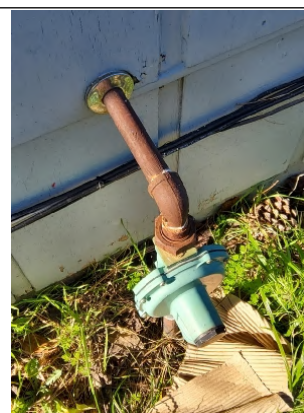
Rust is evident on gas line, recommend further evaluation and repair by a licensed plumber

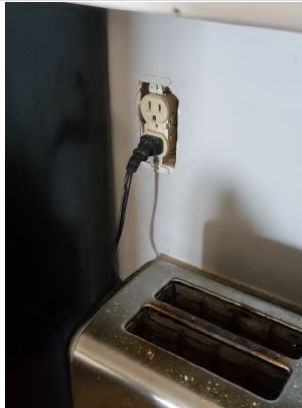
Missing cover plate, recommend repair

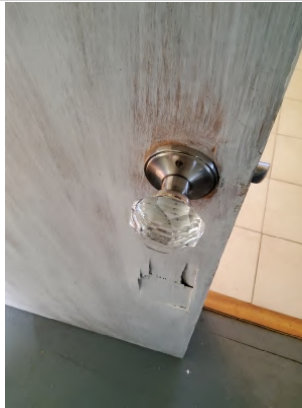
Damaged door slab, recommend replacing

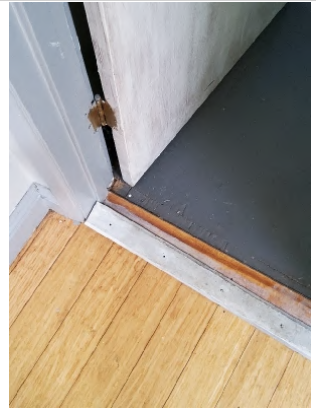
Threshold is loose, recommend fastening
