# Professional

### *Inspection Report*

Address: 1595 Los Osos Valley Rd Spc 10C Los Osos, CA 93402 04/27/2026

Inspector: Keith Vreeken, MCI, FCI  
P.O. Box 415 Templeton, CA 93465 O: 805.462.1978 C: 805.440.5050

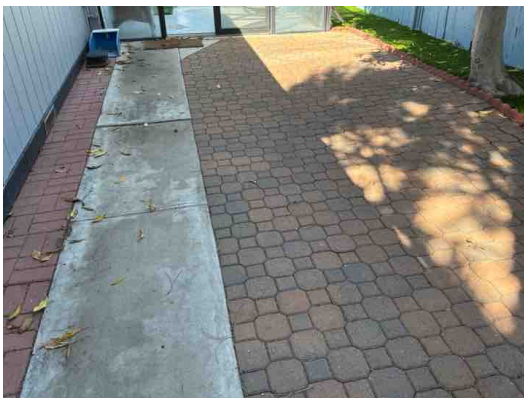
**UPG DS 23:** Areas of poor drainage with a visible improper slope of the patio(s) toward the house.

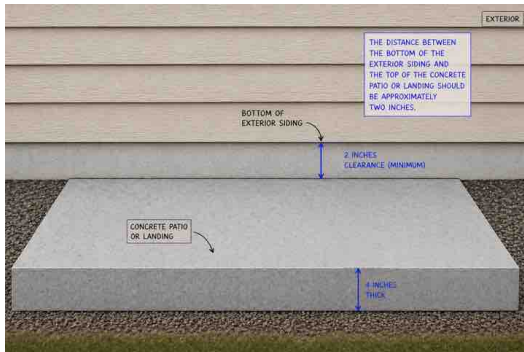
**UPG DS 25: Disclosure:** Areas of some patios were installed high at or above the exterior siding. This can potentially under certain conditions, allow for moisture to accumulate at the base of the siding and can cause deterioration or water intrusion inside the wall cavities.

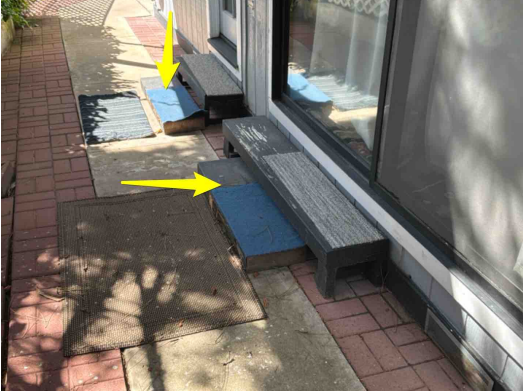
**SC 36:** Improper, loose and unsecured step found off the PRIMARY BEDROOM exterior sliding glass door AND at the French door.

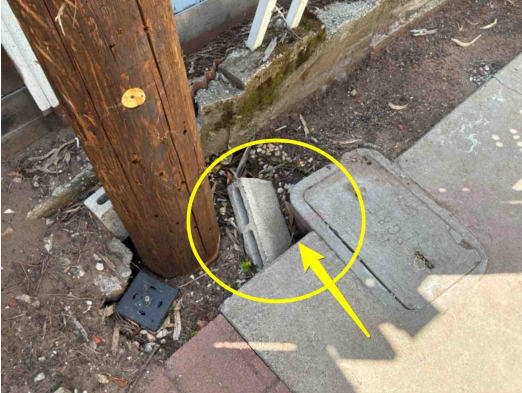
**FI** **UPG** **43:** A small sink-hole found at the exterior dirt area on the southwest corner next to the telephone pole. Additional review is recommended to determine the cause, current condition and potential future issues. Proper upgrades or repairs are recommended.

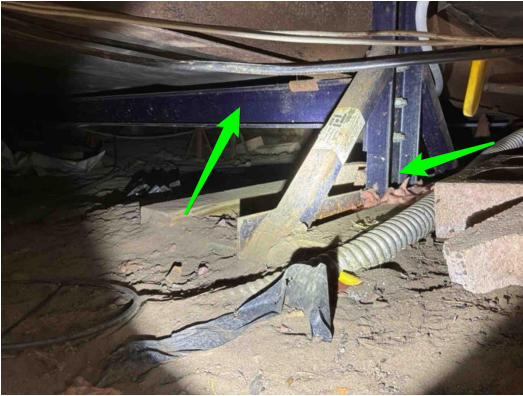
**E&C FI 48:** Some Rusted, Deteriorated and/or damaged metal foundation piers found in areas of the crawlspace. Some metal foundation piers appear to be below the winter water level or are in contact with the dirt in areas of the crawlspace. Recommend replacement of damaged piers and adding additional pads to lift the newer piers above water level and/ or remove the building up of soil where needed.

**E&C MR 49:** Some of the metal foundation piers are found to be in contact with the soil in areas in the crawlspace. This can deteriorate the metal foundation supports. Recommend removal of the dirt and inspect each pier for deterioration.

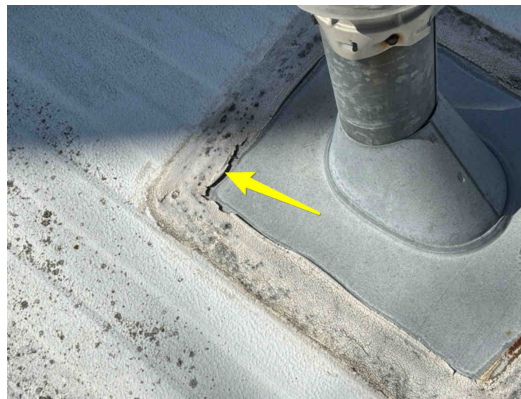
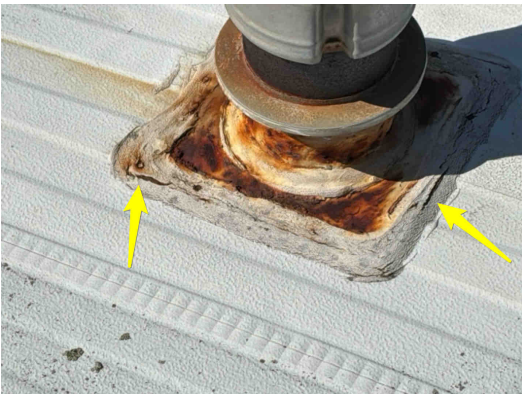
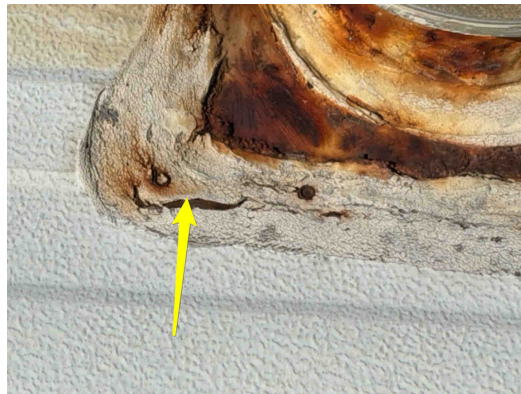
Deteriorated sealant around the fireplace chimney roof flashing

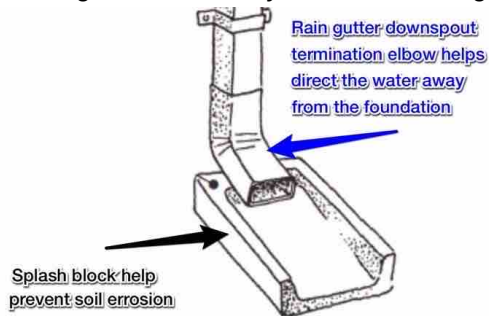
**UPG 65:** Improper termination of some rain gutter downspouts. Rain gutter downspout should be terminated in such a way that it directs the water away from the building. Missing the lower angled portion of the rain gutter downspout diverting the water away from the building.

Improper termination of the carport awning downspouts

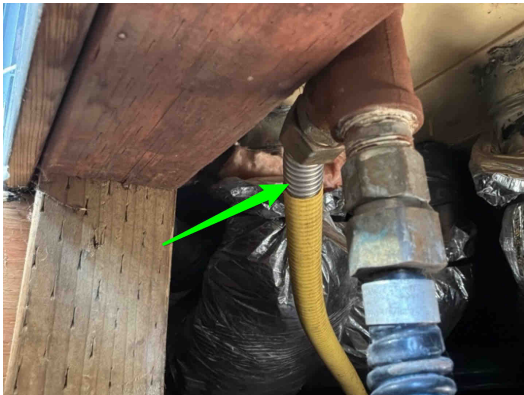
**SC SU 80:** Missing / recommend the required electrical bonding or grounding of the gas piping and/or gas meter due to the installation of CSST flex gas pipe for safety per the Manufacturer's installation instructions and California Building Standards (since 2009). Bonding / grounding connections may be installed in areas not visible however, should be visible or labeled for inspection if installed in a non-visible space.

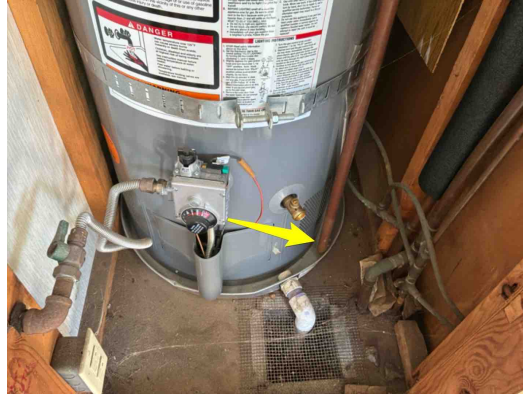
**SC 85:** Water heater TPR (Temperature Pressure Relief) pipe found improperly terminating into the water heater catch pan drain. This is considered a safety concern and warrants correction per minimum standards.

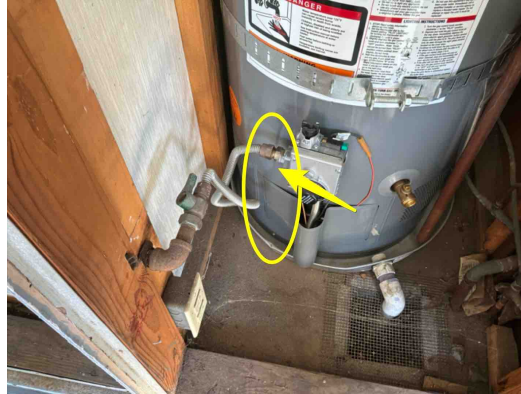
**UPG 89:** Recommend the installation of a sediment trap / drip leg at the WATER HEATER gas piping at flex connection by a certified or licensed plumbing professional familiar with minimum requirements.

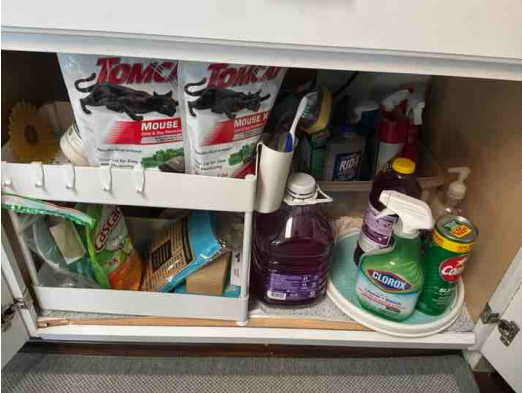
**FI 97:** Damaged cabinet trim at the front floor area at the kitchen sink cabinet.

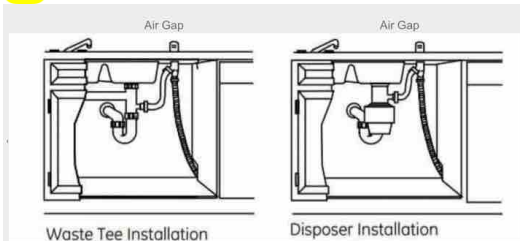
**SU 99:** Recommend an Air Gap Device at the dishwasher drain.

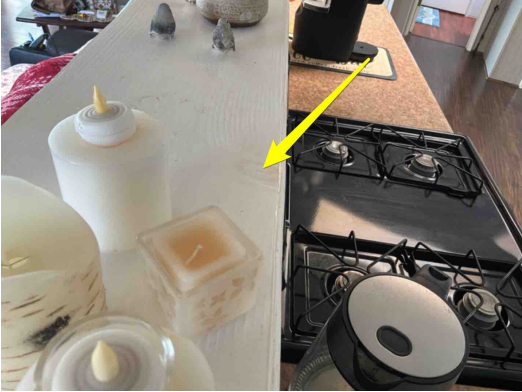
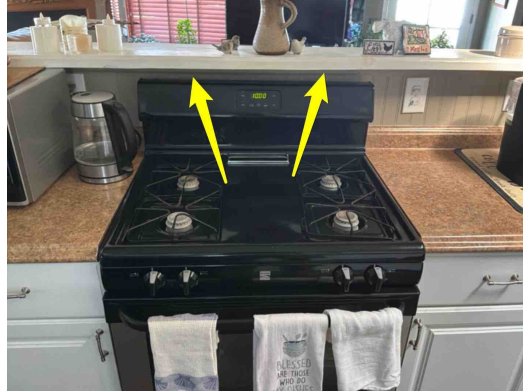
**SU 110:** Improper installation of the wood shelf, overhanging the cooktop in the kitchen. This is considered flammable cabinetry or shelving within 30 inches of the cooktop recommend a proper fire break.

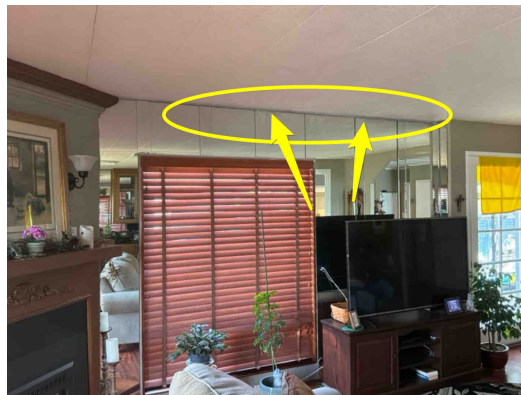
**FI 154:** Evidence of past moisture stains & damage at ceiling area in the LIVING ROOM - right of the fireplace above the window. Recommend further review of the water stains to determine the cause, the current condition and if repairs are needed.

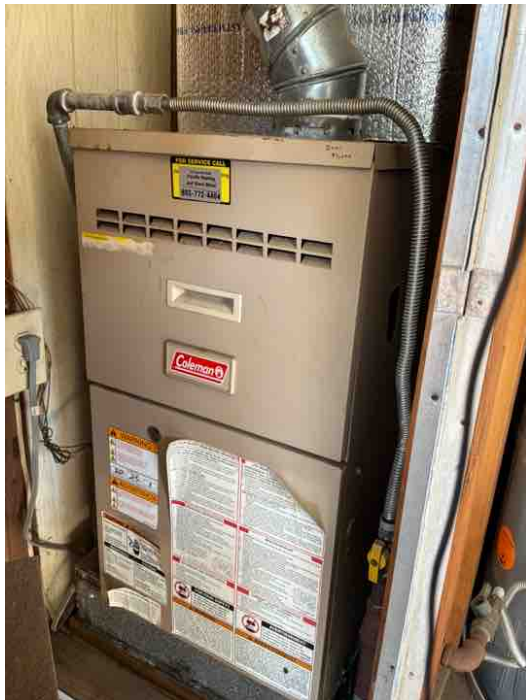
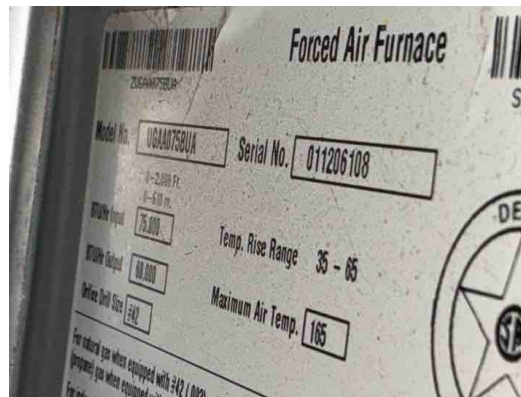
**SC 157: FURNACE CONDITION:** The Furnace found defective and/or not operating properly. Furnace appears to be cycling on its limit switch. Further evaluation, servicing or repair by a licensed HVAC professional is warranted.

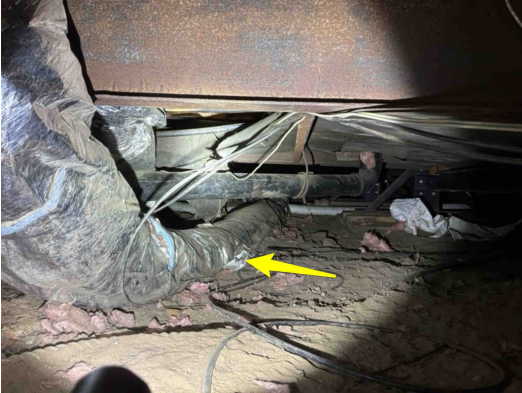
Example

**E&C 163:** Ducting found in contact with ground in crawlspace. Proper strapping and lifting of the ducting off the ground is warranted. Deterioration has or may occur if not corrected. Have qualified HVAC professional evaluate ducting to determine if replacement is needed.

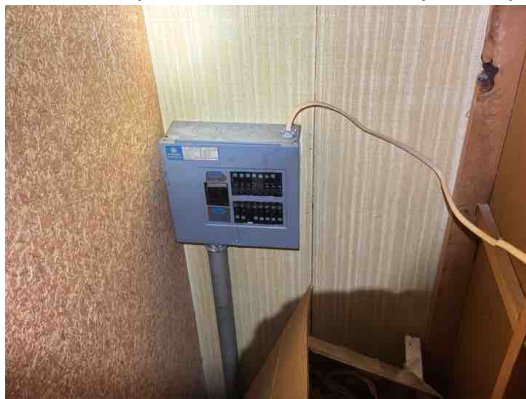
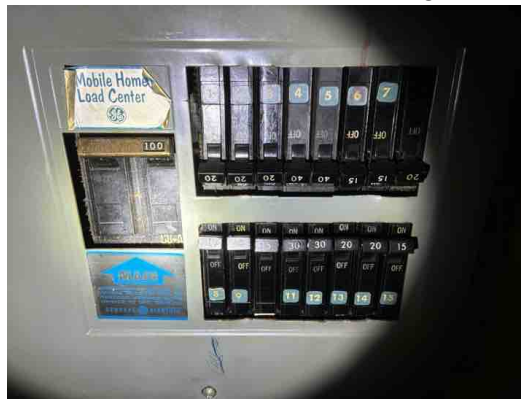
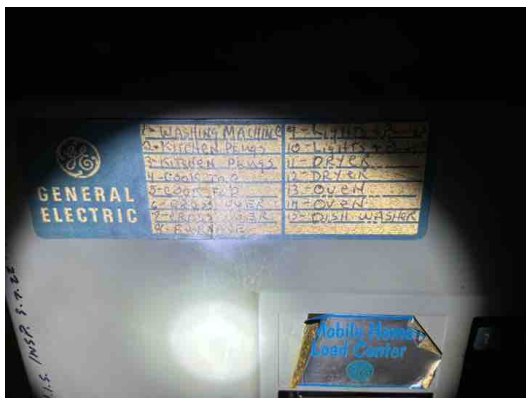
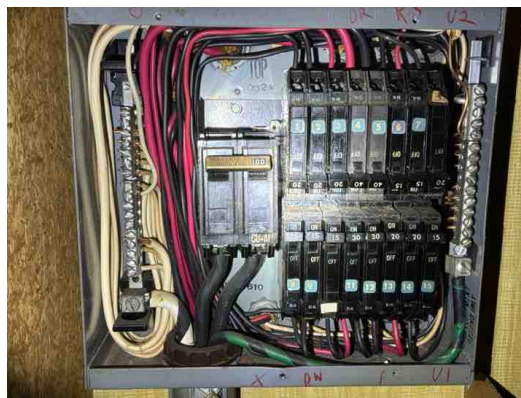
**168: MAIN ELECTRICAL PANEL CONDITION:** \*No visible significant wiring defects in the MAIN ELECTRICAL PANEL.

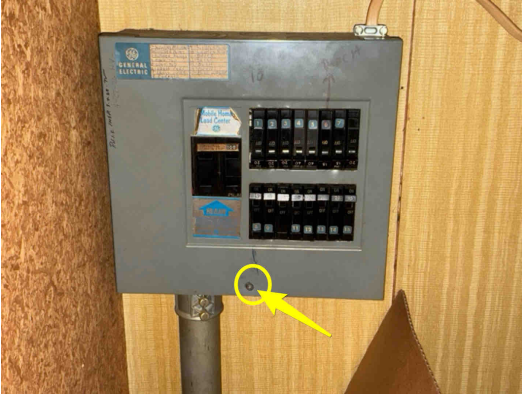
**SU 169:** It is not recommended to use a sharp tipped wood-type screws at the metal MAIN electrical panel dead front cover. Recommended replacement with the appropriate type of screw fastener for safety per standards.

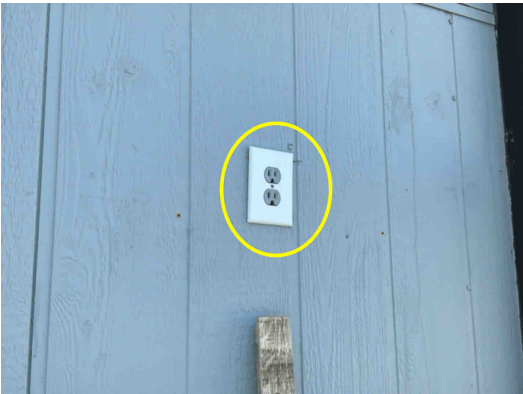
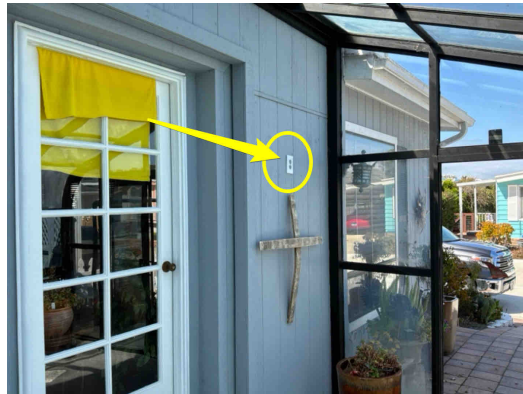
**SC 177:** Three-prong electrical outlets did not test properly grounded: IN THE ENCLOSED SUNROOM. Contact a licensed electrical contractor for evaluation and repairs.

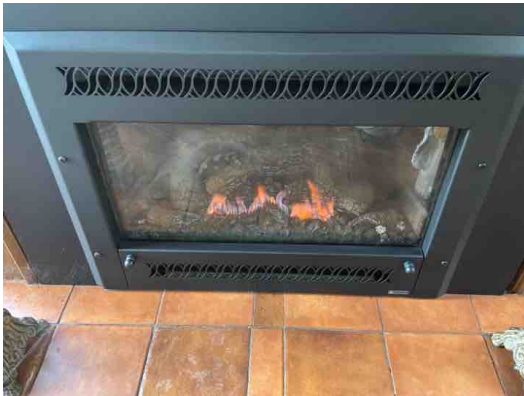
**183:** **GAS FIREPLACE CONDITION:** The LIVING ROOM GAS fireplace operated when tested.

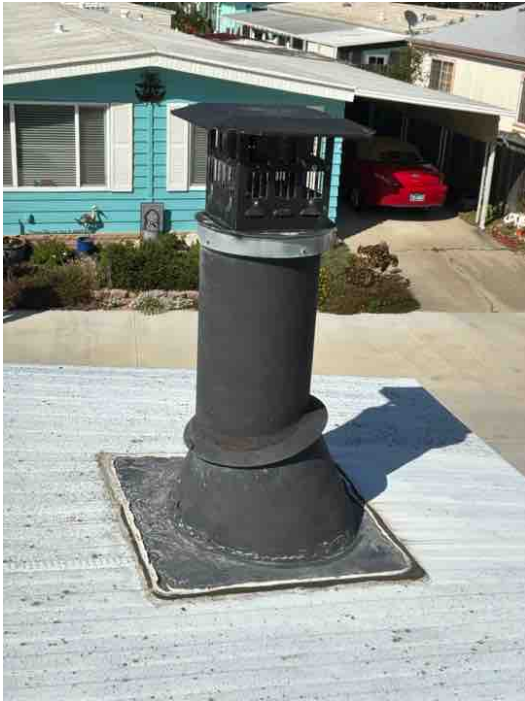
**186:** The LIVING ROOM fireplace metal chimney pipe and cap above the roof appear serviceable and in good condition.
