ENSLING property works

Inspected By: Travis Ensling

Prepared For: Victoria Aiken, Alexis Aiken

Inspected On Fri, Apr 24, 2026 at 9:00 AM

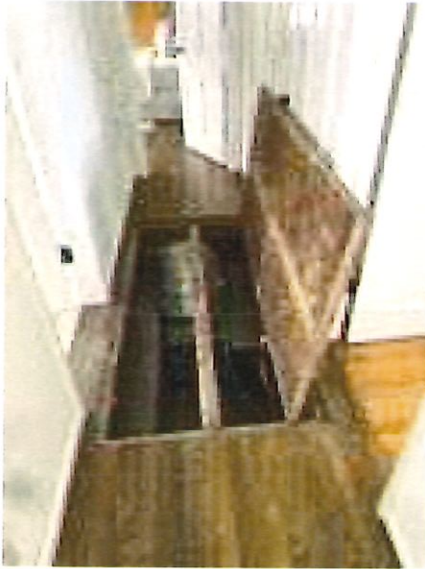
Overview Photos Of Crawlspace

...vidence of rodent activity (e.g., droppings, nesting, etc.) observed in the crawlspace. This condition may lead to damage to insulation, wiring, and building materials, and can pose health concerns. Recommend evaluation and treatment by a licensed pest control professional, and repair/cleaning of affected areas as needed.

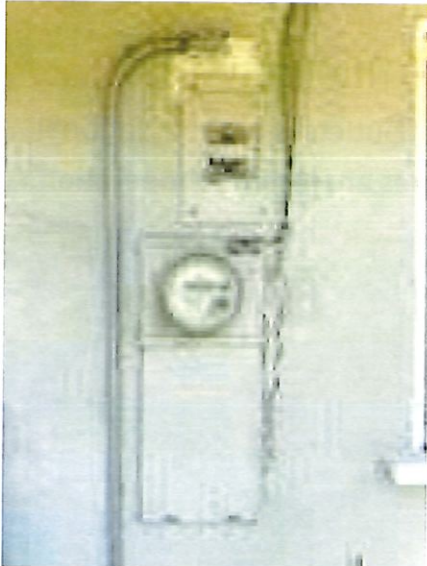
Photo of Panel

The electrical panel (possibly Schneider Electric) is missing a front cover (dead front), leaving breakers and internal components exposed; the panel is also obsolete and shows visible corrosion and deterioration. Recommend evaluation by a licensed electrician and repair or replacement as needed; full panel replacement is likely due to age and condition.
