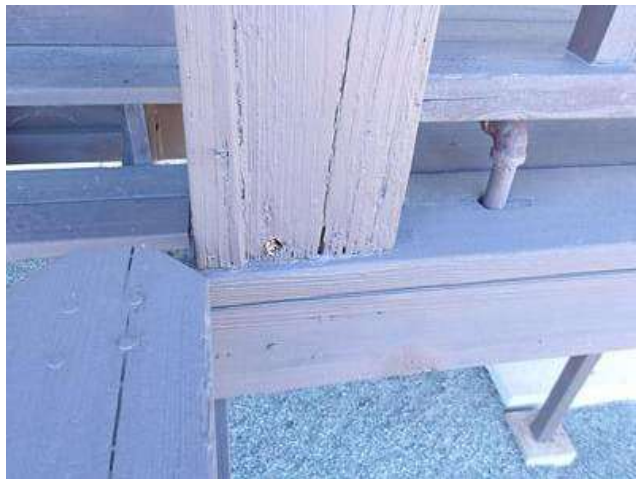
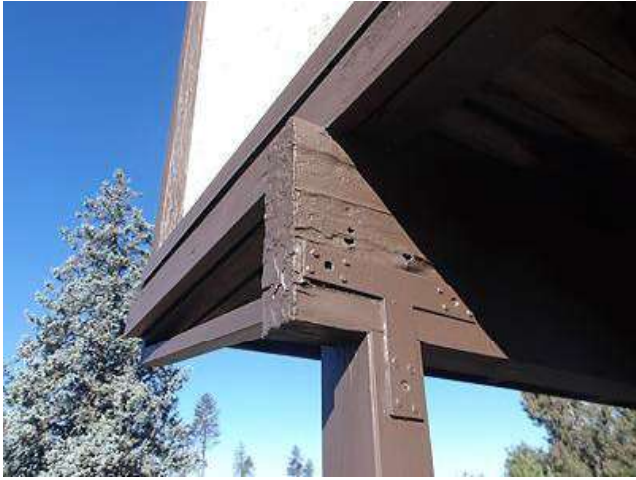
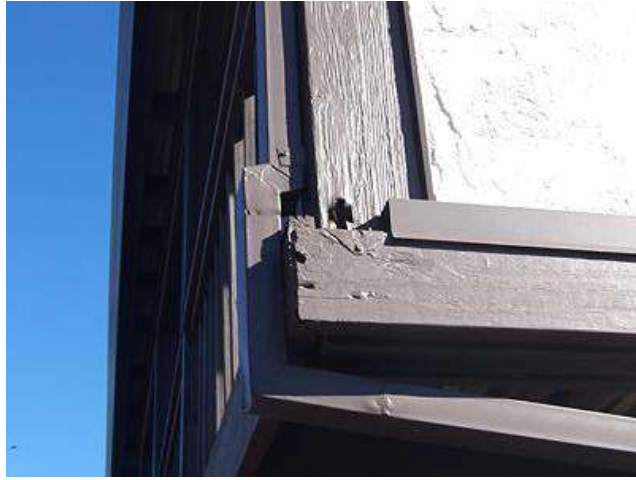
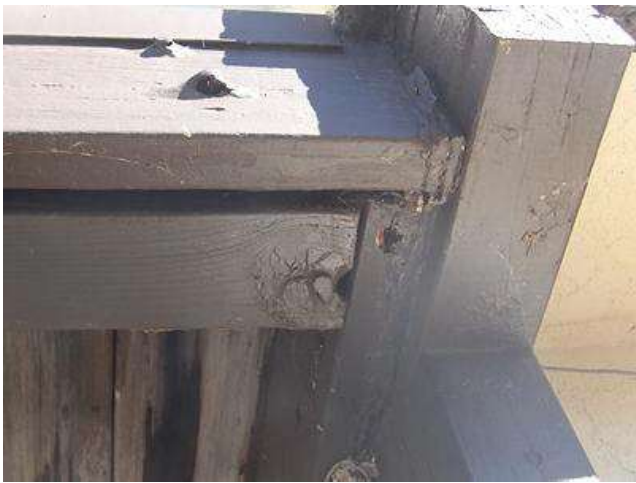
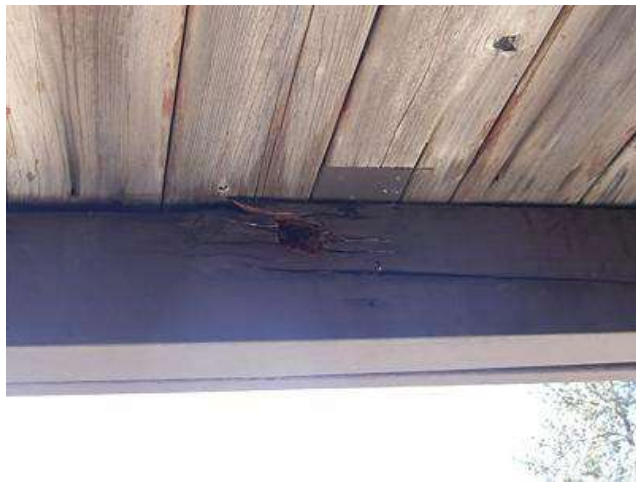
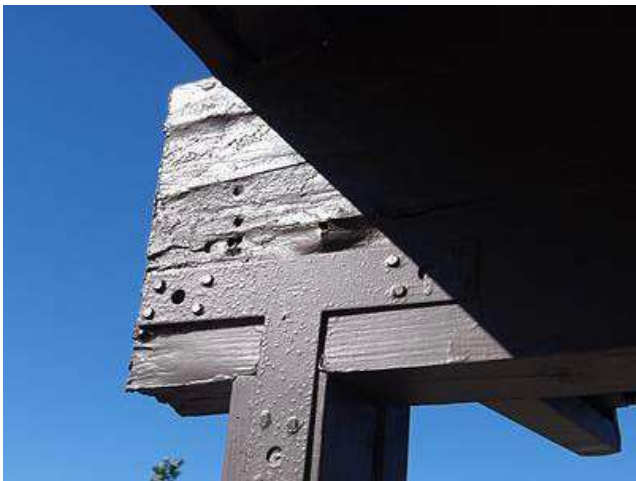
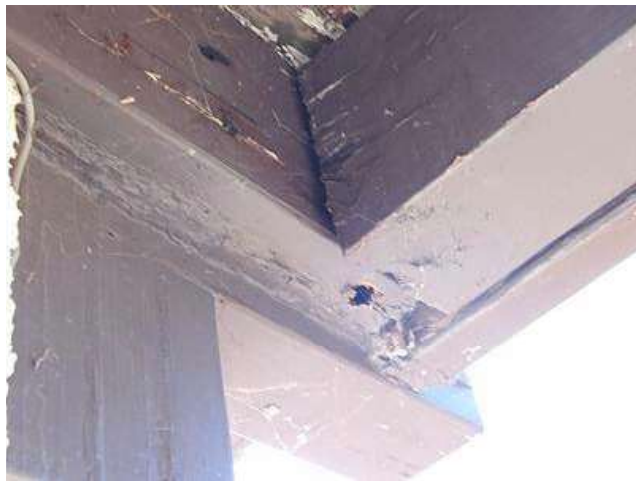
5) 🔍 🪵 🪵 Rot or water damage was found at one or more decks, porches or balconies in decking boards, joists, beams and/or support posts. A qualified person should evaluate and repair as necessary. All rotten wood should be replaced.

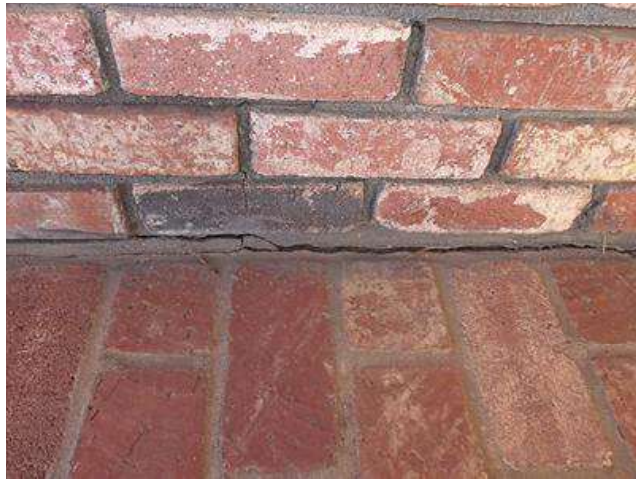
Photo 7-2 Front porch

One or more decks, porches and/or balconies were damaged and/or deteriorated. A qualified person should evaluate and repair or replace as necessary.

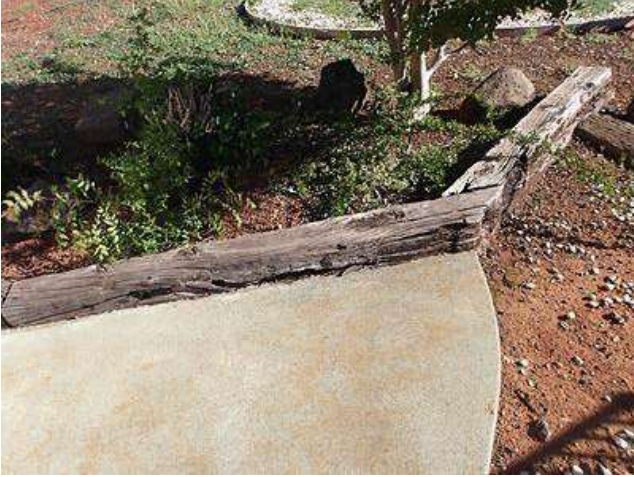
Photo 9-1 East side

-
- 9) 🐜 One or more landscaping timbers were rotten or damaged by wood destroying insects. Landscaping timbers should be replaced as necessary.

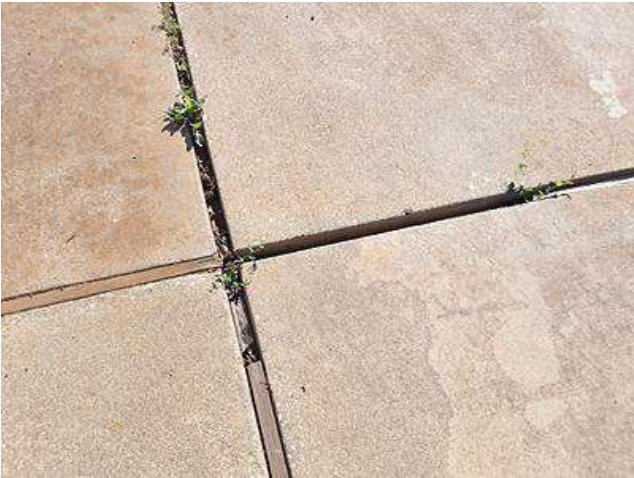
Photo 10-1 Driveway

-
- 10) 🐜 One or more wood spacers in the driveway were rotten or damaged by unspecified wood destroying insects. These spacers typically fill expansion joints that are meant to prevent the concrete slabs from breaking. Recommend replacing wood spacers as necessary with a rot and insect resistant material that compresses and expands, such as treated wood.

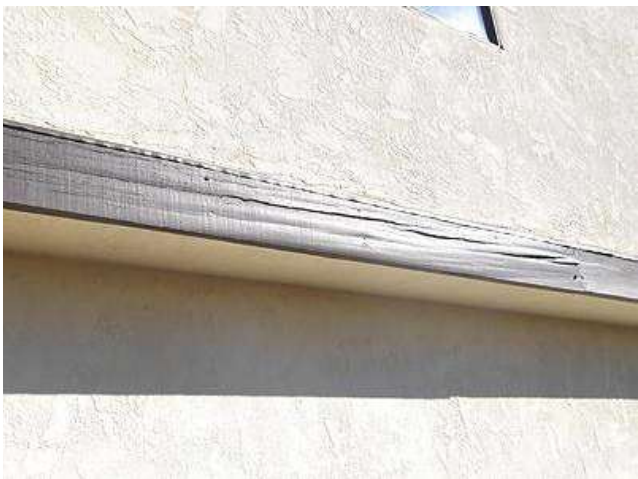
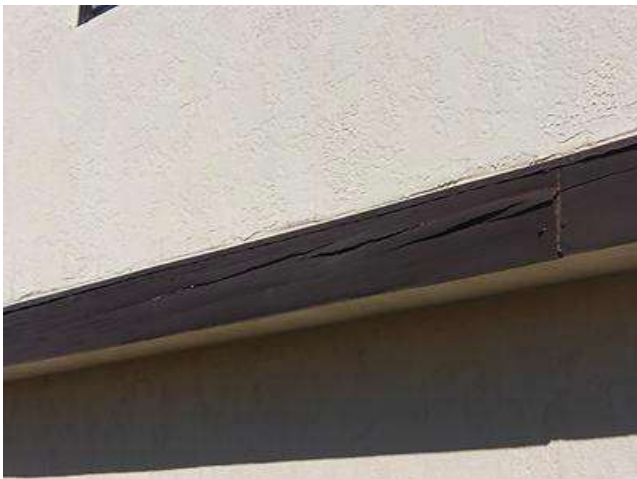
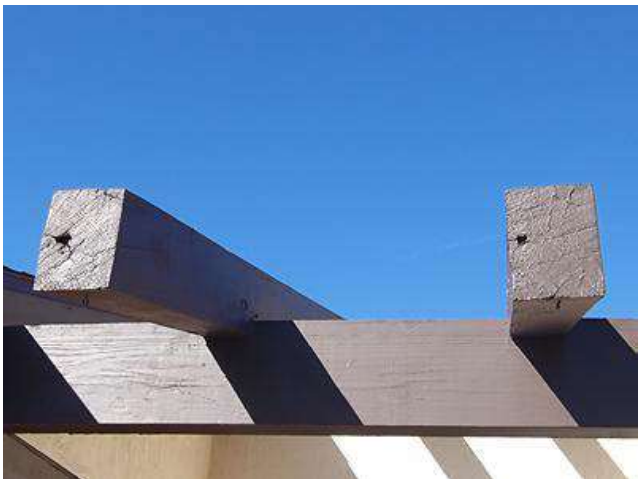
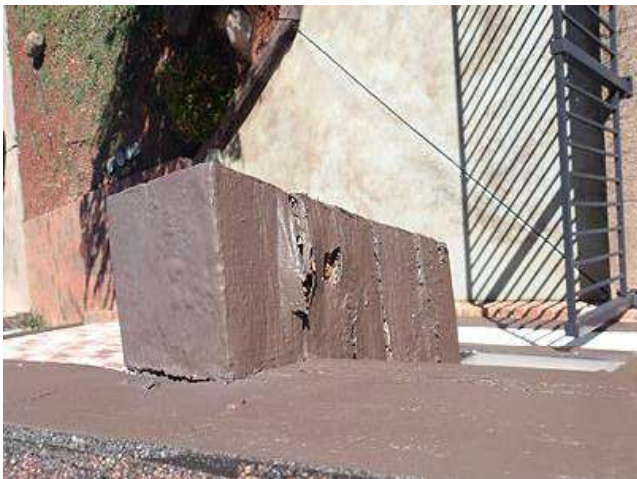
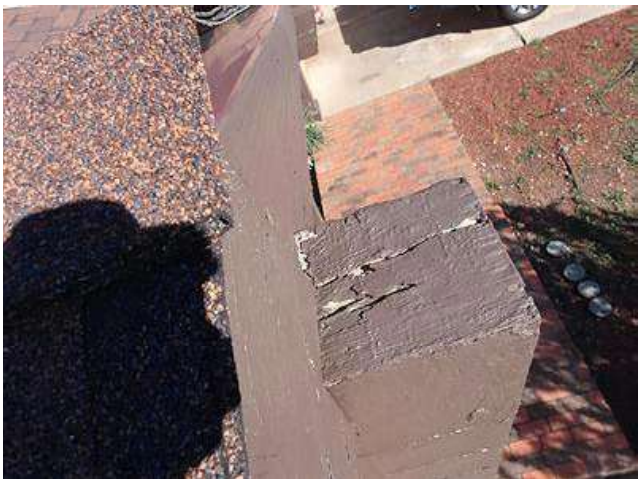
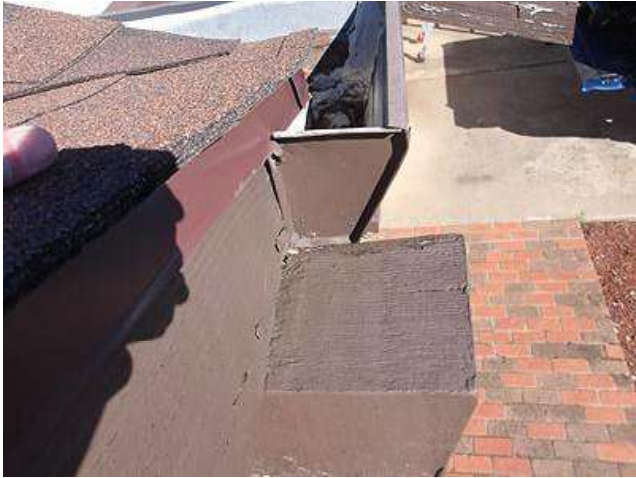
Rot or water damage was found at one or more sections of trim, fascia and/or exposed beams. A qualified person should evaluate and repair as necessary. All rotten wood should be replaced.

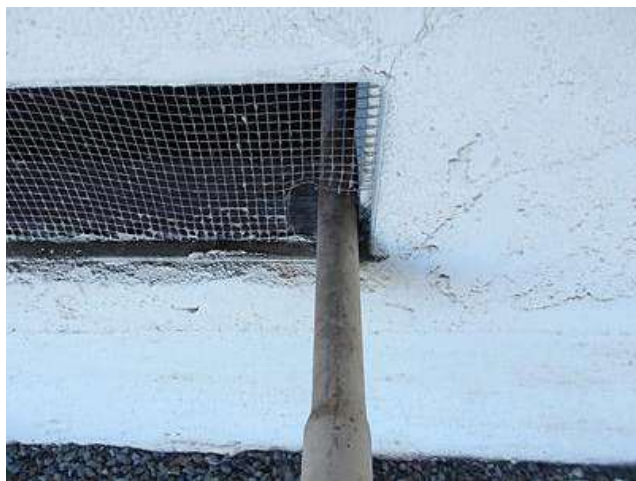
Photo 17-2 West side

17) 🗑️🔧 Gaps existed at one or more openings around the exterior, such as those where outside faucets, refrigerant lines, and/or gas supply pipes penetrate the exterior. Gaps should be sealed as necessary to prevent moisture intrusion and entry by vermin.

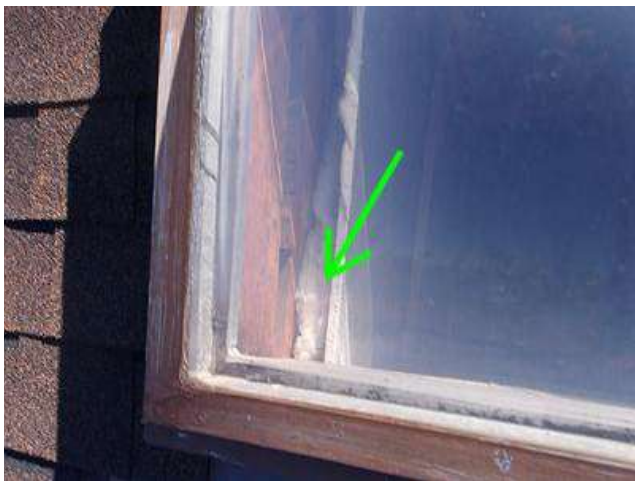
Photo 22-2 Skylight, interior substandard construction

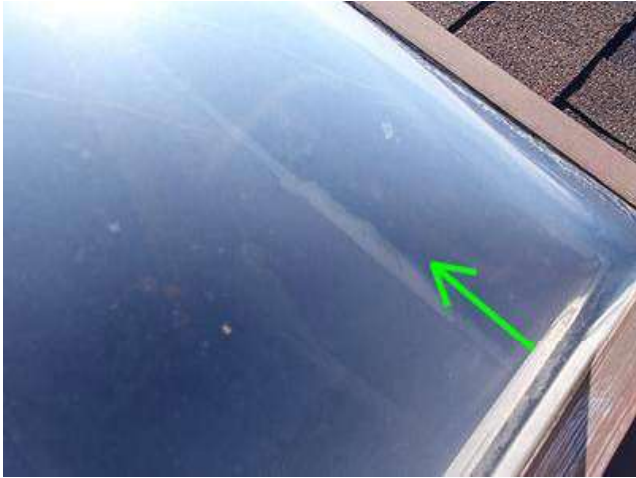
Photo 22-3 Skylight, interior substandard construction

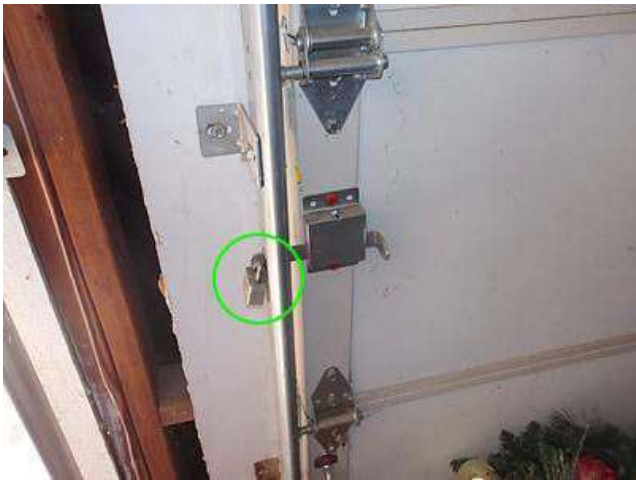
30) **i** One or more vehicle doors couldn't be fully evaluated due to lack of access from being locked and/or stored items blocking.

Photo 30-1 South vehicle door (locked)

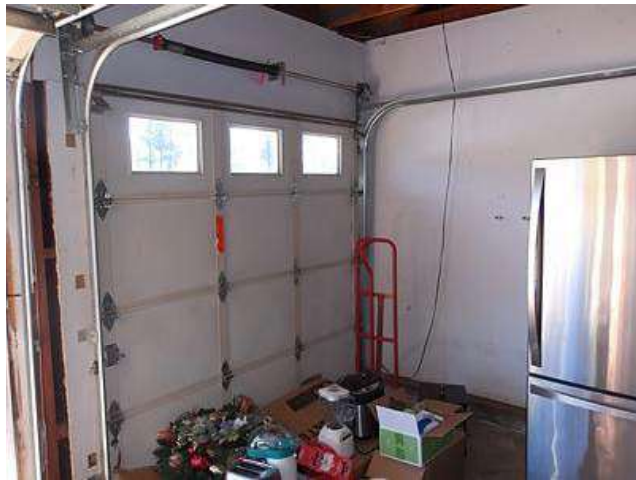
Photo 30-2 South vehicle door (locked)

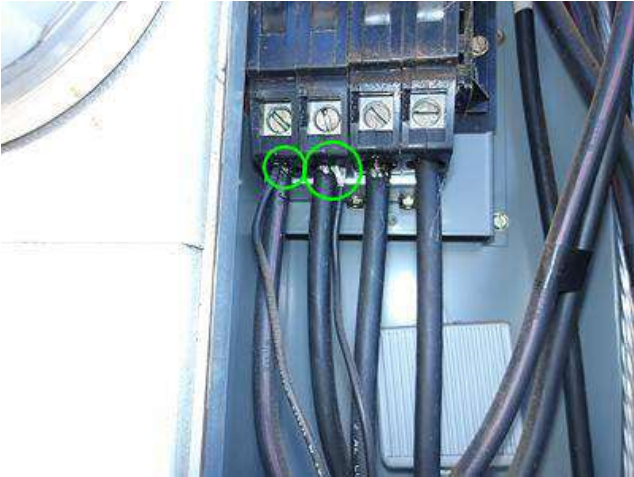
Photo 32-1 Main panel

One or more overcurrent protection devices (circuit breakers or fuses) in panel #A were "double tapped", where 2 or more wires were clamped in a terminal designed for only one wire. This is a safety hazard since the bolt or screw may tighten securely against one wire, but leave others loose. Arcing, sparks and fires may result. A qualified electrician should evaluate and repair as necessary.

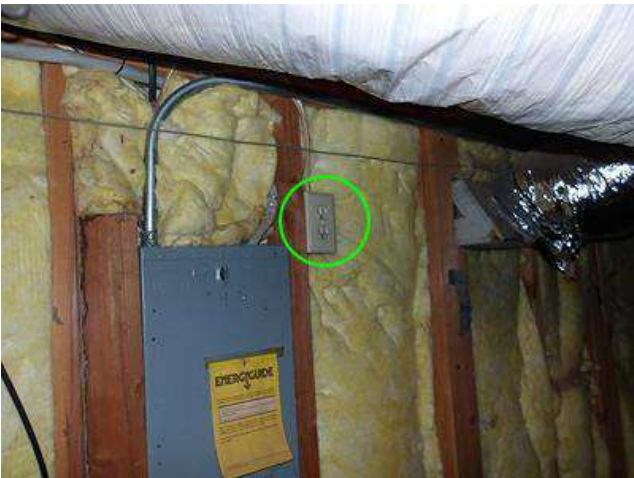
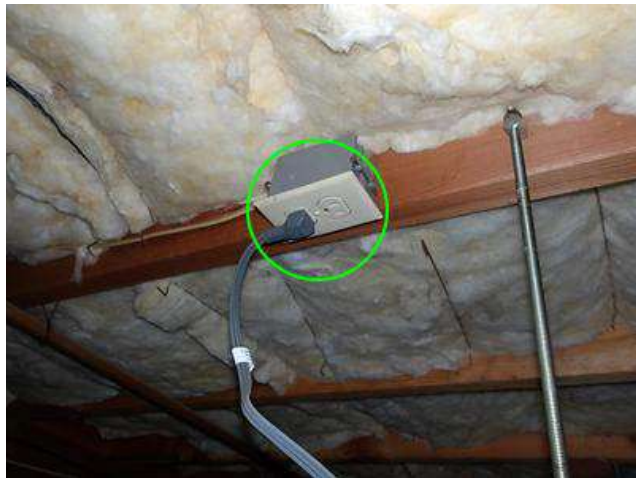
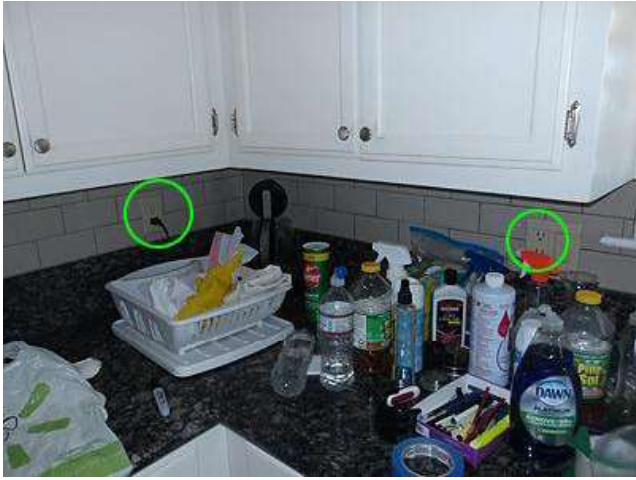
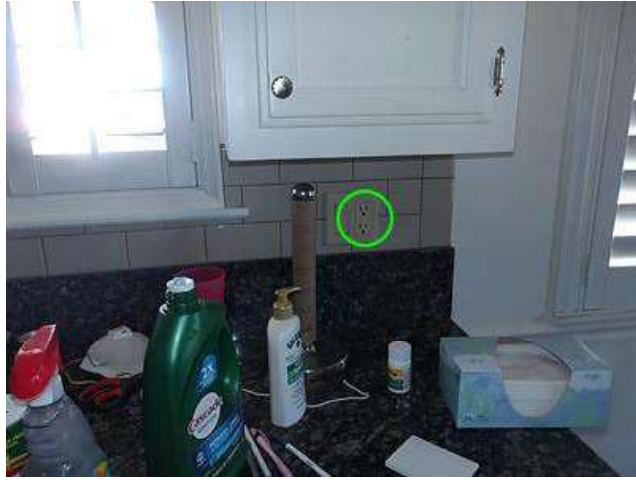
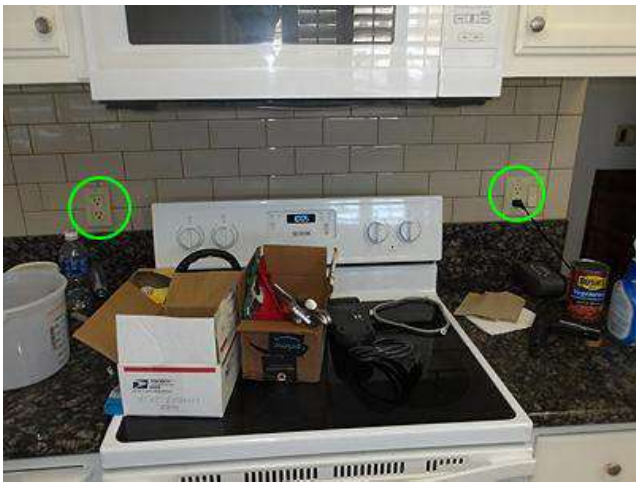
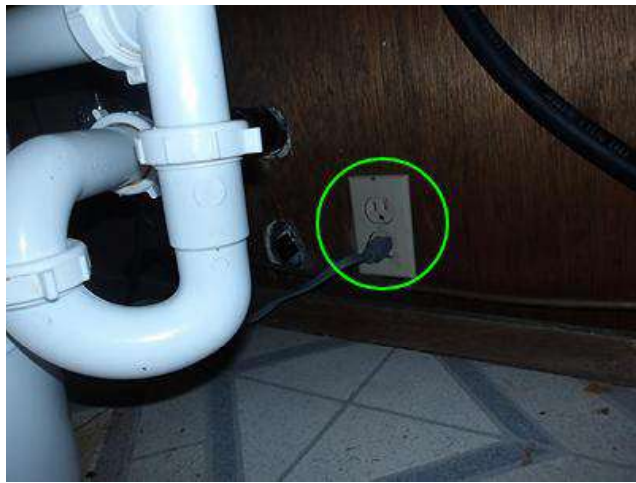
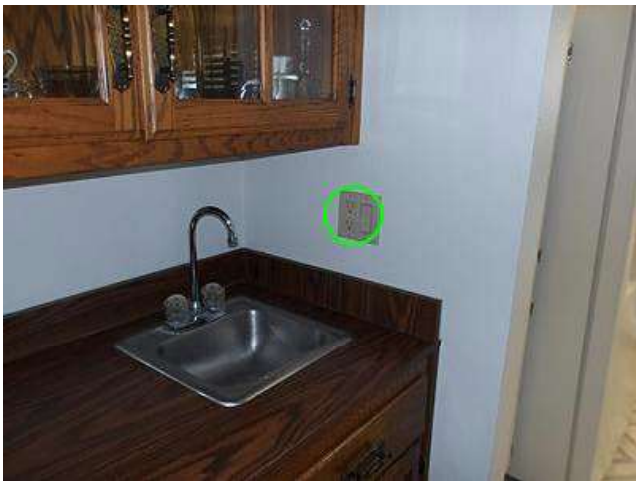
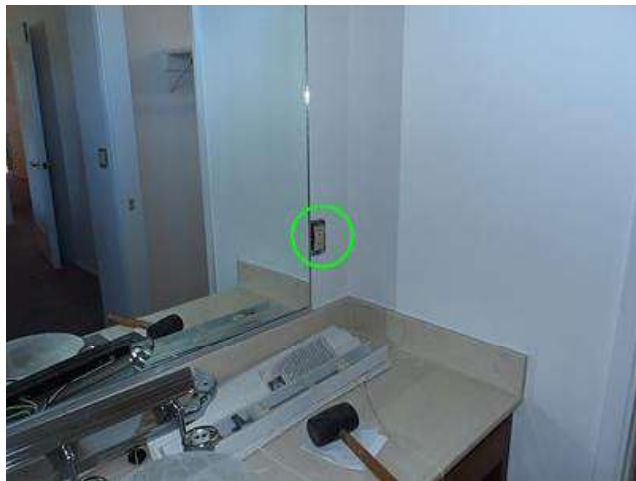
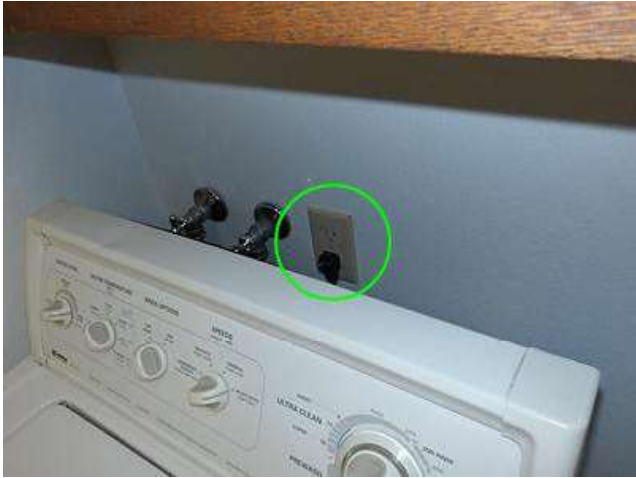
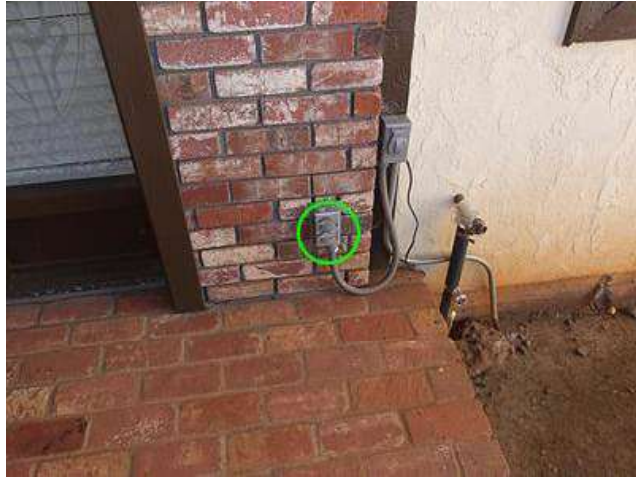
One or more electric receptacles at the following "wet" locations appeared to have no ground fault circuit interrupter (GFCI) protection: kitchen, bathroom(s), wet bar, laundry room, exterior, basement and/or crawl space. This is a safety hazard due to the risk of shock. A qualified electrician should evaluate to determine if GFCI protection exists, and if not, repair as necessary. For more information, visit: http://www.mikeholt.com/documents/nec/pdf/GFCI_requirement_page2.pdf

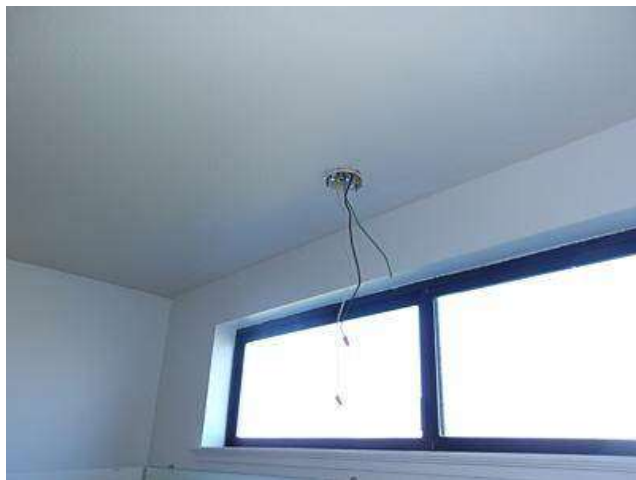
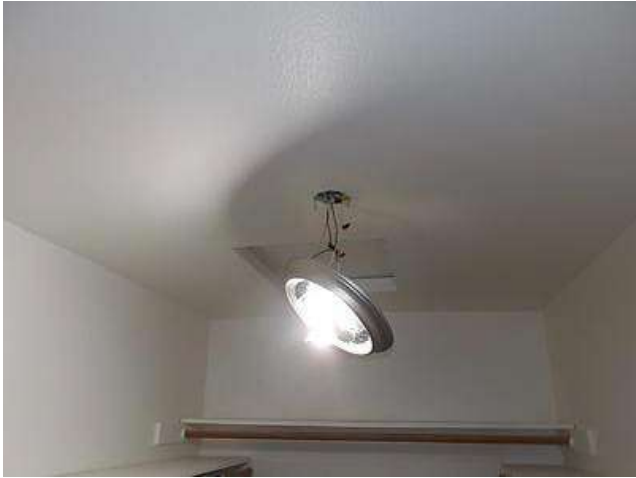
Some light fixtures were missing, deteriorated and/or loose. A qualified person should evaluate and repair or replace as necessary.

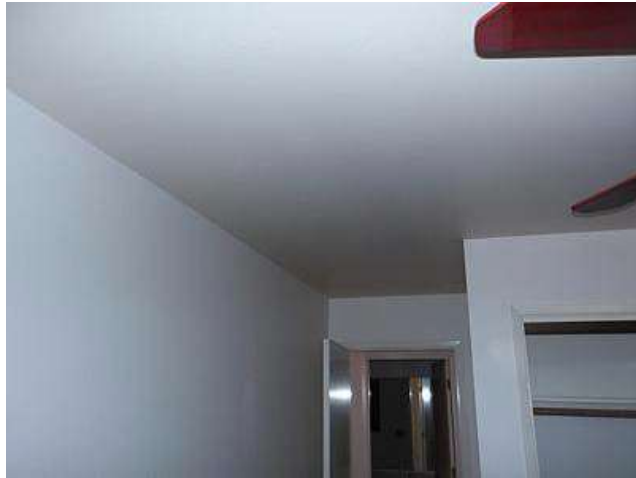
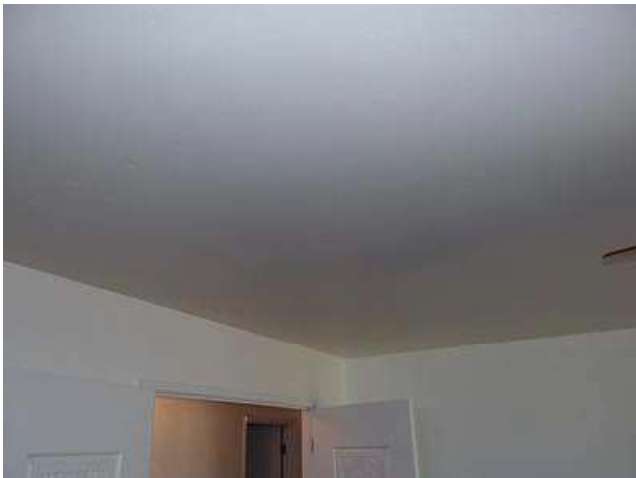
Smoke detectors were missing from bedrooms and/or on one or more levels. Additional smoke detectors should be installed as necessary so a functioning one exists in each hallway leading to bedrooms, in each bedroom, and one each level of the building. For more information, visit <http://www.cpsc.gov/cpsc/pub/pubs/5077.html>

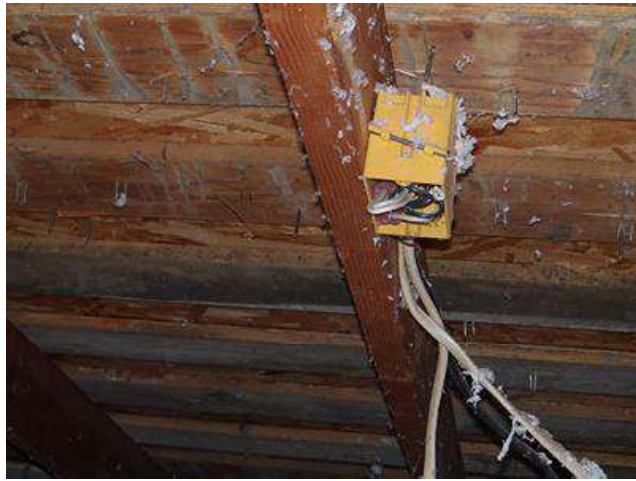
Photo 42-2 Attic above master bathroom

Some cover plates on junction boxes were missing. They are intended to contain fire and prevent electric shock from exposed wires. This is a safety hazard due to the risk of fire and shock. A qualified person should repair as necessary.

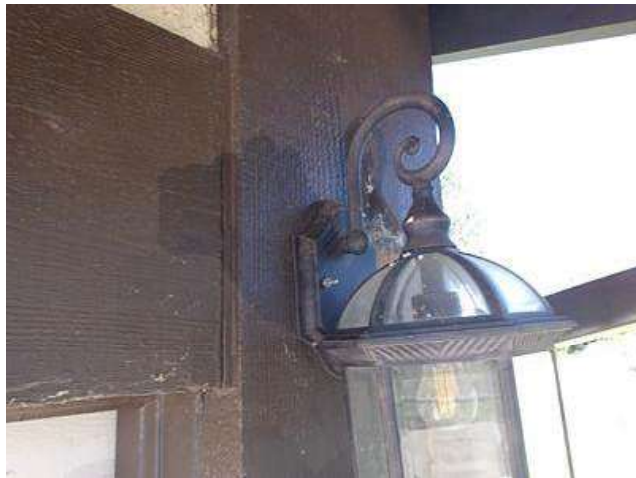
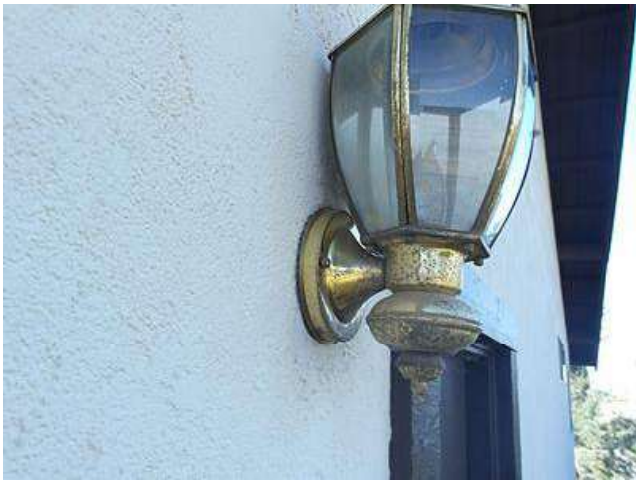
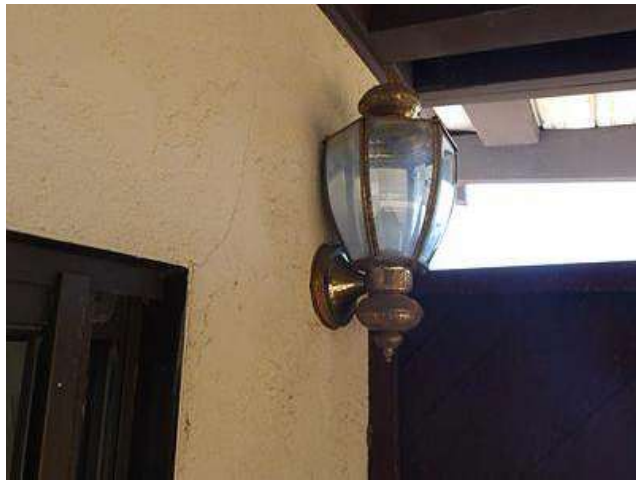
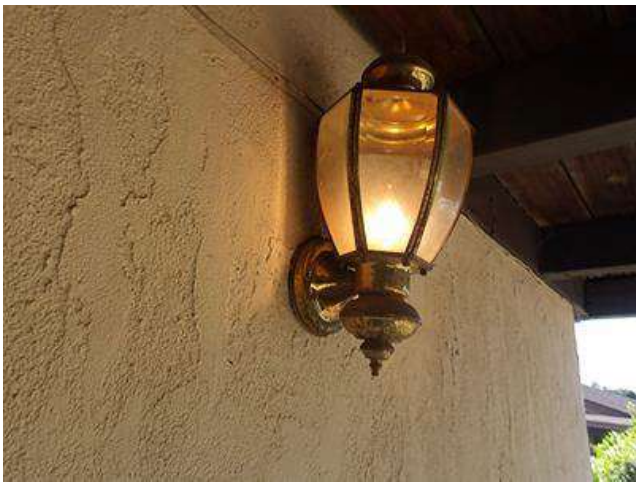
One or more wall-mounted exterior light fixtures had wiring that's subject to water intrusion due to caulk not being installed around the light fixture's back plate. Caulk should be applied around the perimeter of back plates where missing. A gap should be left at the bottom for condensation to drain out.

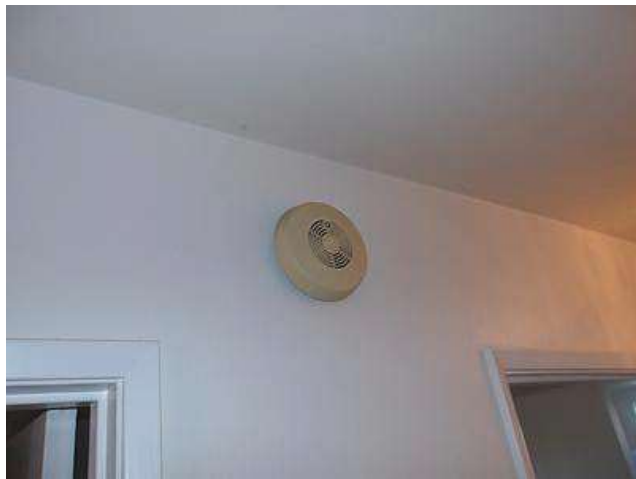
Photo 44-2 Hall

Based on the age of this structure and the appearance of existing smoke alarms, the alarms may be older than 10 years old. According to [National Fire Protection Association](#), aging smoke alarms don't operate as efficiently and often are the source for nuisance alarms. Older smoke alarms are estimated to have a 30% probability of failure within the first 10 years. Newer smoke alarms do better, but should be replaced after 10 years. Unless you know that the smoke alarms are new, replacing them when moving into a new residence is also recommended by NFPA. For more information, visit this article: [NFPA urges replacing home smoke alarms after 10 years](#).

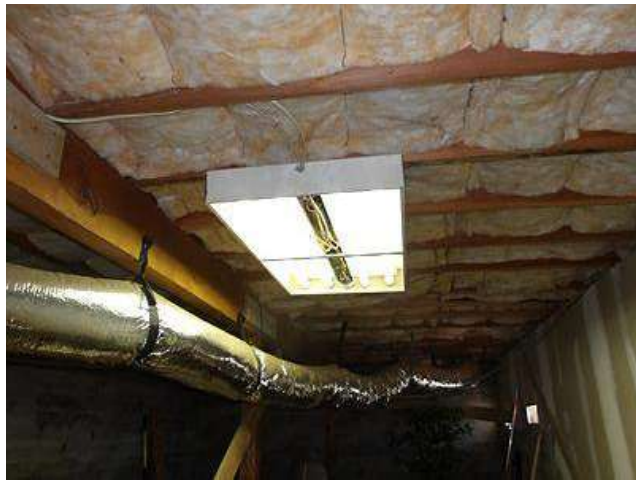
Photo 45-2 Crawl space

One or more lamp covers were missing and should be replaced as necessary.

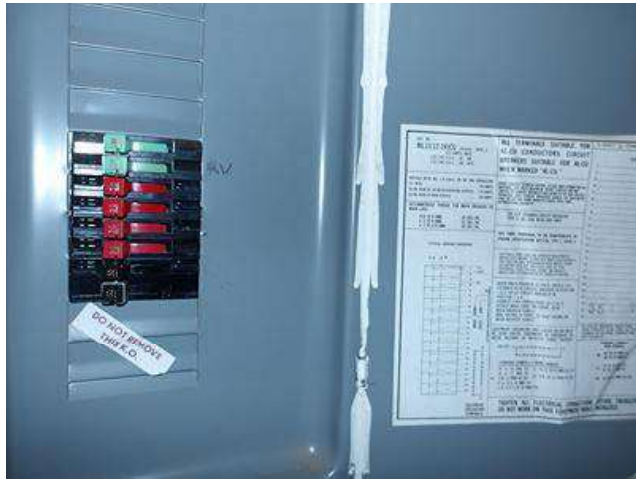
Photo 46-2 Sub panel basement

The legend for overcurrent protection devices (breakers or fuses) in panel #A and C was missing and/or substandard. Recommend installing, updating or correcting the legend as necessary so it's accurate. Evaluation by a qualified electrician may be necessary.

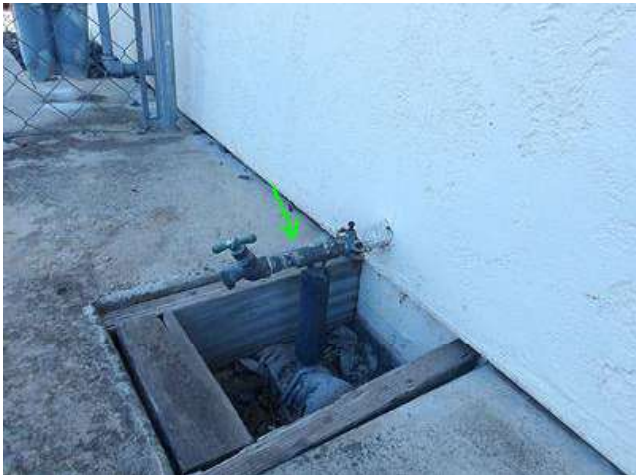
Photo 51-1 North side garage

51) 🖐️ Water supply lines were routed outside and are subject to freezing. Pipe wrap or foam sleeves are inexpensive and easily installed. Recommend insulating pipes as necessary to prevent pipes from freezing and bursting.

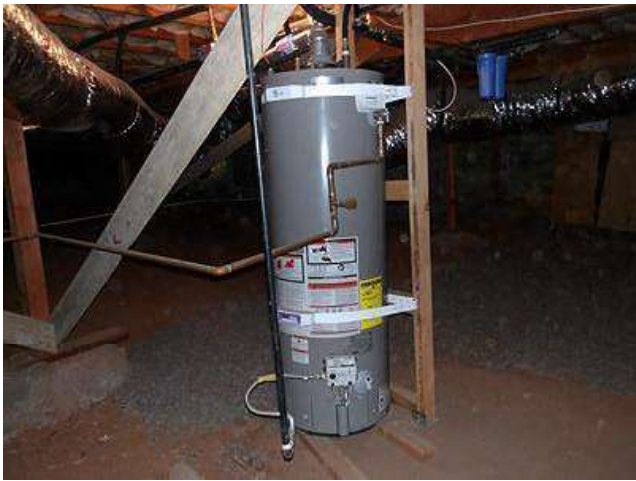
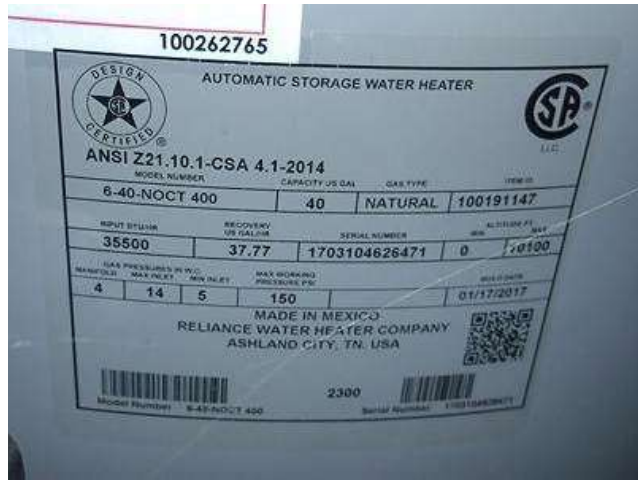
The estimated useful life for most water heaters is 8 to 12 years. This water heater appears to be near this age.

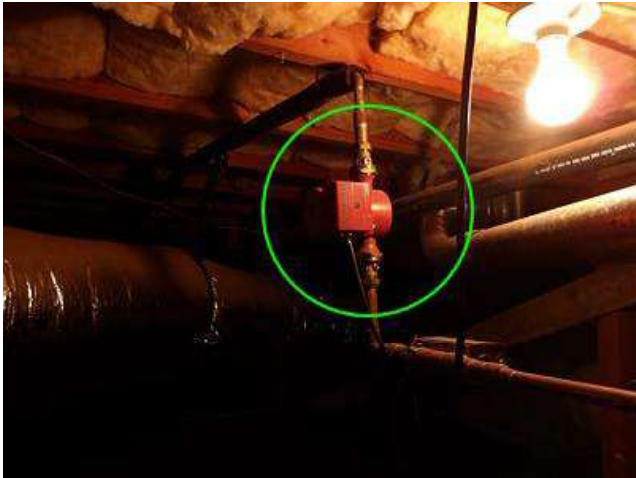
Photo 58-1 Circulation pump

58) **i** A circulating pump was installed for the hot water supply. It is intended to make hot water immediately available when faucets are turned on. Timers are typically integrated with these pumps, and should be configured so water circulates only at desired times for better energy efficiency. The client should familiarize themselves with the timer's operation and configure it as needed.

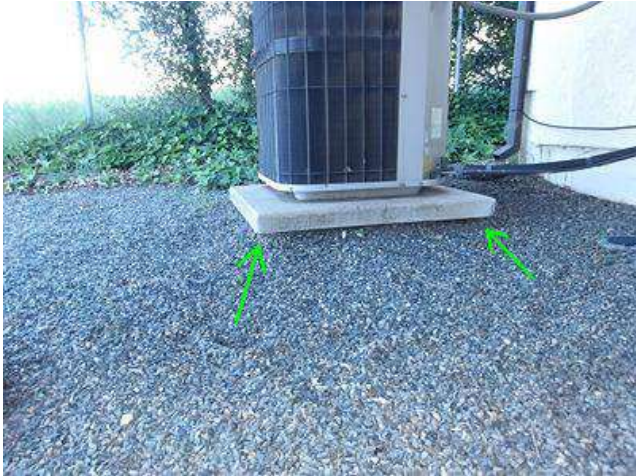
Photo 61-1 AC condenser pad

The pad for the AC condenser was undermined. This unit requires adequate support. The compressor may be damaged if this unit is tilted ten or more degrees. The pad should elevate the unit above the soil to prevent corrosion too. A qualified contractor should evaluate and repair as necessary.

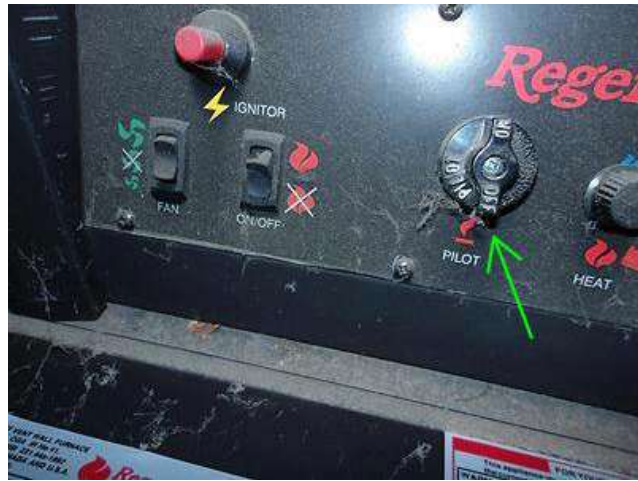
Photo 63-2 Pilot light off

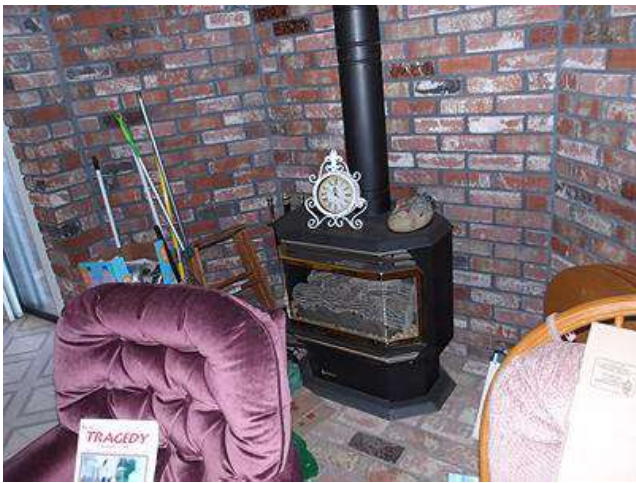
The gas stove at location #A was not fully evaluated because of the following conditions: pilot light turned off. As per the Standards of Practice for both the [National Association of Certified Home Inspectors \(NACHI\)](#) and the [American Society of Home Inspectors \(ASHI\)](#) the inspector does not operate gas shut off valves or light pilot lights during inspections.

Photo 63-3 Gas stove

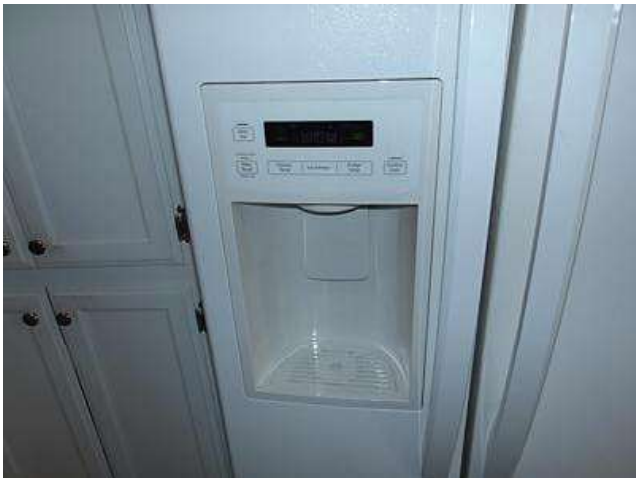
Photo 65-1

The refrigerator's ice maker, ice dispenser and/or water dispenser was inoperable. A qualified person should evaluate and repair as necessary.

NOTE: Water turned off?

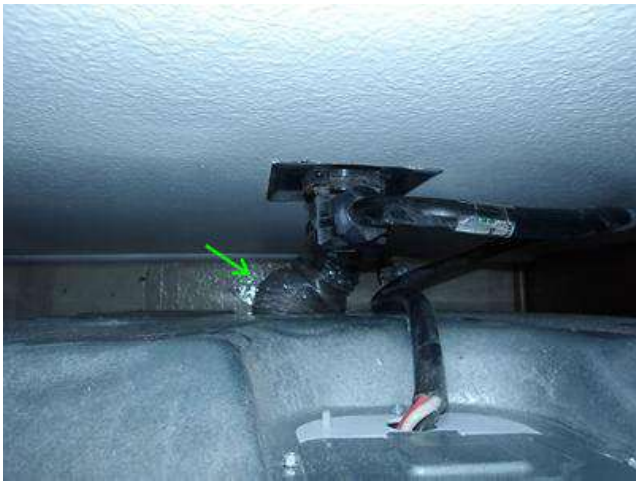
The clothes dryer was equipped with a foil, accordion-type, flexible exhaust duct. The U.S. Consumer Product Safety Commission considers these types of ducts to be unsafe, and a fire hazard. These types of ducts can trap lint and are susceptible to kinks or crushing, which can greatly reduce the air flow. This duct should be replaced with a rigid or corrugated semi-rigid metal duct, and by a qualified contractor if necessary. Most clothes dryer manufacturers specify the use of a rigid or corrugated semi-rigid metal duct. For more information on dryer safety issues, visit:

Photo 67-1 Behind dryer

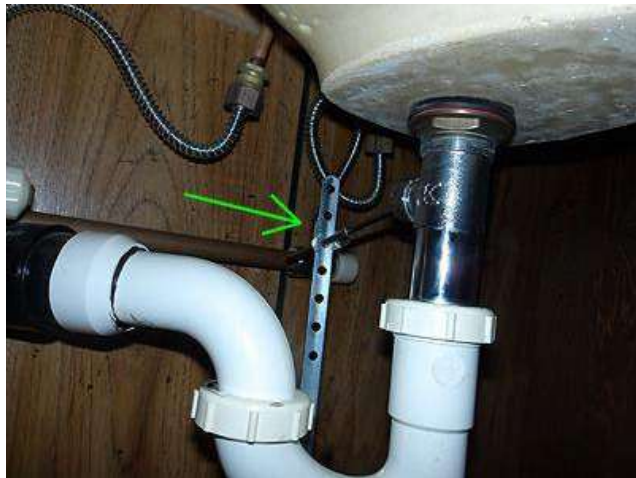
The sink drain stopper mechanism at location #A and B was missing and/or inoperable. A qualified person should repair or replace as necessary.

Photo 71-2 Hall bathroom

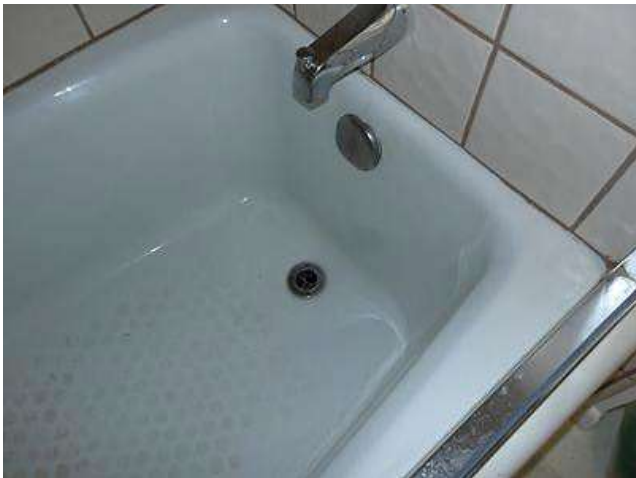
73) 🛠️👉 The bathtub drain stopper mechanism at location #A was missing. A qualified person should repair or replace as necessary.

Photo 73-1 Hall bathroom

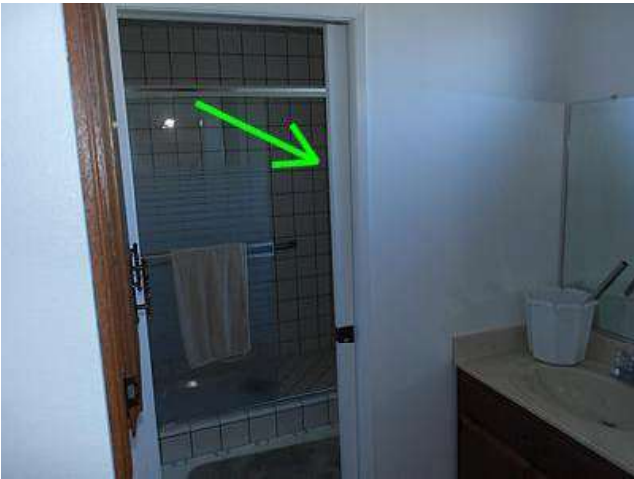
Some interior doors were difficult to open or close and/or were misaligned. A qualified person should evaluate and repair as necessary.

Photo 74-1 Master bathroom

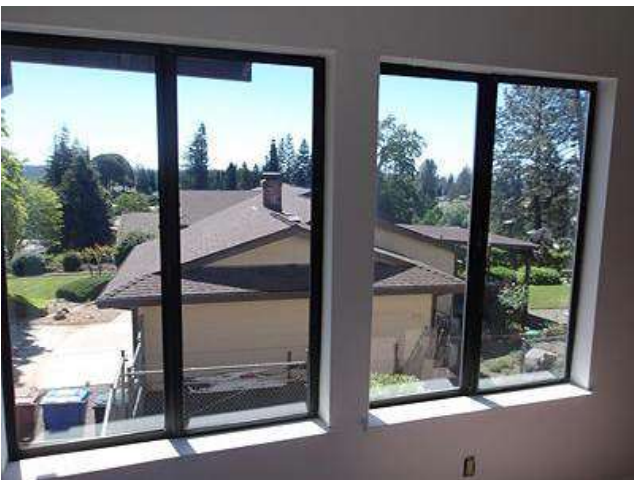
Some windows that were built to open were difficult to open and close. A qualified person should evaluate and repair as necessary.

Photo 75-1 Living room

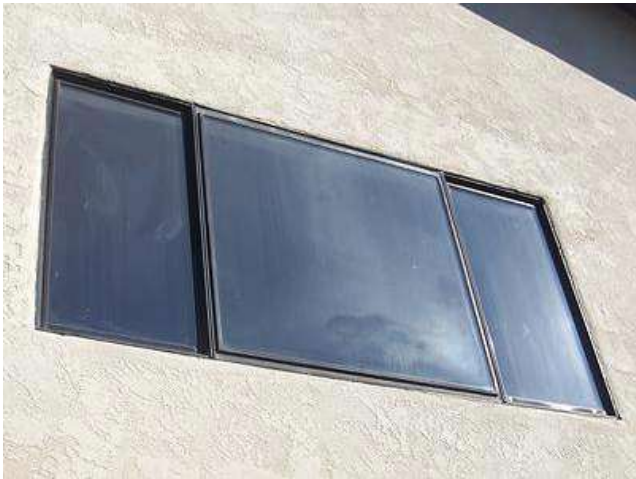
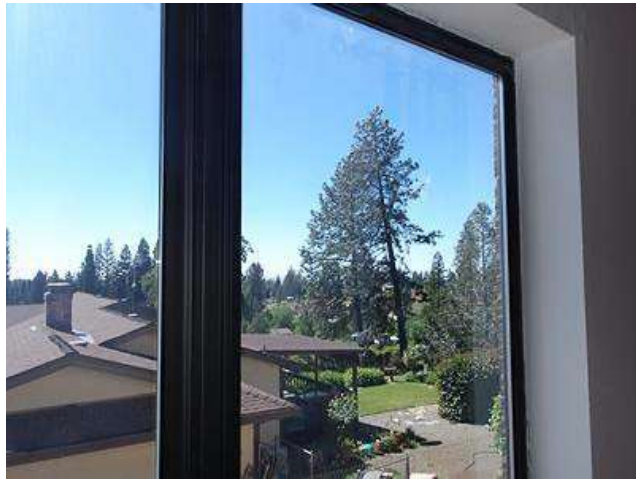
Seals between multi-pane glass in some windows appear to have failed based on condensation or stains between the panes of glass. A qualified contractor should evaluate and replace glass where necessary.

Photo 76-1 South side

Photo 76-2 Living room

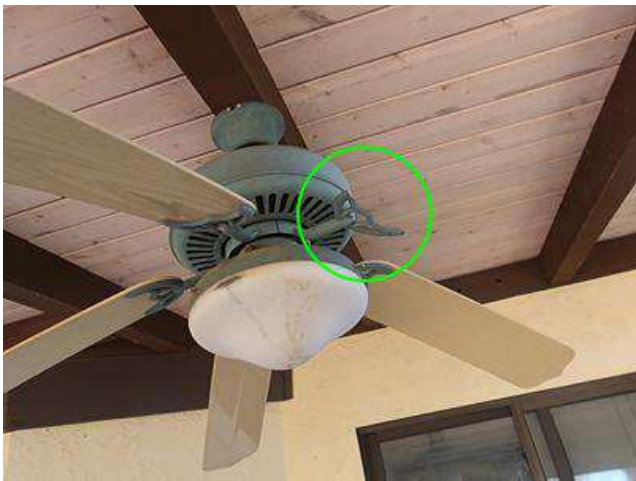
One or more ceiling fans was missing a blade. This is a potential safety hazard. Recommend having a qualified contractor evaluate and repair as necessary.

Photo 77-1 Deck

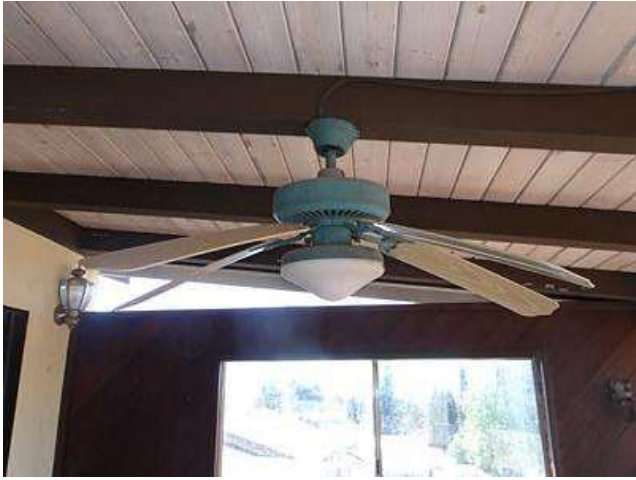
One or more ceiling fans appear to be inoperable. Recommend asking the property owner about this, and if necessary, having a qualified electrician evaluate and repair as necessary.

Photo 78-1 Deck

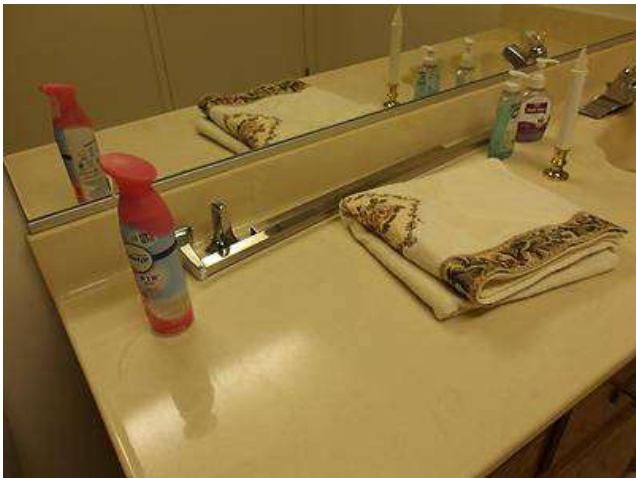
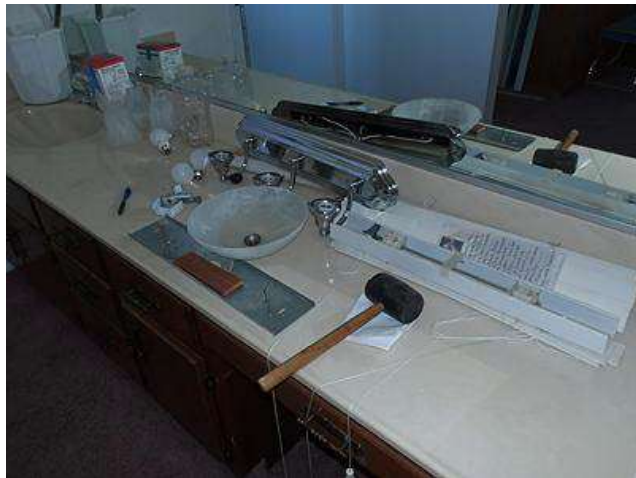
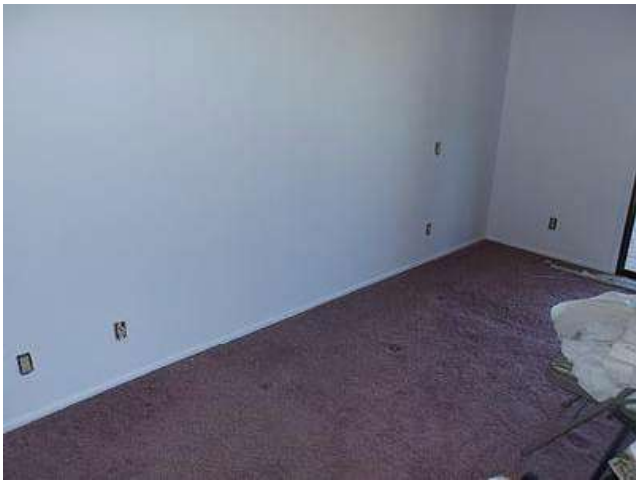
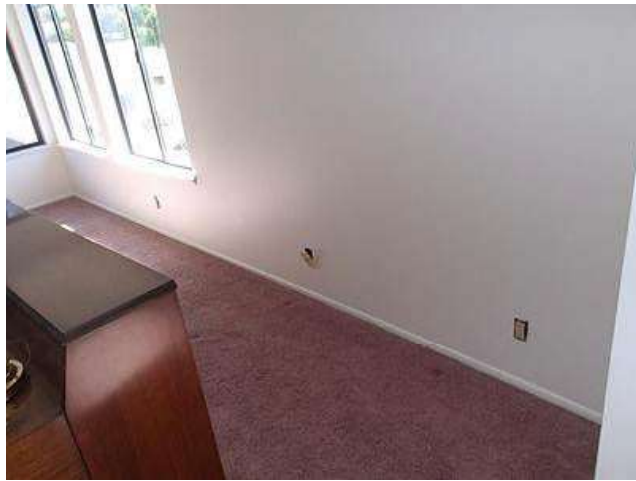
80) **i** During the inspection, there were many switch and receptacle covers, towel bars and light fixtures that were taken down to facilitate painting. This is not necessarily a defect as they should be reinstalled when painting is complete.

Photo 80-1 Hall bathroom

Photo 80-2 Master bathroom

Photo 80-3 Dining area

Photo 80-4 Living room
