Professional
Inspection Network

INSPECTION REPORT
3616 N Bellflower Blvd
Long Beach CA 90808

INSPECTED BY
Christopher Vella
Professional
Inspection
Network

INSPECTION DATE
📅 4/24/2026
🕒 03:30 PM

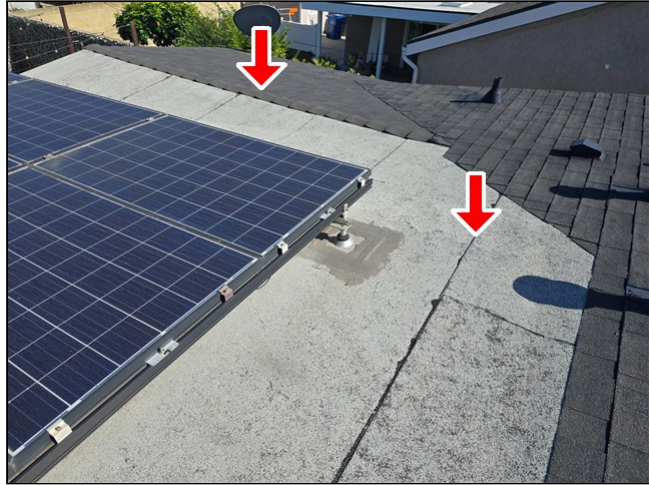
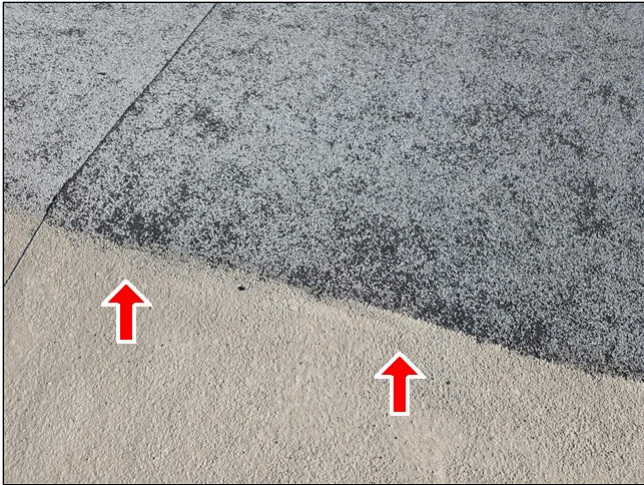
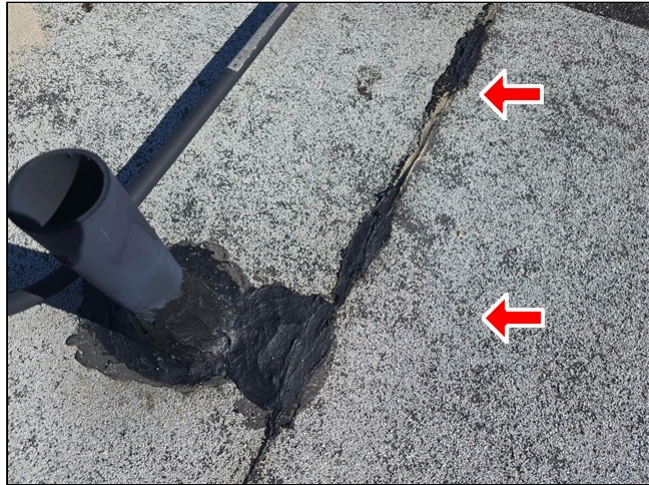
- 1. (1) Repair or Replace:** The rolled asphalt roofing at the flat roof areas shows visible signs of deterioration. The roofing material appears worn and weathered, indicating reduced effectiveness in protecting against water intrusion. Deteriorated rolled roofing is more susceptible to cracking, blistering, and leaks over time. Evaluation and replacement by a qualified roofing contractor is recommended to restore a watertight condition.

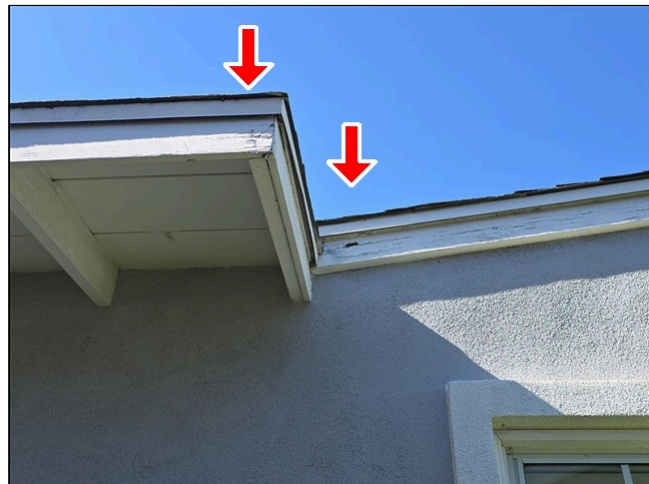
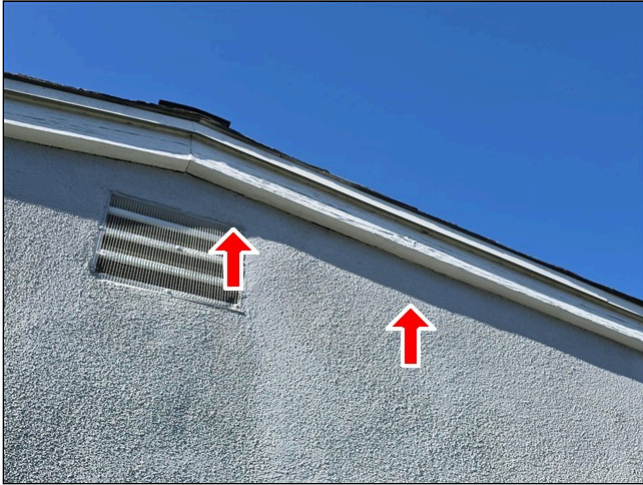
4. (2) **Repair or Replace:** There is wood deterioration observed at the fascia boards in one or more locations. This deterioration can be caused by various factors such as moisture, pests, or age-related wear and tear. It is important to address this issue to prevent further damage. Due to the presence of wood deterioration, it is advisable to have a pest control company inspect the area for any signs of pest activity or infestation. Certain pests can cause significant damage to wood structures. A professional inspection will help determine if pests are present and if further treatment is necessary. It is recommended to hire a licensed contractor experienced in wood repairs and replacements. They will assess the extent of the wood deterioration and provide appropriate recommendations. Depending on the severity of the damage, the contractor may suggest repair techniques such as wood patching, reinforcement, or complete replacement of deteriorated wood components. Please be aware that this report is based on a visual inspection, and it is essential to consult a qualified professional, such as a licensed contractor and a pest control company, for a comprehensive assessment and appropriate repairs.

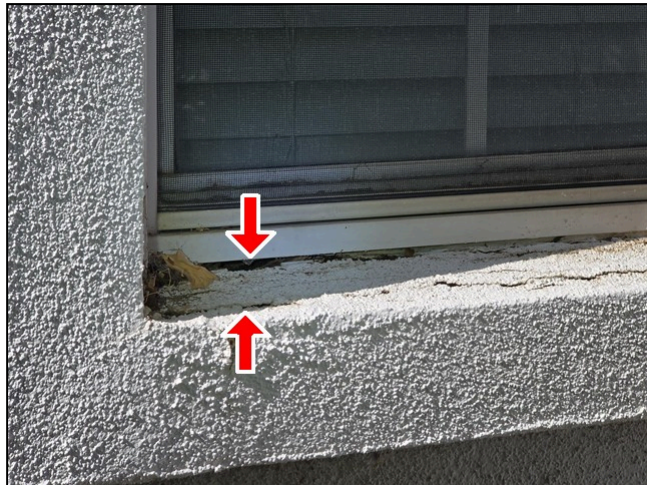
7. (1) **Repair or Replace:** A gap was observed between the exterior cladding and the window frame at the south exterior wall of the home. This condition can allow water intrusion, air infiltration, and pest entry, potentially leading to concealed damage within the wall assembly. Evaluation and repair by a qualified contractor is recommended to properly seal the gap and restore a weather-resistant condition.

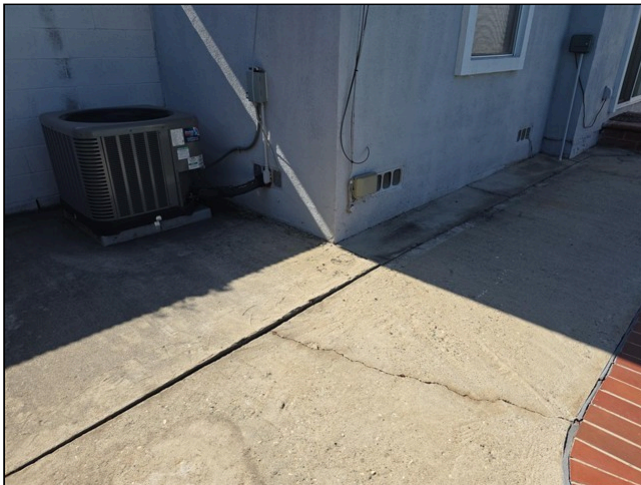
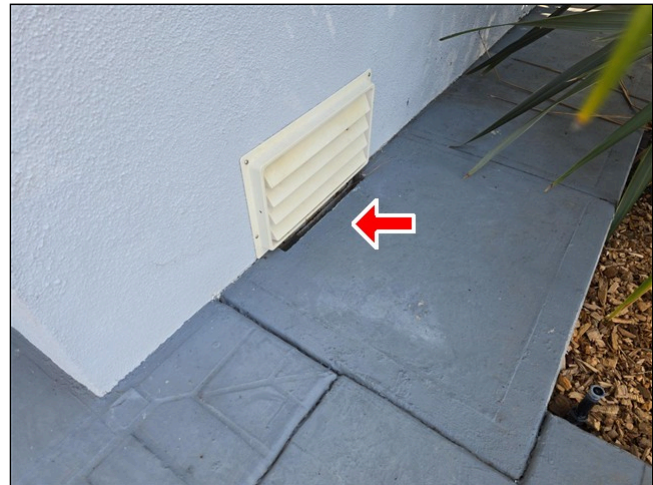
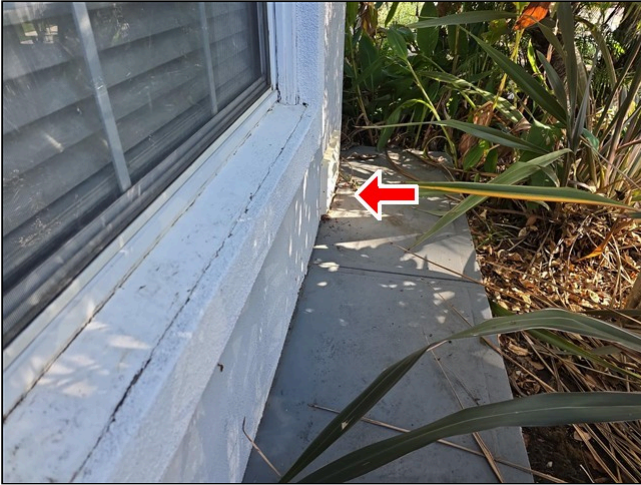
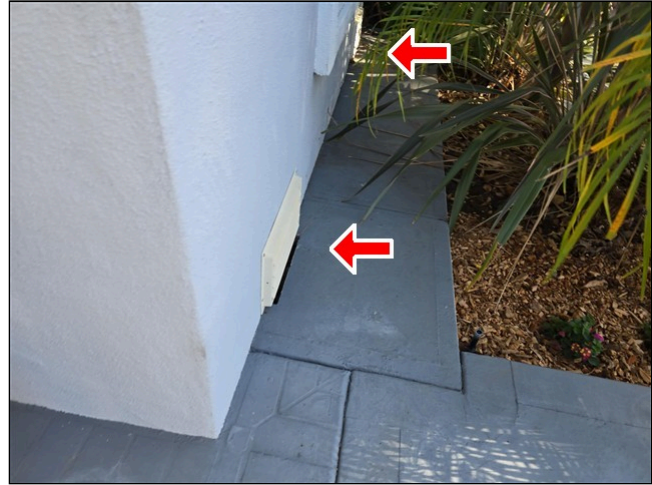
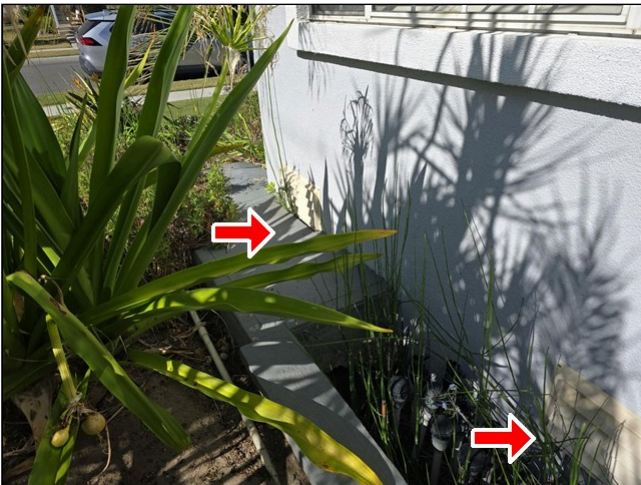
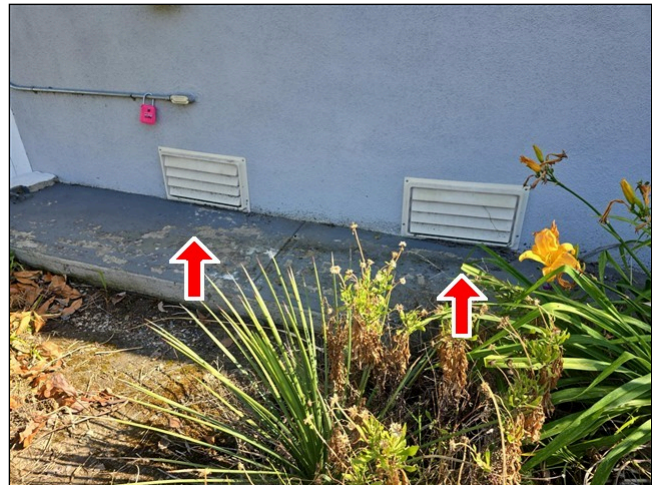
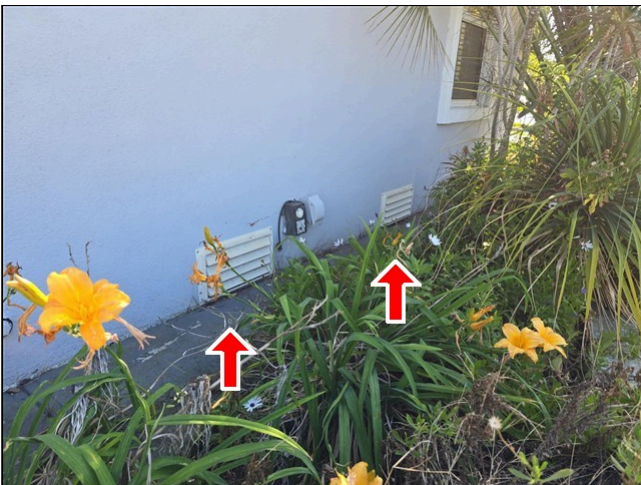
9. (1) **Improve:** The crawl space vent openings are installed at or near grade level, and a curb/footing has been constructed along the front and north exterior walls of the home. This configuration can allow water intrusion into the crawl space during rain or irrigation events, as the vents are not elevated above the surrounding grade. The added curb may also trap water against the foundation, further increasing the risk of moisture entry. This condition can contribute to elevated moisture levels within the crawl space, potentially leading to wood deterioration, structural concerns, and possible organic growth. Evaluation by a qualified contractor is recommended to improve drainage and modify the vent configuration as needed to reduce the risk of water intrusion.

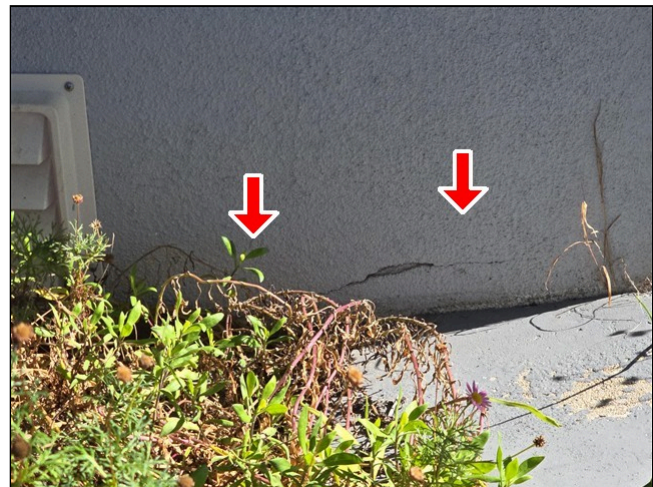
- 13. (1) Repair or Replace:** Signs of cracking and movement were visible in portions of the foundation at more than one location. Although the cracking is isolated to these areas, we feel this could affect the performance of the entire foundation, especially during seismic activity. We suggest a qualified foundation contractor or structural engineer should evaluate the foundation, and determine what repairs are needed.

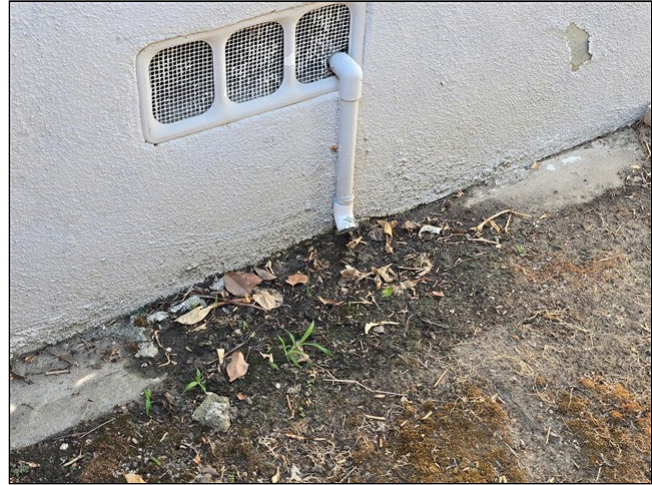
- 17. (1) Improve:** The condensate drain line(s) for the indoor air component of the air conditioning system should be improved. It is suggested that the drain line terminate in a graveled area and or pit to prevent soil saturation when operating the system.

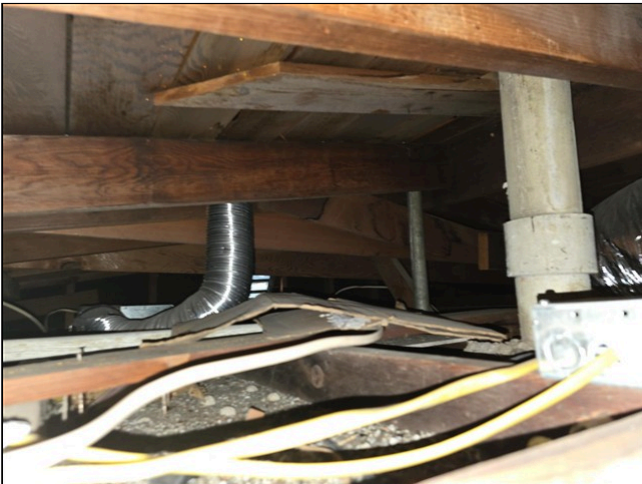
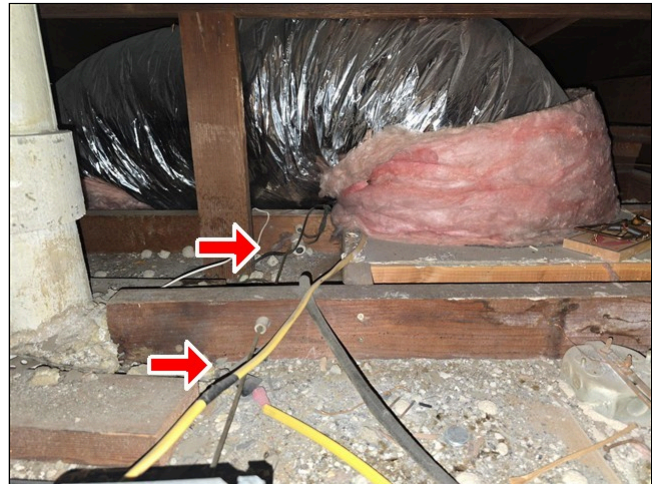
- 22. (2) Monitor:** Older knob-and-tube wiring was observed in the attic space. Due to the presence of newer Romex wiring installed adjacent to the older conductors, it was not possible to determine whether the knob-and-tube system is still active or has been fully abandoned. Knob-and-tube wiring is considered obsolete and may present safety concerns, particularly if it remains energized or has been modified. Evaluation by a licensed electrician is recommended to determine if any of the knob-and-tube wiring is still in use and to advise on proper decommissioning or upgrading as needed.

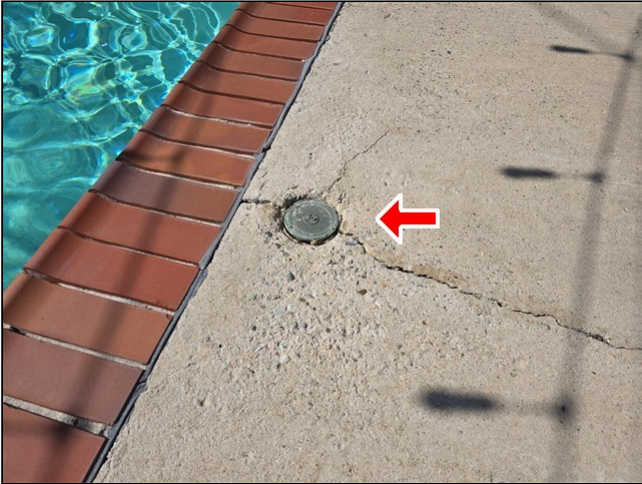
Item 23 - Item 1 (Picture)

- 23. (3) Safety Issue:** A flush-mounted electrical junction box was observed at the pool light. This configuration is considered outdated and may not meet current safety standards for pool and spa

electrical installations. Improper or outdated junction box installations in wet environments can increase the risk of electrical shock. Evaluation and correction by a licensed electrician is recommended to ensure the installation meets current safety requirements for pool lighting systems.

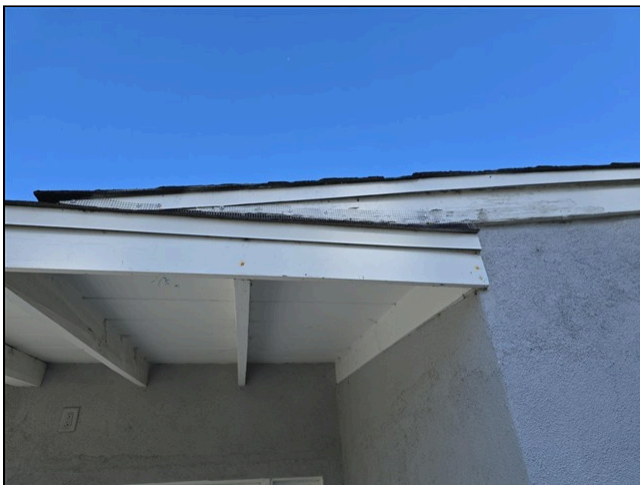
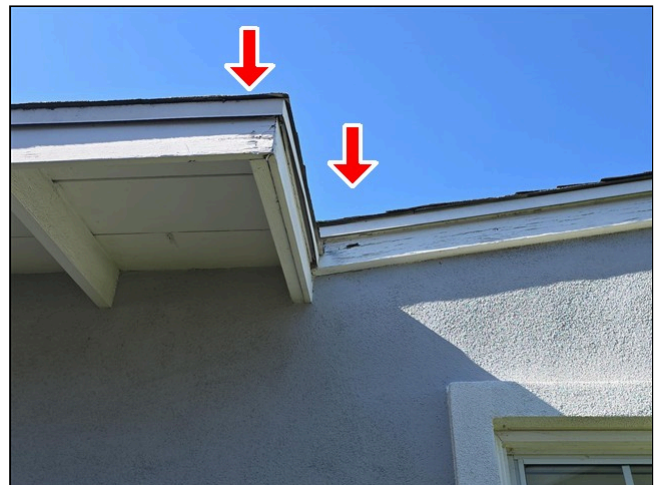
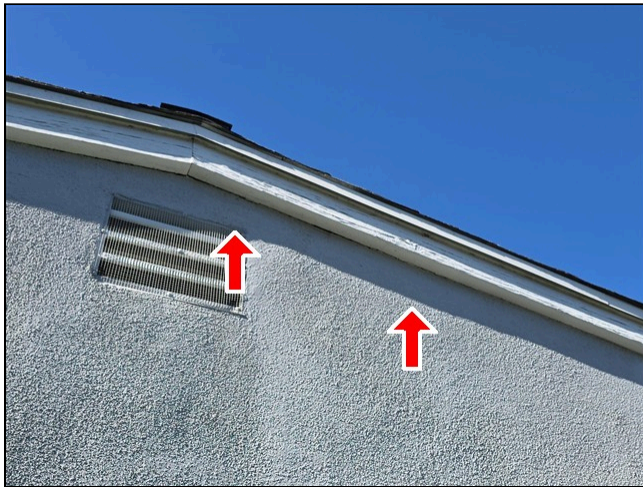
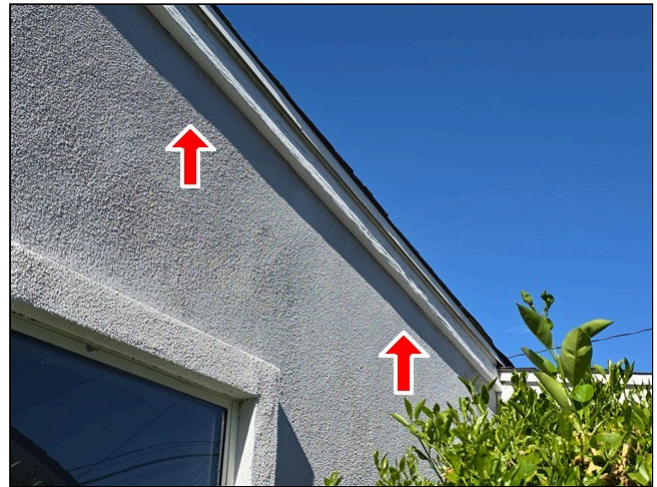
(2) **Repair or Replace:** There is wood deterioration observed at the fascia boards in one or more locations. This deterioration can be caused by various factors such as moisture, pests, or age-related wear and tear. It is important to address this issue to prevent further damage. Due to the presence of wood deterioration, it is advisable to have a pest control company inspect the area for any signs of pest activity or infestation. Certain pests can cause significant damage to wood structures. A professional inspection will help determine if pests are present and if further treatment is necessary. It is recommended to hire a licensed contractor experienced in wood repairs and replacements. They will assess the extent of the wood deterioration and provide appropriate recommendations. Depending on the severity of the damage, the contractor may suggest repair techniques such as wood patching, reinforcement, or complete replacement of deteriorated wood components. Please be aware that this report is based on a visual inspection, and it is essential to consult a qualified professional, such as a licensed contractor and a pest control company, for a comprehensive assessment and appropriate repairs.

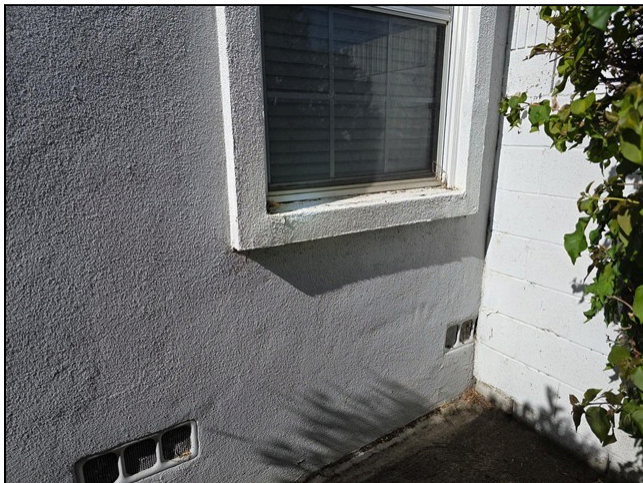
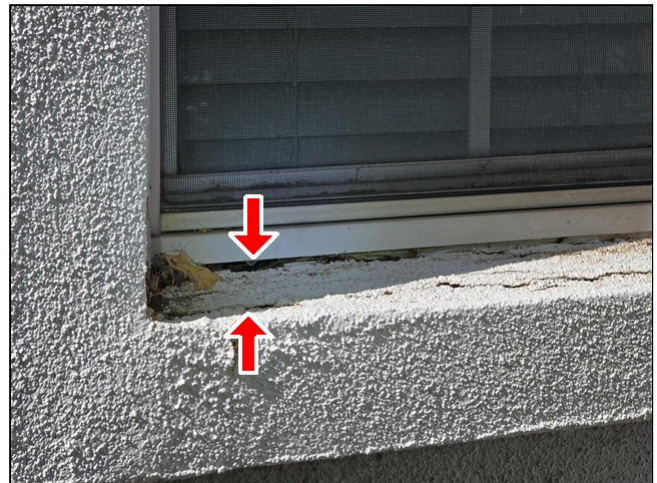
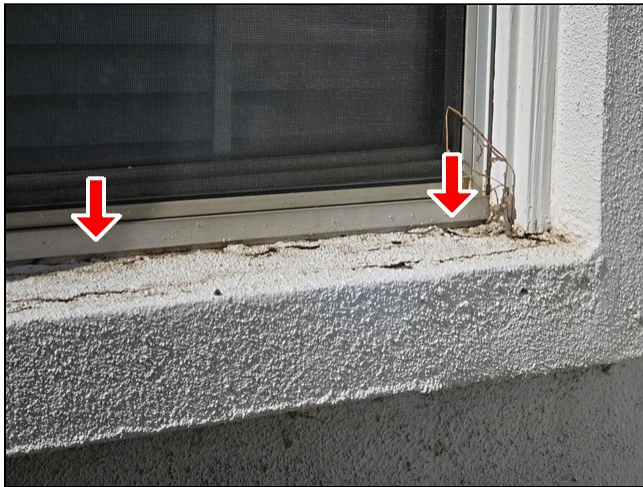
(1) **Repair or Replace:** A gap was observed between the exterior cladding and the window frame at the south exterior wall of the home. This condition can allow water intrusion, air infiltration, and pest entry, potentially leading to concealed damage within the wall assembly. Evaluation and repair by a qualified contractor is recommended to properly seal the gap and restore a weather-resistant condition.

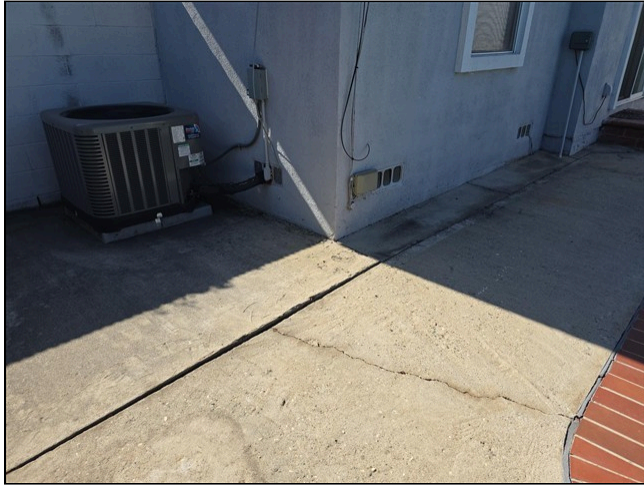
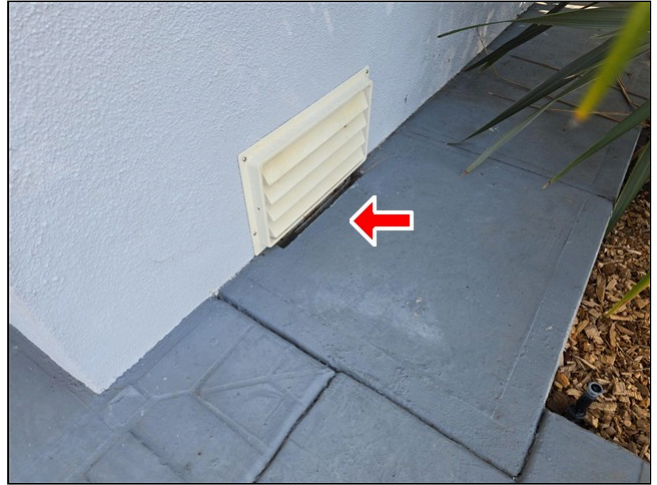
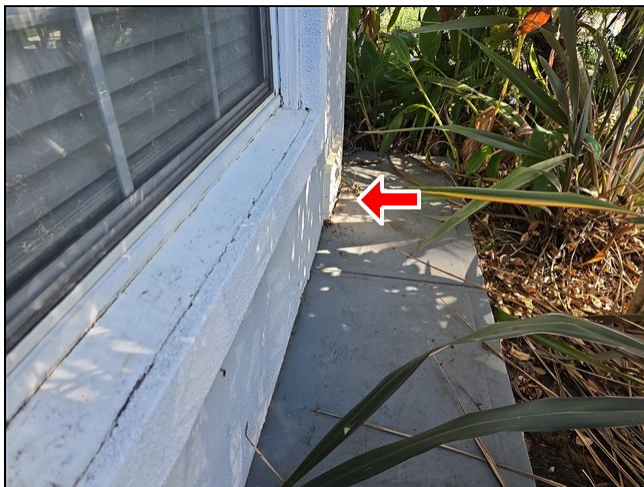
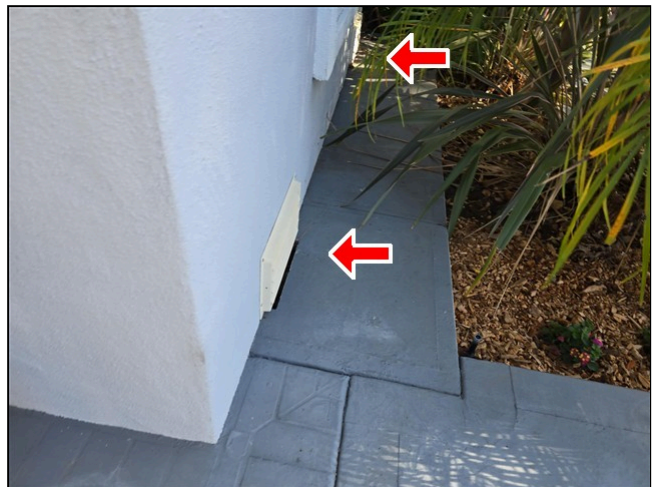
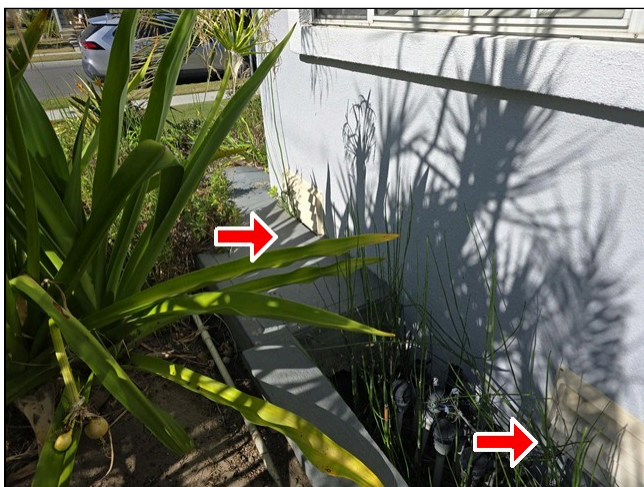
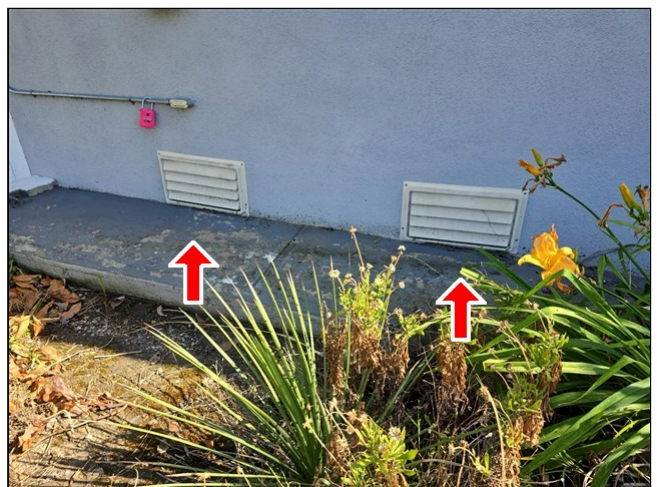
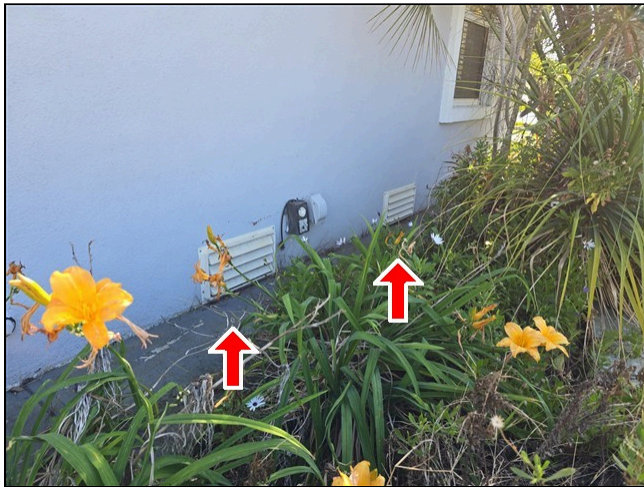
(1) **Improve:** The crawl space vent openings are installed at or near grade level, and a curb/footing has been constructed along the front and north exterior walls of the home. This configuration can allow water intrusion into the crawl space during rain or irrigation events, as the vents are not elevated above the surrounding grade. The added curb may also trap water against the foundation, further increasing the risk of moisture entry. This condition can contribute to elevated moisture levels within the crawl space, potentially leading to wood deterioration, structural concerns, and possible organic growth. Evaluation by a qualified contractor is recommended to improve drainage and modify the vent configuration as needed to reduce the

risk of water intrusion.

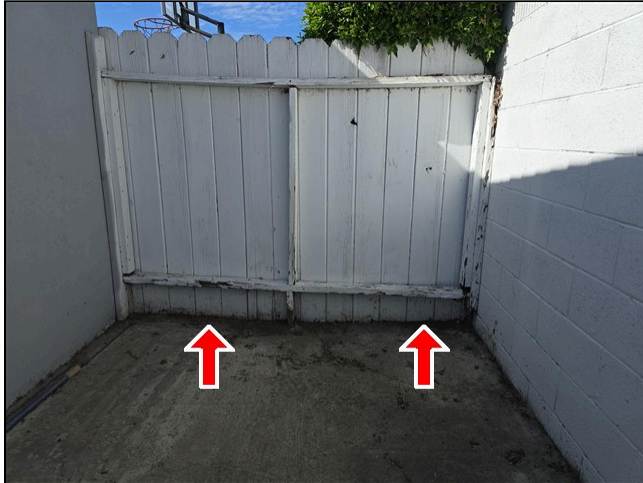
2.5 Item 1 (Picture)

Repair or Replace: The fence at the sidewall of the garage is deteriorated. This condition may affect structural stability, reduce security, and allow for further damage over time. It is recommended that the fence be evaluated and repaired or replaced by a qualified contractor to restore proper function and durability.

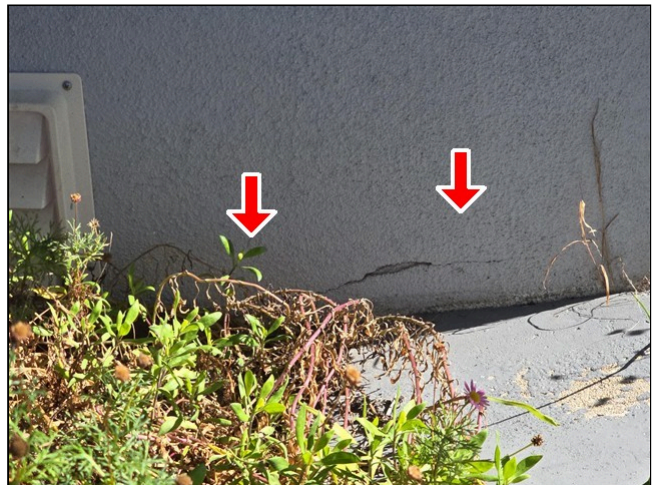
3.0 Item 2 (Picture)

(1) **Repair or Replace:** Signs of cracking and movement were visible in portions of the foundation at more than one location. Although the cracking is isolated to these areas, we feel this could affect the performance of the entire foundation, especially during seismic activity. We suggest a qualified foundation contractor or structural engineer should evaluate the foundation, and determine what repairs are needed.

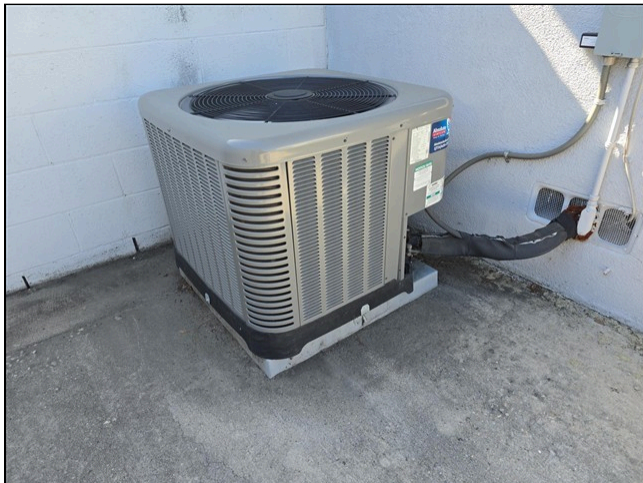
4.7 Item 3 (Picture)

(2) **Monitor:** During the inspection of the property, it was observed that the heating and cooling system installed for the home was operational and provided adequate heating and cooling. The system was tested and found to be functioning properly, effectively maintaining the desired temperature within the home. This positive finding indicates that the home is equipped with a functional and efficient heating and cooling system, allowing for comfortable use of the space throughout the year. Please note that the specific details of the heating and cooling system, including its type, capacity, and any maintenance or service records, should be obtained from the seller or previous owner for a complete understanding of the system's condition and history.

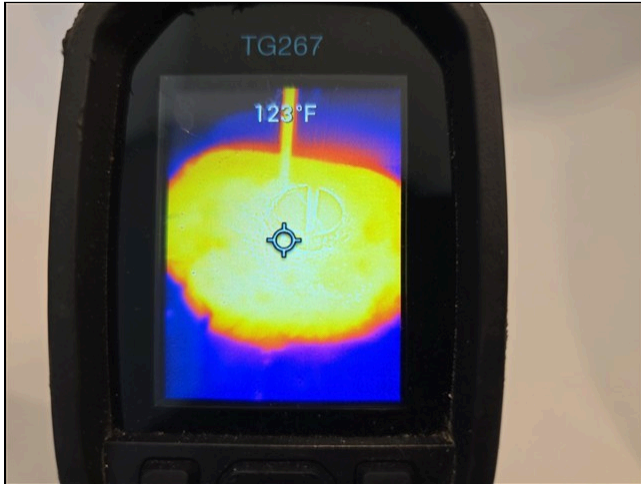
5.2 Item 4 (Picture)

(4) **Note/Monitor:** The water heater was operational and produced hot water at time of inspection.

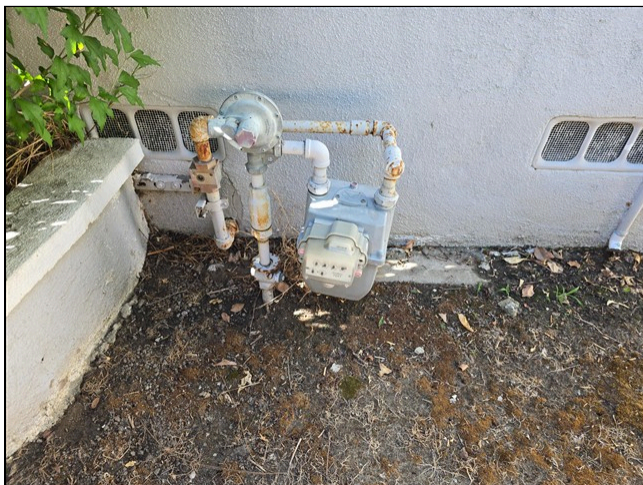
5.5 Item 1 (Picture)

Inspected: The main gas meter is located at the South wall of the home. The gas meter is equipped with a seismic shut off valve.

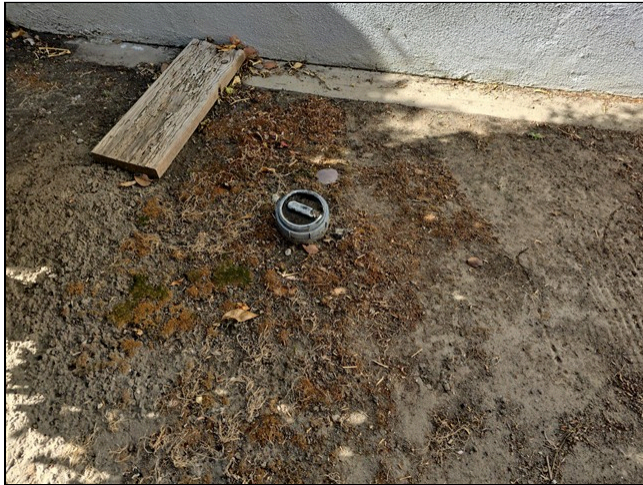
5.7 Item 1 (Picture)

Inspected: The main clean-out for the sewer line is located in the South side yard. This provides access for inspecting, maintaining, and clearing the sewer line, which is essential for preventing blockages and ensuring proper drainage. The location of the clean-out should be clearly marked and kept accessible for future maintenance or inspections. A licensed plumber should inspect the clean-out periodically and ensure it is functioning properly and free from obstructions. Regular sewer line maintenance, such as hydro-jetting or camera inspections, is recommended to prevent issues and ensure the longevity of the drainage system.

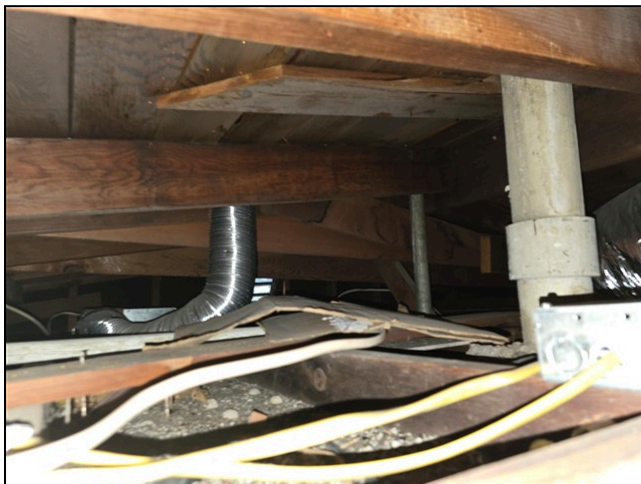
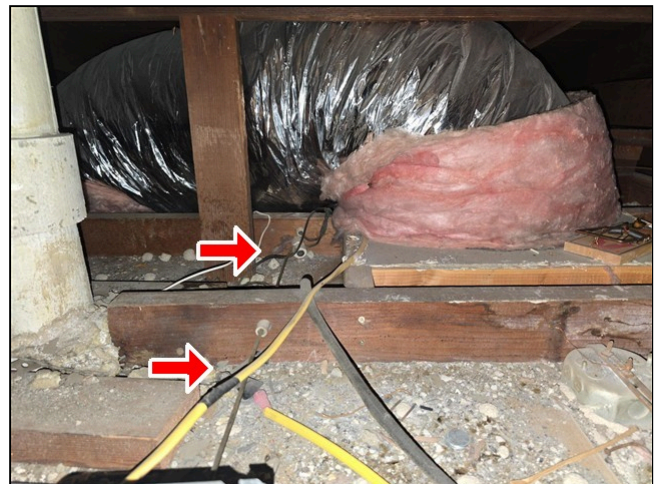
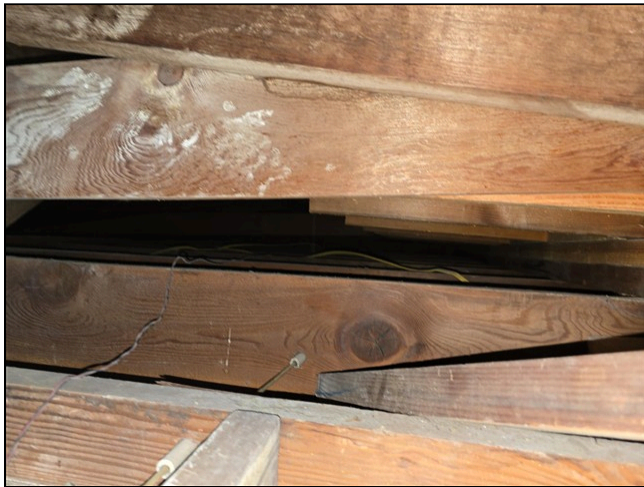
(2) **Monitor:** Older knob-and-tube wiring was observed in the attic space. Due to the presence of newer Romex wiring installed adjacent to the older conductors, it was not possible to determine whether the knob-and-tube system is still active or has been fully abandoned. Knob-and-tube wiring is considered obsolete and may present safety concerns, particularly if it remains energized or has been modified. Evaluation by a licensed electrician is recommended to determine if any of the knob-and-tube wiring is still in use and to advise on proper decommissioning or upgrading as needed.

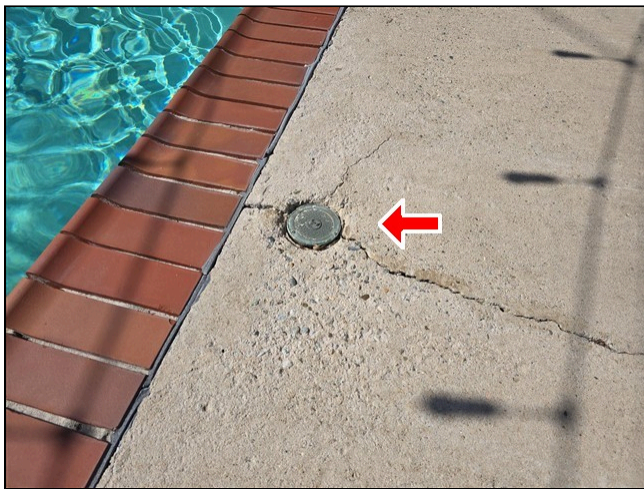
6.1 Item 5 (Picture)

(3) **Safety Issue:** A flush-mounted electrical junction box was observed at the pool light. This configuration is considered outdated and may not meet current safety standards for pool and spa electrical installations. Improper or outdated junction box installations in wet environments can increase the risk of electrical shock. Evaluation and correction by a licensed electrician is recommended to ensure the installation meets current safety requirements for pool lighting systems.

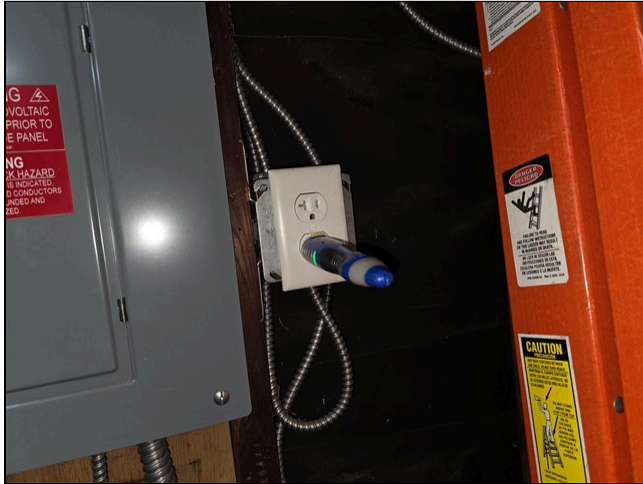
6.2 Item 1 (Picture)

Safety Issue: The electrical outlets in the garage lack Ground Fault Circuit Interrupter (GFCI) protection. GFCI outlets are designed to protect against electrical shocks and are typically required in areas where water and moisture are present, such as garages, bathrooms, kitchens, and outdoor locations. Since garages are susceptible to damp or wet conditions, the absence of GFCI protection in this area poses potential electrical hazards, especially if electrical equipment or tools are used in close proximity to water sources. The absence of GFCI protection in the garage electrical outlets poses potential electrical hazards, especially in damp or wet conditions.

To enhance the safety of the garage's electrical system, it is strongly recommended to install GFCI outlets or provide GFCI protection at the circuit level. Hiring a qualified electrician to perform the installation and ensure proper wiring is essential for maintaining a safe and compliant electrical system in the garage. Regular maintenance and awareness of safety measures will help prevent electrical accidents and create a secure environment for everyone using the garage area.

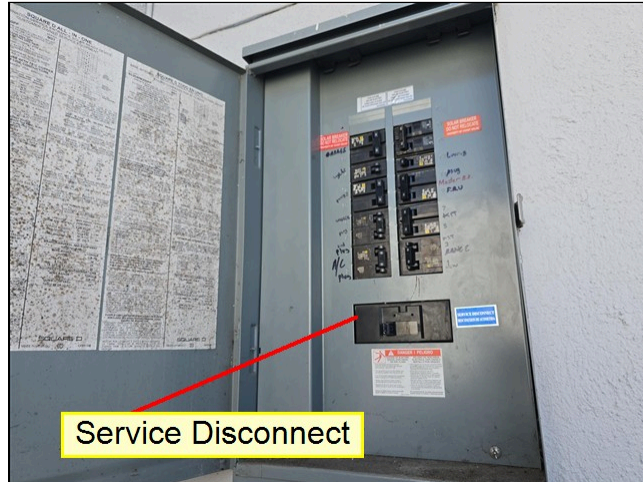
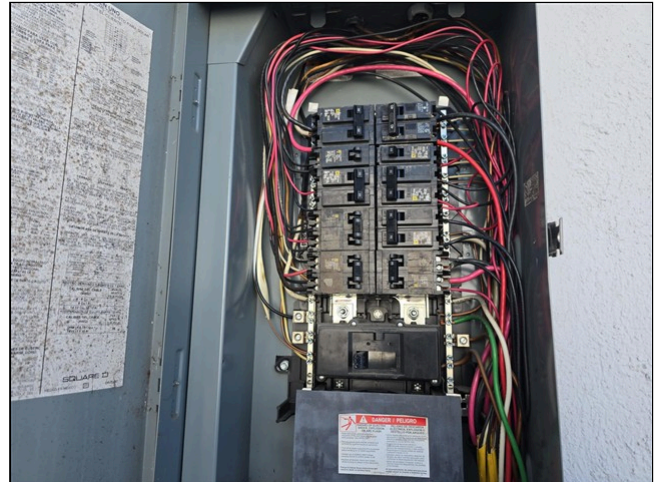
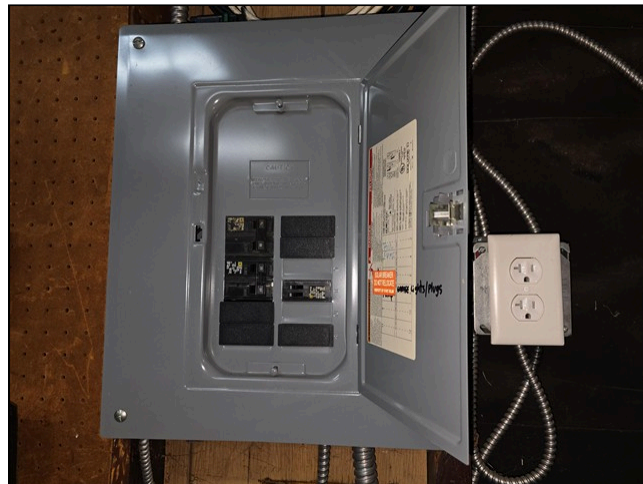
Inspected: The main electrical panel is located at the rear wall of the home. The subpanel is located at the garage.

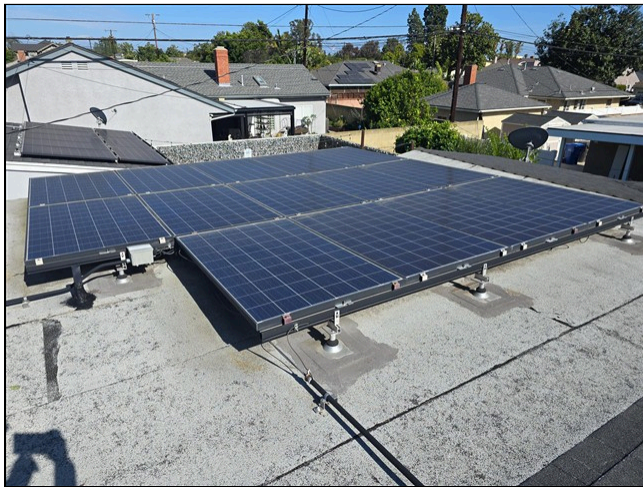
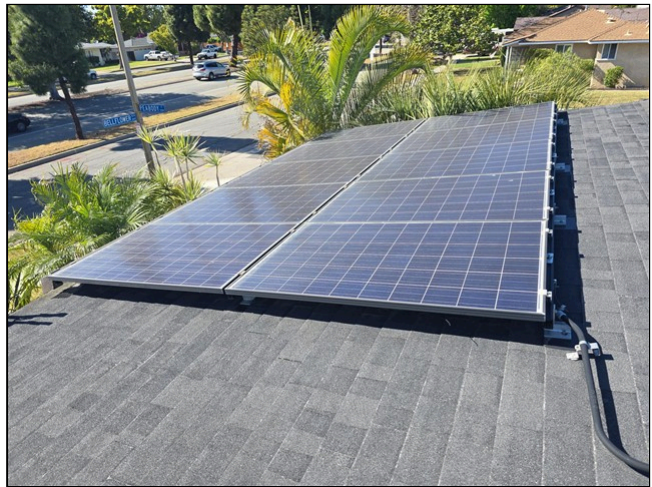
Monitor: Inspection of the solar collector panels/equipment is beyond the scope of this inspection. For information regarding the panels and the operation of the solar system, we suggest consultation with an expert in this field.

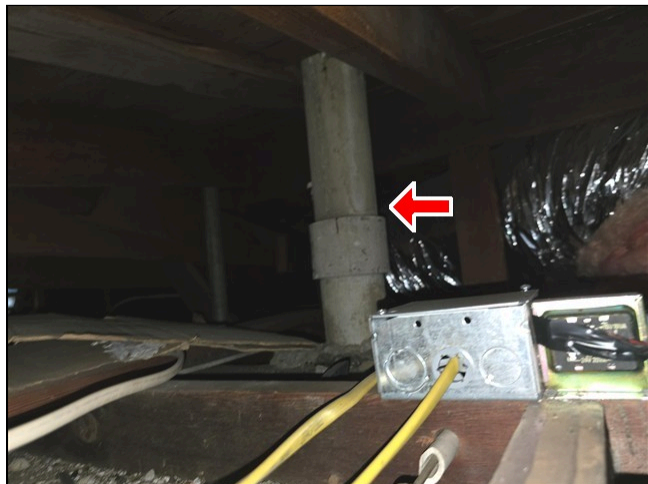
7.4 Item 1 (Picture)

Improve: The ceramic vent(s) in the crawl space, may contain asbestos. Asbestos-containing materials can pose health risks if disturbed, releasing fibers into the air that can be inhaled. Have a certified asbestos abatement professional assess the ceramic vent for asbestos content. If asbestos is present, follow proper abatement procedures for safe removal and disposal. Do not disturb or handle the vent material until it has been evaluated to prevent potential asbestos exposure.

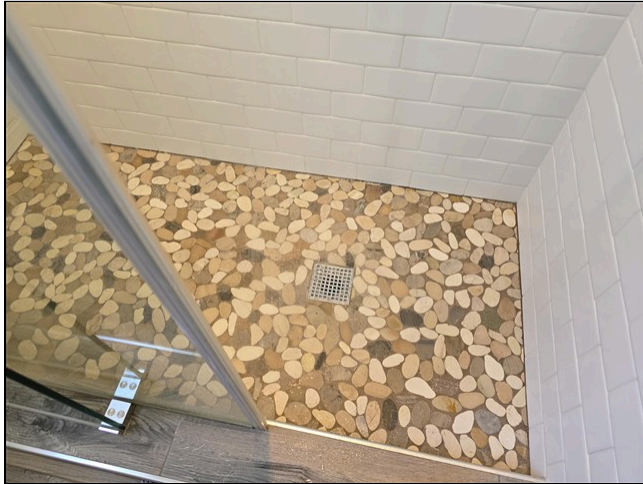
8.9 Item 1 (Picture)

Monitor: The testing of shower pan systems are beyond the scope of this inspection. A shower pan is a waterproof barrier that is made of various materials. Typically, they are placed under the tiles of a shower or tub so that they can catch the water and direct it to the drain. It is suggested that all shower pan systems throughout the home be further investigated by a qualified plumber to verify the presence of any leaks that will require repair within the inspection contingency period.

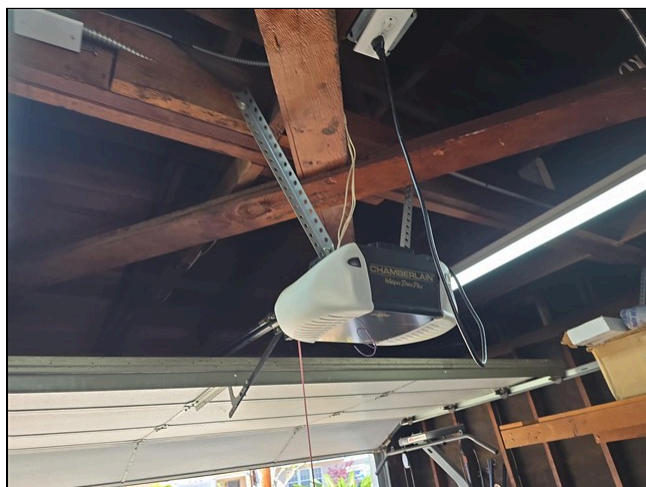
10.2 Item 1 (Picture)

Monitor: The garage door and opener were functional and opened and closed the door. The light beams responded when tested and caused the door(s) to stop and auto reverse. Testing of the downward force (pressure test) was not performed as this can damage the door and is outside the scope of this inspection. Proper operation of the reversing mechanism should be verified prior to the close of the inspection contingency period. Information on garage door openers is available from the Consumer Product Safety Commission at www.cpsc.gov.
