**JG Home Inspections**  
PO BOX 941314  
Simi Valley CA 93094  
805-551-5744  
james@jginspections.com

**Confidential Inspection Report**  
**24713 Choke Cherry Ln**  
**Newhall, CA 91321**

**Prepared for: James & Aalice Tolle**

September 13, 2025

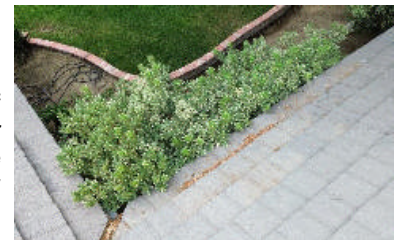
1.7 Trees Condition: **Attention Needed** - Some trees and/or shrubs on the site need to be trimmed. Trees overhanging the structure need to be trimmed so that limbs, leaves, and rain will not drop off the tree onto the roof covering and clog the gutters, damage the roof, or promote moss growth. Trees that rub against the roof can cause severe damage and can drastically reduce the life of the roofing material. Large tree's around property or close to siding/foundation, concern for root growth damaging or lifting sidewalks and/or foundation-Recommend consulting with a tree arborist.

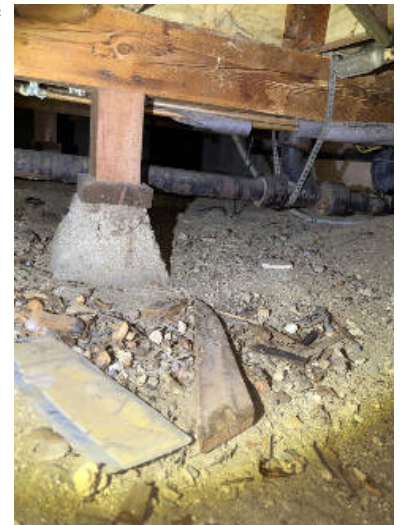
- 3.8 *Crawlspace Entrance:* **Rear side of structure .**
- 3.9 *Location of Crawlspace Entrance:* Exterior.
- 3.10 *Crawlspace Ceiling Exposed Percent:* Only about 25% to 50%
- 3.11 *Comments/Observations:* **Attention needed-** Debris observed, Removal of debris is necessary because it is a condition conducive to wood destroying organisms.

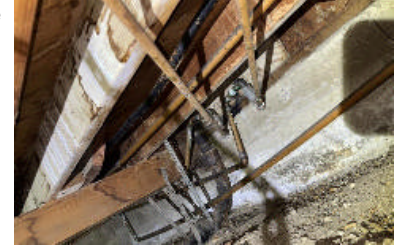
3.13 *Foundation Bolts Noted:*

No - This inspection was unable to locate foundation bolts or brackets installed.

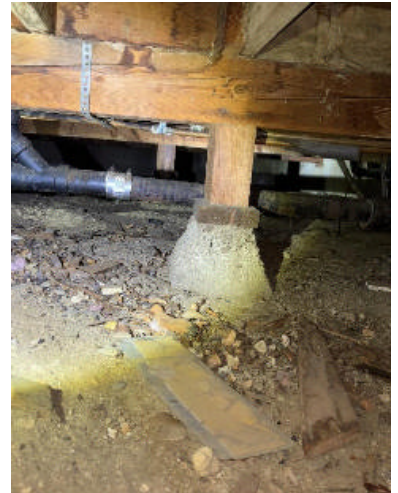
**3.18 Crawlspace Floor:** Soil.

**3.19 Vapor Barrier Installed:** No - There is no vapor barrier installed. Exposed soils in a crawlspace should be covered with a retardant material to prevent moisture or standing water from deteriorating wood framing above. Approved materials include: polyethylene sheeting, roofing paper, concrete, or blacktop. If the ground is saturated, wall vapor barriers of like materials are also recommended.

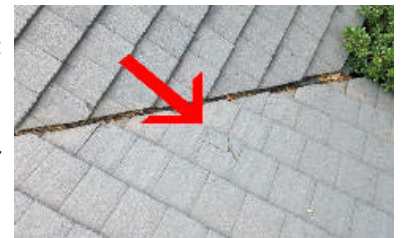
4.7 Means of Roof Inspection: The roof edge was the location of the inspection of the roof covering. The surface of the roof was not walked on. The type of roof covering material is such that it could be damaged if walked on. Further inspection is needed to evaluate the roof covering. Evaluation by a licensed qualified roofing contractor is suggested. Debris removal is needed from roof, gutters and valleys for proper drainage during wet conditions.

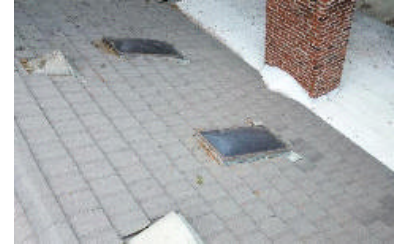
Satisfactory - The skylight(s) appears to be satisfactory and shows no signs of leaking. Skylights are prone to leaking.

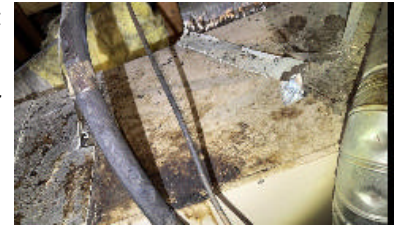
4.16 Comments/Observations:

**Attention needed-**I observed widespread rodent droppings throughout the attic. I recommend having a qualified pest control company rodent proof the house and remove any droppings and/or contaminated insulation or ducting in the attic. Stained area should be cleaned and sanitized by a qualified professional.

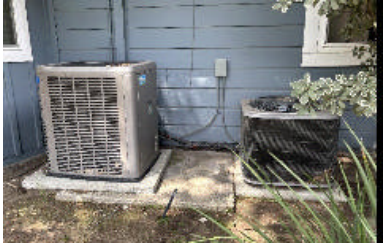
- 6.7 *Unit/Condenser Location:* Rear left side.
- 6.8 *Unit Tested:* Yes, The scope of this inspection does not include the effectiveness or adequacy of the system.
- 6.9 *Insulation Wrap on the Suction Line:* **Attention Needed** - The insulation wrap on the suction line to the condenser/compressor is in need of attention due to deteriorated or missing insulation.
- 6.10 *Condenser Clear of Obstruction:* **Attention Needed** - The clearances do not appear to be adequate. Verifying clearances with the manufacturer's installation instructions is recommended.
- 6.11 *Condenser Cabinet Level:* **Attention needed-** The condensing unit(s) should be fastened to pad for stability and to prevent movement in accordance with present standards. Recommend proper strapping of the unit(s)

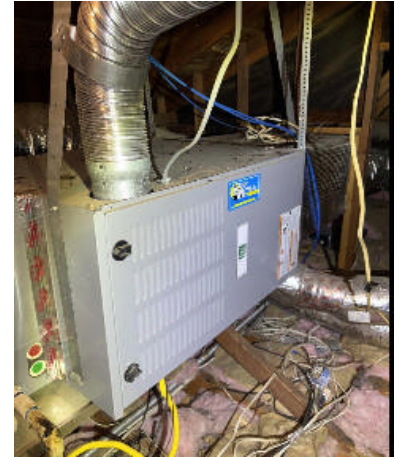
6.24 Heating System Location: Attic.

6.26 Fuel Source: The fuel source is natural gas. Be advised that there is no drip leg/sediment trap installed on the incoming gas line to the furnace. Installation of a drip leg is recommended to prevent debris from getting into the gas valve and may be required by manufacture(see installation manual) .

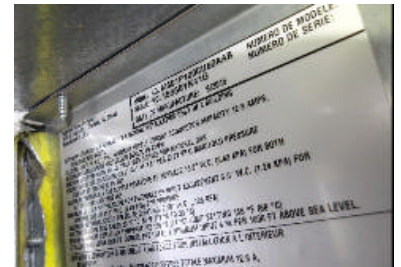
6.27 Model/Serial Number/Size: Brand -; This unit appear to have been manufactured **about 2015**.

6.29 Flue Condition: **Attention Needed** - The furnace flue as installed appears to need some attention. Either it is not secured properly, or it has inadequate clearance to roof sheathing in attic. Required to have a minimum of 1" inch clearance from a combustible material. Refer to qualified professional for repairs.

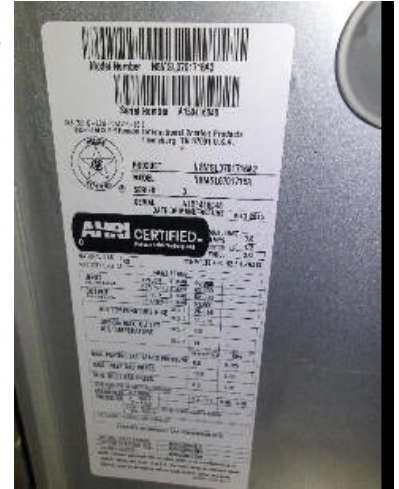
6.45 Model/Serial Number/Size:

Brand Day & Night -; This unit appear to have been manufactured **about 2015**. The typical service life for a forced air natural gas furnace is 15 - 20 years.

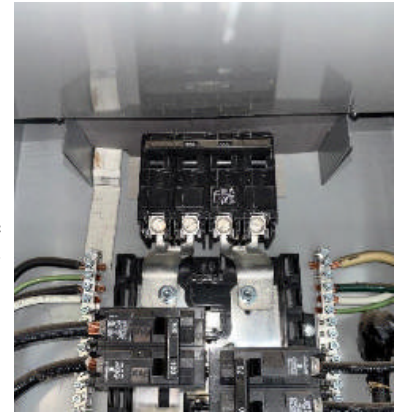
7.4 Main Power Panel Size:

200 amp - The ampacity of the main power panel appears to be within the normal parameters for the structure's age. However, electrical additions and/or alterations appear to have been made to this property a load analysis is recommended if you anticipate adding more circuits or load to the system. Inspector does not perform a load calculation to determine service capacity adequacy. Panel appears to be under sized with the amount of breaker installed that appear to be leading to other panels

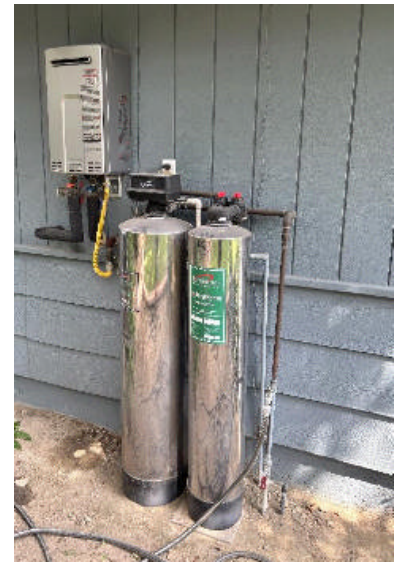
- 8.21 Water Softener: Yes, there is a water softener installed in this structure. Beyond the scope of this inspection. Determine ownership of the equipment. The inspection merely states the presence of the unit. We are unable to determine ownership and if it is functioning correctly.

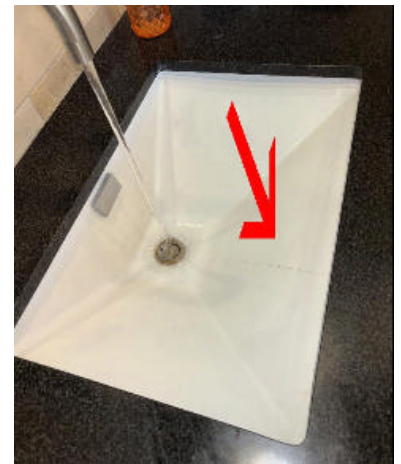
#### 11.2 Basin and Drain Fixture:

**Attention needed-** The finish on the bowl is damaged/cracked at right sink, replacement is advised. Refer to a qualified professional.

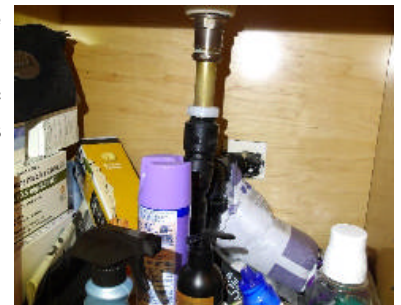
#### 11.3 Faucet and Supply Lines:

**Action needed-** There are No shutoffs valve installed for both hot and cold water pipes under the basin as required per plumbing standards. Installation is necessary so water can be shutoff under basin if a line needs changing and/or a leak is present so entire house doesn't have to be shutoff for repairs.

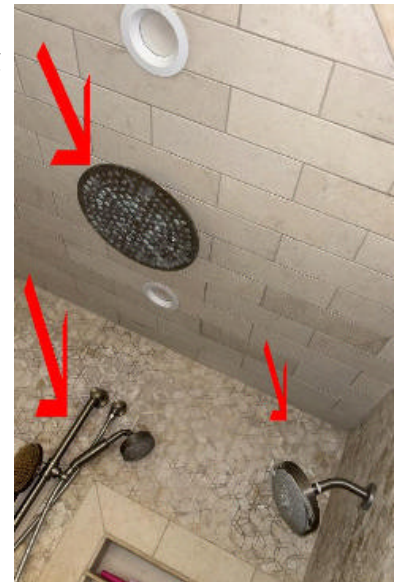
11.6 Tub or shower Mixing Valve & Stopper:

**Attention needed-** The shower water mixing valves and diverters difficult to operate. Shower heads & control valves have corrosion and hard water buildup- Refer to a licensed plumber for repairs.

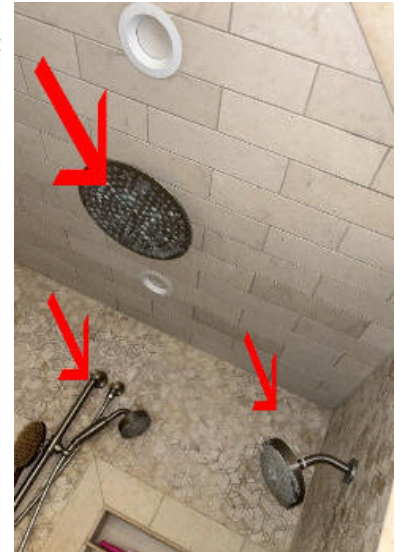
11.7 Shower/Shower Head and Mixing Valves & steamer :

The steamer was not tested or verified. Beyond the scope of inspection. Refer to a licensed plumber. It appears to be inoperable.

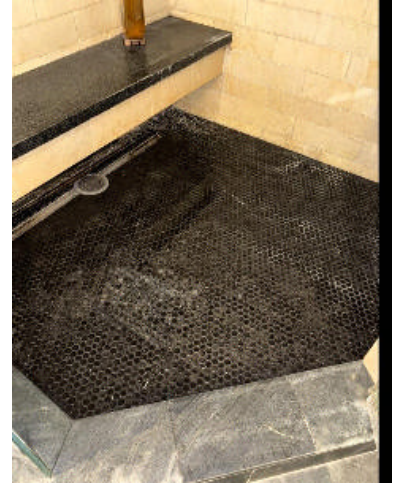
11.8 Shower Pan:

Disclaim - This is a visual inspection of the readily accessible portions of the shower stall and was not invasive. Therefore, it is a limited inspection and may not have noted any hidden defects. Flood testing of the shower pan was not included as part of this inspection. Cracked tiles observed, further evaluation and repair.

Improper shower pan installation. The slope of shower stall pan installation is improperly pitched in order to carry the water effectively to the drain .

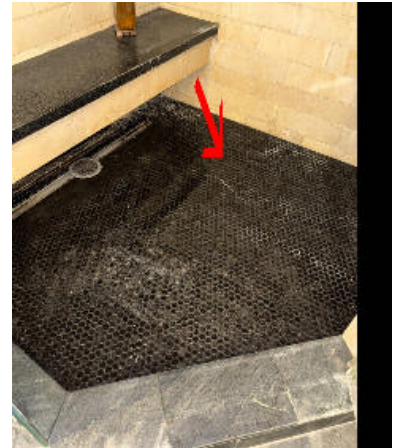
11.9 Tub & Shower Walls:

**Attention Needed** - The shower pan show some deterioration and damage. Cracking in shower pan observed. Refer to a qualified professional for repairs.

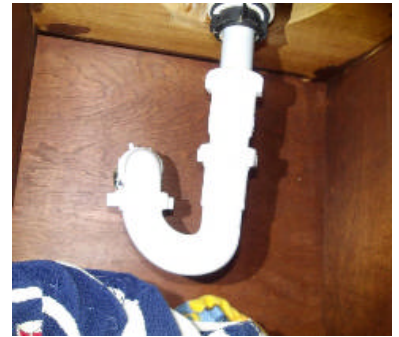
11.19 Basin and Drain Fixture:

**Attention Needed** - The basin or drainage fixture needs attention. The lavatory drains slowly. There may be some blockage either in the fixture or the drain line.

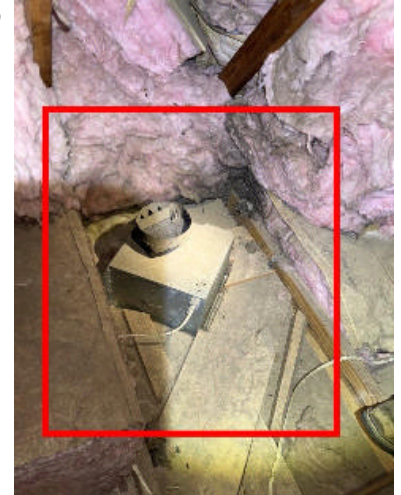
11.32 Ventilation Fans:

**Attention needed-** The ventilation fan vents into the attic space. This introduces moisture into the attic that must be removed from the attic. Required to discharge to exterior per building standards. Refer to a qualified professional to repair.

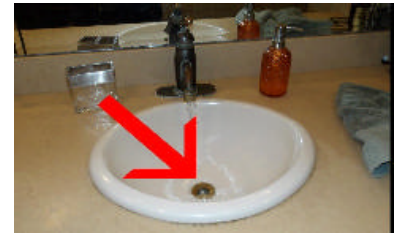
11.34 Basin and Drain Fixture:

**Attention Needed** - The basin or drainage fixture needs attention. Sink stopper not installed and should be to prevent drain blockage.

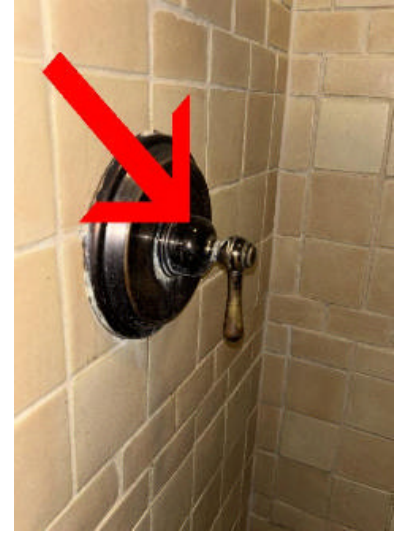
11.37 Shower/Shower Head and Mixing Valves:

**Attention Needed** - The faucet in the bathroom needs repairs or replacement on hot side due to the position temp stop assembly being broken that sets temperature or allows water to be shutoff in proper position. Refer to plumber to repair or replace.

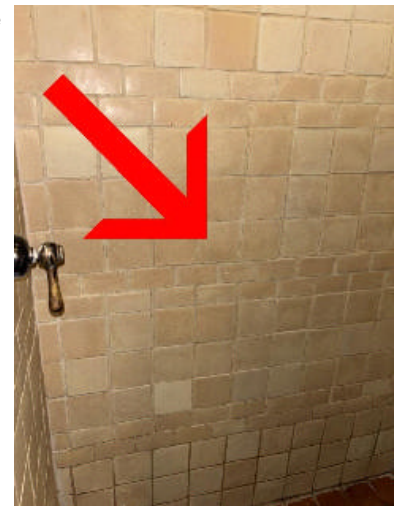
11.39 Tub & Shower Walls:

**Attention Needed** - The walls show some deterioration & cracked tiles. Cracked tiles should be replaced.

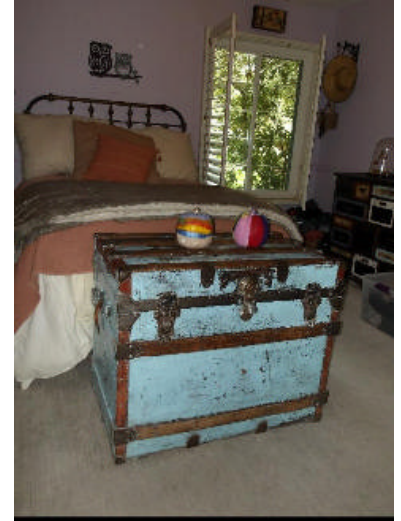
12.11 Walls:

Satisfactory - The walls in the room appear to be satisfactory. Due to stored items, furniture, picture frames, etc, it is not possible to determine the condition of the walls and ceiling that are not visible.

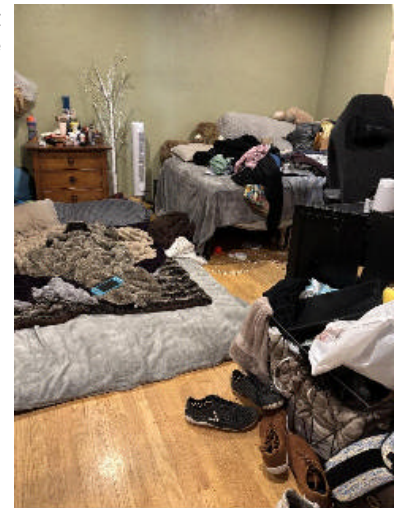
12.17 Walls:

Due to stored items, furniture, picture frames, etc, it is not possible to determine the condition of the walls and ceiling that are not visible.

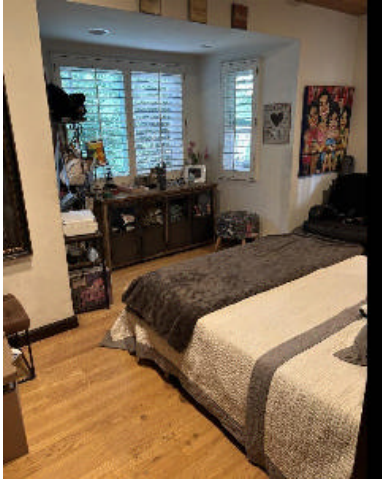
Due to stored items, furniture, picture frames, etc, it is not possible to determine the condition of the walls and ceiling that are not visible.
-

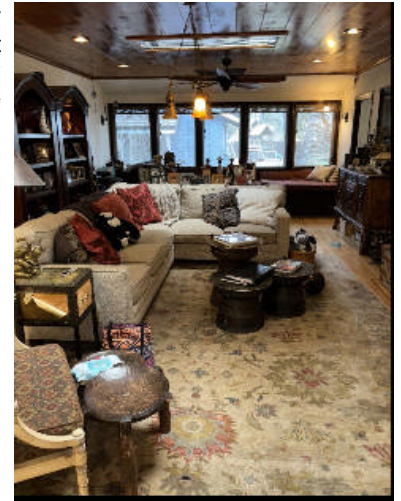
#### 13.4 Floor:

Satisfactory - The floors are in satisfactory condition. There is some sagging in the floor that would be considered typical. Due to the floor covering, furniture, or stored items, it is not possible to view the conditions of the entire area. Only visible areas are commented on if a observation is present.

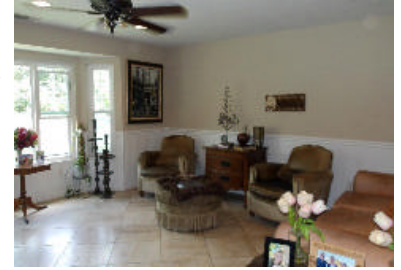
13.11 Floor:

Due to the floor covering, furniture, or stored items, it is not possible to view the conditions of the entire area. Only visible areas are commented on if a observation is present.

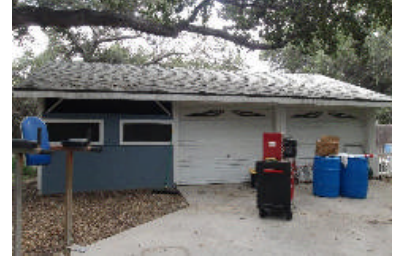
*14.1 Garage Type*

The garage is detached and free standing. Converted into a storage shed. Garage has limited access due to personal belongings being stored.

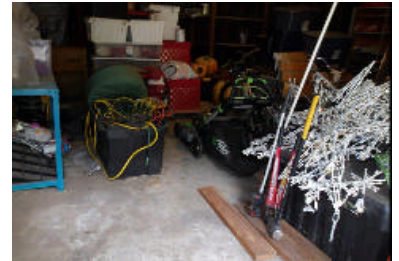
*14.7 Floor Condition:*

Garage floor is cracked or damaged in areas. Garage floor cracks may be due to settlement, tree roots, improper installation by installer or possibly expansive soils. Limited access at time of inspection due to storage and vehicle. Recommend sealing cracks with approved materials. Refer to a qualified professional. Due to personal belongings & stored items in the garage prevented a full visual inspection, I was unable to determine the condition of the portions of the floor that are not visible. Recommend a re-inspection and/or review areas not seen during final walkthrough.

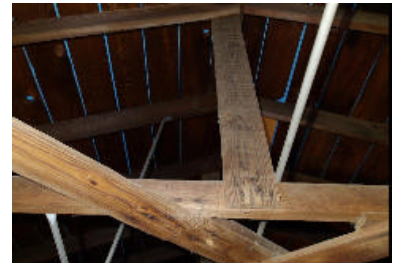
*14.10 Ceiling:*

Previous Leak - There are signs of a previous water leak in the ceiling in this room. It does not appear to be an active leak.

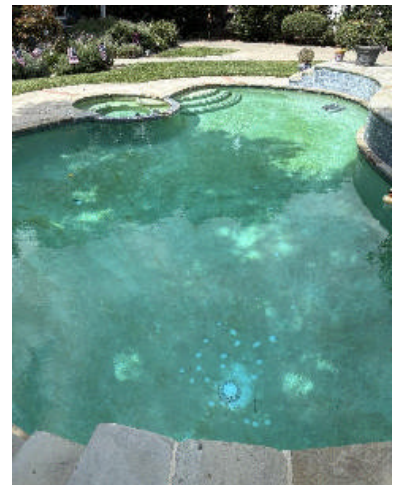
15.1 Comments/Observations:

**Attention needed-** Pool inspection is a limited observation and not part of home inspection any information given as a courtesy only. Due to conditions observed at time of inspection I recommend contacting a qualified and licensed pool contractor to determine cost of repairs needed for pool to function properly and safely. Pool surface appears to need re-plastering. Licensed pool contractors for further review.
