# PROPERTY INSPECTION REPORT

**FOUR POINT**  
HOME INSPECTION INC.

**4960 Glenhill Ln**

**Date of Inspection: 4/29/2026**

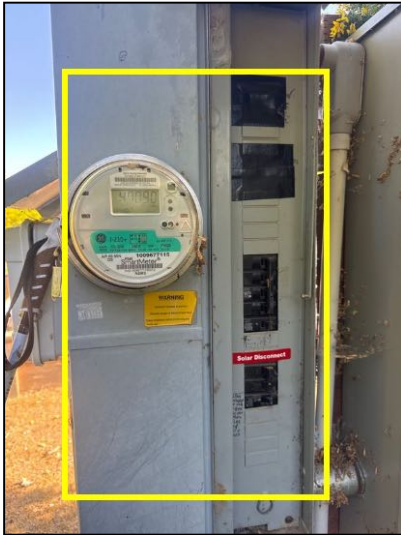
Main electrical service panel to the home.

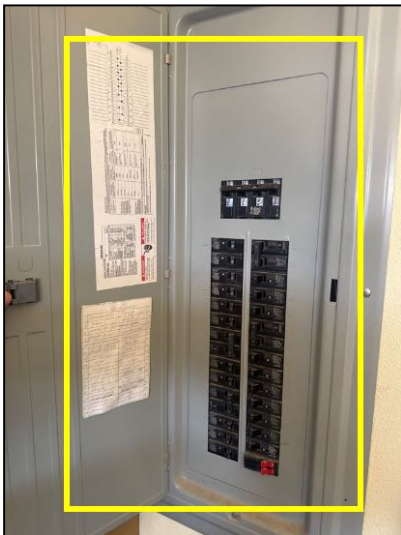
Sub panel to the home in the garage

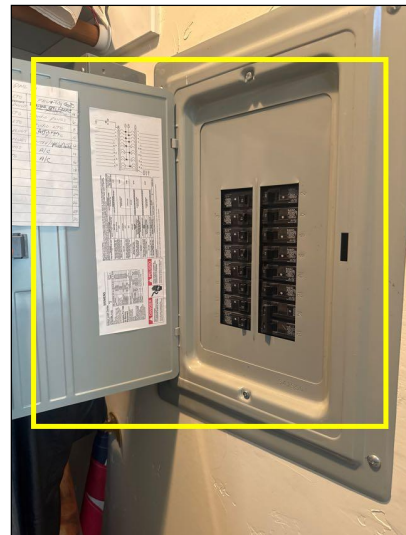
Sub panel to the home in the closet

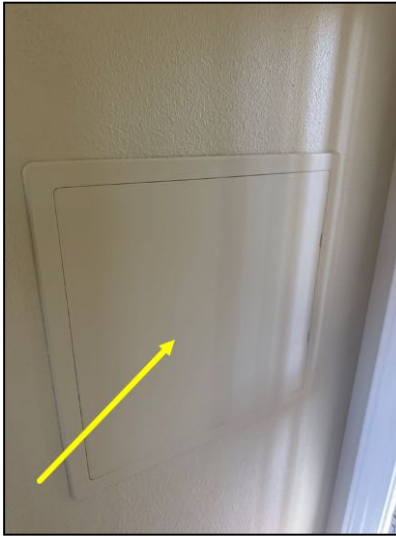
Access for faucet shut offs in the laundry room
