# Cornerstone Home Inspections

## Home Inspection Report

**20550 Ponderosa Way  
Tuolumne, CA 95379**

Inspected on Tue, Jan 13 2026 at 9:17AM

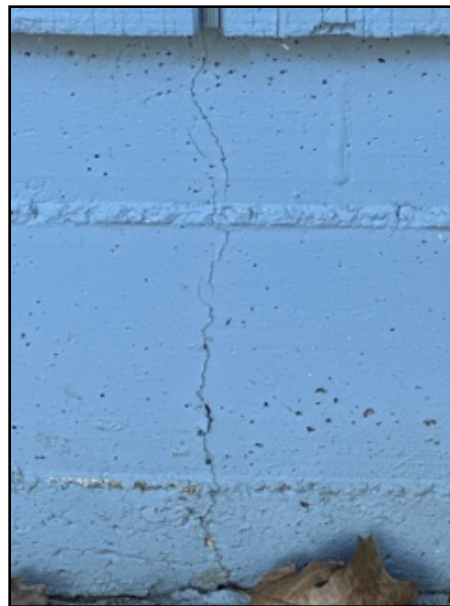
Figure 1-2

Minor cracks noted on various areas of foundation. Considering these cracks are less than 1/8" in width, not considered a structural issue. This is a common find.

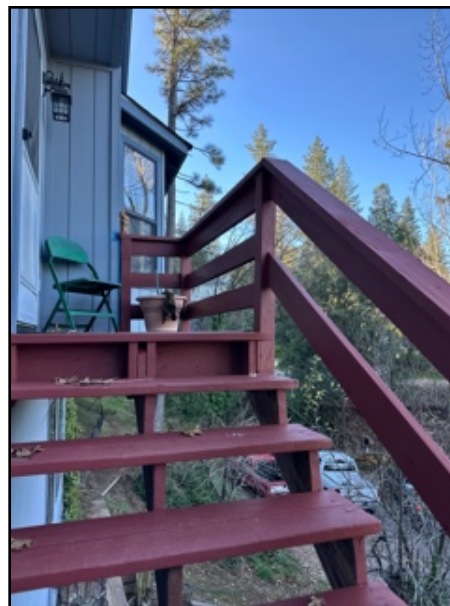
Figure 2-2

Deck/stair railing picket spacing is not up to code. Current CA building code allows a maximum picket spacing of 4". However, this spacing was acceptable at the original time of construction and would only need replaced if there was a permit pulled on the structure.

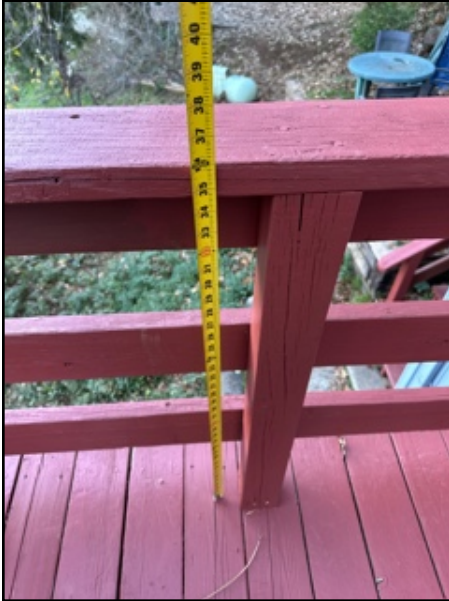
Figure 3-1

Deck/stair railing height is not up to code. Current CA building code requires a minimum railing height of 42". However, this height is pre-existing and would only need replaced if a permit were pulled on the property.

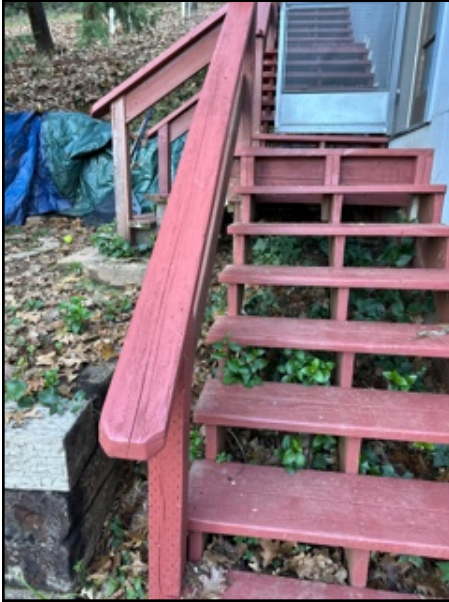
Figure 8-1

**Comment 8:**  
Current CA building code requires railings have a surface of graspable size installed.

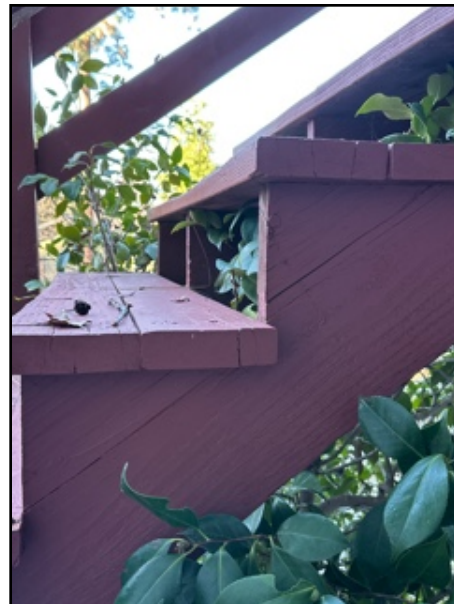
Figure 9-2

**Comment 9:**  
Stairs stringers in front of home noted as cracked/ damaged.

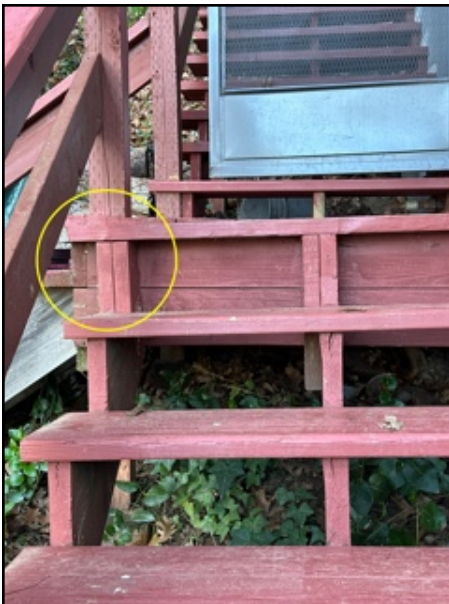
Figure 11-1

Comment 11:  
Stair stringers leading to lower apartment are sagging on the left side.

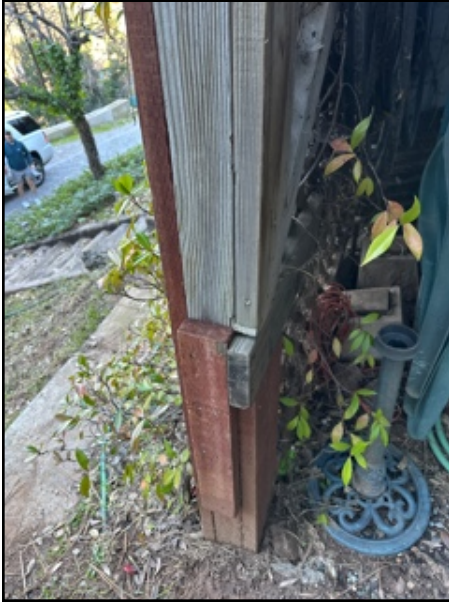
Figure 12-1

**Comment 12:**  
Deck support post on front right corner of home is multiple pieces of lumber scabbed together. Refer to a licensed contractor for replacement.

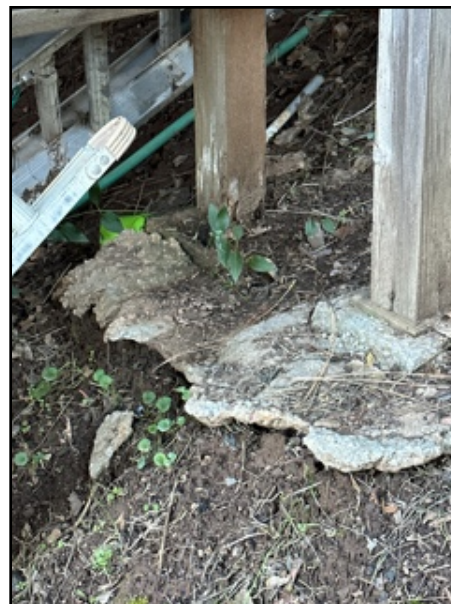
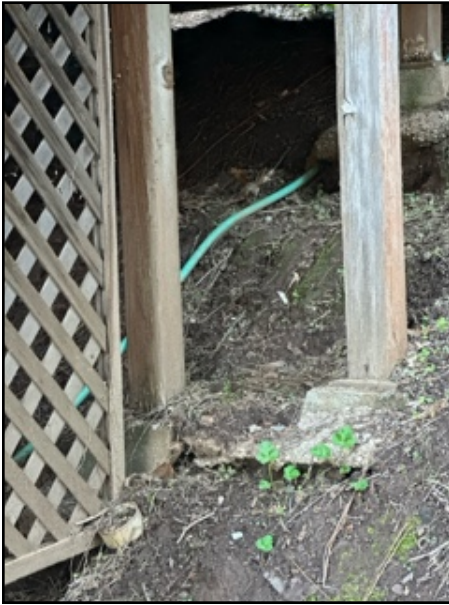
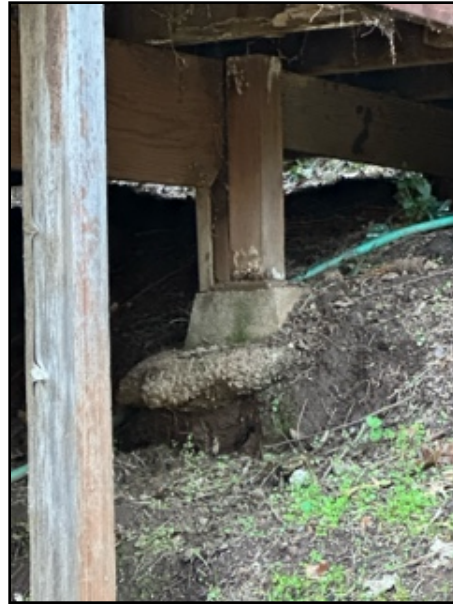
**Comment 13:**  
Soil has eroded away below the deck piers on right side of home. Refer to a licensed contractor for repair.

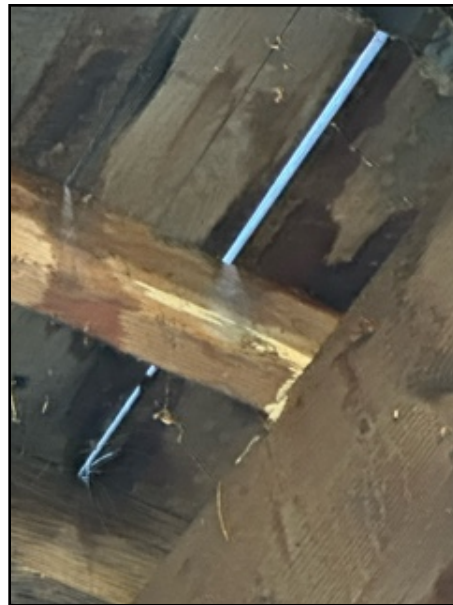
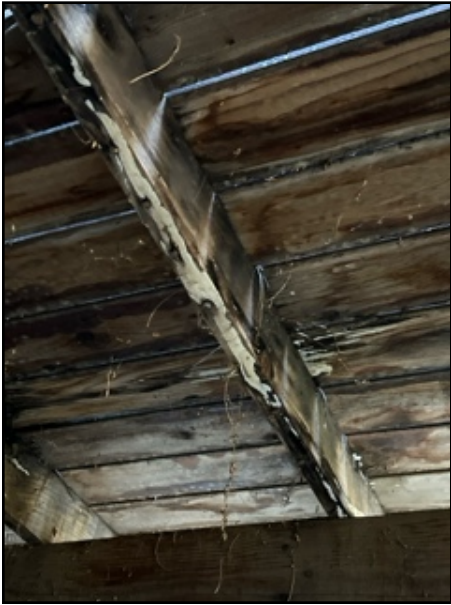
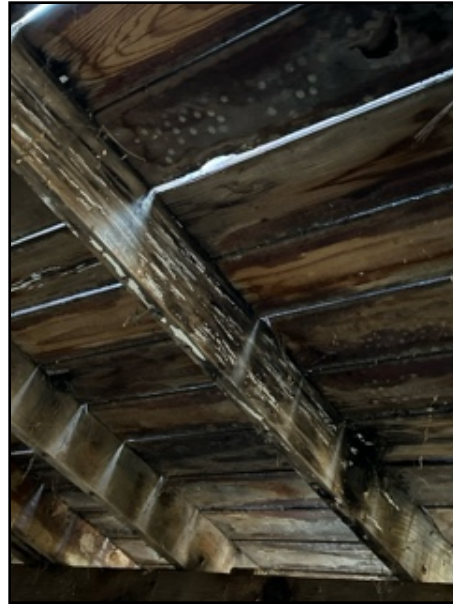
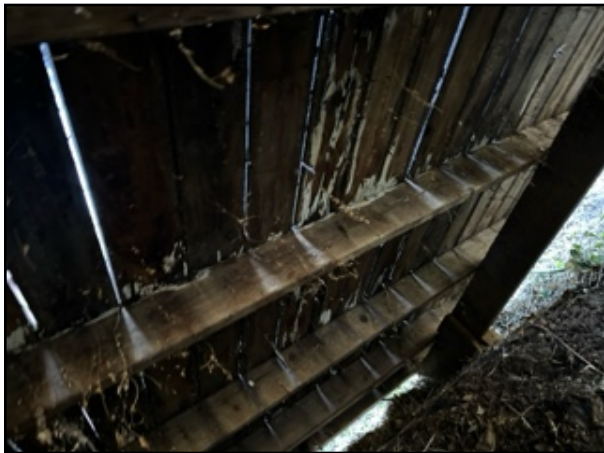
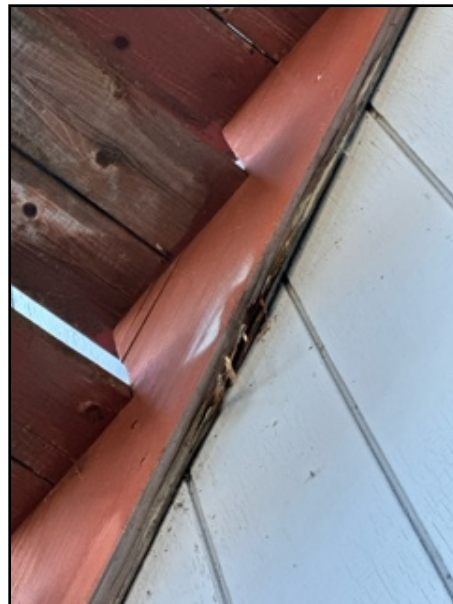
Fungus and decay noted on various areas throughout deck structures/attached sidings. Refer to a licensed pest inspector for further evaluation.

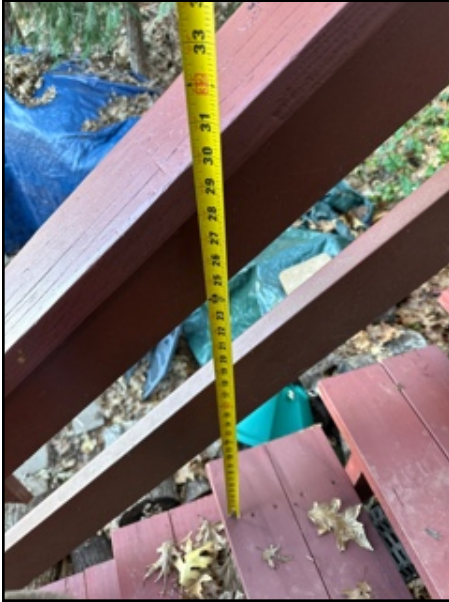
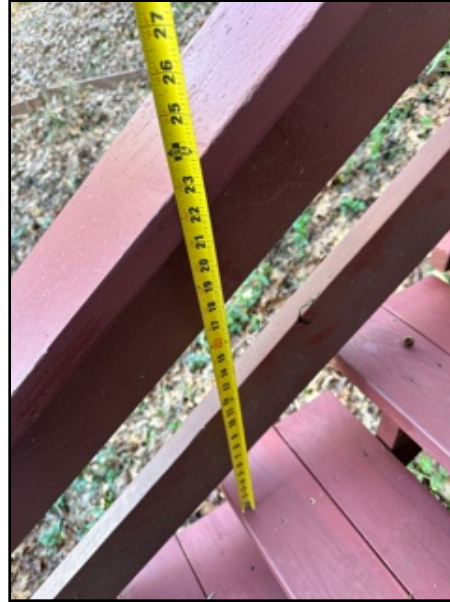
Stair railings on home are inconsistent heights, some areas are not to minimum height code. Refer to a licensed contractor.

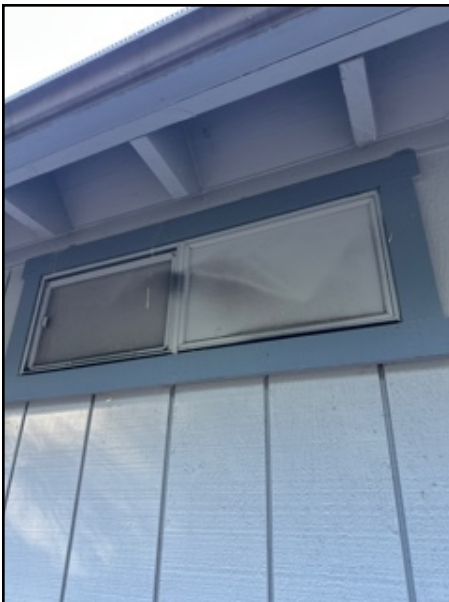
Figure 16-1

Bathroom window behind home has been painted over.

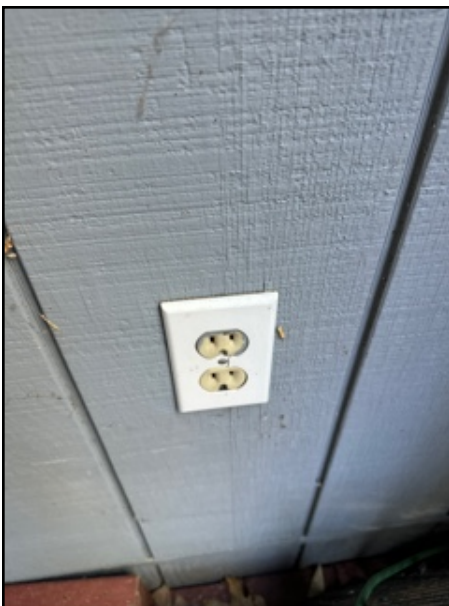
Figure 18-1

Receptacle near back door is not weatherproof. Refer to a licensed electrician.

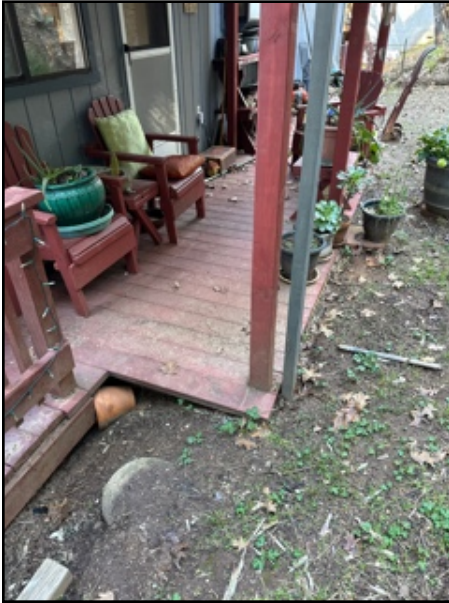
Figure 19-1

Back porch is built into the soil.

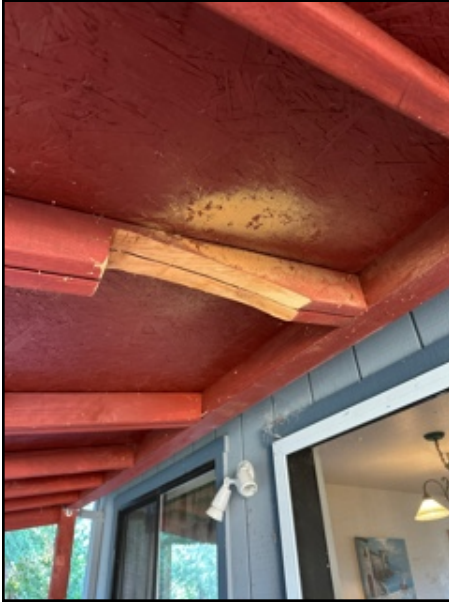
Figure 21-1

Rafters for back porch have been cut & should be replaced. Refer to a licensed contractor.

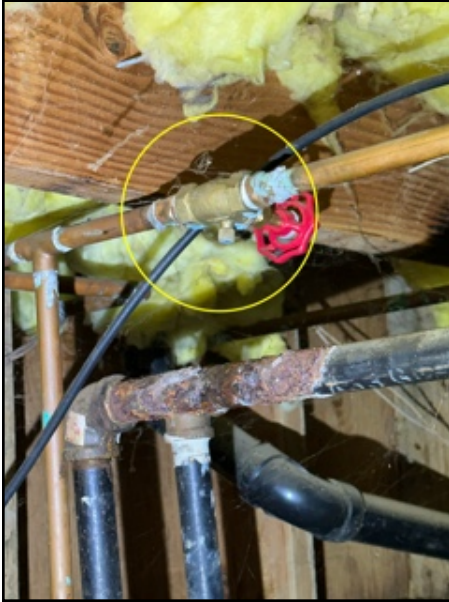
Figure 24-1

(Lower left side access). Water valve inside door is leaking onto the gas line below causing corrosion. Refer to a licensed plumber.

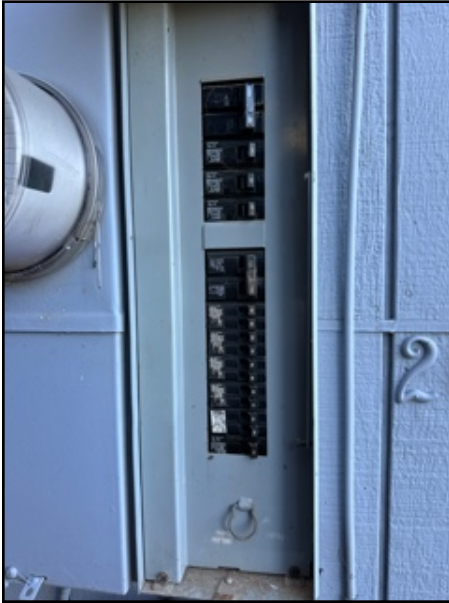
Figure 25-1

Comment 25:  
Main service panel labeling is not complete.

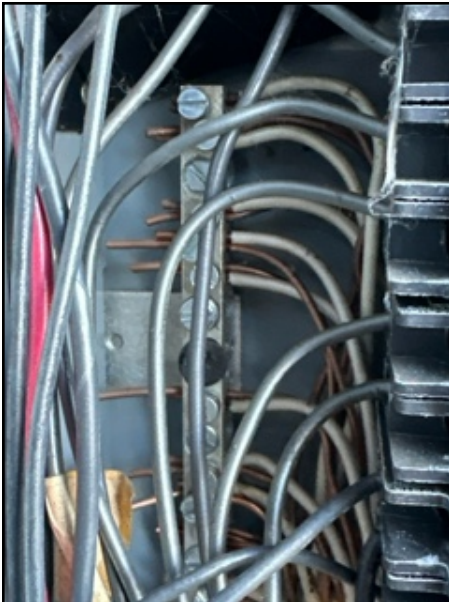
Figure 26-1

Comment 26:  
Each neutral should be attached to its own dedicated lug on the buss bar in the main panel. Refer to a licensed electrician.

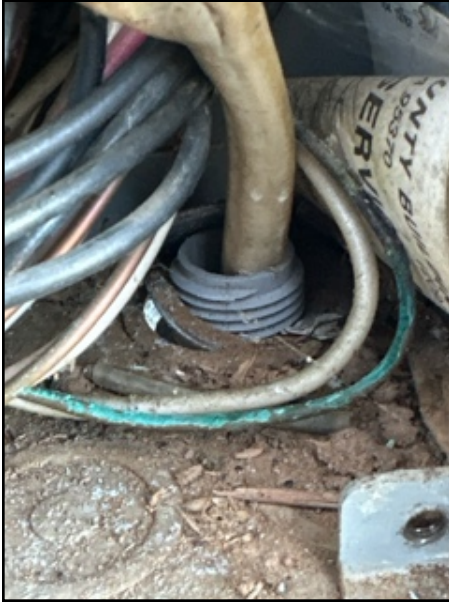
Figure 27-1

Conduit connected to base of panel is not attached properly & is providing access for pests.

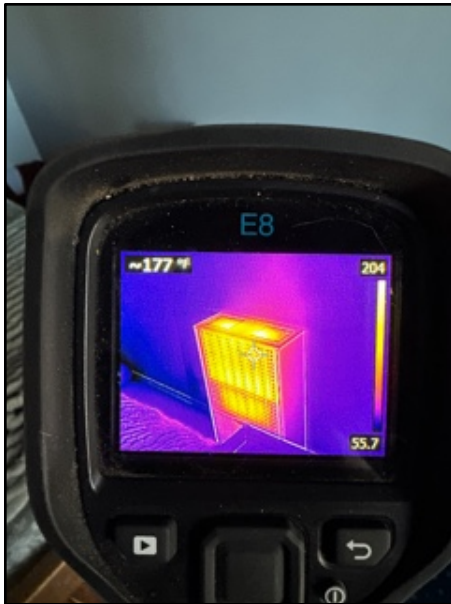
Figure 31-1

Apartment-  
Wall furnace tested & determined functional.

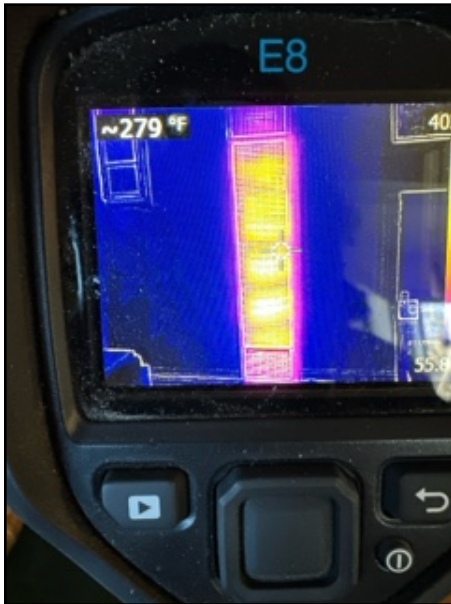
Figure 32-1

Wall furnace tested & determined functional.

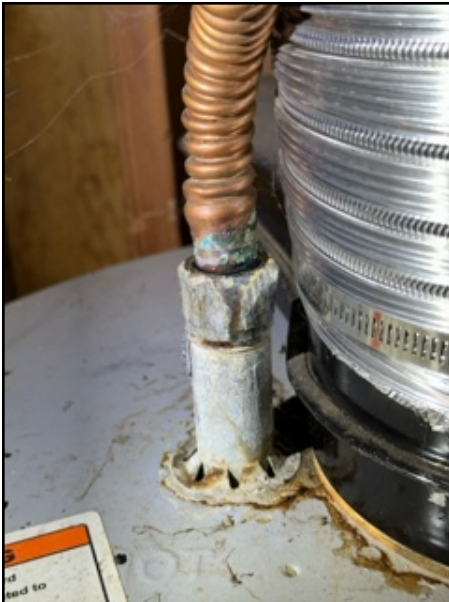
Figure 36-1

**Comment 36:**  
Hot water connection above water heater noted to leak. Refer to a licensed plumber.

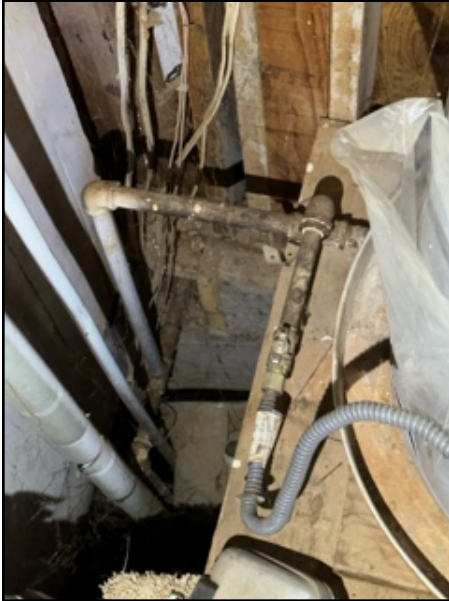
Figure 37-1

No drip leg installed on water heater propane supply line. Recommend installing to catch any particles/debris traveling through the line to prevent orifices from clogging. Refer to a licensed plumber.

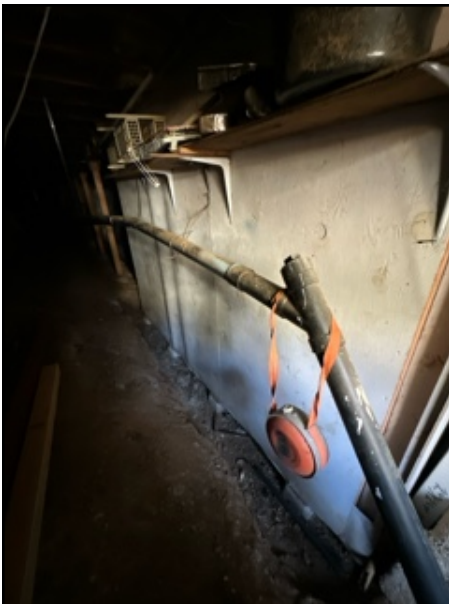
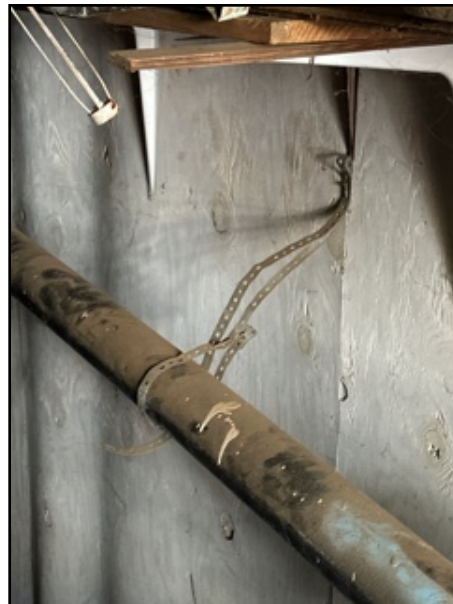
Waste lines in crawl space are not properly supported & move freely.

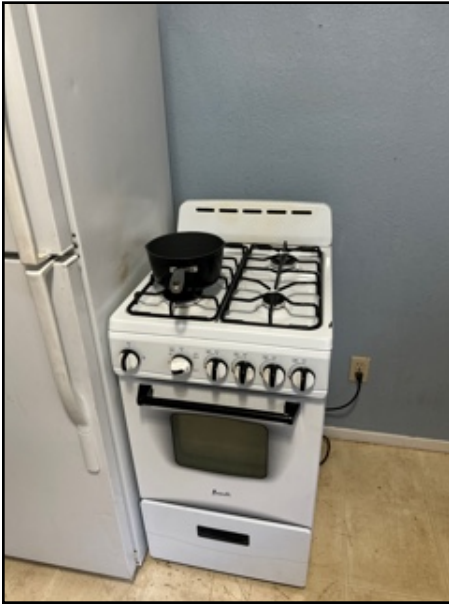
Figure 41-1

Current Ca building code requires ranges have a minimum clearance of 6" on each side.

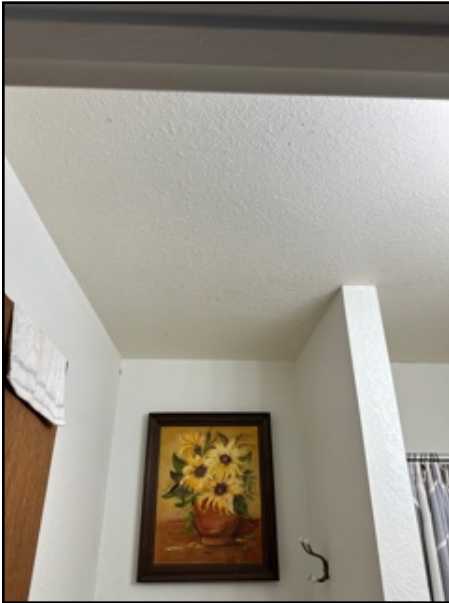
Figure 46-1

No vent fan installed in bathroom. Current CA building code states an exhaust vent fan must be installed in all bathrooms that contain a tub or shower.

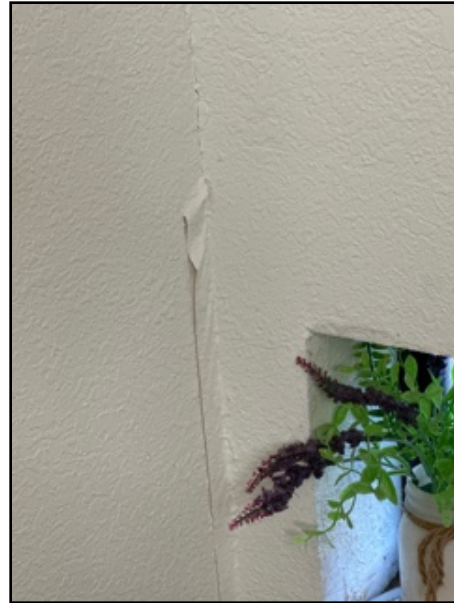
Figure 49-2

Moisture damage & poor drywall tape job noted in area surrounding bathroom window. Refer to a licensed contractor.

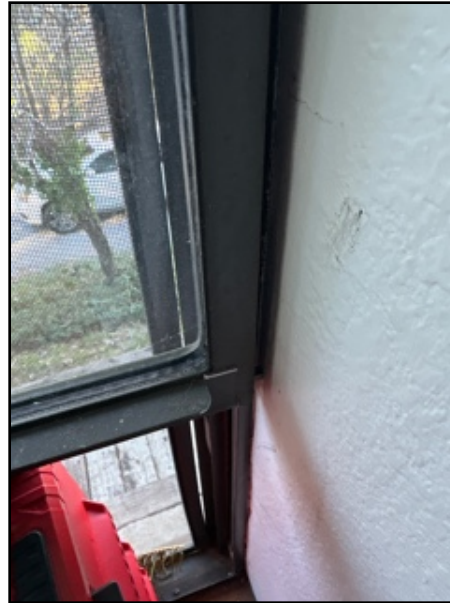
Figure 52-2

Right bedroom window is outside the frame and propped up. Refer to a qualified tradesman for repair. Frame also noted to contain large dents.

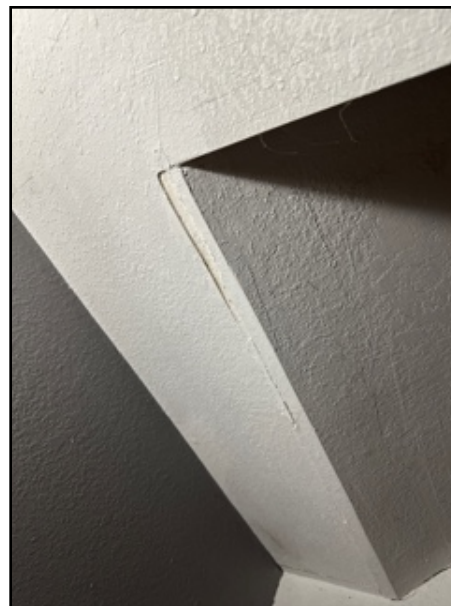
Figure 54-2

Cracked drywall noted in area around stairs. Considering these cracks only occur on tape seams, likely caused due to a poor drywall tape job.

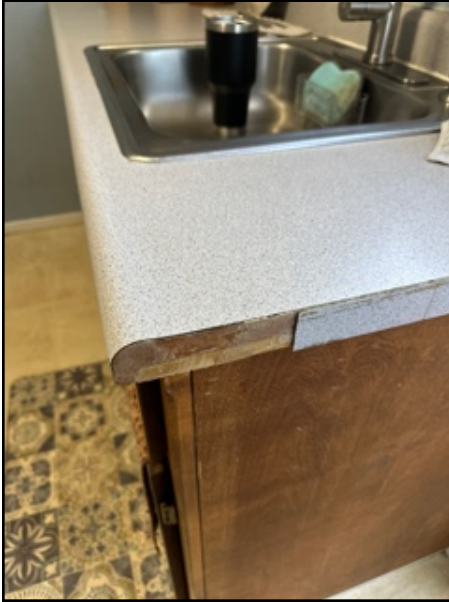
Figure 55-1

Comment 55:  
Apartment-  
Edges of kitchen counter noted as delaminated.

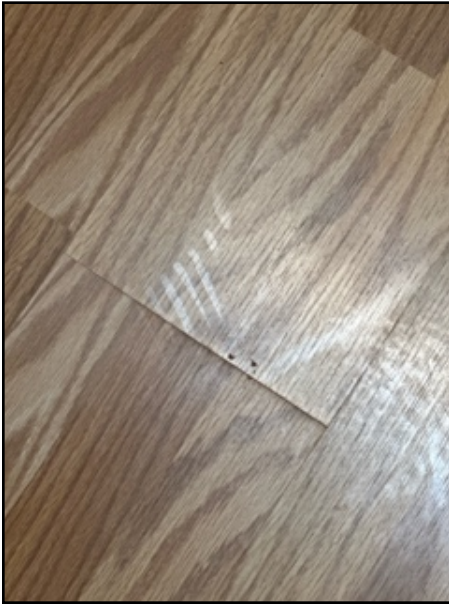
Figure 58-3

Laminate floor in kitchen area noted as damaged.

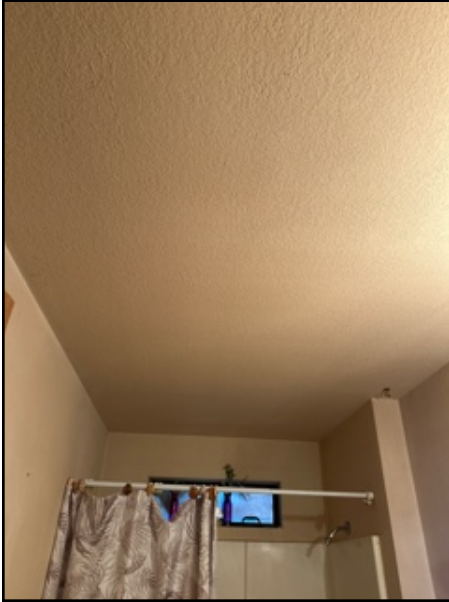
Figure 60-1

No vent fan installed in hallway bathroom. Current CA building code states an exhaust vent fan must be installed in all bathrooms that contain a tub or shower.

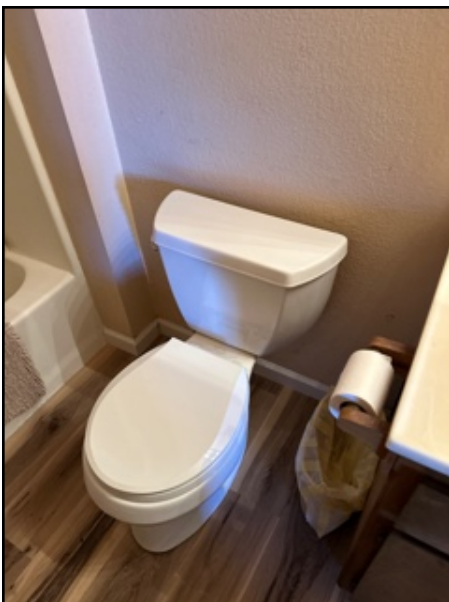
Figure 61-1

Guest bathroom toilet noted as loose. Recommend tightening to prevent any future leaks.

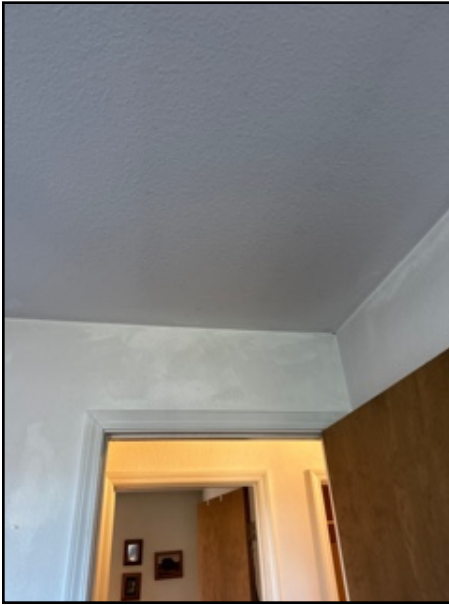
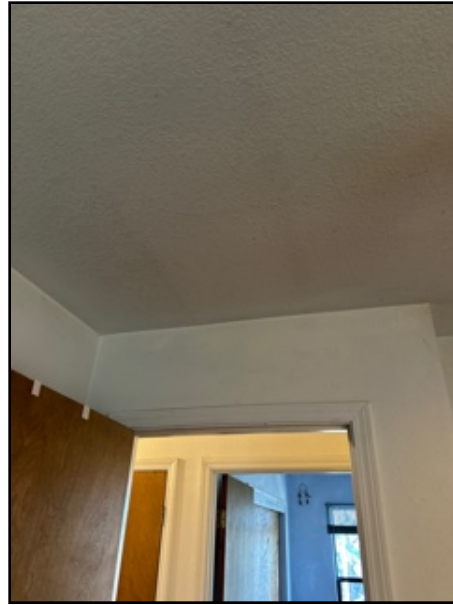
Multiple smoke alarms missing in home. Recommend to install as required.

Section 310.9.1.4 of the California Building Code. One smoke alarm should be placed on each floor in non-sleeping areas. In addition, one smoke alarm must be installed in each room where sleeping occurs and one smoke alarm should be located in each hallway that leads directly to sleeping rooms.

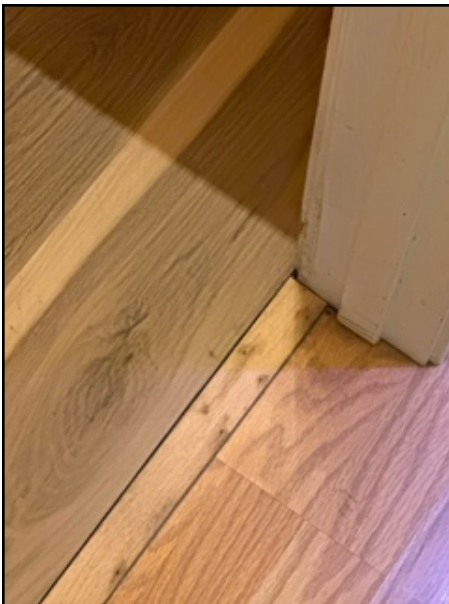
Figure 64-1

Bathroom transition strip does not overlap the edge of bathroom flooring.

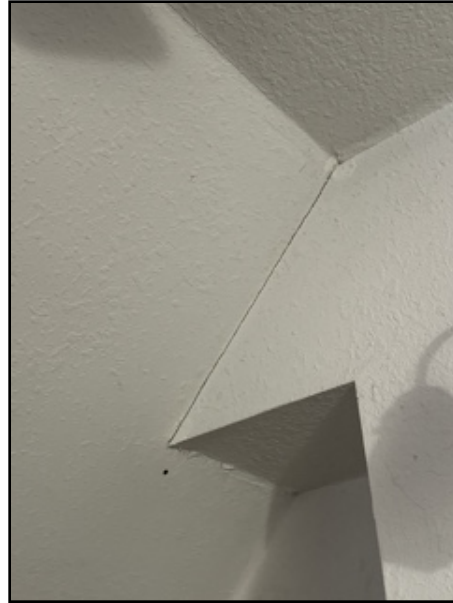
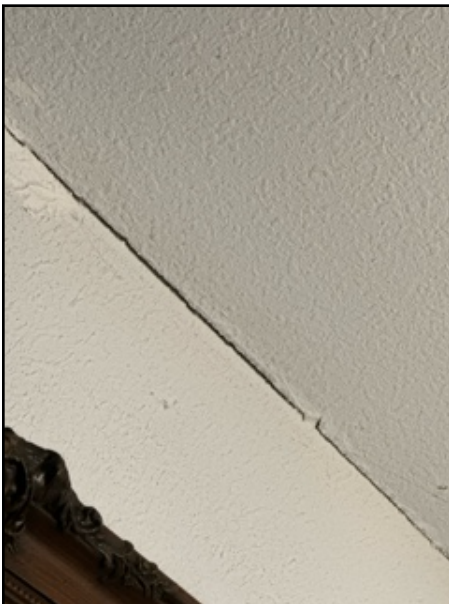
Comment 65:  
Drywall cracks noted in various areas throughout home.

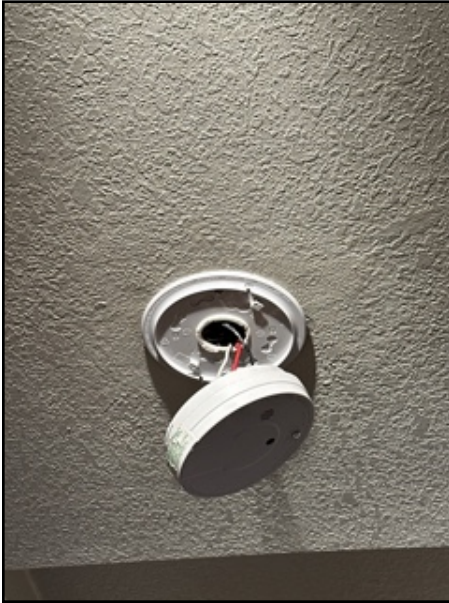
Figure 66-1

Hallway smoke alarm is hanging by the wires.

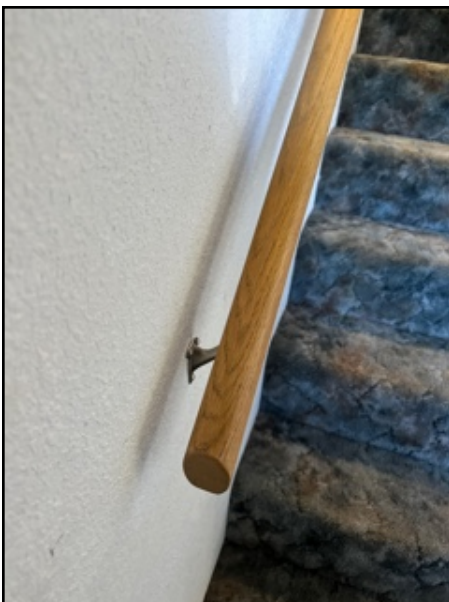
Figure 67-1

Current CA building code requires hand railings to re-connect to the structure. However, since this railing is pre-existing it would only need replaced if a permit were pulled on the property.

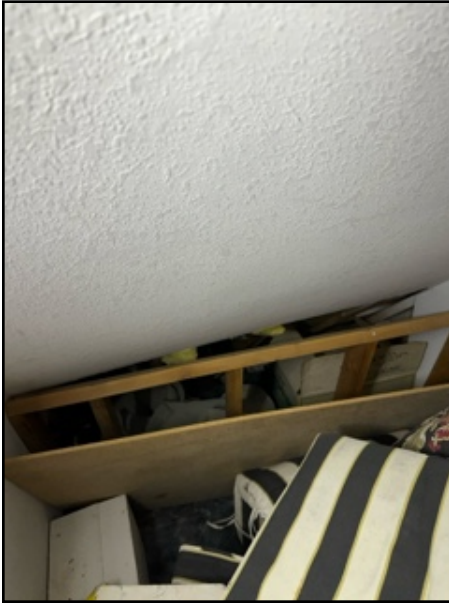
Figure 68-1

**Comment 68:**  
Upstairs right bedroom closet remains unfinished & is open into the attic.

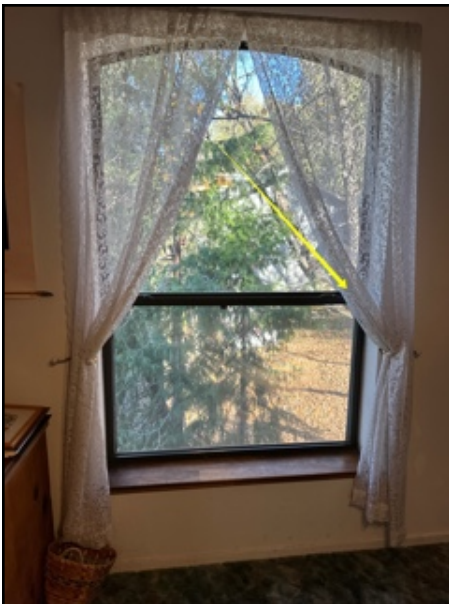
Figure 69-1

**Comment 69:**  
Left guest bedroom upstairs window shown is falling out from frame on the right side. Refer to a qualified tradesman.

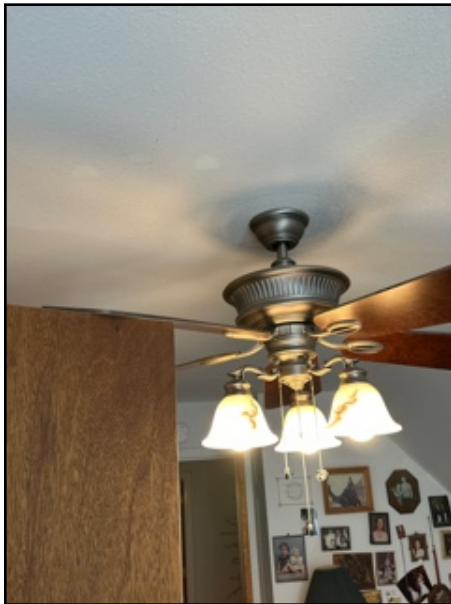
Figure 70-1

Master bedroom fan upstairs strikes the bathroom door.

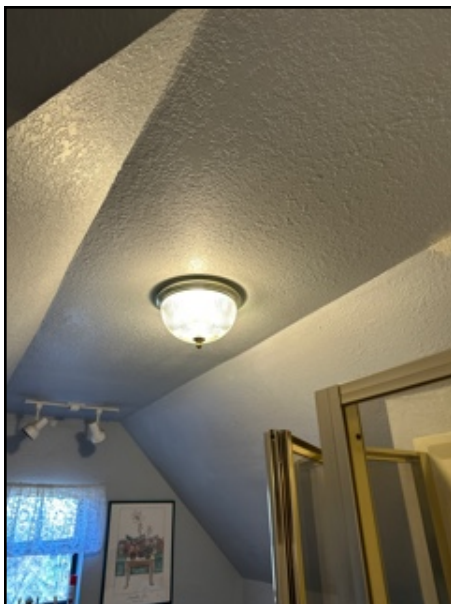
Figure 71-1

No vent fan installed in master bathroom. Current CA building code states an exhaust vent fan must be installed in all bathrooms that contain a tub or shower.

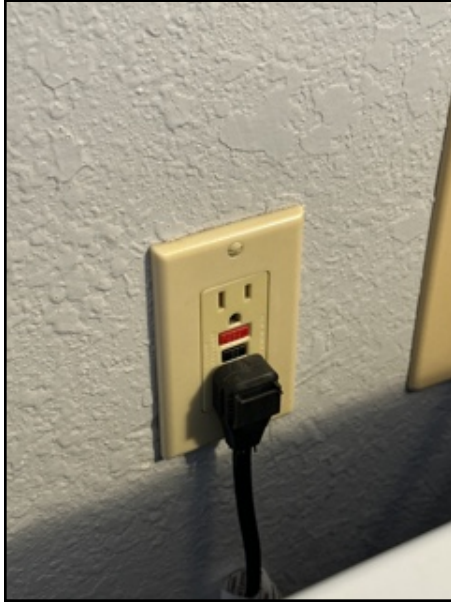
Figure 72-1

Bathroom receptacles are tied into the laundry GFCI circuit. Washing machines should be on their own dedicated electrical circuit. Refer to a licensed electrician.

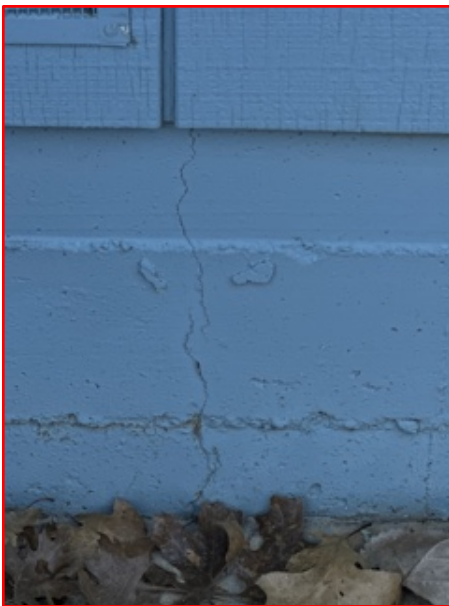
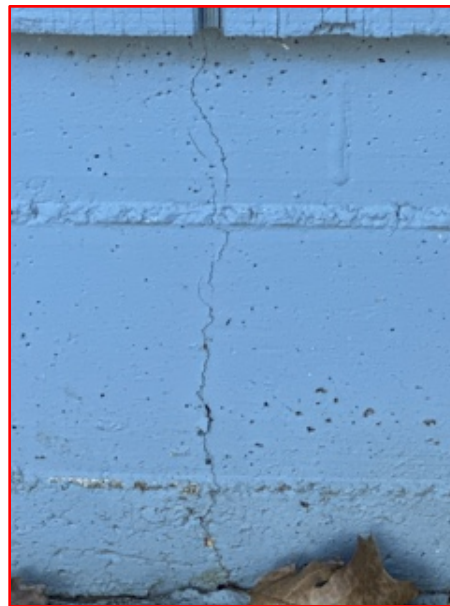
1) Minor cracks noted on various areas of foundation. Considering these cracks are less than 1/8" in width, not considered a structural issue. This is a common find.

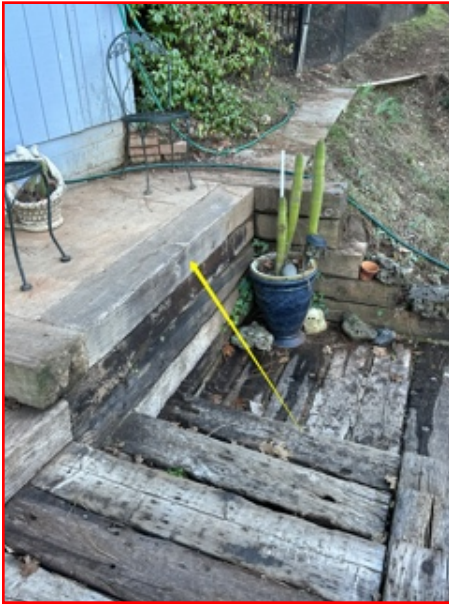
Figure 4-1

2) Recommend installing a proper railing on retaining wall above entry steps. Current CA building code requires a railing be installed with a maximum picket spacing of 4" above any ledge with a 30" or larger drop. Refer to a licensed contractor.

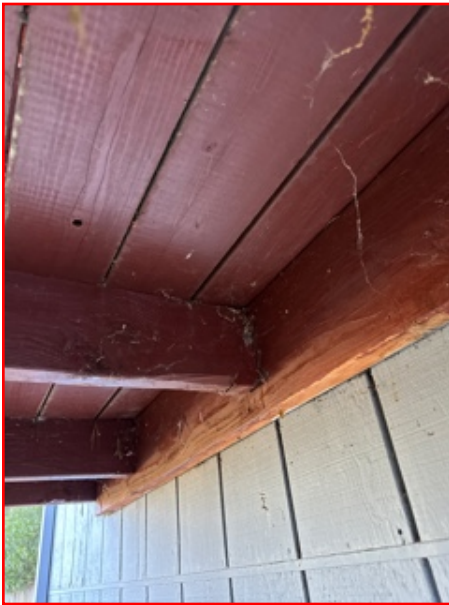
Figure 5-1

3) No flashing installed on deck ledger. Recommend installing to prevent any future moisture damage from occurring.

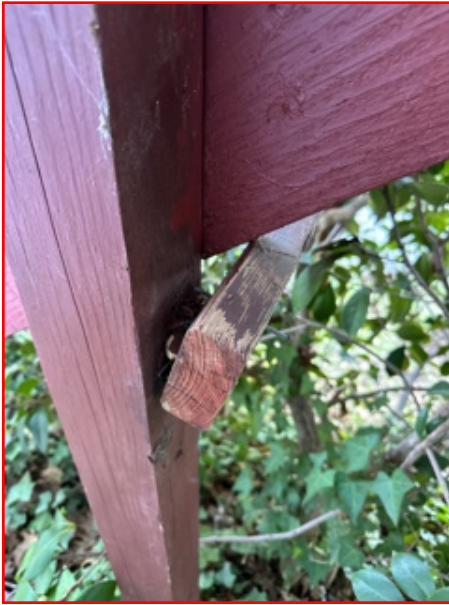
Figure 6-1

4) Center stair stringer brace in front of home is loose.

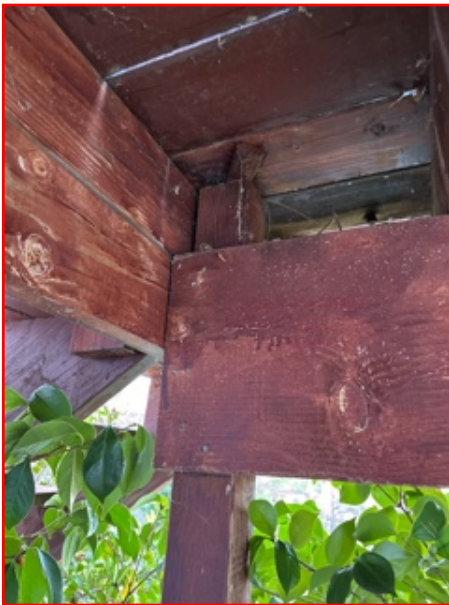
Figure 7-1

5) Recommend bolting deck/porch girders to the posts.

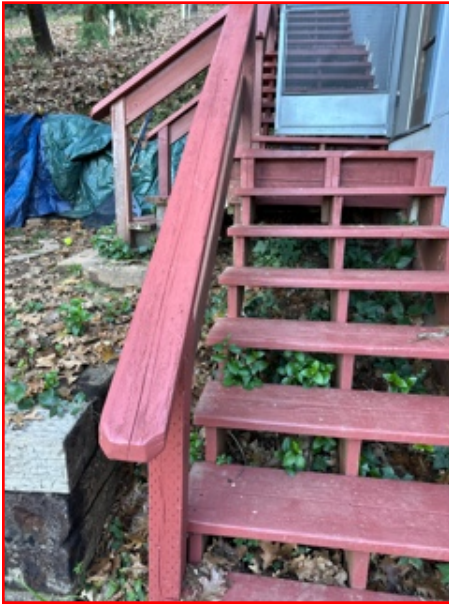
Figure 8-1

6) Current CA building code requires railings have a surface of graspable size installed.

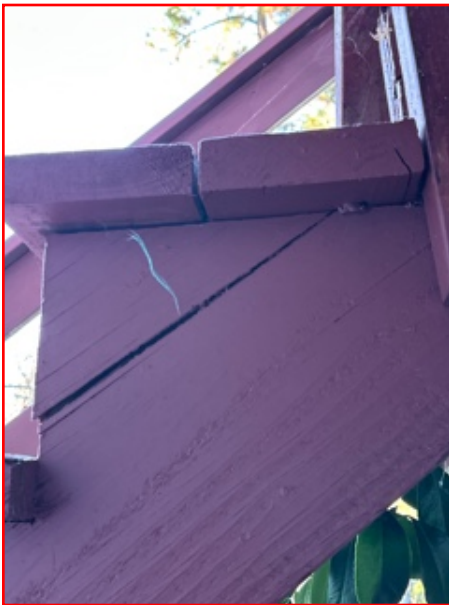
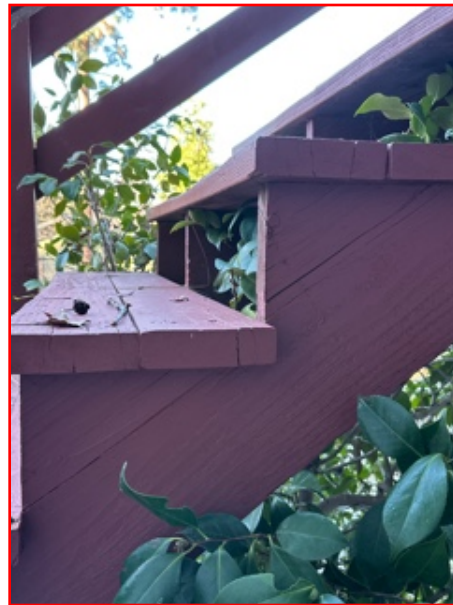
7) Stairs stringers in front of home noted as cracked/ damaged.

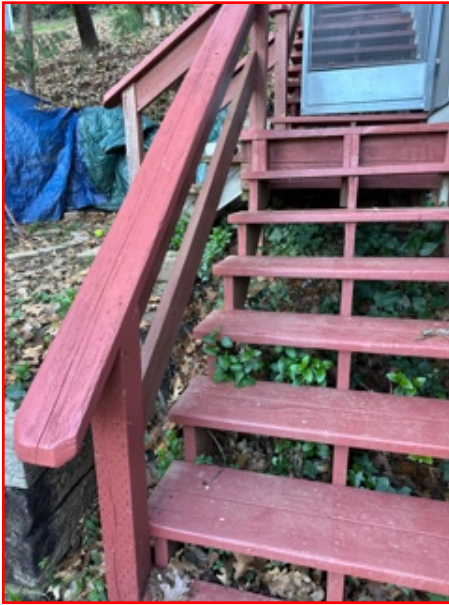
Figure 10-1

8) Railing to lower apartment noted as loose.

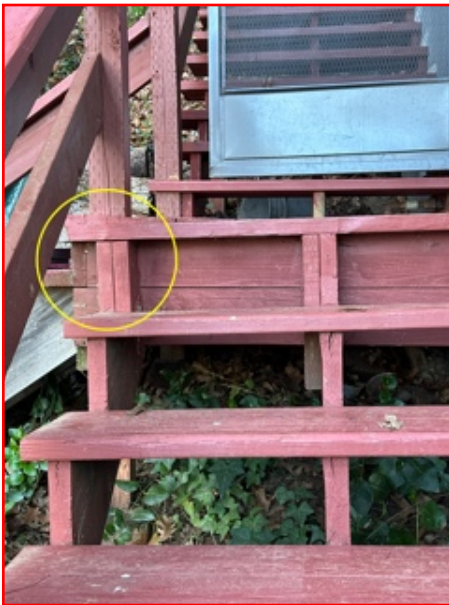
Figure 11-1

9) Stair stringers leading to lower apartment are sagging on the left side.

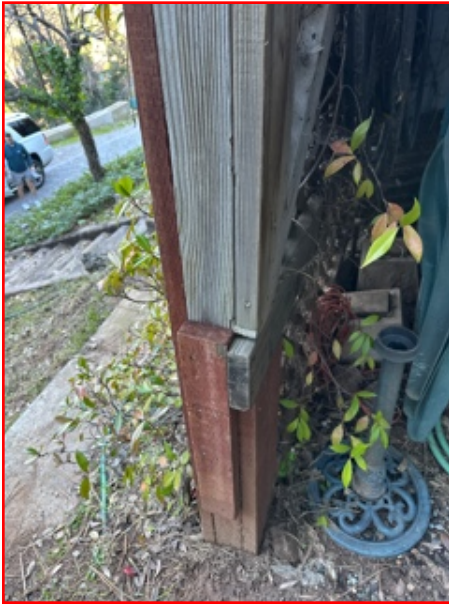
Figure 12-1

10) Deck support post on front right corner of home is multiple pieces of lumber scabbed together. Refer to a licensed contractor for replacement.

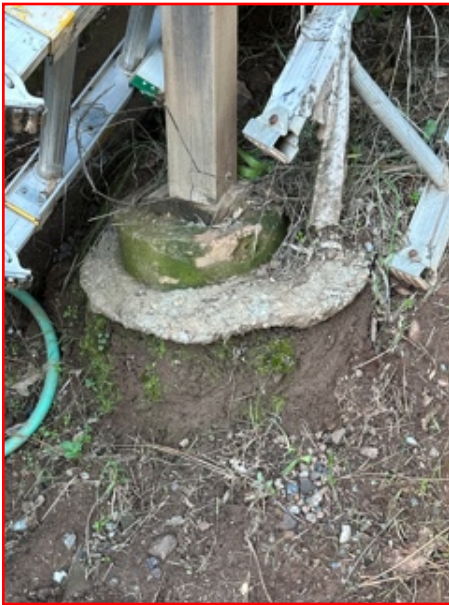
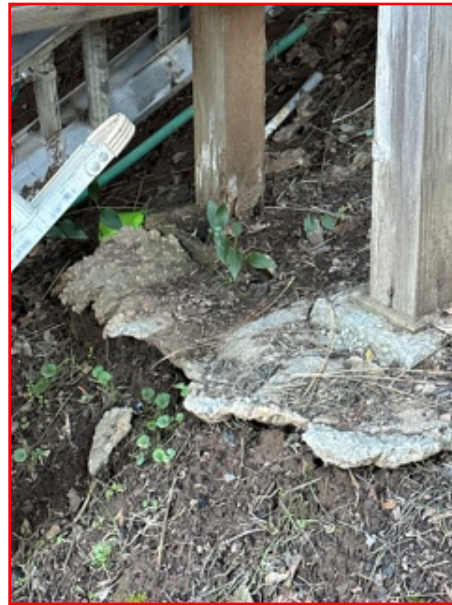
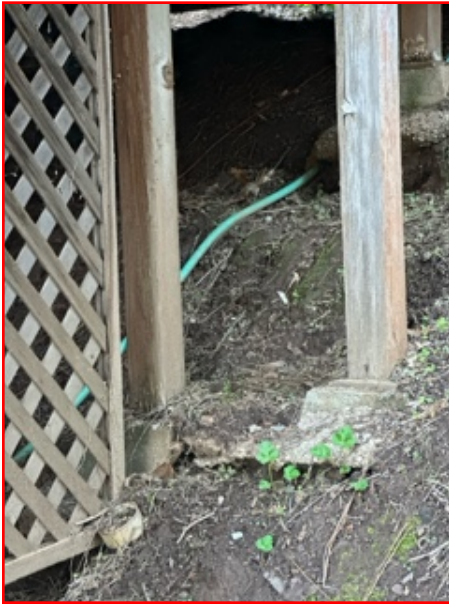
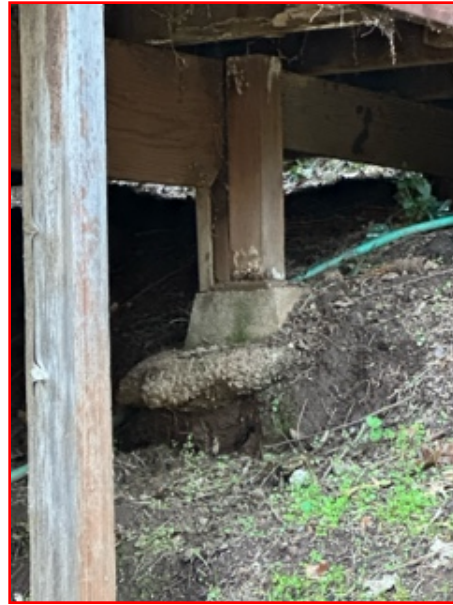
11) Soil has eroded away below the deck piers on right side of home. Refer to a licensed contractor for repair.

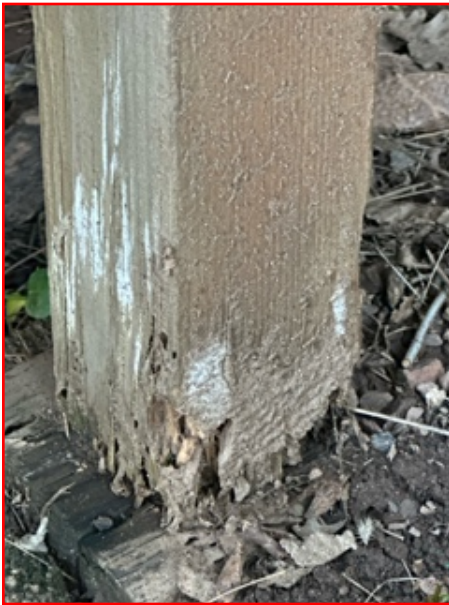
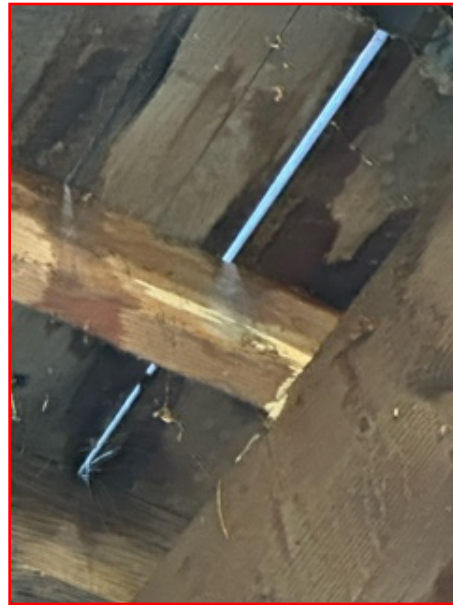
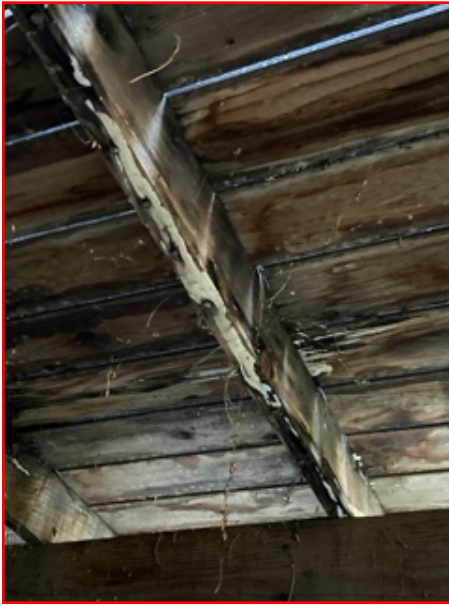
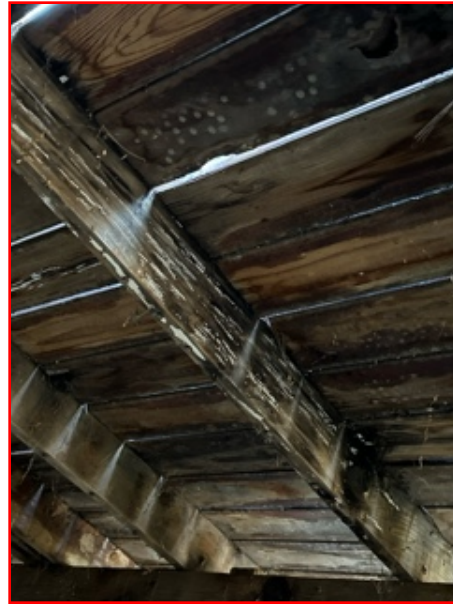
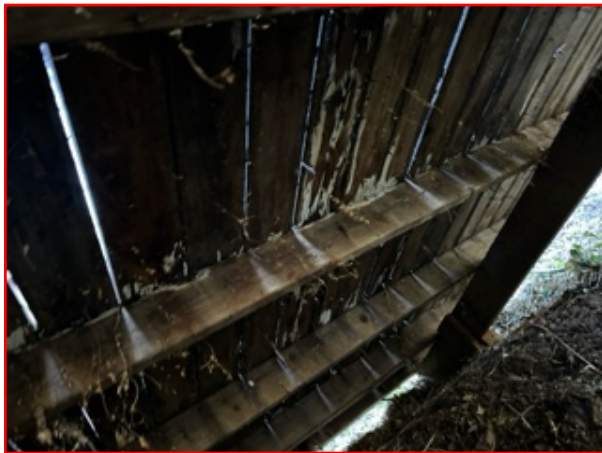
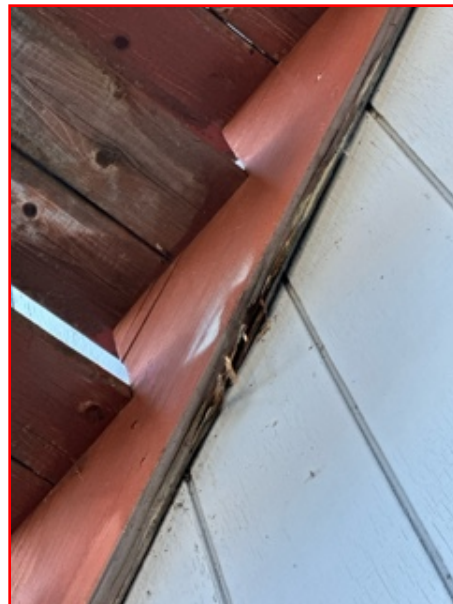
12) Fungus and decay noted on various areas throughout deck structures/attached sidings. Refer to a licensed pest inspector for further evaluation.

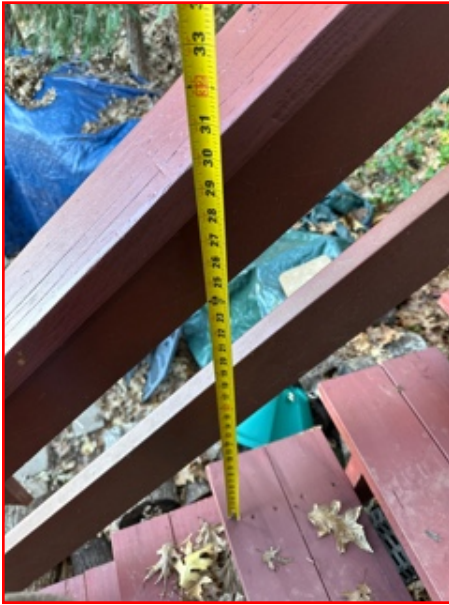
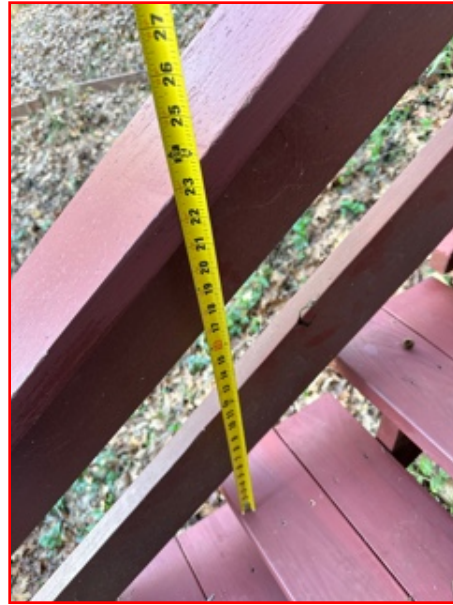
13) Stair railings on home are inconsistent heights, some areas are not to minimum height code. Refer to a licensed contractor.

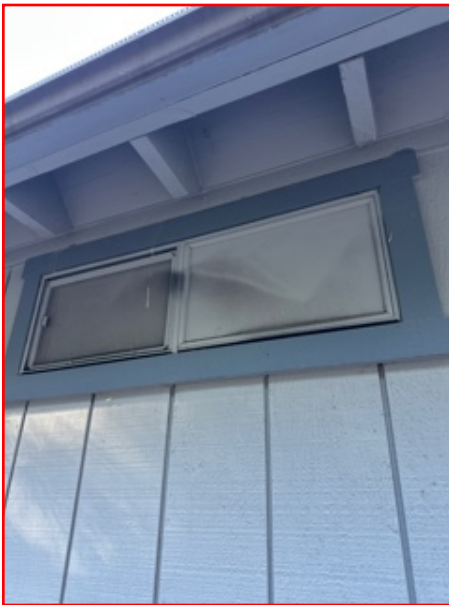
Figure 16-1

14) Bathroom window behind home has been painted over.

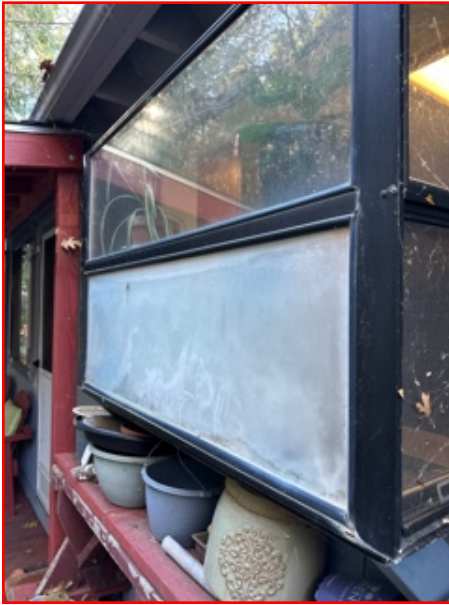
Figure 17-1

15) Kitchen window noted to sweat & in poor condition.
