# Cornerstone Home Inspections

## Home Inspection Report

**20550 Ponderosa Way  
Tuolumne, CA 95379**

Inspected on Tue, Jan 13 2026 at 9:17AM

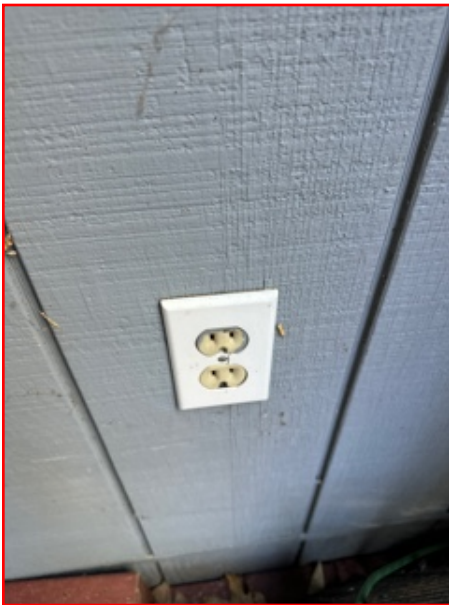
Figure 18-1

16) Receptacle near back door is not weatherproof. Refer to a licensed electrician.

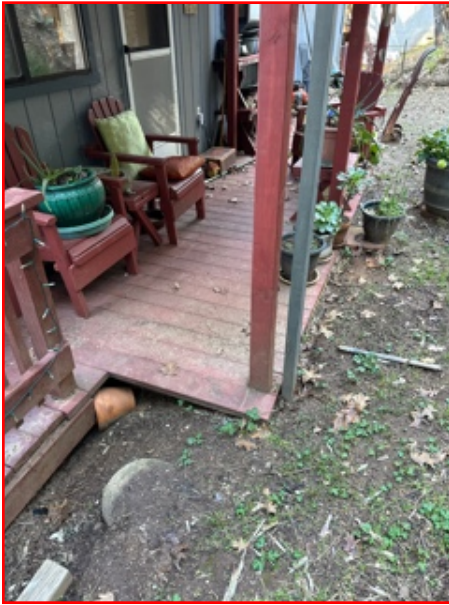
Figure 19-1

17) Back porch is built into the soil.

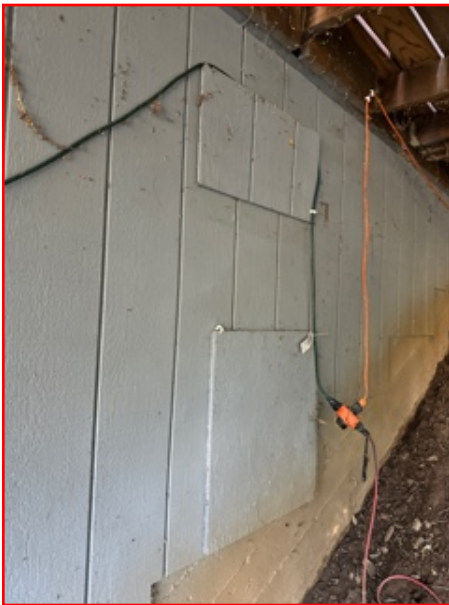
Figure 20-1

18) Improper siding patched noted below deck on right side of home.

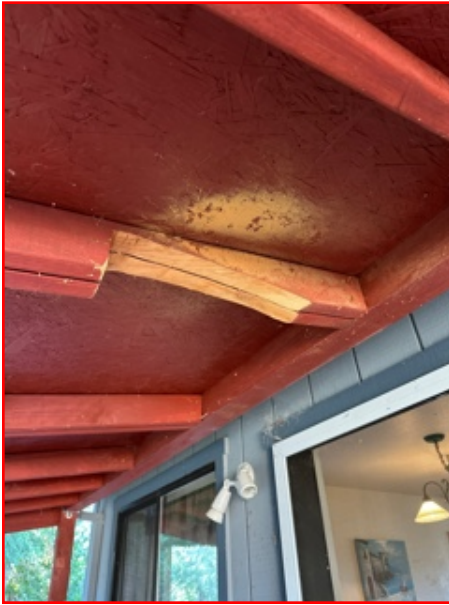
Figure 21-1

19) Rafters for back porch have been cut & should be replaced. Refer to a licensed contractor.

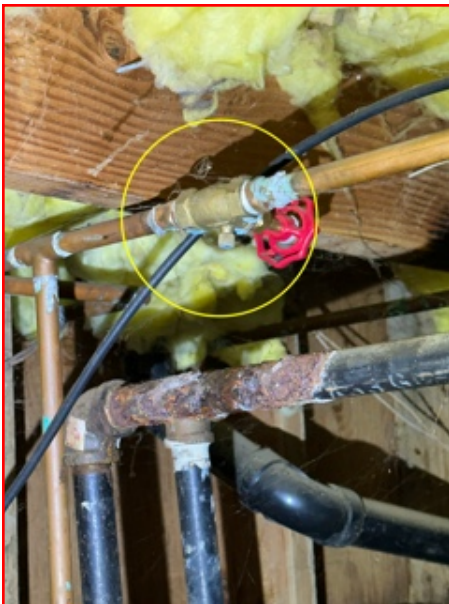
Figure 24-1

21) (Lower left side access). Water valve inside door is leaking onto the gas line below causing corrosion. Refer to a licensed plumber.

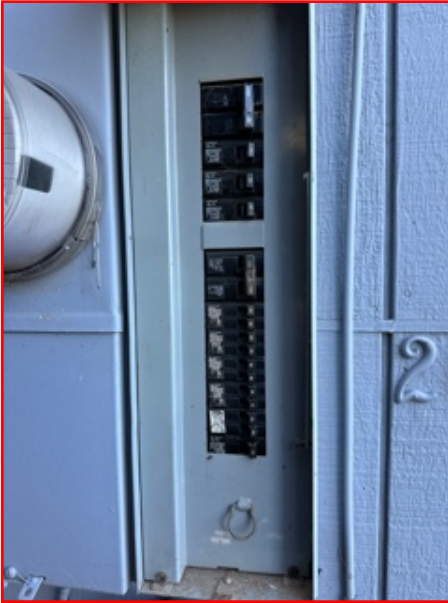
Figure 25-1

22) Main service panel labeling is not complete.

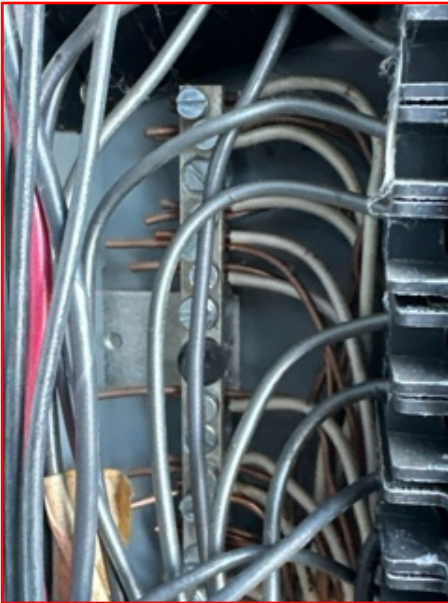
Figure 26-1

23) Each neutral should be attached to its own dedicated lug on the buss bar in the main panel. Refer to a licensed electrician.

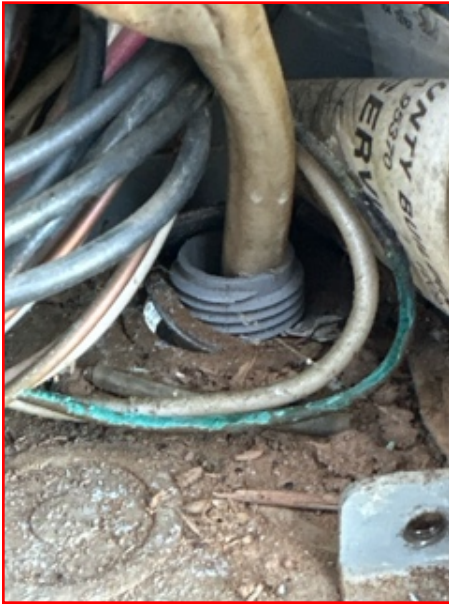
Figure 27-1

24) Conduit connected to base of panel is not attached properly & is providing access for pests.

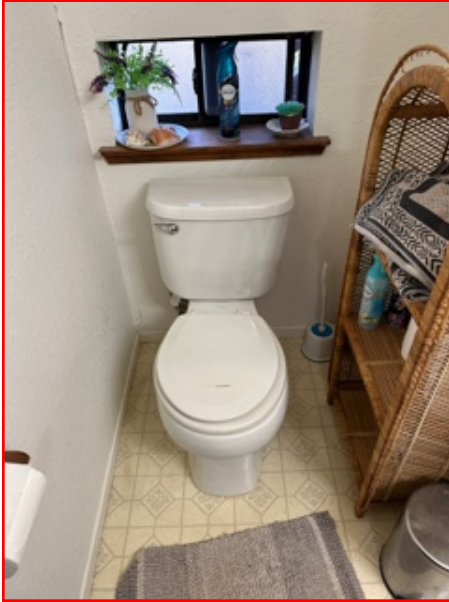
Figure 34-1

Comment 34:  
Apartment-  
Bathroom toilet noted as loose. Recommend tightening to prevent any future leaks.

Bathroom toilet noted as loose. Recommend tightening to prevent any future leaks.

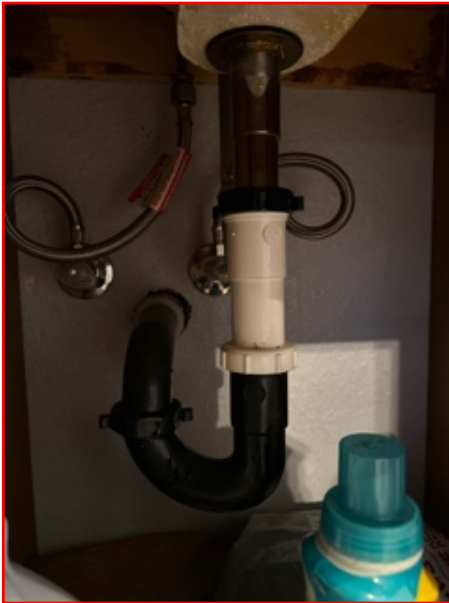
Figure 35-1

**Comment 35:**  
Upstairs bathroom sink drain noted to leak. Refer to a licensed plumber.

29) Upstairs bathroom sink drain noted to leak. Refer to a licensed plumber.

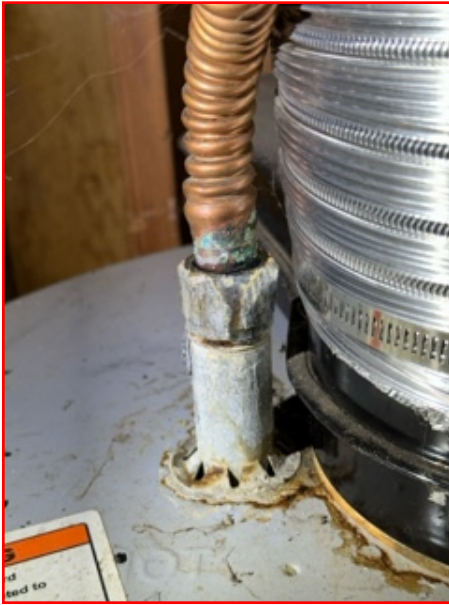
Figure 36-1

**Comment 36:**  
Hot water connection above water heater noted to leak. Refer to a licensed plumber.

30) Hot water connection above water heater noted to leak. Refer to a licensed plumber.

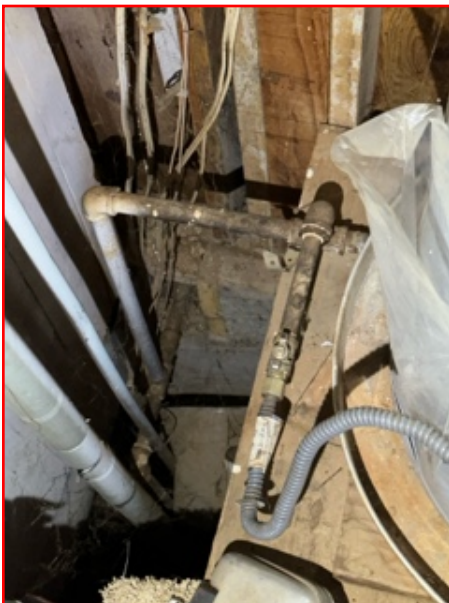
Figure 37-1

No drip leg installed on water heater propane supply line. Recommend installing to catch any particles/debris traveling through the line to prevent orifices from clogging. Refer to a licensed plumber.

31) No drip leg installed on water heater propane supply line. Recommend installing to catch any particles/debris traveling through the line to prevent orifices from clogging. Refer to a licensed plumber.

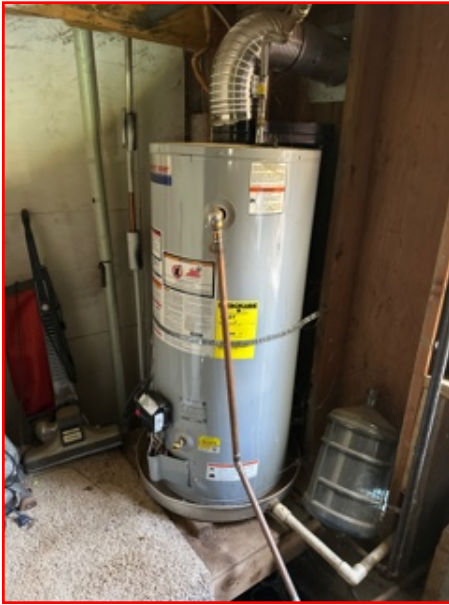
Figure 38-1

Water heater is not properly strapped. One strap should be in the top third, and one strap installed in the bottom third a minimum of 4 inches above the control. Recommend installing as required.

32) Water heater is not properly strapped. One strap should be in the top third, and one strap installed in the bottom third a minimum of 4 inches above the control. Recommend installing as required.

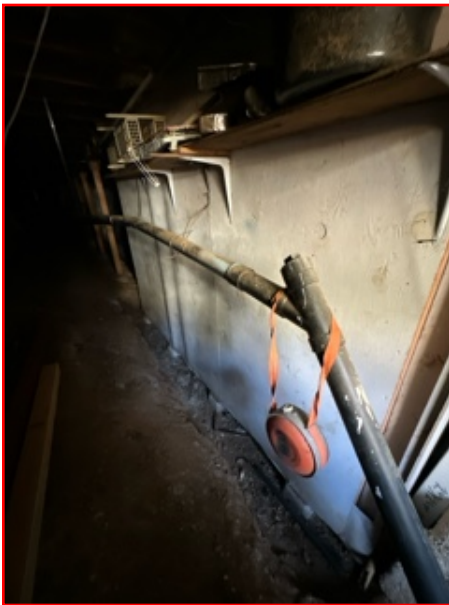
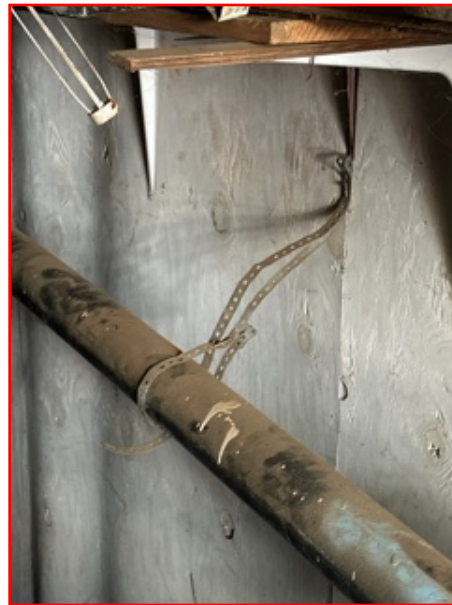
33) Waste lines in crawl space are not properly supported & move freely.

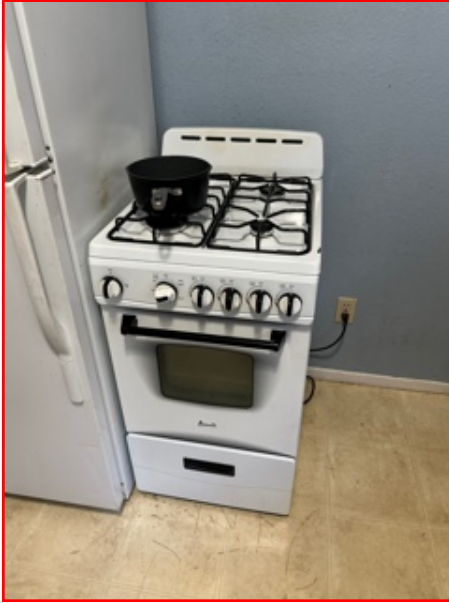
Figure 40-1

No anti-tip bracket installed on oven. Recommend installing to ensure the safety of the appliance.

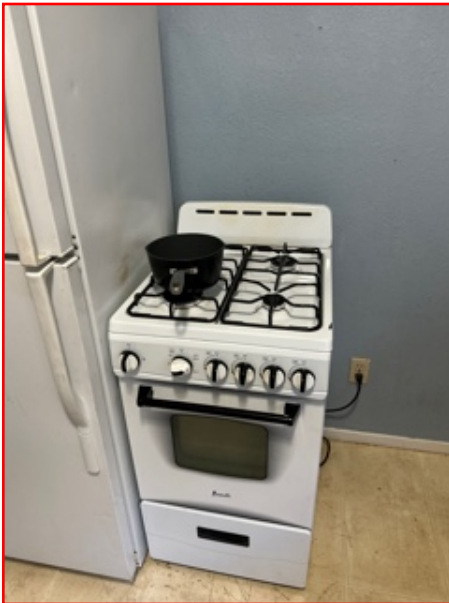
Figure 41-1

Current Ca building code requires ranges have a minimum clearance of 6" on each side.

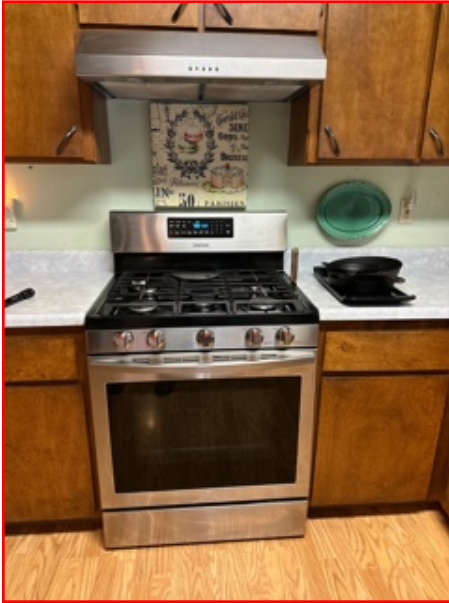
Figure 43-1

No anti-tip bracket installed on oven. Recommend installing to ensure the safety of the appliance.

36) No anti-tip bracket installed on oven. Recommend installing to ensure the safety of the appliance.

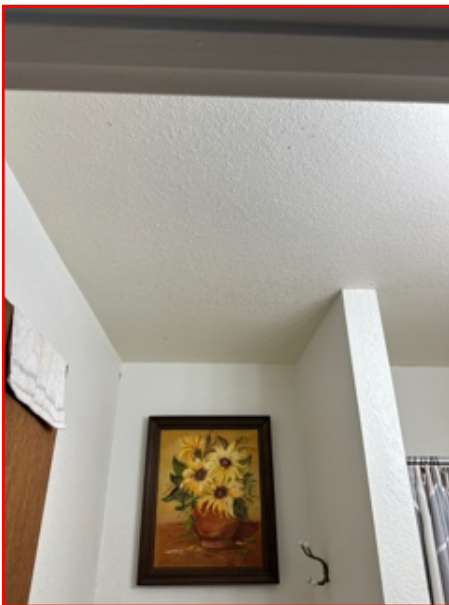
Figure 46-1

No vent fan installed in bathroom. Current CA building code states an exhaust vent fan must be installed in all bathrooms that contain a tub or shower.

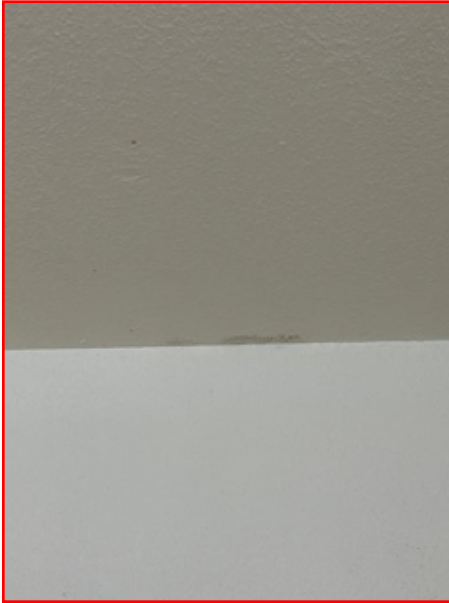
Figure 47-1

Organic type growth noted above shower on ceiling.

38) Apartment-  
Organic type growth noted above shower on ceiling.

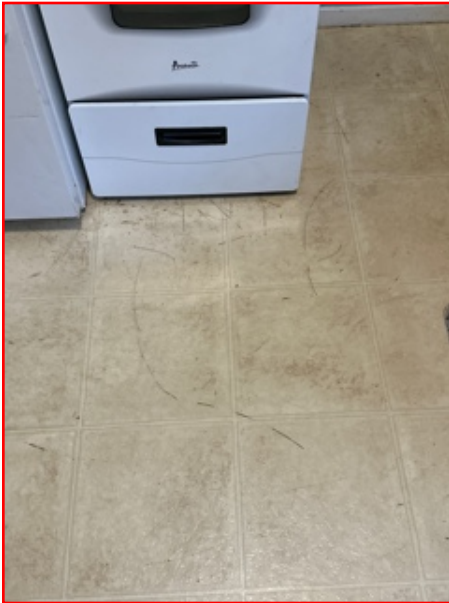
Figure 48-1

Comment 48:  
Apartment-  
Damaged floor noted in kitchen.

39) Apartment-  
Damaged floor noted in kitchen.

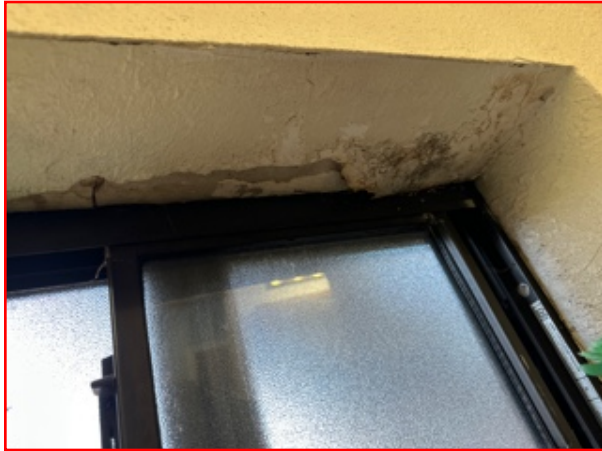
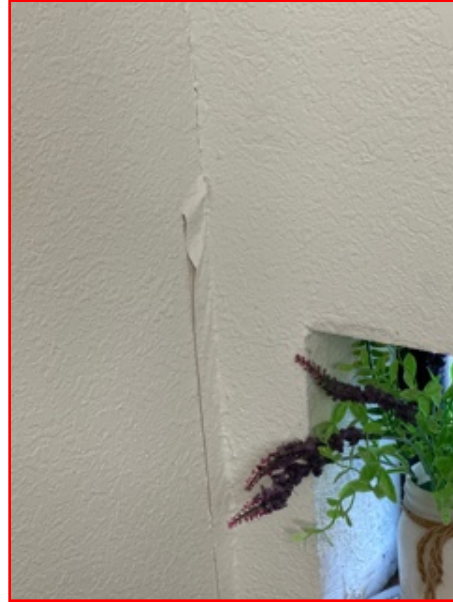
Moisture damage & poor drywall tape job noted in area surrounding bathroom window. Refer to a licensed contractor.

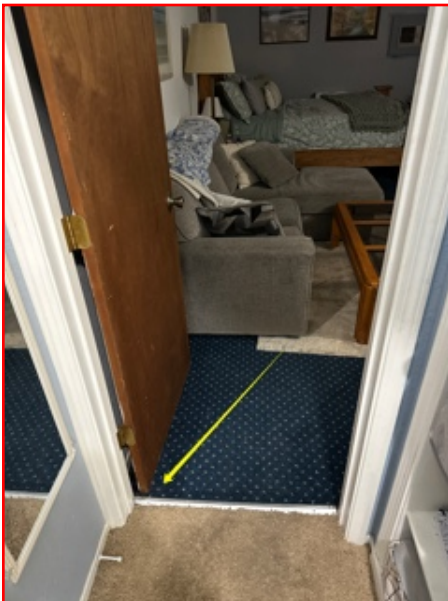
Figure 50-1

Bedroom door hits transition and fails to close.

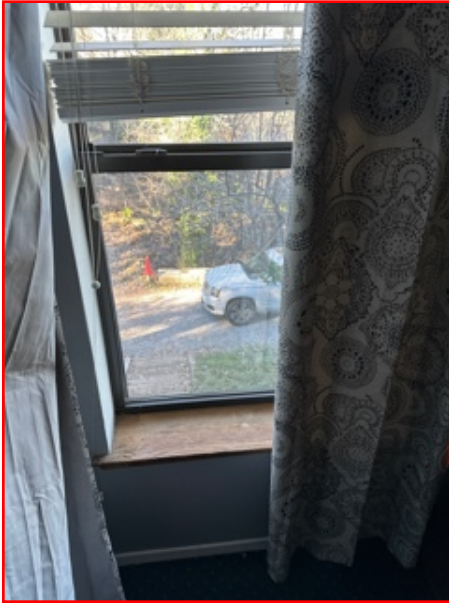
Figure 51-1

Comment 51:  
Apartment-  
Left bedroom window fails to stay open.

42) Apartment-  
Left bedroom window fails to stay open.

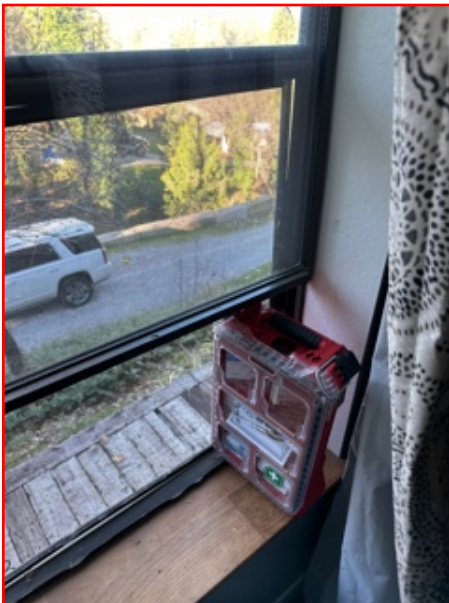
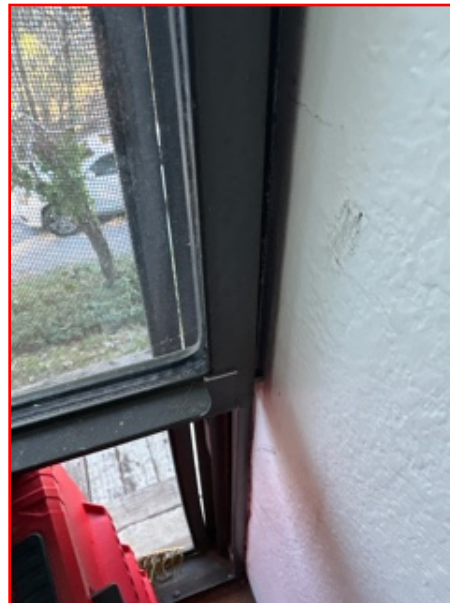
Right bedroom window is outside the frame and propped up. Refer to a qualified tradesman for repair. Frame also noted to contain large dents.

43) Apartment-  
Right bedroom window is outside the frame and propped up. Refer to a qualified tradesman for repair. Frame also noted to contain large dents.

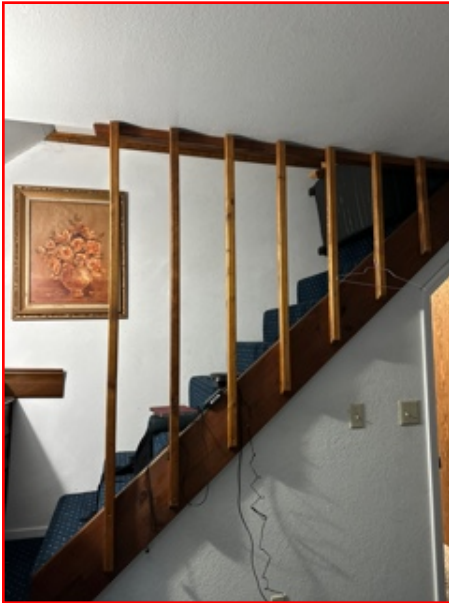
Figure 53-1

Stairs are not closed off. Any area with a 30" + drop must be secured with a guardrail. Current CA building code requires pickets be installed with a spacing of 4" or less. Recommend repair, refer to a licensed contractor.

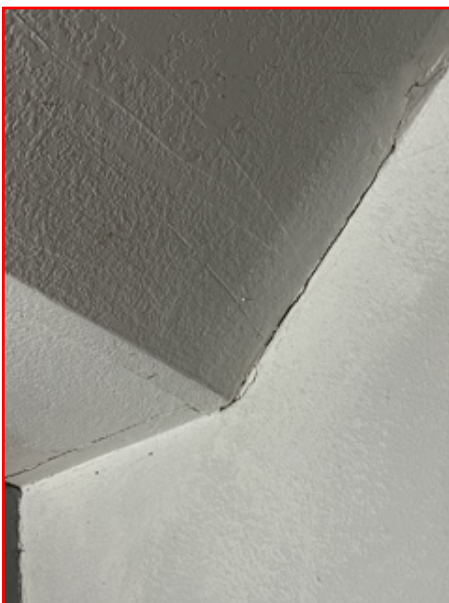
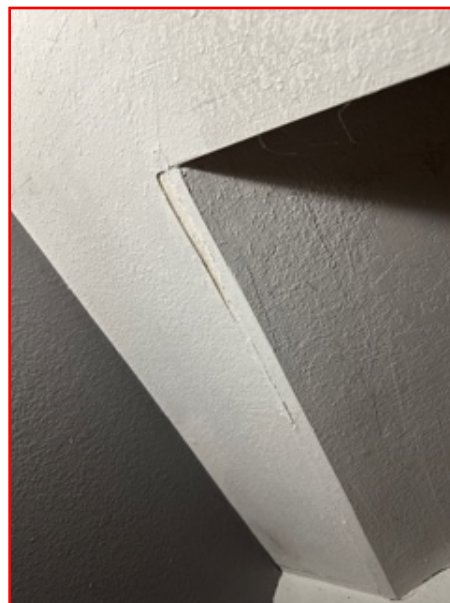
Cracked drywall noted in area around stairs. Considering these cracks only occur on tape seams, likely caused due to a poor drywall tape job.

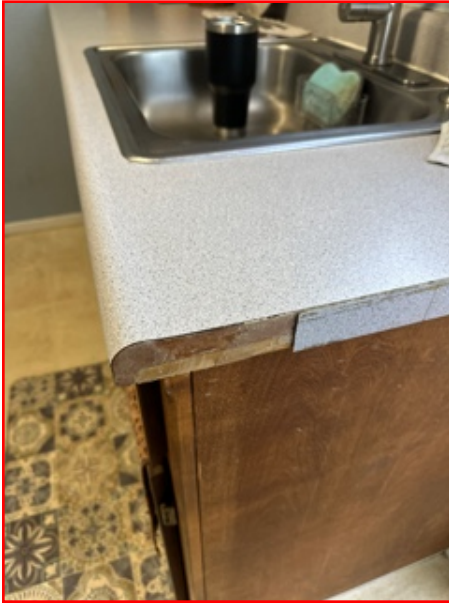
Figure 55-1

Comment 55:  
Apartment-  
Edges of kitchen counter noted as delaminated.

46) Apartment-  
Edges of kitchen counter noted as delaminated.

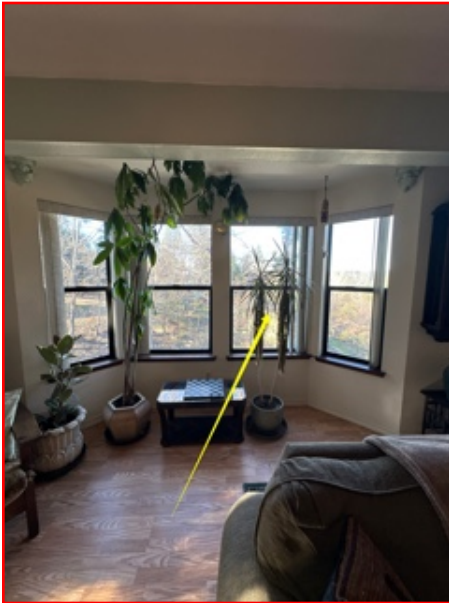
Figure 56-1

Comment 56:  
Window shown in living area has a broken or disconnected channel balance on right side.

47) Window shown in living area has a broken or disconnected channel balance on right side.

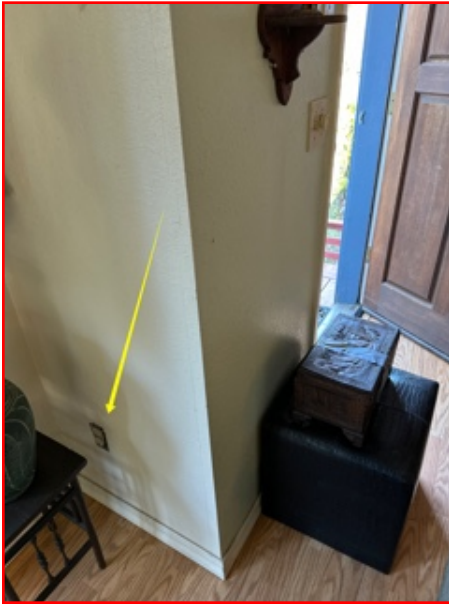
Figure 57-1

Receptacle near front door is missing the faceplate.

48) Receptacle near front door is missing the faceplate.

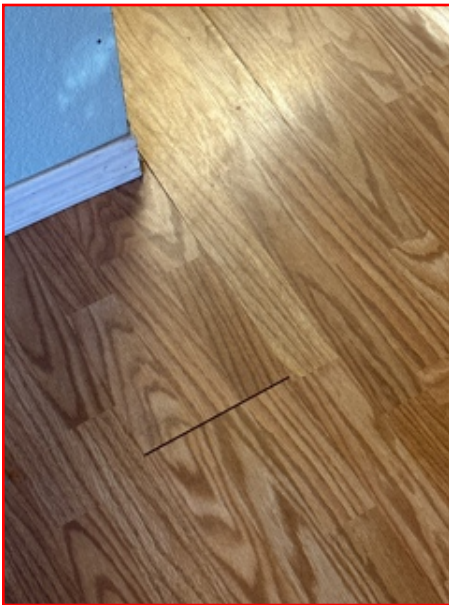
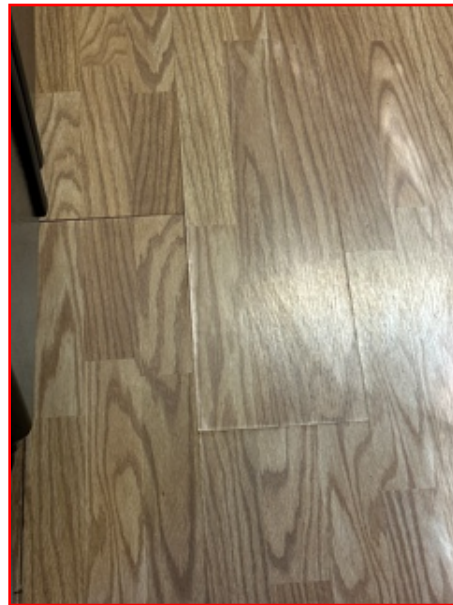
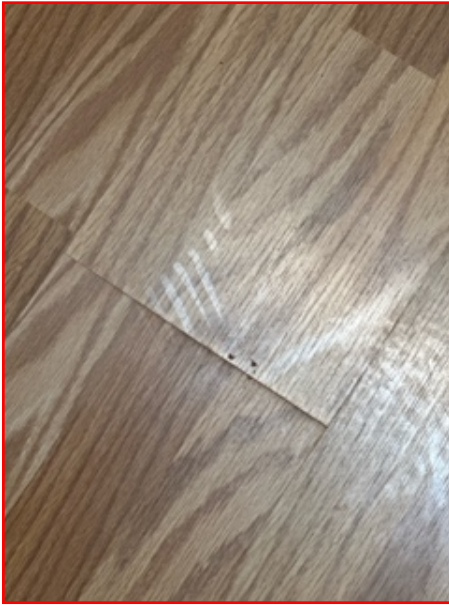
Laminate floor in kitchen area noted as damaged.

49) Laminate floor in kitchen area noted as damaged.

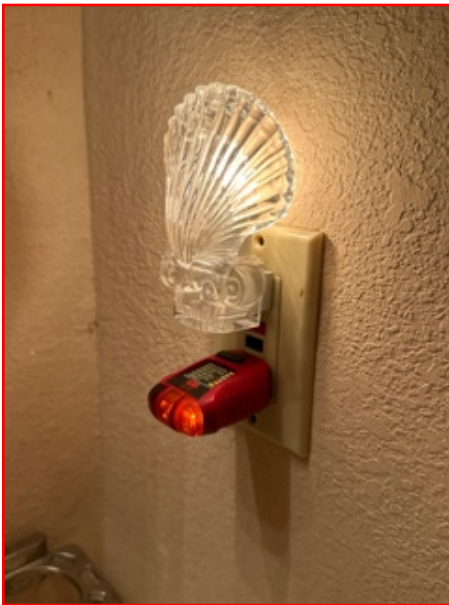
Figure 59-1

GFCI in bathroom on main level fails to trip.

50) GFCI in bathroom on main level fails to trip.

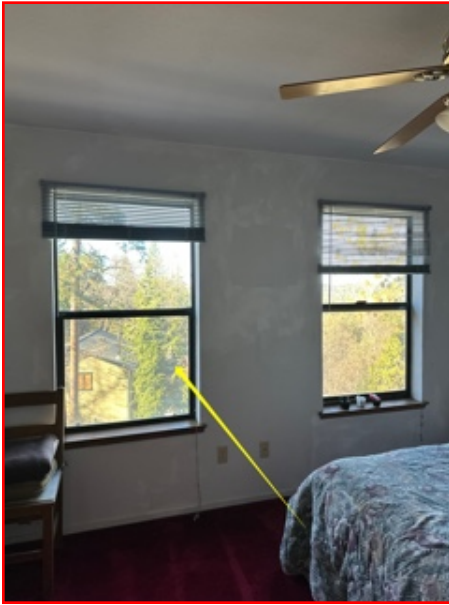
Figure 62-1

Left guest bedroom window shown has broken/ disconnected channel balances.

53) Left guest bedroom window shown has broken/ disconnected channel balances.

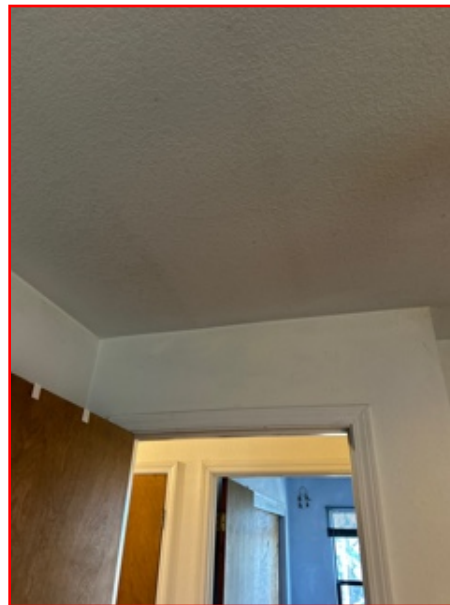
Figure 63-2

Multiple smoke alarms missing in home. Recommend to install as required.

54) Multiple smoke alarms missing in home. Recommend to install as required.

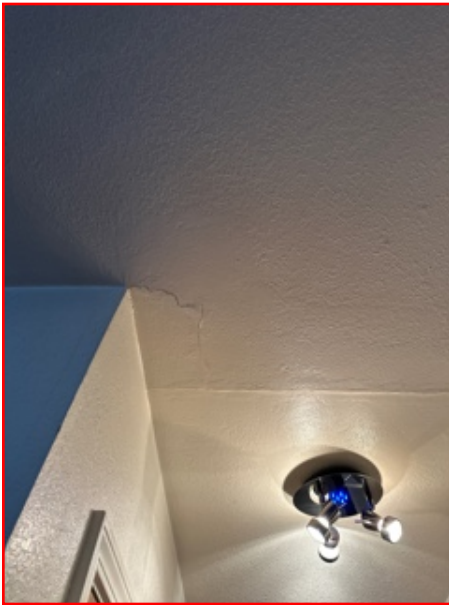
Figure 65-1

56) Drywall cracks noted in various areas throughout home.

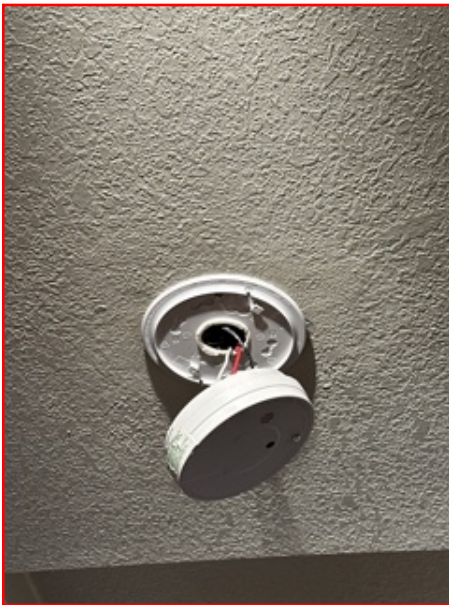
Figure 66-1

57) Hallway smoke alarm is hanging by the wires.

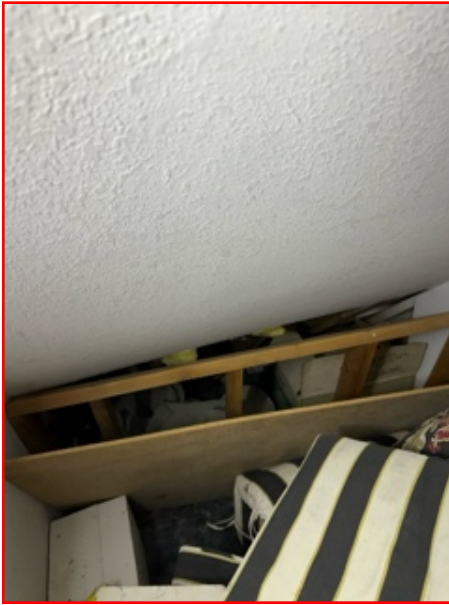
Figure 68-1

58) Upstairs right bedroom closet remains unfinished & is open into the attic.

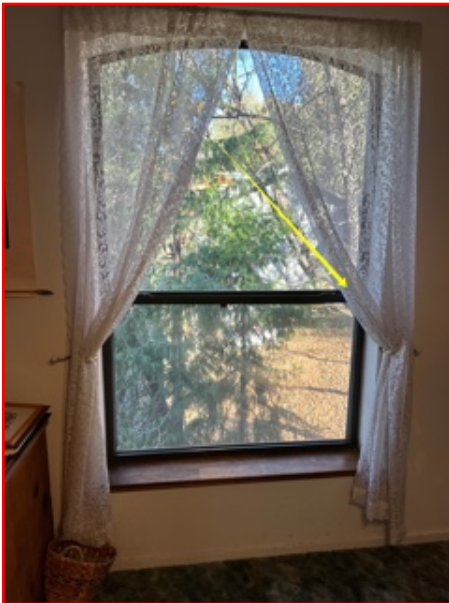
Figure 69-1

59) Left guest bedroom upstairs window shown is falling out from frame on the right side. Refer to a qualified tradesman.

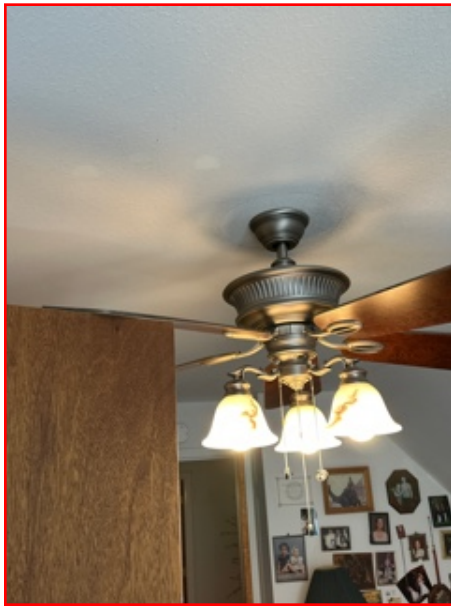
Figure 70-1

60) Master bedroom fan upstairs strikes the bathroom door.

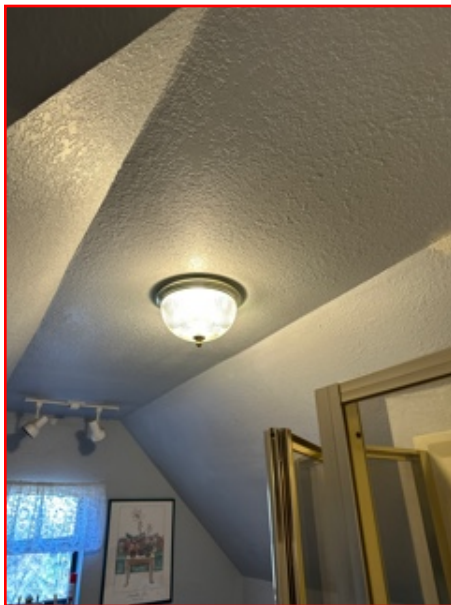
Figure 71-1

61) No vent fan installed in master bathroom. Current CA building code states an exhaust vent fan must be installed in all bathrooms that contain a tub or shower.

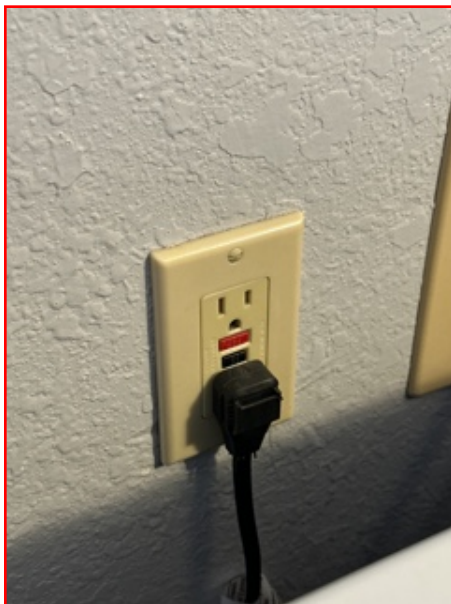
Figure 72-1

62) Bathroom receptacles are tied into the laundry GFCI circuit. Washing machines should be on their own dedicated electrical circuit. Refer to a licensed electrician.
