### *Inspection Report*

Address: 280 Spruce St Arroyo Grande, CA 93420

09/15/2026

Inspector: Taylor Vreeken, CCI

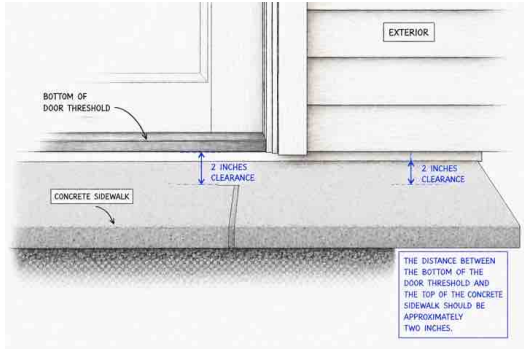
**UPG DS** 23: Areas of the exterior walkways found to be improperly installed high, at or above the exterior siding and and/or the door threshold. This can allow for moisture or water to buildup and collect behind the exterior siding and trim and can potentially wick water into the wall framing and living spaces. This can also allow water to intrude into the framing or living spaces from under the door thresholds.

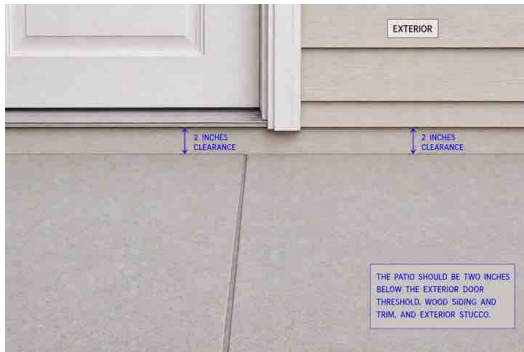
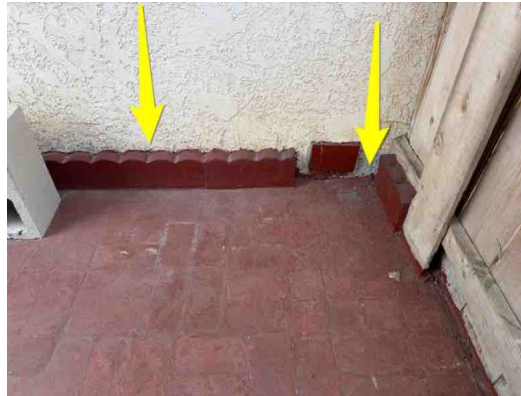
**UPG DS 27: Disclosure:** Areas of some patios were installed high at or above the exterior siding. This can potentially under certain conditions, allow for moisture to accumulate at the base of the sliding and can cause deterioration or water intrusion inside the wall cavities.

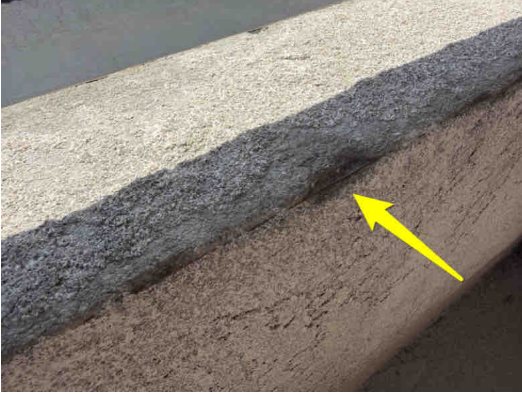
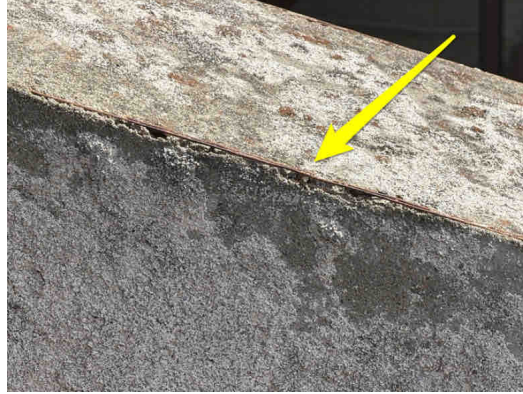
**E&C FI 33:** Areas of the stucco metal lathe found exposed and subject to the elements. Contact a qualified stucco professional for evaluation and upgrades/repairs.

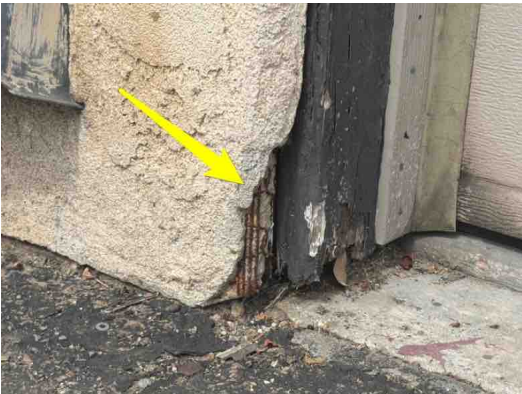
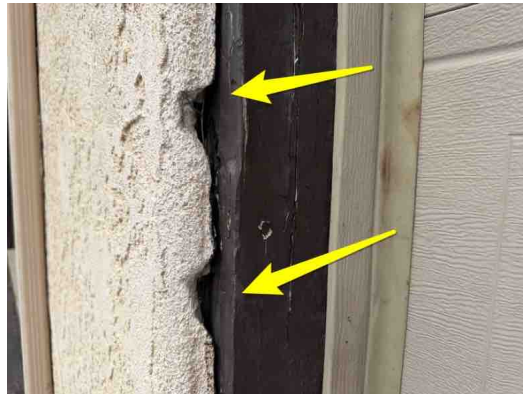
**MR DS 35:** Some moderate and heavy chipping or damage to the exterior stucco. Maintenance or repairs recommended.

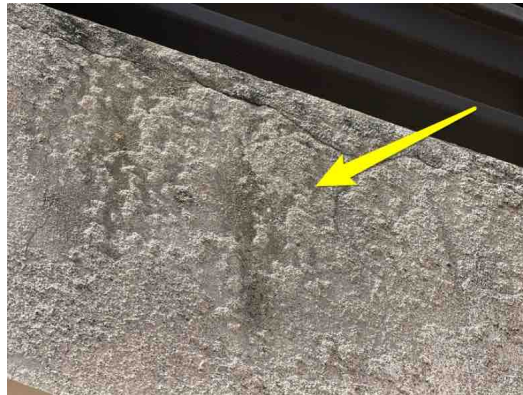
**E&C FI 36:** Some moderate and heavy deterioration or damage to the exterior stucco color coat. Maintenance or repairs recommended.

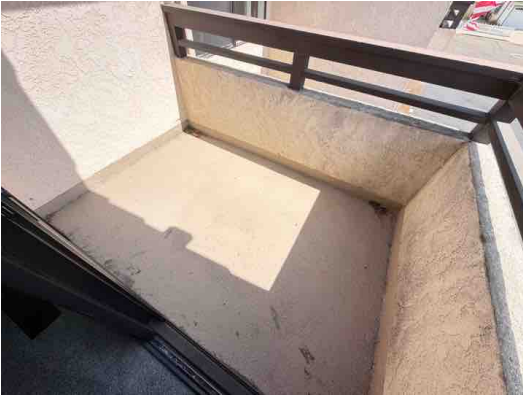
43: DECK LOCATION: **UPSTAIRS DECK OFF THE PRIMARY BEDROOM**

DECK TYPE: Waterproof - Coated

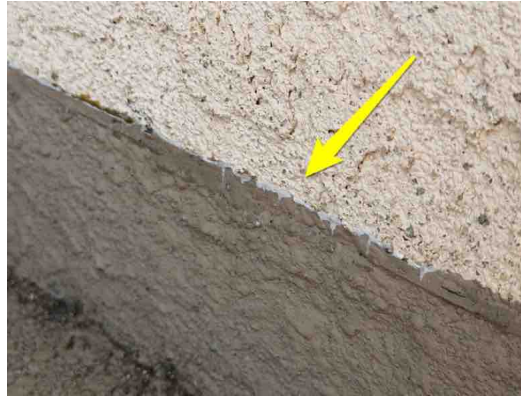
**45:** The waterproof deck coating was not properly separated or flashed at portions of the adjoining stucco walls and exterior sliding-glass door. The coating appears to terminate directly against the stucco and door frame with surface-applied sealant used at the transitions. These conditions can allow moisture intrusion as the sealant deteriorates or separates. Recommend evaluation and correction of the perimeter waterproofing and flashing details by a qualified waterproof-deck contractor.

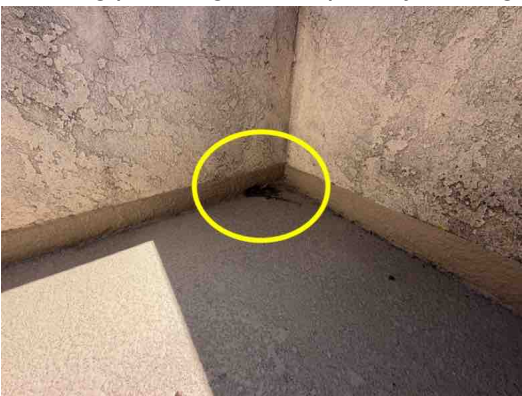
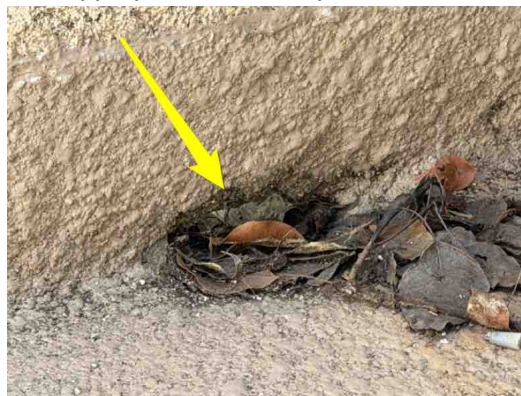
**FI 46:** The waterproof deck was provided with a single small drainage opening at the perimeter wall. The opening was unprotected and partially obstructed by accumulated debris, and no secondary/overflow drainage provision was observed. This arrangement is susceptible to blockage and may result in ponding and moisture intrusion if drainage becomes restricted. Recommend evaluation and correction by a qualified waterproof-deck contractor, including providing reliable primary drainage and an appropriate overflow provision where feasible.

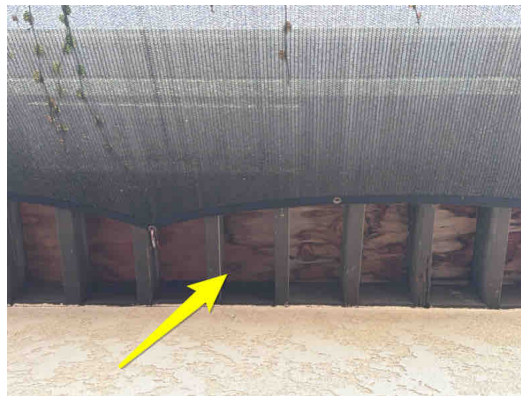
**FI 55:** Evidence of recent roof leakage was observed at the roof overhang area, including visible moisture staining and damage: BACKYARD. These conditions indicate a failure of roofing components and possible concealed damage. Recommend further evaluation by a qualified roofing contractor to determine the source, full extent of damage, and to perform necessary repairs.

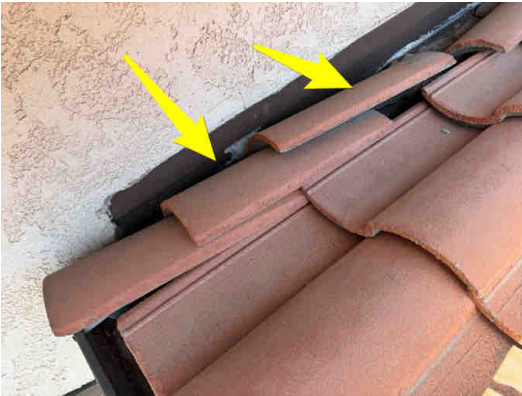
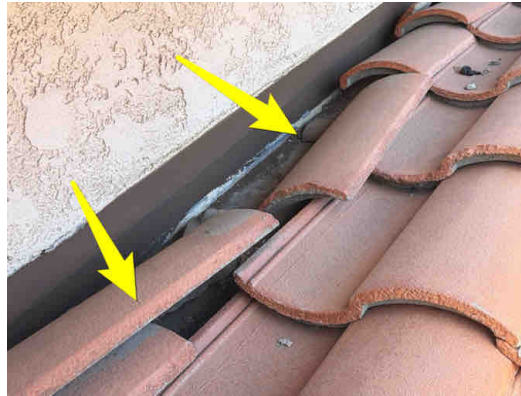
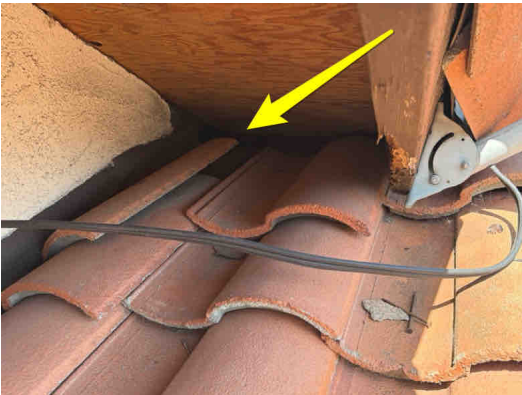
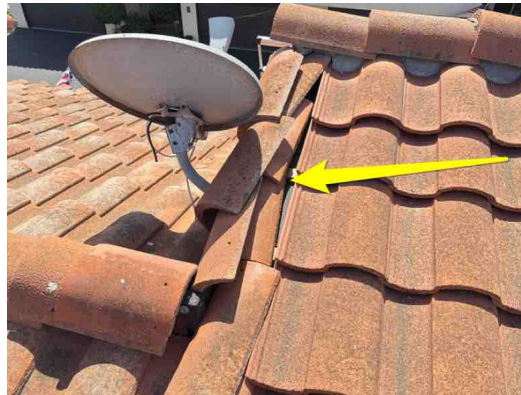
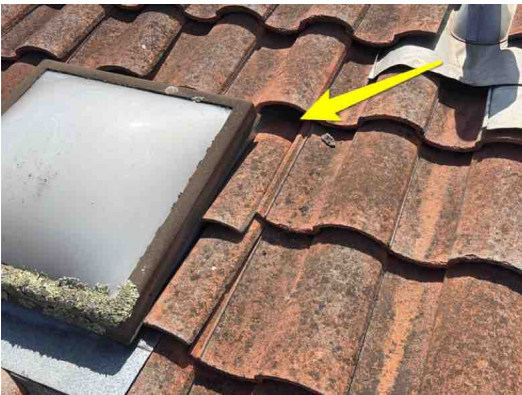
**E&C MR 57:** Some loose roof tiles needing repair or maintenance found missing the required approved fastener, nail, or batten extender at areas of the tile roof. Recommend further review of the roof by a qualified / licensed roofing contractor to determine quantity of repair or maintenance needed.

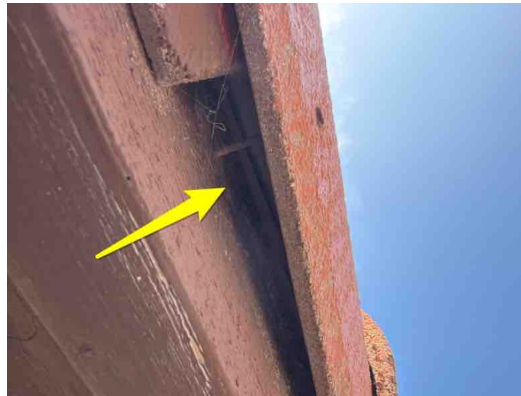
**E&C 60:** Areas found where the roof tar paper was not properly folded over the rake edges along the fascia. Contact a licensed roofer to evaluate and repair as needed. Refer to the manufacturer's requirements.

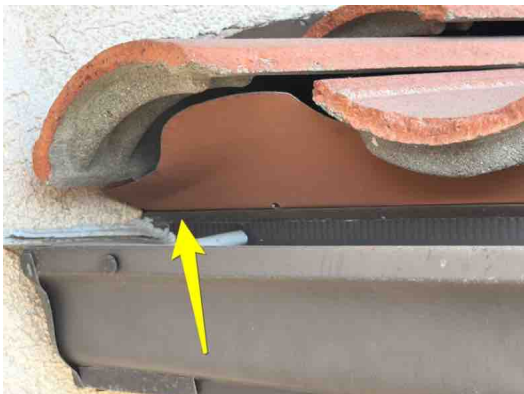
**E&C 61:** Some channel flashings found not properly passing through the roof tile lifter or bird stop flashing or is blocked by an improper installation. This can allow water to backup or be redirected behind the tile lifter of bird stop flashing and can potentially cause a roof leak.

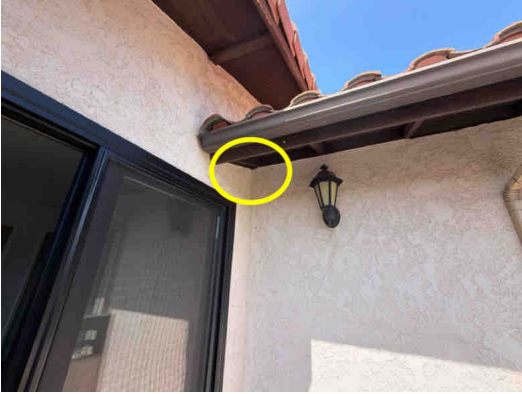
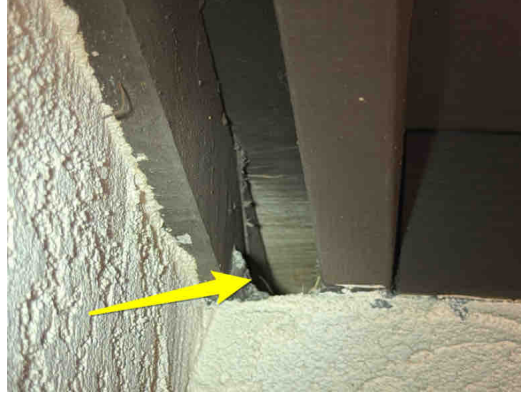
**E&C 73:** Unprotected openings into the attic or confined spaces from the exterior should be sealed or screened per standards to help keep rodents out of the attic.

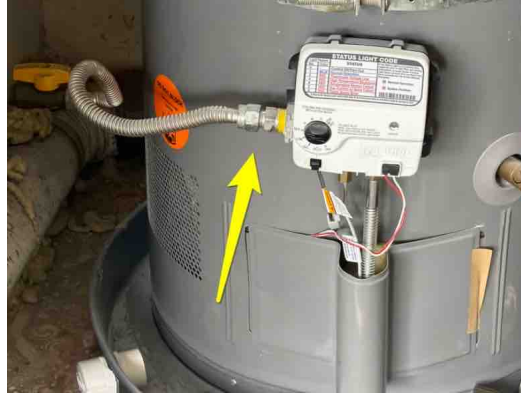
**SU 97:** Recommend the installation of the missing sediment trap / drip leg at the WATER HEATER gas piping at flex connection by a certified or licensed plumbing professional familiar with minimum requirements. [CPC 1212.8]

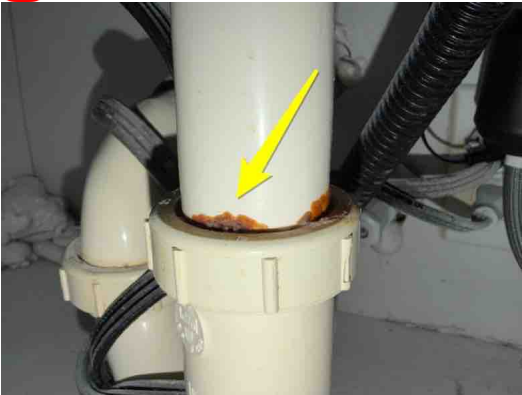
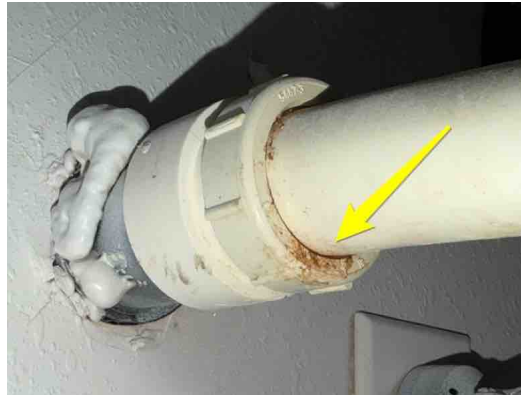
**FI 102:** Some corrosion found at waste pipe connections under the kitchen sink / evidence of past leaking.

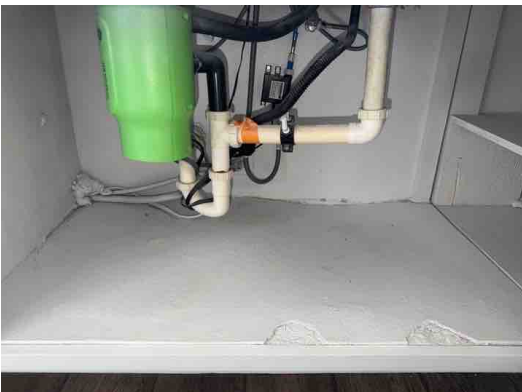
**FI 103:** Moisture stains and damage below the kitchen sink. The full extent of the moisture damage is unknown at this time.

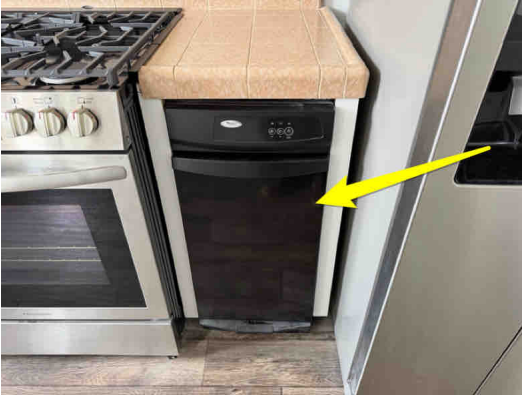
**E&C 118:** Trash Compactor found non-operational.

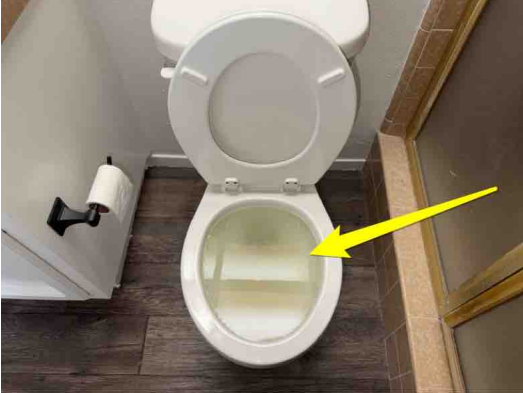
**E&C 131:** The DOWNSTAIRS HALLWAY BATHROOM toilet was clogged and did not drain properly when tested. Recommend clearing the blockage and verifying proper drainage and operation; further evaluation by a qualified plumber is recommended if the issue persists.

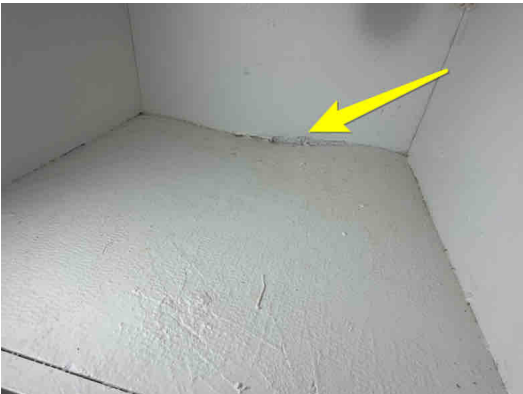
**FI 133:** Some moisture stains and/or damage noted in the cabinetry below the sink in the: UPSTAIRS HALL BATHROOM

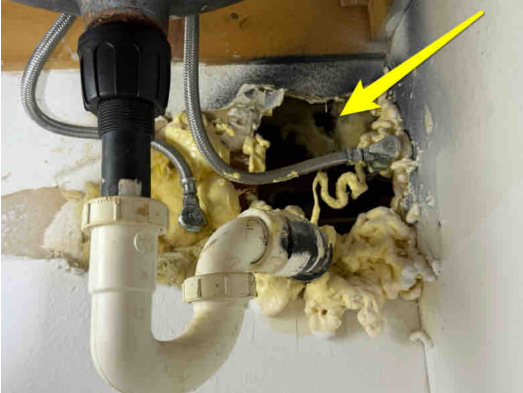
**E&C UPG 134:** Damaged or Missing drywall along the back wall in the cabinet under the UPSTAIRS HALL BATHROOM sink. The drywall may have been removed to perform a plumbing repair or due to water damage. Referred to the seller's disclosure for additional comments or information. Repairs recommended.

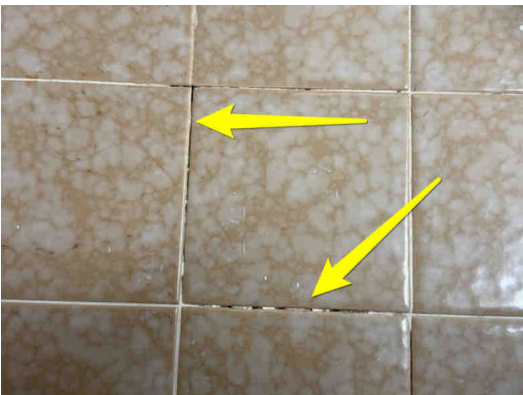
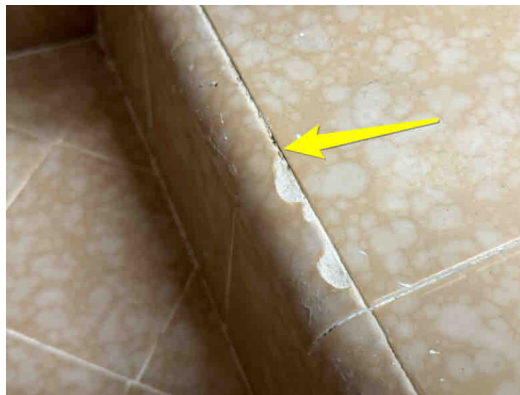
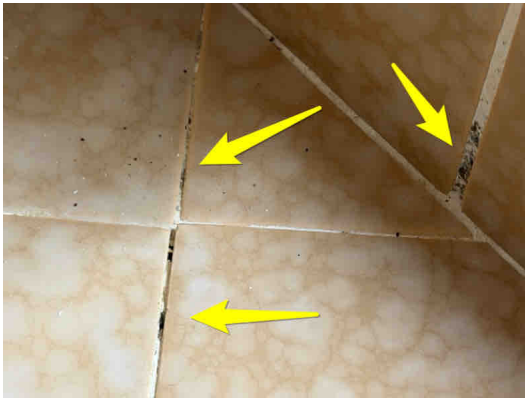
**MR 138:** Some visible, moderate and minor deterioration to the grout in areas of the tiled shower enclosures. Maintenance recommended.

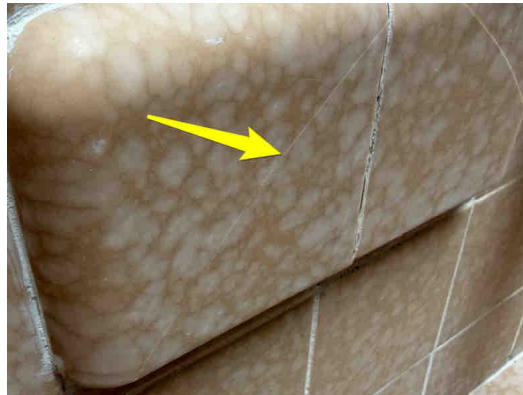
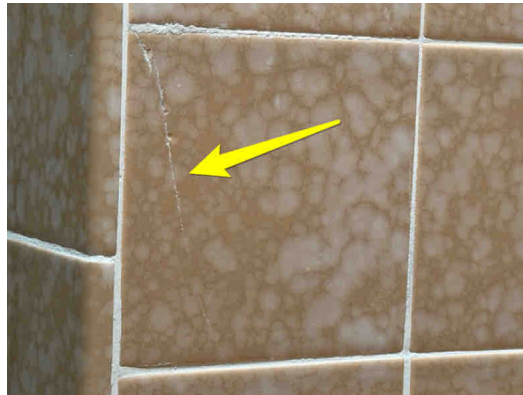
**FI 139:** Some cracked tiles in the UPSTAIRS HALL BATHROOM shower enclosure. Recommend contacting a tile professional to evaluate and determine cause, condition and if repairs are warranted.

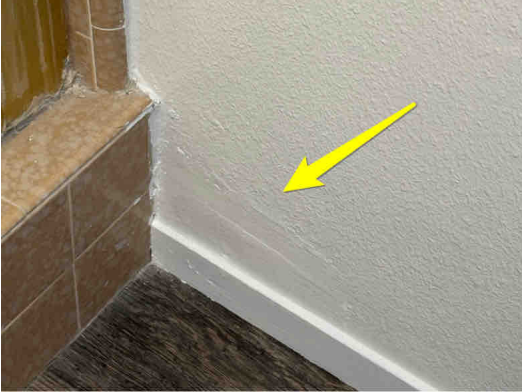
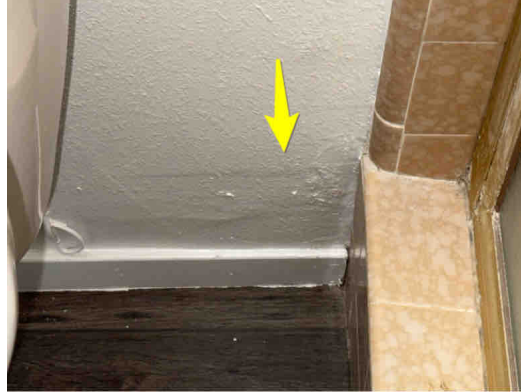
**FI 140:** Moisture stains & damage to walls, baseboards and/or floor outside shower: DOWNSTAIRS HALL BATHROOM

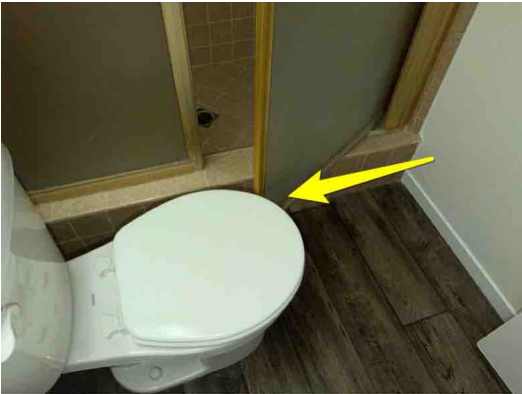
**E&C SC 142:** The DOWNSTAIRS HALLWAY BATHROOM glass shower door contacts the toilet when opened and cannot fully open as intended. This limits normal access to the shower and may result in damage or breakage of the glass door and/or toilet. Recommend modification of the shower door/enclosure as needed to provide adequate clearance and proper operation.

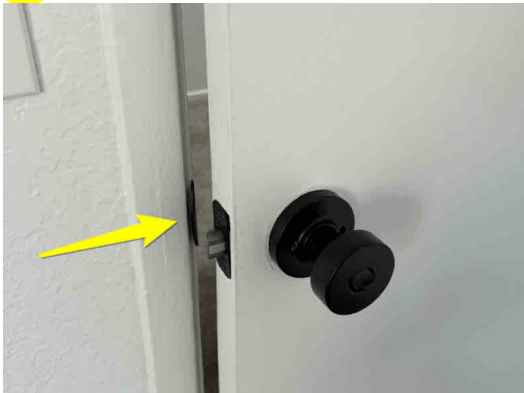
**MR 152:** Interior door does not latch. Recommend adjustment of the strike plate: BEDROOM-1

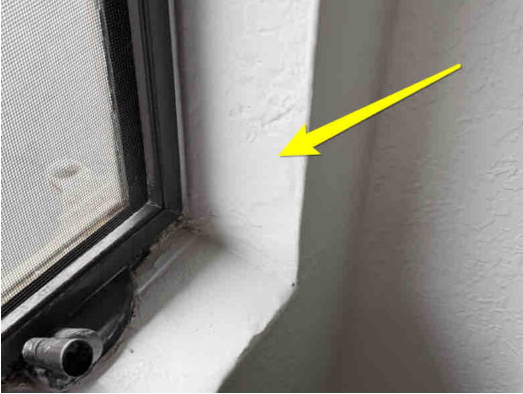
**FI 155:** Moisture stains and/or damage on the inside at some window sills. Refer to the termite report for additional comments and recommendations.

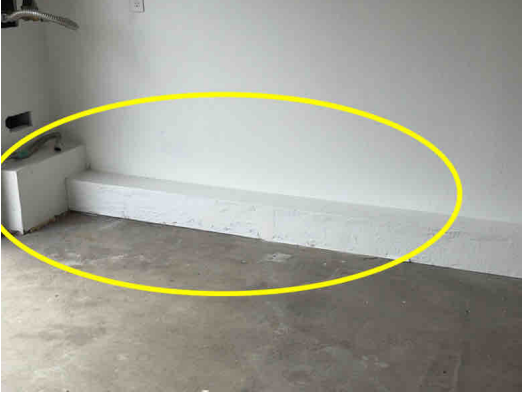
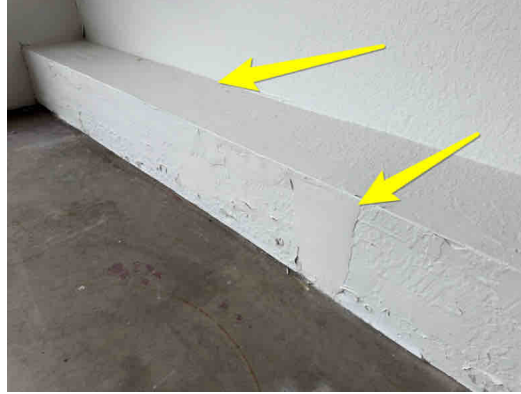
**FI 165:** Evidence of moisture stains and/or damage at the walls in the GARAGE. Recommend further review of the water stains to determine the cause, the current condition and if repairs are needed.

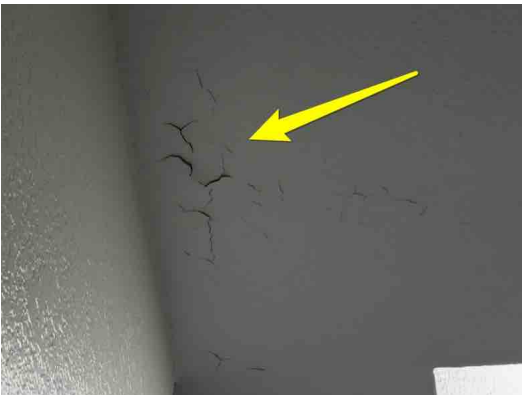
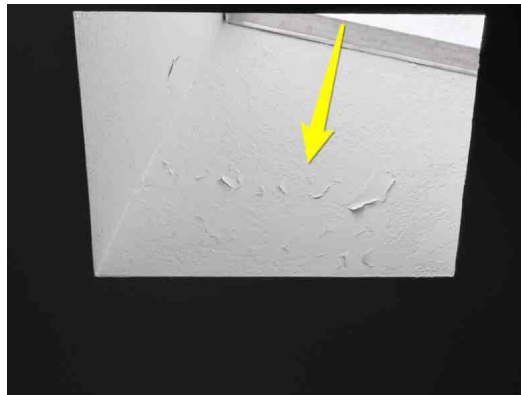
**E&C 166:** Multiple areas of apparent moisture staining and/or paint deterioration were observed at the top of the interior stairway and in the living room. The interior appears to have been recently painted, which limits the ability to determine whether these conditions are recent, ongoing, or related to previous moisture intrusion. Recommend determining the source and repairing as needed, and monitoring these areas for evidence of continued moisture intrusion.

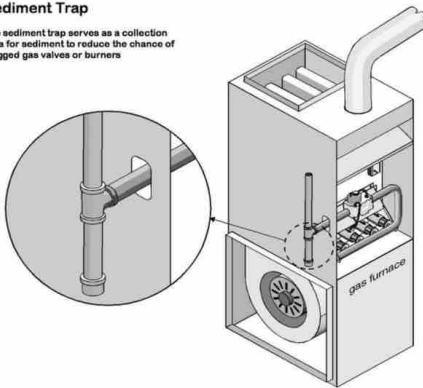
### Sediment Trap

**UPG 173:** Missing the required installation of the sediment trap at the furnace gas piping at flex connection. Correction should be performed by a certified or licensed HVAC professional familiar with minimum requirements.

The sediment trap serves as a collection area for sediment to reduce the chance of clogged gas valves or burners.

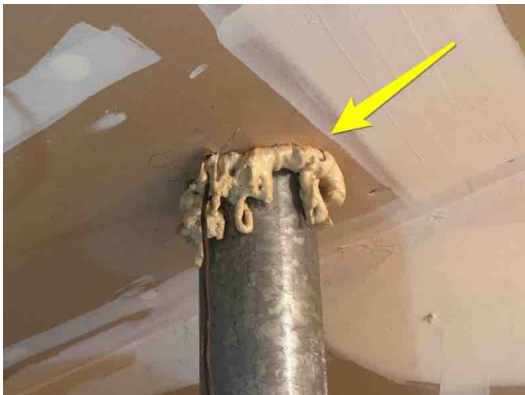
**E&C 175:** Furnace vent pipe lacks proper clearance to combustible material through the drywall ceiling. A minimum of 1 inch of space between the vent pipe and combustibles is needed per minimum standards.

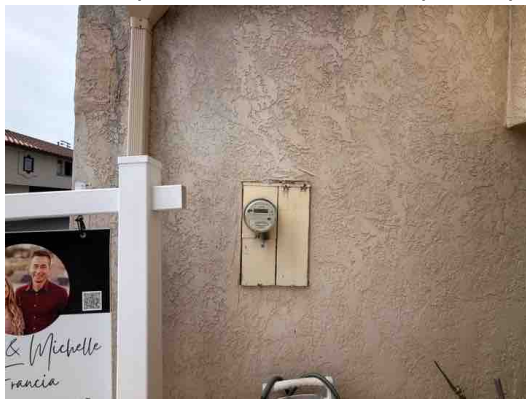
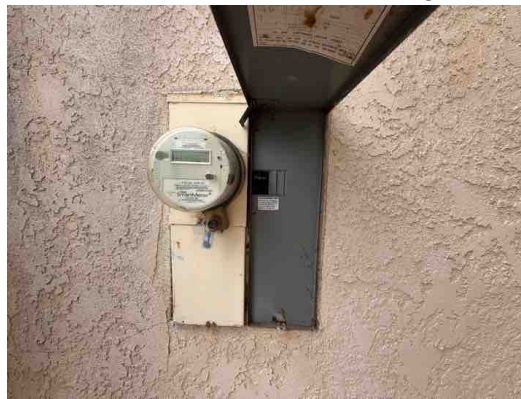
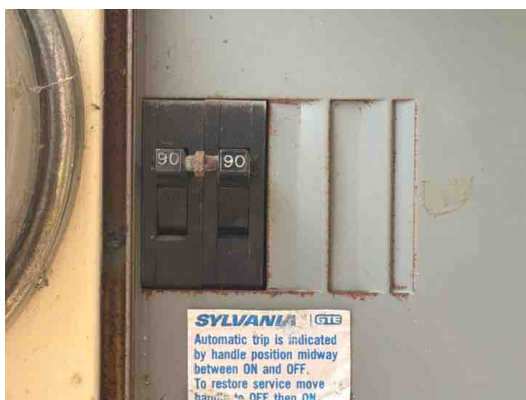
**E&C 183:** The home is equipped with a Zinsco/Sylvania-GTE electrical panel. These panels have a documented history of reliability concerns, including reports of breakers that may fail to operate as intended under certain fault conditions. In addition, some insurance carriers may decline coverage or require panel replacement prior to issuing a policy. Recommend further evaluation by a qualified electrician and consultation with the prospective insurance carrier regarding insurability requirements.

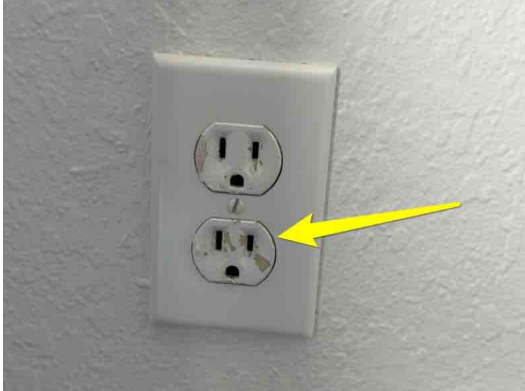
**SU 185:** The outlets were improperly painted. This could make loose or improper connections when appliances are plugged in. Potential safety hazard. All painted receptacles should be replaced for safety.

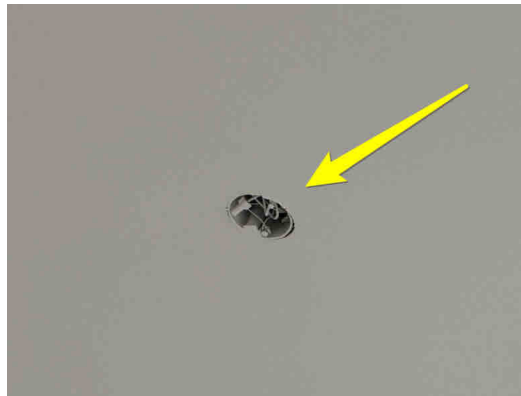
**SC 188:** Light fixture is missing, exposed wiring. Recommend repair or replacement: LIVING ROOM CEILING

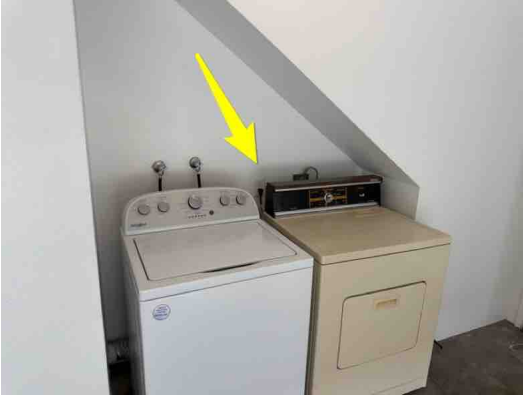
**SC 193:** Missing GFCI protected outlets in some required locations. Recommend repairs and upgrades by a qualified and licensed electrical professional familiar with the minimum GFCI protection requirements. NEC 210.8(A)  
GARAGE AT LAUNDRY (REQUIRED 1978)

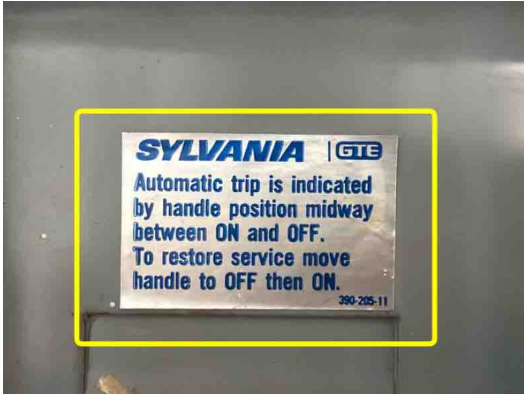
**196:** The home is equipped with a Zinsco/Sylvania-GTE electrical panel. These panels have a documented history of reliability concerns, including reports of breakers that may fail to operate as intended under certain fault conditions. In addition, some insurance carriers may decline coverage or require panel replacement prior to issuing a policy. Recommend further evaluation by a qualified electrician and consultation with the prospective insurance carrier regarding insurability requirements.

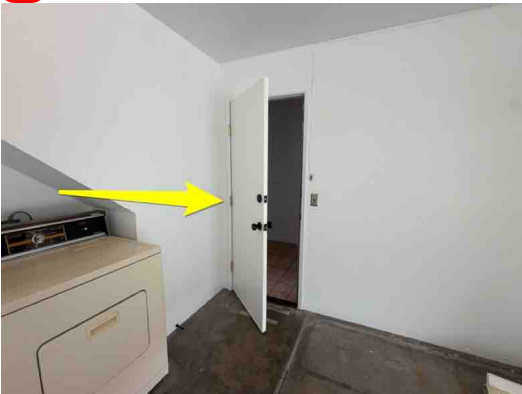
**SC 205:** Self-closer is non-operational at garage fire rated door to the living space.

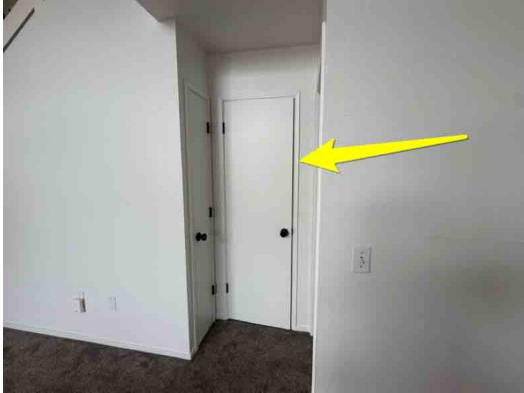
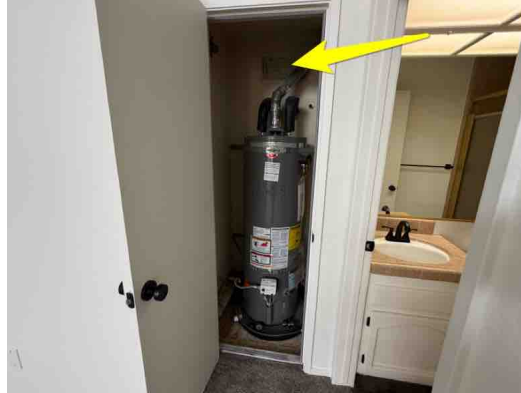
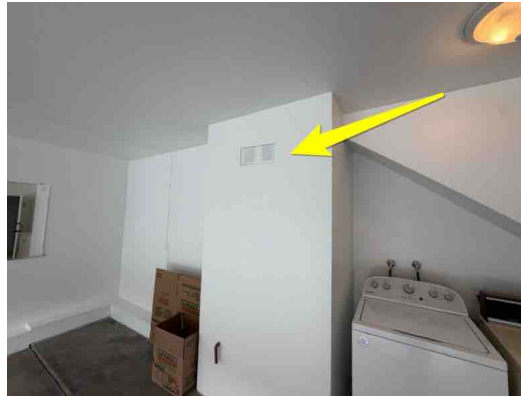
**E&C 206:** The water heater is located in a closet that opens directly to the interior of the dwelling; however, combustion-air openings were observed between the water heater closet and the attached garage. These openings compromise the required separation between the garage and dwelling and can allow garage fumes and combustion products to enter the living space. Recommend correction by a qualified contractor, including providing the required garage/dwelling separation and an approved source of combustion air for the water heater.

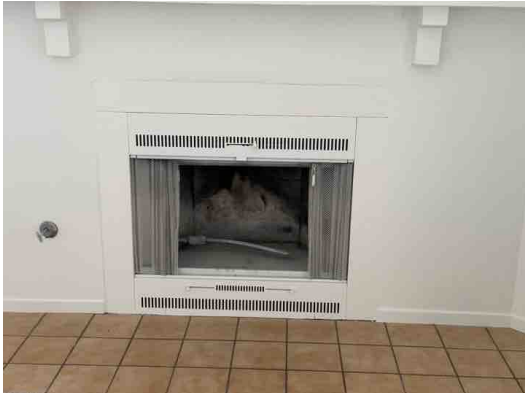
**SC 208:** The metal surround of the prefabricated wood-burning fireplace has been painted with what appears to be conventional/non-heat-rated paint. This portion of the fireplace can become hot during operation, and unsuitable coatings may discolor, blister, produce odors/fumes, or otherwise deteriorate. Recommend removal or refinishing with a coating specifically approved for high-temperature fireplace applications in accordance with the fireplace manufacturer's requirements.

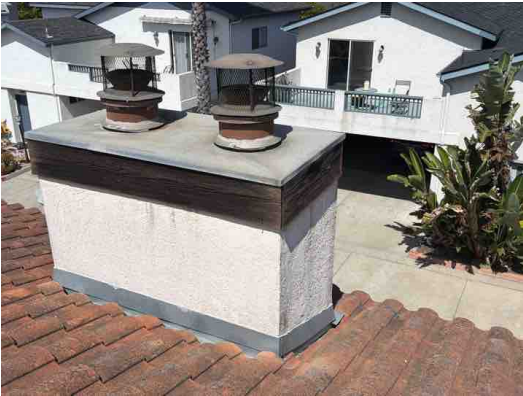
**212:** The LIVING ROOM fireplace chimney.

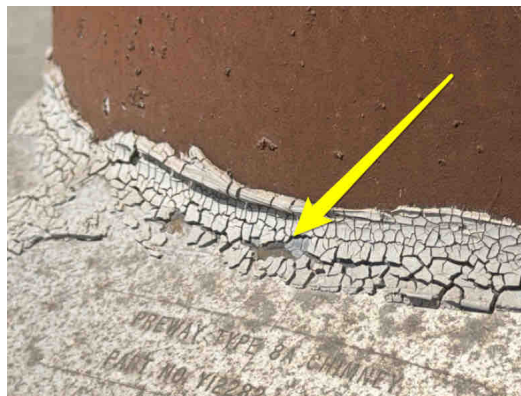
**MR 214:** Some deterioration of the sealant around the LIVING ROOM fireplace chimney chase collar. This is an area where water can intrude and warrants continuous maintenance.

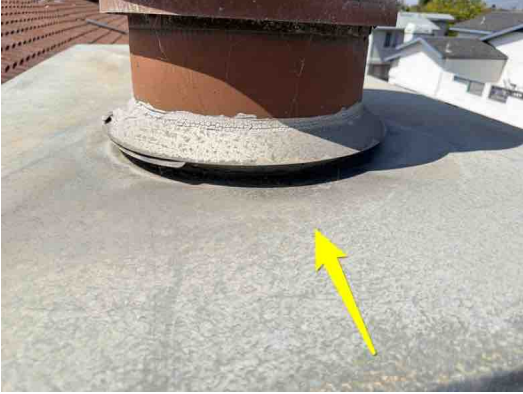
**MR 215: Disclosure:** The fireplace metal chimney chase cap appears to be ponding water: LIVING ROOM.  
Contact a qualified fireplace and chimney sweep to evaluate and correct.
