INSPECTION REPORT
1899 N Gladys Ave
Signal Hill CA 90755

INSPECTED BY
Christopher Vella
Professional
Inspection
Network

INSPECTION DATE
📅 5/13/2026
🕒 03:30 PM

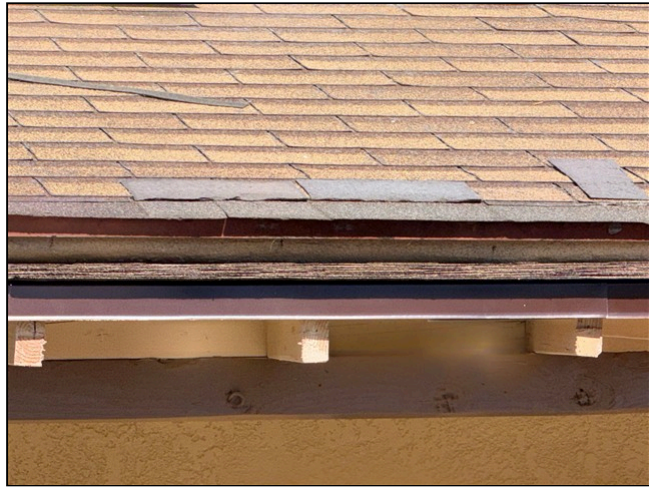
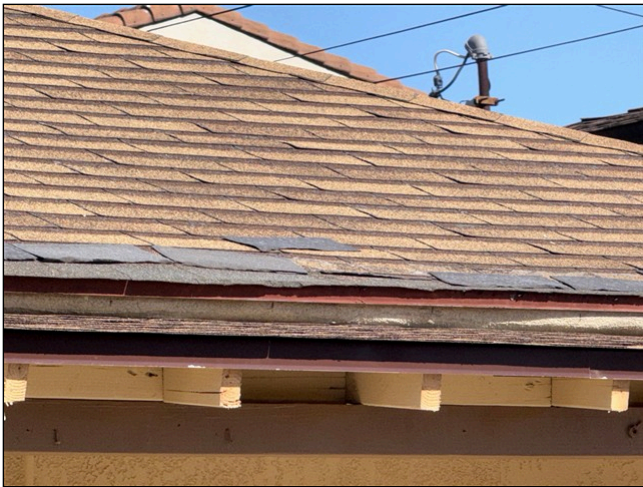
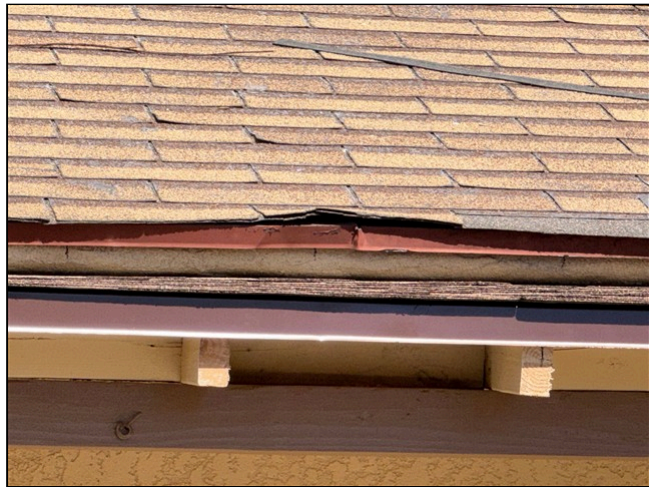
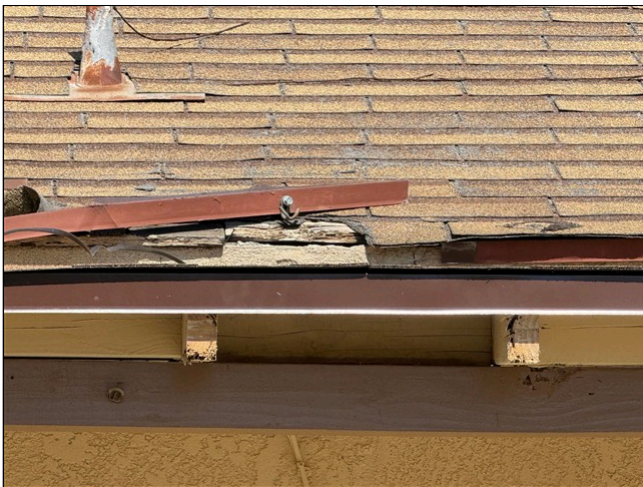
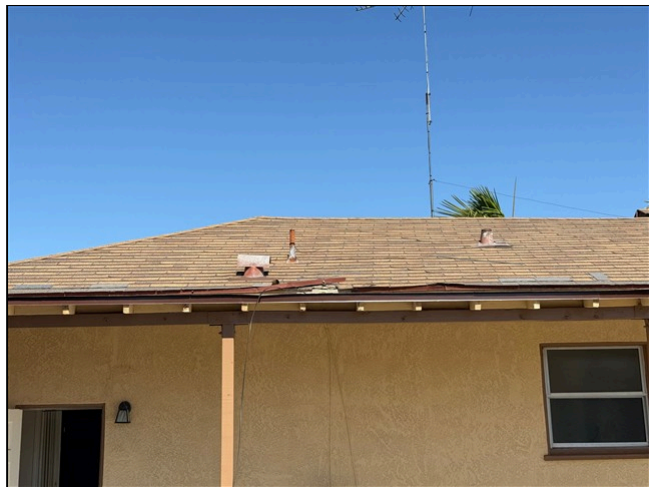
- 1. Major Concern:** The composition shingle roofing is significantly deteriorated and shows extensive wear. The shingles exhibit curling, cracking, granule loss, and overall diminished integrity. These conditions are consistent with an aging roof that appears to have exceeded its expected service life and is at increased risk for leakage and water intrusion. Have the roofing system replaced by a licensed roofing contractor. The contractor should remove the existing roofing materials down to an appropriate substrate, evaluate the roof sheathing and flashing components, and complete any needed repairs prior to installing a new composition shingle roof. The replacement roof should be installed using current, manufacturer-approved materials and methods, including proper underlayment, flashing integration, and ventilation. Obtain documentation of permits/warranties (as applicable) and confirm the selected shingle type, rating, and warranty terms based on durability, aesthetics, and budget.

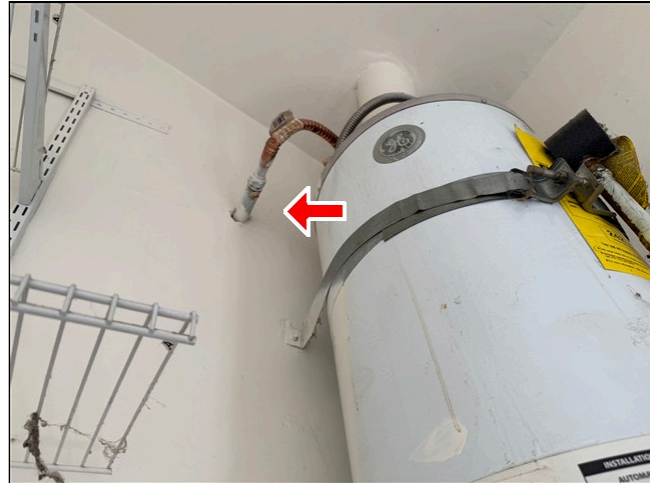
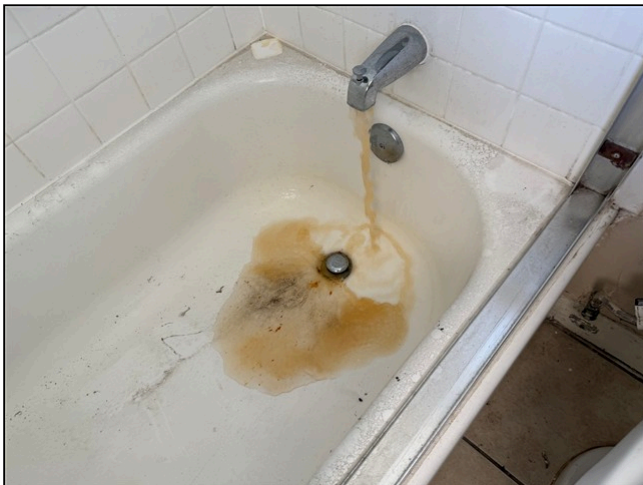
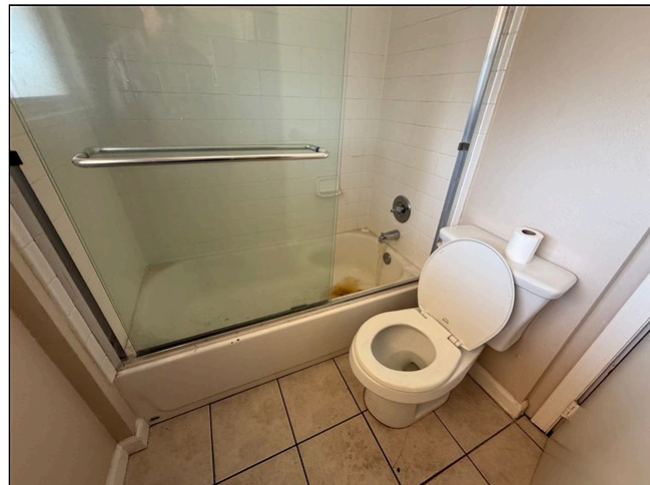
- 18. (1) Major Concern:** The main water supply pipe routed from the street to the home is a galvanized steel pipe. Galvanized steel pipes are used in the interior water supply, and generally have a finite life span. The quality of the plating, installation methods, water temperature, water quality and water usage all factor into the actual serviceable life. Scale builds up inside the pipe which eventually restricts the flow of water to the fixtures. Corrosion eats away at the inside of the pipes, eventually causing leaks. Thirty to forty years is the average life of galvanized pipes. Replacement of the galvanized steel supply pipes will eventually be required. Note: There is visible debris, and possible metal flakes, when water is run to the sinks in the home. The makeup of this debris is unknown.

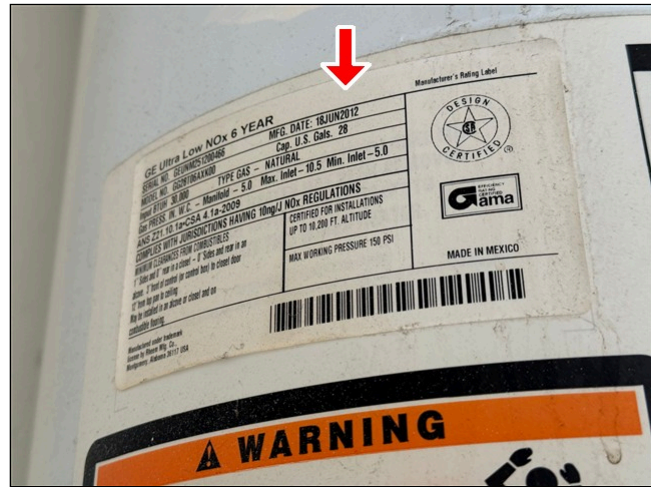
Item 20 - Item 2 (Picture)

- 20. (2) Repair/Replace/Monitor:** The water heater is an older unit. The water heater may be nearing the end of its service life. Typical life expectancy of water heaters is 7 to 12 years. The existing unit is 14 years old. It is difficult to determine when replacement will be necessary. Suggest replacement of the water heater by a licensed and qualified plumber.

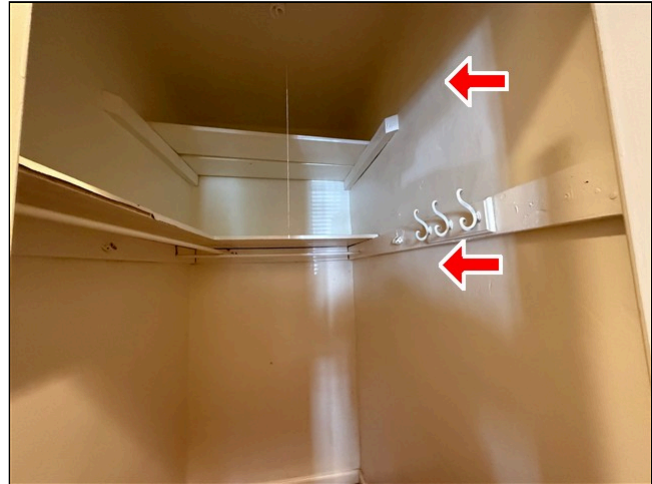
Item 24 - Item 2 (Picture)

- 24. Major Concern:** A significant amount of water damage was observed at the interior walls and floor of the middle North hallway closet. The condition appears to indicate moisture intrusion and/or water intrusion from an exterior source. The exact source of the moisture could not be determined during the inspection. There is an extra risk of hidden damage and possible concealed deterioration within these areas. Further evaluation and repair by a qualified contractor is recommended to determine the source of the moisture intrusion and repair all damaged materials.

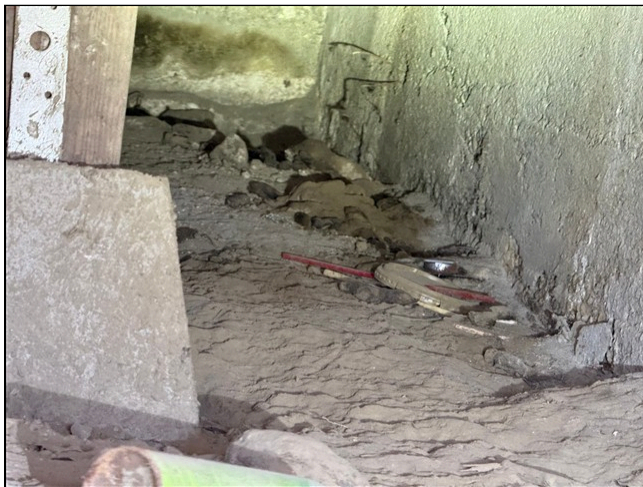
3.0 Item 1 (Picture)

(1) **Improve:** Trash and debris should be removed from the crawl space. Accumulated debris can obstruct access, retain moisture, attract pests, and conceal conditions that may affect the structure and components within the crawl space. Cleaning and removal by a qualified contractor is recommended.

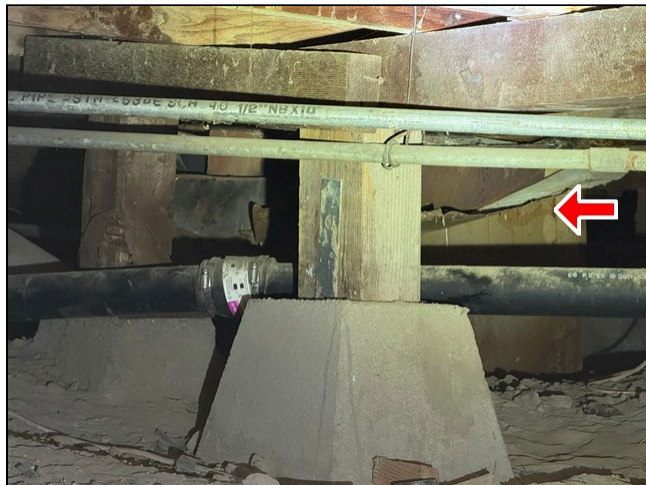
3.0 Item 2 (Picture)

- 14. (2) Improve:** An abandoned floor furnace was observed at the crawl space of the home. The unit is no longer in use and is recommended for removal. Components associated with the older furnace system may contain asbestos-containing materials. Further evaluation and removal by qualified professionals familiar with asbestos handling procedures is recommended.

(2) **Improve:** An abandoned floor furnace was observed at the crawl space of the home. The unit is no longer in use and is recommended for removal. Components associated with the older furnace system may contain asbestos-containing materials. Further evaluation and removal by qualified professionals familiar with asbestos handling procedures is recommended.

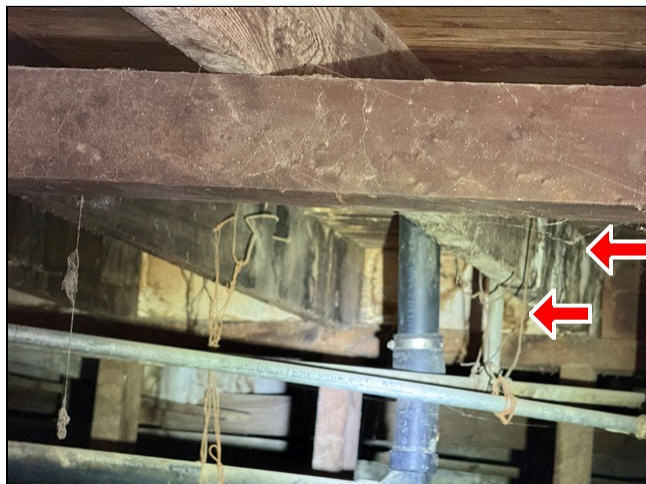
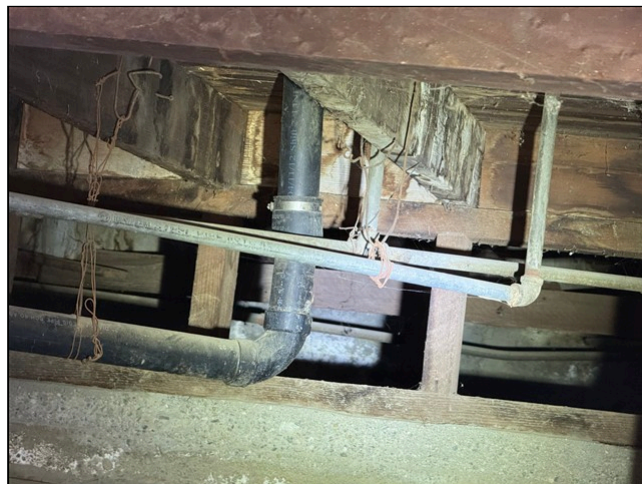
(1) **Repair or Replace:** Water staining, wood deterioration, and potential fungus were observed at the hallway bathroom subfloor. The presence of water staining and deterioration suggests possible past or ongoing moisture intrusion. Wood deterioration can compromise the structural integrity of the subfloor, leading to potential safety hazards. The presence of fungus indicates the potential for mold growth, which can have adverse health effects. It is strongly recommended to have a qualified contractor assess the condition of the subfloor below the hallway bathroom. Based on the contractor's evaluation, necessary repairs or replacement of the subfloor may be required to address any structural or moisture-related issues. Identify and address the source of moisture to prevent future damage. This may involve addressing leaks, improving ventilation, or

other moisture control measures. Timely intervention and professional assessment are crucial to address potential structural issues and ensure the safety and integrity of the bathroom subfloor.

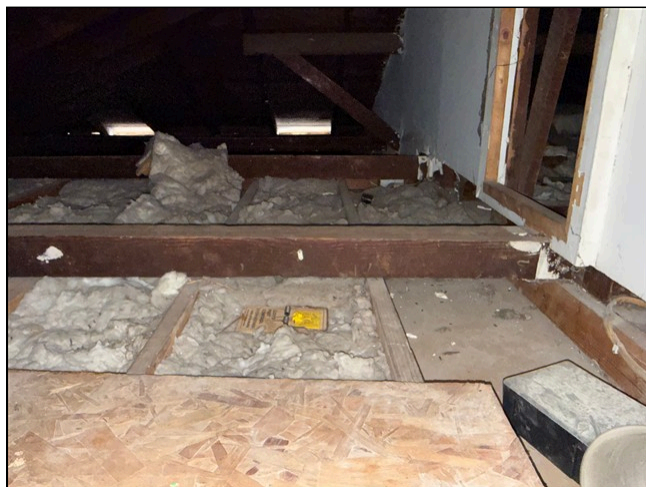
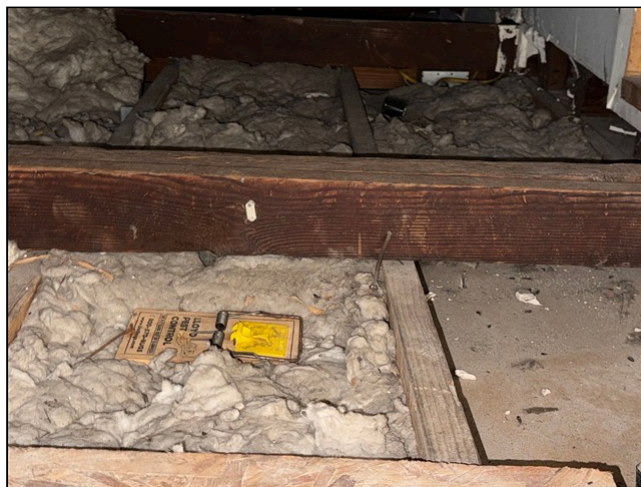
(1) **Improve/Safety Issue:** Evidence of rodents was found in the form of feces was observed in the attic space of the home. Consult with the property owner about this. A qualified person should make repairs to seal openings in the structure, set traps, and clean rodent waste as necessary. Future costs could be incurred from prior rodent damage not visible at time of inspection.

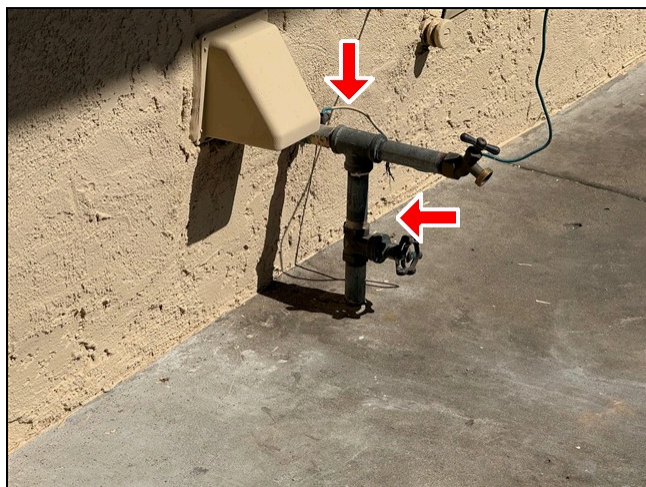
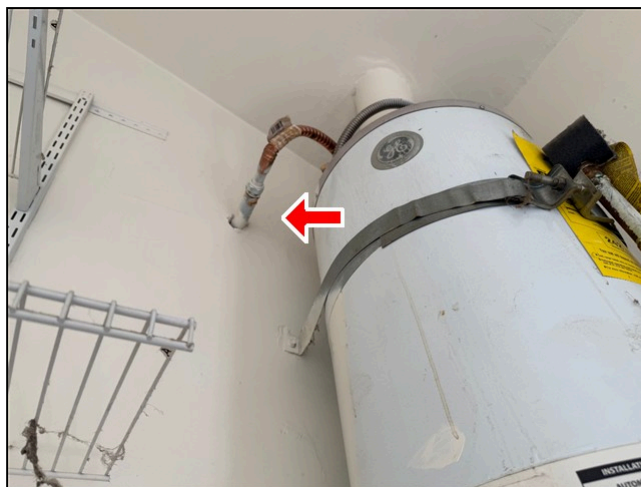
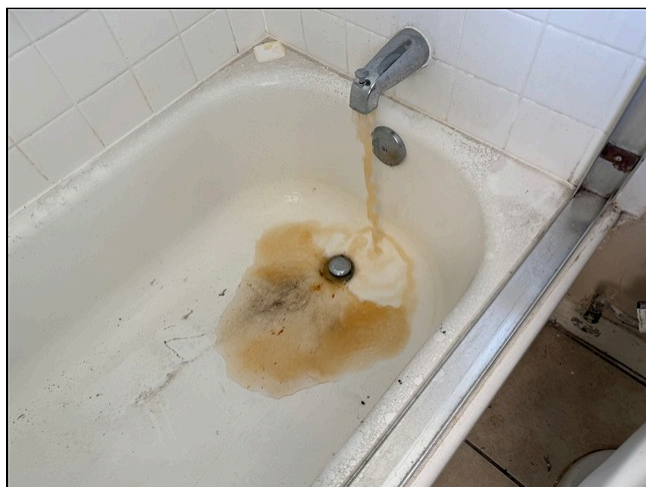
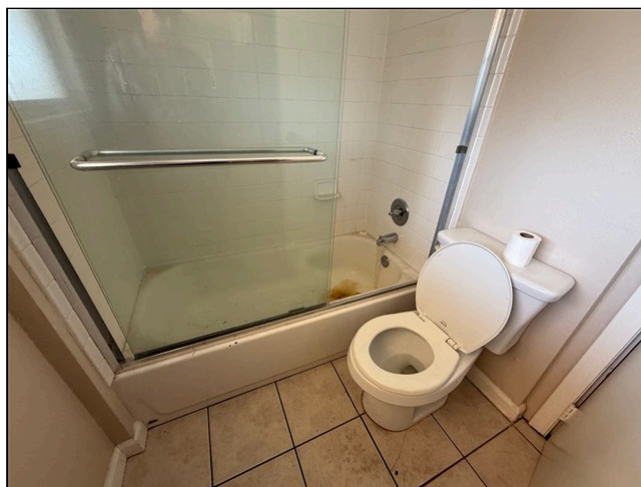
(1) **Major Concern:** The main water supply pipe routed from the street to the home is a galvanized steel pipe. Galvanized steel pipes are used in the interior water supply, and generally have a finite life span. The quality of the plating, installation methods, water temperature, water quality and water usage all factor into the actual serviceable life. Scale builds up inside the pipe which eventually restricts the flow of water to the fixtures. Corrosion eats away at the inside of the pipes, eventually causing leaks. Thirty to forty years is the average life of galvanized pipes.

Replacement of the galvanized steel supply pipes will eventually be required. Note: There is visible debris, and possible metal flakes, when water is run to the sinks in the home. The makeup of this debris is unknown.

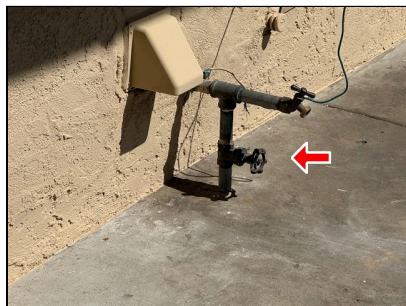
5.6 Item 1 (Picture)

Inspected: The main water shut off valve is located at the West wall of the home.

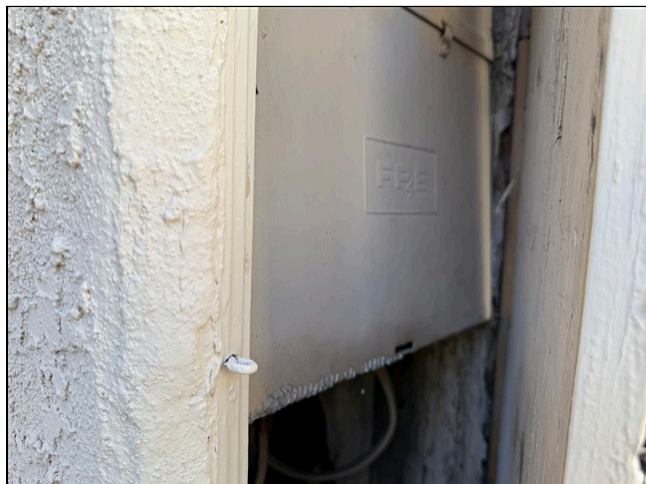
6.0 Item 1 (Picture)

Safety Issue: The main electrical panel for the home is manufactured by a company known as Federal Pacific. Federal Pacific electrical equipment is considered obsolete, due to design flaw in which the circuit breaker's connection to the bus bar becomes loose, causing arcing and subsequent overheating. Long term exposure to this heat can cause the breaker(s) to fuse to the bus bar, making it impossible to remove. Even worse, it can cause the breaker's contacts to fuse together, thus preventing the breaker from tripping even in an overcurrent situation, thereby causing a potential fire hazard. Federal Pacific Electric (FPE) electrical panels were widely used in residential homes and buildings from the 1950s through the 1980s. However, over the years, these panels have been found to have significant defects that could lead to serious safety concerns. These defective panels may fail to trip, even in the event of a power surge or electrical overload, causing electrical fires. The Consumer Product Safety Commission (CPSC) conducted an investigation in the 1980s and found that some FPE panels and breakers failed to trip and that many of these panels were still in use in residential homes. As a result, the CPSC recommended that homeowners replace these panels, especially those with a Type Stab-Lok circuit breaker, which was found to have the most significant defects. Replacing an FPE panel can be a costly and time-consuming process, but it is essential for the safety of your family and your home. It is

strongly urged and advised that the main electrical panel for the home be replaced with a new, modern and safe electrical system/panel by a licensed and qualified electrician.

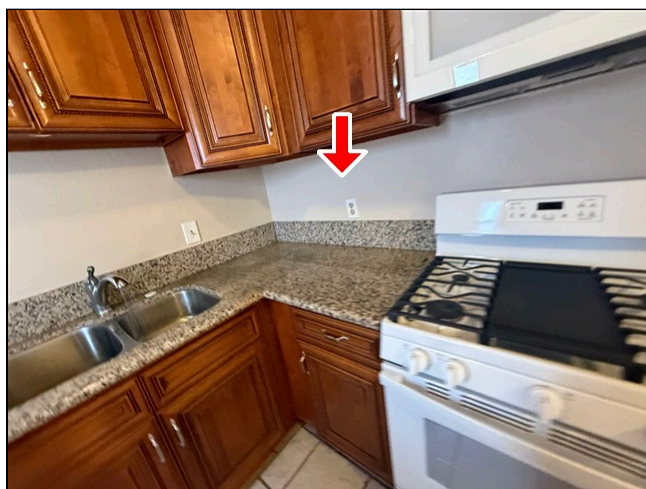
6.2 Item 1 (Picture)

Safety Issue: The kitchen countertop outlets were found to lack Ground Fault Circuit Interrupter (GFCI) protection during the inspection. GFCI outlets are essential safety devices that help protect against electrical shocks and potential hazards in wet areas, such as kitchens and bathrooms. It is highly recommended to have GFCI outlets installed at the kitchen countertop to ensure the safety of the electrical system in the area. GFCI outlets detect imbalances in electrical currents and quickly interrupt the power supply, reducing the risk of electrical shock. To address this issue, it is advised to consult with a qualified electrician who can install GFCI outlets at the kitchen countertop according to local electrical codes and regulations. This will help ensure compliance with safety standards and provide enhanced protection for you and your household.

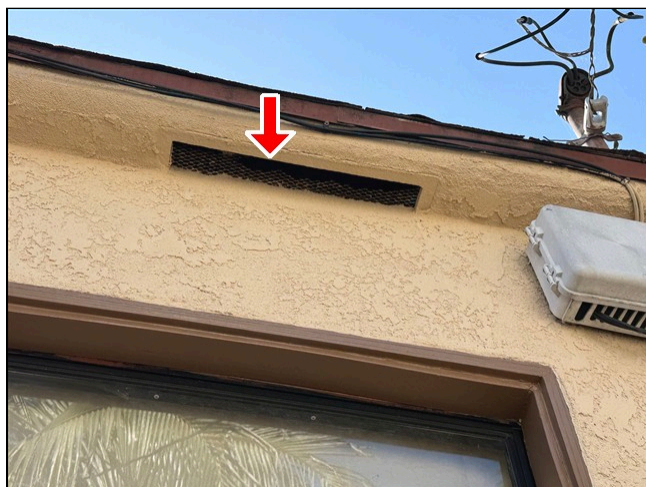
7.3 Item 1 (Picture)

Repair or Replace: The screens for the crawl space vent openings are loose, torn or displaced in various locations. These areas are large enough to allow pest entry into the building. We suggest the screens be repaired/replaced to prevent vermin/animals from entering the home.

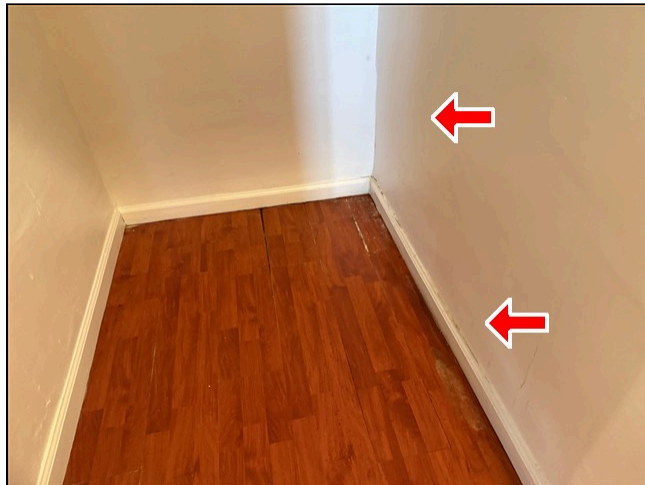
8.0 Item 1 (Picture)

Major Concern: A significant amount of water damage was observed at the interior walls and floor of the middle North hallway closet. The condition appears to indicate moisture intrusion and/or water intrusion from an exterior source. The exact source of the moisture could not be determined during the inspection. There is an extra risk of hidden damage and possible concealed deterioration within these areas. Further evaluation and repair by a qualified contractor is recommended to determine the source of the moisture intrusion and repair all damaged materials.

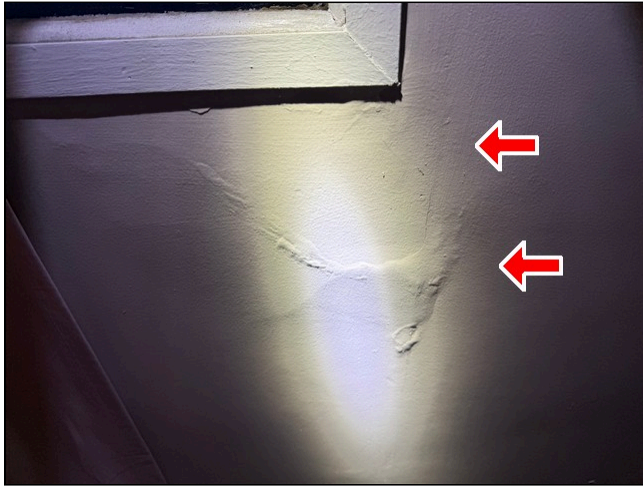
8.1 Item 1 (Picture)

(1) **Major Concern:** Water damage was observed at the interior walls below the windows, indicating that the windows may be leaking. The condition appears to be related to the non-professional installation of the replacement windows. Continued water intrusion may result in additional hidden damage, deterioration, and possible organic growth within the wall assemblies. Further evaluation and correction by a qualified window contractor is recommended.

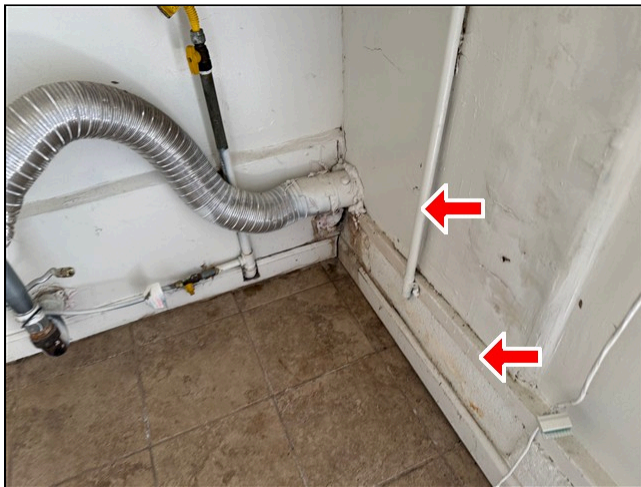
8.1 Item 3 (Picture)

(2) **Major Concern:** A significant amount of water damage was observed at the interior walls of the garage along the rear interior wall. The damage appears to be related to prolonged moisture intrusion and/or water penetration. Continued moisture exposure may result in additional deterioration and possible concealed damage within the wall assembly. Further evaluation and repair by a qualified contractor is recommended.

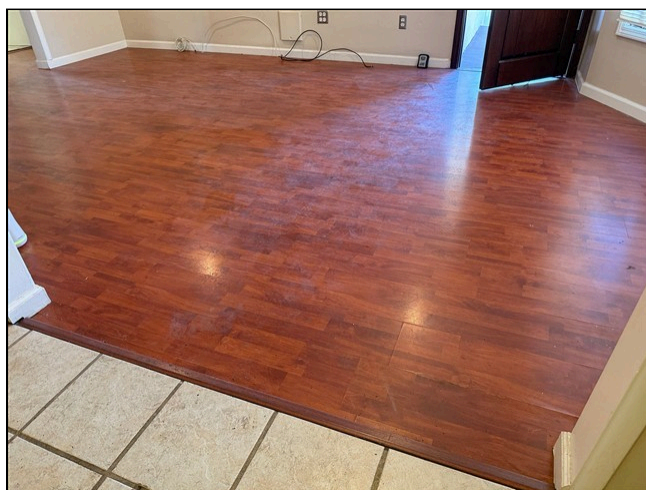
8.2 Item 1 (Picture)

Monitor: The interior floor of the home has an apparent slope in several locations. If the interior floor of a building has an apparent slope in several locations, it may indicate a structural problem or issue with the foundation of the building. Contact a structural engineer or a licensed contractor to evaluate the slope of the floors. They will be able to determine the cause of the slope and assess whether there are any safety concerns. If the slope is determined to be a safety

concern, take steps to ensure that the area is safe for use. This may include restricting access to the area or providing temporary support or reinforcement. Address any underlying issues with the building's foundation or structure. This may involve repairs to the foundation or installation of additional support structures to stabilize the building. Ensure that the building is up to code and meets safety standards. This may involve obtaining permits and inspections from local building authorities. It's important to address any issues with the slope of a building's floor as soon as possible, as it can affect the safety and structural integrity of the building. A professional evaluation is crucial to identifying the underlying issue and determining the appropriate course of action to address it. This might be the result of the age and framing design of the home. Suggest further evaluation by a qualified trades person and structural engineer for determination, evaluation and/or corrective repairs if required. Since this inspection is visual in nature, it is always recommended that any movement observed be further evaluated to prevent damage and to insure the integrity of the structure is kept in tact.

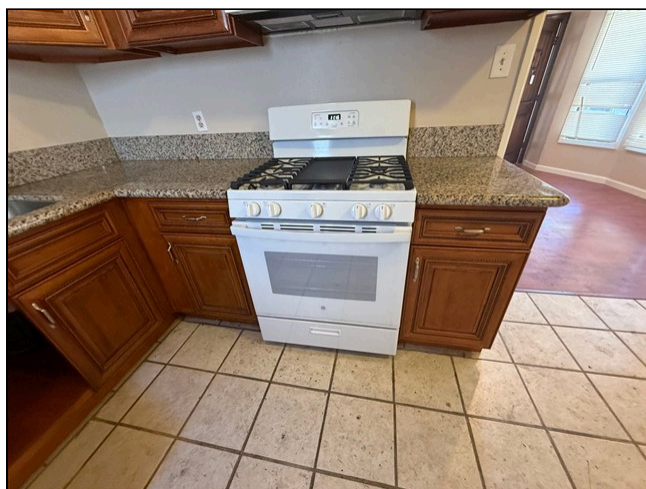
9.1 Item 1 (Picture)

Safety Issue: The stove at the kitchen lacks an anti-tip bracket. An anti-tip bracket is an important safety feature that helps prevent the stove from tipping over, especially in situations where excessive weight or force is applied to the open oven door or if a child were to climb or hang on the stove. The absence of an anti-tip bracket increases the risk of the stove tipping over, which can result in serious accidents or injuries. It is recommended to have anti-tip brackets installed for each stove to enhance the safety of the property. It is advisable to consult with a qualified professional or appliance technician to properly install the appropriate anti-tip brackets for the stoves. They can ensure that the brackets are correctly attached to the stove and securely anchored to the floor or wall, following the manufacturer's guidelines and local building codes. Improving the safety features of the stoves by installing anti-tip brackets is an important step in preventing accidents and promoting the well-being of the occupants.

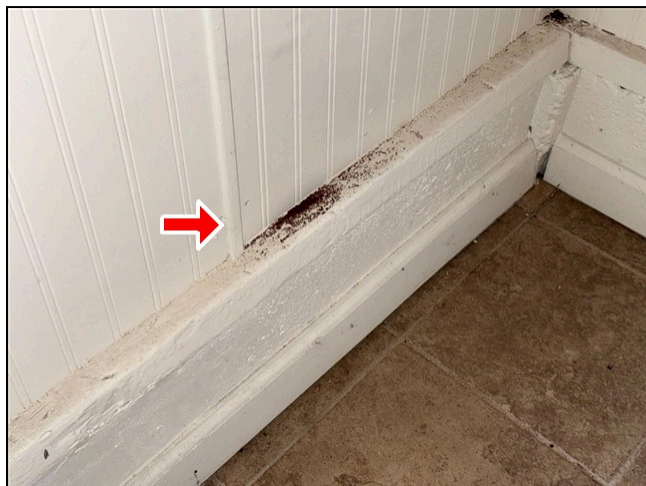
10.4 Item 1 (Picture)

(1) **Improve/Monitor:** If evidence of insect droppings has been observed at the garage in one or more locations, it is important to take action immediately to address any possible infestation. Termite droppings, also known as frass, are small pellets or sawdust-like particles that termites leave behind as they consume wood and other cellulose-based materials. The presence of termite droppings can indicate a termite infestation in your home or property. To address a insect infestation, it is best to hire a professional pest control company that specializes in termite control. They will be able to inspect your property and determine the extent of the infestation, as well as recommend appropriate treatment options. Treatment for termite infestations typically involves the use of chemicals or baits that are designed to eliminate the entire colony of termites. The type of treatment used will depend on the severity of the infestation, the type of termites involved, and other factors.

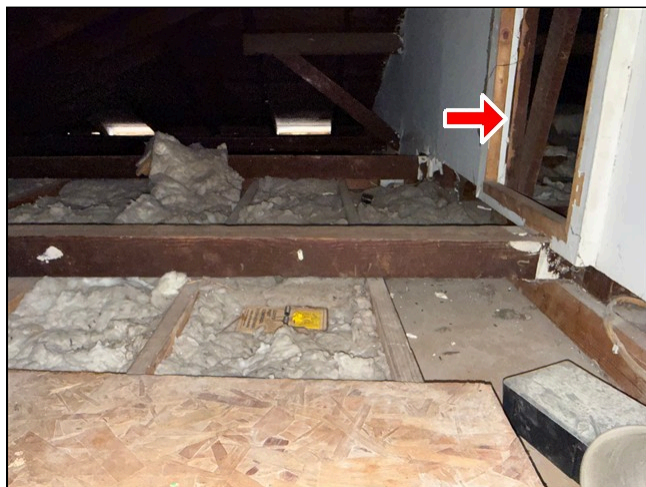
10.4 Item 2 (Picture)

(2) **Safety Issue:** The firewall separation between the home and the garage is missing and/or sections have been removed in one or more areas. This condition is considered a fire and safety concern, as the required fire-resistive barrier between the garage and living areas has been compromised. Further evaluation and repair by a qualified contractor is recommended to restore the proper firewall separation.
