Property Inspection Report

Property address: 27741 Havana Ave
Hayward CA 94544-5005

Inspection date: Tuesday, June 16, 2026

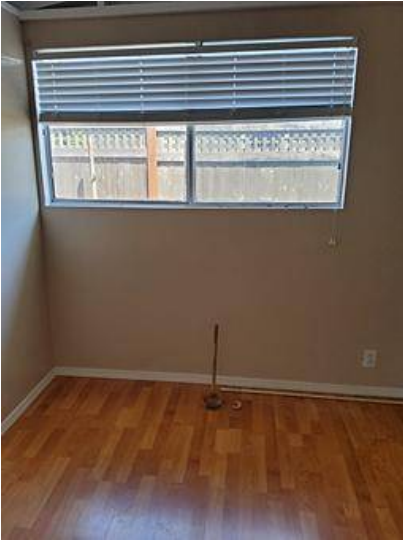
Photo 54-1

54) *Safety, Repair/Replace* - Some of the bedrooms have windows that are too high off the floor. At least one window in each bedroom requires adequate egress in the event of a fire or emergency to allow escape or to allow access by emergency personnel. Such windows should have a maximum sill height of 44 inches off the floor. At a minimum, keep a chair or something that serves as a ladder below the window at all times. If concerned, have a qualified contractor repair or make modifications per standard building practices. For more information, visit:
