### *Inspection Report*

**Address: 2760 Trenton Ave Cambria, CA 93428**

**07/09/2025**

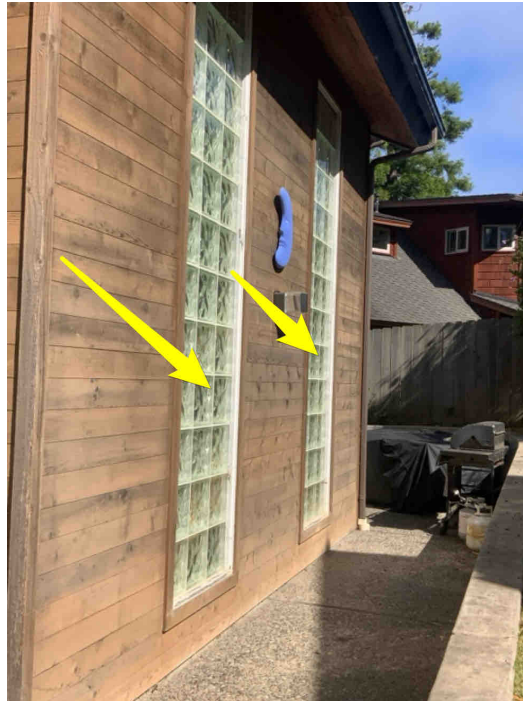
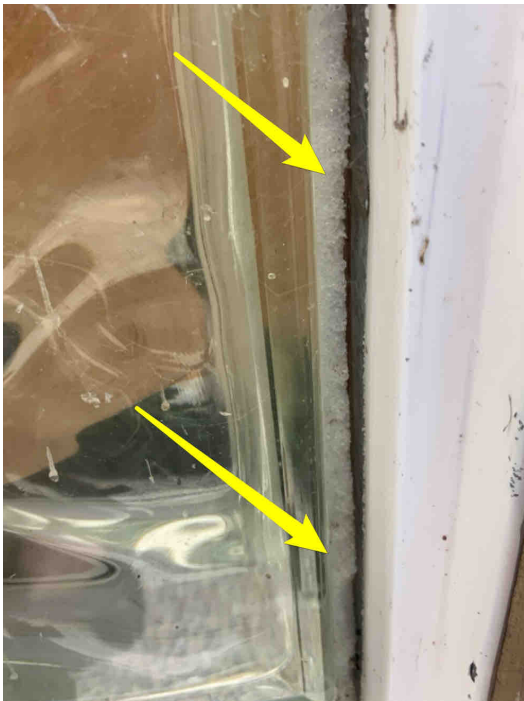
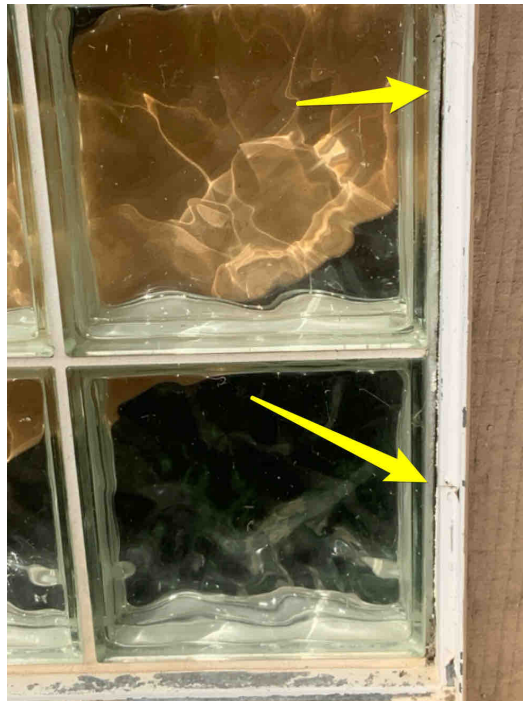
**E&C MR 32:** Deteriorated and missing sealant around the glass block windows installed on the back of the building. Contact the qualified painter or window installation professional to seal or reseal windows to help prevent additional deterioration and water intrusion.

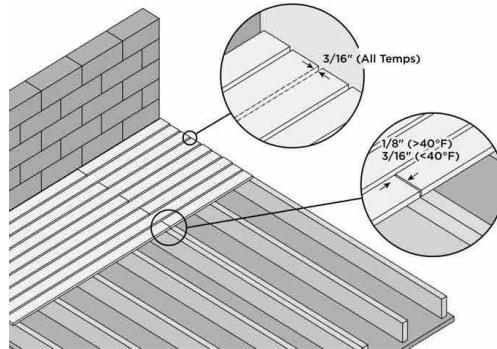
**E&C 38:** Installation of the FRONT ENTRY DECK synthetic planks do not meet minimum installation standards. The end splices at the synthetic deck planks are required to have a minimum of 1-1/2 inch support under each side of the end splice. Currently the joints are only supported by splitting the single 1-1/2 inch joist and is supported by only 3/4 of an inch. Proper blocking at each splice per minimum standards is recommended per the installation requirements.

For butt joints, where boards meet over a single joist, add a 2" x 4" "nailer" board at the butt joint. This allows screw-in at 90 degrees and allows fasteners to be used at end of each board.

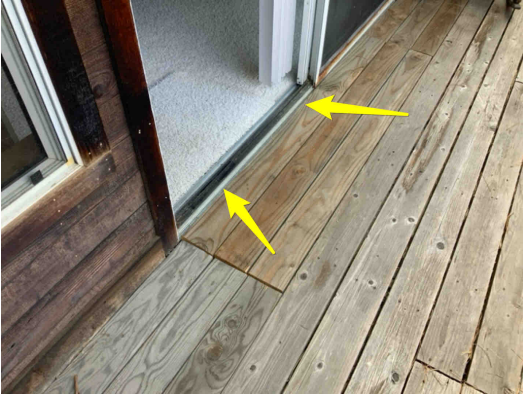
**MR** **UPG** **40:** Decking found to be installed unusually high at the exterior door threshold. This could lead to water intrusion under the door threshold. Upgrade and monitor as future moisture conditions could manifest.

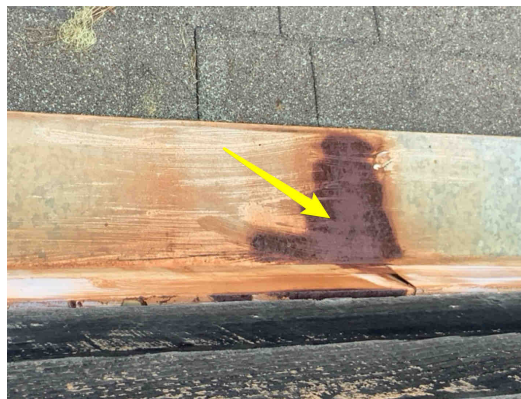
**58:** Some improper, unfinished installation of the ventilated roof ridge shingles.

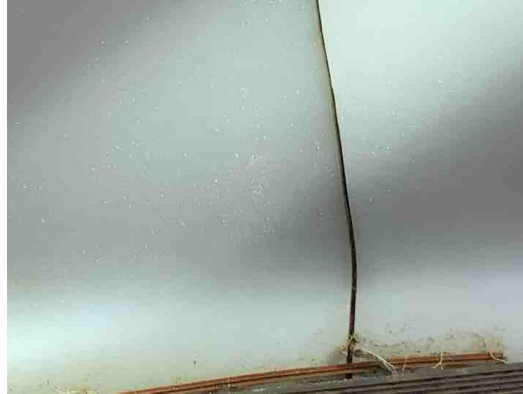
**E&C 61:** Some of the plastic roof skylights are cracked and damaged. Replacement is warranted. Contact a qualified roofer to evaluate and replace damaged skylights.

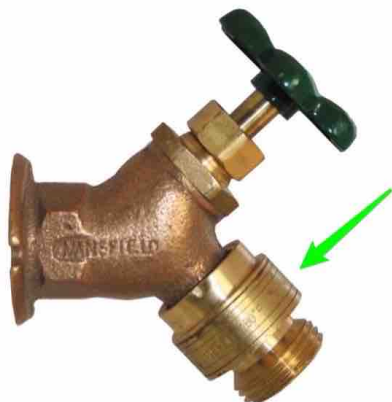
**UPG 74:** Anti-siphon valves are missing / recommended on all exterior hose faucets per Cambria requirements.

Example of an anti-siphon valve on a hose faucet

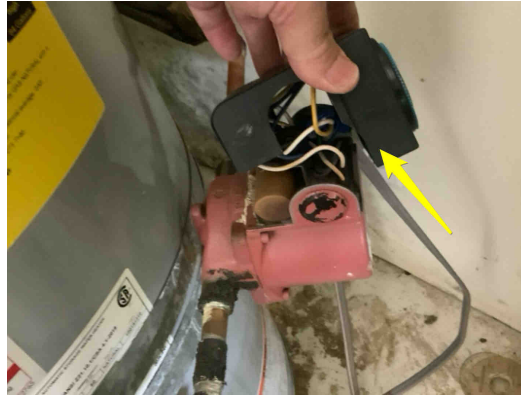
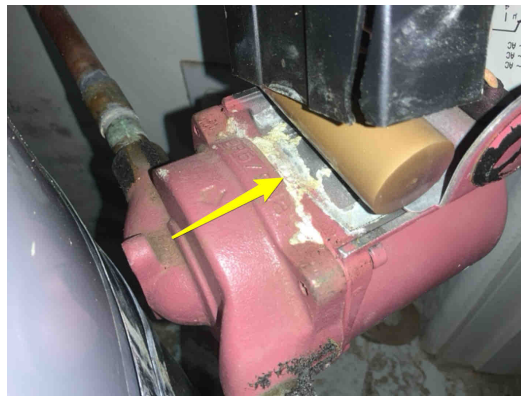
**86:** Water heater circulation pump found damaged and is considered unsafe. Recommend replacement for safety.

Evidence of past leakage

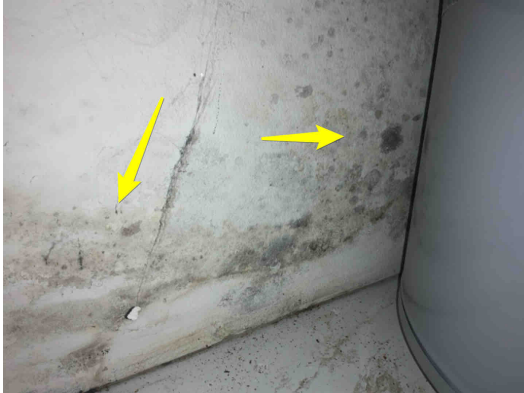
**SC FI 87:** Moisture stains and damage at the drywall areas of the water heater platform and/or enclosure. Some visible mold growth noted on areas of the drywall. Recommend additional review and clean up by a qualified mold remediation professional. Refer to Termite report for additional comments and recommendations.

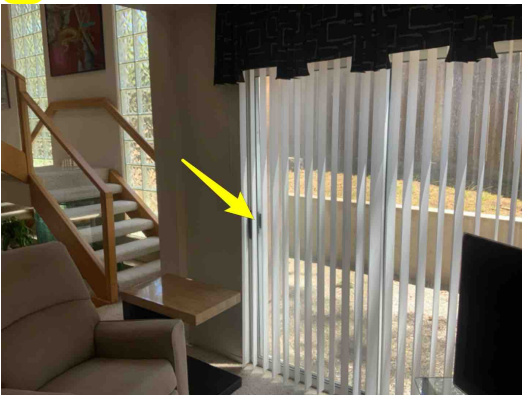
**SU 137:** The locking hardware at the exterior sliding glass door found difficult to operate at the DEN SLIDER.

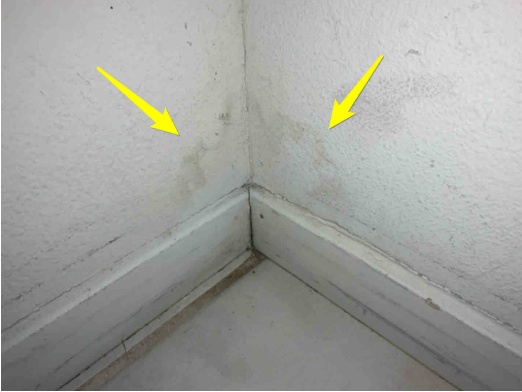
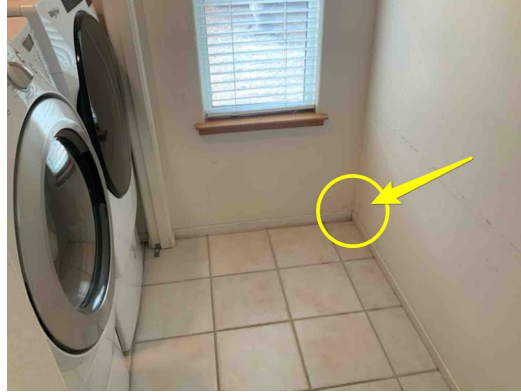
**FI 160:** Evidence of moisture stains and/or damage at the walls in the LAUNDRY ROOM. Recommend further review of the water stains to determine the cause, the current condition and if repairs are needed.

Water heater in the garage in the backside of the water stain

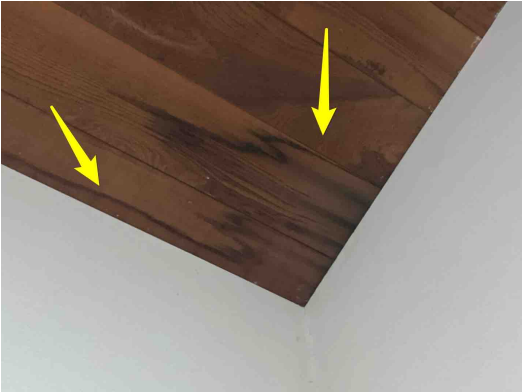
**FI 161:** Evidence of past moisture stains & damage at ceiling area in FRONT ENTRY. Recommend further review of the water stains to determine the cause, the current condition and if repairs are needed.

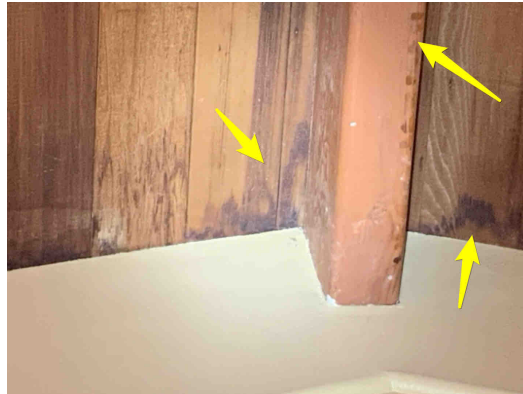
**FI 162:** Evidence of past moisture stains & damage at ceiling area in INSIDE THE UPSTAIRS HALLWAY BATHROOM-ABOVE THE TOILET. Recommend further review of the water stains to determine the cause, the current condition and if repairs are needed.

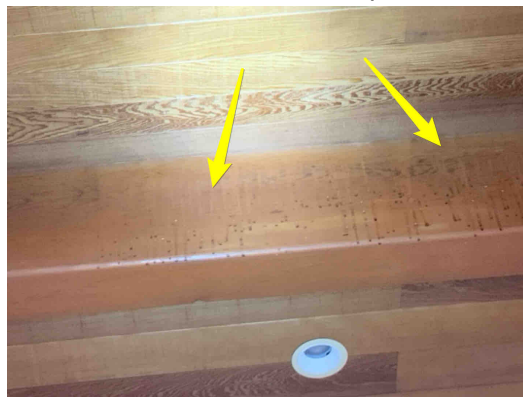
**FI 163:** Evidence of past moisture stains & damage at ceiling area in PRIMARY BEDROOM at the upper wood beam. Suspected condensation buildup due to poor or improper ventilation of the roof system. Recommend further review of the water stains to determine the cause, the current condition and repairs as needed.

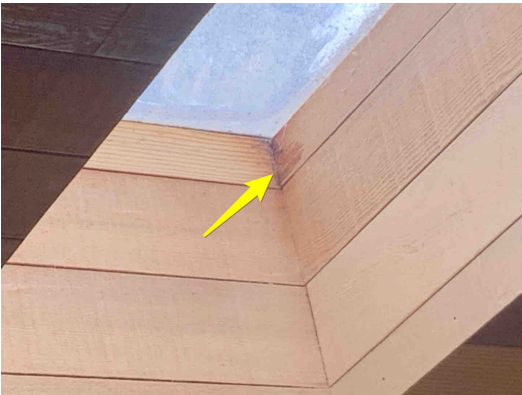
**FI 164:** Evidence of past moisture stains & damage at ceiling area in AROUND THE STAIRWAY AREA SKYLIGHT. Recommend further review of the water stains to determine the cause, the current condition and if repairs are needed.

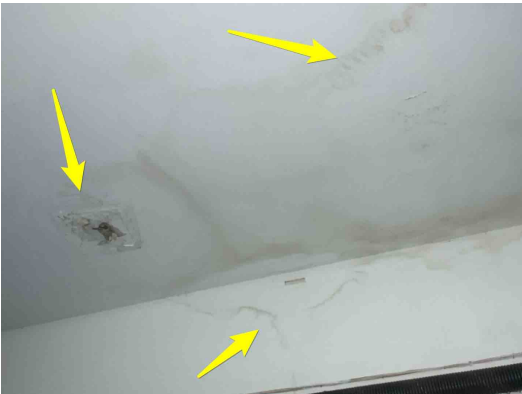
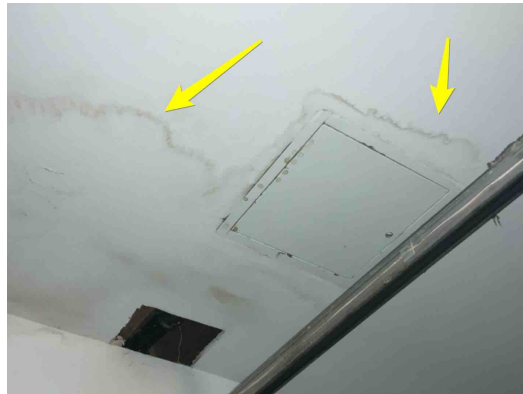
**FI 165:** Evidence of past moisture stains & damage at ceiling and walls in the GARAGE ABOVE THE VEHICLE DOOR (Upstairs bedroom waterproof deck above the stains). Recommend further review of the water stains to determine the cause, the current condition and if repairs are needed.

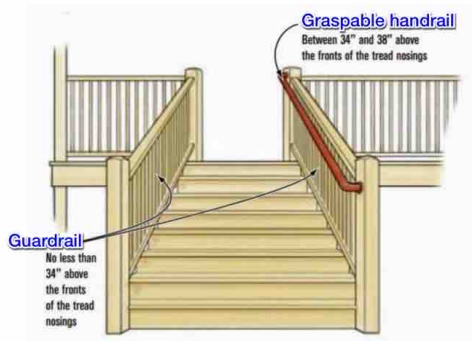
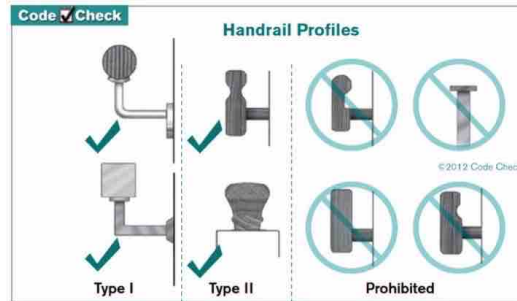
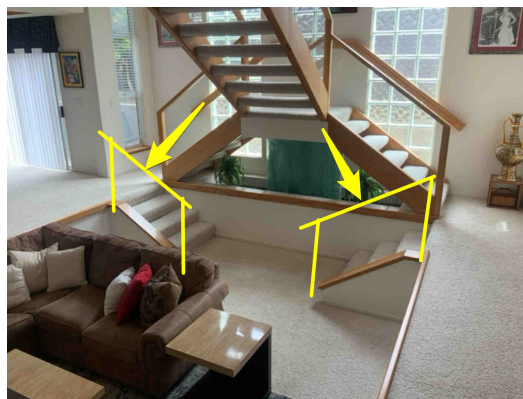
**SC 168:** Missing a proper gripable handrail and guardrail at some of the interior stairway for safety per standards.

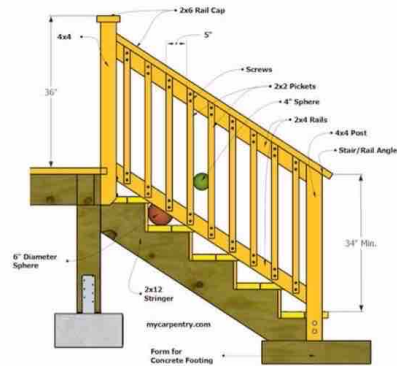
**SC 169:** Missing the required guardrail at areas of the interior stairway. A Guardrail is required on all interior stairways where the potential fall from the stairway is greater than 30 inches.

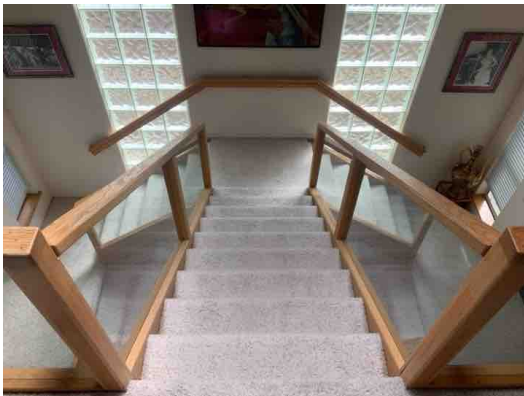
**SC 171:** Missing a proper gripable handrail at the upper portion of the interior stairway to the UPPER STAIRWAY TO THE SECOND STORY for safety per standards.

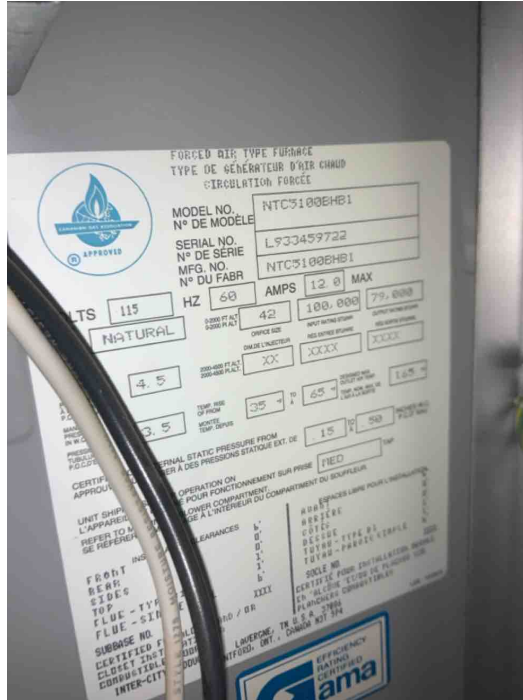
**MR 173: HEATING SYSTEM CONDITION:** The heating system operated when tested.

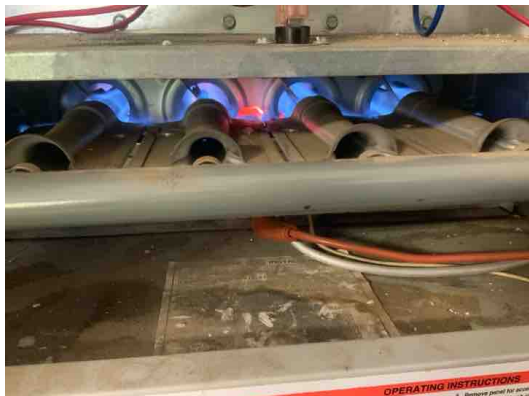
**SU 175: Disclosure:** It is considered an improper installation to have the flex gas connector pass through the metal sidewall of the furnace cabinet. Upgrades recommended.

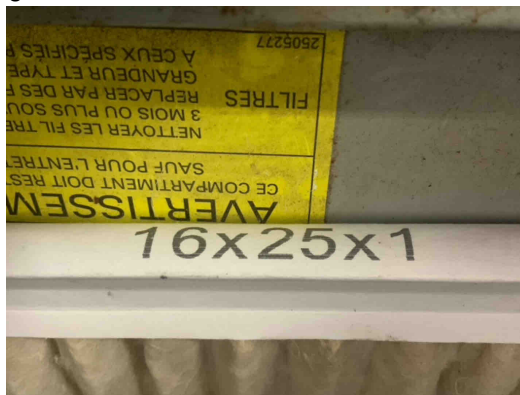
air filter size

**MR 179:** Dirty Heating air filter found inside the furnace blower box at the furnace. Recommend cleaning or changing the furnace air filters as part of ongoing maintenance.

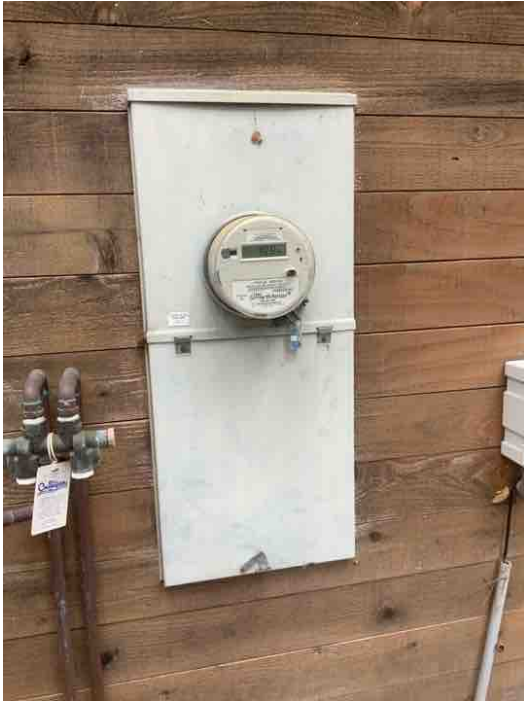
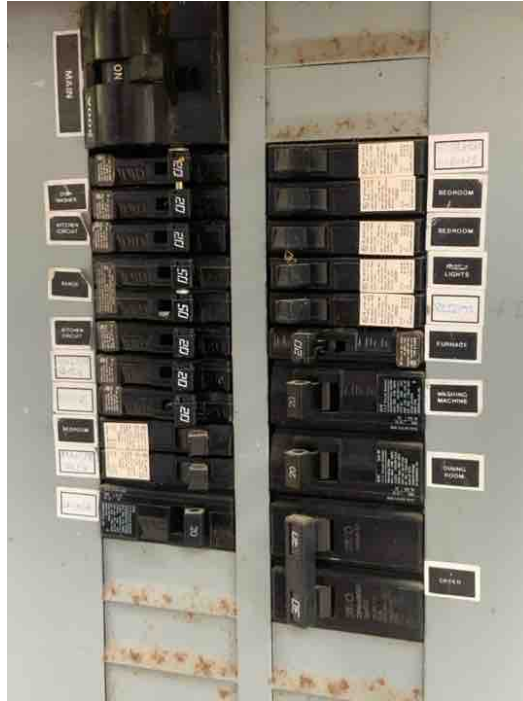
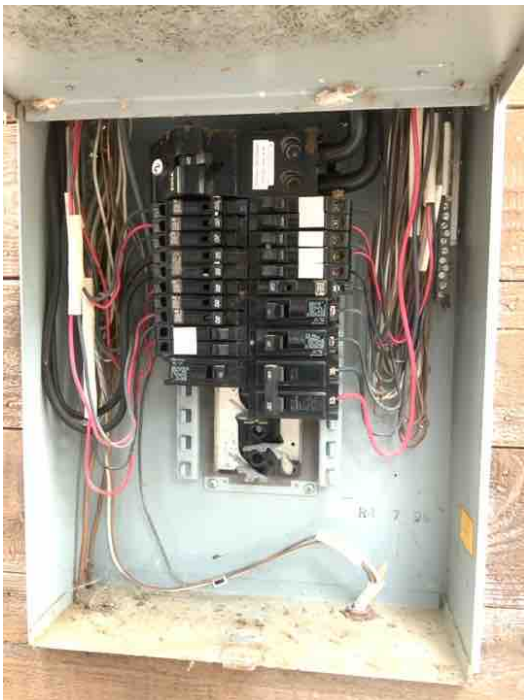
Panel Voltage: **240 volt**

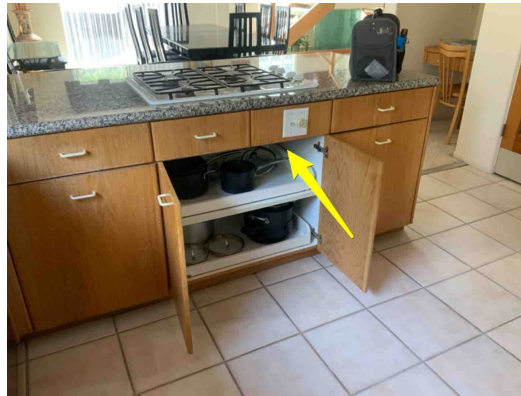
Example

**SC 189:** Improper and unsafe electrical wiring. Exposed electrical wiring, "Romex" improperly installed subject to physical damage, not in a conduit or raceway per standards inside the kitchen cabinet below the cooktop.

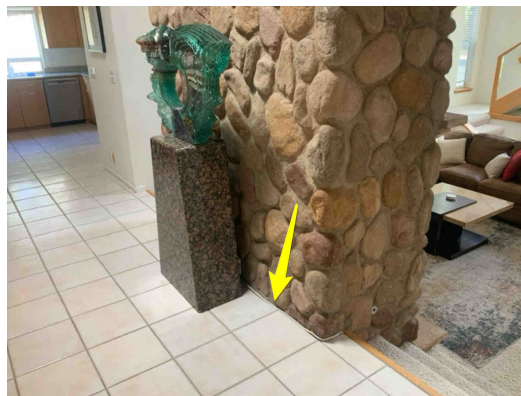
Example

**SC 190:** Improper and unsafe electrical wiring. Exposed electrical wiring, "Romex" improperly installed subject to physical damage, not in a conduit or raceway per standards: AT SOME ADDED ELECTRICAL WIRING AND OUTLET FOR THE FRONT ENTRY GLASS SCULPTURE

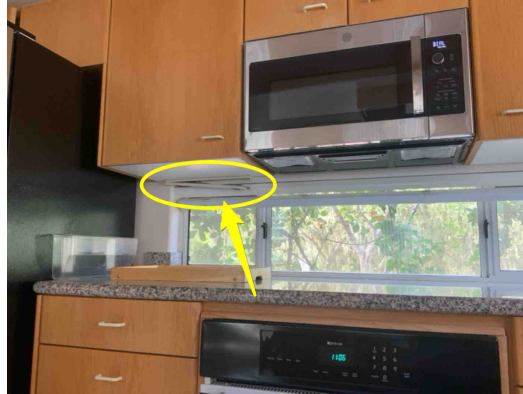
**SC 191:** The electrical outlet strip installed under the kitchen cabinet - left of the kitchen microwave, found loose and in need of some minor upgrades. Corrections warranted for safety.

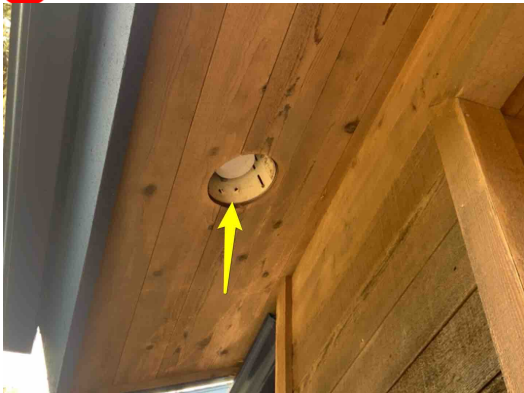
Example

**E&C 194:** Lens at light fixture is missing at some exterior light

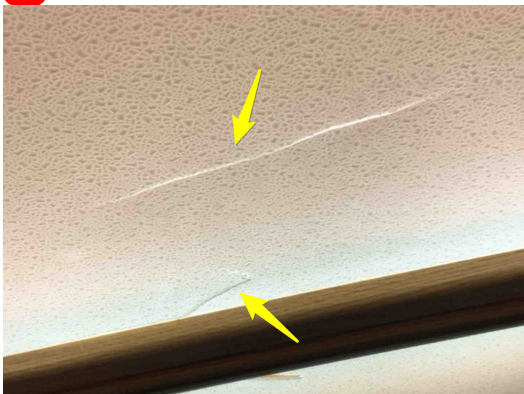
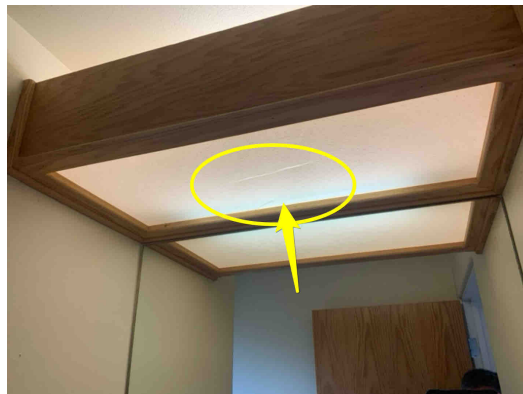
**E&C 195:** Lens at light fixture is damaged: LAUNDRY ROOM 1/2 BATHROOM

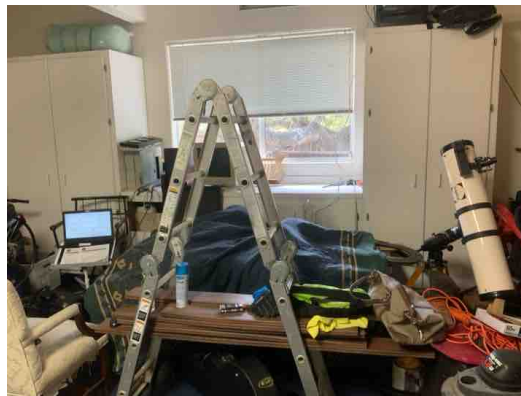
Example

**DS 200:** Due to an excessive amount of stored items and/or cabinetry in the garage, the majority of the garage walls and/or floor, is not accessible, not visible, nor inspected. A re-inspection is recommended once access is made available.

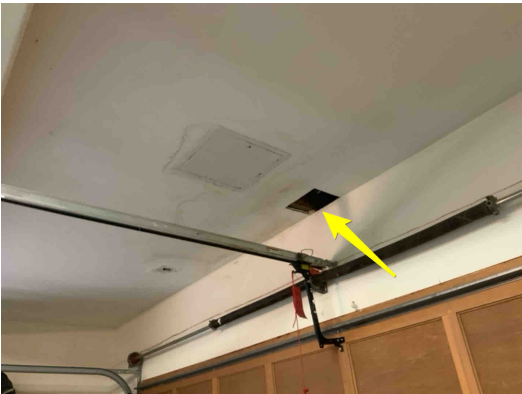
**SC FI 204:** Some small holes or openings found in the garage firewall. Corrections warranted for fire safety. Contact an appropriate professional to repair or correct as needed.

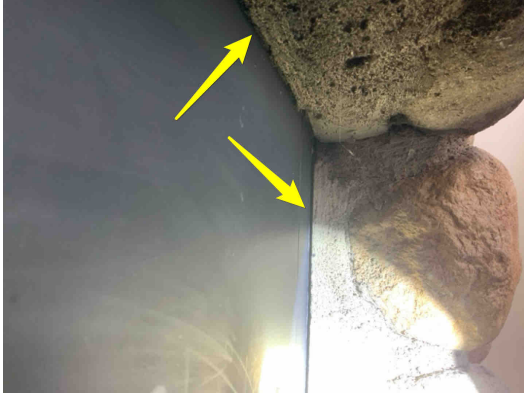
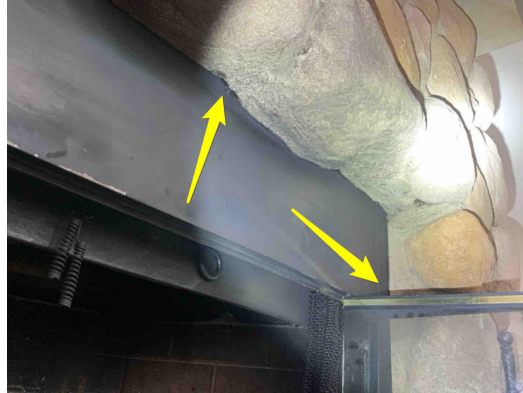
Example

**MR 216:** Some minor separations noted at the face of the LIVING ROOM fireplace firebox around the metal prefabricated fireplace where it butts to the back of the rock fireplace face and metal lintel. Maintenance is recommended for fire safety to prevent superheated fireplace gasses from intruding into the confined spaces behind the rock and into the wood framed chase. Contact a qualified Fireplace Professional to perform the needed maintenance.

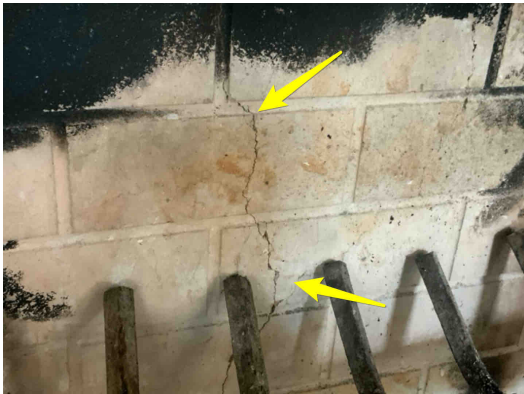
**MR DS 217: Disclosure:** Some minor cracks and/or deterioration found in the back wall and floor refractory shields inside in the LIVING ROOM fireplace. These cracks and deterioration can be typical of this type of fireplace and do not warrant replacement until cracks or deterioration become excessive or displaced. Monitor as future replacement may be warranted.

Example at the back wall

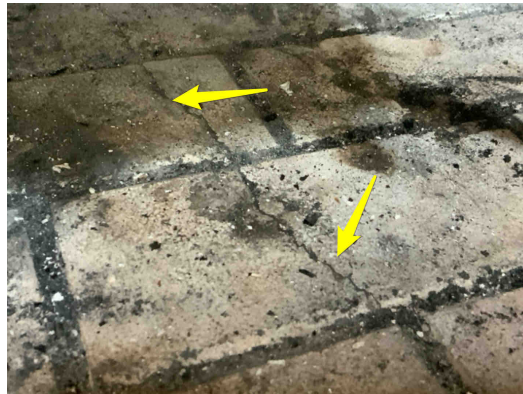
Example at the fireplace floor
