### *Inspection Report*

Address: 1143 16th St Baywood-Los Osos, CA 93402

03/13/2026

Inspector: Taylor Vreeken, CCI

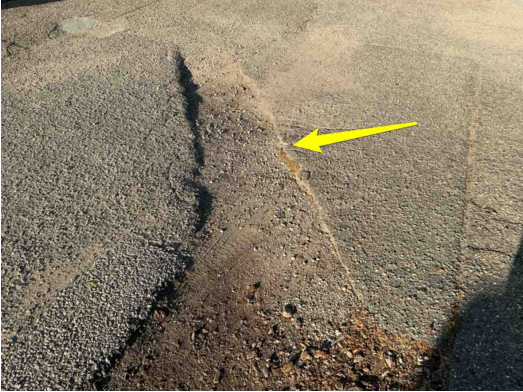
**FI MR 17:** Eroded or damaged asphalt found in some areas of the driveway. Maintenance or repairs are recommended.

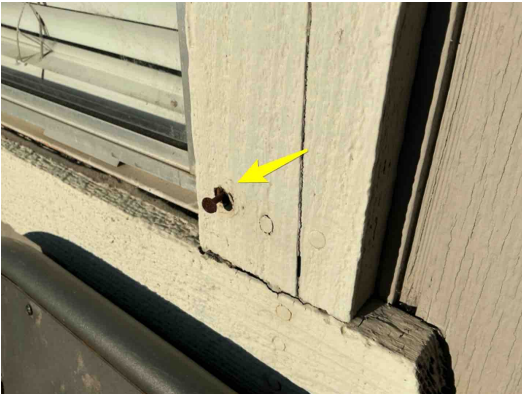
**E&C MR 35:** Multiple loose, unsealed, and/or damaged fasteners noted throughout the exterior. Further evaluation in corrections/ maintenance recommended.

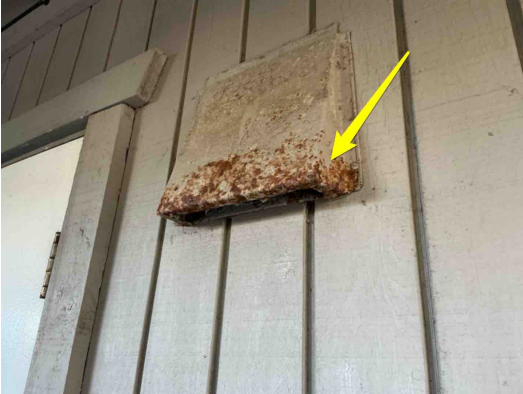
**E&C 38:** Multiple exterior ventilation hoods/screens found rusted and deteriorated. Maintenance, repairs, or replacement recommended.

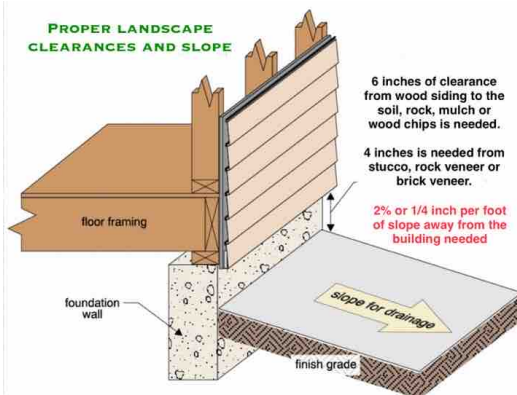
**MR 41:** Soil level found high along areas of the perimeter of the foundation and exterior siding (recommend 6 inches from the bottom of the exterior siding to dirt, rock, mulch or wood chips).

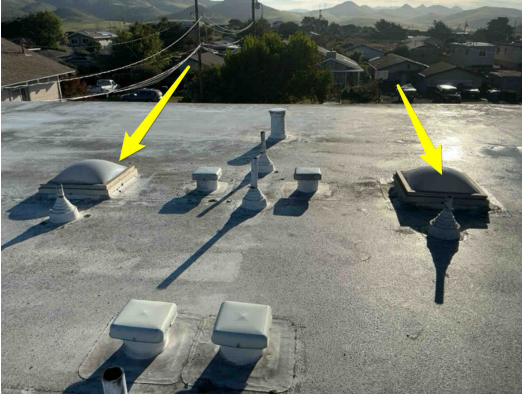
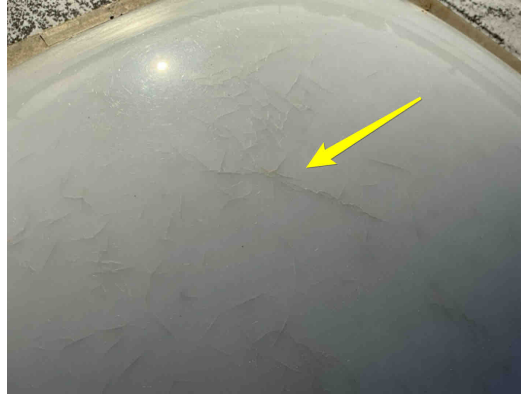
**E&C 57:** BOTH of the plastic roof skylights are cracked and damaged. Replacement is recommended. Contact a qualified roofer to evaluate and replace damaged skylights.

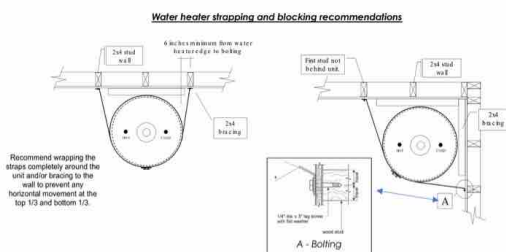
**E&C 79: The Water heater is loosely strapped & not secured well - moves when pushed .** Recommend adding BRACING OR BLOCKING to the wall to properly secure the tank per Uniform Plumbing Code and State Architect Requirements.

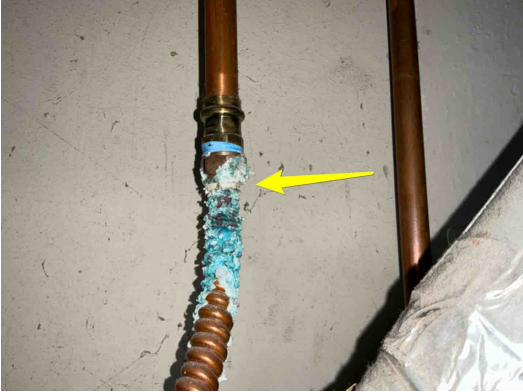
**FI 88:** Evidence of past leaking with corrosion at the HOT water supply piping at the water heater. Contact a qualified plumber to evaluate and correct.

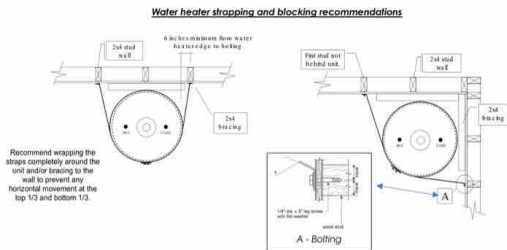
**E&C 94:** The Water heater is loosely strapped & not secured well - moves when pushed. Recommend adding BRACING OR BLOCKING to the wall to properly secure the tank per Uniform Plumbing Code and State Architect Requirements.

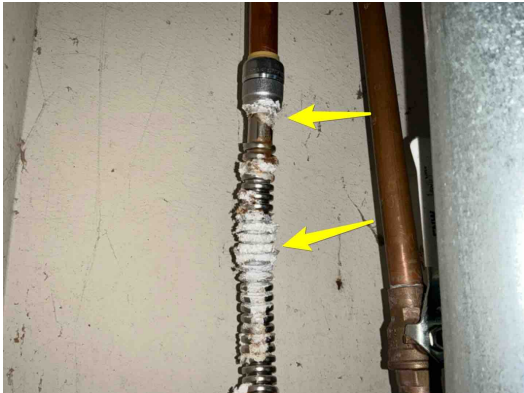
**FI 102:** Evidence of past leaking with corrosion at the HOT water supply piping at the water heater. Contact a qualified plumber to evaluate and correct.

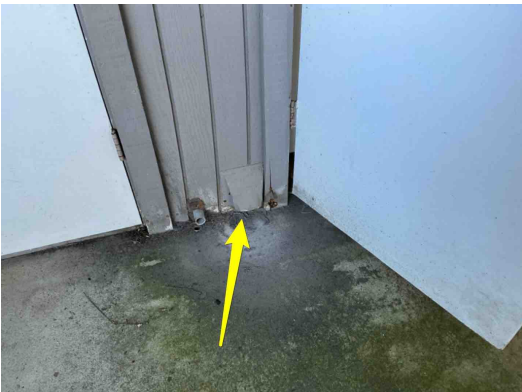
**MR 163:** Recommend cleaning and servicing the laundry dryer vent system, pipe and cap for safety as part of typical ongoing maintenance.

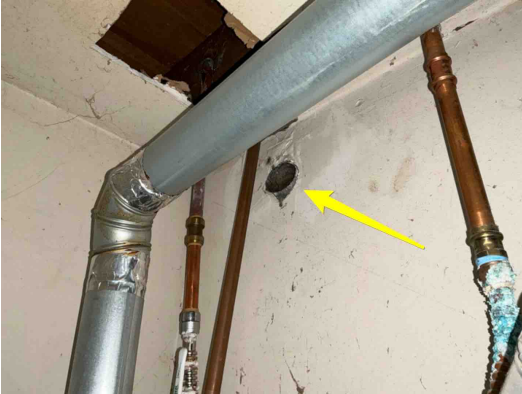
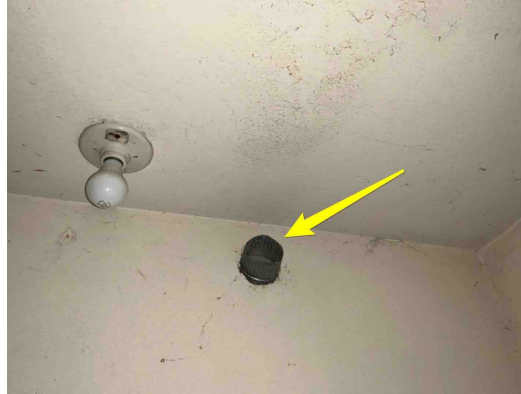
**E&C 177:** Improper termination of both downstairs bathroom exhaust fans into the laundry room/ mechanical room. Exterior ventilation required per minimum standards.

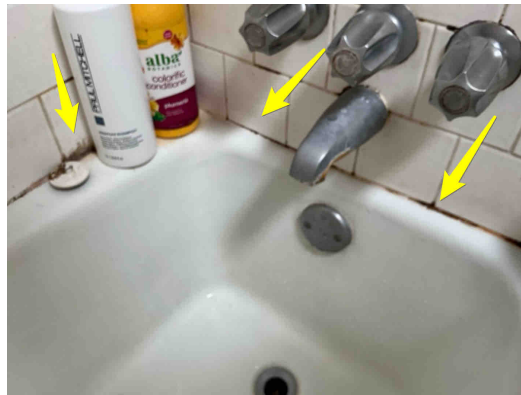
**UPG 180:** Deteriorated/ moldy grout and caulking found in the shower enclosure. Some general maintenance and/or upgrades are recommended: UNIT-1/ UNIT-2/ UNIT-3/ UNIT-4

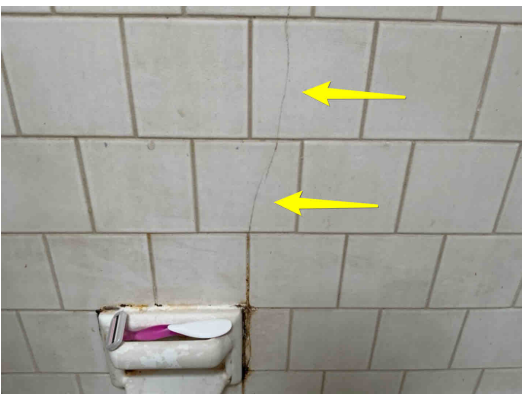
**FI 181:** Some cracked tiles in the UNIT-3 shower enclosure. Recommend contacting a tile professional to evaluate and determine cause, condition and if repairs are warranted.

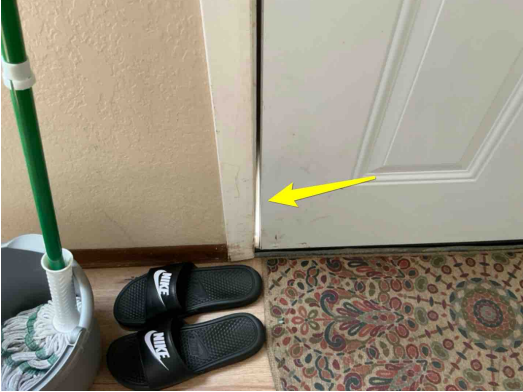
**MR UPG 191:** Loose, unsupported threshold found at multiple exterior doors. This could damage the threshold and/or create a water leak.

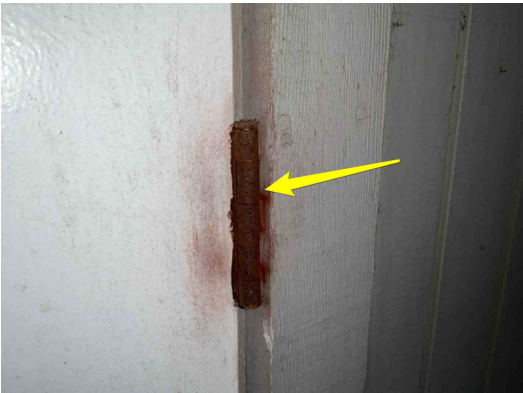
**MR 192:** Deteriorated / corroded door latching hardware and/ or hinges noted at exterior doors. Maintenance recommended.

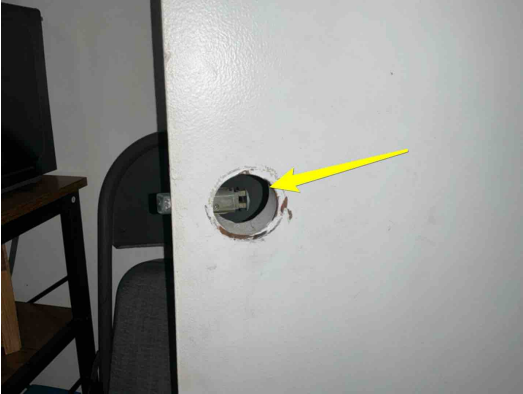
**MR 194:** Interior door knob found damaged: UNIT-1 KITCHEN

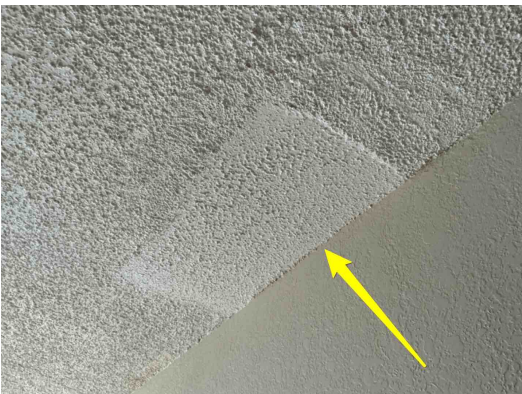
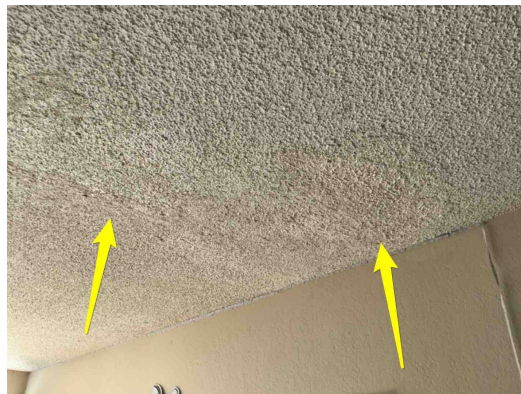
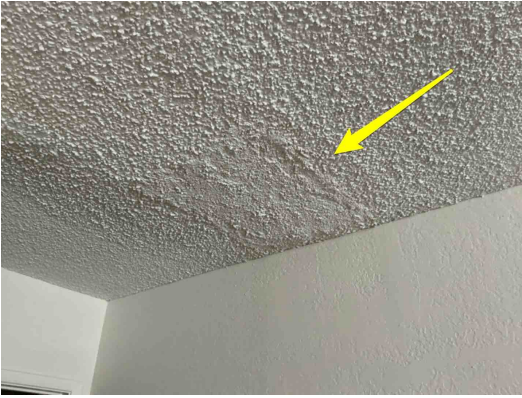
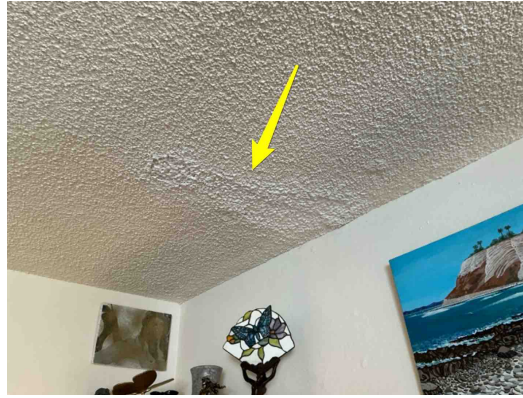
**FI DS 212:** Evidence of past ceiling and wall repairs found throughout. Client should investigate further to satisfy themselves as to the cause and current conditions.

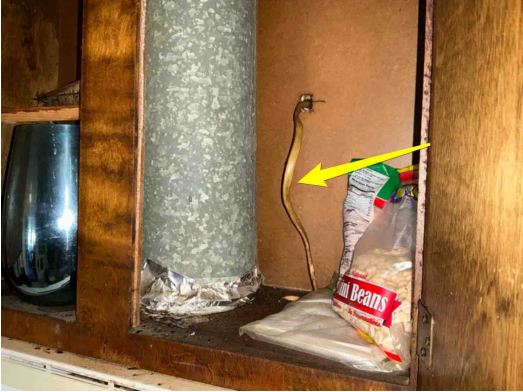
**SC 248:** Improper exposed electrical wiring, "Romex" improperly installed subject to physical damage, not in a conduit or raceway per standards: UNIT-3

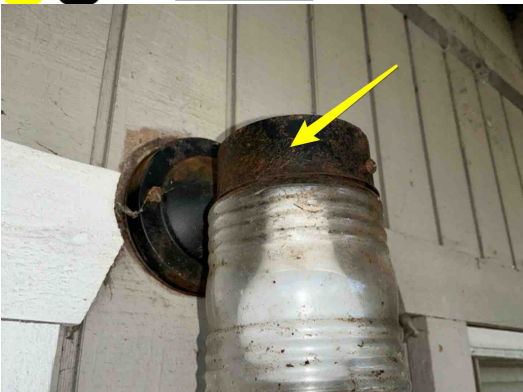
**MR DS 251: Disclosure:** Some exterior light fixtures found corroded and/or deteriorated.

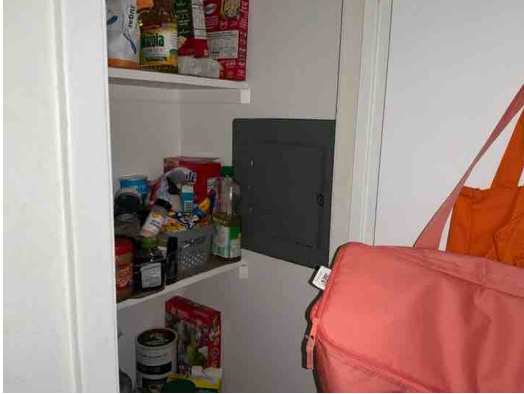
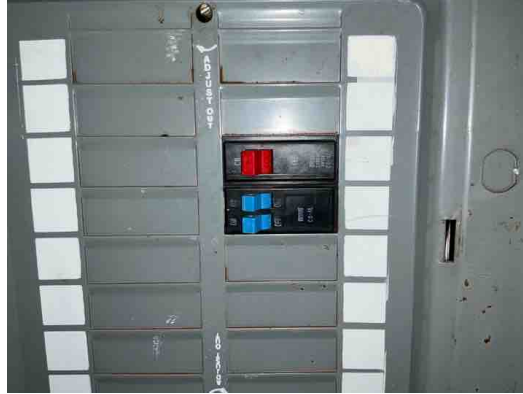
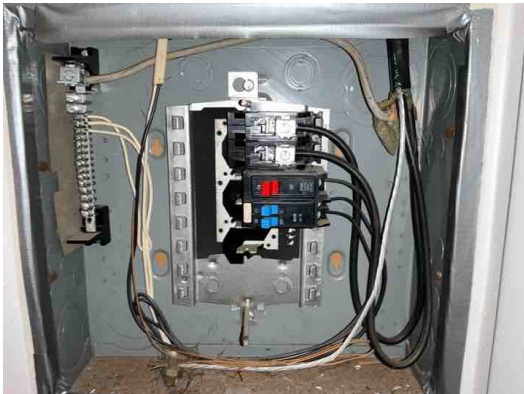
**255:** Location: **UNIT-1**

**SU 256:** Breakers in the ELECTRICAL SUB PANEL are not fully or properly labeled per standards.

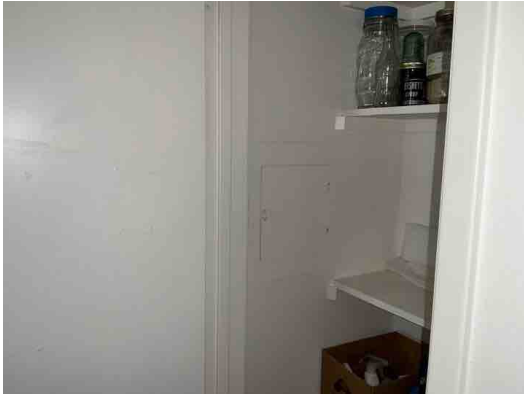
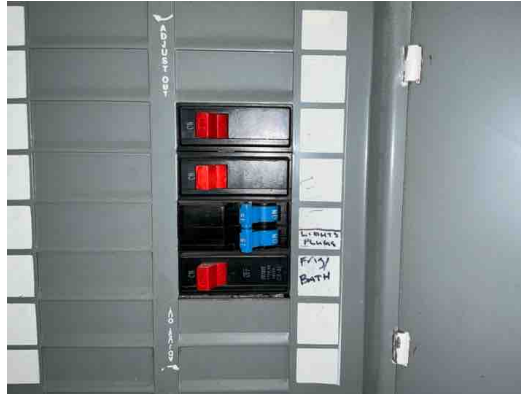
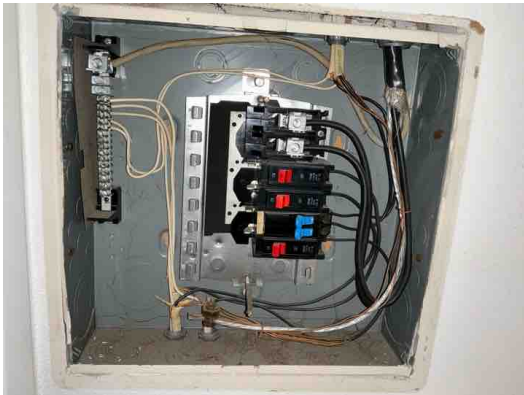
258: Location: UNIT-2

**SC 259:** Electrical panel defect / Over-fusing (breaker found too large for wire), (15-amp wire on a 20-amp breaker) in the ELECTRICAL SUB PANEL.

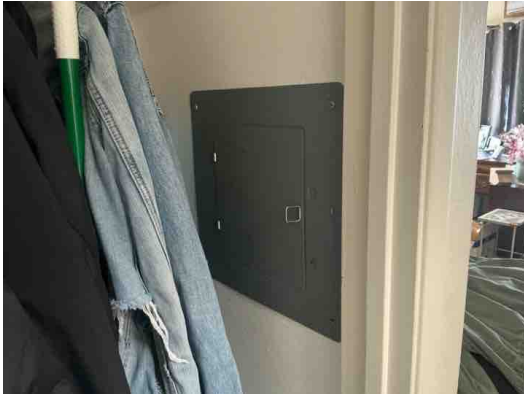
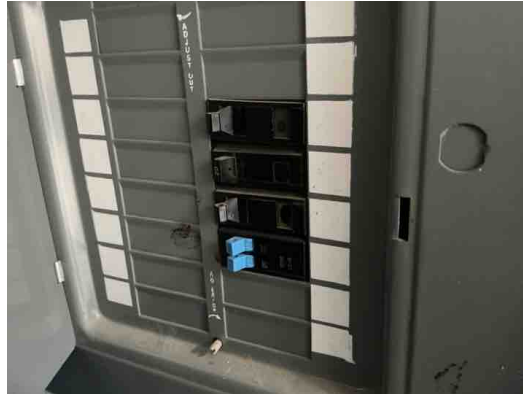
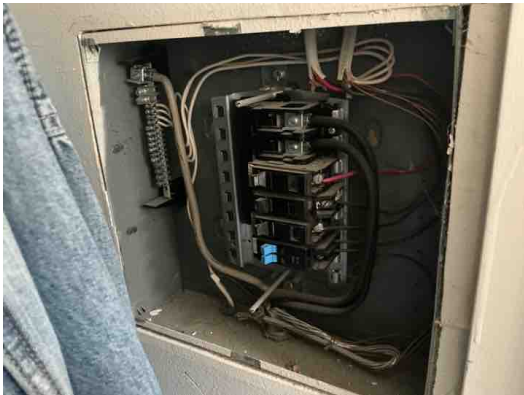
**262:** Location: **UNIT-3**

**SU 263:** Breakers in the ELECTRICAL SUB PANEL are not fully or properly labeled per standards.

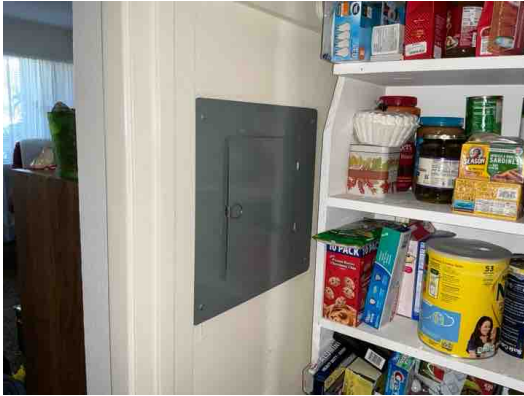
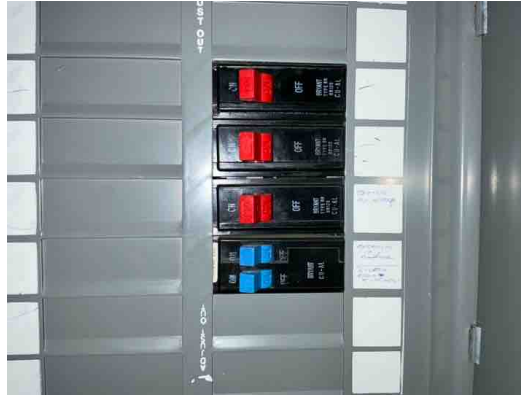
265: Location: UNIT-4

**E&C** 266: The Electrical Sub-panel was not accessible (due to permanently installed shelving) and could not be inspected at this time. Recommend further review once access is made available.
