YOUR INSPECTION REPORT

**637 Tiffany Court
Chula Vista, CA 91990**

Inspected Date: 5/16/2026

Report ID: 1138963

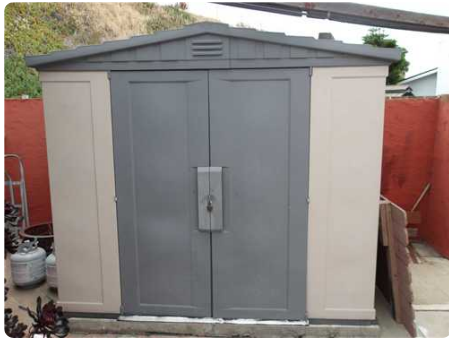
- There is evidence of rodent droppings and/or activity in several areas. This could be a potential health and safety concern. Have a pest control contractor locate the vermin entrance point and make repairs, and remove all waste and debris.

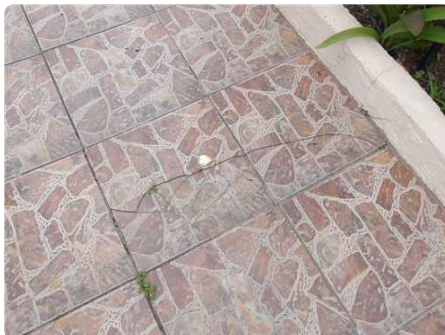
- We observed cracking of the walkways around the building. The damaged areas should be evaluated and repaired as needed.

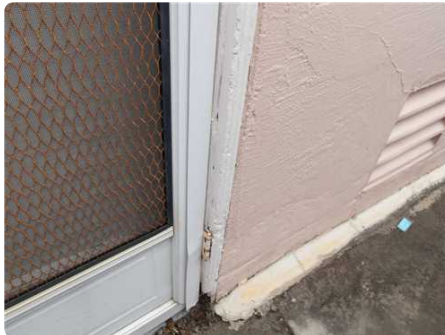
- 🔑 • Some of the exterior trim is damaged in several areas.
 - A qualified technician should examine all exterior trim for damage or deterioration and repair or replace material as necessary. Refer to the termite inspection report for repairs of all wood.

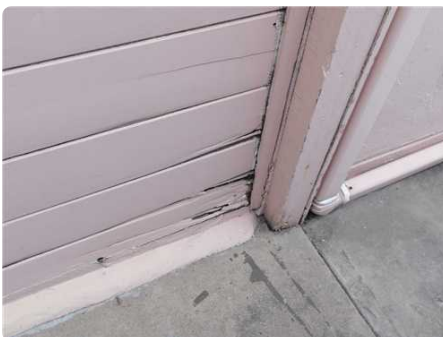
- Conditions associated with wood-destroying organism activity are present in several areas.
 - A qualified, licensed pest control operator should evaluate these conditions, and determine what further steps are necessary.
 - NOTE: Observations by a building inspector, who is not otherwise specially qualified to inspect for evidence of pests, is not a substitute for inspection by a licensed Pest Inspector or exterminator. This report includes comments on current visible conditions only.

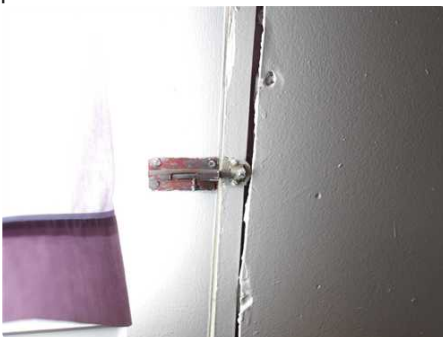
- The door locks and hardware at several areas need to be adjusted so they properly latch and lock. A qualified technician should make any needed repairs or modifications.

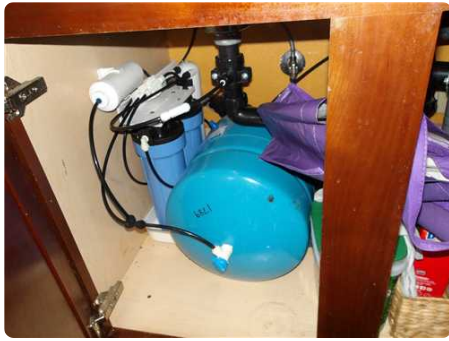
- There is a water softener and/or filtration system on the property. Testing the function of this device is not within the scope of this inspection.

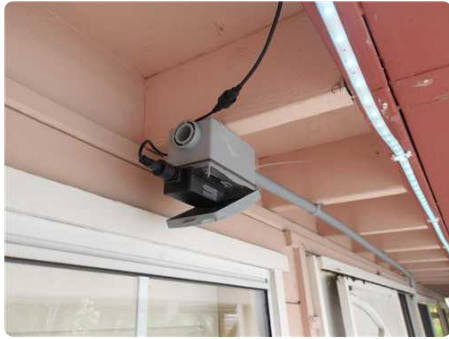
- There is a permanently installed extension or appliance cord on the back of the building. All permanently installed cords are required to have a cover that allows the plug to be installed and still maintain a weather-tight enclosure. An approved weatherproof cover should be installed.

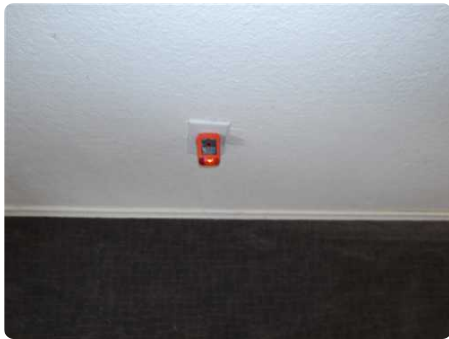
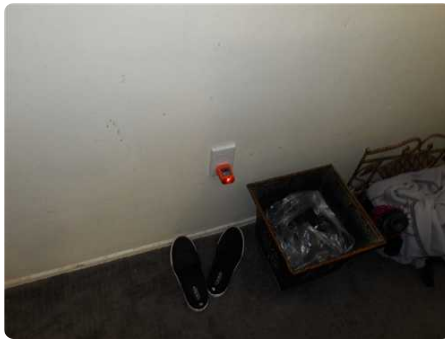
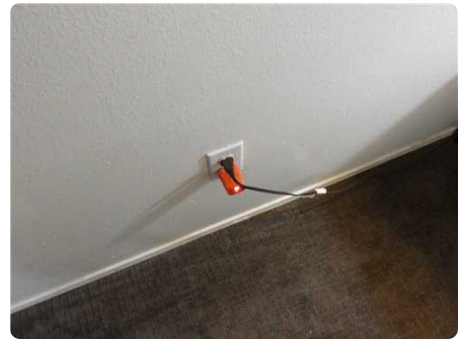
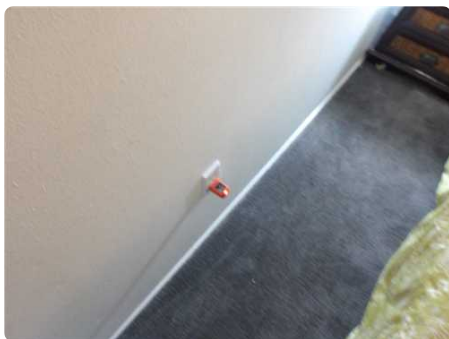
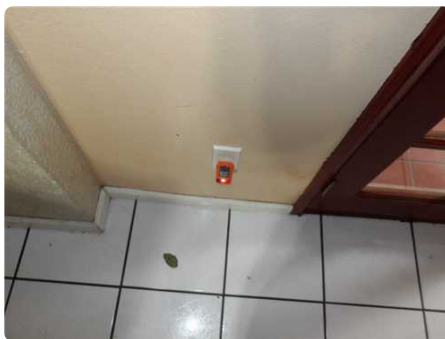
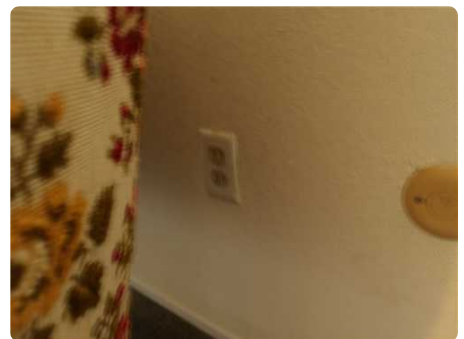
- Receptacles are a mix of older two-pronged receptacles and modern three-pronged receptacles. Some are grounded, and some are ungrounded. Electrical safety would be improved if all receptacles were grounded.

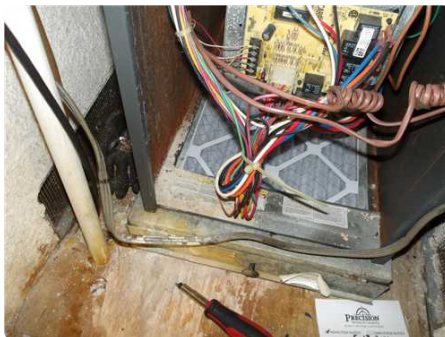
- The heater unit showed signs of aging and wear, but were in otherwise functional condition. The system is approximately 20 years old and the average life expectancy is approximately 20 years for this type of unit. Routine service will assist in the longevity of the unit. We recommend you have the unit serviced by a licensed HVAC technician prior to close of escrow.
- The heating system shows evidence of water intrusion or damage. A qualified technician should evaluate the system and effect repairs as needed.

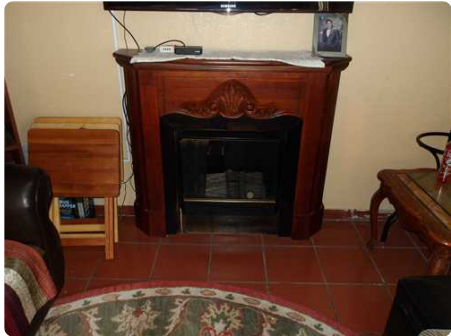
- A false fireplace is installed in the back add on room. This unit is not designed to burn any type of fuel. The unit should be evaluated and removed if not used.

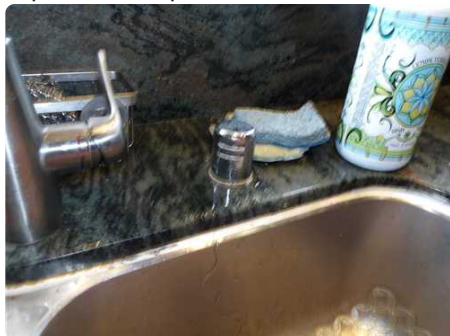
- The air gap or its connection to the disposal is restricted or kinked. This causes water to flow out of the air-gap during the drain cycle of the dishwasher. The dishwasher drain system should be cleaned or modified to restore proper operation. A qualified technician could do the work.

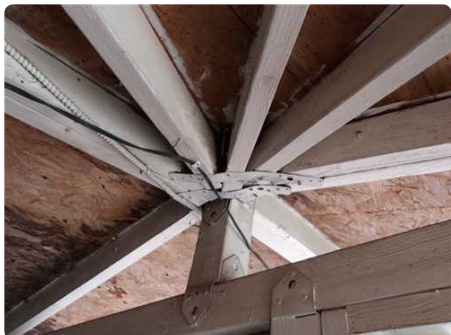
- There is a poor joint at a rafter connection. The parts of the roof structure must be properly joined and fastened together to withstand its own weight. - A qualified contractor can provide repair specifications and costs, and perform the work.

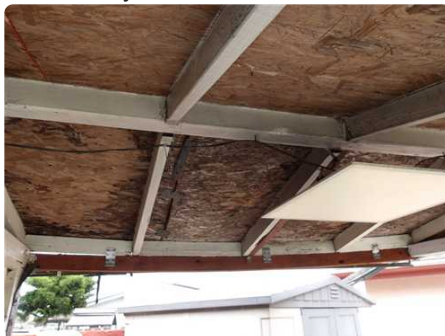
- There are some dips or sags in the roof in areas. The roof sheathing shows signs of deterioration. We recommend a licensed roofer repair and or replace as necessary.

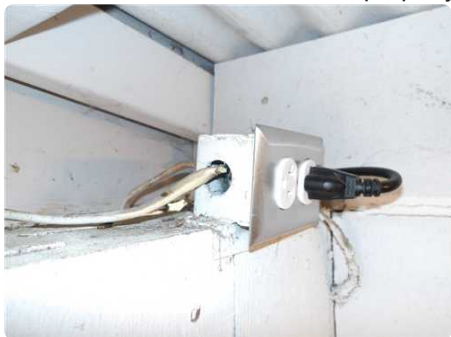
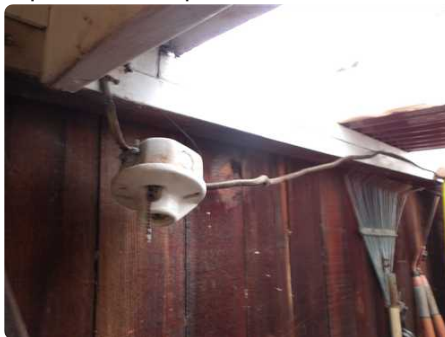
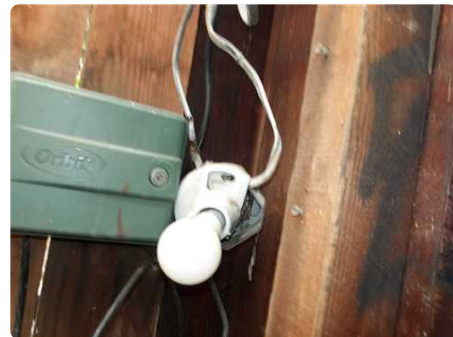
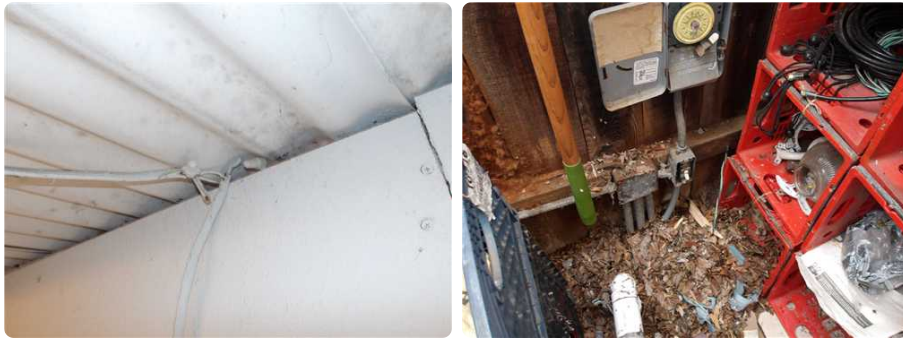
- There is exposed wiring, light fixtures are not mounted and damaged and outlets should be GFCI protected. - A licensed electrician should properly repair and or replace.
