## HOME INSPECTION REPORT

**PROPERTY ADDRESS**  
36305 Colbert Place, Newark

**REPORT NUMBER**  
668218

**DATE OF INSPECTION**  
December 6, 2025

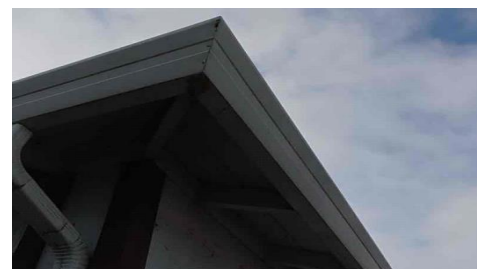
Photo 01

2. Leaks were noted in the downspouts and/or gutters at the front. During wet weather conditions these areas are more obvious and during dry weather conditions they are noted from the stains at the areas where the leaks have occurred. We recommend all leaks be repaired. (See Illustration 2D) (See Photo 1)
3. Loose downspouts at the rear corner should be repaired or replaced. (See Photo 11)

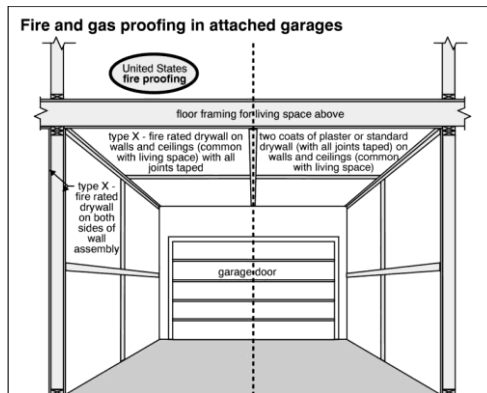
Illustration 3A

5. Damaged, open or missing wall and/or ceiling finishes of attached garages should be repaired and sealed where they abut the interior of a house. This reduces the potential of toxic automobile gases entering the house and serves as a fire break. Current standards require all walls/ceilings common to the finished living spaces be covered with 5/8" fire resistant sheetrock double taped at all seams. (See Illustration 3A) (See Photo 18)

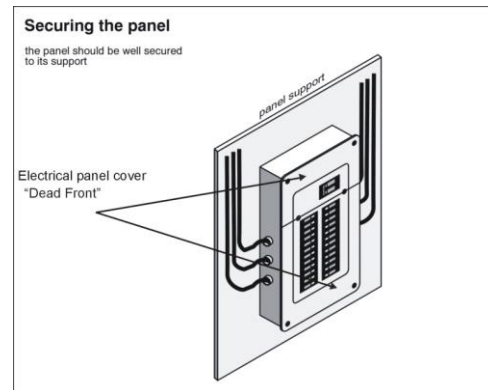
Illustration 4S

14. The main electric panel cover plate sometimes called the "Dead Front" is missing. It should be replaced. (See Illustration 4S) (See Photo 6)

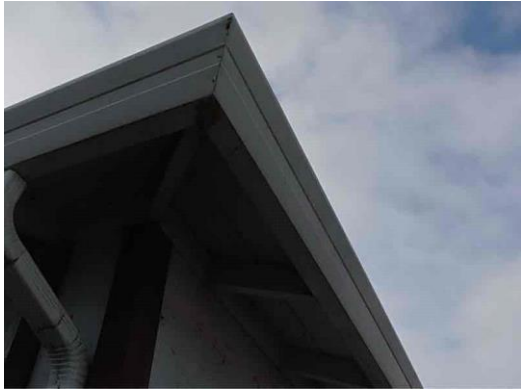
Photo 01

- ! 1. Leaks were noted in the downspouts and/or gutters at the front. During wet weather conditions these areas are more obvious and during dry weather conditions they are noted from the stains at the areas where the leaks have occurred. We recommend all leaks be repaired. (See Illustration 2D) (See Photo 1)
- ! 2. Loose downspouts at the rear corner should be repaired or replaced. (See Photo 11)
3. The downspouts discharge water adjacent to the structure. Water should be directed to flow at least 5 feet away from the building at the point of discharge. The installation of underground drainage where applicable will help control surface drainage.
4. The gutter at the rear is cosmetically dented. This does not affect the function of the gutter/downspout system and repair is optional.

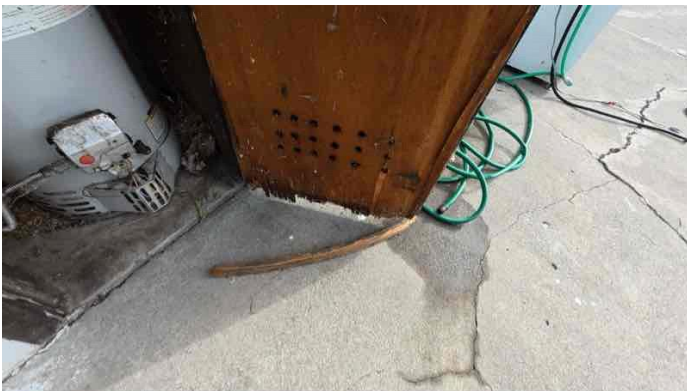
Photo 05

8. Water damage was noted at the rear door. We recommend the services of a licensed general contractor and/or structural pest control company regarding repairs. (See Photo 5)

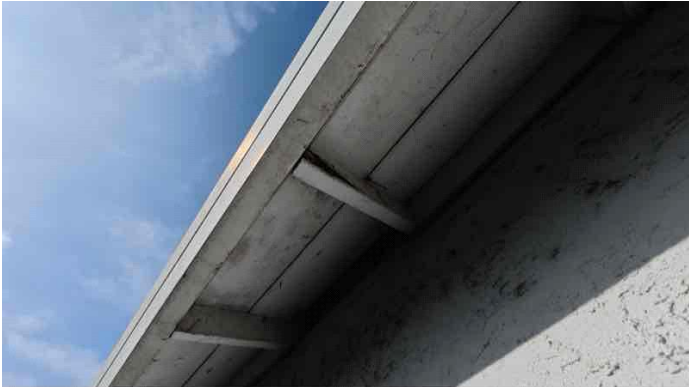
Photo 09

11. Water damage was observed to the rafters at the front and various areas. We recommend the services of a licensed general contractor and/or structural pest control company. (See Photo 2) (See Photo 9) (See Photo 14)

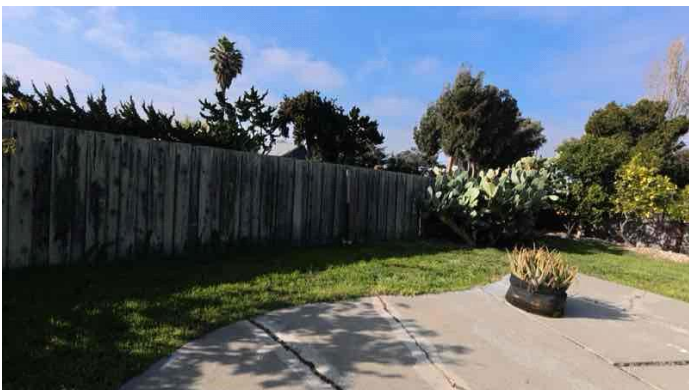
Photo 13

13. The fence is in satisfactory condition, however one or more fence posts are loose at the rear. We recommend all loose, damaged or deteriorated posts be reinforced or replaced as necessary. (See Photo 13)

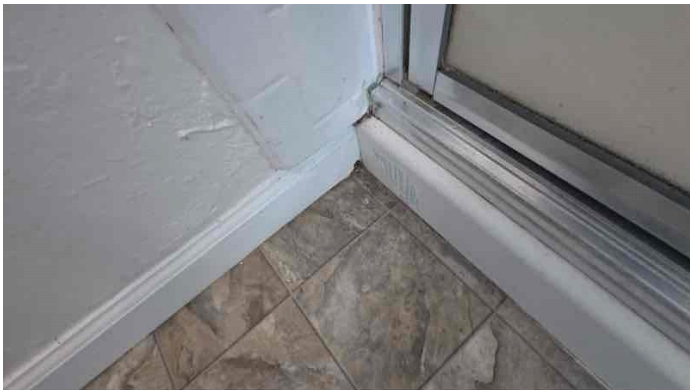
Photo 29

33. The wall trim and/or baseboard at the master bathroom was observed to be water damaged. We recommend the services of a licensed general contractor and/or structural pest control company. (See Photo 29)

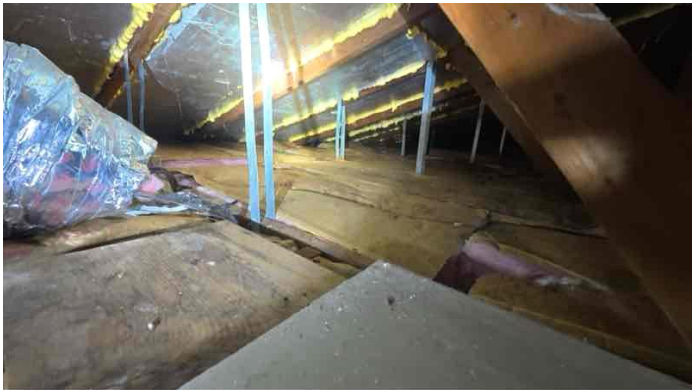
Photo 32

1. The attic fiberglass insulation has been installed backwards. We recommend consideration be given to reinstalling the insulation with the moisture barrier against the living space. (See Photo 32)
2. One or more of the ventilation screens for the crawl space is torn, damaged or missing. We recommend the damaged or missing ventilation screens be repaired or replaced as necessary.

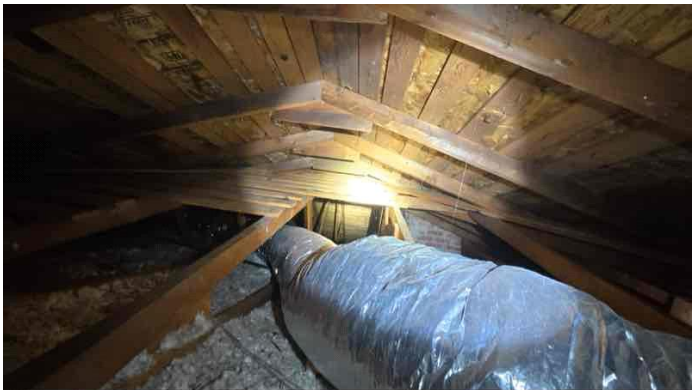
Photo 33

1. Evidence of past repairs and/or modifications have been made to the roof structure. The owner should be consulted for further information regarding any repairs or remodeling work, and any permits that were required, obtained and completed. (See Photo 33)
2. A vapor barrier was present at the time of inspection in the crawlspace and/or basement area. Installation of this barrier is typically done to aid in preventing damage to wood members from excessive moisture conditions. Inspection of the vapor barrier and its installation is beyond the scope of this inspection. The owner or interested parties should consult a licensed soils and drainage specialist for further information.
