ANDERSON INSPECTIONS

Inspection Report

25482 Westborne Dr
Dana Point CA 92629

061126RA2

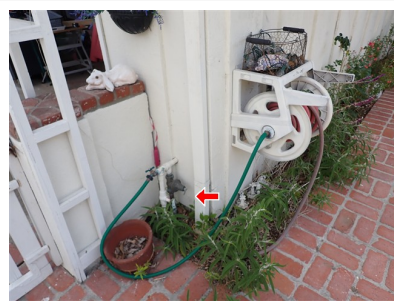
Item 50 - Item 1 (Picture)

50. **CLIENT INFO:** The main water shut off is located at the right front. We recommend familiarizing yourself with this location during your final walkthrough.

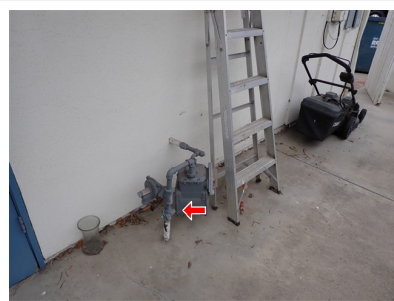
Item 52 - Item 1 (Picture)

51. (1) **CLIENT INFO:** The gas utility shut off is located at the right rear. We recommend familiarizing yourself with this location during your final walkthrough.
52. (2) **CLIENT INFO:** The gas utility shut off is located at the right side. We recommend familiarizing yourself with this location during your final walkthrough.

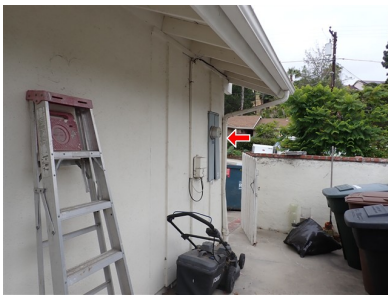
Item 53 - Item 1 (Picture)

53. **CLIENT INFO:** The main electric disconnect is located at the right rear. We recommend familiarizing yourself with this location during your final walkthrough.
