# Summary Report, prepared exclusively for:

952 Seaside Ct. Ventura (Main Report - Upstairs) - Paul & Suzanne Guthrie 06 10 2026 By

June 10, 2026

RE: 952 Seaside Ct. (Main Report - Upstairs)  
Ventura, CA

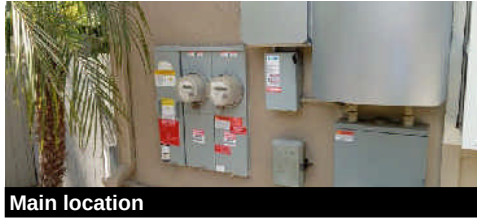
Main location

Main electric panel box is located at exterior of house. Main panel box, wiring, and breakers were tested or observed by the inspector and found they are wearing well, durable and capable of being used.

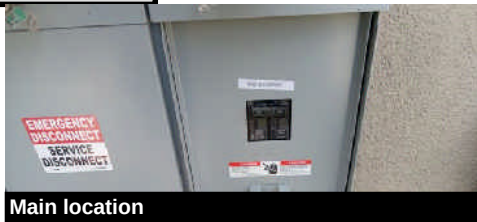
Main location

Circuit breakers and wire sizing are correct so far as visible. Electrical grounding system is present, was tested or observed by the inspector and found it is wearing well; is durable; is capable of being used.

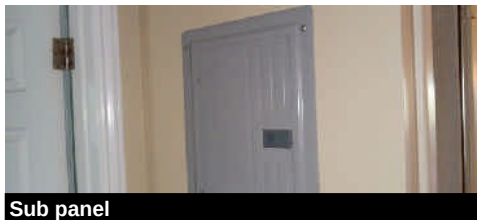
Sub panel

Hallway.

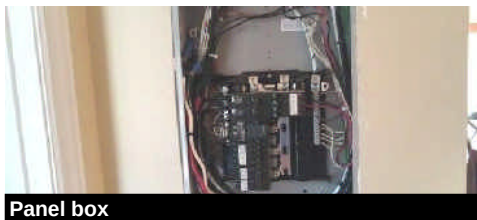
Panel box

Circuit and wire sizing correct so far as visible. Grounding system is present. SUB PANEL breakers and wiring were tested or observed by the inspector and found they are wearing well, durable and capable of being used.

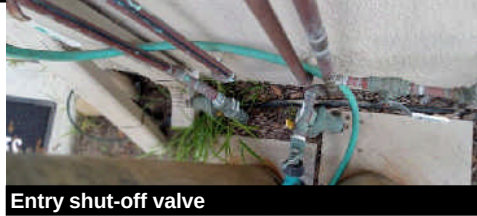
Entry shut-off valve

Copper water lines were observed.

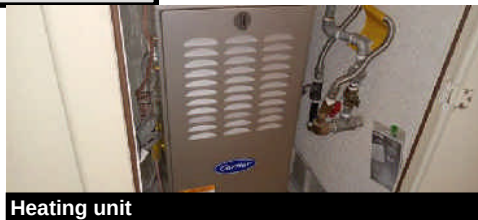
Heating unit

Upstairs hallway closet.

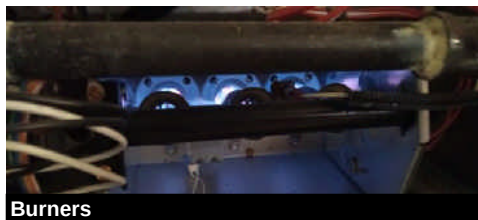
Burners

3-Burners. Burner flame(s) appear typical. Inspection of interior burner / heat exchanger area is beyond the scope of this inspection. The heat exchanger portion of a gas fired heater is difficult to access without disassembly, and cannot be adequately checked during a visual inspection.

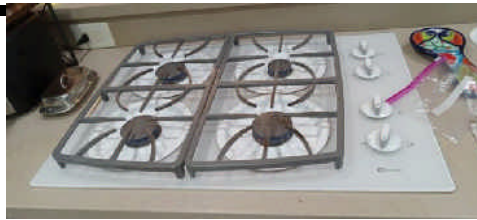
Gas. Electric ignition. Cook top was tested or observed by the inspector and found it is wearing well, is durable and capable of being used.

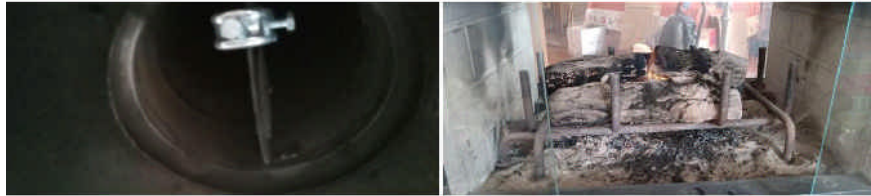
Zero clearance prefabricated metal type. Damper is operational. Gas log set is installed and appears serviceable.
