# PROPERTY INSPECTION REPORT

**995 Jacqueline Pl**  
**Inspection Prepared For: Terry Robert's**  
**Agent: -**

**Date of Inspection: 5/27/2026**

**Year Built: 2007 Size: 2110**

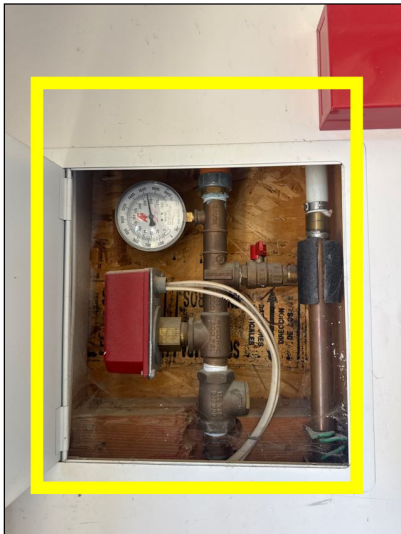
Fire sprinkler riser

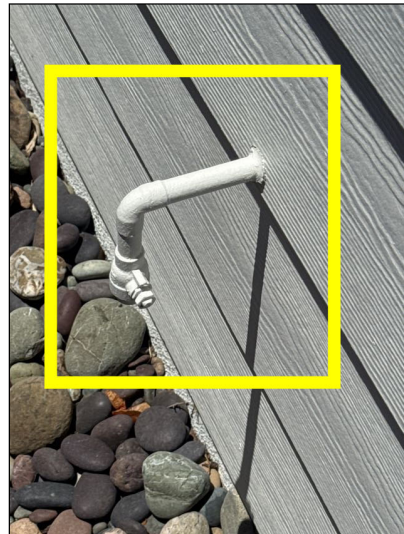
This ball valve is used to test the fire bell of the fire sprinkler system by creating water flow from the system that should activate the fire bell.

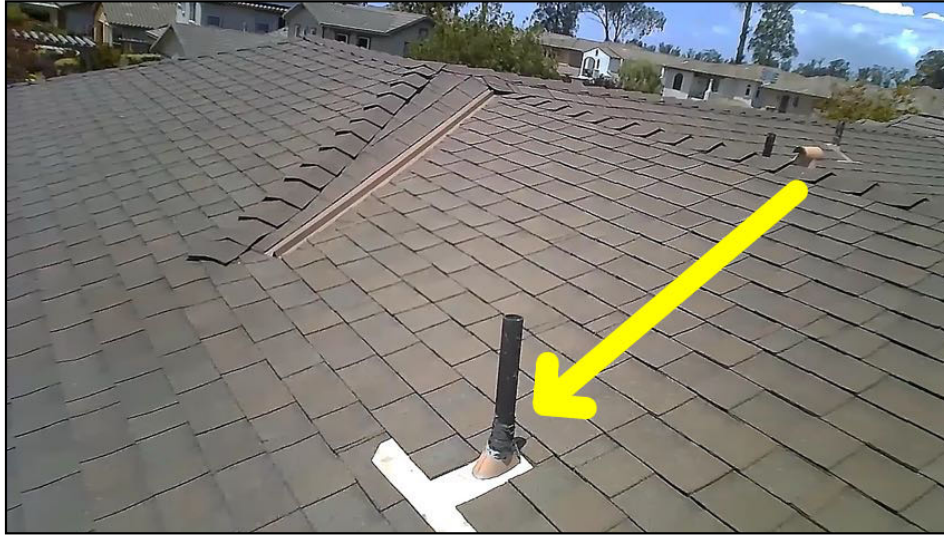
**Routine Maintenance:** Plumbing vent flashings are mastic covered and will start to show signs of mastic deterioration from sun exposure over time.

**Routine Maintenance:** Plumbing vent flashings are mastic covered and will start to show signs of mastic deterioration from sun exposure over time. Recommend re-sealing all through the roof vents and projections as a part of routine maintenance to prevent unwanted moisture intrusion.

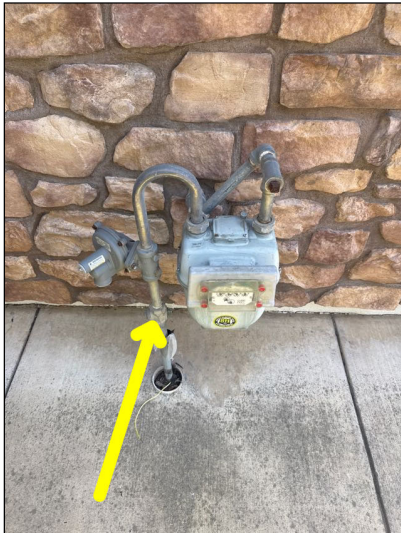
Main gas shut off to the home.

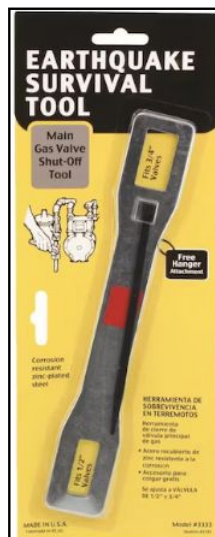
- The gas shut-off appeared to be in serviceable condition at the time of the inspection. Shut-offs were not operated, but were visually inspected.
- The home was located in an area known to experience significant earthquakes having a gas shut off tool readily available in an emergency is a recommended safety improvement.

Having a gas shut off tool readily available in an emergency is a recommended safety improvement.

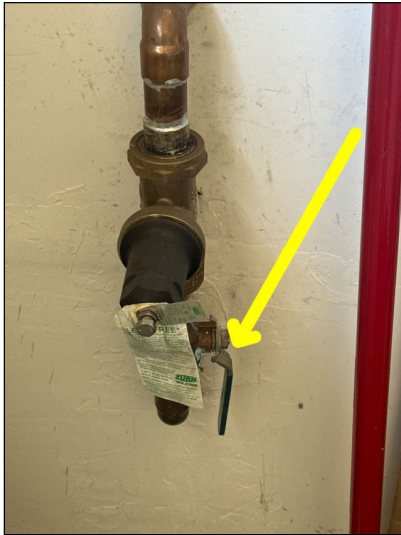
**Observations:** At the time of the inspection, the Inspector observed no deficiencies in the condition of the main water supply shut-off valve. It was not operated but was visually inspected.

Main water shut off to the home where the main water line enters the home.

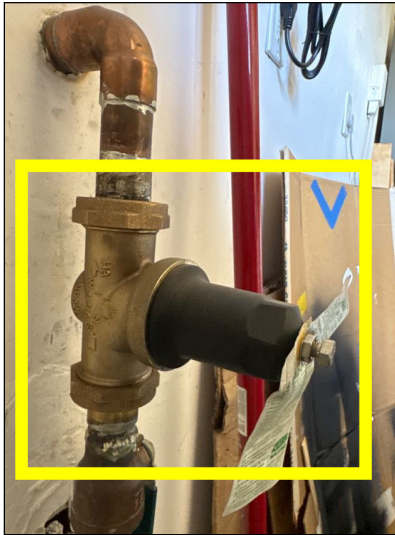
- ✓ • The water distribution system was equipped with a pressure regulator. A pressure regulator is designed to regulate water pressure from the city water supply to between 25-75 PSI (they are factory set at 50 PSI).
- At the time of the inspection, the Inspector observed no deficiencies in the condition of the pressure regulator.

The water distribution system was equipped with a pressure regulator.

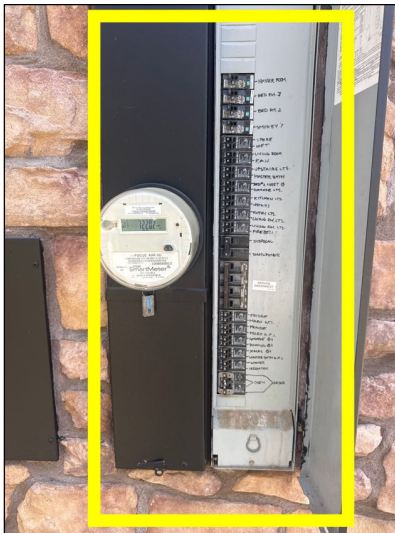
Main electrical service panel to the home.

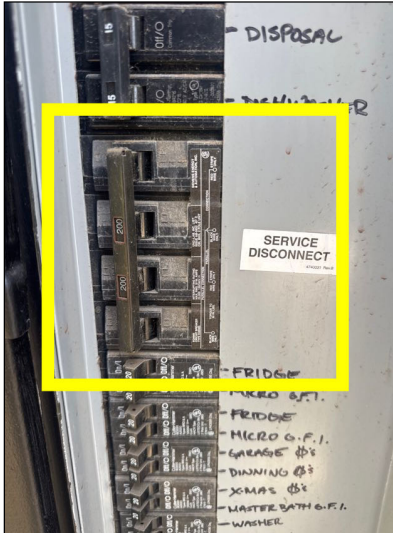
- ✓ The main amp breaker is rated at 200 AMPS.
- The Inspector observed no deficiencies in the condition of the electrical service disconnect. It was inspected visually but was not operated.

Main electrical shut off to the home

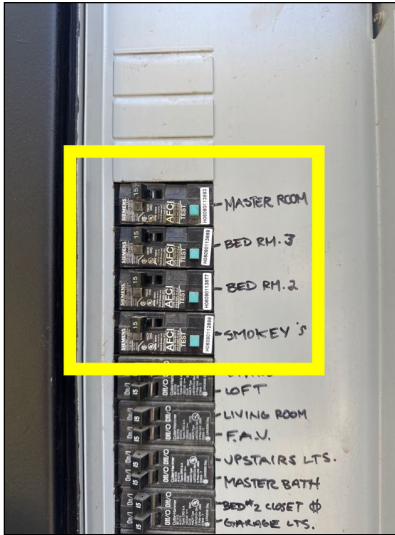
The arc fault circuit interrupter (AFCI) breaker(s) in the electrical panel properly responded to testing at the time of the inspection.

Note: AFCI circuit breakers installed at the main electrical panel.

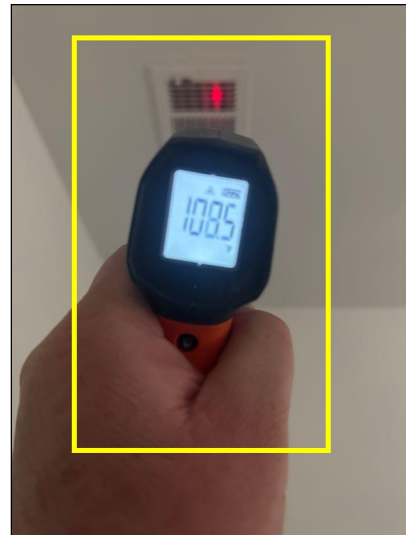
The supply air temperature at the registers should be 100 °F - 125 °F + to be considered running efficiently.

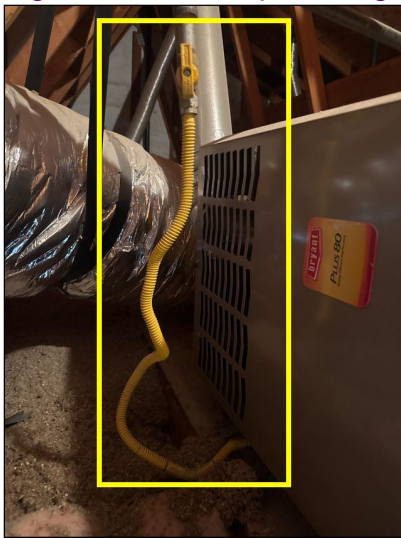
### Sediment Trap

**Recommended Improvement:** The gas supply pipe contained no sediment trap. A sediment trap is generally recommended but not always required, depending on the local Authority Having Jurisdiction (AHJ). The purpose of a sediment trap is to prevent sediment or debris particulates from entering and clogging the heaters gas valve, which can cause the heater to shut down. You may wish to consult with local contractor concerning the advisability of installing a sediment trap in the gas line.

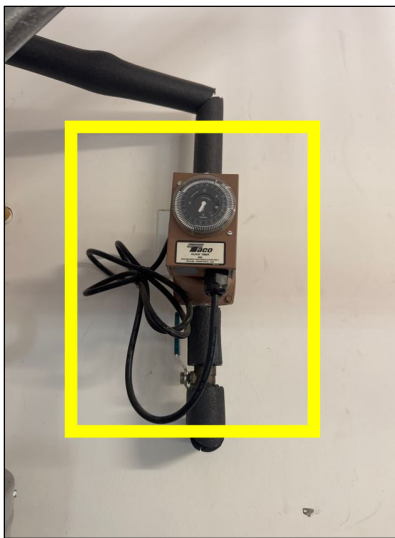
**Note:** The home had a hot water re-circulation system installed. This system includes a second hot water supply pipe in which hot water circulates through the home. When a hot water valve is opened, hot water supplied by this re-circulation pipe is available almost instantly. This is especially convenient for plumbing fixtures located far from the water heater and at which water normally takes a long time to get hot. The re circulation pump was connected to a timer that shuts off the pump at night when hot water is seldom needed. The system responded to the demand for hot water.

**Note:** The home had a hot water re-circulation system installed.

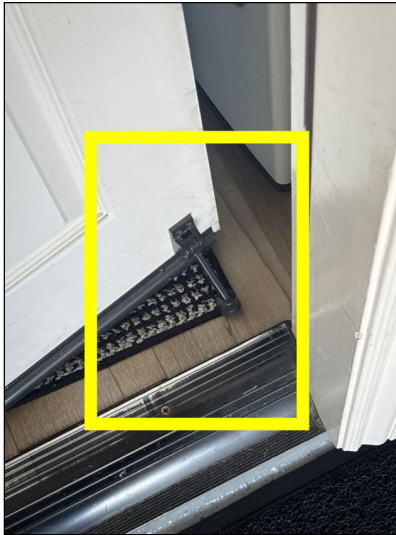
The door in the wall between the garage and the home living space did not meet generally-accepted current safety standards. Door stops that prevent the door from self-closing are considered a breach in the firewall.
