## Inspection Services

### *Inspection Report*

Address: 2315 Autumn Pl Arroyo Grande, CA 93420

06/08/2026

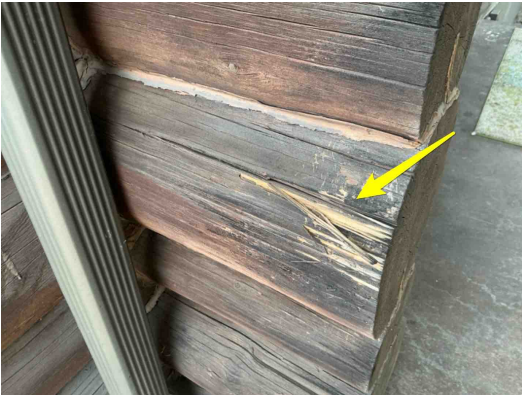
**MR 31:** Deteriorated finish at areas of the exterior.

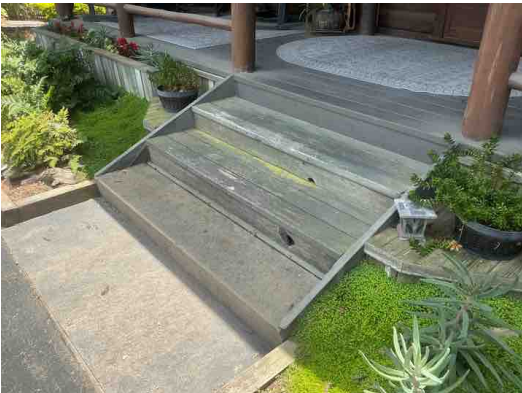
**34:** OFF THE FRONT DECK

**SC 37:** Recommend a proper graspable handrail at the OFF THE FRONT DECK stairway for safety per current standards.

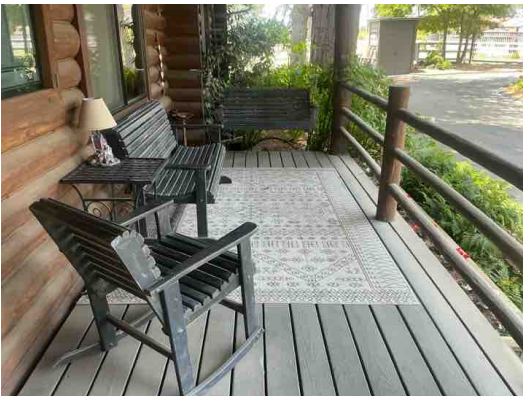
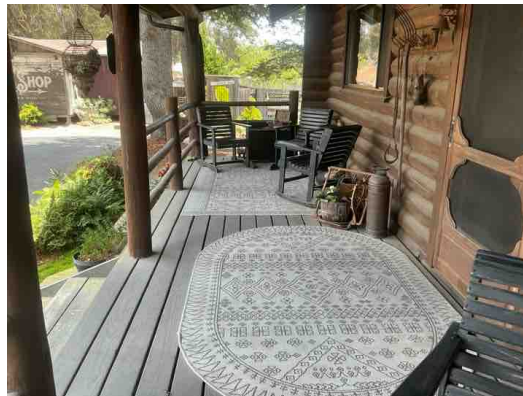
**38: DECK LOCATION:** **FRONT ENTRY DECK**

**UPG 41:** Earth-to-wood contact visible at areas of the FRONT ENTRY DECK wood framing. Refer to the termite report for additional comments and if damage to the wood is occurring in areas not visible below grade.

**DS 42:** The ENTRY deck framing was observed with wider joist spacing than is typically associated with modern deck construction standards for nominal 2x6 decking. While this condition may reflect construction practices common at the time of installation, wider joist spacing can contribute to increased flexing and reduced rigidity of the deck surface. Upgrades may be considered during future repairs or renovations.

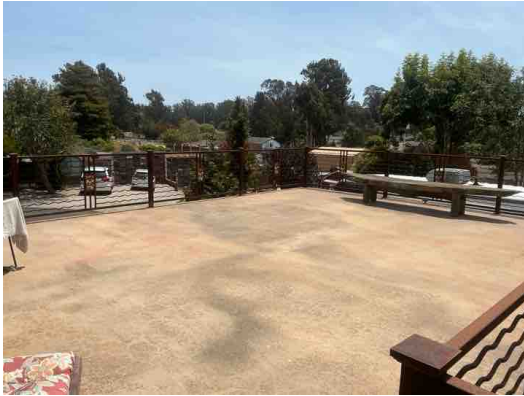
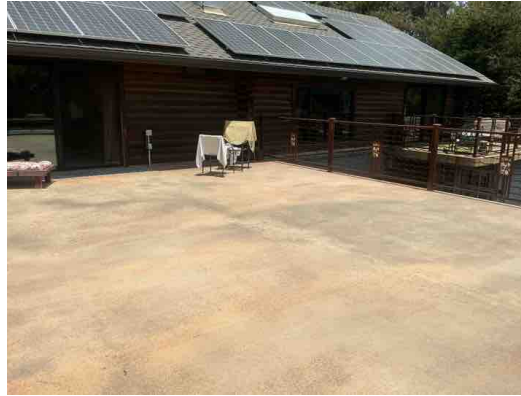
**39: DECK LOCATION:** UPSTAIRS DECK OFF THE PRIMARY BEDROOM

**E&C 44:** Some rust deterioration and/or damage noted at areas of the metal railings at the UPSTAIRS DECK OFF THE DINING ROOM and UPSTAIRS DECK OFF THE PRIMARY BEDROOM. Maintenance repair or upgrades are recommended for safety.

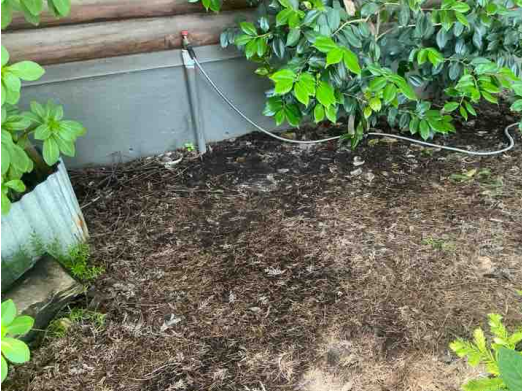
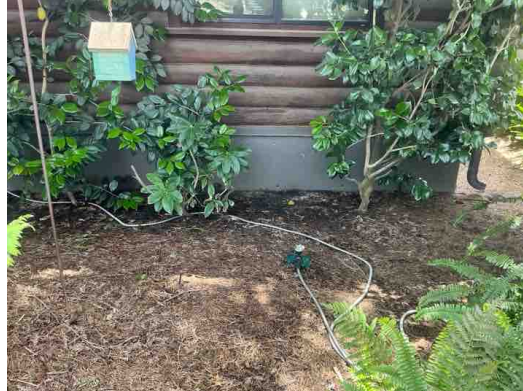
**MR UPG 46:** Evidence of ponding water was observed in areas of the property at and/or near the home. Recommend improving site drainage and landscape grading as needed to help direct water away from the structure and off the property.

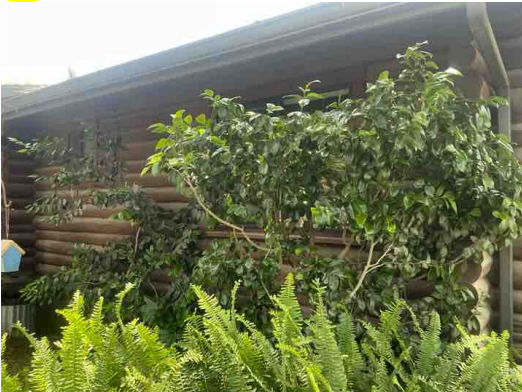
**MR 47:** Plants and/or Trees touch the buildings exterior. Proper landscape maintenance needed.

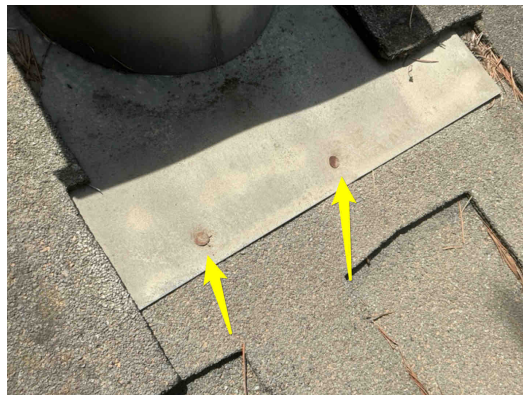
**DS 55: Disclosure:** Exposed fasteners noted at areas of the roof and/ or roof flashings.

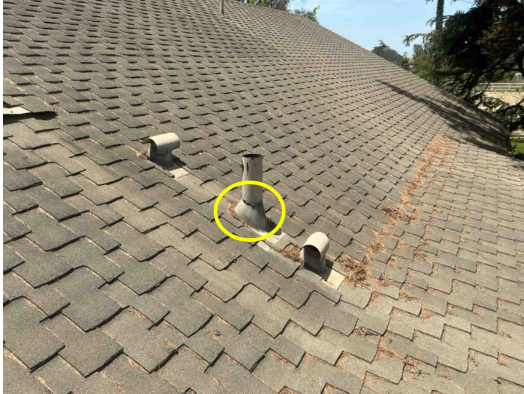
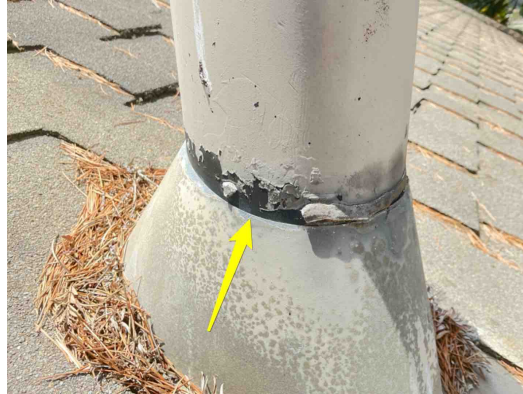
**MR 57:** Deteriorated sealant at some roof flashings, around the roof penetrations. Maintenance recommended to help prevent water intrusion into areas of the attic. Have roofer evaluate the roof flashings and correct as needed.

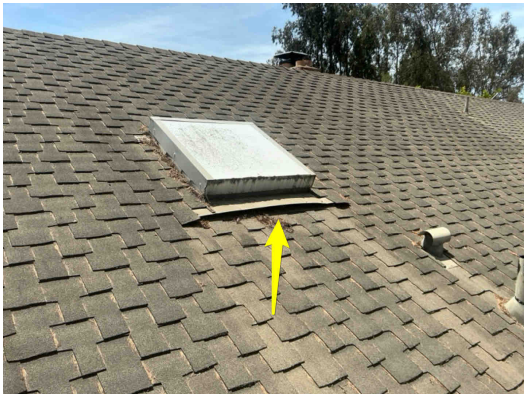
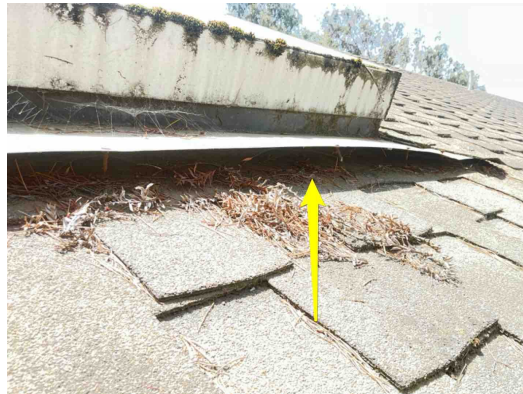
**E&C MR 58:** Some lifting roof flashings. Corrections, maintenance or repairs are recommended to help prevent water intrusion and/or roof leakage from windy, wet weather.

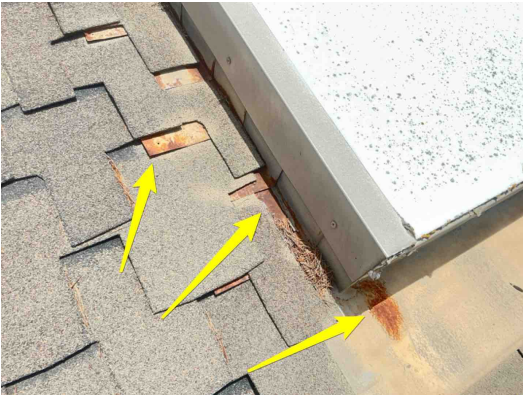
**FI 59:** Some roof flashings found rusted and deteriorated. Maintenance or replacement of deteriorated and damaged roof flashings are recommended.

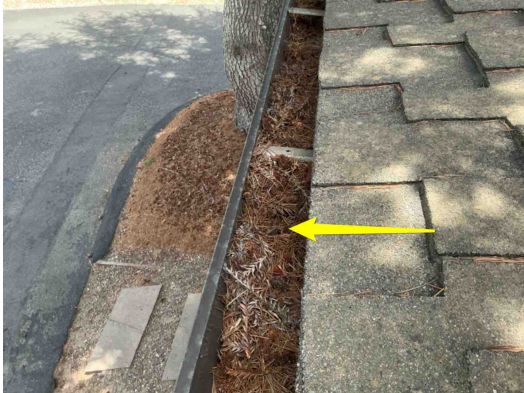
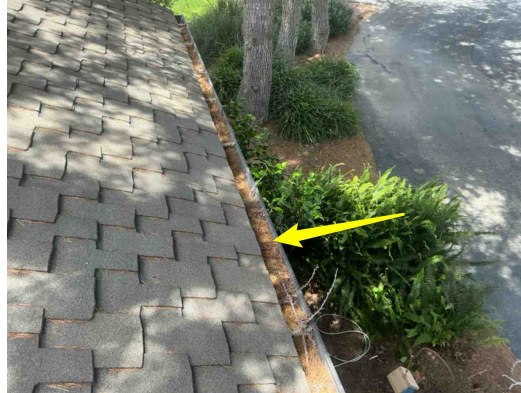
**MR 70:** Recommend some typical rain gutter maintenance. This should at minimum consist of cleaning, sealing, and re-fascinating of loose gutters and downspouts.

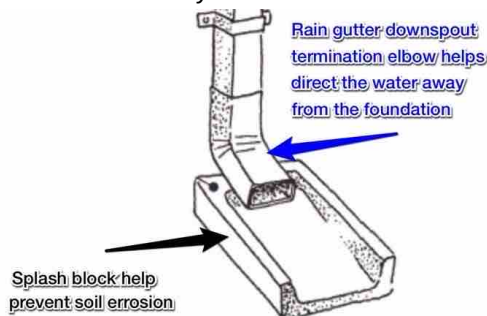
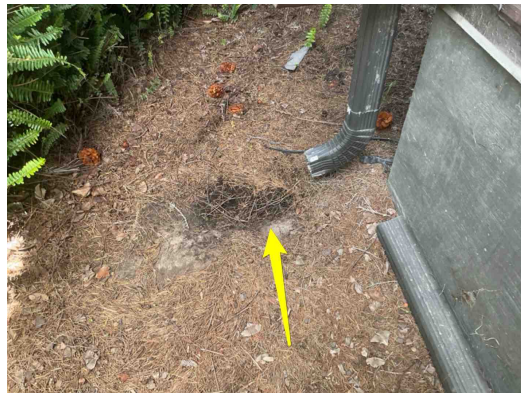
**MR 72:** Recommend splash blocks and diverting the rain gutter downspouts at the bottom to assist in proper flow of roof water away from the house and to help prevent soil erosion where not installed.

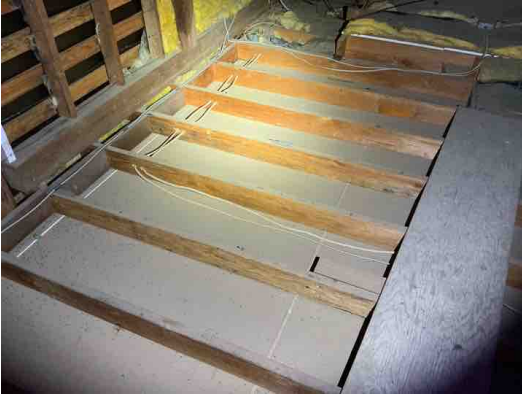
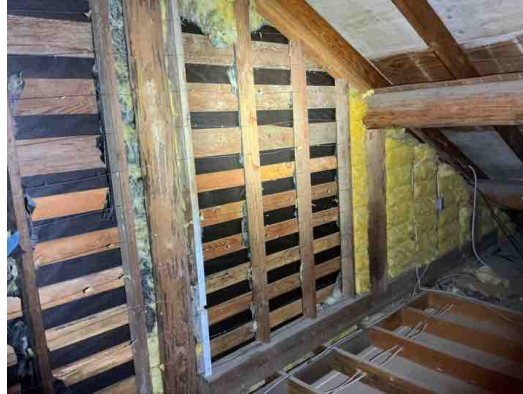
**E&C 73:** Missing insulation in the areas attic. Some of the attic Insulation in has been moved, displaced or was not originally installed for reasons unknown.

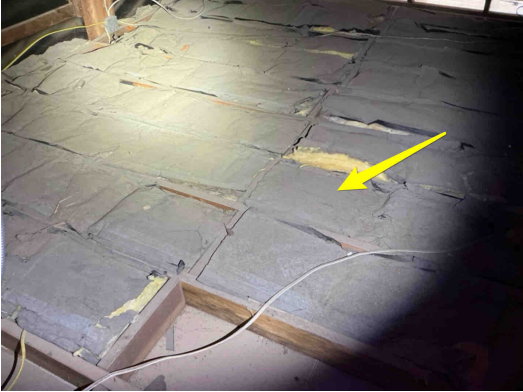
**E&C 74:** Attic Insulation installed upside down. The paper on the insulation should be towards the living space below.

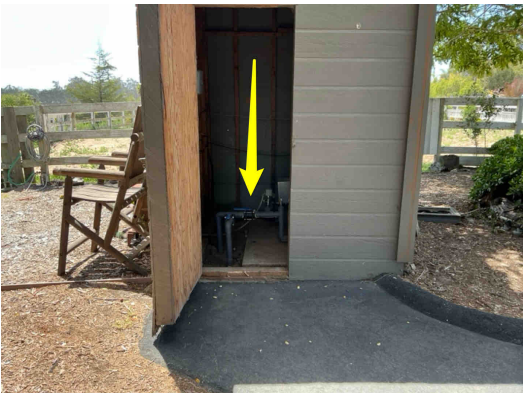
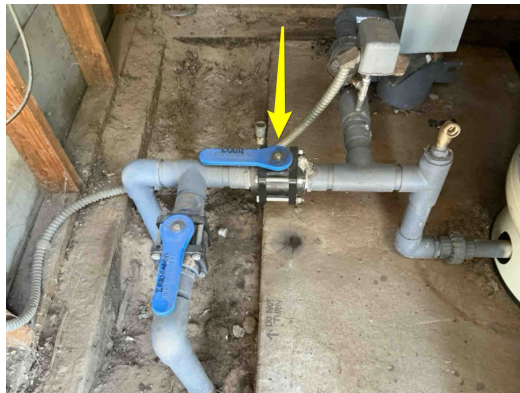
**E&C** 77: A small active water leak noted at the main water supply pipe or valve. Contact the qualified professional for repairs.

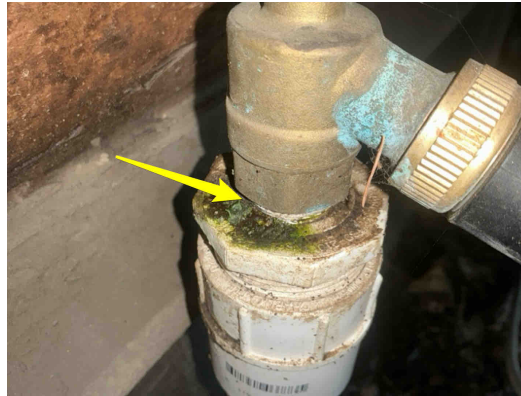
**E&C 84:** A small active water leak found at the exterior NORTHWEST HOSE BIB. Corrections recommended.

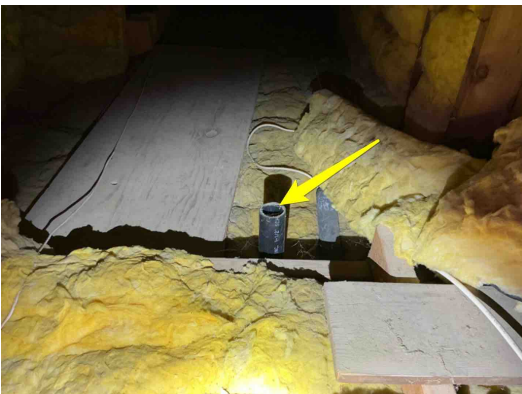
**DS 91:** Disclosure: An open waist vent noted in the attic over the HALLWAY BATHROOM. Unable to confirm if vent is still a functioning component in the waist system or has been abandoned. Buyer may wish to contact a licensed plumbing professional for evaluation.

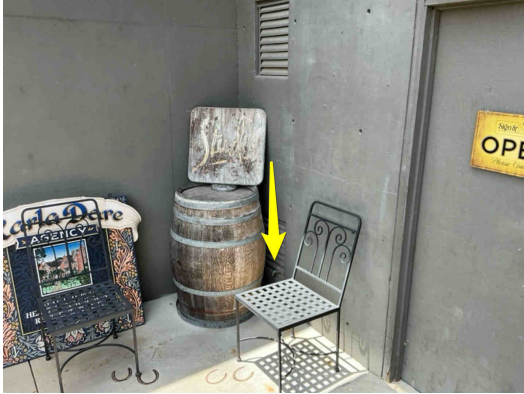
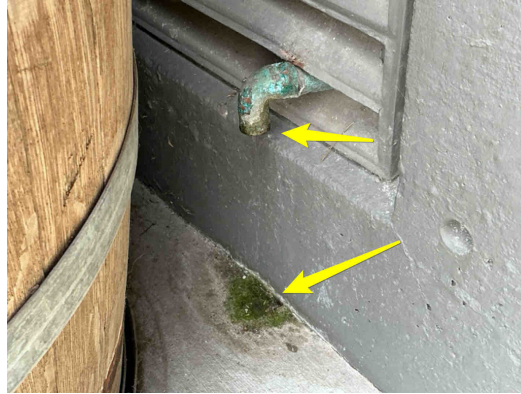
**SC 100:** The Water heater TPR (temperature pressure relief) valve is actively leaking and dripping water. Contact qualified plumber to correct.

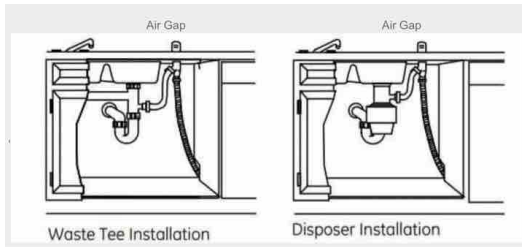
**SU 120:** Improper installation of the dishwasher drain hose. Missing the Air Gap Device at the dishwasher drain per minimum codes and standards (California does not allow for high-loop methods or direct waste connections). {CPC 801.2}

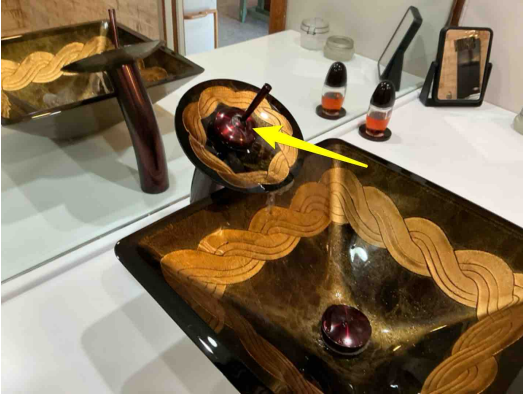
**E&C** 147: Hot & cold reversed at the bathroom sink faucet: PRIMARY BEDROOM BATHROOM

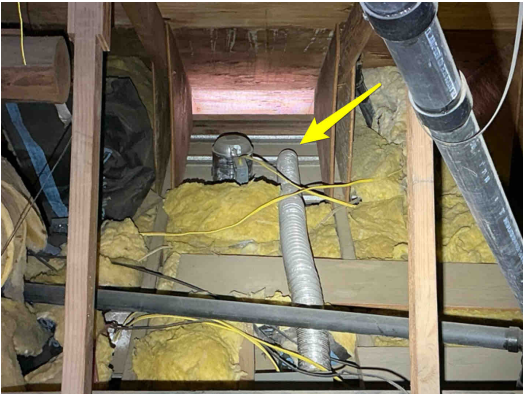
**E&C** 149: The PRIMARY BEDROOM BATHROOM exhaust fan vent pipe found improperly terminating in the attic. Recommend contacting a licensed HVAC contractor to evaluate all bathroom exhaust venting systems and properly terminate to the exterior per standards.

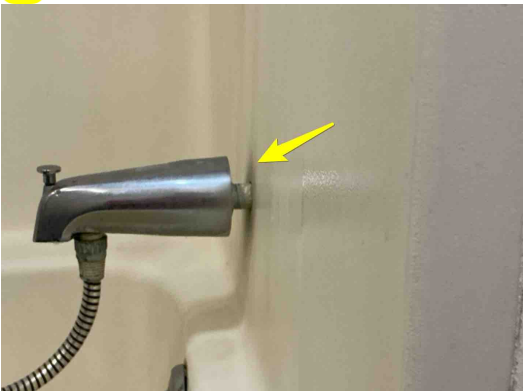
**MR** 151: Tub spout found loose and not sealed well at the shower wall connection in the: GARAGE BATHROOM

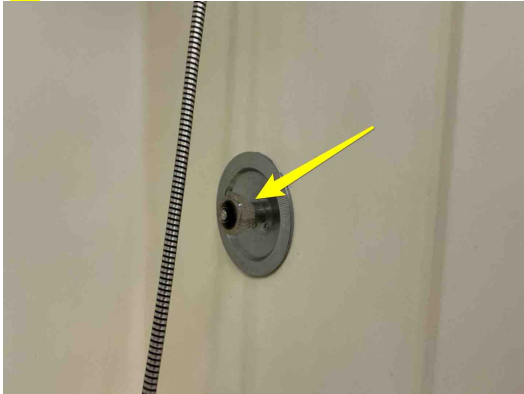
**SU 155:** Hot & cold reversed at the shower faucet: GARAGE BATHROOM

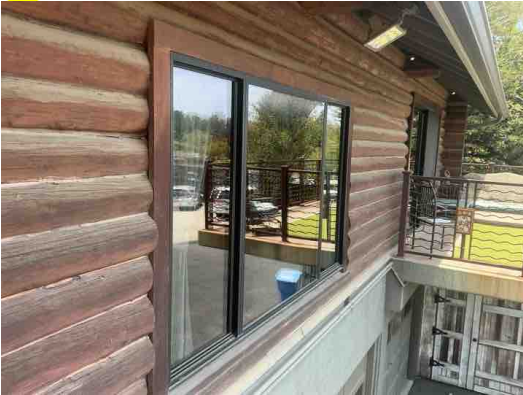
**MR 172:** Disclosure: Missing and/or damaged screens found at some windows.

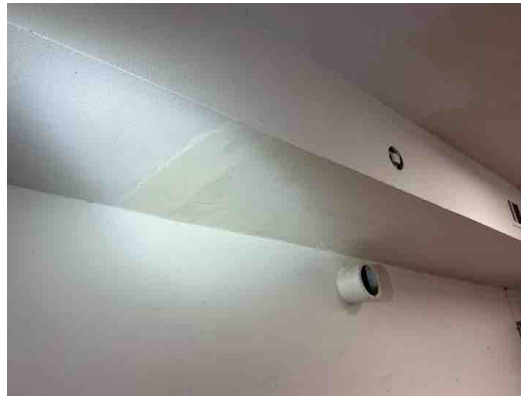
**FI DS 186:** Evidence of past ceiling and wall repairs found throughout. Client should investigate further to satisfy themselves as to the cause and current conditions.

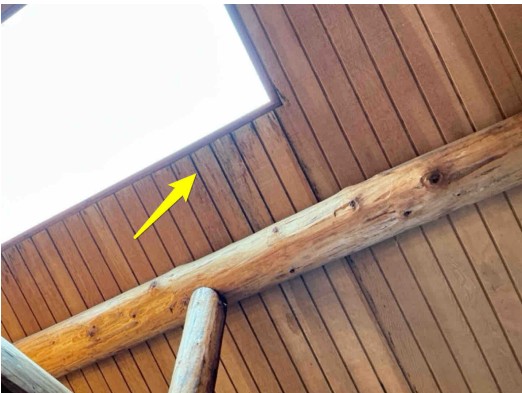
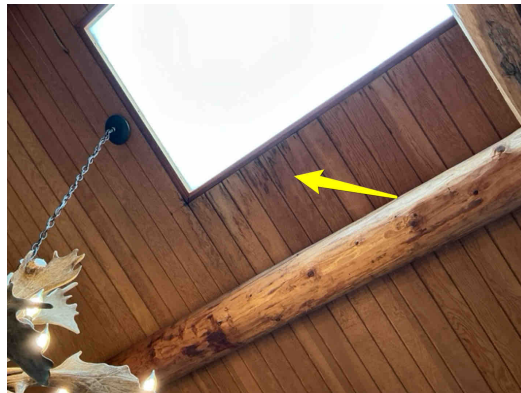
**FI 187:** Evidence of past moisture stains & damage at ceiling area in the LIVING ROOM and ENTRY AREA. Recommend further review of the water stains to determine the cause, the current condition and if repairs are needed.

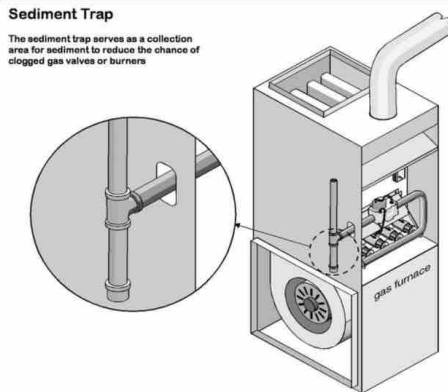
**UPG 195:** Missing the required installation of the sediment trap at the furnace gas piping at flex connection. Correction should be performed by a certified or licensed HVAC professional familiar with minimum requirements.

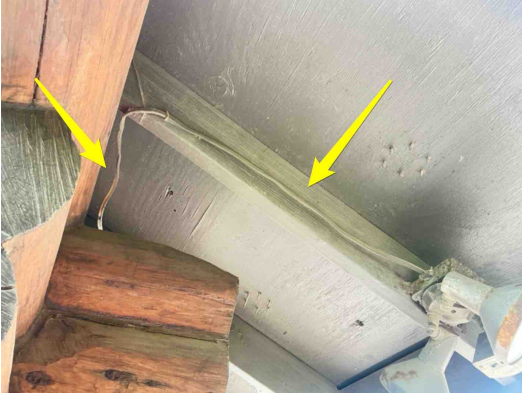
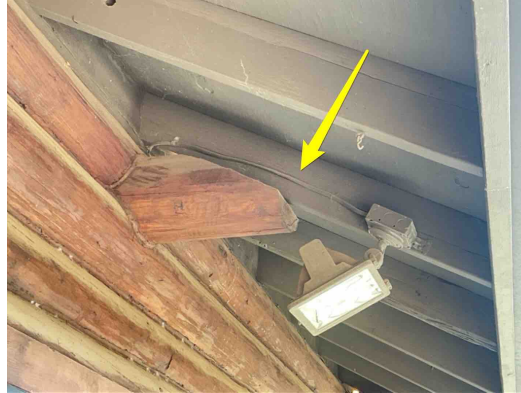
**SC 214:** Improper exposed electrical wiring, "Romex" improperly installed subject to physical damage, not in a conduit or raceway per standards: SOUTH EXTERIOR AT EAVES and SHOP DESIGN STUDIO STORAGE ROOM  
NEC 334.15(B)  
NEC 300.4

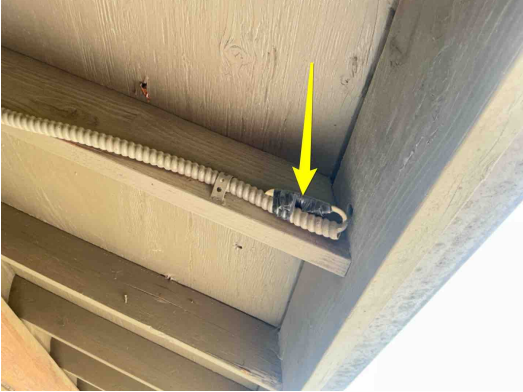
**SC 215:** Improper electrical wiring. Exposed electrical wires and/or splices not protected in a box with a cover:  
SOUTHWEST EXTERIOR AT EAVE

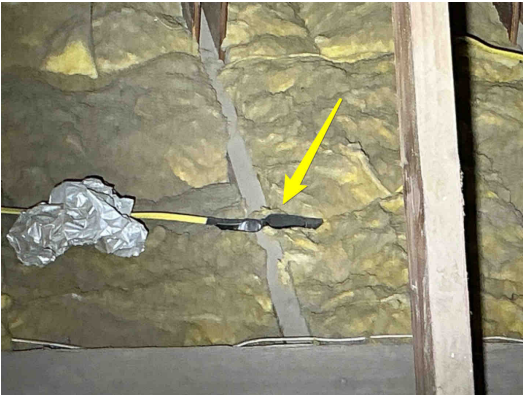
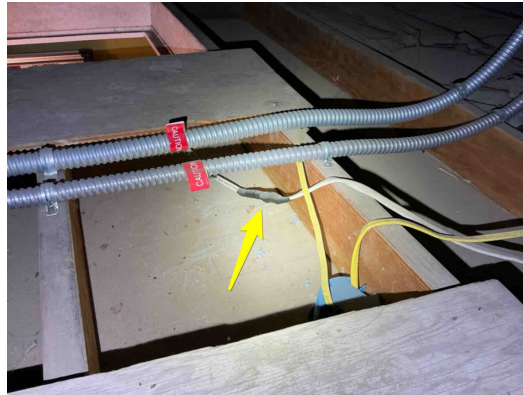
**SC 216:** Improper electrical wiring. Exposed electrical splices / wires not protected in a box with a cover:  
MULTIPLE IN THE ATTIC

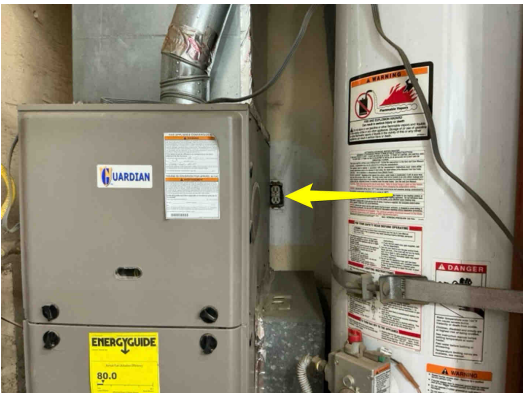
**SC 217:** Missing electrical cover plate. Safety Hazard: GARAGE MECHANICAL ROOM CLOSET and  
BEDROOM-2 NORTH WALL

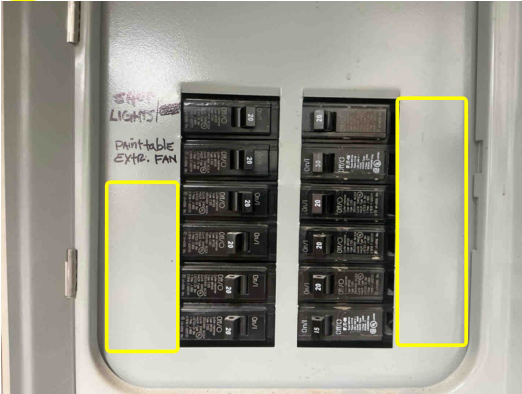
**SU 227:** Breakers in the ELECTRICAL SUB PANEL are not fully or properly labeled per standards.

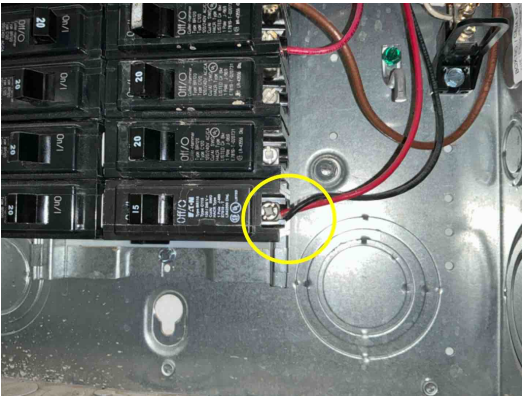
**SC 228:** Improper installation of two wires on single-wire rated circuit breaker in the SHOP ELECTRICAL SUB PANEL.

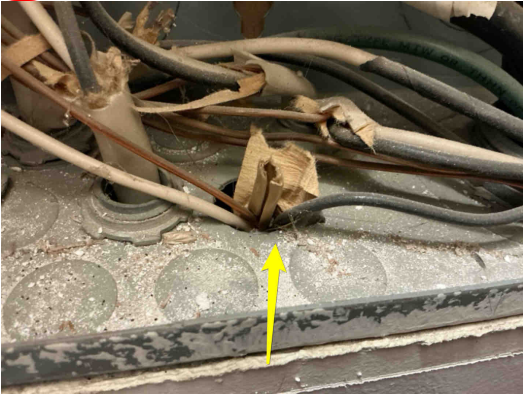
**SC 230:** Missing bushing clamp as wires are passing into the KITCHEN ELECTRICAL SUB PANEL.

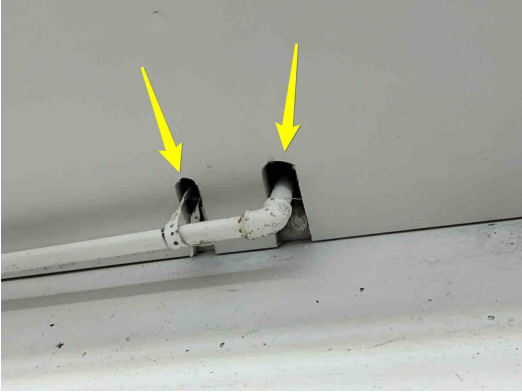
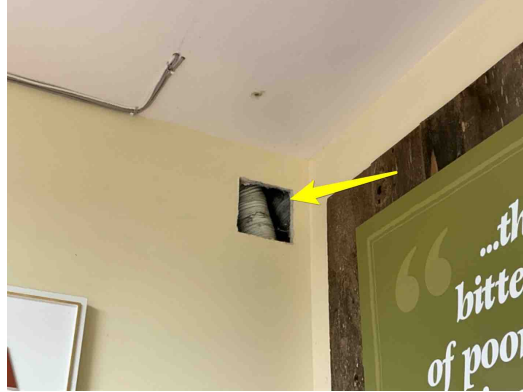
**SC FI 244:** Some holes or openings found in the garage firewall. Corrections are warranted for fire safety. Contact an appropriate contractor to review the entire garage repair as needed.

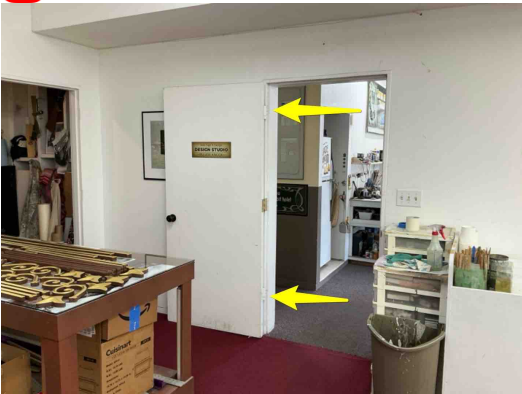
**SC 245:** Self-closer is non-operational at garage fire rated door to the SHOP DESIGN STUDIO.

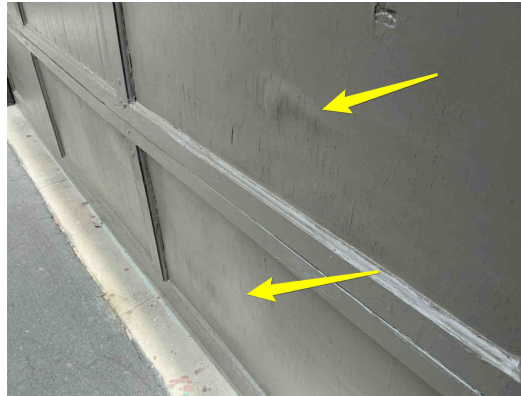
**E&C 252:** Some moisture stains & damage at garage vehicle door, door jam and/or trim. Refer to the termite report for additional comments and recommendations.

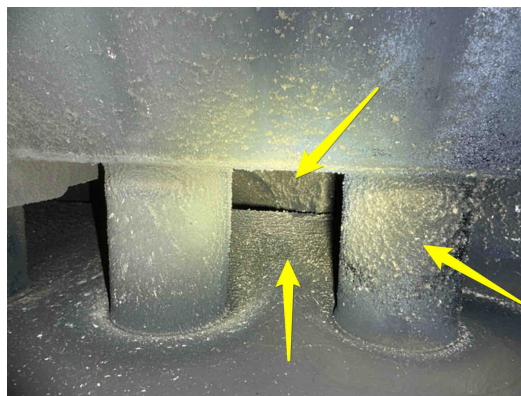
Heavy creosote buildup

**MR 263:** Visible cracks and separations found in the mortar crown located at the top of the LIVING ROOM fireplace chimney. Maintenance / caulking or sealing is recommended to help prevent water intrusion into the confined spaces within the masonry chimney.

**E&C 262:** Recommend cleaning & sweeping the LIVING ROOM fireplace and chimney by a qualified chimney sweep.
