# Summary Report, prepared exclusively for:

**7718 Eisenhower St. Ventura-Ransi Samantre 07-03-26 By Alex**

Inspected by: **BEST HOME** Inspection

RE: 7718 Eisenhower Street  
Ventura, CA.

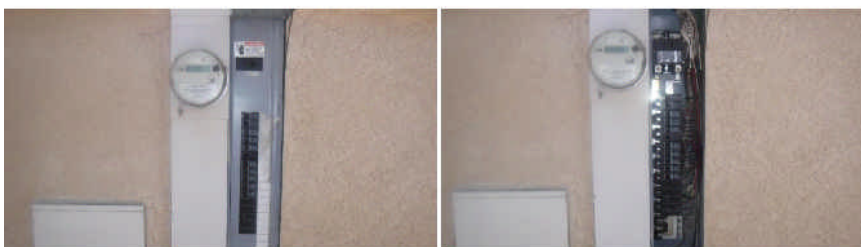
Main electric panel box is located at exterior of house. Main panel box, wiring, and breakers were tested or observed by the inspector and found they are wearing well, durable and capable of being used.

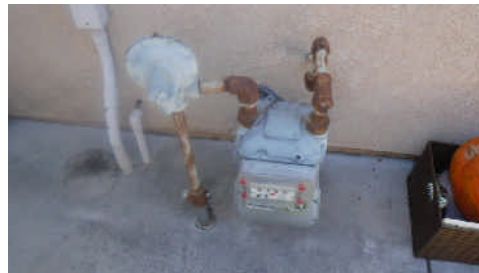
Gas meter is located at left side of garage.

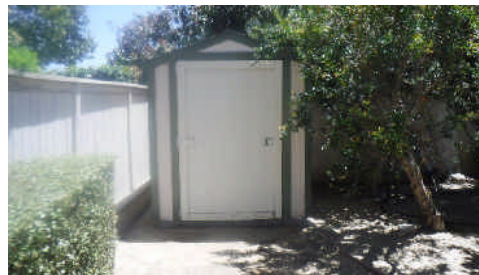
Wood framed structure, was observed by the inspector and found it is wearing well, is durable and capable of being used.

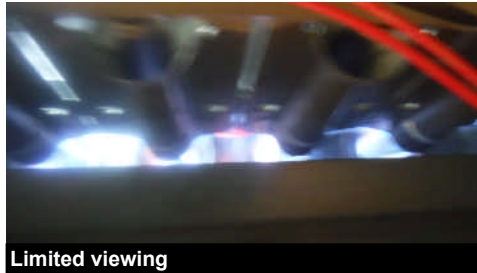
Burner flame(s) appear typical. 4-Burners. NOTE: Inspection of interior burner / heat exchanger area is beyond the scope of this inspection. The heat exchanger portion of a gas fired heater is difficult to access without disassembly, and cannot be adequately checked during a visual inspection. (see photo, detailed report

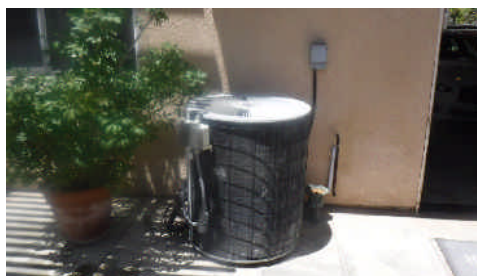
240 Volt. Electrical disconnect present near the unit.

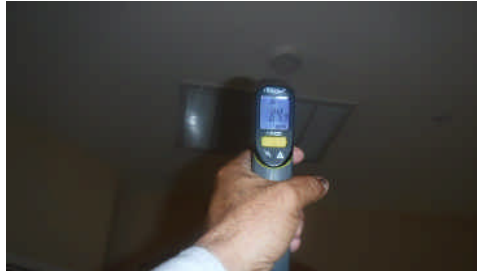
Degrees reading at cold air return grille - 84.

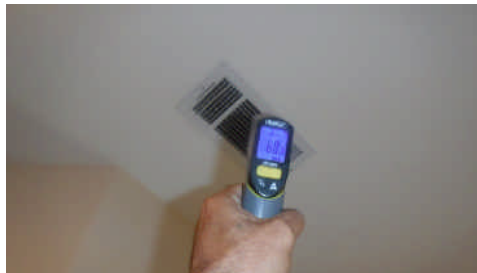
Degrees reading at wall register - 68.

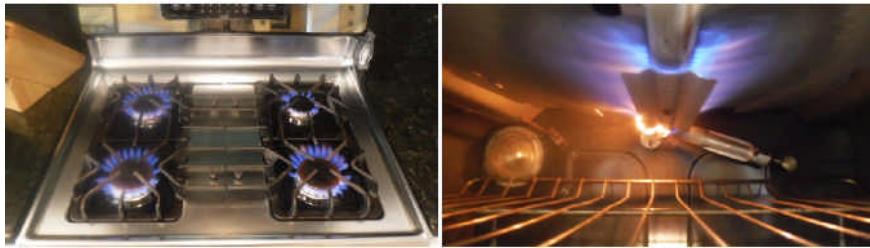
Gas. Electric ignition. Testing of self-cleaning or continuous cleaning cycles are not a part of this inspection. Oven light(s) - OK. Range / Oven / broiler was tested or observed by the inspector and found it is wearing well, is durable and capable of being used.

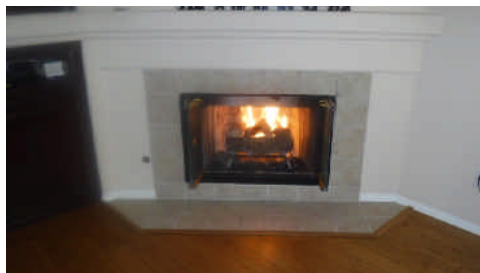
Zero clearance prefabricated metal type. Tile facing and hearth appear serviceable. Damper is operational. Gas log set is installed and appears serviceable.

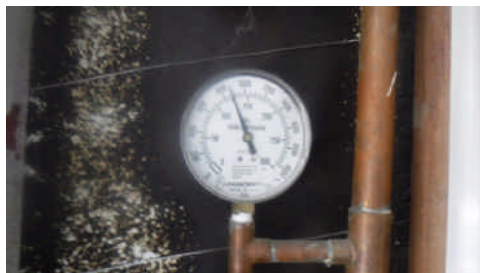
Wet type, ceiling mounted sprinkler heads throughout the house and garage. Water pressure at incoming gauge appears OK, PSI - 130.
