Inspection reference: 26099

## Confidential Inspection Report

18301 Taylor Ct  
Torrance CA 90504

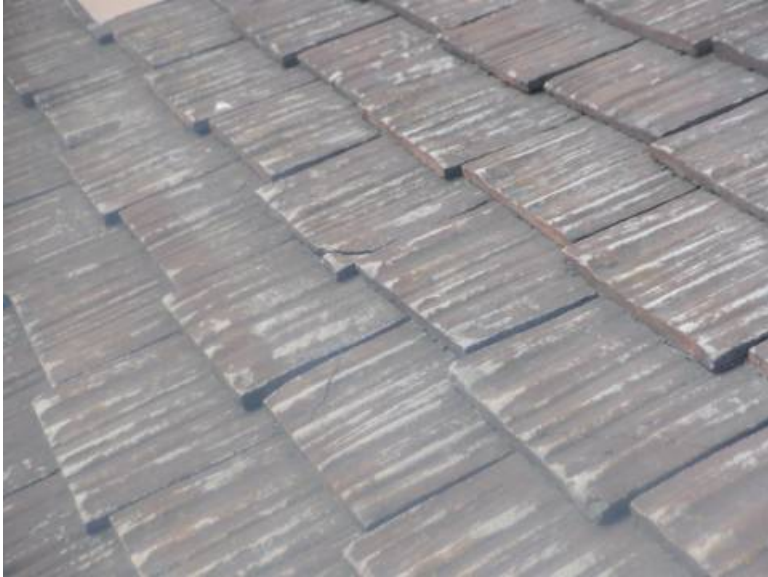
**3.3 Roof Comments:**

The roof has many cracked tiles and deterioration, replacement is suggested to prevent leakage. Contact a licensed roofing contractor for replacement options.

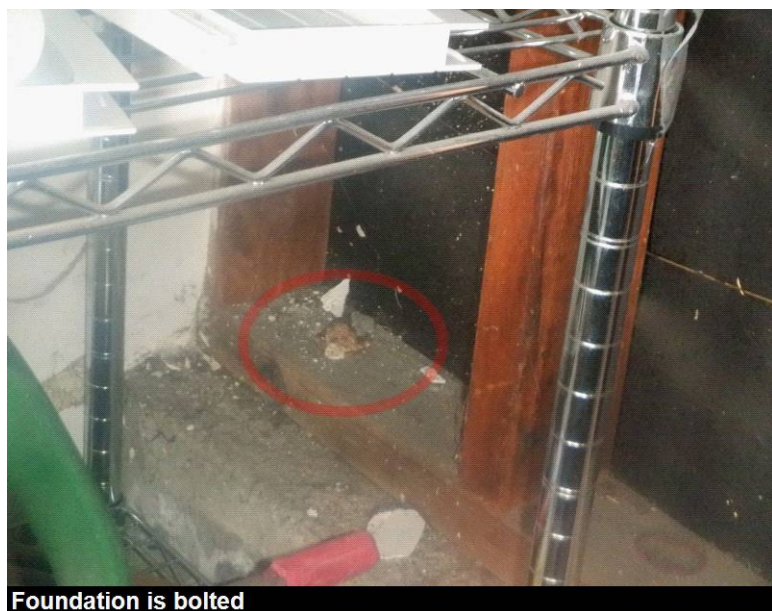
Foundation is bolted

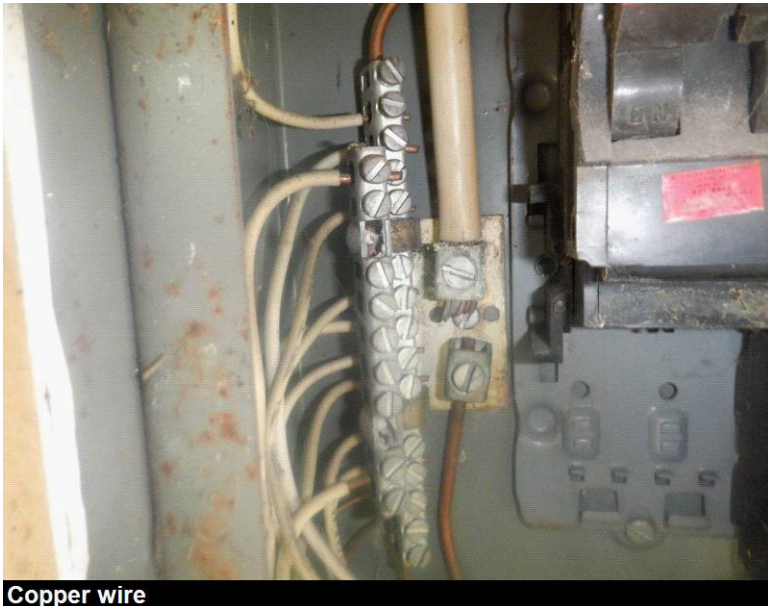
Copper wire

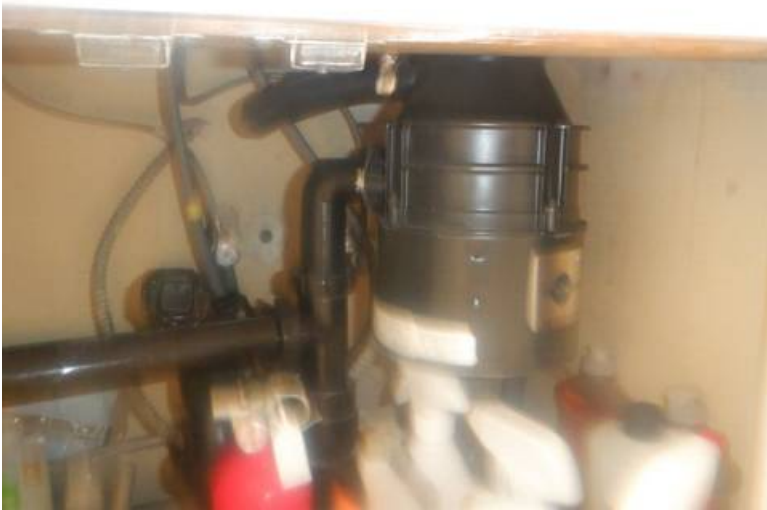
**9.11 Dishwasher Comments:**

Water is exiting through the dishwasher air gap (top of sink), this may indicate a blocked or improperly installed drainage line, contact licensed contractor for repair.

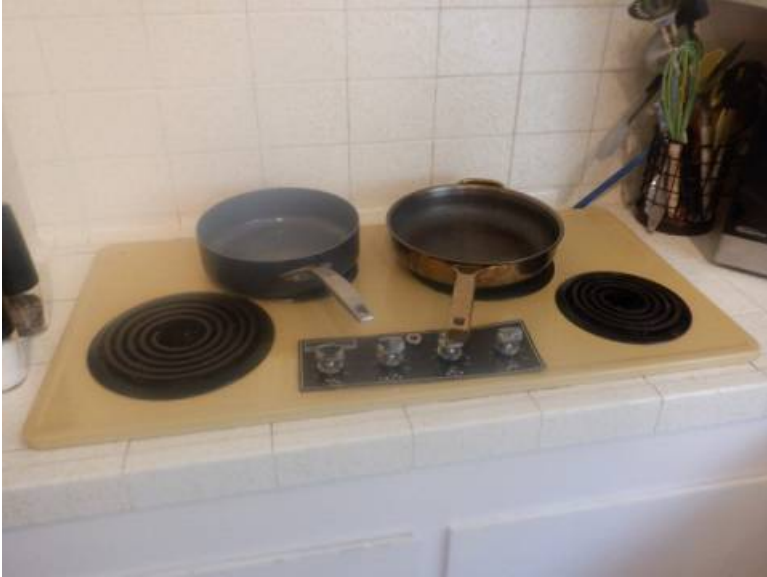
**9.13 Oven/ Cooktop Comments:**

Damaged control panel and inoperable burner at cooktop.
