# PROPERTY INSPECTION REPORT

**FOUR POINT**  
HOME INSPECTION INC.

**810 Sebastian**

**Inspection Prepared For: Paso Robles Waste**  
**Agent: Alicia DiGrazia - RE/MAX Parkside**  
**Date of Inspection: 7/2/2026**  
**Year Built: 2010 Size: 1742**  
**Weather: Mild/Dry**

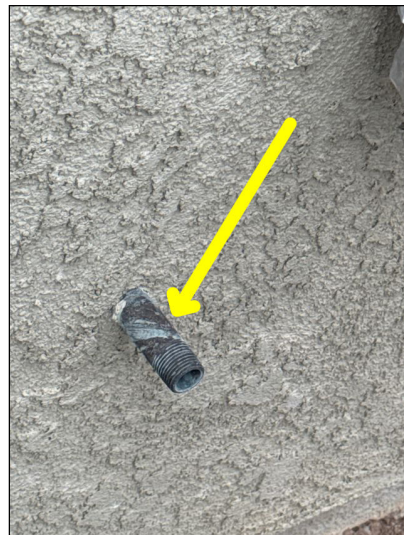
This pipe is the drain for the fire sprinklers when they are tested

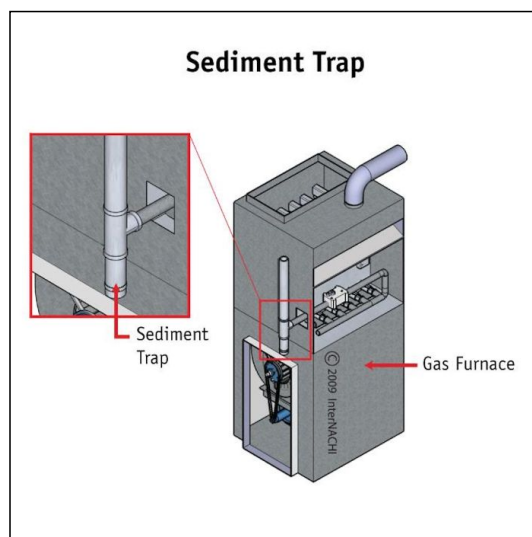
**Improvement:** The gas supply pipe contained no sediment trap.

The purpose of a sediment trap is to prevent sediment or debris particulates from entering and clogging the heaters gas valve.

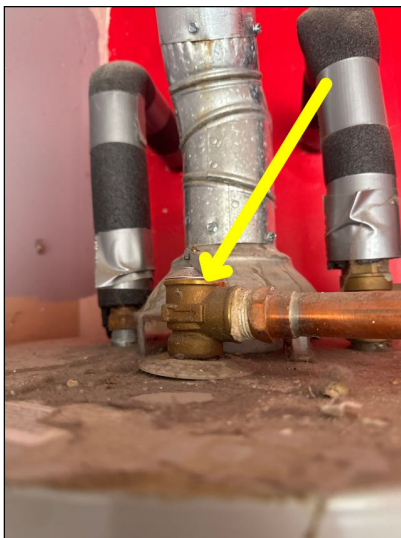
| Heat/AC | | | |
|---|---|---|---|
| | Page 31 Item: 4 | TPRV | The pressure relief valve was leaking at the time of the inspection and should be replaced by a qualified HVAC technician or plumbing contractor. |

The pressure relief valve was leaking at the time of the inspection and should be replaced by a qualified HVAC technician or plumbing contractor.

This is the TPRV valve

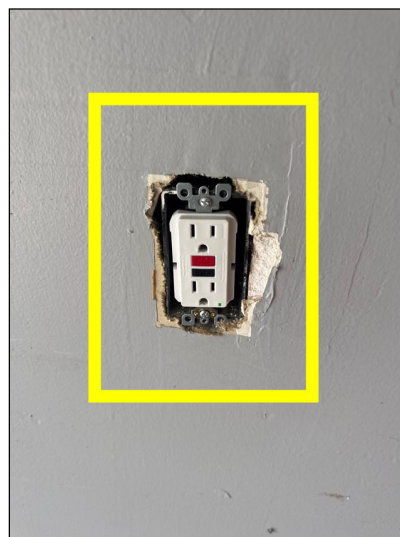
| Heat/AC | | | |
|---|---|---|---|
| | Page 35 Item: 5 | Garage Electrical | <b>GFCI</b> electrical receptacle was inoperable at the time of the inspection. The Inspector recommends evaluation and correction by a qualified electrical contractor. |

GFCI electrical receptacle was inoperable

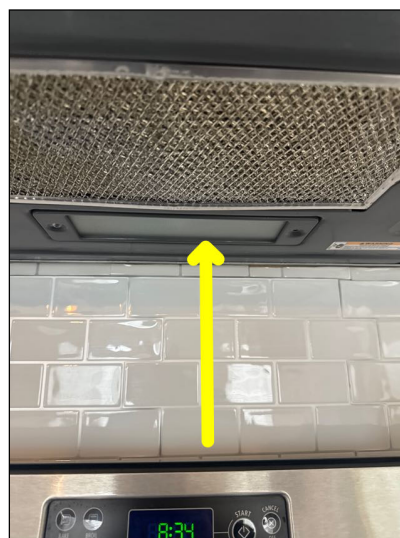
| Heat/AC | | | |
|---|---|---|---|
| | Page 44 Item: 10 | Vent Condition | • Range hood lights were inoperable. The bulb may be burned out, or there may be a problem with the switch, wiring or light fixture. If after replacing the bulb the light fixture still does not respond, the Inspector recommends service by a qualified contractor. |

Range hood lights were inoperable.

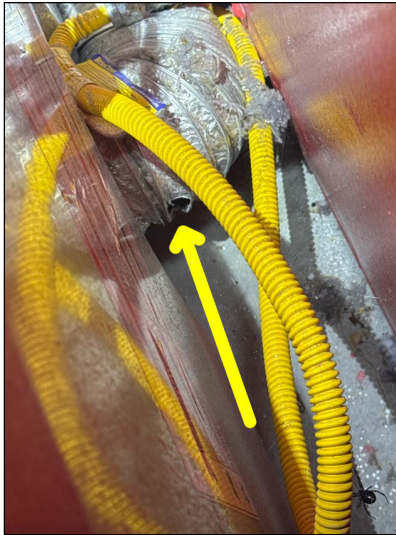
| | Page 47 Item: 6 | Dryer Vent | The dryer exhaust duct had become disconnected and should be reconnected to properly route to dryer exhaust to the exterior. Failure to reconnect the duct may result in unsatisfactory condition from excessive humidity and lint accumulation in the home. Excessively high humidity can damage home materials or components and may encourage the growth of microbes. |

**The dryer exhaust duct had become disconnected and should be reconnected to properly route to dryer exhaust to the exterior. Failure to reconnect the duct may result in unsatisfactory condition from excessive humidity and lint accumulation in the home. Excessively high humidity can damage home materials or components and may encourage the growth of microbes.**

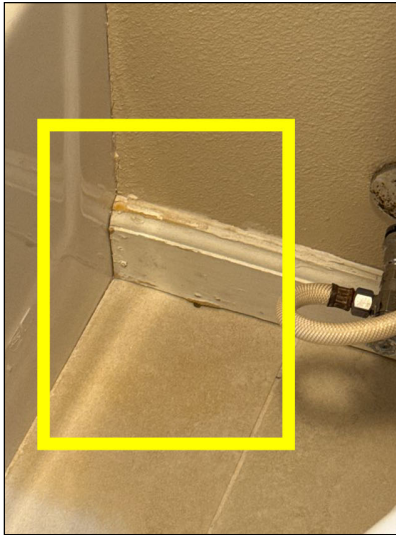
- **Monitor:** Evidence of past water intrusion on the baseboards next to the tub/shower. Probable cause from water escaping past shower curtain/door when shower is in uses. Tested dry at the time of inspection.

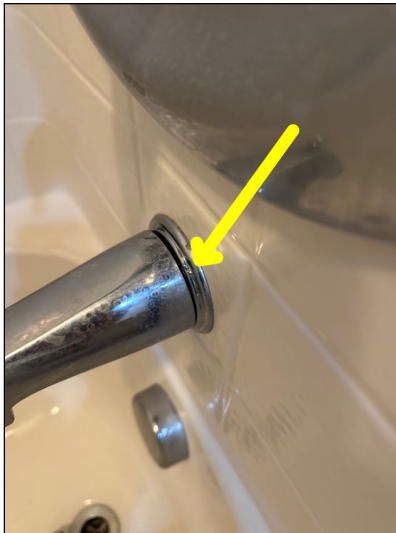
**Maintenance Needed:** The tub faucet in this bathroom not flush to wall.

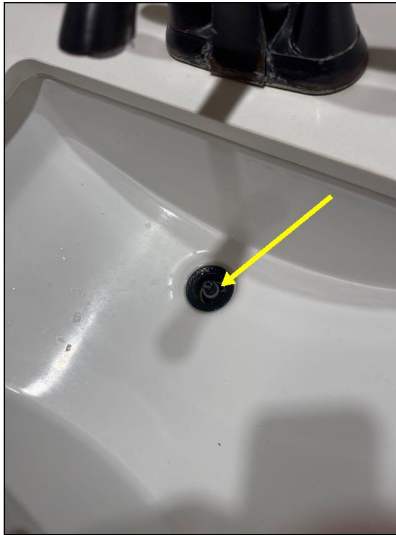
**Maintenance Needed:** Pop up drain assembly is inoperable. Recommend having pop up assembly adjusted to work properly.

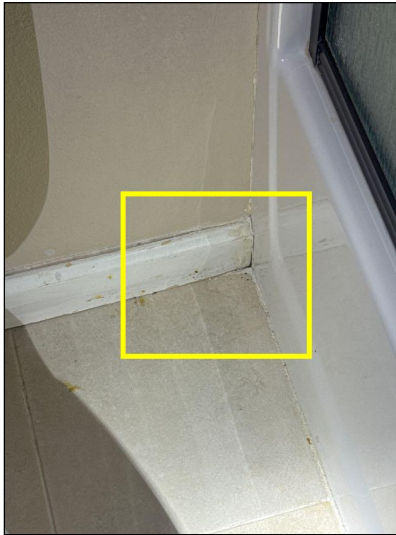
- **Monitor:** Evidence of past water intrusion on the baseboards next to the tub/shower. Probable cause from water escaping past shower curtain/door when shower is in uses. Tested dry at the time of inspection.
