# Professional

## Inspection Services

### *Inspection Report*

Address: 329 N 14th St Grover Beach, CA 93433

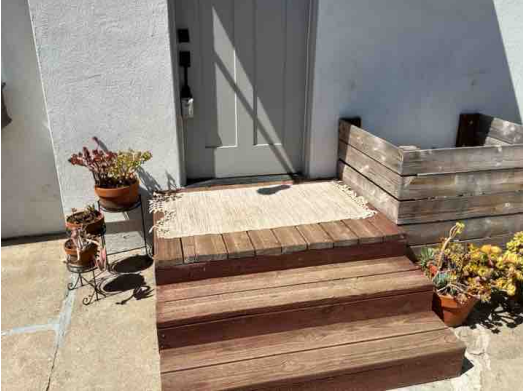
**UPG 22:** The exterior wood door landing off the front entry was installed improperly too high at or above the exterior door threshold. This can allow potential water intrusion.

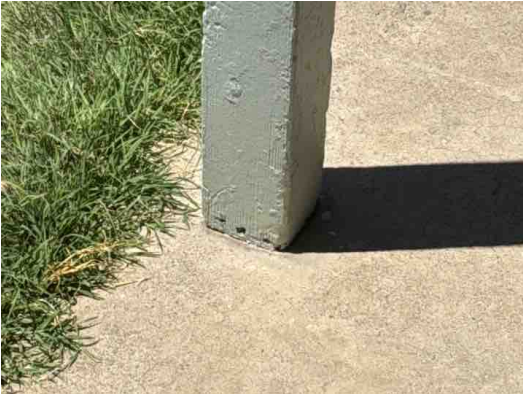
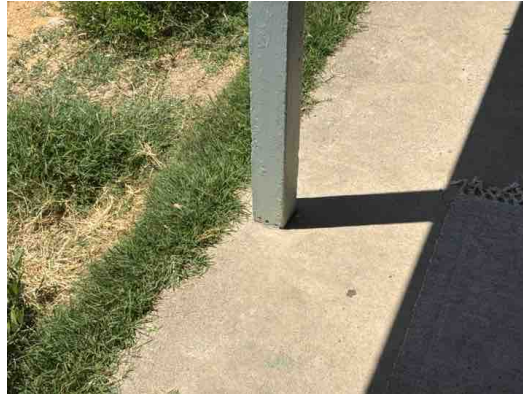
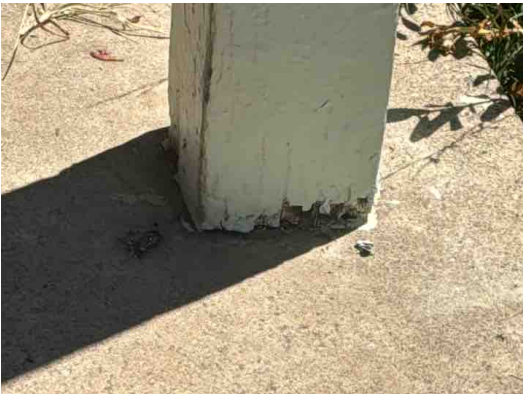
**E&C 23:** Some moisture damage found at the FRONT PORCH COVER wood post(s). Refer to the Termite Report for additional comments and recommendations.

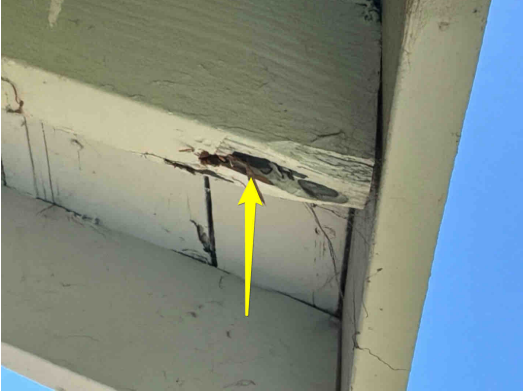
**E&C 31:** Some moisture and/or bug type damage & deterioration found at exterior areas such as eaves, fascia and/or trim. Refer to the termite report for locations and extent.

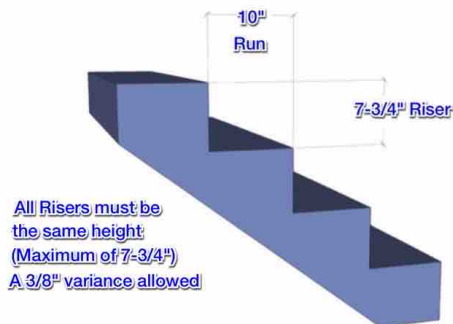
**SC 33:** Uneven step tread rise, step heights are not all the same, AND top tread exceeds maximum height at the exterior stairway off the FRONT PATIO WEST END CONCRETE STEPS. Potential trip or fall hazard.

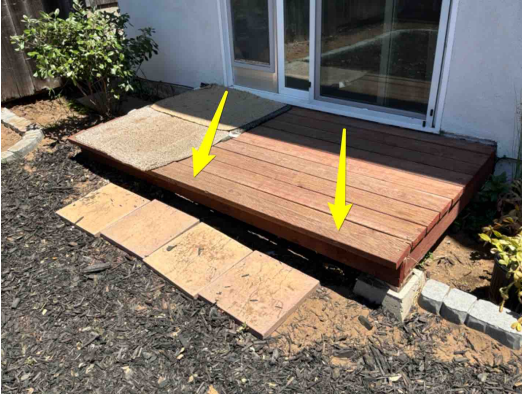
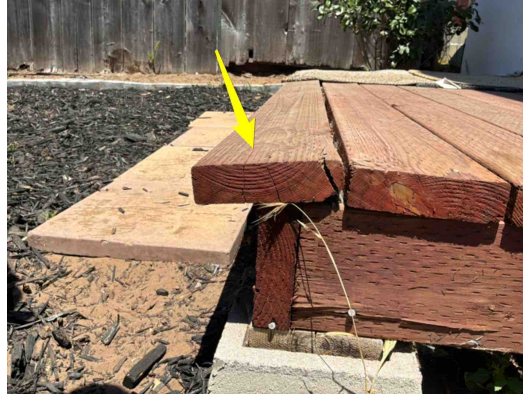
**E&C 36:** A loose deck board, potential fall hazard found at OUTER EDGE AT THE BACKYARD WOOD DECK due to an improper support.

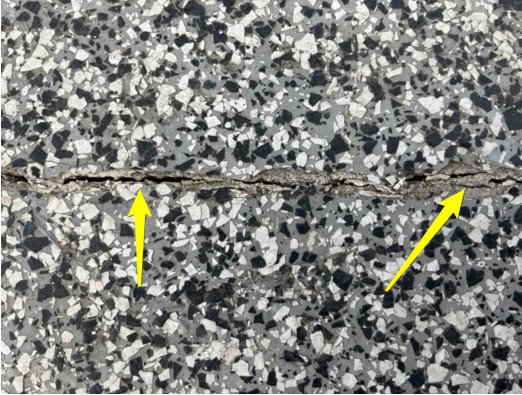
**E&C 39: WATERPROOF DECK COATING CONDITION:** Areas of deterioration, cracking of the waterproof deck coating noted at areas of the UPSTAIRS DECK OFF THE UPSTAIRS BEDROOM. Repairs or replacement is needed by a licensed waterproof deck contractor. Recommend further review and/or repairs by a certified or licensed waterproof deck coating professional familiar with minimum requirements.

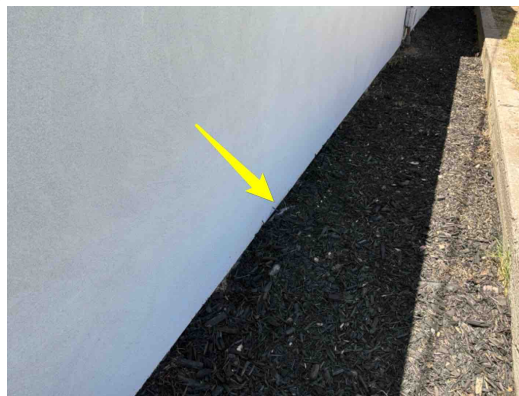
**E&C** **MR** **45:** Soil level found high at areas of the foundation. (Recommend 4 inches from the bottom of the exterior stucco siding to dirt, rock, mulch or wood chips).

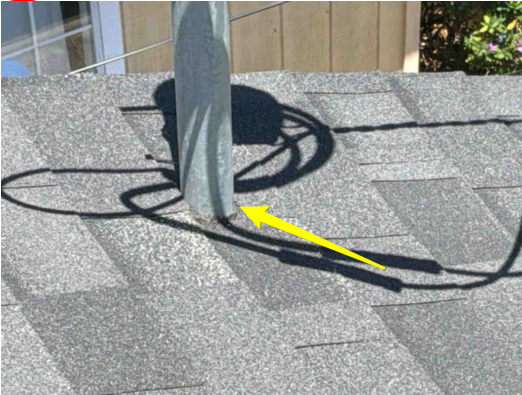
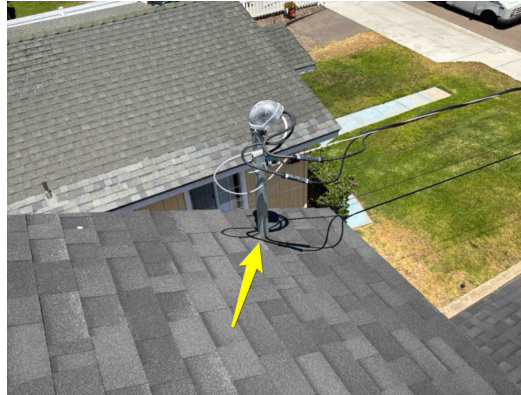
**E&C 62:** Missing a roof jack flashings at the main electrical service mat where penetrate through the roof.

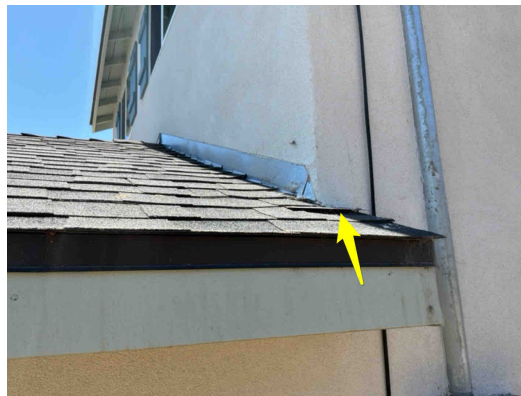
At the main house on the back at the primary bedroom

**E&C MR 63:** Some lifting roof flashings. Corrections, maintenance or repairs are recommended to help prevent water intrusion and/or roof leakage from windy, wet weather.

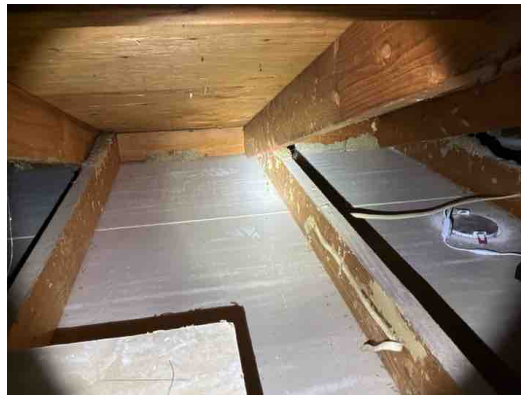
**E&C 66:** Areas of poor coverage, missing attic insulation above the UPSTAIRS ATTIC. Corrections recommended.

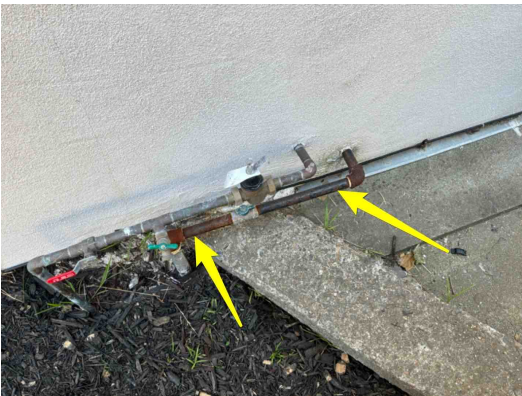
Example

"Where gas piping is installed underground or outdoors, it shall be protected against corrosion. Black steel pipe installed outdoors must be painted with an approved rust-preventive coating or otherwise protected against corrosion."

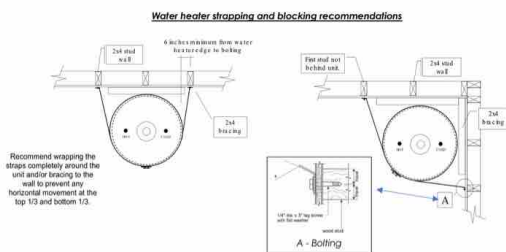
**E&C 83:** The MAIN HOUSE WATER HEATER is loosely strapped & not secured well - moves when pushed . Recommend adding BRACING OR BLOCKING to the wall to properly secure the tank per Uniform Plumbing Code and State Architect Requirements.

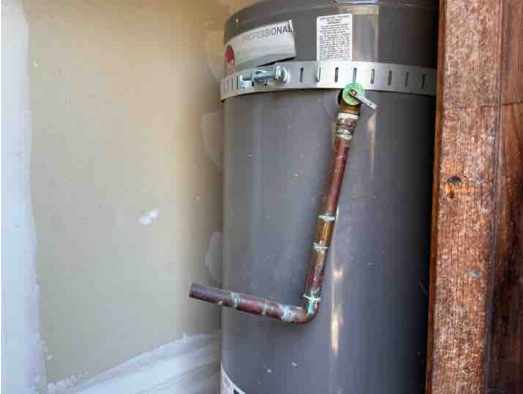
**SC 84:** The MAIN HOUSE WATER HEATER TPR (temperature pressure relief) pipe is missing / not installed. The pipe must terminate downward at the exterior outside the enclosure at 6 to 24 inches from the ground.

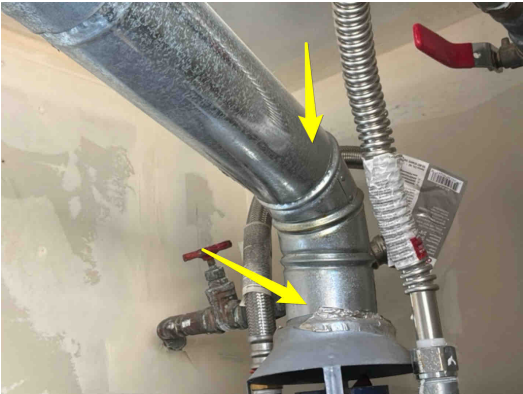
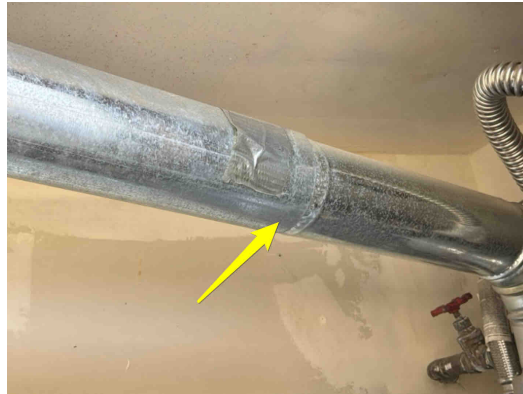
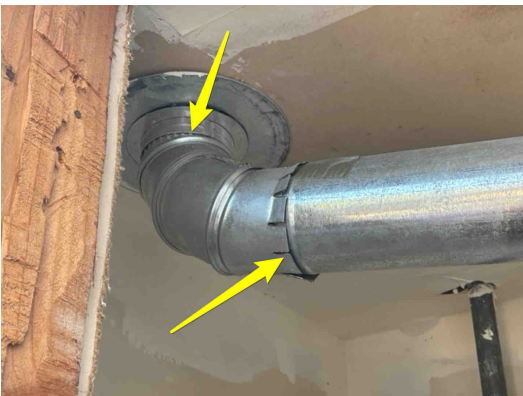
**SC 85:** The MAIN HOUSE WATER HEATER vent connector pipe (single-wall) is not properly fastened with the required 3-fasteners at each connection including the draft hood per standards.

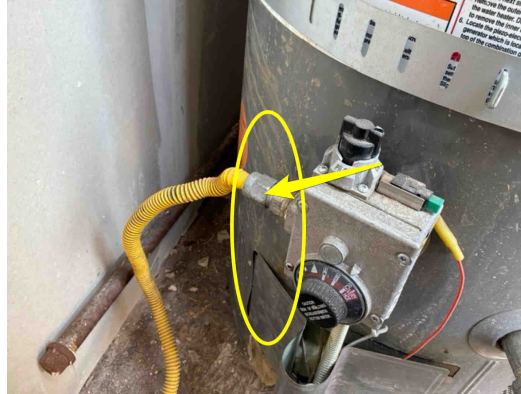
**UPG 87:** Recommend the installation of a sediment trap / drip leg at the MAIN HOUSE WATER HEATER gas piping at flex connection by a certified or licensed plumbing professional familiar with minimum requirements.

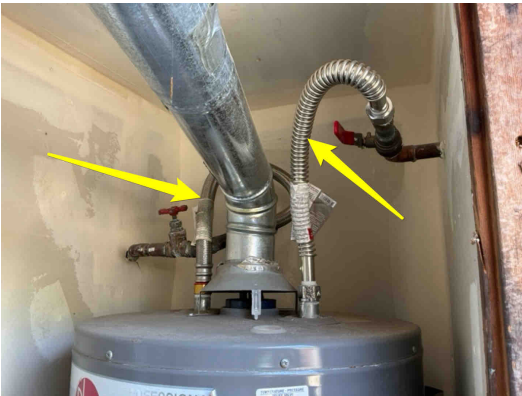
**MR 88:** Recommend insulation on the HOT and COLD water supply pipes at the MAIN HOUSE WATER HEATER per minimum codes and standards.

California's energy standards require insulation on the first 5 feet of both cold water piping and All of the hot water piping from the water heater, to reduce heat loss&

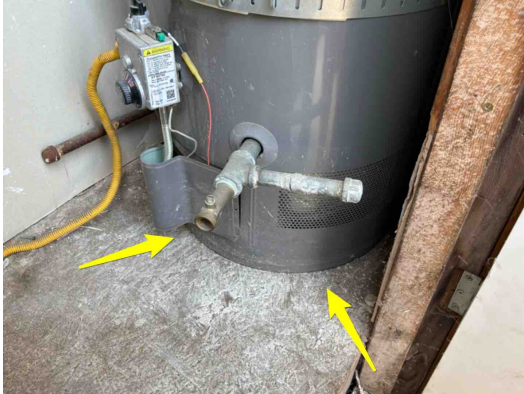
**E&C 90:** Missing / recommend a drip pan under the MAIN HOUSE WATER HEATER. A drip pan is needed to help prevent damage if a leak were to occur per California plumbing codes and standards. [CPC 507.5]

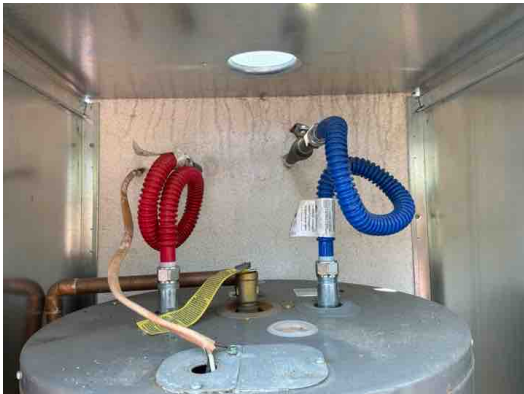
**UPG 96:** Missing the insulation on areas of the Hot and Cold water supply piping at the ADU WATER HEATER.

*California's energy standards require insulation on the first 5 feet of cold and ALL the hot water piping from the water heater, to reduce heat loss and sweating (condensation).*

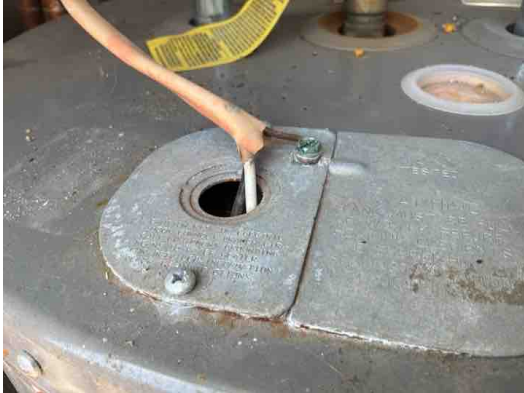
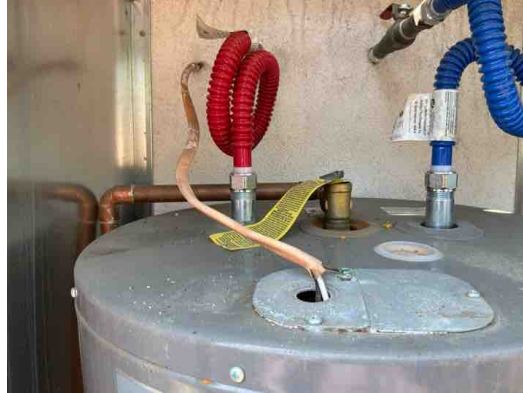
### **SC 98: Improper and unsafe electrical found at the ADU ELECTRIC WATER HEATER:**

1. Missing the required electrical service disconnect for the electric water heater. (2001) [CEC 422.31(B)]
2. Improper use of exposed Romex as an appliance cord.
3. Missing a proper bushing clamp
4. Exposed electrical wires at the water heater connection.

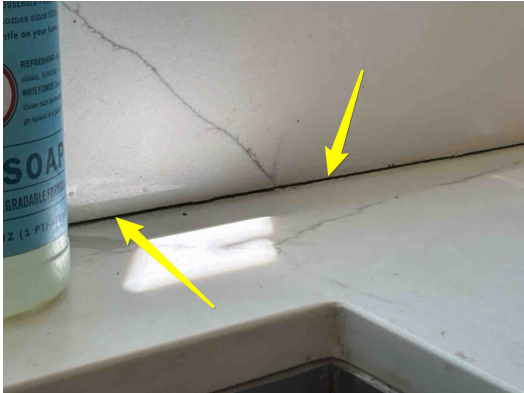
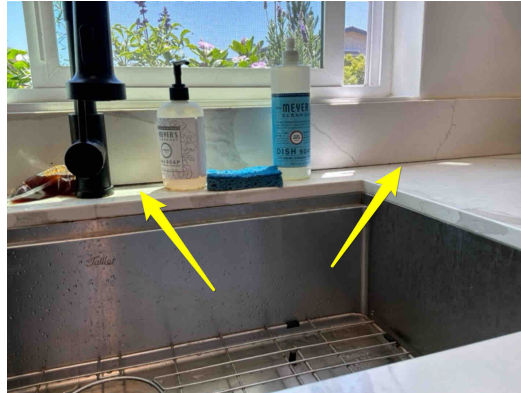
**MR UPG 103:** Some cracks and separations noted at the MAIN HOUSE KITCHEN countertop to backsplash connections. Recommend re-grouting or caulking the separations to help prevent water intrusion into the wall cavity or cabinet below.

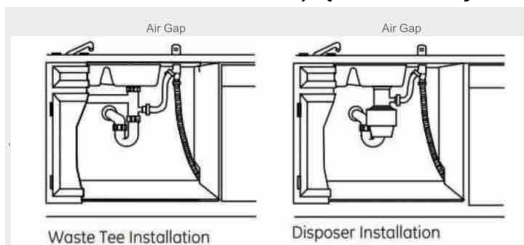
**SU 104:** Improper installation of the MAIN HOUSE KITCHEN dishwasher drain hose. Missing the Air Gap Device at the dishwasher drain per minimum codes and standards (California does not allow for high-loop methods or direct waste connections). {CPC 801.2}

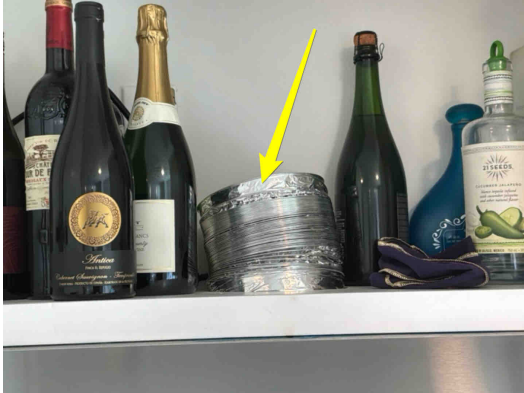
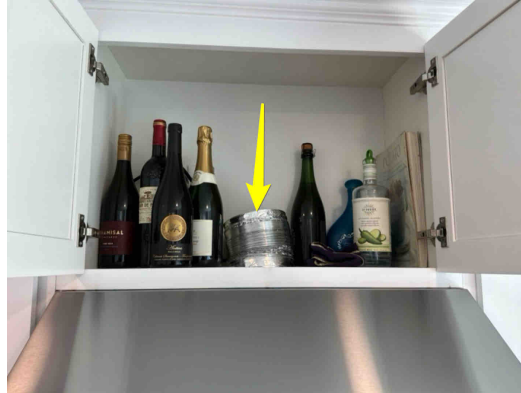
**SC 109:** Improper installation and use of a non-fire rated flexible pipe terminating into the MAIN HOUSE KITCHEN cabinet above the cook top for the cook top exhaust vent pipe. A rigid fire-rated metal duct is required for fire safety. Contact a qualified HVAC professional to correct as needed.

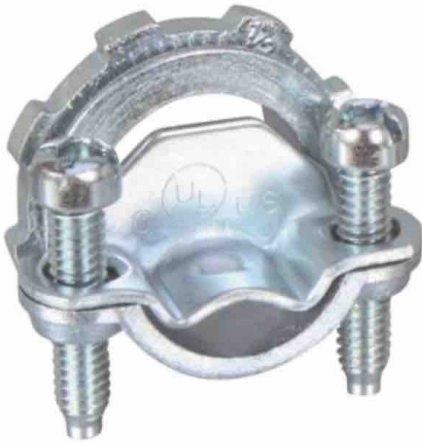
**SC 121:** Missing a proper electrical wire-bushing clamp at bottom of ADU kitchen sink disposal.

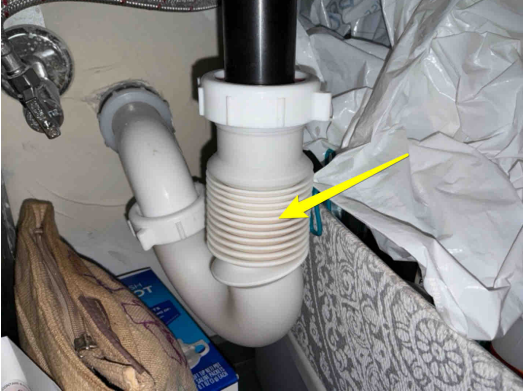
**UPG 146:** It is not recommended to use corrugated flex drain piping bellow the sink as this can collect debris and clog or create slow draining: DOWNSTAIRS HALL BATHROOM

Example. At both sinks

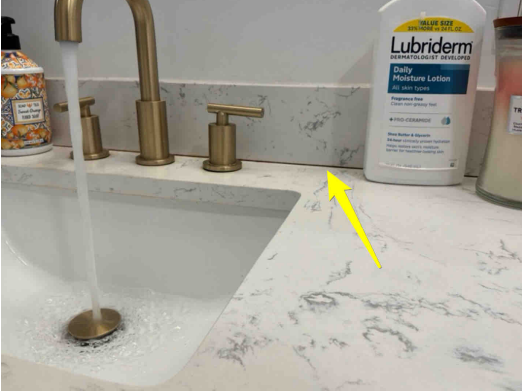
**MR 148:** Recommend re-caulking at the sink to counter connections as part of needed maintenance:  
DOWNSTAIRS HALL BATHROOM

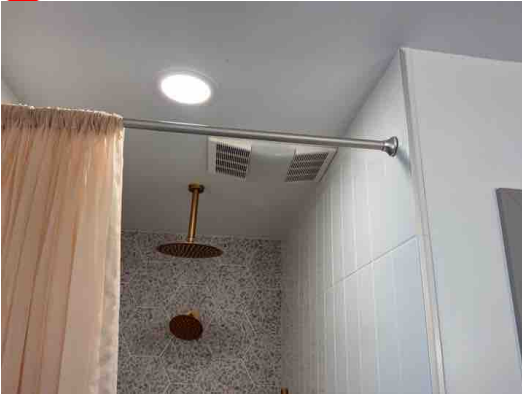
**E&C 149:** The bathroom exhaust fan did not operate: UPSTAIRS BEDROOM BATHROOM SHOWER

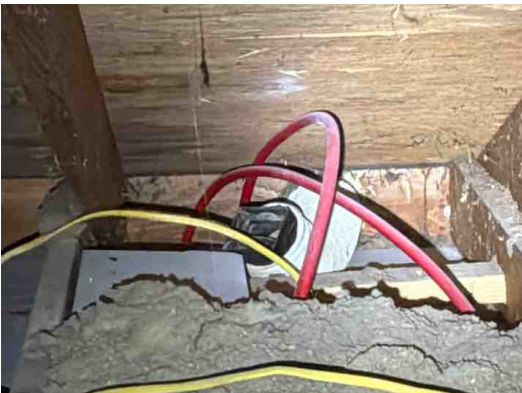
**E&C 150:** The UPSTAIRS BEDROOM BATHROOM SHOWER exhaust fan vent pipe found improperly terminating in the attic. Recommend contacting a licensed HVAC contractor to evaluate all bathroom exhaust venting systems and properly terminate to the exterior per standards.

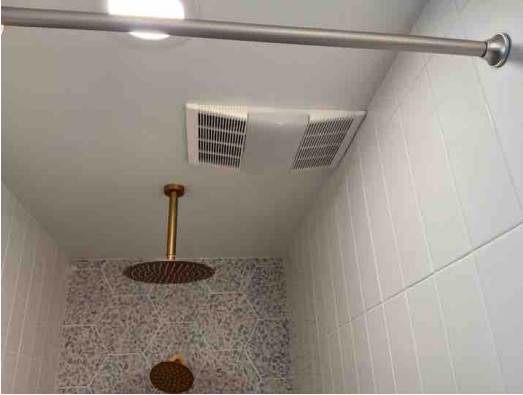
**SC 151:** The bathroom exhaust fan installed within the UPSTAIRS BEDROOM BATHROOM shower enclosure does not appear to be GFCI protected as required for electrical equipment located within shower spaces. This condition may present an increased electrical shock hazard in wet locations. Recommend evaluation and correction by a qualified licensed electrician. (NEC/CEC 410.10(D)).

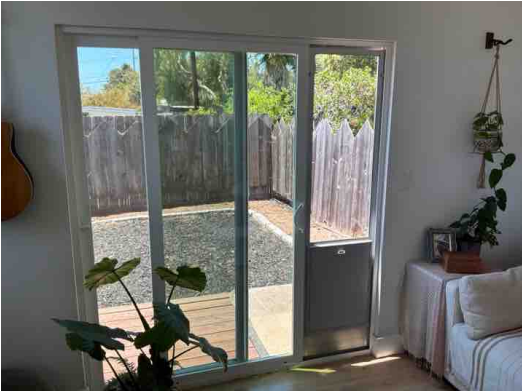
**SC 163:** The door locking hardware found non-operational at the: LIVING ROOM exterior sliding glass door, DUE TO THE INSTALLATION OF A PET DOOR.

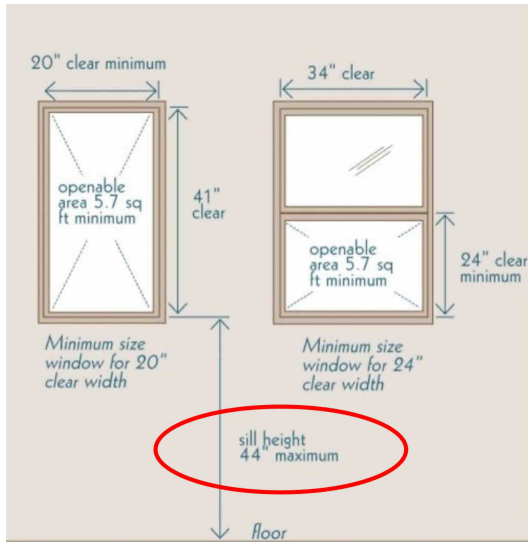
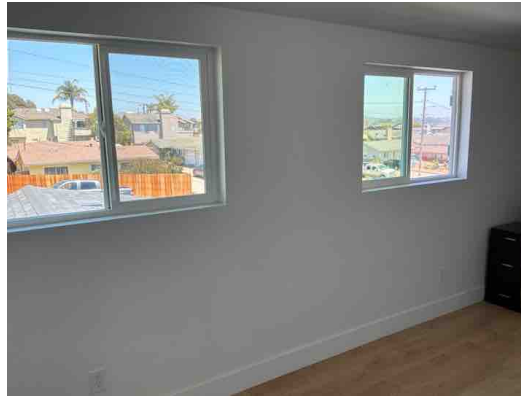
East room

**SU 167:** Windows in TWO UPSTAIRS ROOMS are a too high off the floor and do not meet the current minimum fire egress standards. Standards for fire egress windows are no more than 44 inches off the floor AND are too small.

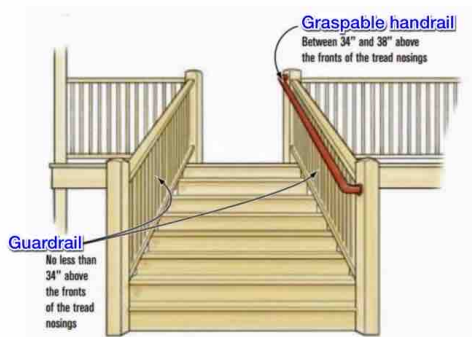
**SC 181:** An improper gripable handrail at the interior stairway for safety per standards. The Graspable portion of the railing is too thick and does not meet current standards. Upgrade recommended.

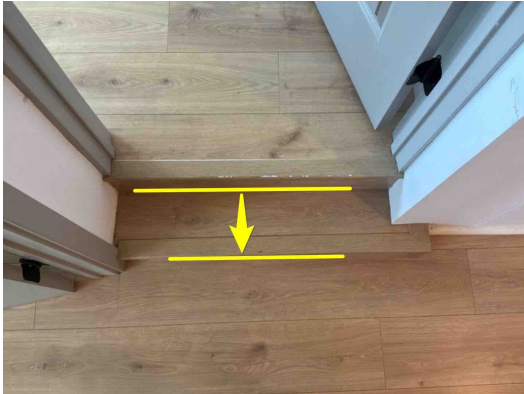
**184:** The steps into the upstairs guest bedroom outside the front entry door do not meet minimum step size standards. The minimum tread length is 10 inches, at only 7 1/2 inches  
And - improper tread height, both threads not the same height.

Too small

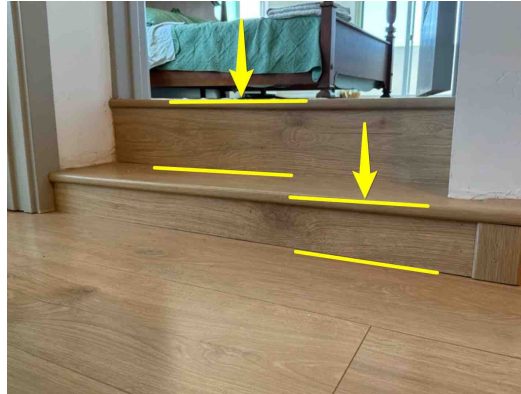
Both tread should be the same height

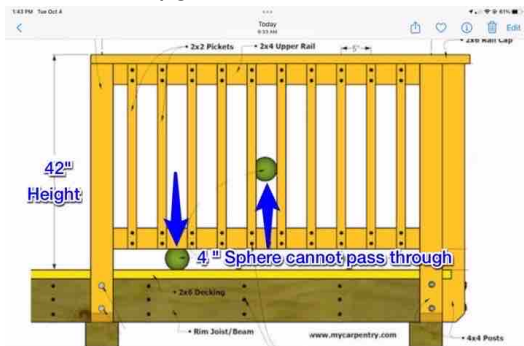
**185:** Openings between the spindles and the height of the railings at the stairway landings do not meet current standards. Upgrades Recommended for safety.

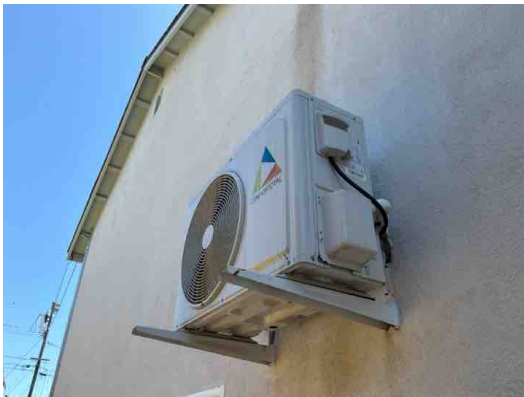
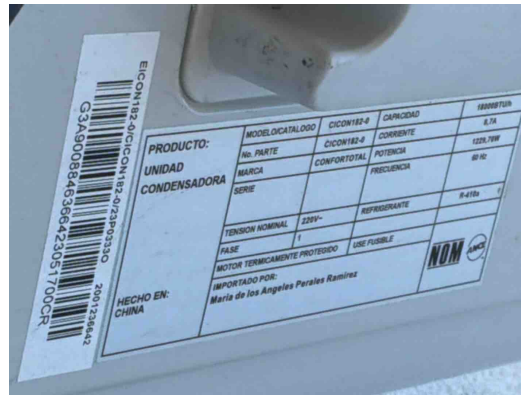
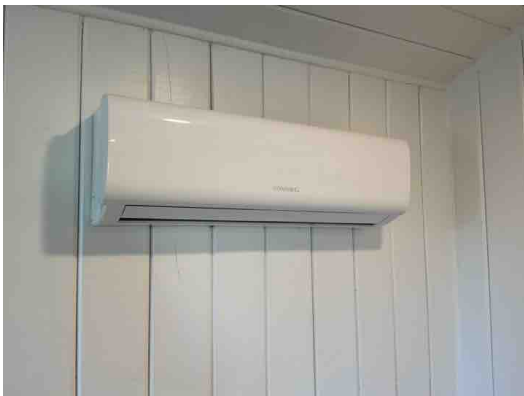
**187:** The required electrical service disconnect for the air conditioner compressor is provided at the electrical panel which is in sight of the compressor.

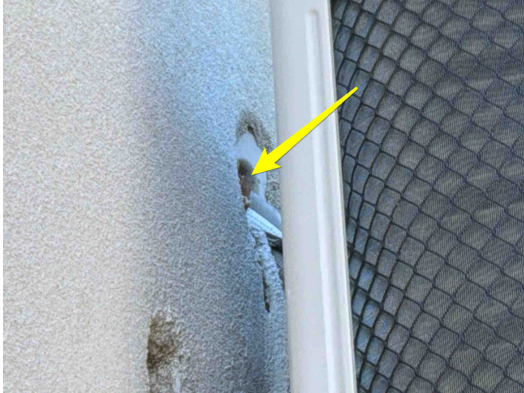
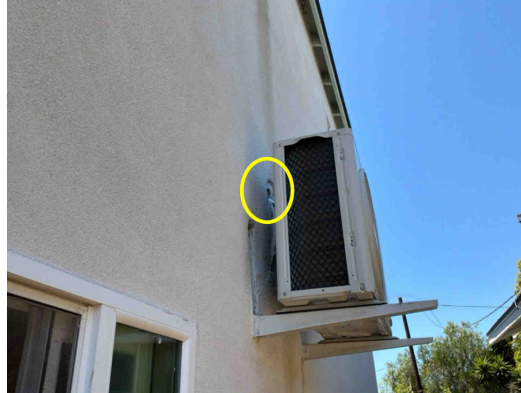
**188:** The UPSTAIRS Heating and Cooling unit found not functioning properly. The temperature differential is improper at 0°F. The temperature differential should be between 15°F and 25°F at the coldest register.

**E&C 189:** Recommend sealing the hole or opening BETTER - then using only expandable foam, through the exterior wall where the Air Conditioner's refrigeration pipes enter the building. This will help prevent rodent, bug and /or water intrusion through this area as need per standards.

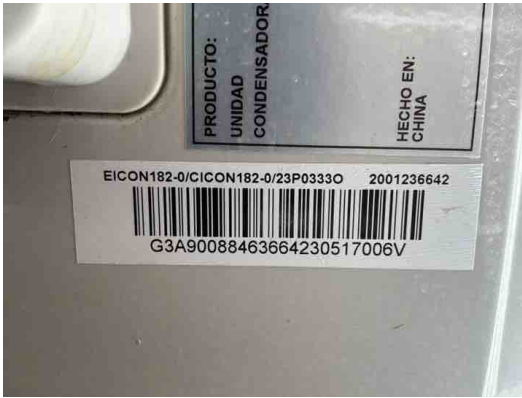
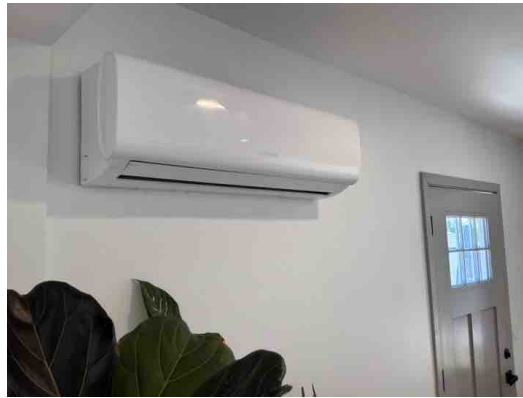
**191:** Missing the required electrical service disconnect for the air conditioner compressor.

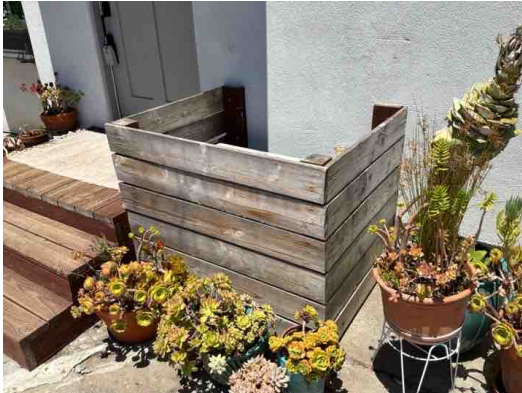
**192:** An improper installation of a wood fence around the condenser located around the front entry unit. Unit requires 3 feet of clearance in the front

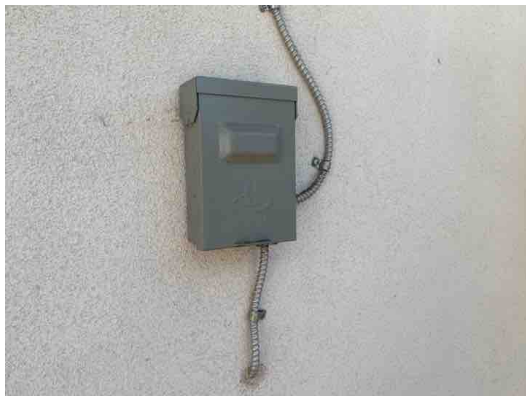
**195:** The required electrical service disconnect for the air conditioner compressor is provided at the condenser.

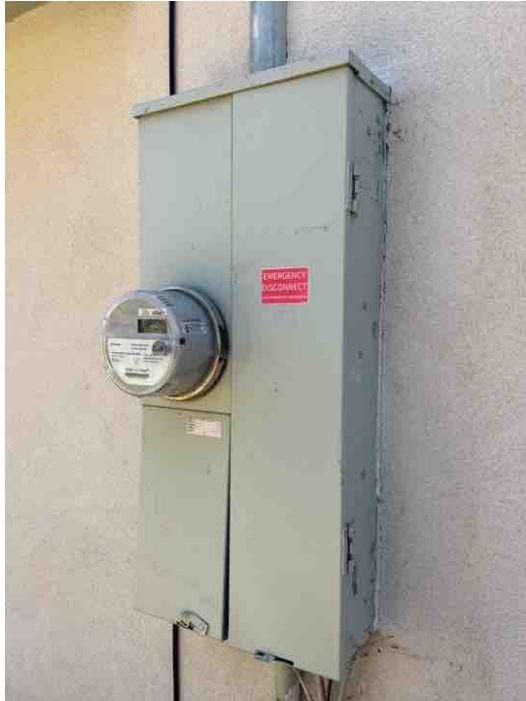
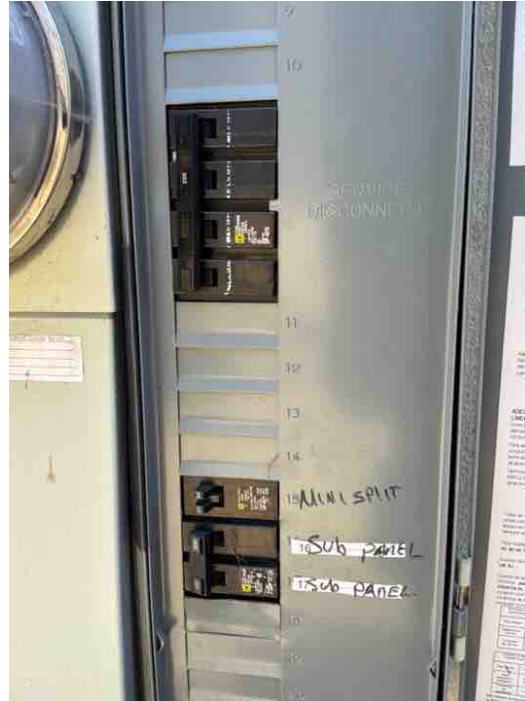
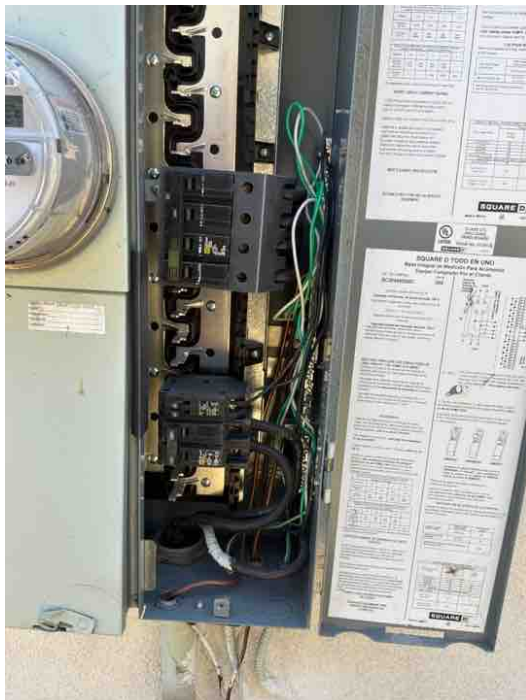
*Determining the capacity of the circuits in the electrical panel(s) is outside the scope of this inspection. This is only a visual inspection of the electrical panels per the CREIA standards. No load testing of the circuits was performed.*

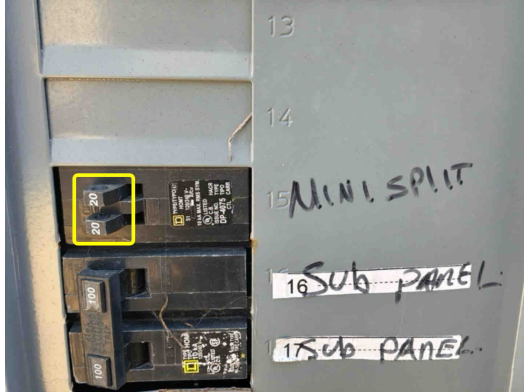
**SC 200:** Missing the required split-branch coupler at the THE MINI SPLIT 20 amp 240-volt breaker in the: MAIN ELECTRICAL PANEL.

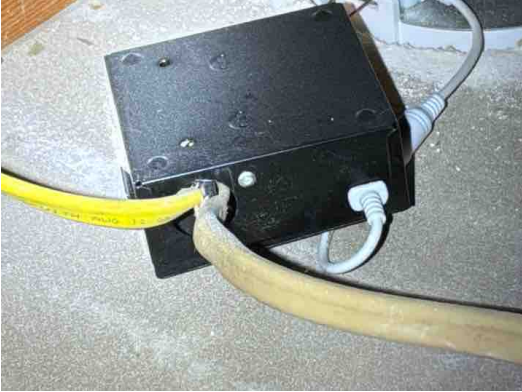
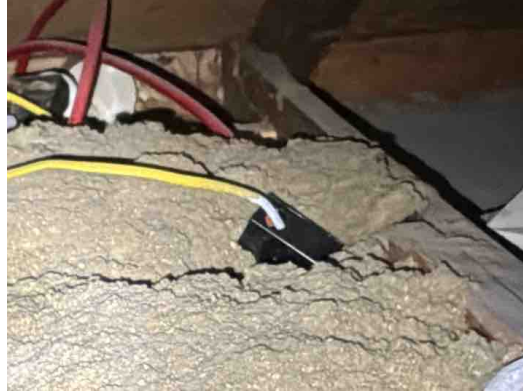
**SC 204:** Improper and unsafe electrical wiring IN THE MAIN HOUSE ATTIC. recommend additional review by licensed electrician.

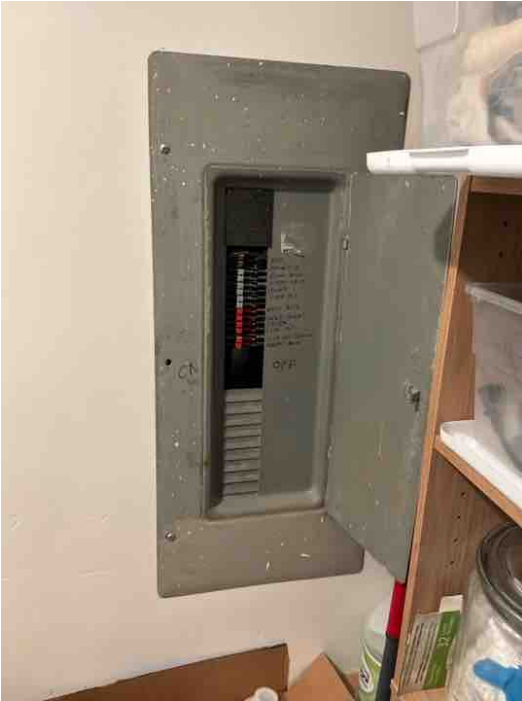
**SC 208: Some Visible defects found in the LAUNDRY ROOM ELECTRICAL SUB PANEL.** Recommend further review the electrical sub panels by a qualified licensed electrical professional and correct as needed.

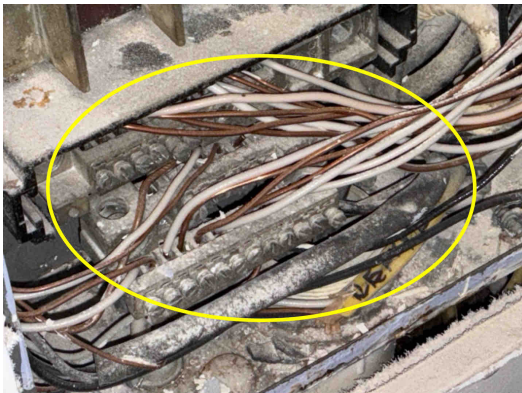
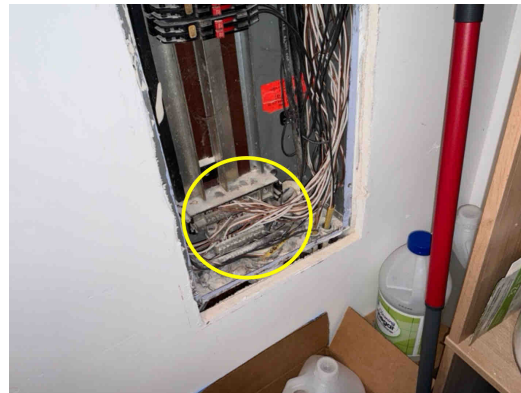
**SC 210:** Improper and unsafe openings in the dead front cover inside the LAUNDRY ROOM ELECTRICAL SUB PANEL. Openings are needing to be plugged or sealed for safety per standards.

**SC 212:** Improper and Unsafe cross connection of the Neutrals and Grounds connected together on the floating bus bar inside the: LAUNDRY ROOM ELECTRICAL SUB PANEL

**SU 211:** It is not recommended to use a sharp tipped type screws at the LAUNDRY ROOM ELECTRICAL SUB PANEL cover. Recommended replacement with the appropriate type of screw fastener for safety per standards.

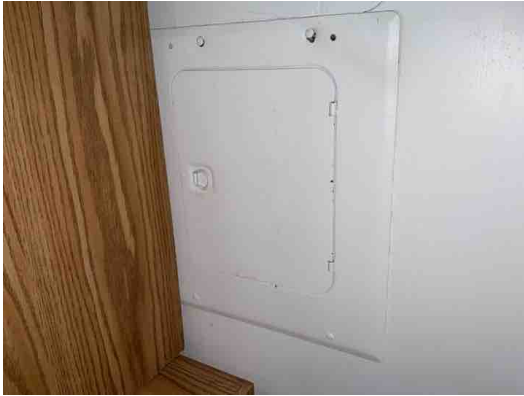
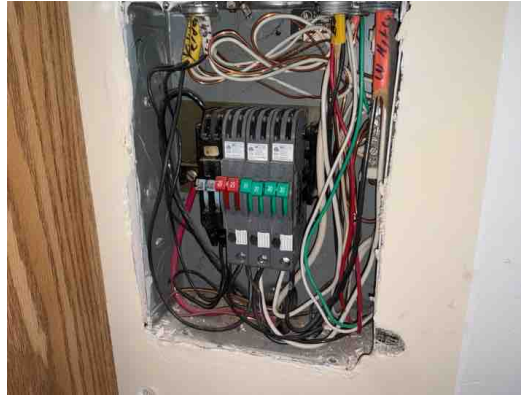
**SC 214:** Some Visible defects found in the ADU ELECTRICAL SUB-PANEL. Recommend further review the electrical sub panels by a qualified licensed electrical professional and correct as needed.

**FI SU 215:** These types of "Zinsco" electrical sub-panels are known to be problematic. I recommend further review and possible replacement of the electrical panel by a licensed electrical contractor familiar with the issues of this type of panel and modern electrical system upgrades.

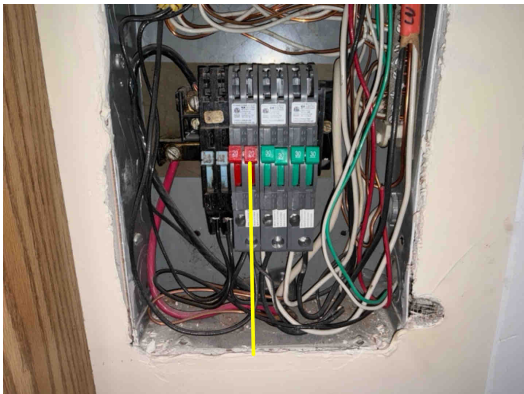
**SC 216:** Electrical panel defect / Over-fusing (breaker found too large for wire), (15-amp wire on a 20-amp breaker) in the ADU ELECTRICAL SUB-PANEL.

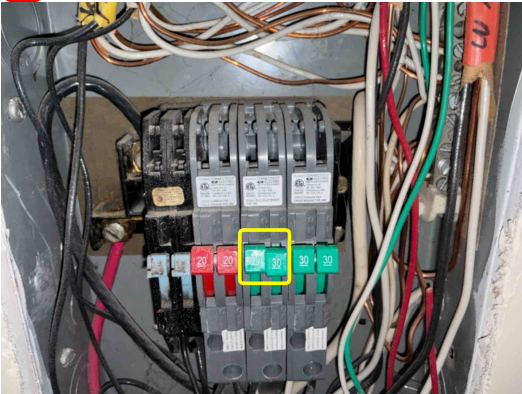
**SC 220:** Missing the required split-branch coupler at a 240-volt breaker in the: ADU ELECTRICAL SUB-PANEL.

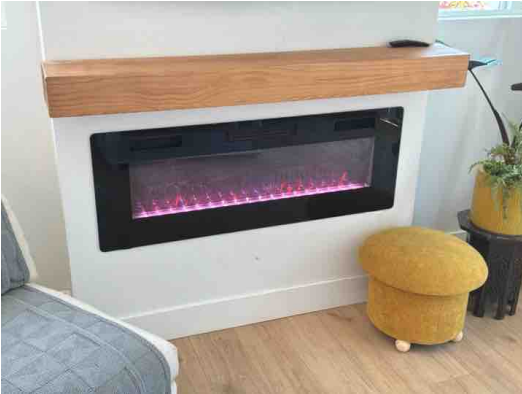
223: **LIVING ROOM**

225: **ELECTRIC FIREPLACE CONDITION**: The LIVING ROOM Electric fireplace operated when tested.
