# PROPERTY INSPECTION REPORT

**519 W Taylor St Spc 185**

**Santa Maria CA 93458**

**Date of Inspection: 7/20/2026**

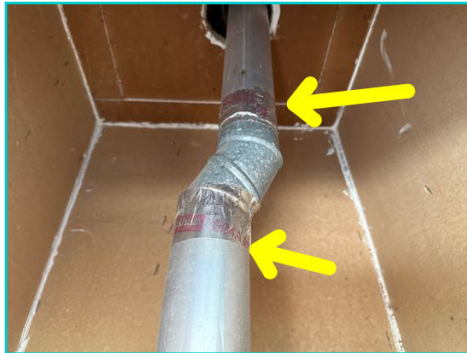
- Water heater exhaust flue vent connections require 3 screws at any connection. Suggest this be repaired.
- There was no firestop wall/ceiling plate installed. Suggest repair.

*vent pipe needs screws at connections*

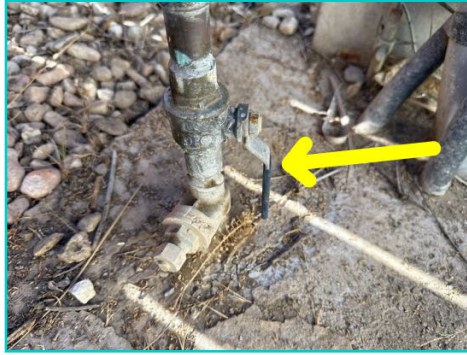
*main water shutoff valve*

- At the time of the inspection, the Inspector observed no deficiencies in the condition of the main water supply shut-off valve. It was not operated but was visually inspected.
- Main water shutoff valve was located at the rear of the house.

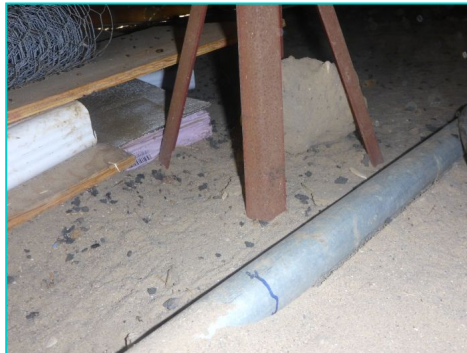
*screw jacks covered in soil*

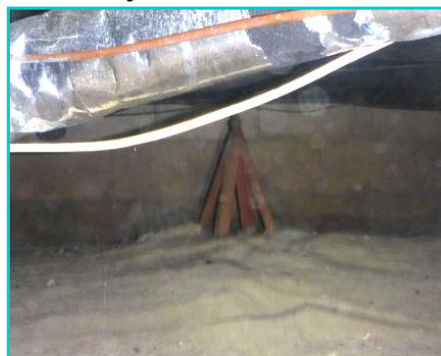
*screw jacks covered in soil*

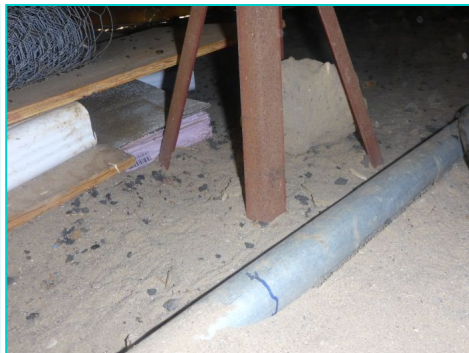
*screw jacks covered in soil*

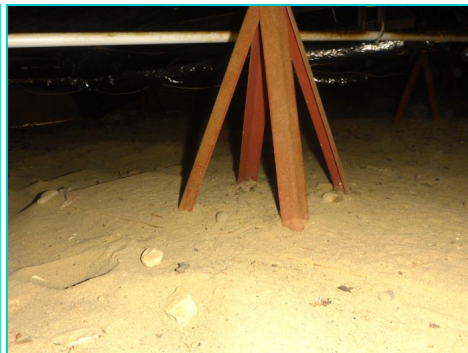
*screw jacks covered in soil*

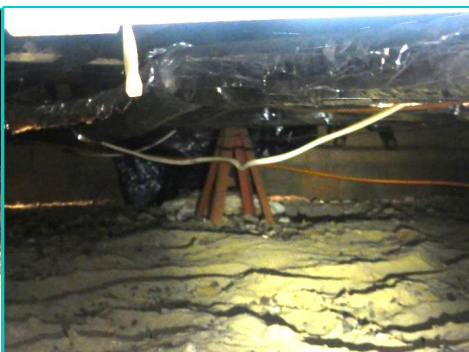
*screw jacks covered in soil*

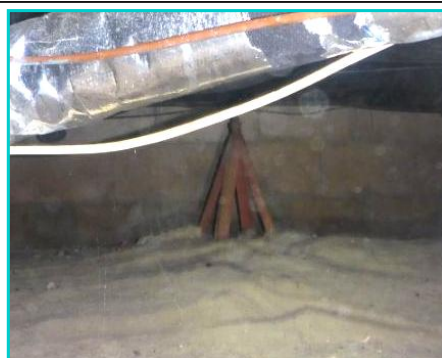
*screw jacks covered in soil*
