**Service:** Full Home Inspection

**Prepared for:** Austin & Jenie Vang

Site Address: **4200 Canyon Crest Road West, San Ramon, CA, 94582**

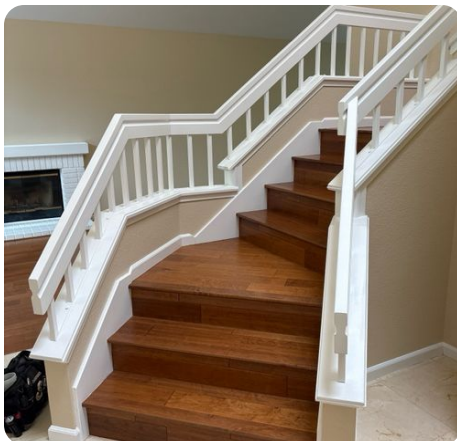
Stairwell railing installed on pony wall.

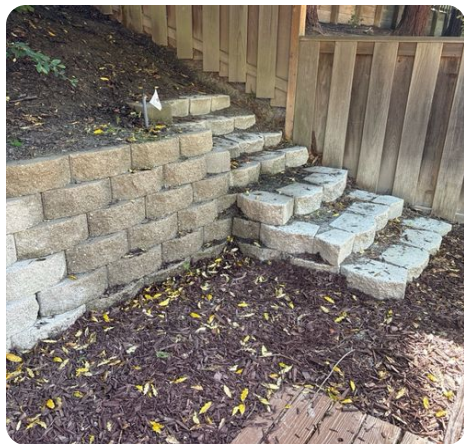
Functional masonry, retaining wall.

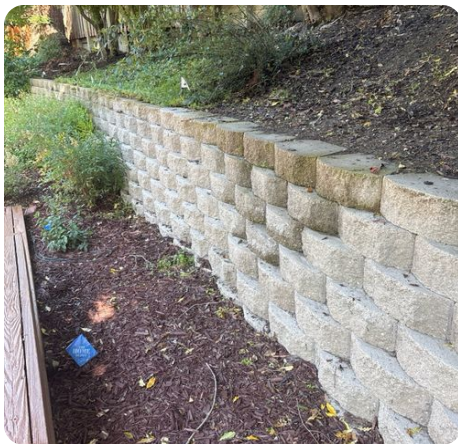
Functional masonry retaining wall. Good morning how are you?

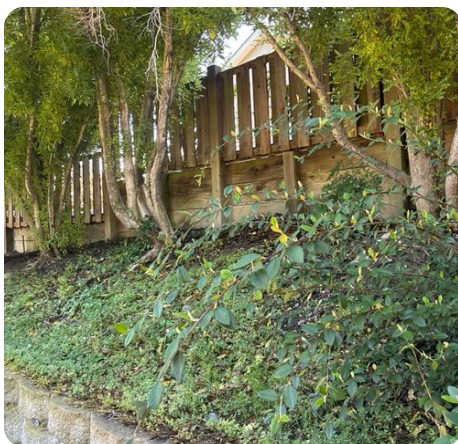
Functional wooden retaining wall at rear property edge.

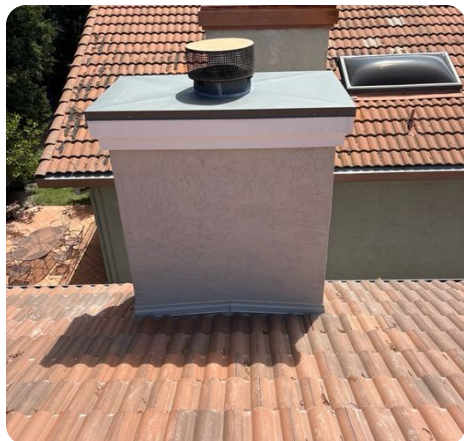
Family room fireplace chase as viewed from upper roof surface.

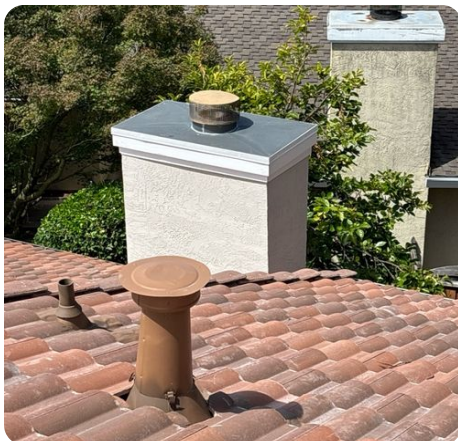
Living room fireplace chase as viewed from upper roof surface.

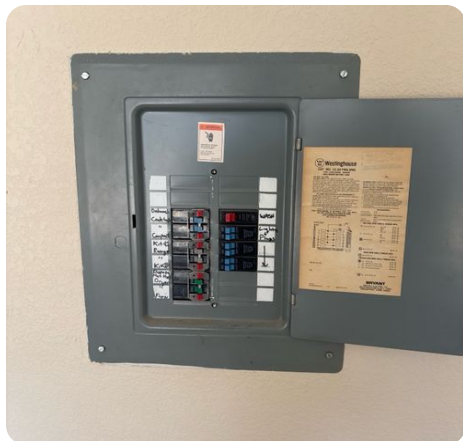
Original interior sub-panel within garage.

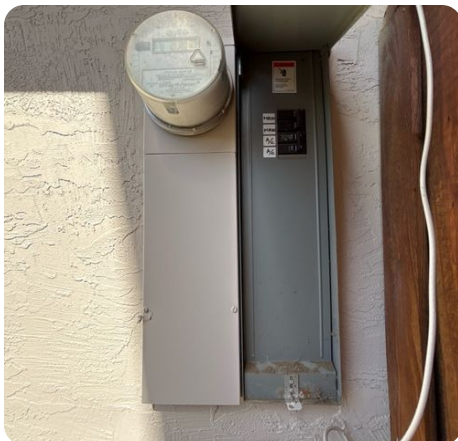
Original main service panel at garage exterior.

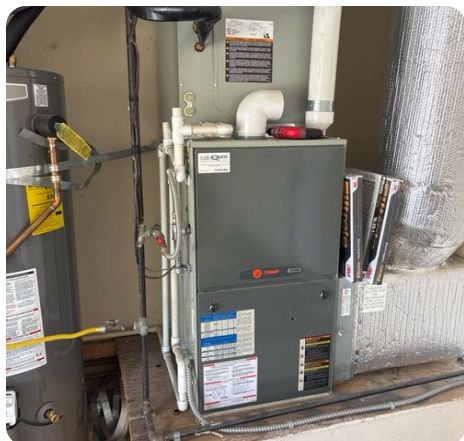
Trane branded, high efficiency, natural gas furnace within garage.

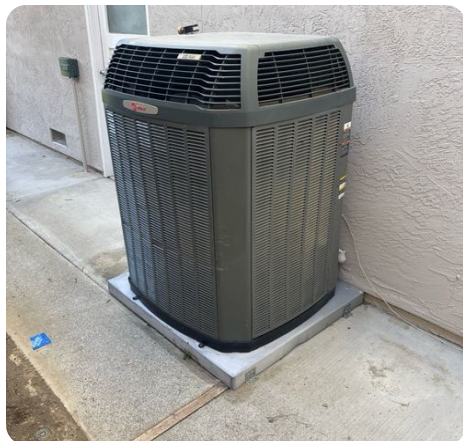
Trane branded condensing unit at bathroom exterior.

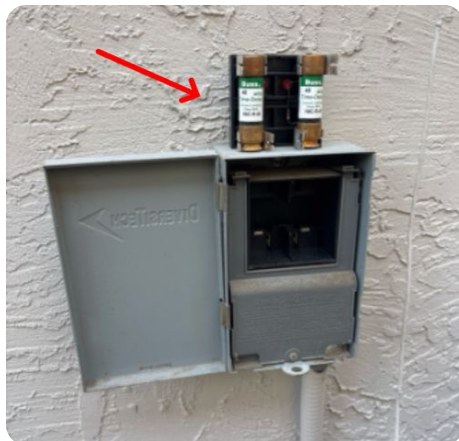
Appropriately sized condensing unit cartridge fuses at service disconnect.

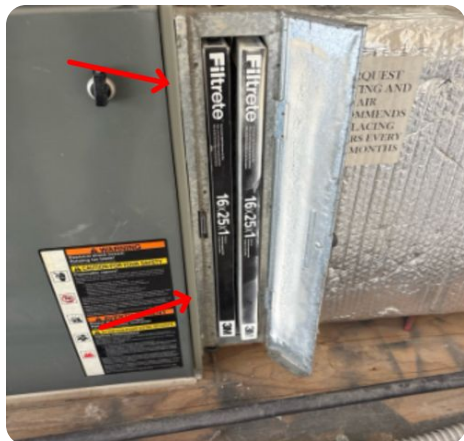
Clean, disposable HVAC filters at enclosure adjacent to furnace.

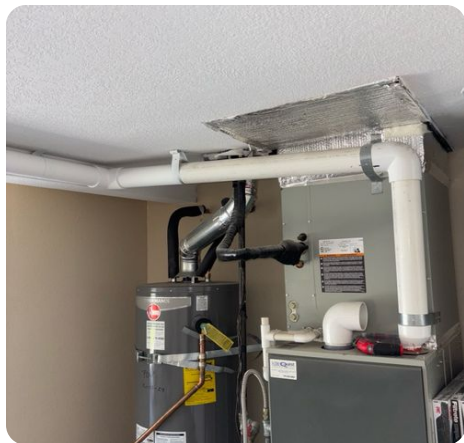
Functional furnace exhaust flue.

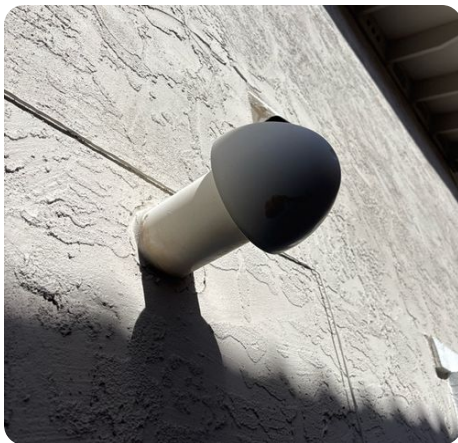
Functional furnace exhaust vent cover.

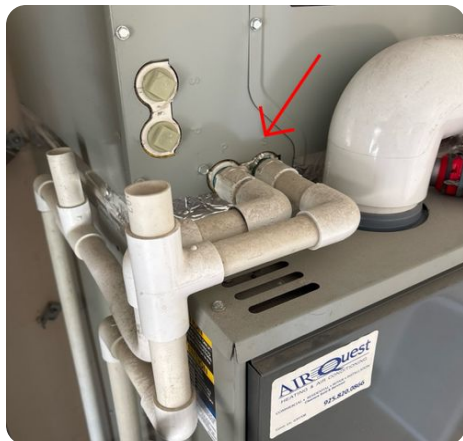
Dual HVAC condensate drain lines serving evaporation coil.

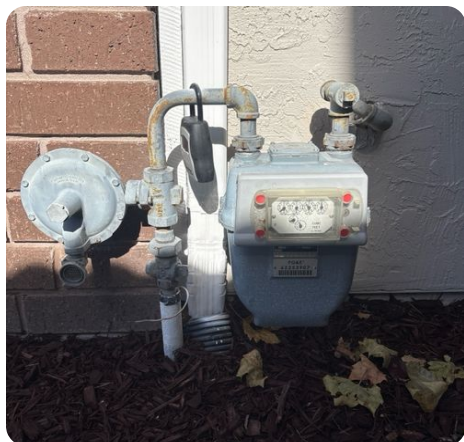
Natural gas service to the home can be terminated at the meter in the event of an emergency or should a gas odor be identified within the structure. The meter is not equipped with a seismic control or excess flow valve designed to terminate gas service in the event of an earthquake or other significant service issue. Storing a gas pipe safety wrench near the meter for emergency usage is recommended.

Natural gas meter at garage exterior.

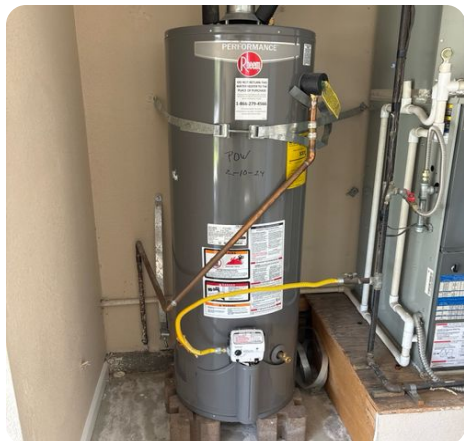
Rheem branded natural gas water heater within garage.

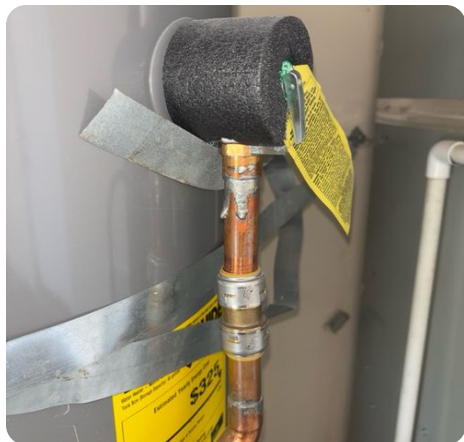
Water heater TPR valve with discharge tube.

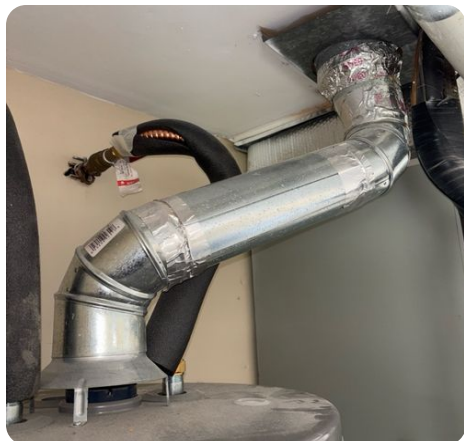
The visible and accessible segments of the water heater exhaust flue was found in functional condition at the time of the inspection.

Functional water heater exhaust flue.
