SUBJECT: BALCONY INSPECTION

ADDRESS: 4301 FULTON AVENUE

SHERMAN OAKS, CA 91423

DATE: JUNE 9, 2023

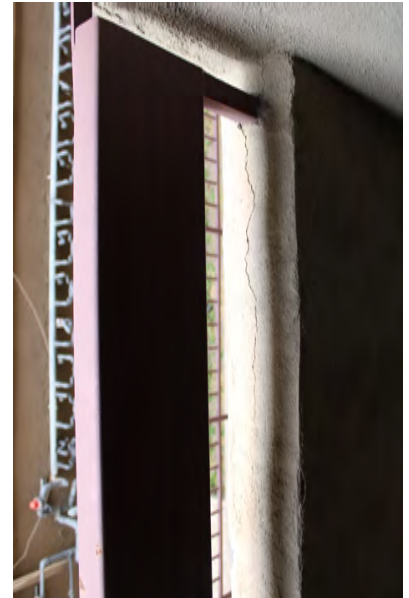
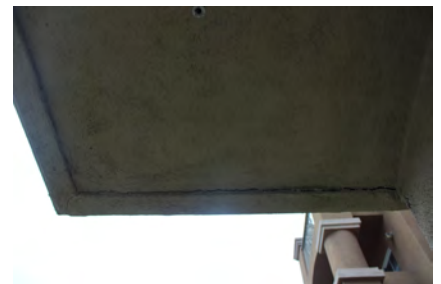
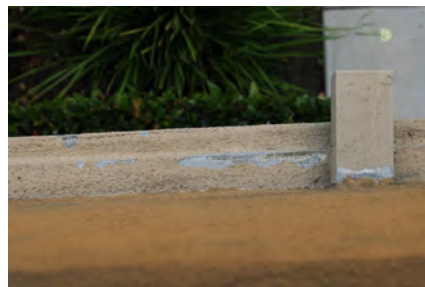
EAST FACING BALCONY HAS A BIG CRACK IN THE CEILING, AND THE STUCCO IS WEARING OUT AT THE EXTERIOR TRIM THE FLOOR FEELS LIKE IT IS BUBBLING. SOUTH FACING BALCONY- THERE IS A CRACK AT THE TOP OF THE RAIL WALL AND MINOR BUBBLING IN THE STUCCO.

THE EAST SIDE IS THE SIDE THAT TAKES THE BRUNT OF THE RAIN EXPOSURE, AND IT IS WORN OUT THE MOST. IT IS IMPORTANT TO REPAIR THE ACCESS POINTS, WHERE WATER FINDS ITS WAY INTO THE STRUCTURE, AND KEEP THE BUILDING'S SKIN INTACT.

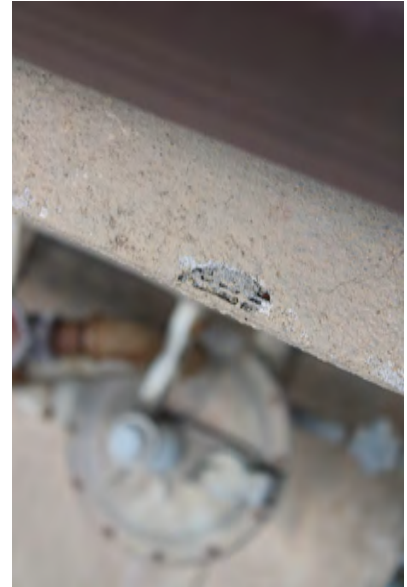
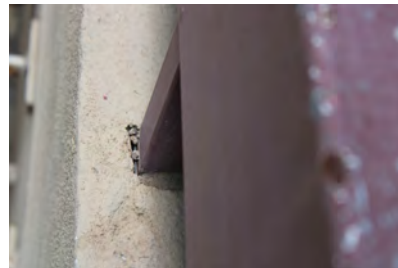
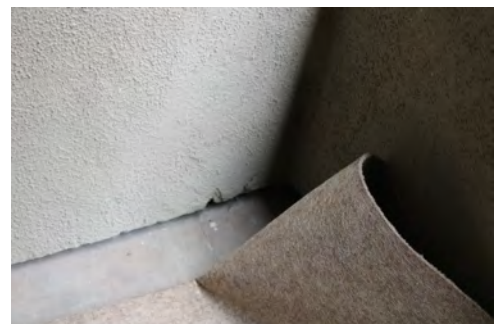
THE BALCONY @ THIS UNIT IS IN GRAT SHAPE. THERE ARE STUCCO CRACKS IN THE TYPICAL PLACES.

THE STUCCO SHOULD BE REPAIRED TO CURB FUTURE DETERIORATION.

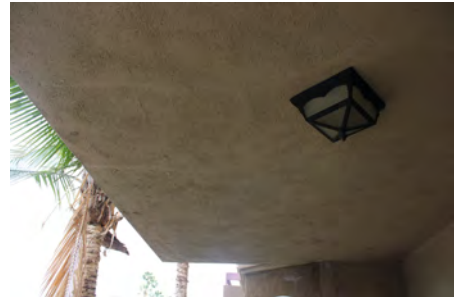
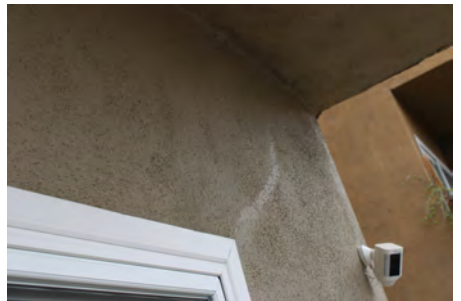
LIVING ROOM BALCONY- THE BEST ONE I HAVE SEEN TO THIS POINT. MASTER BEDROOM BALCONY- THERE ARE SOME STUCCO CRACKS IN THE CEILING, SOME AT THE EDGE OF THE BALCONY ABOVE. THEY ARE CAUSED BY WATER EXITING THE STRUCTURE. EXPECT THIS DAMAGE TO GET WORSE WITH TIME- KEEP AN EYE ON IT.

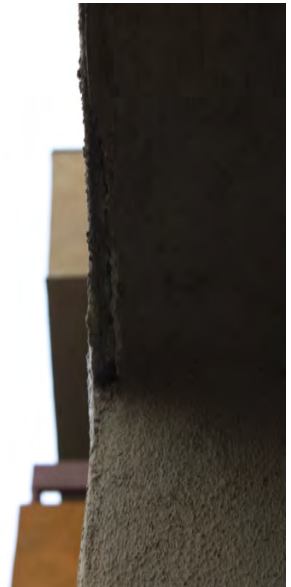
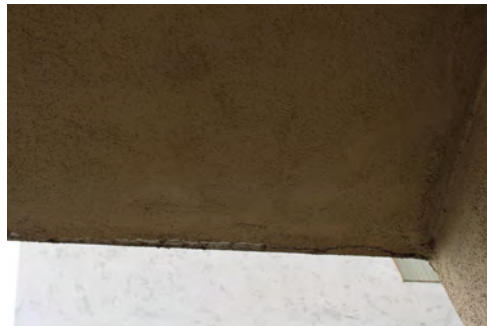
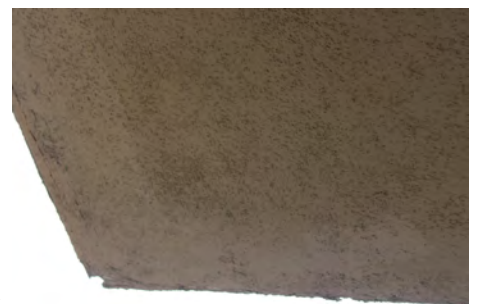
BOTH BALCONIES FOR THIS UNIT ARE IN GREAT SHAPE. THERE ARE CRACKS AT THE CEILING AT THE ABOVE BALCONY'S EDGE- NEED TO KEEP AN EYE ON IT, IF NOT REPAIR.

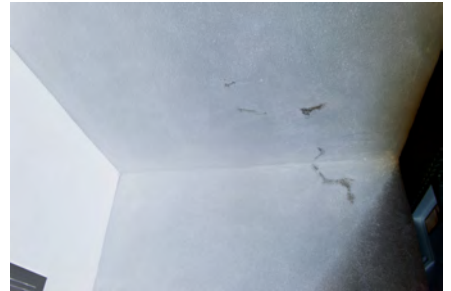
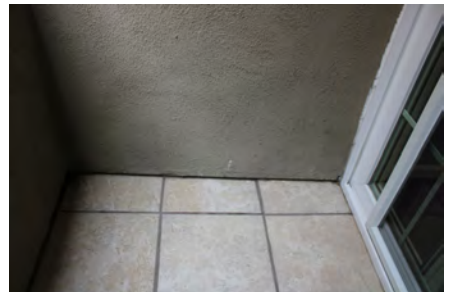
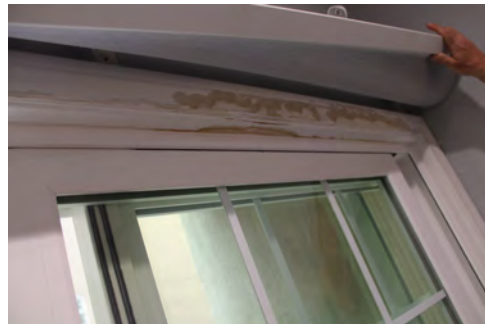
UNIT # 203

LIVING ROOM BALCONY- WATER MARKS IN THE CEILING, STUCCO DETERIORATION @ RAIL CONNECTION.  
MASTER BEDROOM BALCONY- THE TILE IS VERY CLOSE TO THE WEEP SCREED. THERE IS EVIDENCE OF WATER INTRUSION @ THE BALCONY DOOR'S HADDER, FROM THE BALCONY ABOVE.

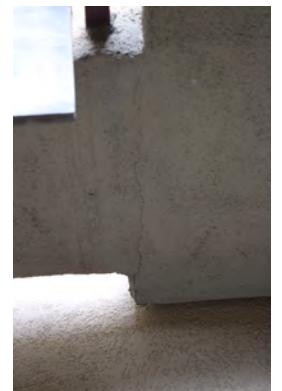
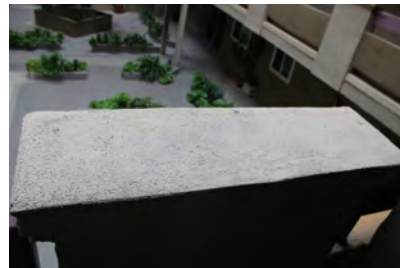
UNIT # 205

LIVING ROOM BALCONY- THE STUCCO HAS MINOR CRACKS. THE FLOOR IS BUBBLING, THE FLOOR FINISH AT SOME AREAS IS TOO CLOSE TO THE WEEP SCREED. MASTER BEDROOM BALCONY- THE FLOOR IS A LITTLE SOFT. THERE ARE STUCCO GAPS BETWEEN THE WALL AND RAIL @ CONNECTION.

THIS UNIT'S BALCONIES SHOULD BE OBSERVED FOR FURTHER DETERIORATION OF THE FLOOR WATERPROOFING MEMBRANE.

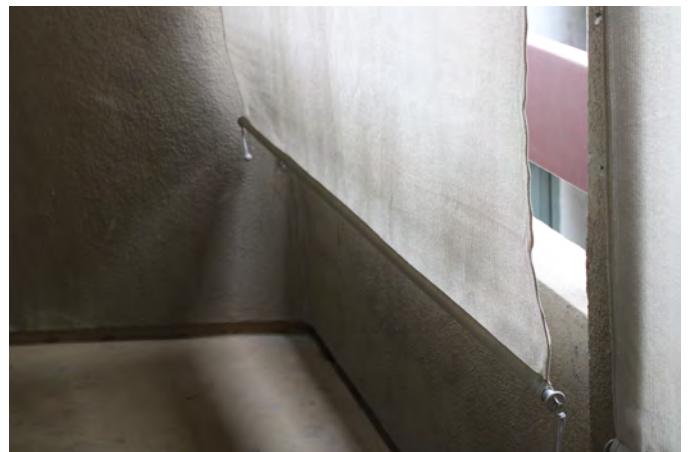
EXPECTED FUTURE PERFORMANCE AND REMAINING USEFUL LIFE OF THE LOAD-BEARING COMPONENTS AND ASSOCIATED WATER PROOFING SYSTEMS:  
 THE BALCONY @ THIS UNIT IS IN GREAT SHAPE. THERE IS A SHADE, PROTECTING IT.

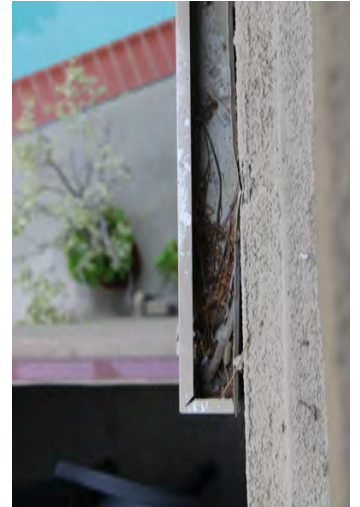
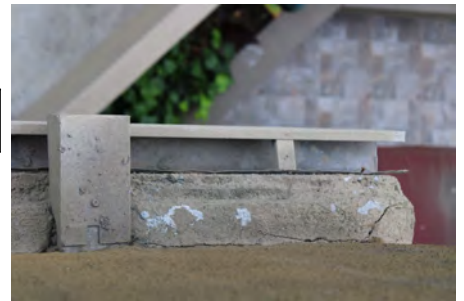
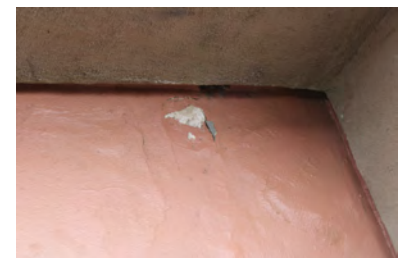
LIVING ROOM BALCONY- THERE IS A HOLE IN THE PAINT COVERING THE FLOOR MEMBRANE, OR THE MEMBRANE ITSELF. THERE ARE CRACKS IN THE STUCCO TRIM, AT THE EEND OF THE BALCONY. MASTER BEDROOM BALCONY- THE GUTTER SHOULD B KEPT CLEAR OF DEBRIS.

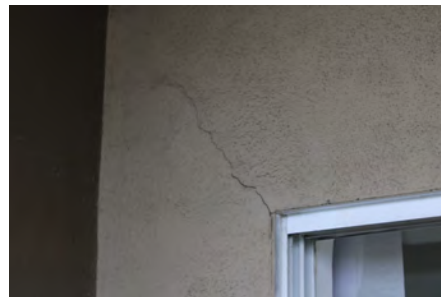
THIS UNIT HAS THE WORST BALCONIES. THEY FEEL SOLID, BUT THEY ARE CLEARLY LEANING HEAVILY TOWARDS THE ENDS. THERE ARE CRACKS EVERYWHERE.

THE ROOF TOP HAS A BROKEN ELECTRIC COVER THAT NEEDS REPLACING, BUBBLING IN THE STUCCO, AND A CLEAR PATCH JOB @ THE ROOF WALL CONNECTION.

THE MASTER BEDROOM BALCONY FLOOR MEMBRANE SHOULD BE REDONE. WHEN THE CURRENT TOP IS STRIPPED, CHECK THE STRUCTURE, TO SEE WHY THE FLOOR IS SLOPING MORE THAN IT USED TO. FINDING OUT WHAT HAPPENED TO THIS BALCONY, MIGHT LEAD TO STRIPPING THE LIVING ROOM BALCONY TOO.

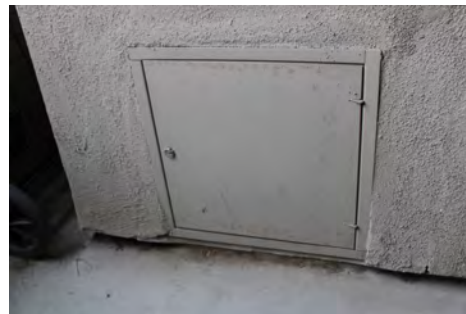
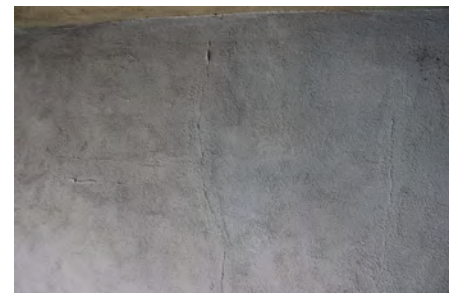
SOUTH BALCONY- COVERED BUT HIGH ROOF. THERE IS A BIG CRACK AT THE RAIL/WALL CONNECTION ON THE RIGHT SIDE. THERE IS A GAP BETWEEN THE TILE AND DOOR THRESHOLD IN 2 OF THE BALCONIES- IDEAL LOCATION FOR WATER TO ENTER THE STRUCTURE. THE TILE FINISH IS TOO CLOSE TO TH WEEP SCREEDS IN SOME AREAS. AT THE ROOF, THERE IS AN AREA WHERE THE WEEP SCREED WAS SEALED. THERE IS A WATER LEAK FROM ONE OF THE WATER STOPS

CHECK @ THE UNIT BELOW THIS ONE, FOR WATER DAMAGE. FIX/STOP ANY WATER LEAKS.

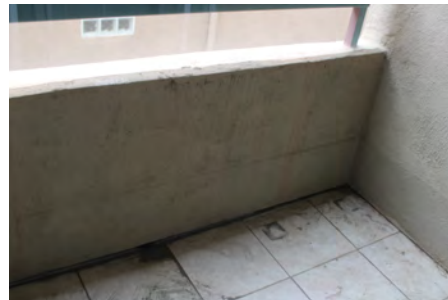
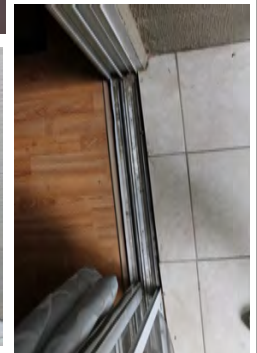
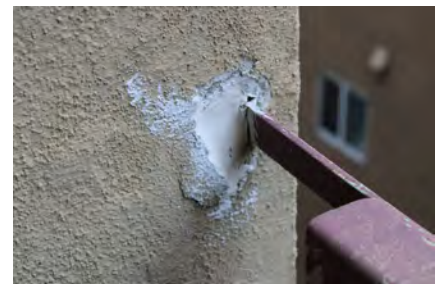
STUCCO ISSUES AT ALL THE TYPICAL PLACES. THERE IS A GAP BETWEEN THE TILE AND THE DOOR THRESHOLD. IT SEEMS LIKE THERE WAS WATER DAMAGE @ THE MASTER BEDROOM BALCONY, AND THE LOWER 1' OF STUCCO WAS REDONE. THE WEEP SCREED IS TOO CLOSE TO THE TILE.

SEAL THE HOLES IN THE STUCCO TO PREVENT FURTHER DETERIORATION. SEAL THE GAP BETWEEN THE TILE AND THRESHOLD.

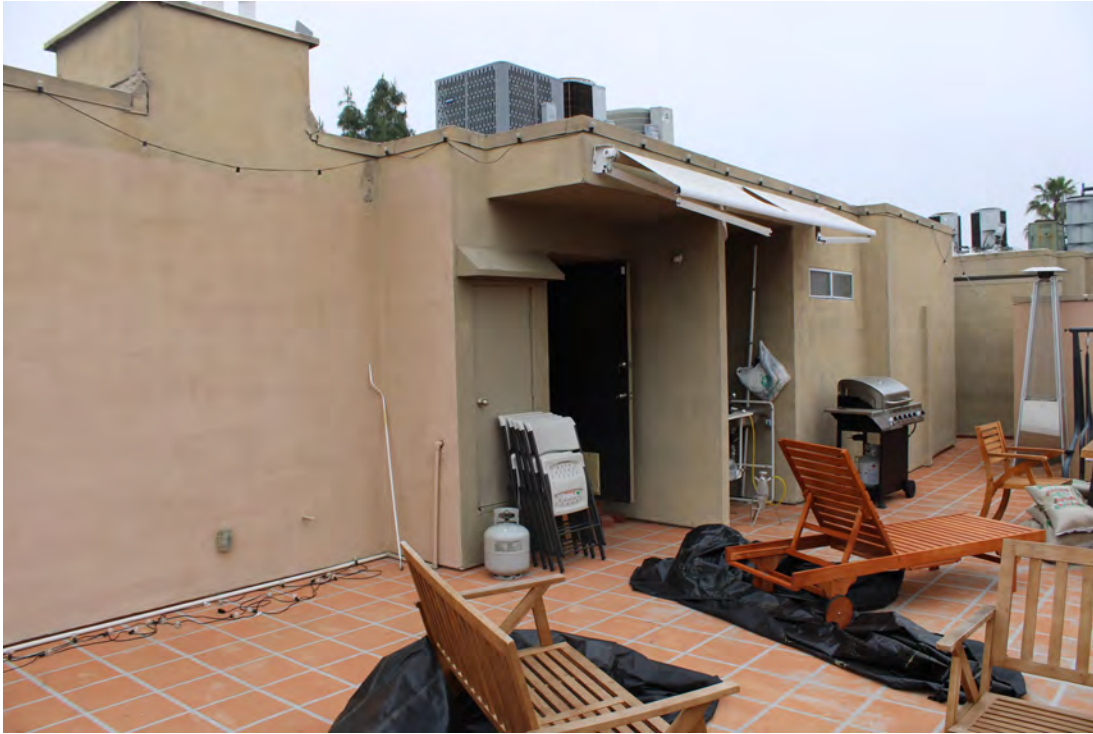
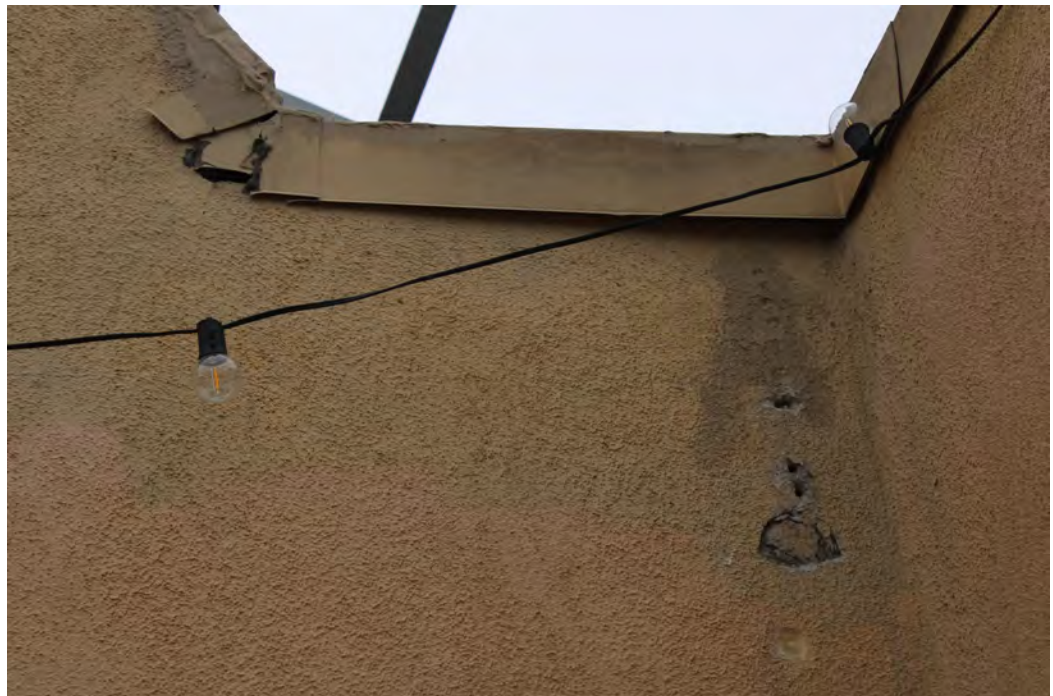
UNIT # 304

LIVING ROOM BALCONY- THE MEMBRANE MADE NOISE OF AIR BUBBLES WHEN WALKED ON IT. MASTER BEDROOM BALCONY- IN GREAT SHAPE. THERE IS A SPOT OF PAINT, PEELING NEAR THE DOOR JAMB, FROM WHEN THE DOOR WAS REPLACED. ROOF DECK- IN GREAT SHAPE. THERE ARE HOLES IN THE STUCCO, REMNANTS FROM SOMETHING THAT WAS REMOVED. THEY SHOULD BE SEALED.

KEEP AN EYE ON THE LIVING ROOM BALCONY FLOOR, FOR FURTHER DETERIORATION.  
SEAL HOLES @ WALL AT ROOF LEVEL.

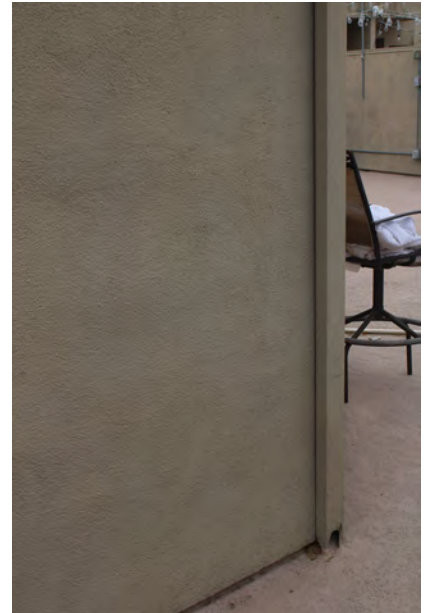
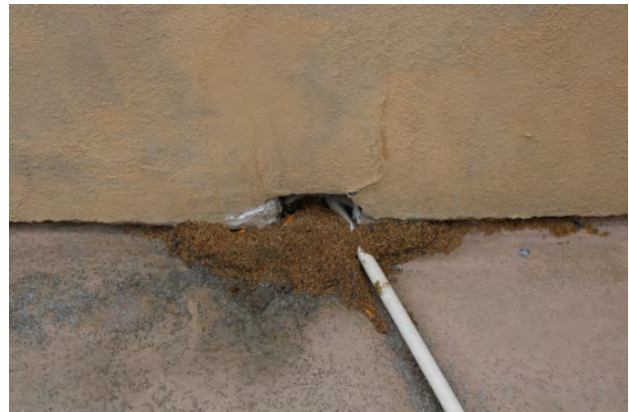
THERE IS ONLY ONE BALCONY IN THIS UNIT. IT IS IN GREAT SHAPE, JUST HAS A LOT OF FLIES, SIMILAR TO THE BALCONY @ UNIT 106, TWO FLOORS BELOW IT. IT MIGHT BE A TREE RELATED ISSUE- I DID NOT LOOK FOR THE SOURCE OF THE FLIES. THERE IS DETERIORATION IN THE STUCCO AT THE BOTTOM OF THE DOOR JAMB. ROOF DECK- THERE IS DEBRIS AT THE DRAIN OPENING, THE GUTTERS FROM THE ROOF ABOVE DRAIN DIRECTLY TO THE ROOF DECK FLOOR. STUCCO DETERIORATING 2 WEED SCREEN (TYPICAL)

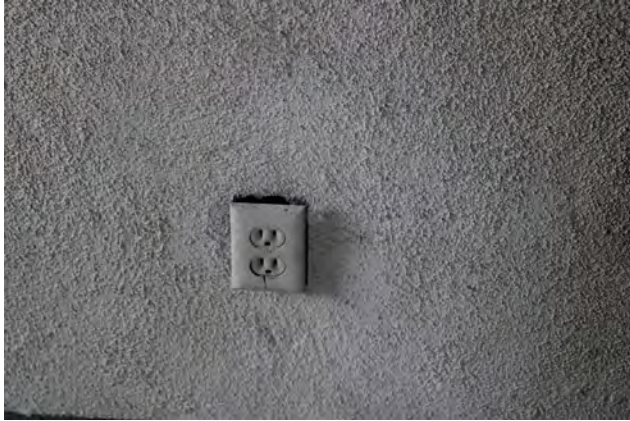
Second floor common balcony

There is a loose electrical outlet, and the planter rail is rotting and letting water enter the structure.
