# INSPECTION REPORT

For the Property at:  
**714 SUZANNE DR**  
MERCED, CA 95348

RE: Report No. 8956  
714 Suzanne Dr  
Merced, CA  
95348

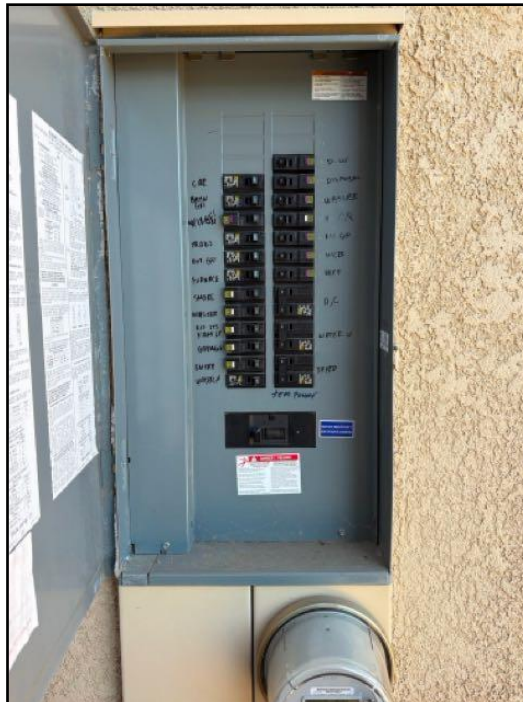
25. Breakers - exterior wall

Appears serviceable

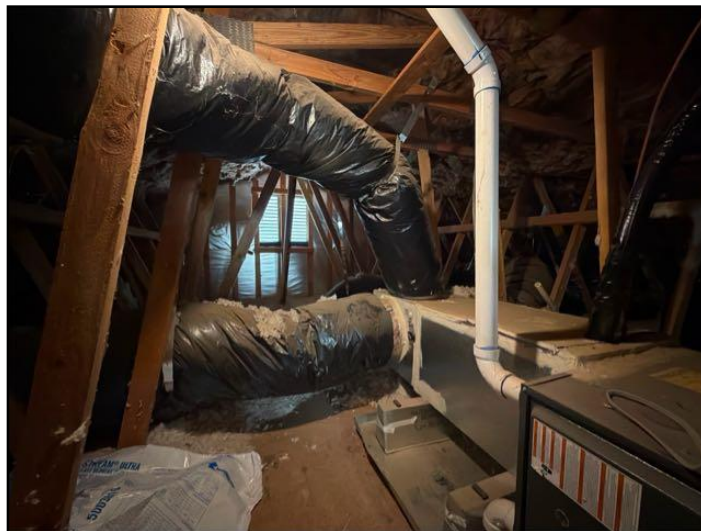
28. Ducts and registers

Appears serviceable
