### *Inspection Report*

Address: 1363 Black Sage Cir Nipomo, CA 93444

07/29/2026

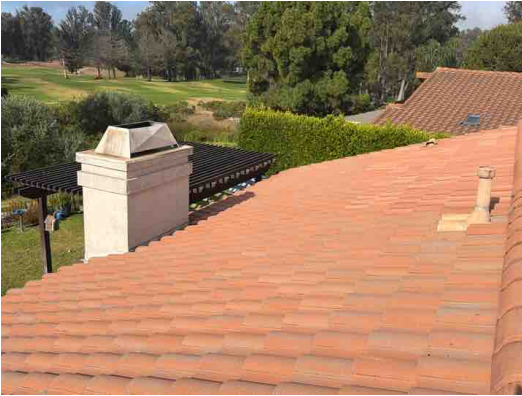
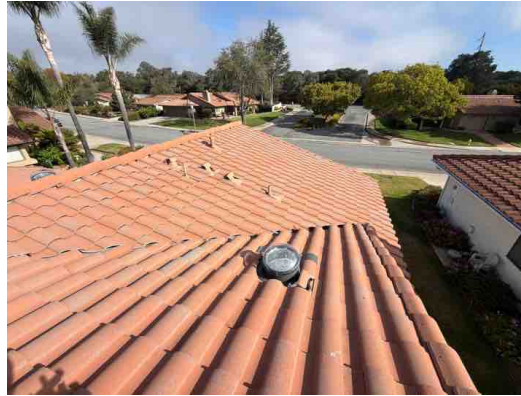
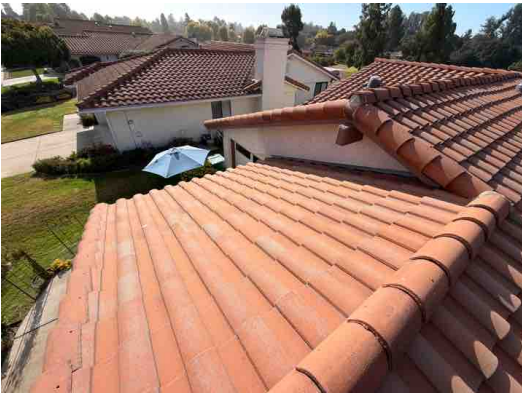
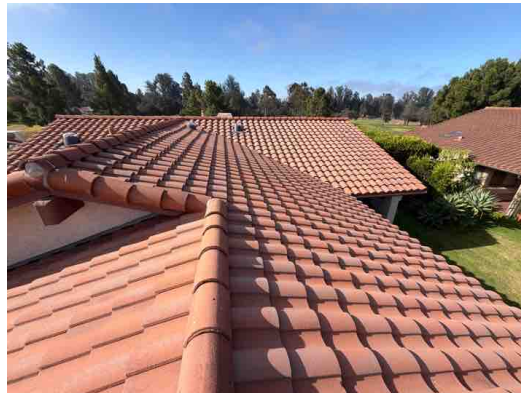
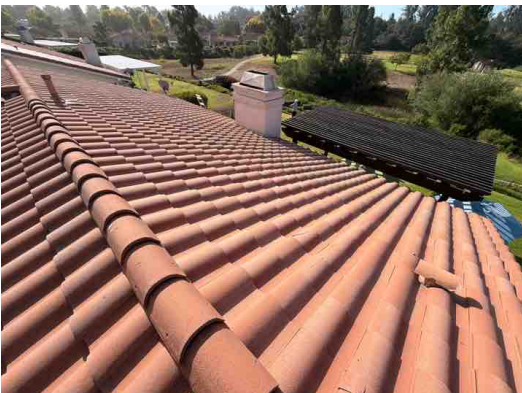
#### 45: Gable

#### 46: Roof was walked

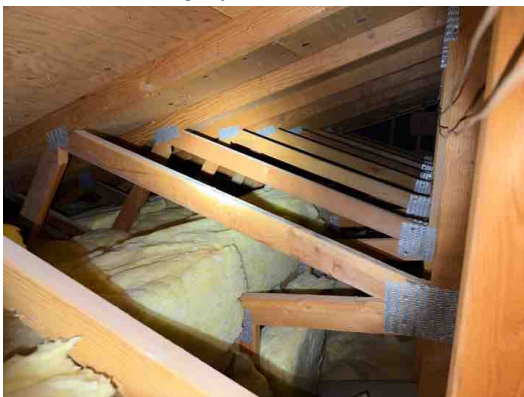
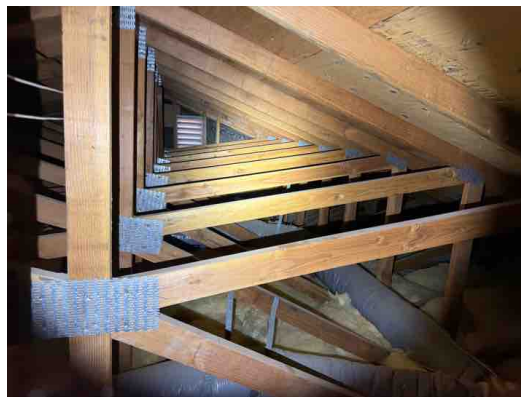
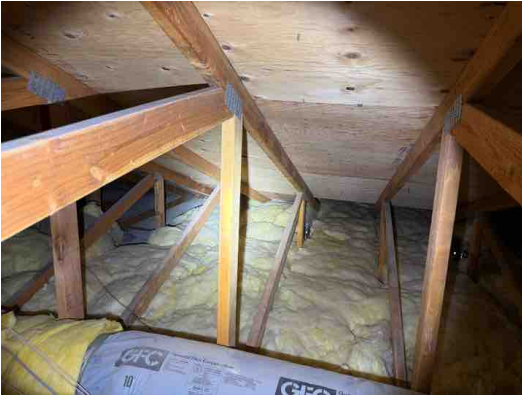
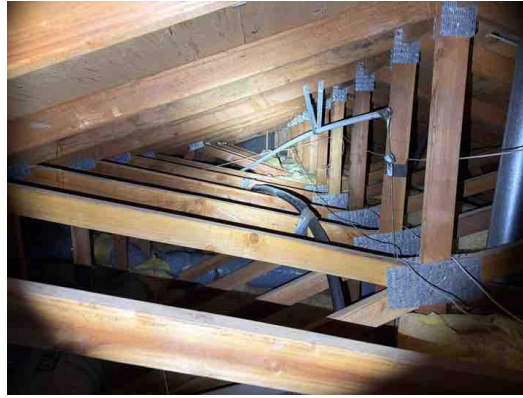
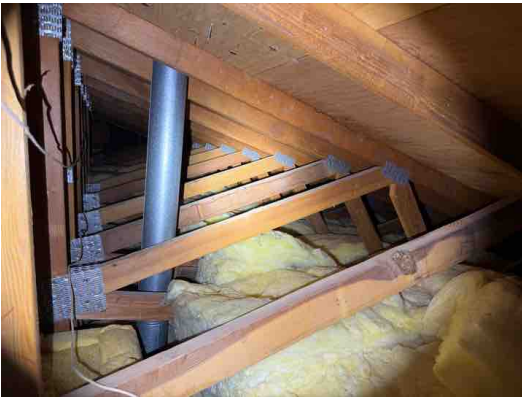
### 61: Attic Photographs

**DS 60:** Disclosure: Areas of the attic are not fully visible, not accessible and not inspected due to insulation, ducting and some areas are too small for physical access.

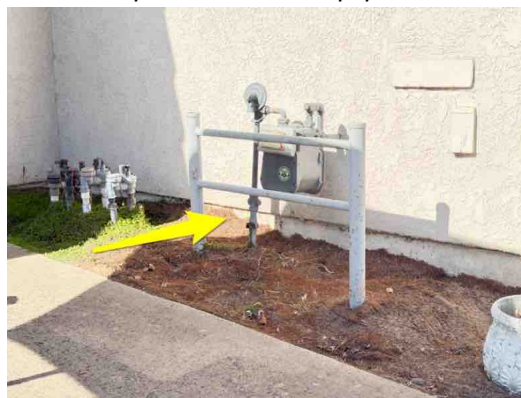
**79:** Gas shut-off appears serviceable.

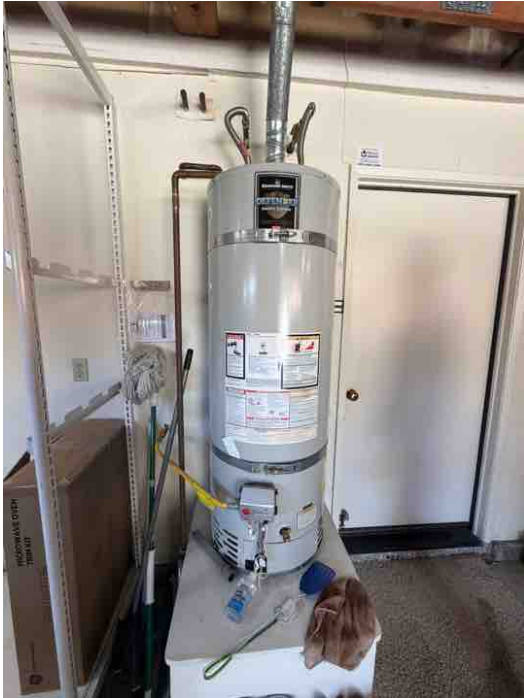
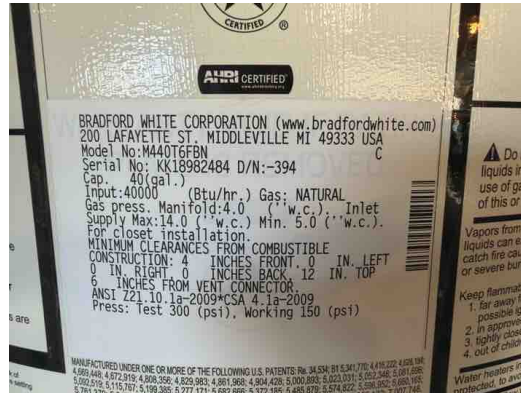
**MR SU 81:** **CONDITION:** The water heater operated when tested. However, some maintenance and repairs are recommended. Contact a qualified and licensed plumbing professional.

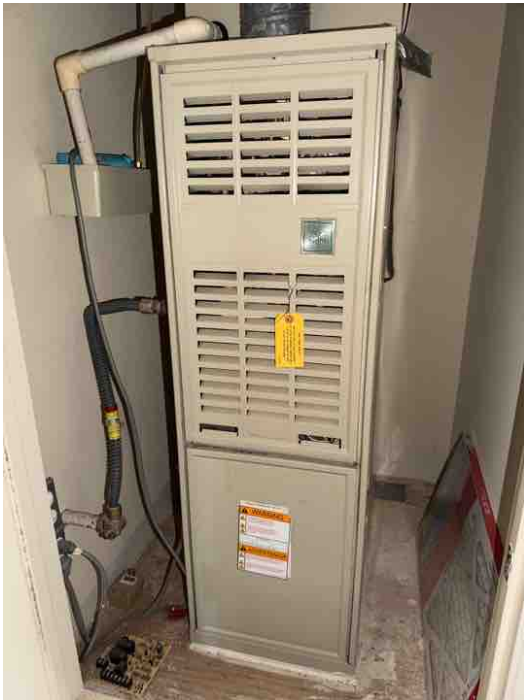
**SU DS 156:** Disclosure- This type of heating unit has an anticipated 15-20 year life span and is currently **41 years old**. The heating unit operated today but is past anticipated life expectancy. Continuous maintenance and inspection recommended.

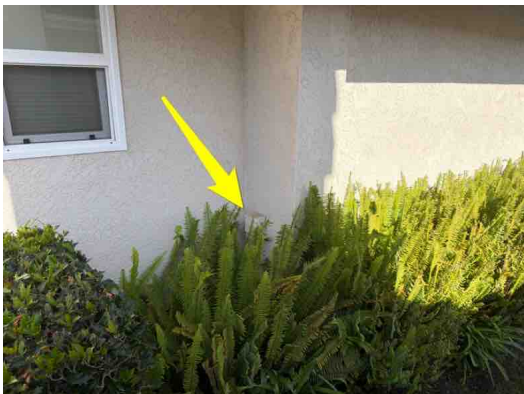
**167:** The required electrical service disconnect for the air conditioner compressor is provided at the compressor.

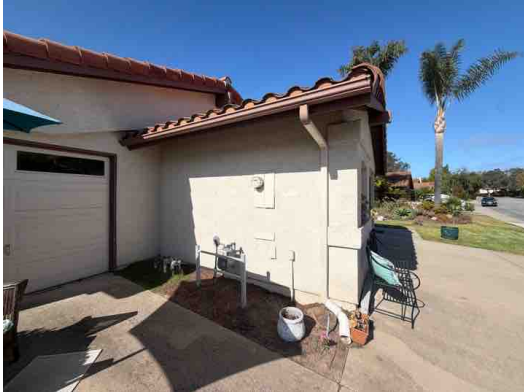
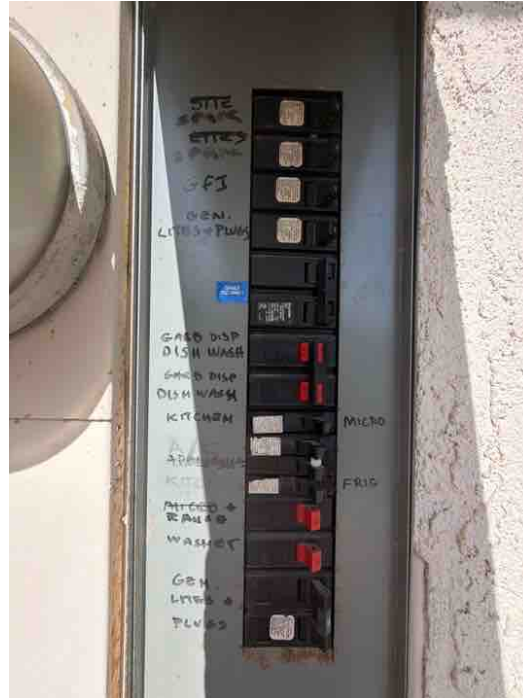
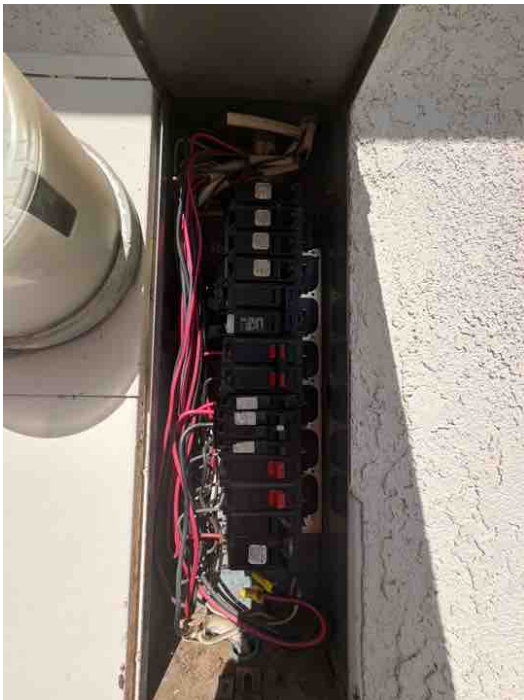
**177: MAIN ELECTRICAL PANEL CONDITION:** \*No visible wiring defects in the MAIN ELECTRICAL PANEL.

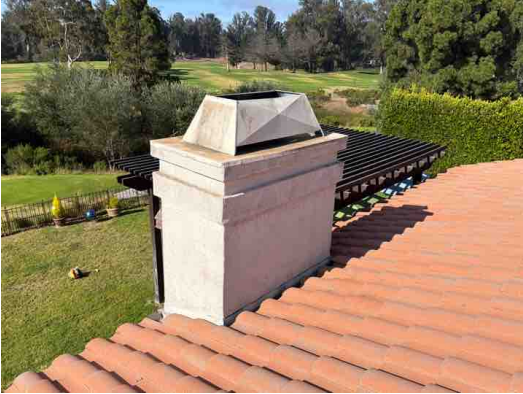
**207:** The LIVING ROOM fireplace chimney.

**SU 208:** Improper use and installation of a non-UL listed decorative surround atop the chimney. All UL listed four sided surrounds require a 4 inches air inlet opening on all four sides of the surround at the bottom. This surround only has opening on two sides. This can negatively affect the drafting of the chimney. Proper repairs are warranted per standards. Recommend having a qualified professional open the two sides, easy repair.
