# THE HOMETEAM INSPECTION SERVICE

## Property INSPECTION REPORT

July 13, 2026

24354 Chandler Rd  
Hayward, Ca 94545

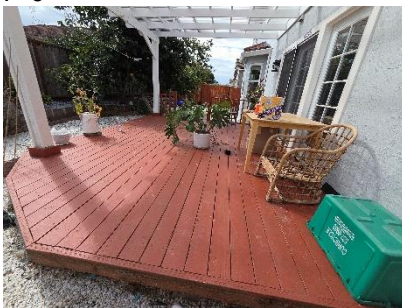
P-7

There was a corrugated plastic roof over the deck. P- 8

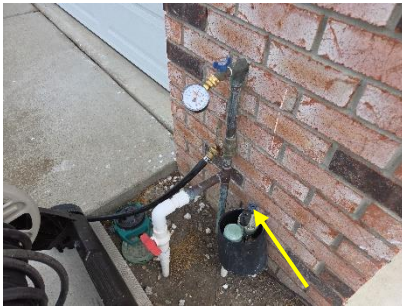
Main water shut-off valve was located on the front side. P-14

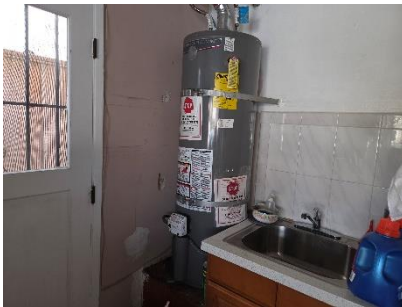
P-16

The temperature and pressure relief valve (T & P) was present. Because of the lime build-up typical of T & P valves, we do not test them. An overflow leg was present. It did terminate close to the floor. Proper placing is 6" to 24" above the floor. Your safety depends on the presence of a T & P valve and an overflow leg terminating close to the floor.

The water heater was functional.

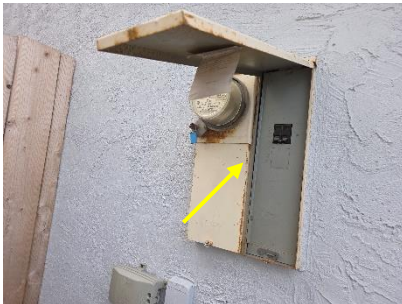
P-18

The underground electric service wire entered the home on the left wall. The electric meter was located on the exterior wall. The main shut-off was noted but not tested. The main disconnect switch serves as a safety device to permit convenient shutdown of the system for emergencies or service. The main disconnect switch should always be kept accessible for use in emergencies.

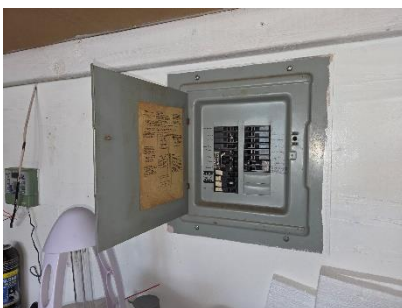
P-19

**IMPROVE:** The electrical system components did not appear to meet current arc-fault circuit-interrupter (AFCI) standards. This may be an "as-built" condition, but according to today's local building standards, lack of AFCI protection is considered a defect.

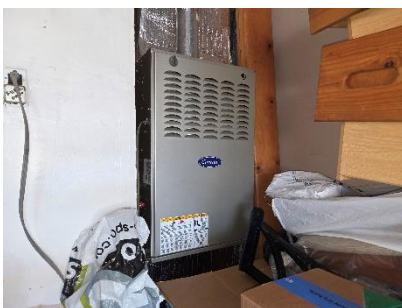
The home was heated by a Carrier natural gas forced air furnace. P-25

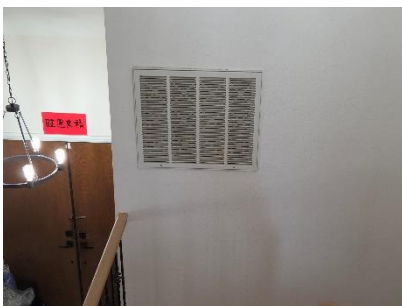
The disposable filter was located on the wall in the stairway. P-26

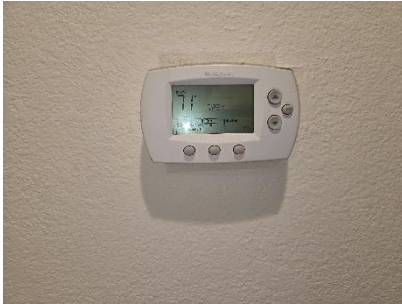
The thermostat was manufactured by Honeywell and was found to be in working order. P-27
