# ***Cornerstone Inspection***

## **Property Inspection Report**

***3315 Barranca Ct, San Luis Obispo, CA 93401***

***Date of Inspection: 6/26/2026 Time: 9:00 AM***

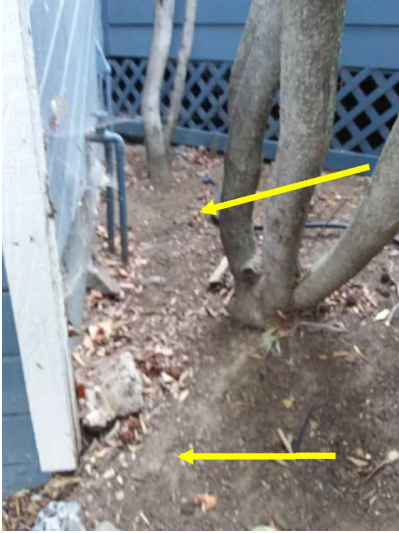
2.3. There are areas at the front where water will be directed toward the house instead of away from it, as recommended. This not only allows for the possibility of moisture intrusion but also differential settling.

There are areas at the front where water will be directed toward the house instead of away from it, as recommended. This not only allows for the possibility of moisture intrusion but also differential settling.

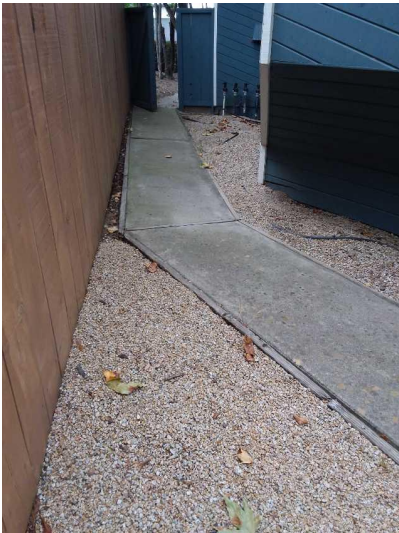
There are areas at the residence where water will percolate and pond, which is not ideal. You may wish to consider upgrading the site by adding hard surfaces, or area drains that direct water away from the residence.

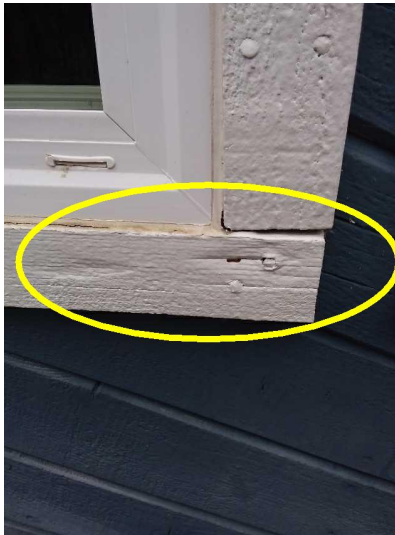
There is damage to the wood trim that should be evaluated by a termite inspector.

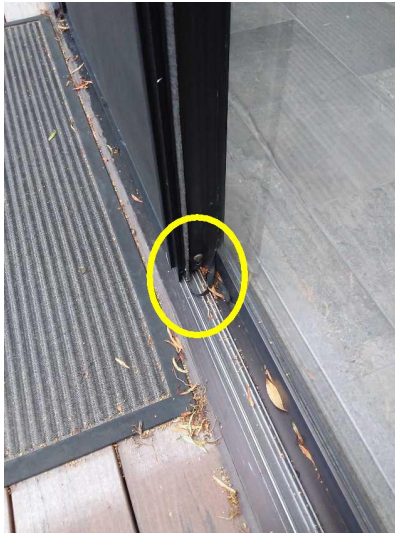
7.2. The sliding glass door or doors are mounted on the outside, which is not as secure as being mounted on the inside.

The sliding glass door or doors are mounted on the outside, which is not as secure as being mounted on the inside.

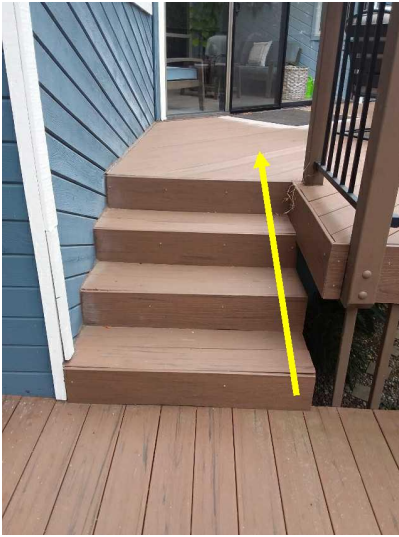
Current building standards require handrails to be installed on steps which have 4 or more risers, and particularly if children or the elderly visit or occupy this property.

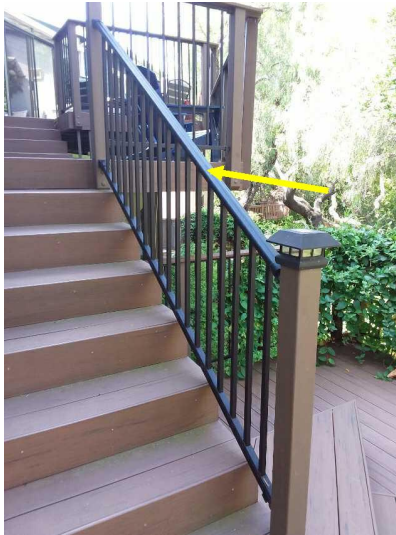
The handrail on the rear steps is not secure and may represent a safety hazard, and should be serviced.

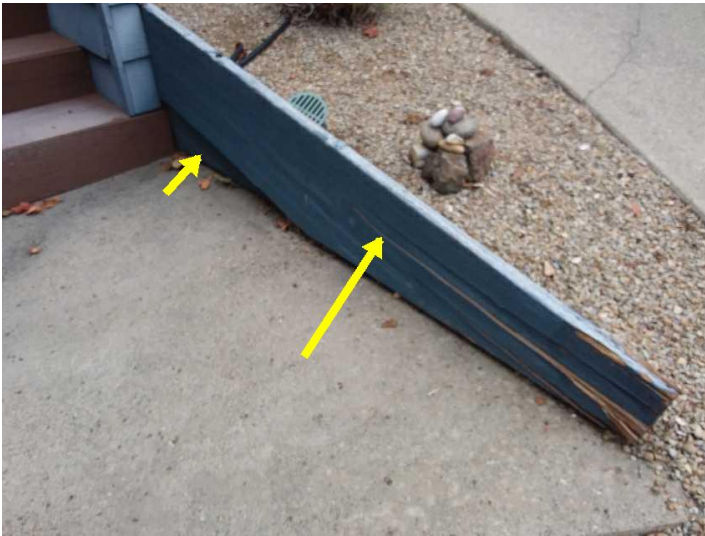
The wooden planks at the property have no structural value, and are intended to inhibit surface soil movement, and should be periodically monitored for damage or stability.

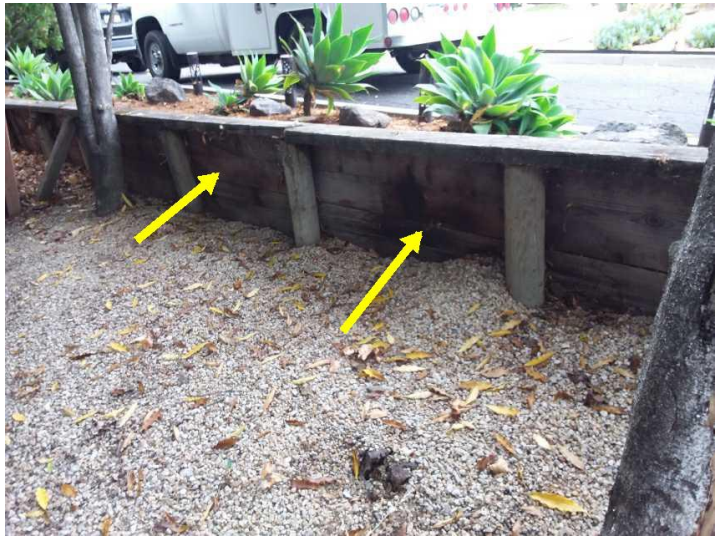
The wooden planks at the property have no structural value, and are intended to inhibit surface soil movement, and should be periodically monitored for damage or stability.

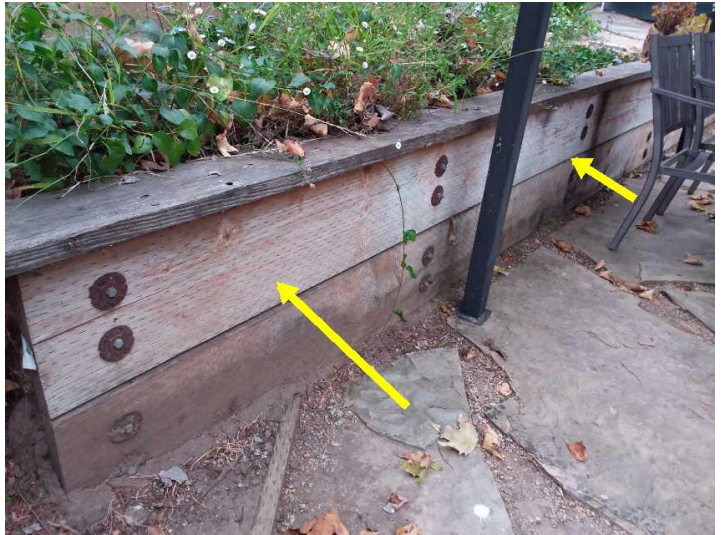
The wooden planks at the property have no structural value, and are intended to inhibit surface soil movement, and should be periodically monitored for damage or stability.

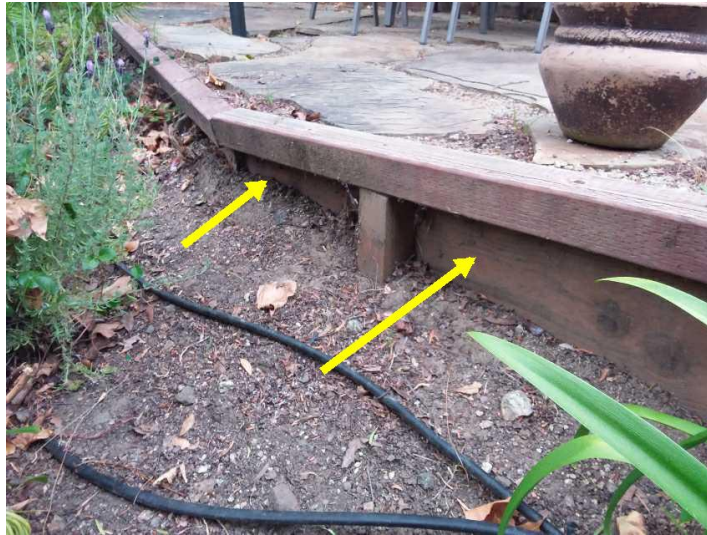
The wooden planks at the property have no structural value, and are intended to inhibit surface soil movement, and should be periodically monitored for damage or stability.

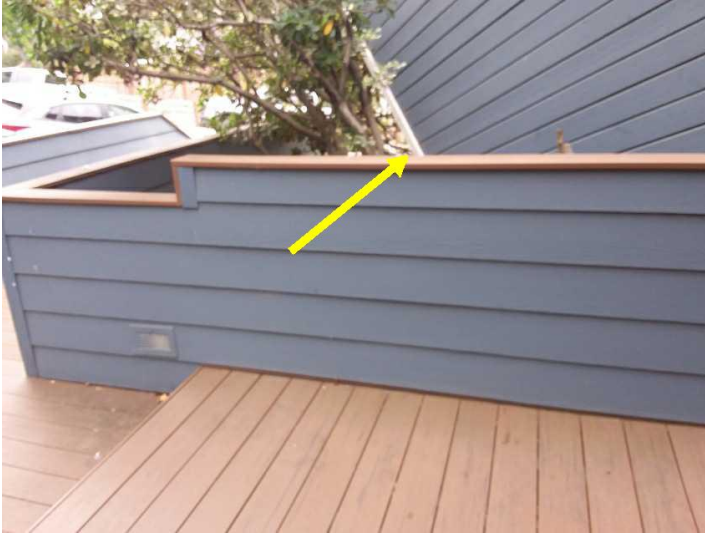
The front balcony/deck guardrail does not conform to common safety standards. Common safety standards require them to be a minimum of 42 inches high when the standing surface is 30" or more above grade.

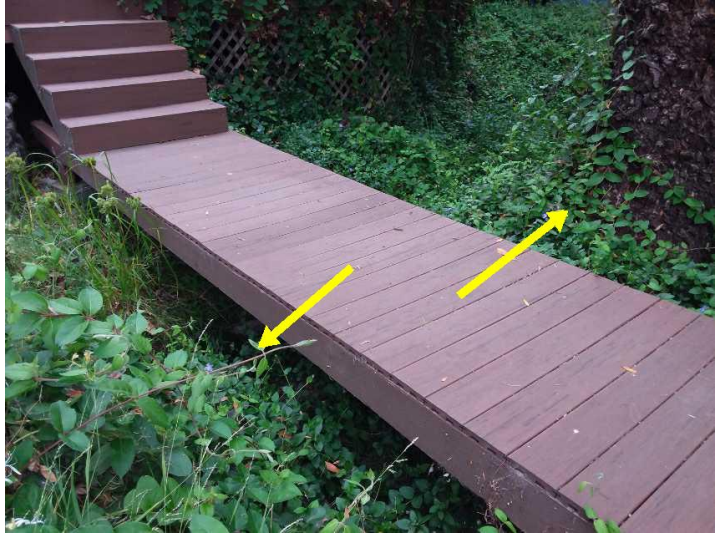
There are areas of this property that do not have guardrails, which are required for walk-offs greater than thirty inches, and appropriate precautions should be taken to safeguard children and the elderly.

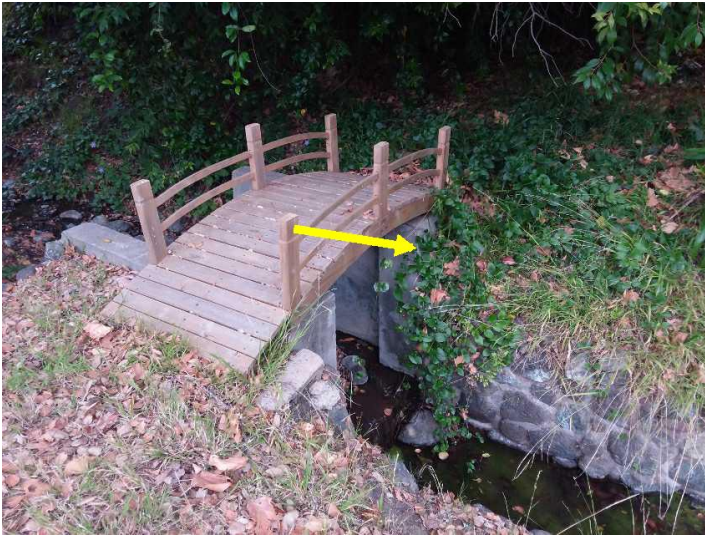
There are areas of this property that do not have guardrails, which are required for walk-offs greater than thirty inches, and appropriate precautions should be taken to safeguard children and the elderly.

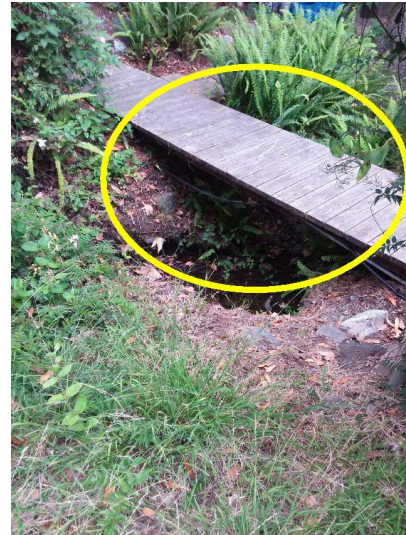
There are areas of this property that do not have guardrails, which are required for walk-offs greater than thirty inches, and appropriate precautions should be taken to safeguard children and the elderly.

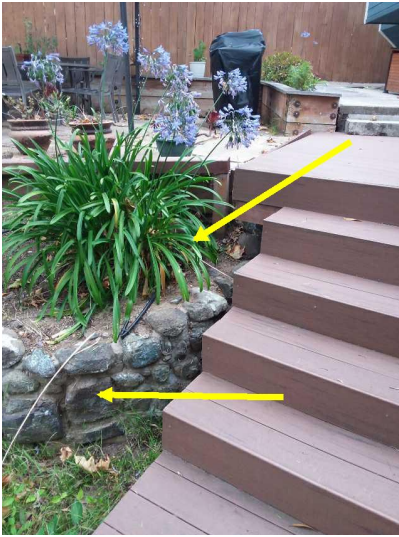
There are areas of this property that do not have guardrails, which are required for walk-offs greater than thirty inches, and appropriate precautions should be taken to safeguard children and the elderly.

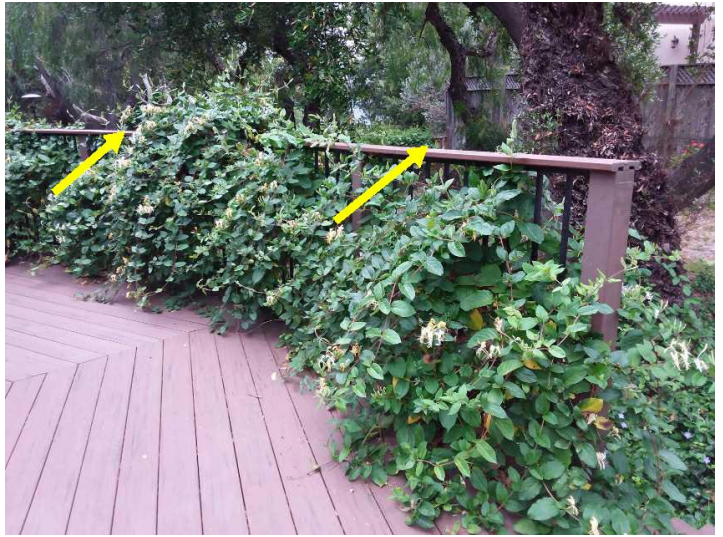
The rear guardrail, or guardrails, is an adequate height and in acceptable condition. However, standards for guardrails are not uniform. Nonetheless, common safety standards require them to be a minimum of 42 inches high when the standing surface is 30 inches or more above grade.

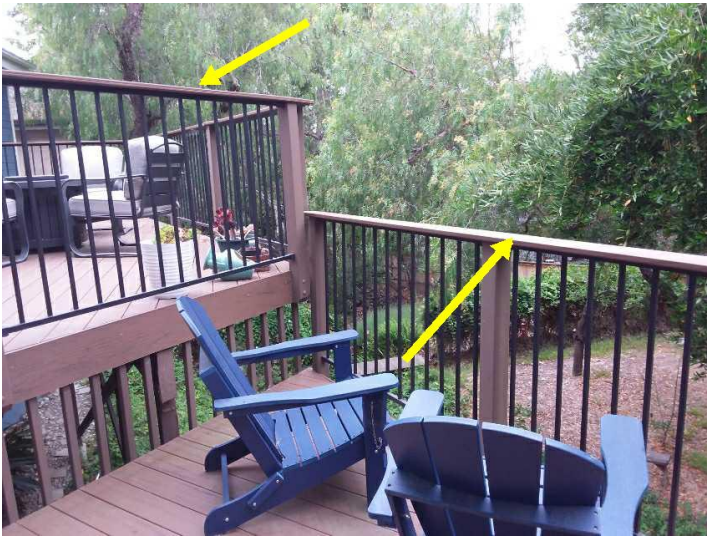
The rear guardrail, or guardrails, is an adequate height and in acceptable condition. However, standards for guardrails are not uniform. Nonetheless, common safety standards require them to be a minimum of 42 inches high when the standing surface is 30 inches or more above grade.

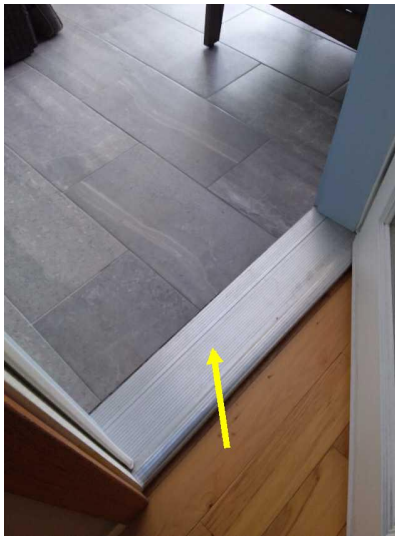
15.6. The door threshold has cosmetic damage that you should view for yourself.

The door threshold has cosmetic damage that you should view for yourself.

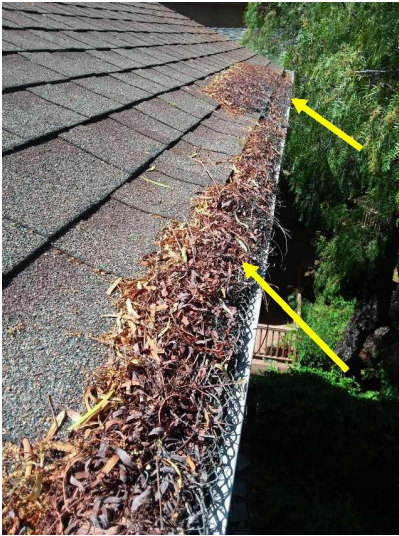
Some of the gutters need to be cleaned to drain properly.

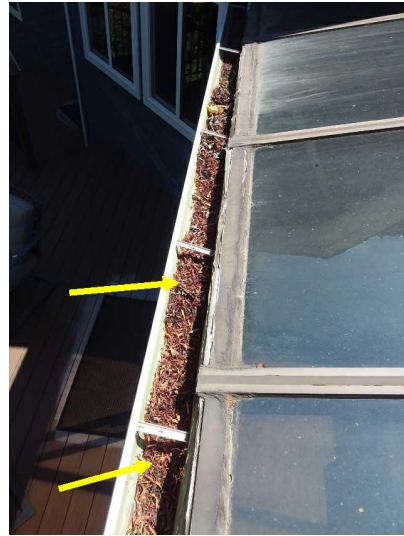
Some of the gutters need to be cleaned to drain properly.

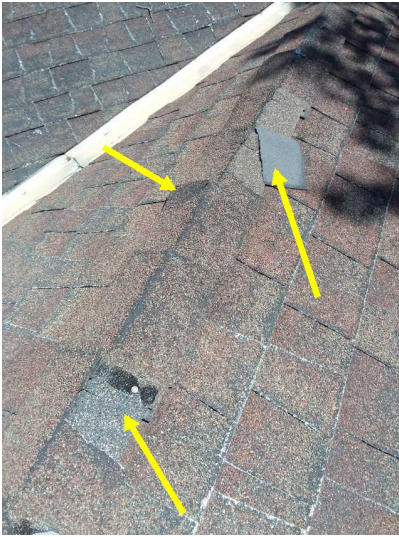
| Page 26 Item: 2 | Composition Shingle Observations | 2.7. The roof is approaching the end of its serviceable life, and should be evaluated by a licensed roofing contractor, because it could leak and the cost of replacing it could affect you evaluation of the property.<br><br>2.8. The roof has one or more damaged or missing shingles that should be repaired by a licensed roofing contractor. |

The roof has one or more damaged or missing shingles that should be repaired by a licensed roofing contractor.

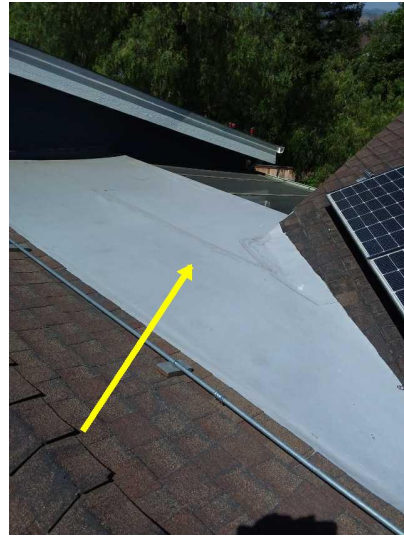
The roof includes a flat-roofed section, and flat roofs can be problematic if they are not kept clean. Water ponds on most of them, particularly along the leading edges, and will only be dispersed by evaporation. Therefore they must be kept clean and inspected regularly. This is important because our service does not include any guarantee against leaks.

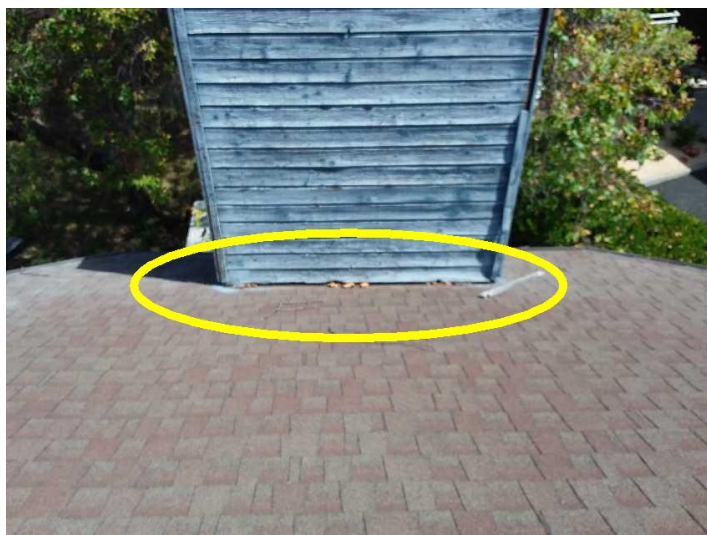
1.13. The chimney is wider than thirty inches and does not have a cricket, or raised metal component, to divert water around it, which is typically mandated, and therefore this area will need to be monitored and kept clean.

The chimney is wider than thirty inches and does not have a cricket, or raised metal component, to divert water around it, which is typically mandated, and therefore this area will need to be monitored and kept clean.

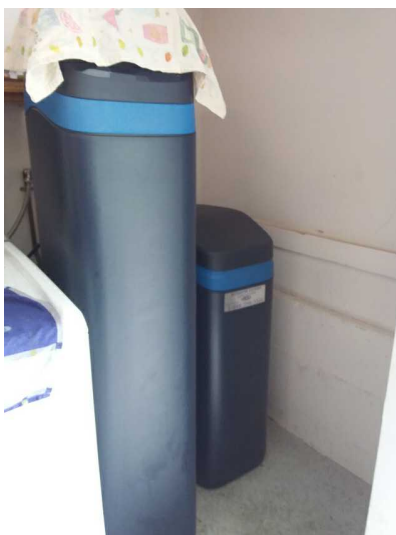
1.1. A water softener is present that we do not have the expertise to evaluate except for visible leaks. We recommend you ask the sellers if the unit was professionally installed and its service history.

A water softener is present that we do not have the expertise to evaluate except for visible leaks. We recommend you ask the sellers if the unit was professionally installed and its service history.

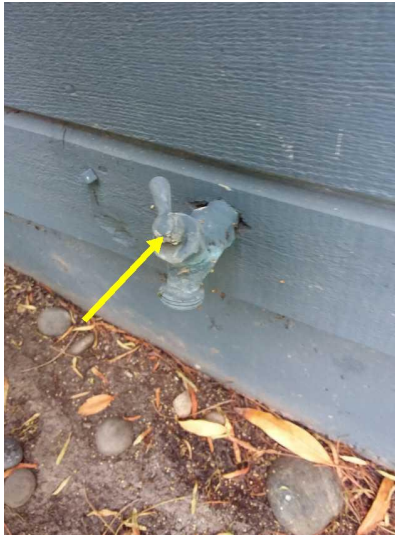
4.3. A hose bib at the rear has a missing or broken handle, which should be replaced. However, we may not have located and tested every hose bib on the property.

A hose bib at the rear has a missing or broken handle, which should be replaced. However, we may not have located and tested every hose bib on the property.

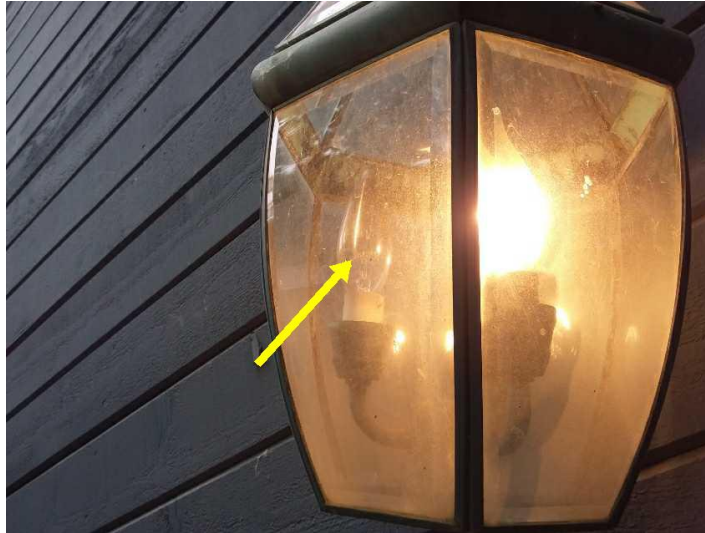
1.2. A wall light did not respond and should be serviced.

A wall light did not respond and should be serviced.

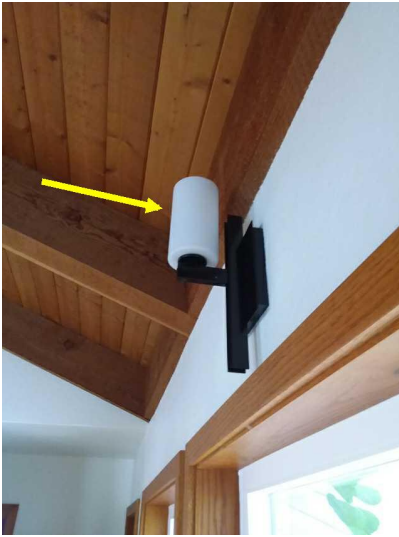
A ceiling light does not respond, and should be serviced.

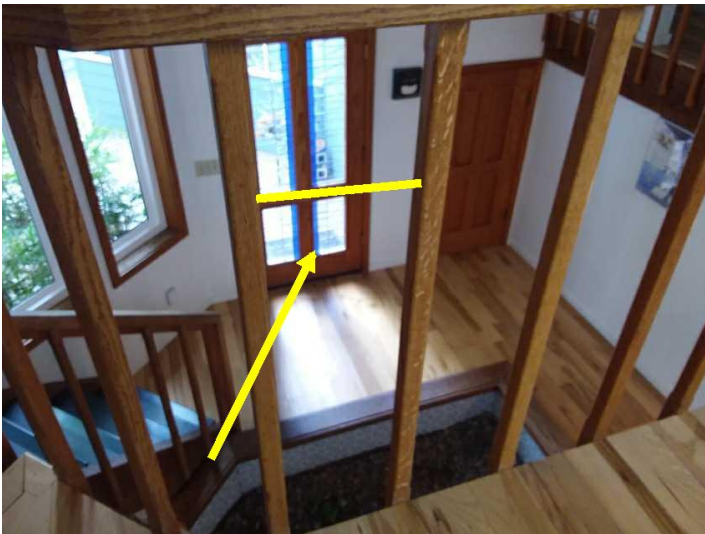
The balusters in the stair or guardrails are more than four-inches apart and are not child safe. Therefore, you may wish to add a protective barrier.

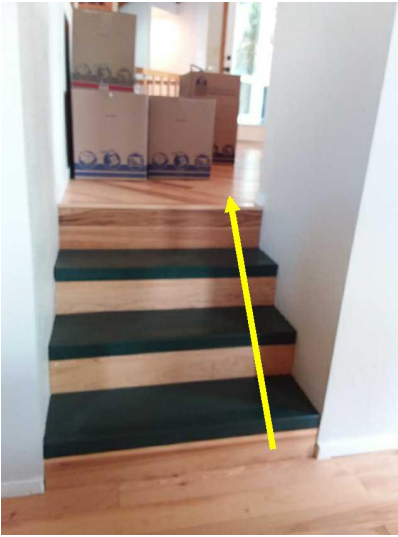
9.5. There is no handrail within the living room stairwell which is required by current standards and should be installed.

There is no handrail within the living room stairwell which is required by current standards and should be installed.

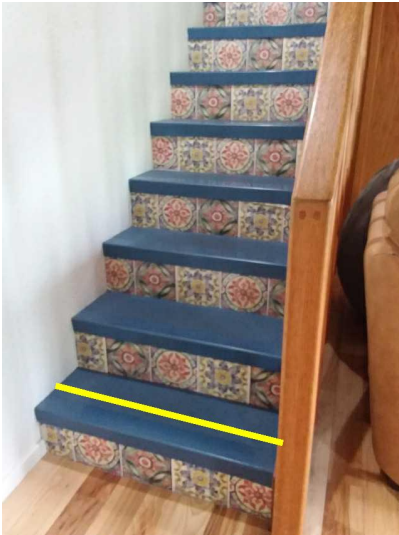
The width of the stairway is less than 36 inches, which could indicate that it was probably installed without permit.

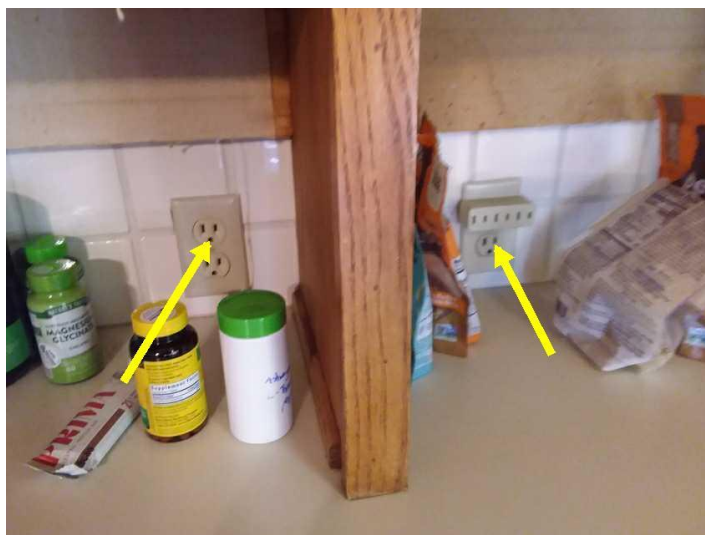
4.2. Some of the outlets at the kitchen counter top are not GFCI protected as required by today standards.

Some of the outlets at the kitchen counter top are not GFCI protected as required by today standards.

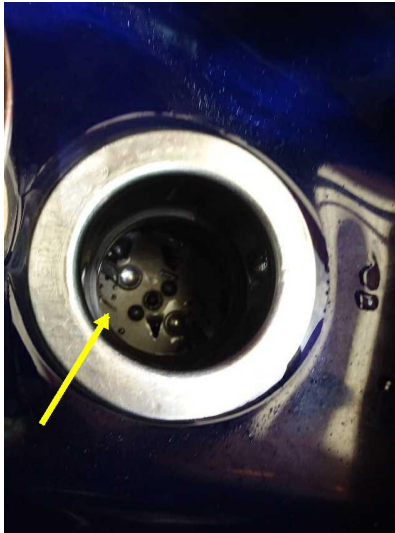
- 6.1. The garbage disposal is functional.
- 6.2. The garbage disposals rubber curtain is deteriorated or missing, and is needed to prevent items from entering, and should be replaced.

The garbage disposals rubber curtain is deteriorated or missing, and is needed to prevent items from entering, and should be replaced.

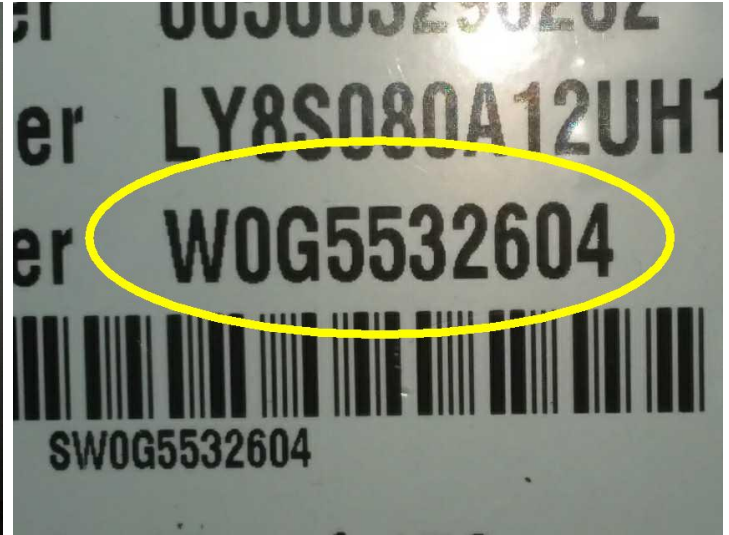
Serial number W0G5532604 - manufactured 2005

| Page 55 Item: 1 | Forced Air Furnace | 1.16. The furnace is functional. However, it is beyond the commonly accepted design life of twenty years, and will need to be monitored more closely for evidence of metal fatigue. We recommend that you have it serviced and evaluated by an HVAC contractor prior to the close of the inspection period. |

- 1.16. The furnace is functional. However, it is beyond the commonly accepted design life of twenty years, and will need to be monitored more closely for evidence of metal fatigue. We recommend that you have it serviced and evaluated by an HVAC contractor prior to the close of the inspection period.

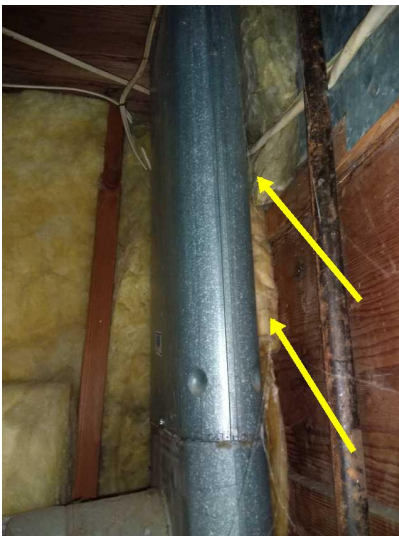
Insulation is in contact with the vent pipe and should be removed to a minimum of three inches away.

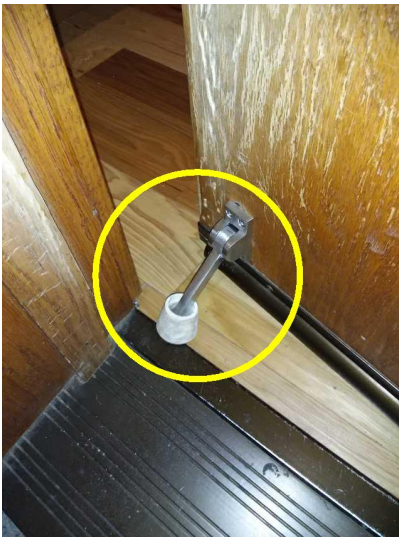
1.23. The fire rating of the house entry door has been nullified by the addition of a foot operated door stop.

The fire rating of the house entry door has been nullified by the addition of a foot operated door stop.

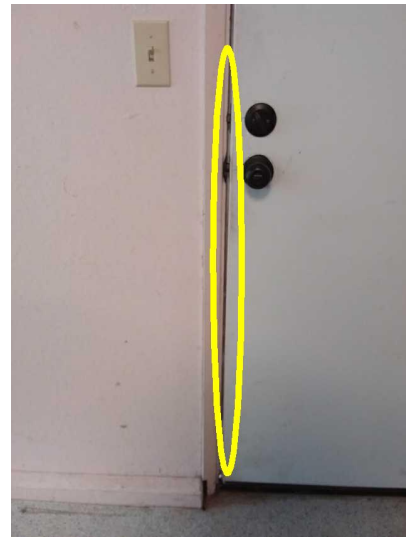
The garage side door is functional but not weather sealed.
